ARCHAEOLOGICAL TEST EXCAVATIONS AT MISSION
SAN FRANCISCO DE LA ESPADA

Anne A. Fox and Thomas R. Hester

Center for Archaeological Research
The University of Texas at San Antonio
Archaeological Survey Report, No. 22

1976

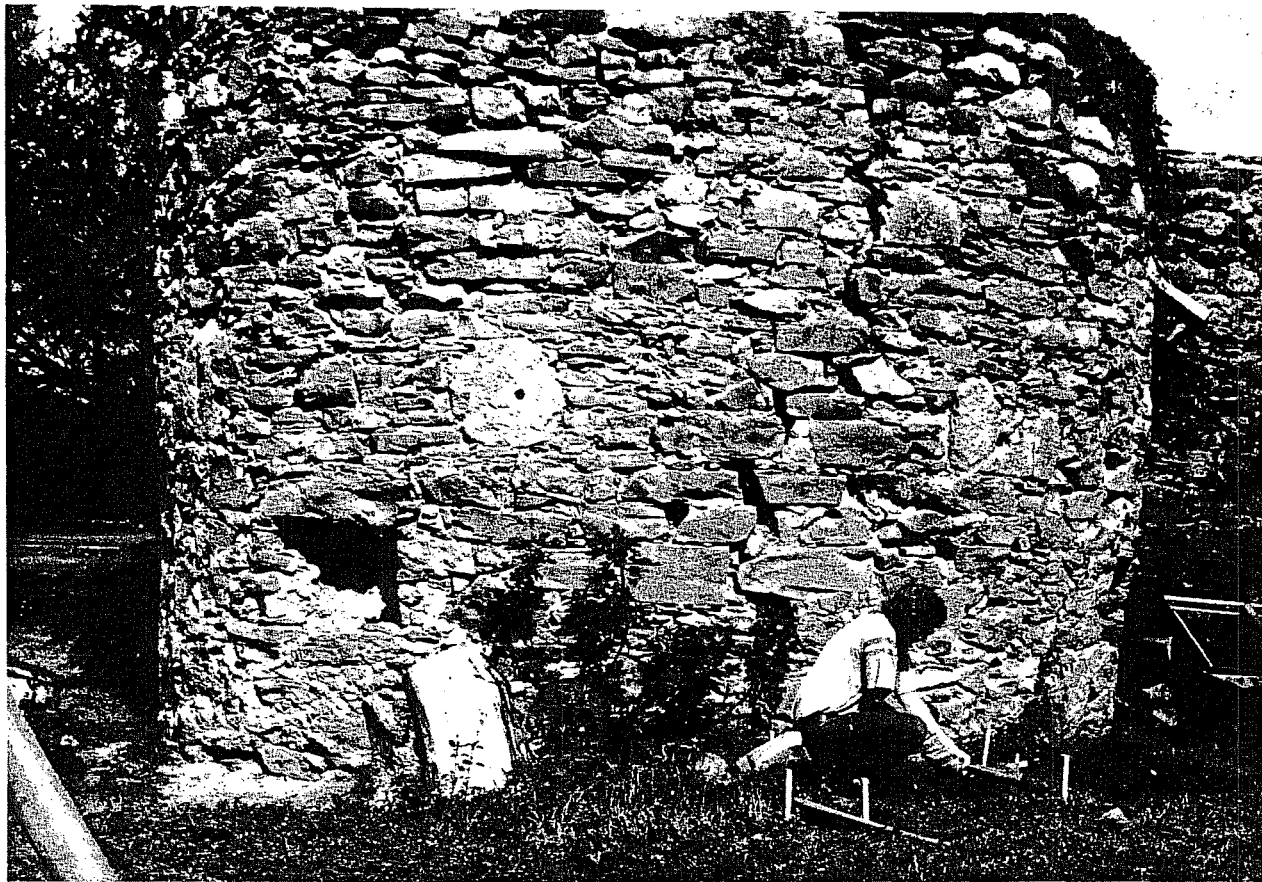
In recent times a large crack has formed in the east side of the tower and the surrounding wall bulges noticeably outward. The purpose of our brief investigation was to determine, if possible, the method of construction of the wall footings in order to aid in planning by architect Caroline Peterson (of Ford, Powell & Carson, Architects and Planners) for the stabilization and repair of the tower.

Three one-meter square test pits were laid out adjacent to the walls of the tower (Fig. 2). Test pit A was located directly under the crack in the tower wall, in order to determine how far the weakness extended and whether there could be any subsurface factors involved in the deterioration. Test pit B was located on the west side of the tower at the intersection of the tower wall with that of the mission in order to examine the building sequence, since Smith indicated that this portion of the original wall was still standing in 1934 (Smith 1934: Sheet 8). Test pit C was located opposite the doorway on the inside of the tower, approximately half way between the other two test pits. A permanent datum from which all depth measurements could be compared was established on the bottom of the southernmost gun port in the tower wall. A temporary datum for each pit was set at its highest corner. All comparative elevations were then determined by alidade.

(upper) View of tower from east, showing crack in wall and location of Test Pit A.

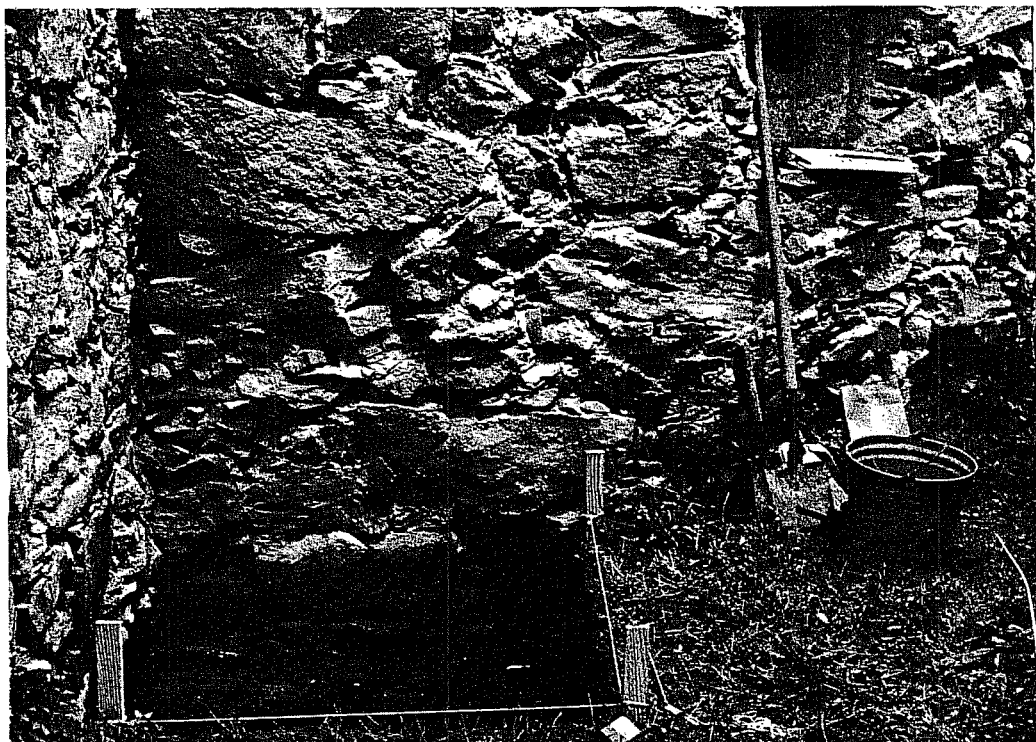
(lower) Test Pit B excavated to 40 cm, showing the junction of the tower wall with the mission building and the top of the wall footing.

Test pit B (Figs. 2,3,4,6) was excavated in the same manner as A. The sequence of soil and artifacts was also similar, though the soil change was difficult to observe due to the moisture in this area caused by a nearby roof drain. It was observed that the top of the footing for the mission wall began 10 cm deeper than that of the tower, and that it extended to the same depth. A close examination of the point where the tower wall joins that of the mission reveals that they were not tied together and may have been built independently of each other. The entrance into the interior of the tower is through an opening which appears to have been formed by removing the corner of the original building (see Fig. 2). However, the workmanship of the two are quite similar and the footings are similar, though not identical. It is interesting to speculate that the difference in level of the top of the tower wall footing might indicate raising of the surrounding ground level due to accretion through time, and that the tower might have been built considerably later than the wall. Archaeology has revealed a surprising consistency in the depth of overburden which has accumulated through time upon the 18th century living surfaces at all the San Antonio missions (see Greer 1967: Figs. 3 and 4; Schuetz 1968:238; Fox 1970:

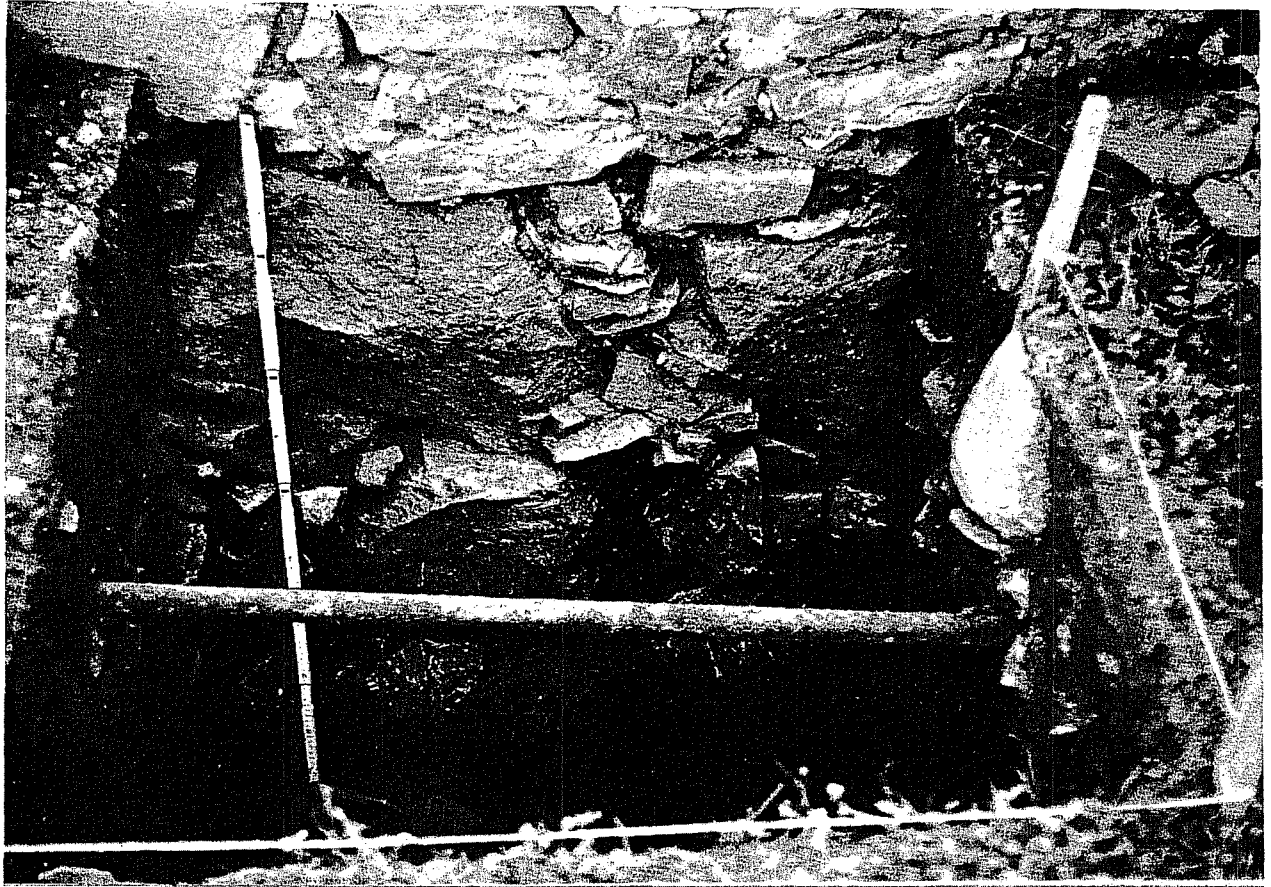
tower wall. No sign of a pipe trench was visible in the walls or floor of the excavation. At 45 cm, beneath a level of slightly more concentrated chips of stone, the soil changed gradually to a dark brown sterile clay. Also at this point, the cut stone and mortar wall of the tower changed to rubble laid in a more casual manner, with occasional flat stones laid vertically against the face of the footing. No wall trench was present, the dark brown clay intruding into all cracks and crevices of the footing with no mortar discernible. The footing continued to a depth of 95 cm.

(upper) West profile of Test Pit A, showing wall and footing construction.

1. The tower walls were constructed of roughly shaped local stone, set in a sand and lime mortar.
2. The wall footing consists of approximately 50 cm of rubble set in soil, packed into a trench the same thickness as the wall (66 cm).

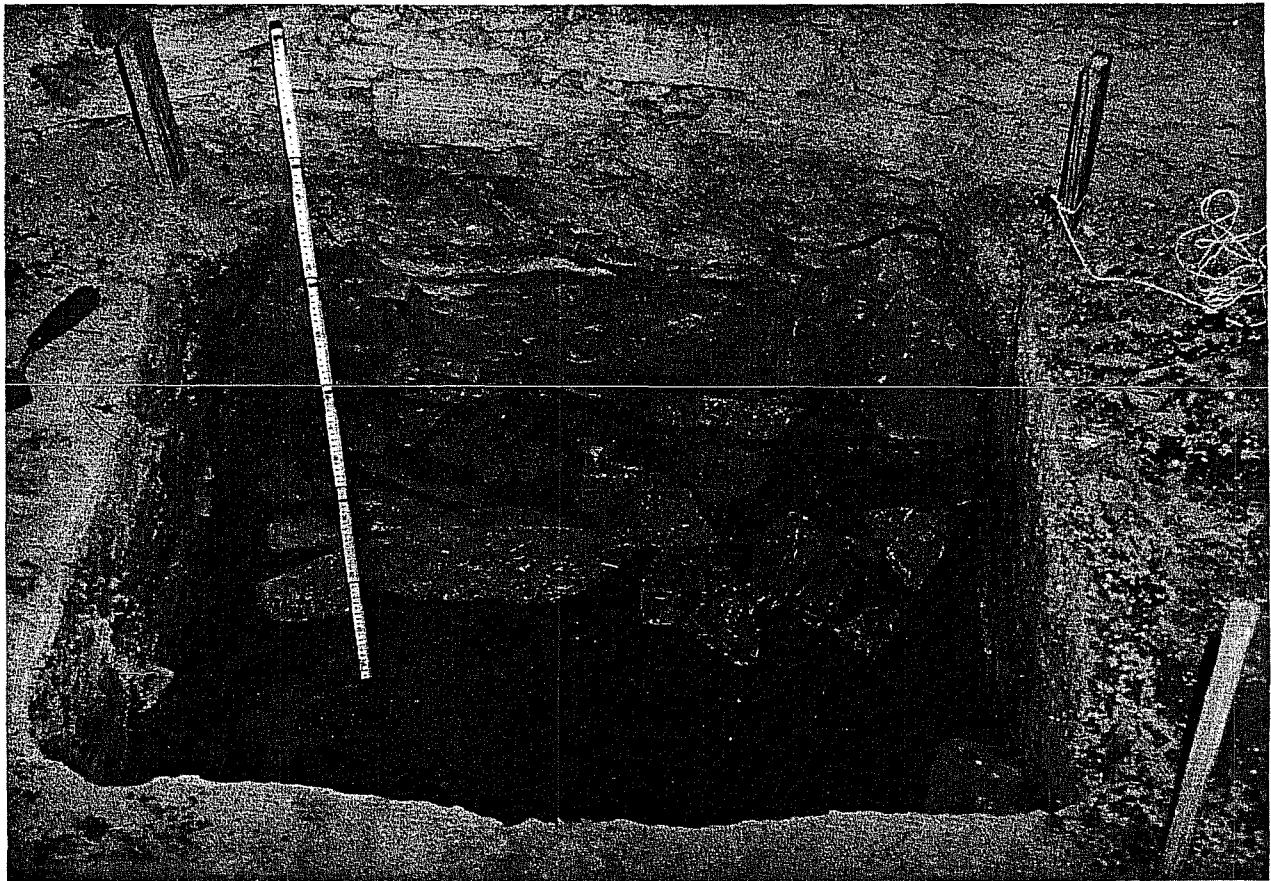
(lower) South profile of Test Pit C excavated to 48 cm, showing contrast between wall and footing construction.

Test pit C (Figs. 3,7), inside the tower, was excavated to 5 cm with trowels and the fine, dry soil screened for maximum artifact recovery. The artifacts in this level represented predominantly late 19th to early 20th century articles, with some more recent bottle fragments and plastic objects. From the 5 cm level to a depth of 45 cm the mottled brown and grey soil was sterile, except for fragments of wall stone. At 45 cm what appeared to be a solid layer of stone fragments was encountered. This was found to be only a few cm thick and directly beneath this began the same dark brown, sterile clay which had been encountered on the outside of the wall. At this same point began the wall footing, continuing to a depth of 85 cm.

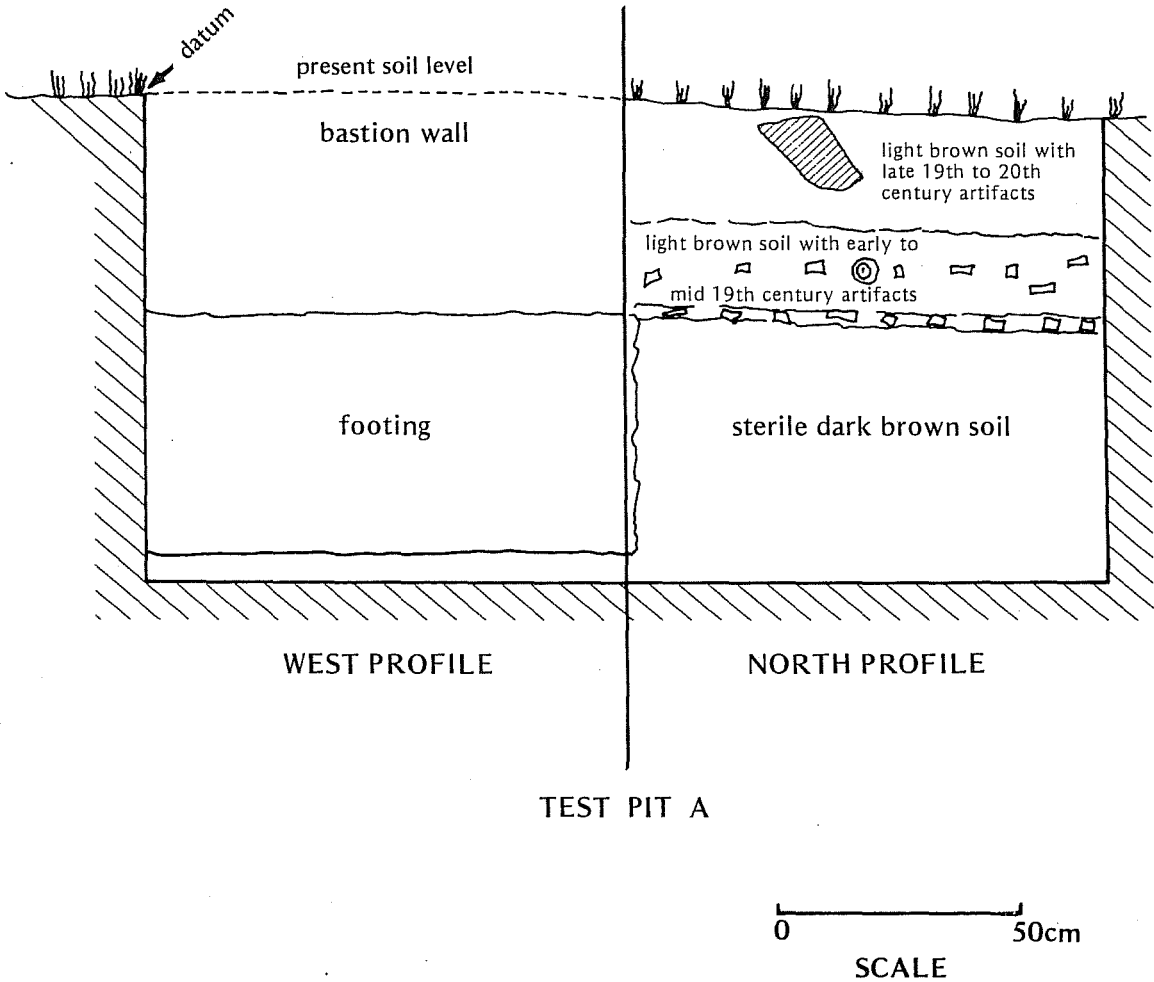
Figure 5. *San Francisco de la Espada*. Profile of Test Pit A.

Test pit A (Figs. 2,3,5) was excavated with trowel and shovel in 10 cm levels. The first 25 cm consisted of light brown soil which contained late 19th and 20th century artifacts. From 25 to 45 cm, earlier 19th century artifacts and small fragments of wall stone were recovered. At 35 cm, an iron pipe (three inches in diameter) was discovered, oriented north and south approximately 50 cm from the
