ARCHAEOLOGICAL INVESTIGATIONS OF PORTIONS OF THE
SAN PEDRO AND ALAZAN ACEQUIAS
IN SAN ANTONIO, TEXAS

Anne A. Fox

Center for Archaeological Research
The University of Texas at San Antonio
Archaeological Survey Report, No. 49

1978

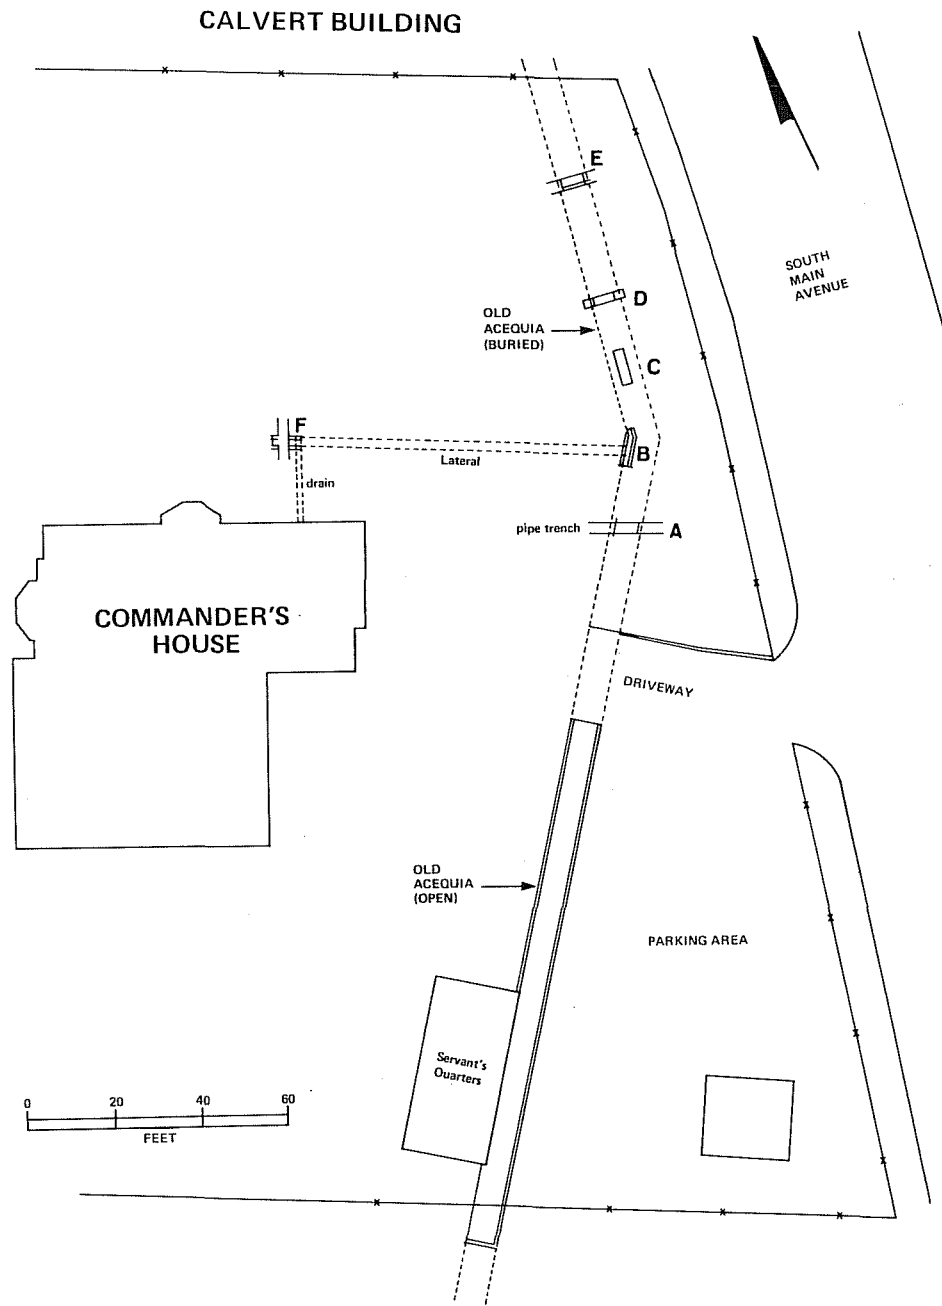
Figure 2. San Pedro Acequia on Grounds of Old Arsenal. Areas of excavations (Areas A-F) are shown.

The first area examined (Fig. 2, Area A) was a section of the acequia which had been exposed in a plumbing trench. At this point the acequia measures 150 cm in width, with cut-stone walls 50 to 60 cm in thickness.

Encouraged by this bit of information, the crew then cleaned out the bottom of a backhoe test pit (Fig. 2, Area C) to determine the depth and construction of the bottom of the acequia. At this point, the floor of the acequia is 105 cm below the present top of the walls, which have been capped by a thin layer of cement. Unfortunately, there is no way to determine the original height of

Continuing along the acequia, an area to the north (Fig. 2, Area D) was cleared sufficiently to check the wall lines and to confirm their angle. Area E was cleared off with the same intent, but it soon became apparent that a number of things were different in this excavation (Figs. 5 and 6). A cross wall appeared which apparently was built to enclose the portion of the ditch to the south, as it is covered on its south side with the same layer of cement which lines the ditch further south (Fig. 6,a). Clearing to the north of this wall revealed another stone-lined lateral gate leading to the east. A significant part of the frame of the wooden gate was still in place, though quite fragile (Fig. 6,b). Although its construction was identical to that of the first gate, this one was a bit wider.

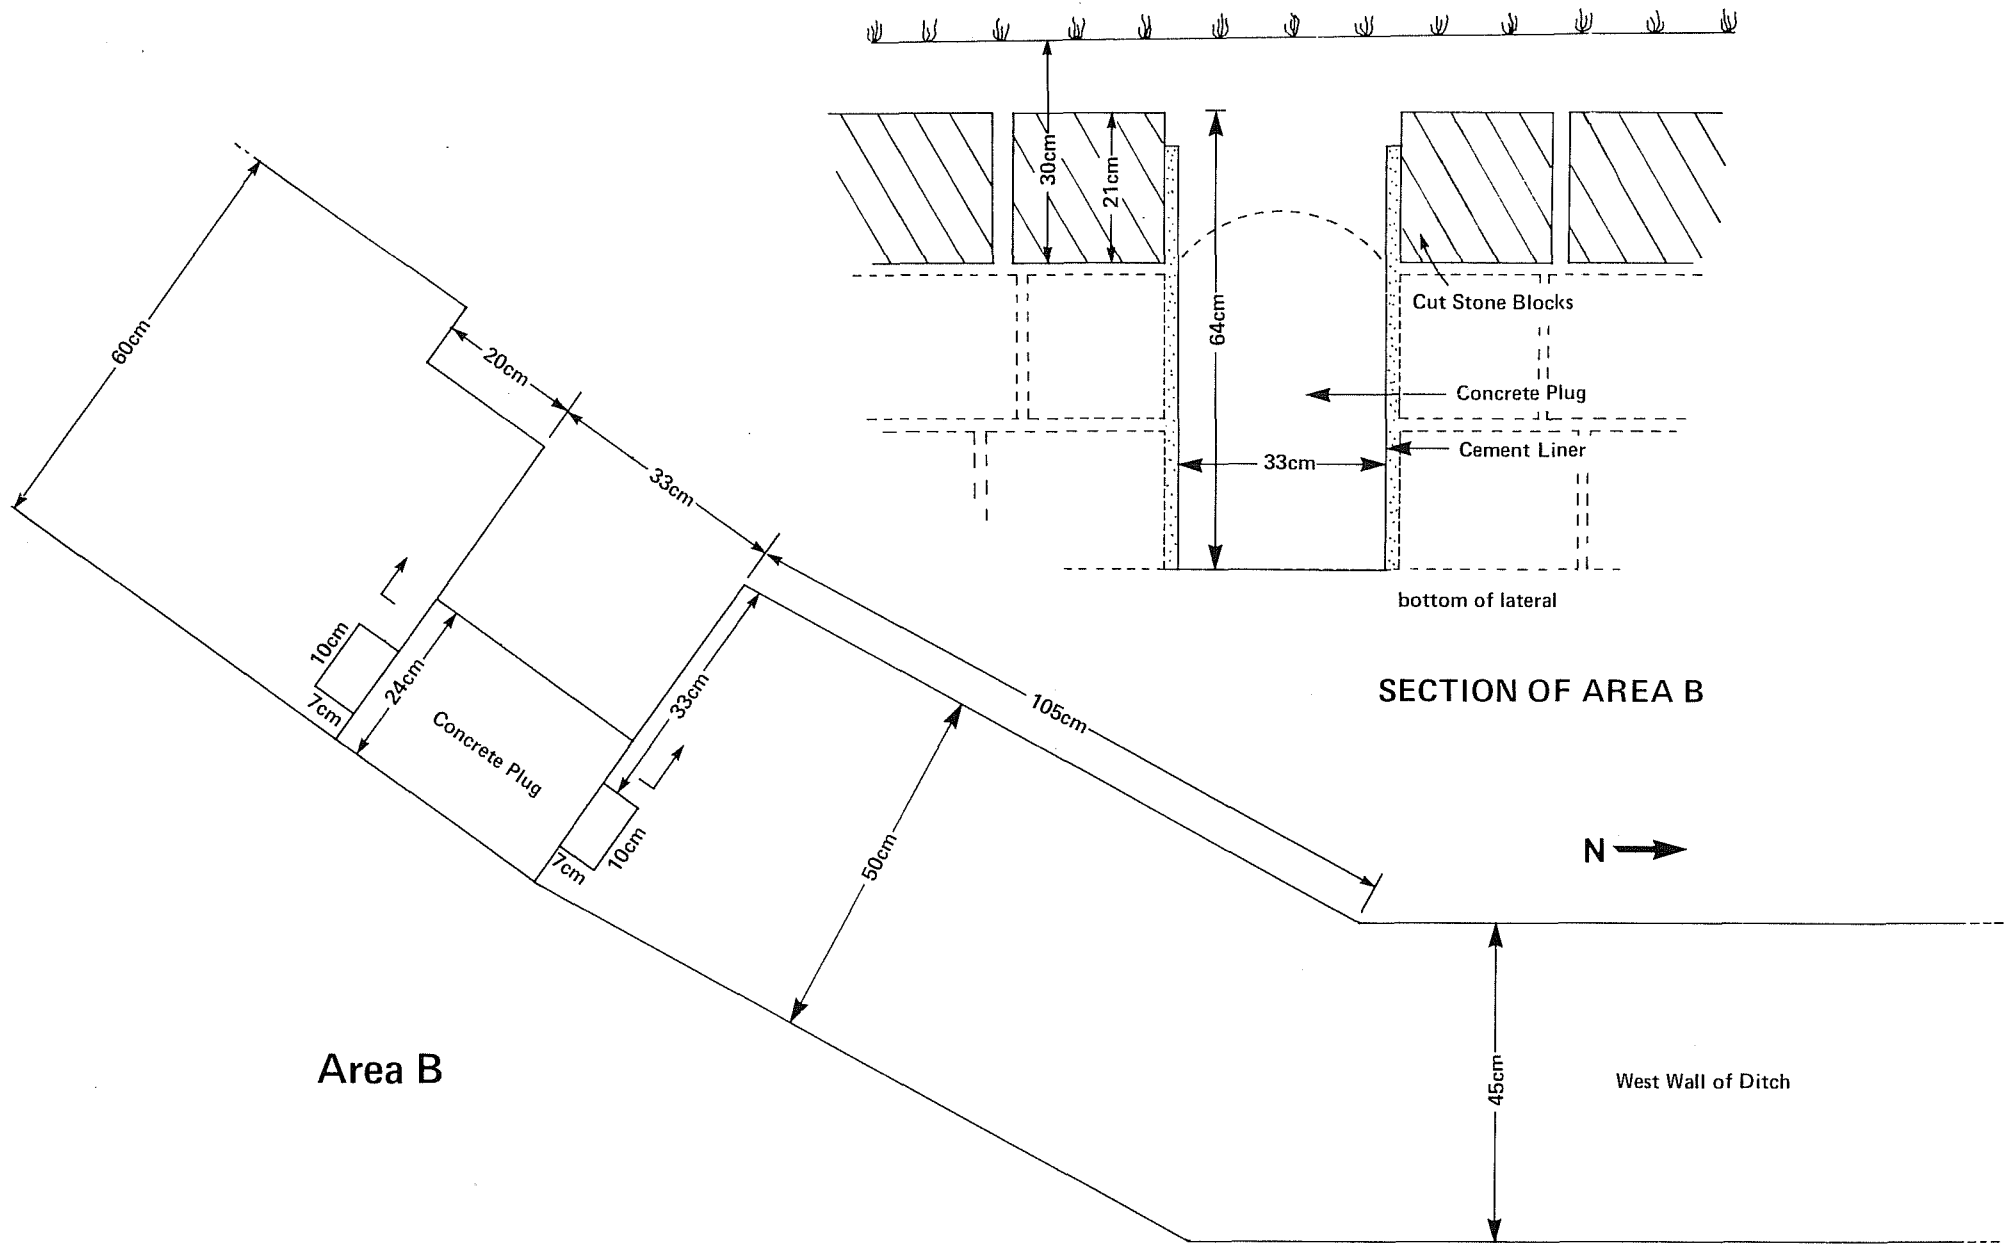
Figure 3. *San Pedro Acequia, Area B.* Plan and section of lateral gate.

Following the line of the ditch to the north, Area B was opened up to expose the west wall and to attempt to determine the construction at a point where there was a bend in the acequia (Fig. 4,a). An interesting bonus was the discovery of a gate which once opened into a stone-lined lateral ditch leading west from the acequia toward the area behind the Commander's House. Small fragments of the wooden water-gate posts still remained in the stones on either side of the opening (Figs. 3 and 4). A plug of concrete had at some time been poured into the opening of the gate in order to close it (Fig. 4,b).

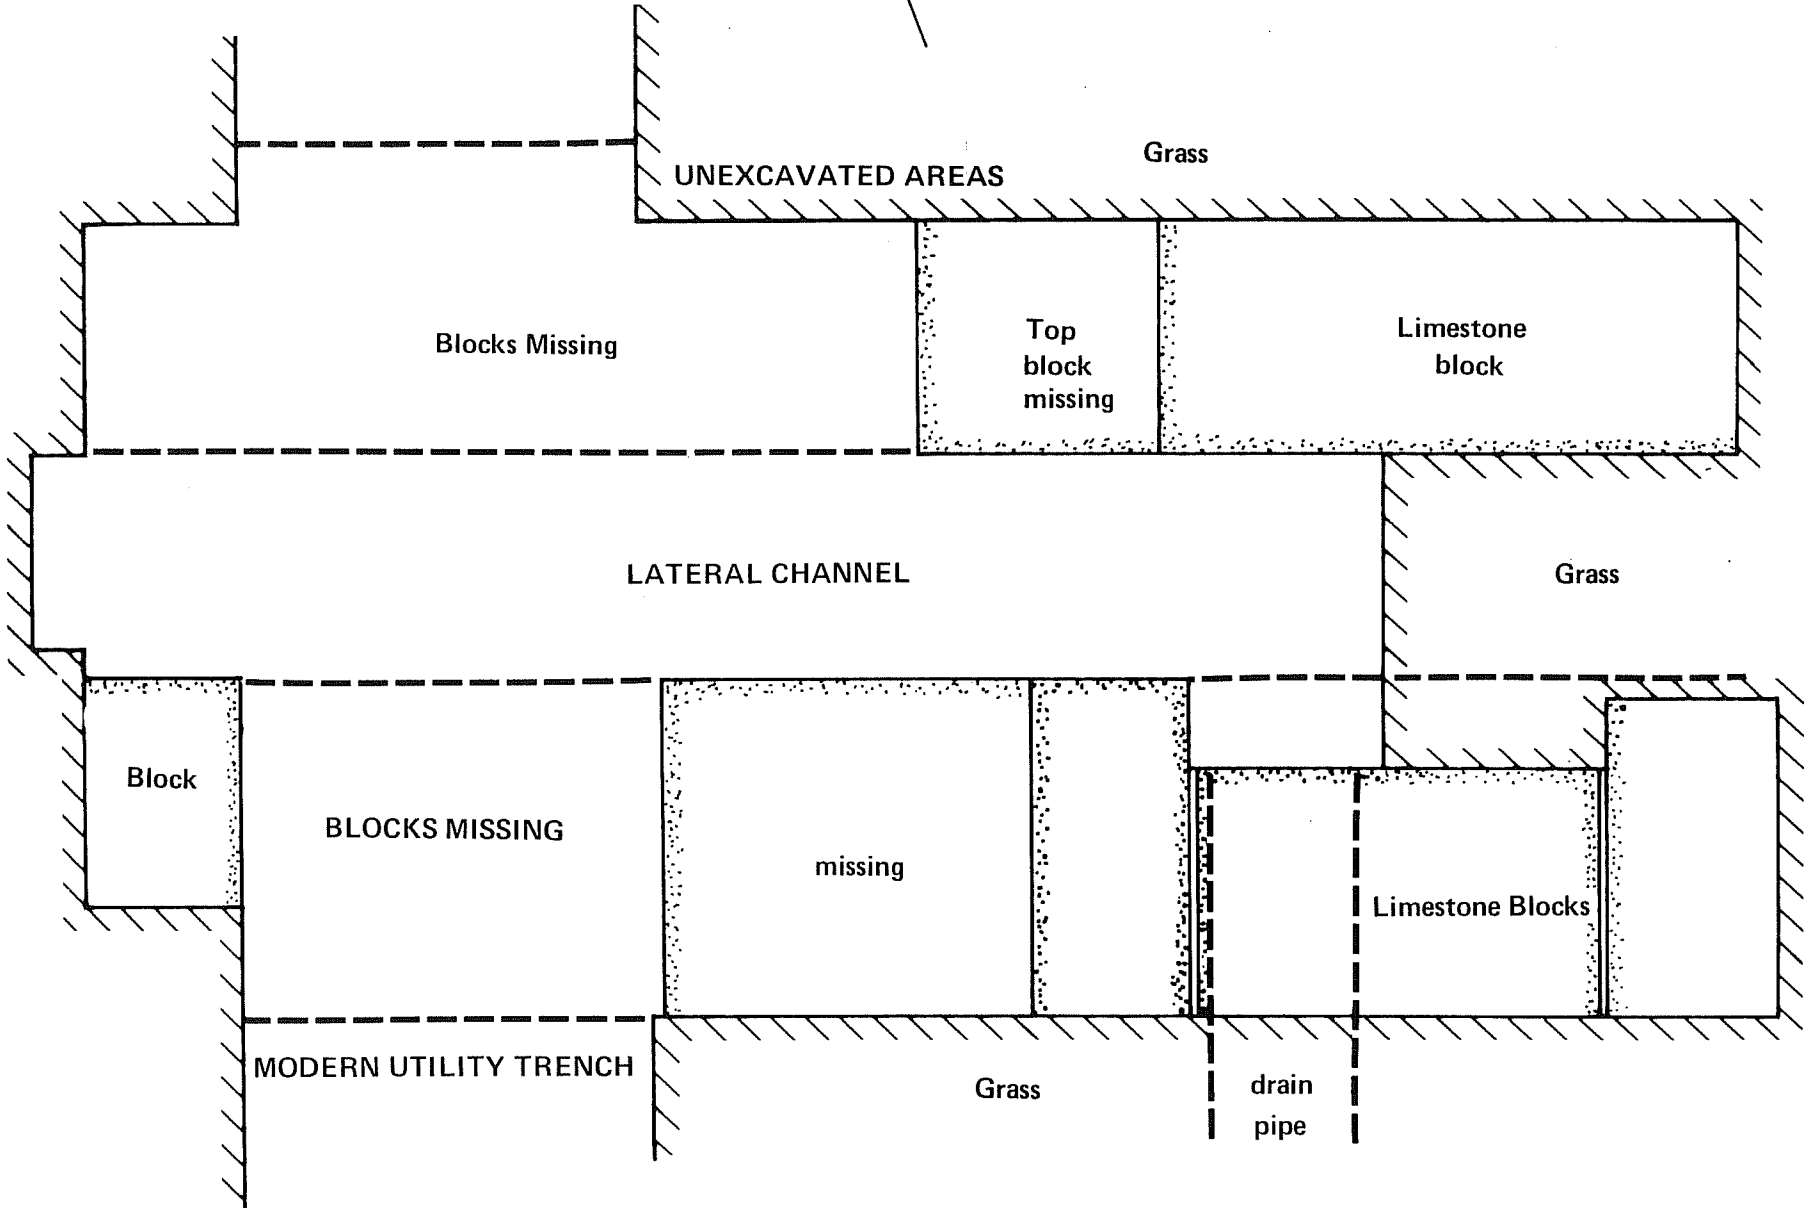
Also found in a pipe trench across this area was the continuation of the stone-lined lateral ditch of the acequia. Subsequent clearing and investigation uncovered a drain pipe leading from the house to an opening in the south wall of this lateral ditch (Figs. 2 and 7). Evidently the ditch was used at one time to dispose of rain water from the roof of the early section of the house, which was built in 1859 (Bert Whiteaker, personal communication).

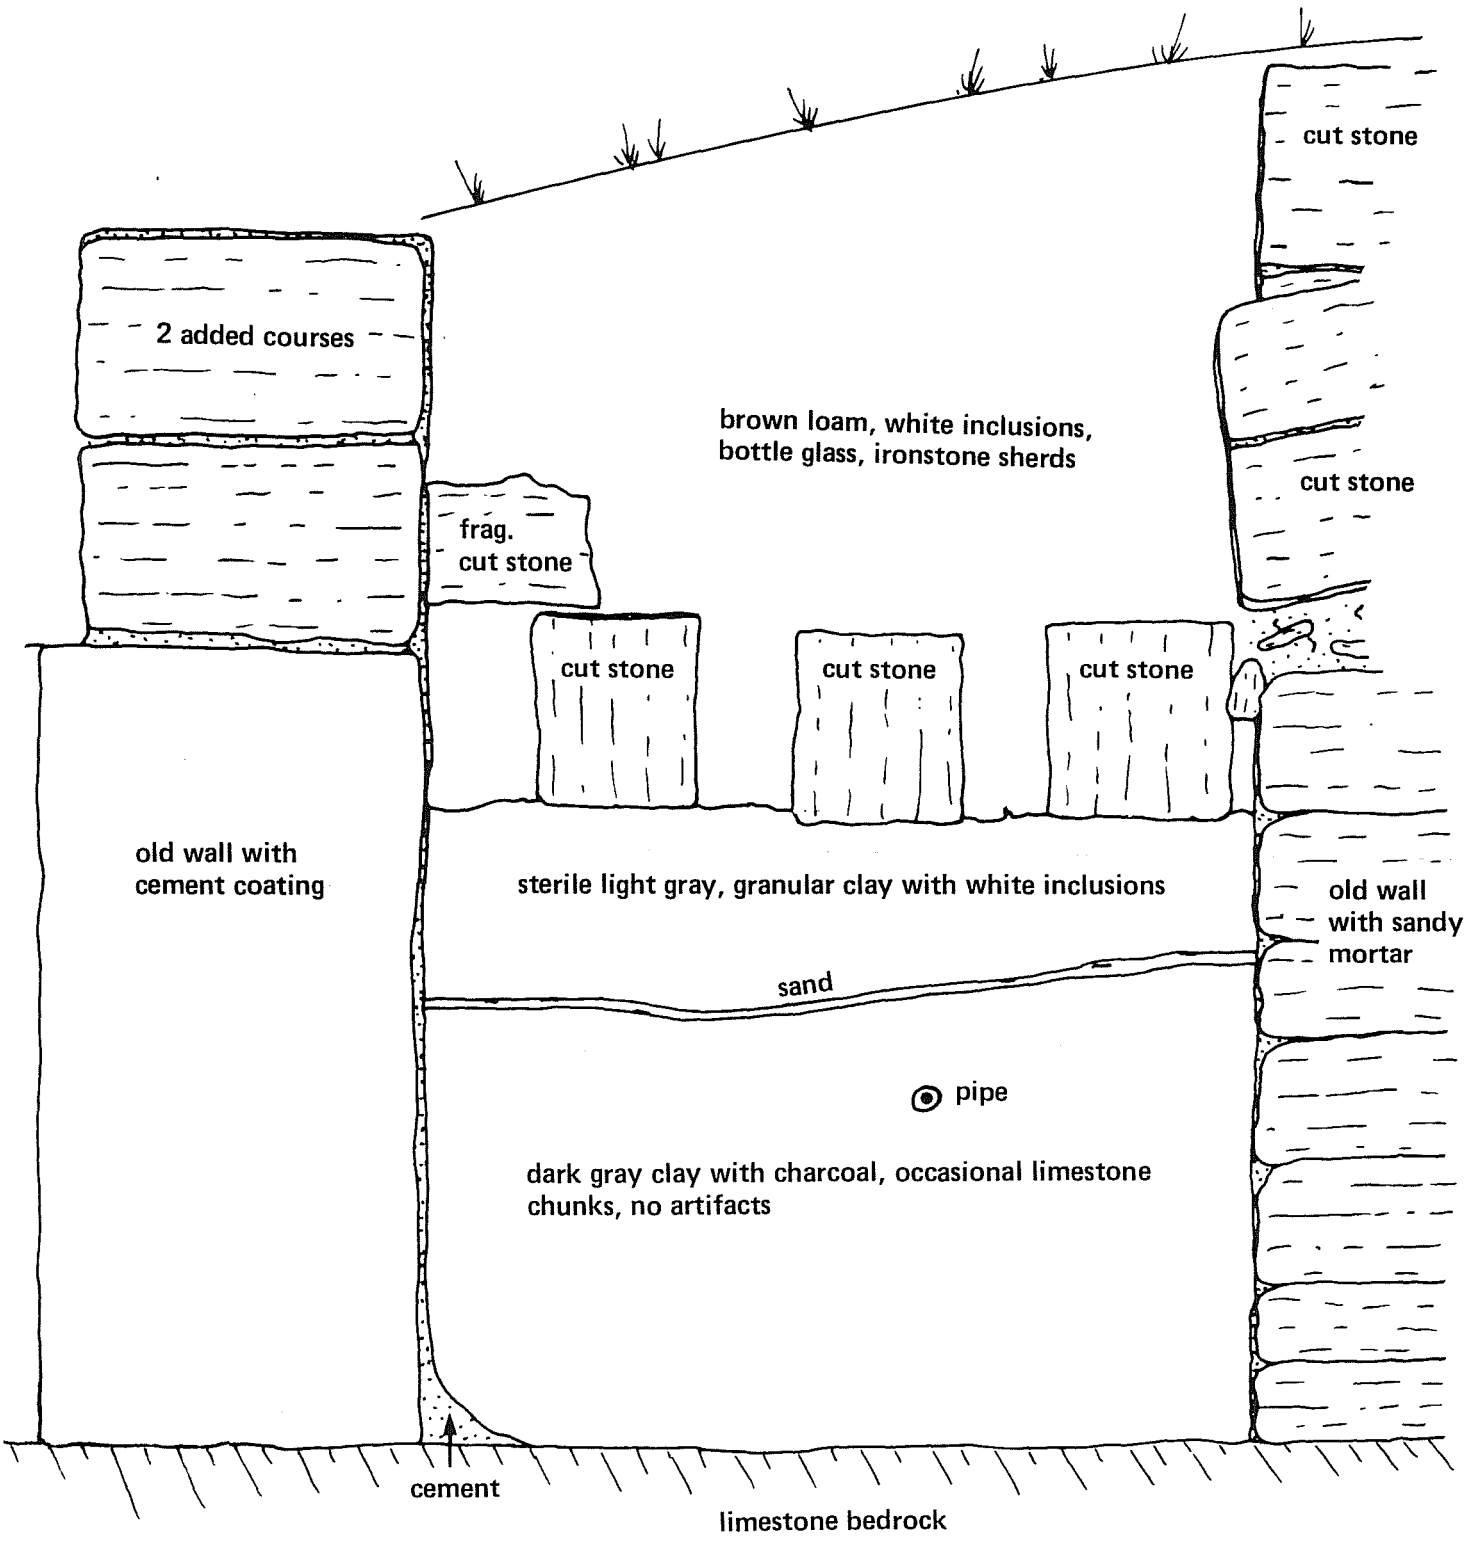
Figure 8. Alazan Acequia. Section looking west.

The stonework of the original acequia is similar to that found in other acequias in San Antonio (Schuetz 1970). An additional two courses of cut limestone have been added to the south wall and three to the north wall at some time after the original ditch was built. A coating of cement has been applied to the south wall over the later additions and lapping onto the floor, which is bedrock. The older portion of the walls is set in a crumbling, sandy lime mortar typical of late 19th century stone construction in south Texas.

The acequia was first filled to the 3/4 level with gray clay, which apparently sat open to the weather for some time. On top of this a thin layer of water-borne sand accumulated. Then a layer of gravelly soil was added, into which were set a series of cut limestone blocks which appear to have been salvaged from another structure. Above this a fill of brown loamy topsoil containing late 19th century artifacts was added, to entirely cover and eliminate the ditch. Research into the history of park improvements would probably reveal the dates for these changes.

Evidently Mr. Giraud attempted to copy the construction of the other earlier acequias in town when he planned the Alazan acequia. It would be interesting to know if the additional courses of stone on the south wall were added in an attempt to correct the problems mentioned by Corner. The addition of the cement lining on the south wall may also have been part of this work. Additional research in the records of City government agencies might tell more about these problems and the attempts to correct them.
