TESTING FOR THE LOCATION OF THE ALAMO ACEQUIA (41 BX 8) AT HEMISFAIR PLAZA, SAN ANTONIO, TEXAS

Anne A. Fox

Center for Archaeological Research The University of Texas at San Antonio Archaeological Survey Report, No. 142

Texas Antiquities Committee Permit No. 396 Thomas R. Hester, Principal Investigator

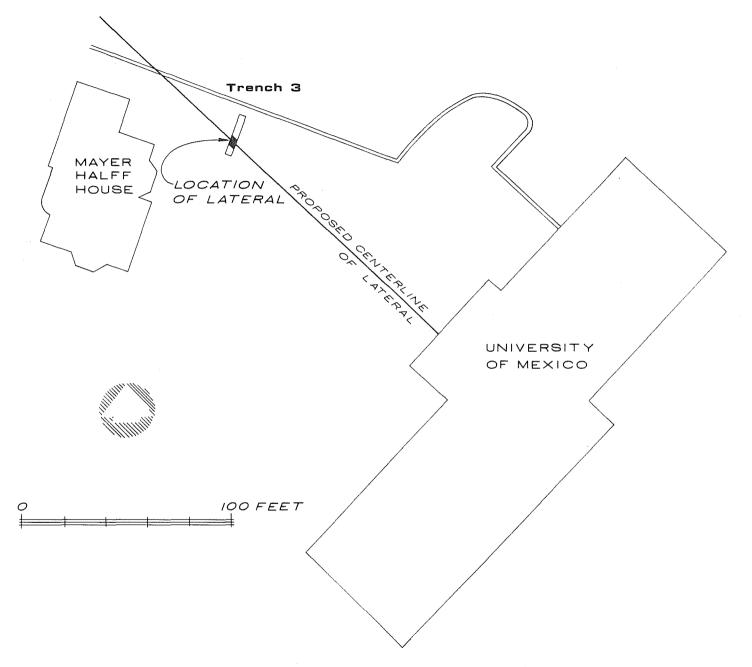
Figure 3. Map Showing Location of Trench 3.

Trench 3 was located across the route of a lateral ditch which once ran to the northwest off the main acequia, toward Alamo Street (Fig. 1). This lateral was seen on early maps primarily as a peculiar angle in the boundary line between properties in this area. While examining the early documents in preparation for the Phase I history, Cox discovered a reference to the lateral in an appraisal of the property of Jose de la Baume in 1841 (Alamo Abstract & Title Guaranty Company 1926). The backhoe trench was planned to cross the lateral and yet to be in an unpaved area so as to avoid trenching through pavement. The only such spot which was readily reached by the backhoe was a grassy area to the east of the Mayer Halff house and south of the Convention Center (Fig. 3). Examination of the walls of the trench revealed the location of the lateral ditch, toward the south end of the trench (Fig. 4). As had been expected, the ditch is not stone lined but merely a rather shallow trench dug into the soil. Apparently the top section was truncated by grading for HemisFair, eliminating the usual mound of earth

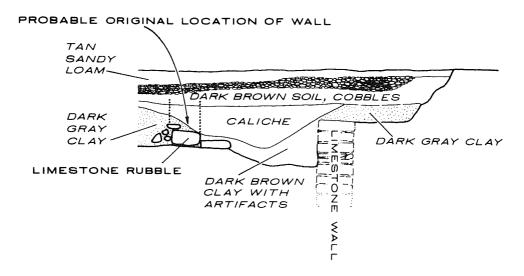
Figure 4. Profiles of Trenches 1, 2, and 3.

Trench 1 was laid out across the point where the maps showed the acequia should cross the intersection of South Alamo and Lavaca Streets (which became the general location of Durango Street when HemisFair was built). Near the west end of the trench an anomaly was recorded which consisted of an irregular intrusion of dark clay into the fairly regular caliche bedrock formation (Figs. 2 and 4). The only artifacts observed in the entire length of the trench were a few fragments of bottle glass and window pane glass and a sherd of white-banded yellow ware (see Appendix). Time did not allow further searching for the acequia in this area.

Trench 2 was a reexcavation and extension of the test units excavated in December. Starting at the west end of the original trench, where the acequia was purported to be located, we deepened the trench by several feet and found, as we had first postulated, that the area was totally undisturbed below the HemisFair construction level. Continuing the trench east beyond our second test unit, we began to find random cut limestone blocks at ca. 20 inches below the surface, and a deposit of packed, sterile caliche. Taking over from the backhoe, the crew excavated the caliche deposit and found it to be a lens of fill over the top and into the channel of the The combined evidence of the remaining limestone wall at the east end of the trench and the deposit of artifacts (see Appendix) to the west of this wall still appearing at five feet below the surface (Fig. 3), convinced us that we had finally found the Alamo Acequia. The west wall of the ditch appeared to be in bad condition, perhaps due to disturbance and/or stone robbing during HemisFair construction. Schuetz (1970:5) remarked that the top course of stone was missing from the section excavated in 1966, and the east wall in that area had been removed down to the bottom two courses in one It may be that the damage in the area we were examining had also been done previous to 1966. All of the intrusive fill above the original ground surface was apparently brought in either as part of the construction effort for the fair or in an attempt to fill in a low area in more recent times after some of the fair buildings had been dismantled.

on either side created by annual ditch cleaning. There is no way to be sure how much of the original ditch was also removed at the time of the grading, and therefore how deep it was originally. Water for irrigation of the lands to the west of the Alamo Acequia was allowed to flow into this ditch through a control gate for a certain number of hours each week on a regular schedule, depending upon the amount of land to be irrigated (Glick 1972:41-43). No artifacts were found in the ditch fill, which consisted of a loose accumulation of caliche, clay, and wood fragments, but numerous fragments of red and yellow brick and rusted metal and one sherd of white earthenware decorated with a contemporary transfer design (see Appendix) were found in the layer of soil above the graded surface level (Fig. 4).
