A RECONNAISSANCE OF  
A CHANNEL DAM SITE AND FLOOD AREA  
ON THE SAN SABA RIVER, MENARD COUNTY, TEXAS

Center for Archaeological Research  
The University of Texas at San Antonio®  
Archaeological Survey Report, No. 147

1985

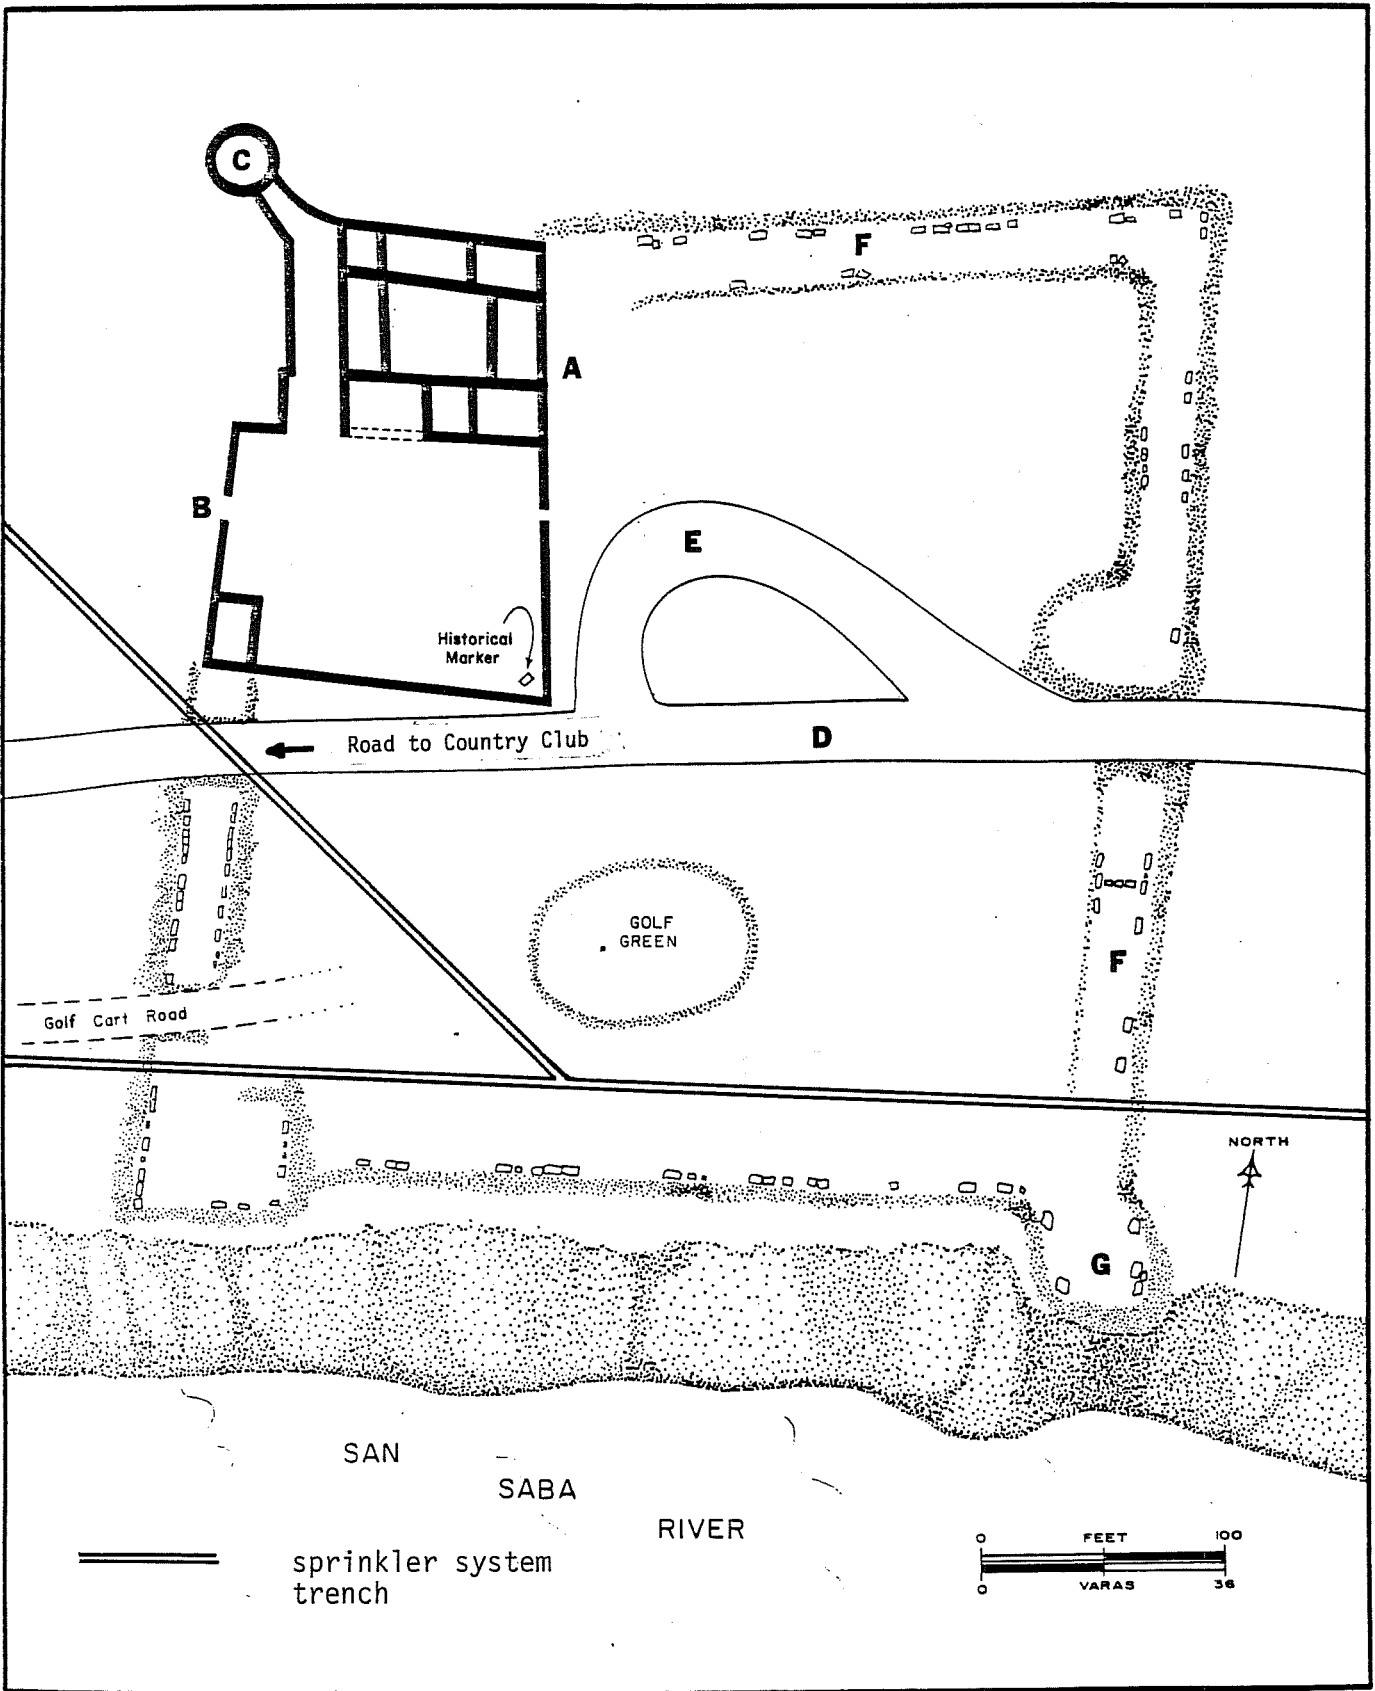
Figure 2. Plan Drawing of the Presidio San Sabá Indicating the Approximate Locations of Machine-Excavated Sprinkler System Trenches Examined by this Reconnaissance (map adapted from Ivey 1981:5). The entire area shown here, from the river bank north, was examined by the field team. A, walls reconstructed in ca. 1932 by the WPA; B, main gate as reconstructed; C, northwest bastion as reconstructed; D, road to the Menard Country Club; E, turnout for visitors to the Presidio; F, mounds of wall ruins; G, mound covering southeast bastion.

The golf course (owned by Menard County) is currently installing an underground sprinkler system to water all nine golf greens. The entire golf course, at present, has a near gridlike series of open trenches (60 cm wide x 50 cm deep) that contain one inch and three inch diameter PVA piping; each golf green has been encircled by a trench which contains a one-inch PVA pipe with four sprinkler heads. The raised linear features that denote the location of Presidio walls have been trenched through in three places.

All of the trenches at the Presidio were walked over, and a selective collection was made from a trench in the area of the southwest wall. This trench, which cut through the buried Presidio wall, revealed a well-defined, gray-ashen lens 30 cm below the present-day ground surface. The lens (20 cm thick x 1.2 m long) is located immediately outside the wall and extends away from the wall. Still visible in the ashen lens were bits of charcoal, small pieces of burned limestone, and several burned mussel shell fragments. Examination of the backdirt from the trench provided additional materials. In all, a selective collection was made in this area, consisting of 11 pieces of bone (four large rib bone sections and seven unidentifiable bone fragments--all well preserved and not burned), eight unburned mussel shell fragments (one with the umbo still attached), a rusty piece of iron, a modified chert cobble, and a large, unglazed, sandy paste pottery sherd. Investigation of the other two open trenches and associated backdirt failed to identify any additional cultural materials. A small sherd of Spanish Colonial period majolica and a tertiary chert flake were found on the surface near the Presidio's northeast corner.

We also noted that the machine excavations of sprinkler system trenches across the southern part of Presidio San Sabá have impacted the cultural resource, including the partial destruction of at least one midden feature. Since no subsurface study of this area of the Presidio has been undertaken in the past, it should be protected from further impact. Should any future disturbances be planned at Presidio San Sabá (a National Register Historic Site and a State Historic Landmark), this should be preceded by a carefully designed project of investigation and documentation to include controlled subsurface excavations.
