**ARCHAEOLOGICAL INVESTIGATION OF THE SAN JUAN DAM,
41 BX 266, BEXAR COUNTY, TEXAS**

**Center for Archaeological Research
The University of Texas at San Antonio
Archaeological Survey Report, No. 179**

1989

On April 18, 1988, an archaeological crew from the Center for Archaeological Research at The University of Texas at San Antonio conducted a testing program at the historic dam for Mission San Juan Capistrano, San Antonio, Texas. The results of the excavations and the corresponding archival research are reported. Conclusions are drawn as to the dam's location, formation, and function.

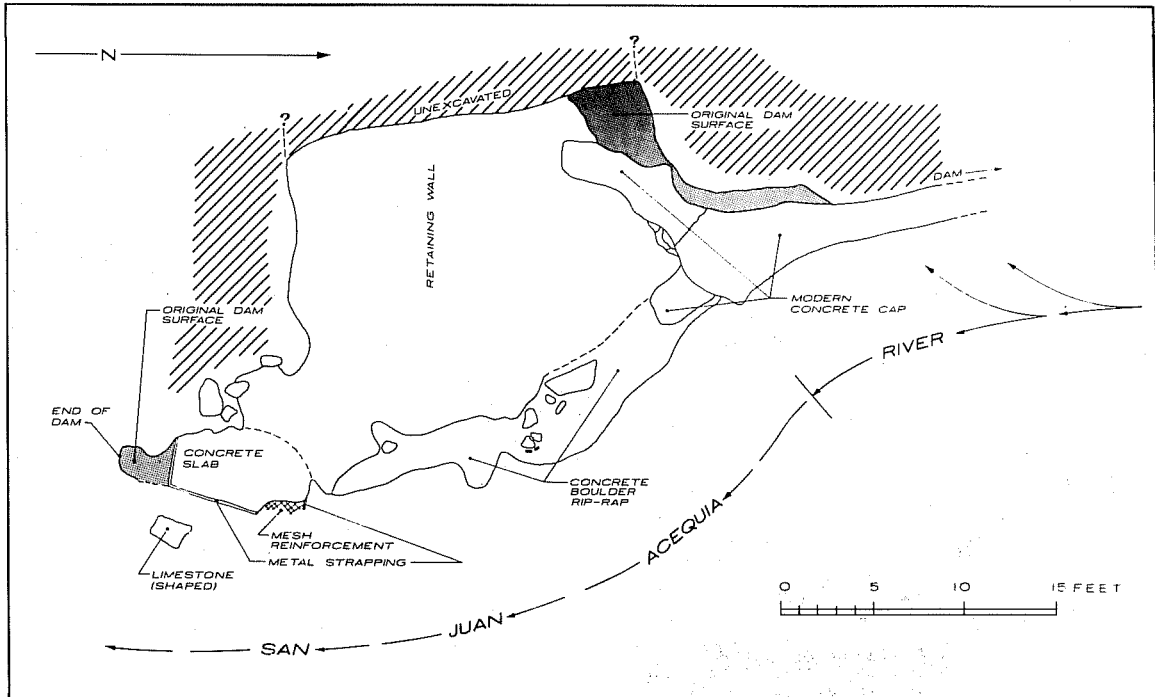
Figure 6. Plan of Trench 6.

Trench 6 was located approximately 20 m to the south of Trench 2 and exposed the southern end of the dam. This end of the dam varies a great deal more in its construction than the other areas previously exposed (Fig. 6). This section flared out to a much wider dimension than the rest of the dam. Partially exposed, it appeared that the end of the dam branched off in a westerly direction.

Modern support and reinforcement are obvious in this section of the dam. Along the eastern edge, a concrete boulder rip-rap is visible. Several of the concrete boulders still have imprints of the burlap bags in which they were formed. On the southern edge is a portion of a concrete slab with metal strapping and wire mesh reinforcement. The modern concrete cap that was noted in the first two trenches can be followed along the ground surface to the northern end of this area. All of the soil that overlies this end of the dam seems to resemble the fill associated with the rechannelization of the river.

The large formation partially exposed by Trench 6 appears to have been used as a retaining wall. This part of the structure was designed to make sure that all of the water coming over the dam was forced back into the river channel. It prevented the area between the acequia and the river channel from becoming a swamp. This also prevented the water from running around the south end and undercutting the dam, and kept the acequia and river from joining together below the dam.

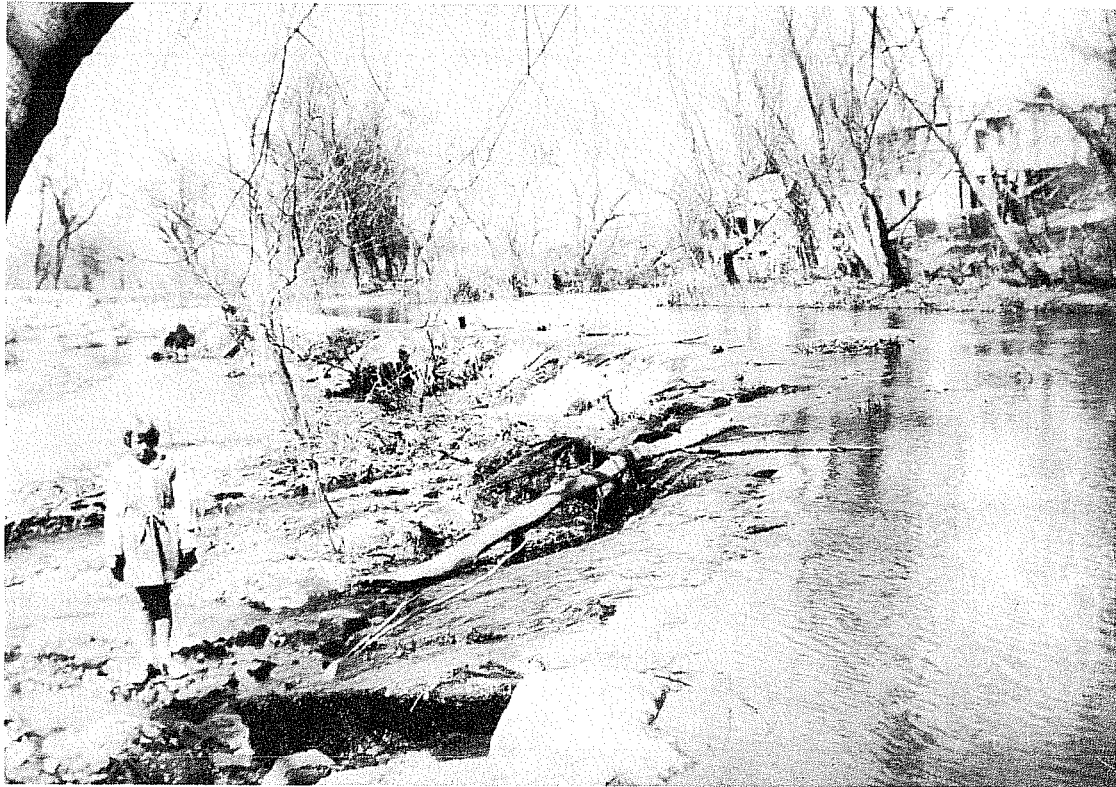
As it turns out, the area first thought to be part of the old river channel is actually the original route of the acequia. Heading southwest, from the dam structure, the river took a route to the south of the dam. The existing ditch to the southeast of the dam is actually the acequia. The dam structure was used to divert water from the San Antonio River into the acequia. Only when the water in the river was over the height of the dam was water put back into the river channel (Fig. 7,a). All of the water that was lower than the top of the dam was directed into the acequia (Fig. 7,b).

Figure 7. *Views of the San Juan Dam in 1940.* a, water flowing over the San Juan dam in 1940, looking north; b, looking south into the acequia from the same location, 1940. Photographs taken from the Schuchard collection at the Daughters of the Republic of Texas Research Library, The Alamo.
