# Excavations for the Upper Labor Dam Site, Brackenridge Park, San Antonio, Bexar County, Texas

Texas Antiquities Permit No. 1755

©copyright 1999 Center for Archaeological Research The University of Texas at San Antonio Archaeological Survey Report, No. 268 The following information is provided in accordance with the General Rules of Practice and Procedure, Chapter 41.11 (Investigative Reports), Texas Antiquities Committee:

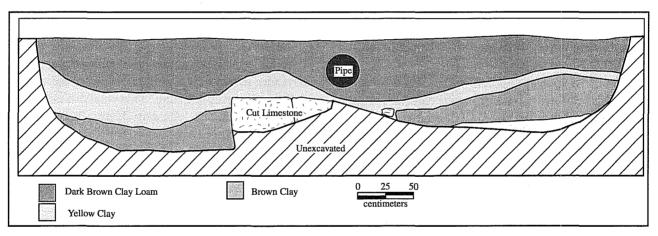
Figure 4. Profile of backhoe trench 3.

bank of the San Antonio River (see Figure 3). The trench revealed a sloping rubble-like stone surface on the south face with an upright cedar pole near the middle of the trench (Figure 4). This was topped by the water main encountered in BHT 2. North of the pipe a flat surface of ashlar-dressed limestone was present and formed the north upstream face of the dam. Below this stone was a stone of similar size but roughly dressed. Water began to seep into the trench from a pond adjacent to the site. Excavations on BHT 3 were stopped and cleaning of the profile undertaken.

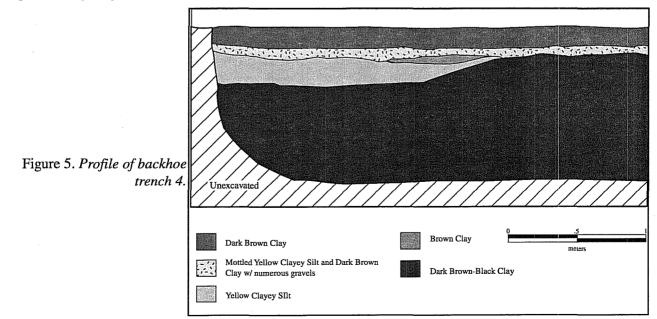
BHT 4 was excavated between BHT 2 and BHT 3, parallel to BHT 3. We found no trace of the dam in this trench, and the deposits consisted of alluvium (Figure 5). Based on the degree of weathering and the

preserved layering, the deposits in BHT 4 appeared to consist of relatively recent deposits.

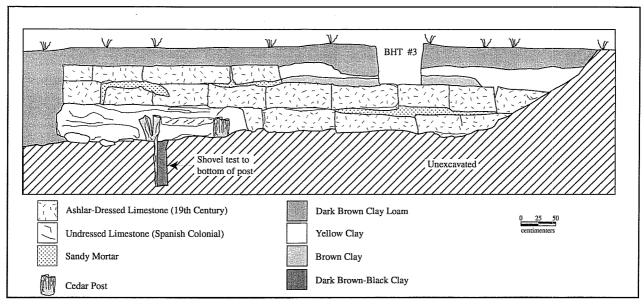
The backhoe was moved back to the north face of the dam and BHT 5 (Figure 3) was excavated toward the east. The end of the dam was exposed just short of BHT 4. BHT 5 was expanded to the west parallel to the exposed hewn stone. Approximately eight linear meters of the Upper Labor dam were exposed in BHT 5. The feature is about 1.5 m wide.

Investigations revealed two distinct episodes of construction (Figures 6 and 7). The lower section of the dam consisted of roughly hewn limestone blocks placed in a low amorphous linear pile . This original component is from the Spanish colonial period. Three vertical cedar posts were also found adjacent to these lower limestone blocks. Although the bottom layer was not entirely exposed, archival documents indicate that the dam ranged between 0.6–2.1 m in height.

On top of the Spanish Colonial component were neatly cut ashlar-dressed stones from the later-nineteenthcentury dam modification attributed to the city's German masons (Figures 6 and 7). The top of the wall was capped by about a foot of caliche. In addition to the two distinct construction methods, it was noted that the two dams were not set on the same axis.

Figure 6. Portion of Upper Labor dam exposed in DHT 5.

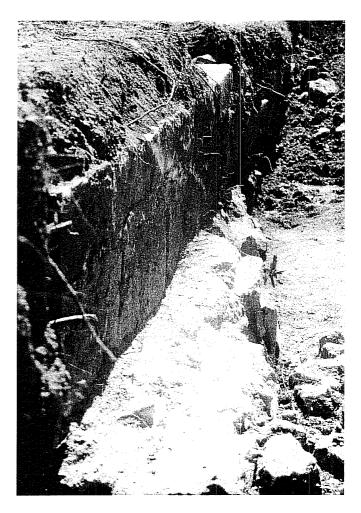
Figure 7. *Upper Labor dam stonework*. Nineteenth century ashler-dressed limestone (upper), undressed Spanish colonial limestone (bottom).
