# Archaeological Survey and Historic Background Research Conducted for the Alamo Community College District at the Former Site of Playland Park, San Antonio, Bexar County, Texas

Texas Antiquities Committee Permit No. 5076

Prepared by:  
Center for Archaeological Research  
The University of Texas at San Antonio  
Archaeological Report No. 400

Prepared for:  
Facility Programming and Consulting  
Alamo Community College District

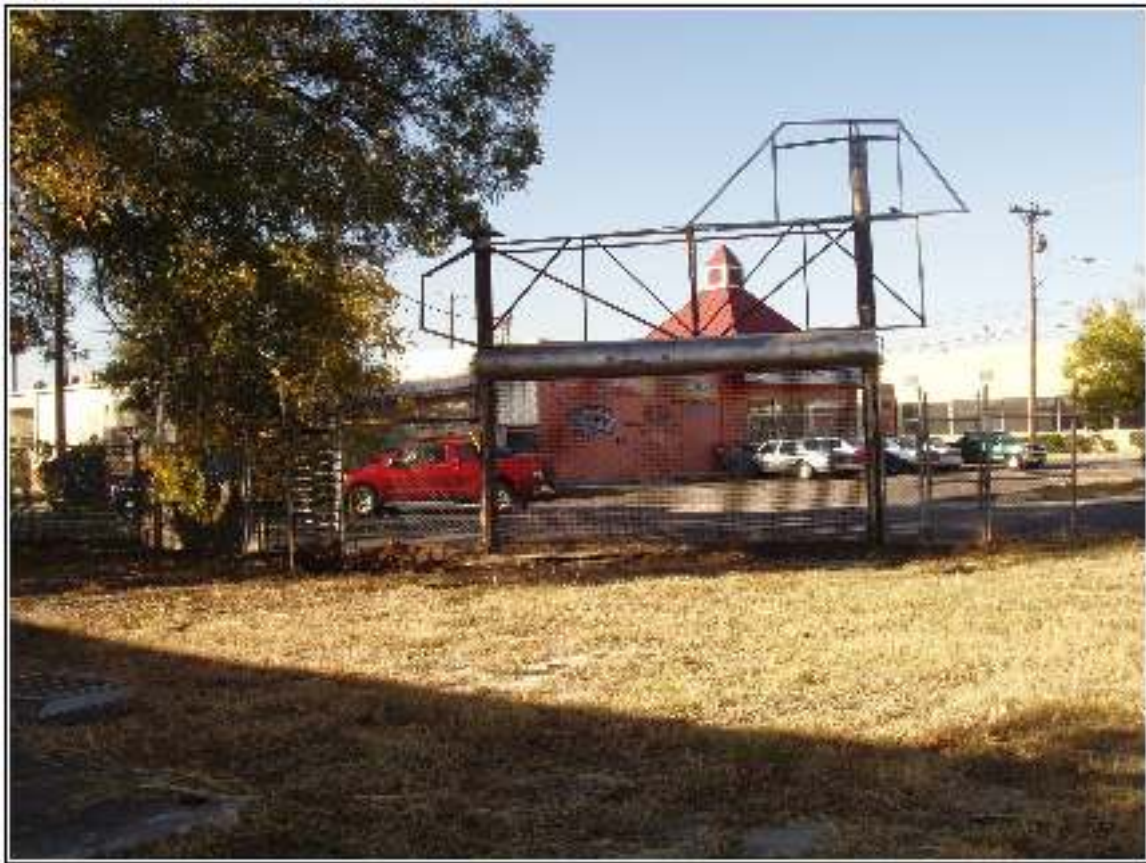
*Figure 2-5. The remains of the main gate of Ploverland, viewed from inside the park, with only the support structures for the main sign still extant.*

Structure 14 is the Main Gate of Playland. Figure 2-5 shows the remains of the gate and the support structure for the large sign at the entrance. The sign has been removed.

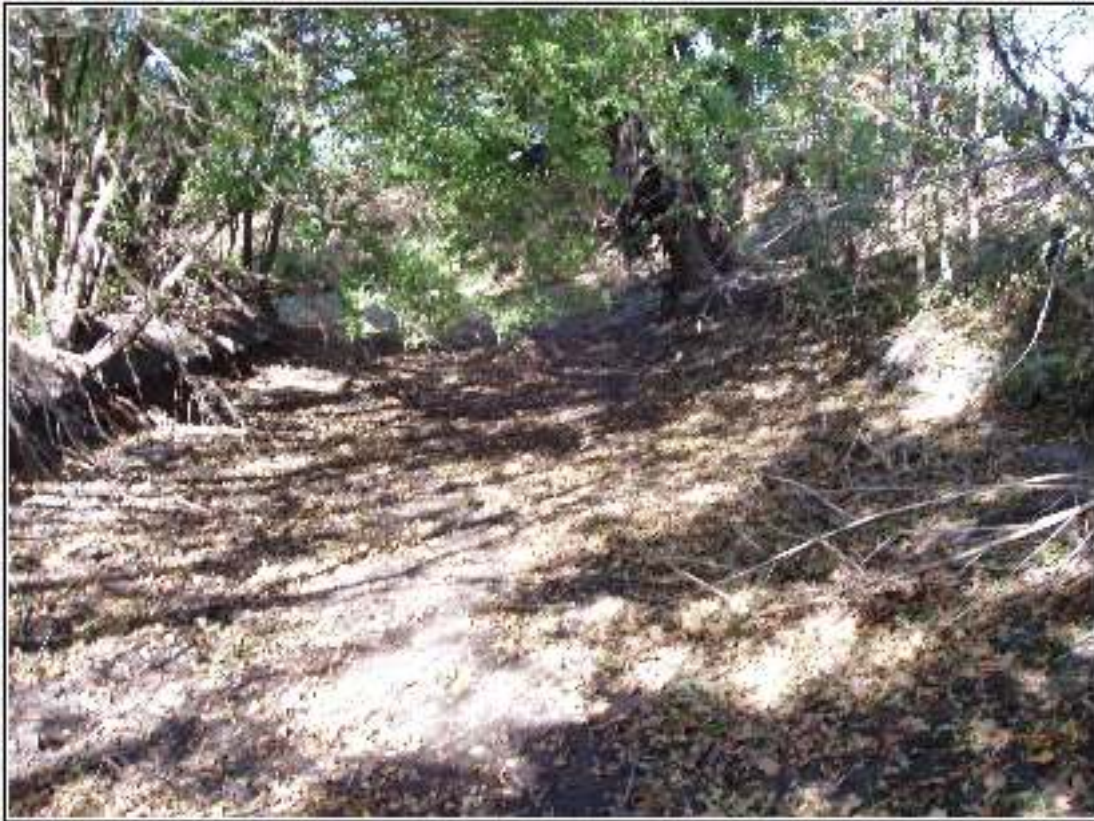
Although there is still a ditch in the same location as the historic Acequia Madre de Valero, erosion, which is active and ongoing (Figure 3-2), has destroyed the original acequia itself, and had probably done so before Jimmy Johnson bought the property. The existing parts of the ditch are as much as 4.9 m (16 ft) deep on the northern end of the APE, near Cunningham Street and as much as 10 m wide. While the original dimensions of the acequia at this location are unknown, it would not have been that deep or wide. A roughly 29 m section of the Acequia Madre de Valero, excavated by Mardith Schuetz in 1966 at Hemisfair Plaza, was found to be in remarkably good condition. That section of the acequia, about 3 km southwest of the APE, was consistently 1.6 m deep and 1.9 m wide (Schuetz 1970:5). The acequia is unlikely to have varied a great deal from these measurements throughout its course, as to do so would have made allocation of water in an equitable manner impossible.

Figure 3-2. The remnants of the Acequia Madre de Valero, showing the active erosion taking place in the ditch as of November 2008.

Therefore, the CAR recommends that the construction of the proposed ACCD facility proceed as proposed with preservation of the Acequia Madre de Valero.

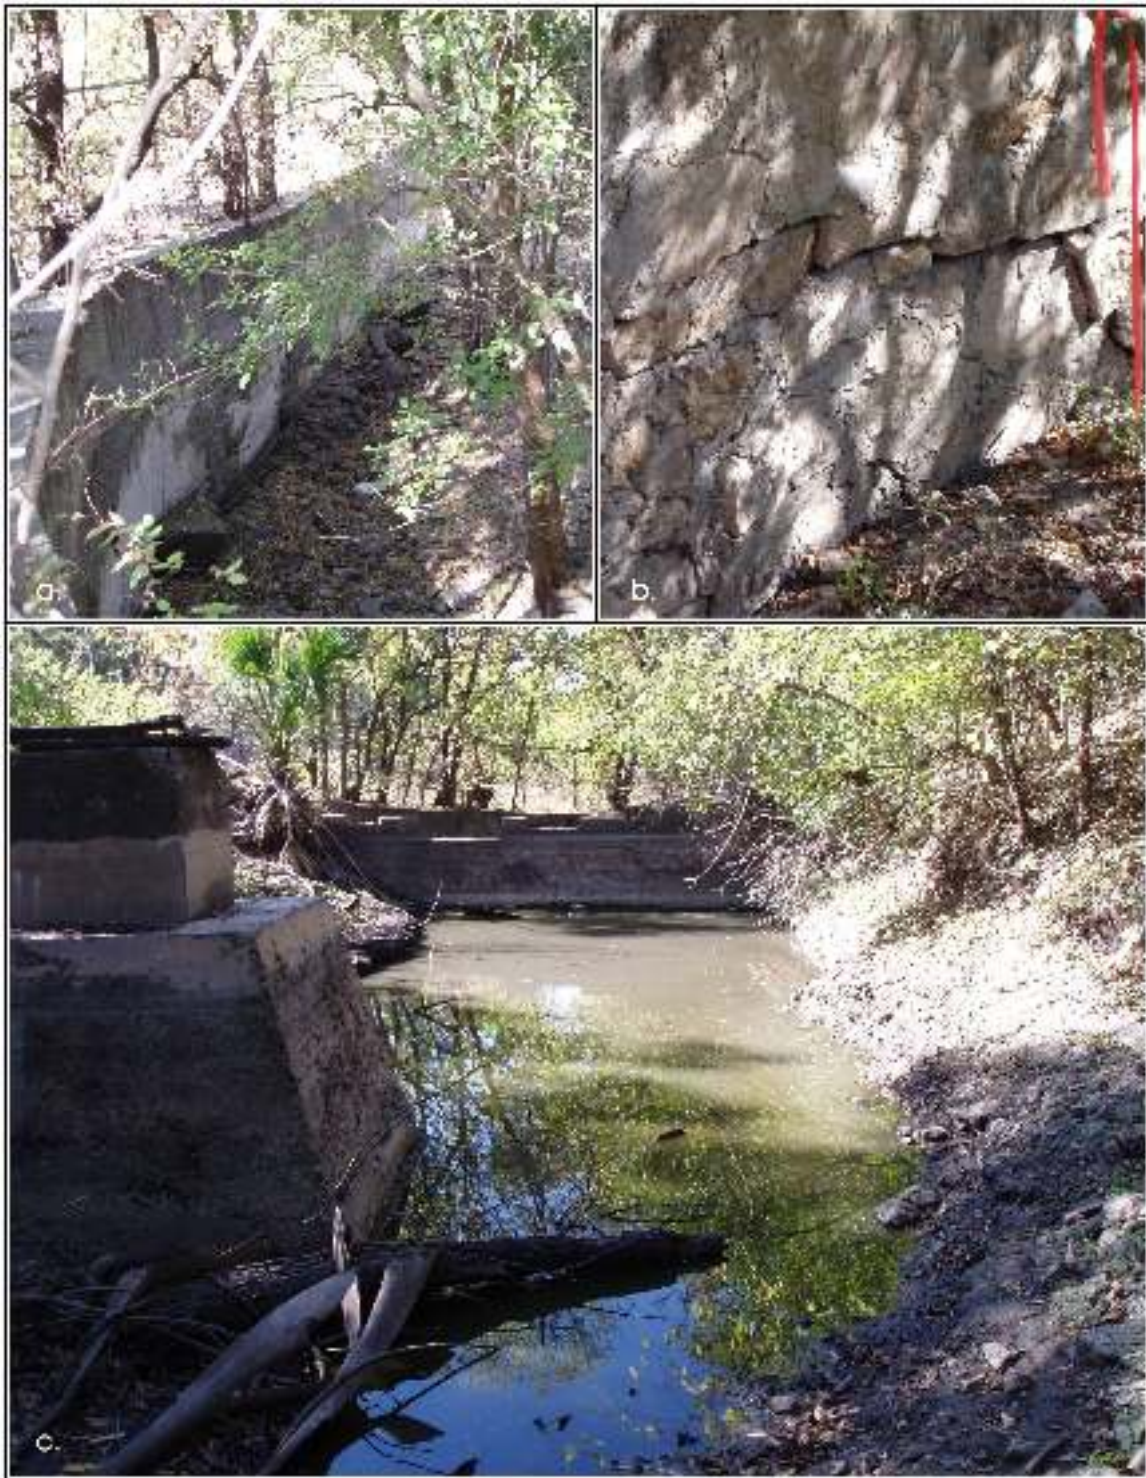
We know that Johnson built a retaining wall on his side of the ditch, following the old acequia channel, intended primarily to prevent floodwaters from spilling over into Playland (Gaida 2007:45). That wall remains (see Figure 3-1 and Figures 3-3a and b), as does a dam Johnson built across the ditch in 1946 (Gaida 2007:45; Figure 3-3c).

Figure 3-3. Modern structures associated with the remnants of the Acequia Madre de Valero. a) overall photo of the acequia with retaining wall (looking west), near the shallower (southern) end; b) a closer view of the retaining wall in a deeper part of the ditch; c) a view of the dam built across the ditch (looking northwest).

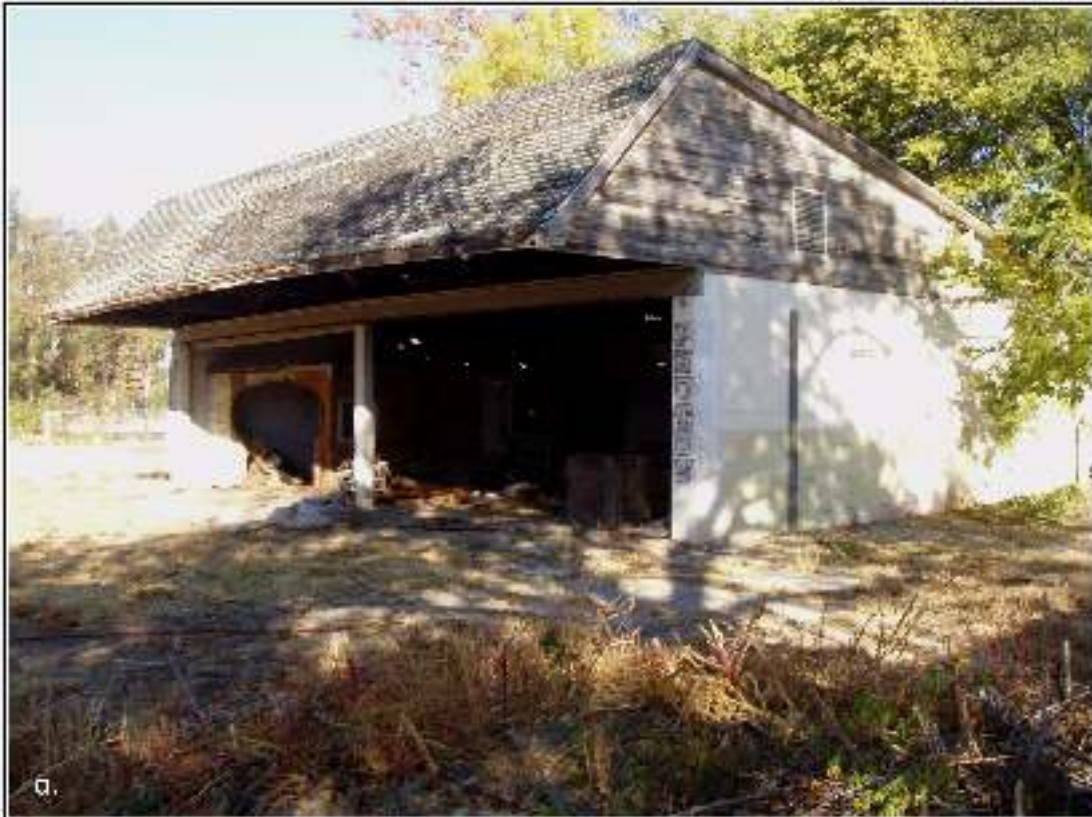
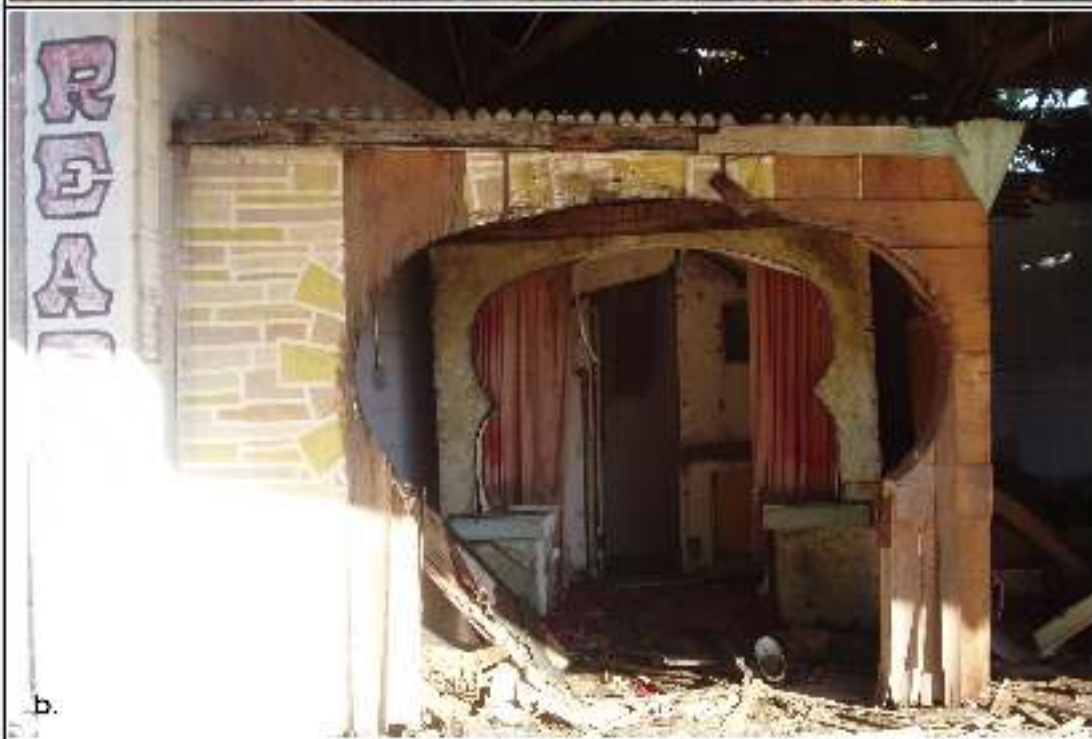
Figure 3-4. Structure 1, showing degree of deterioration: a) view from east b) closer view of the remains of the former-teller's section.

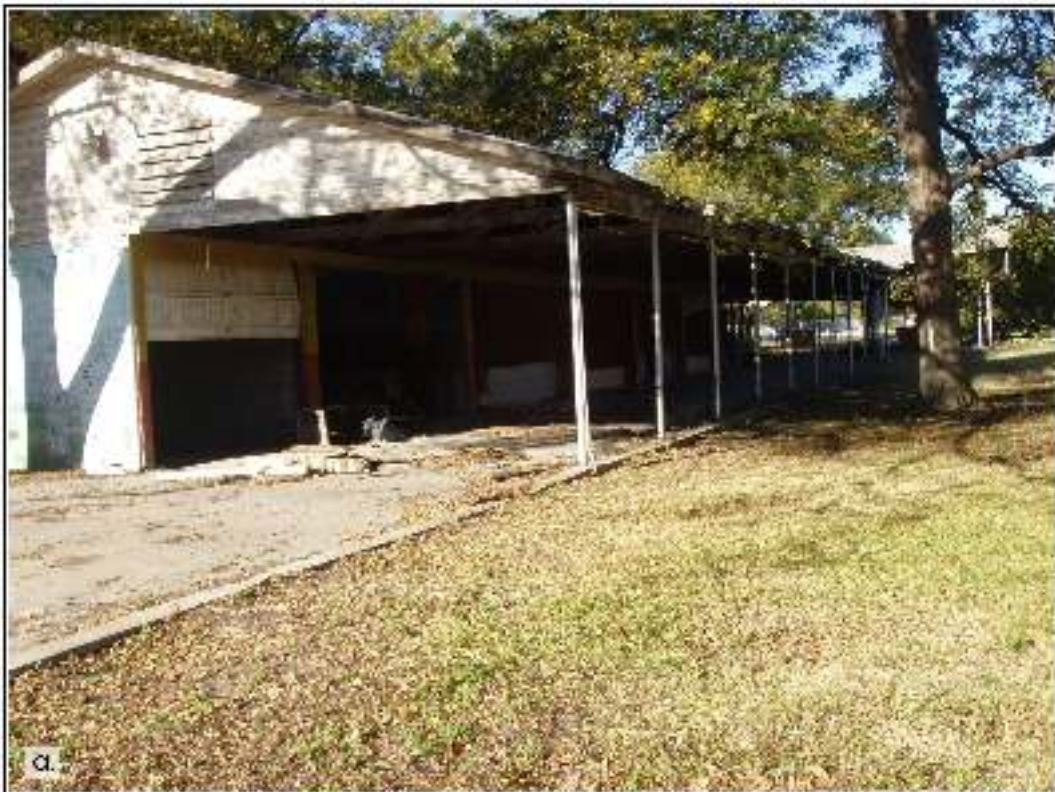
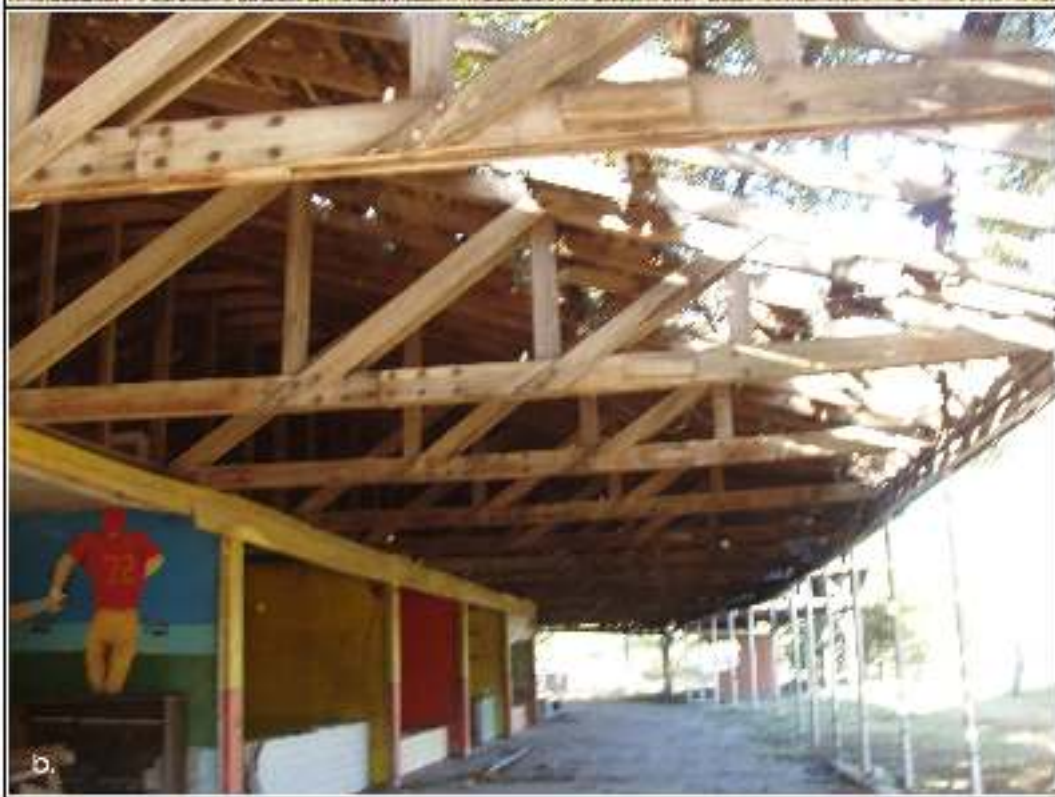
Structure 3 is the remains of the building known as "The Midway" (Figures 3-1 and 3-5), originally constructed on the remains of one of Paul Poppe's greenhouses (Gaida 2007:31). The building was open-sided on the north side, with this area subdivided into several spaced where various "games" were offered. The wooden roof of Structure 3 extended beyond the building to provide cover on the north side (Figure 3-5b). Figure 3-6 shows views of the remains of three of the "games" areas.

Figure 3-5. View of "the Midway" showing open side with wooden roof above it: a) overview from the east side; b) view of condition of the overhang.

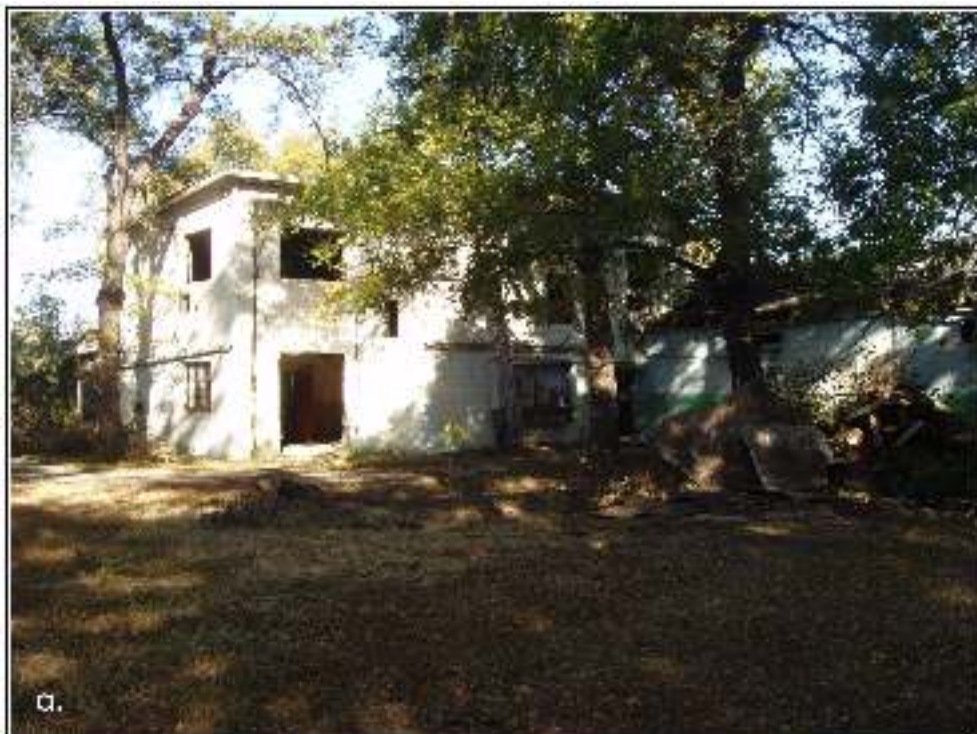
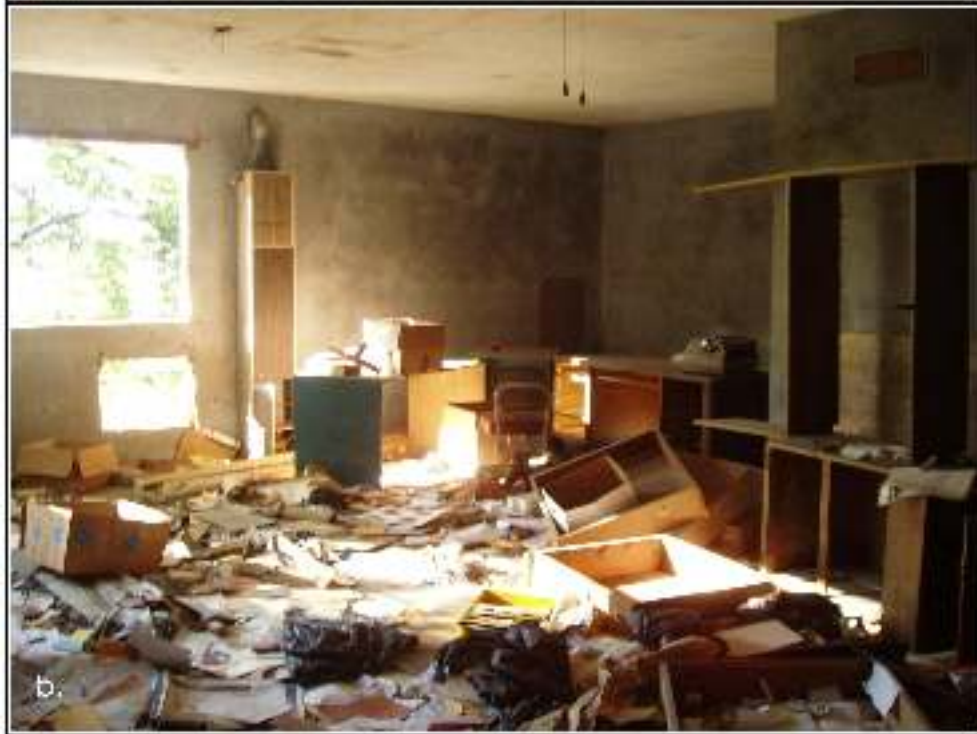
Figure 3-8. Park offices located along the back of the Midway building:  
a) Exterior view of offices; b) condition of one of the offices on the second floor.

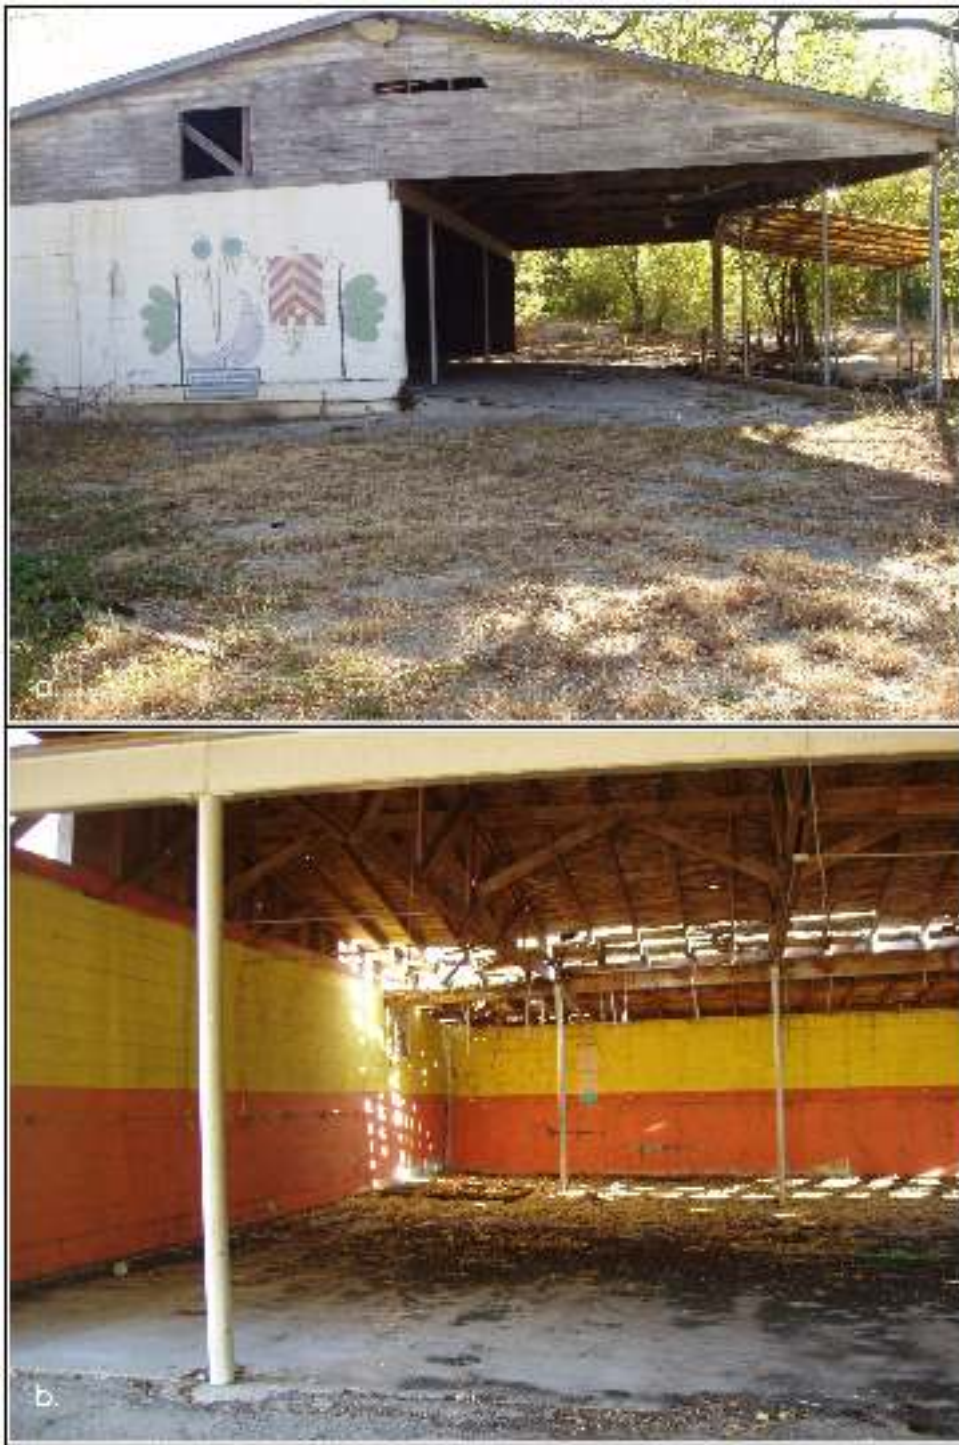
Structure 4 is another open-sided building with a roofed overhang (Figure 3-10a), similar to Structure 1, built of concrete block with a wooden roof, which is bad condition (Figure 3-10b), and another extension, probably intended to provide more shade.

Figure 3-10. Structure 4: a) showing the open roofed side; b) interior of Structure 4, showing poor condition of roof.

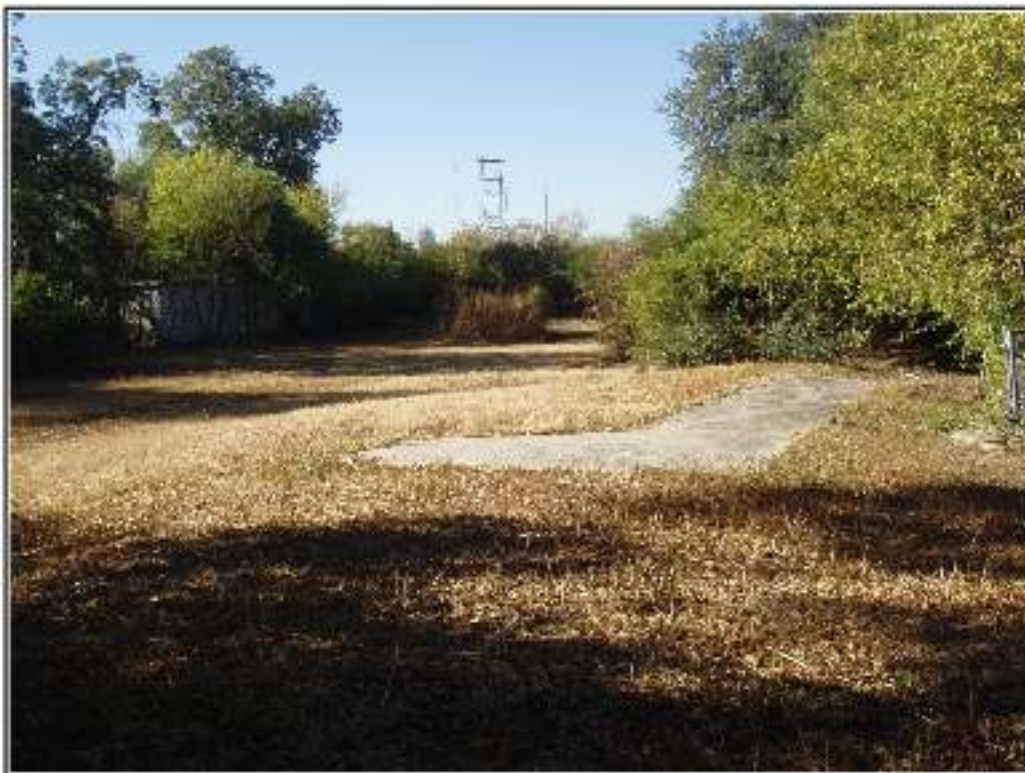
Structure 7 is the sidewalk that once led to the entrance to the "Rocket" roller coaster (see Figure 3-1). It follows along the northern edge of the acequia ditch to a point near the eastern-most part of the APE. In the past, the roller coaster was located in the area shown on the left of Figure 3-12. No remains of the coaster are evident in this location today, and the soil beneath it is contaminated

Figure 3-12. *The eastern end of Structure 7, a sidewalk leading to the entrance to the roller coaster. Note the area to the left of the photograph, where the roller coaster once stood. Also note the remains of the old TV tower (Structure 13) at the center back of the photograph.*

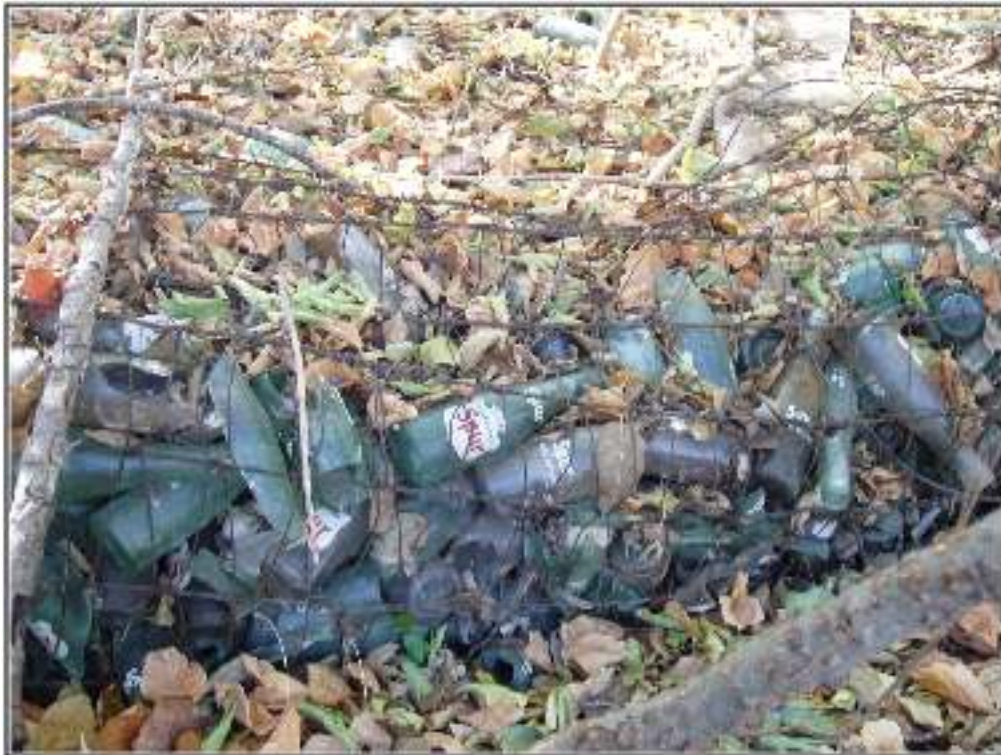
Not actually a structure, this feature is a dump of glass soda bottles (Figure 3-1, Figure 3-13). Gaida (2007:23) tells the story of these bottles, using it as an example of the way that Jimmy Johnson was always looking for a business advantage. Shortly after the end of World War II, the owner of the Mathews Bottling Company mentioned to Johnson that he had thousands of six ounce pop bottles that he no longer wanted because the end of government restrictions on the use of sugar was allowing him to bottle sodas in larger bottles (Gaida 2007:23). Johnson allowed him to dump the bottles behind the roller coaster. Later he made use of the bottles he had gotten for free:

Figure 3-13. *The bottle dump mentioned by Gaida (2007:23).*
