Archaeological Investigations of the Alamo Dam and Upper Labor Dam, Brackenridge Park, San Antonio, Bexar County, Texas

by
Clinton M. M. McKenzie
with contributions by
C. Stephen Smith

Texas Antiquities Permit No. 6449

Prepared by:
Center for Archaeological Research
The University of Texas at San Antonio
One UTSA Circle
San Antonio, Texas 78249-1644
Archaeological Report, No. 444

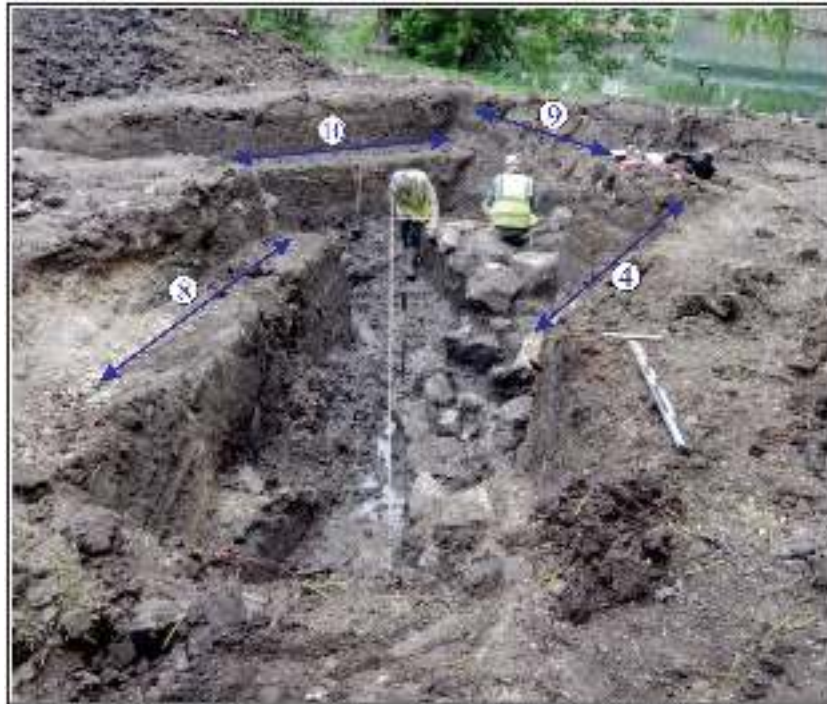
Figure 5-2. Alamo Dam exposed in T 4, T 8, T 9, and T 10, looking northeast.

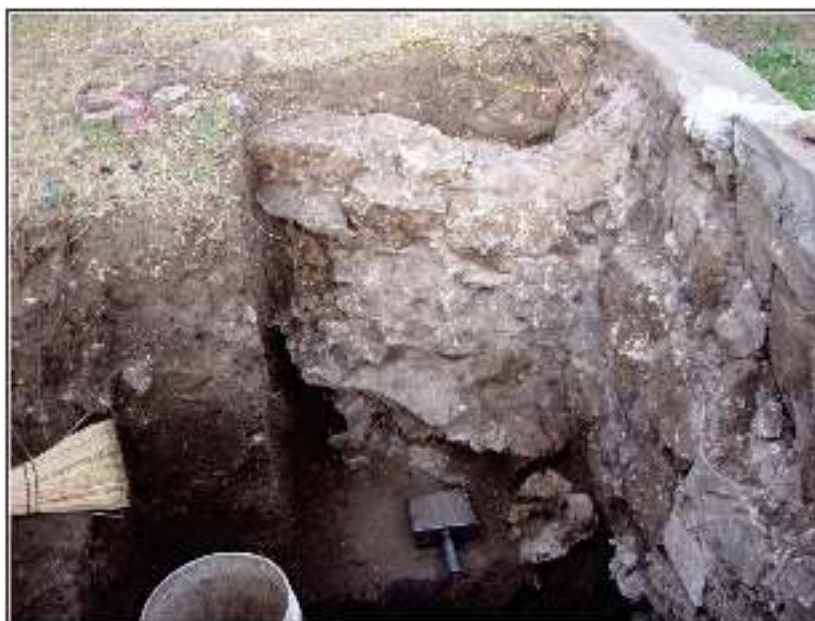
Figure 5-4. Buried deadman buttress associated with F 1 in U 1, facing north.

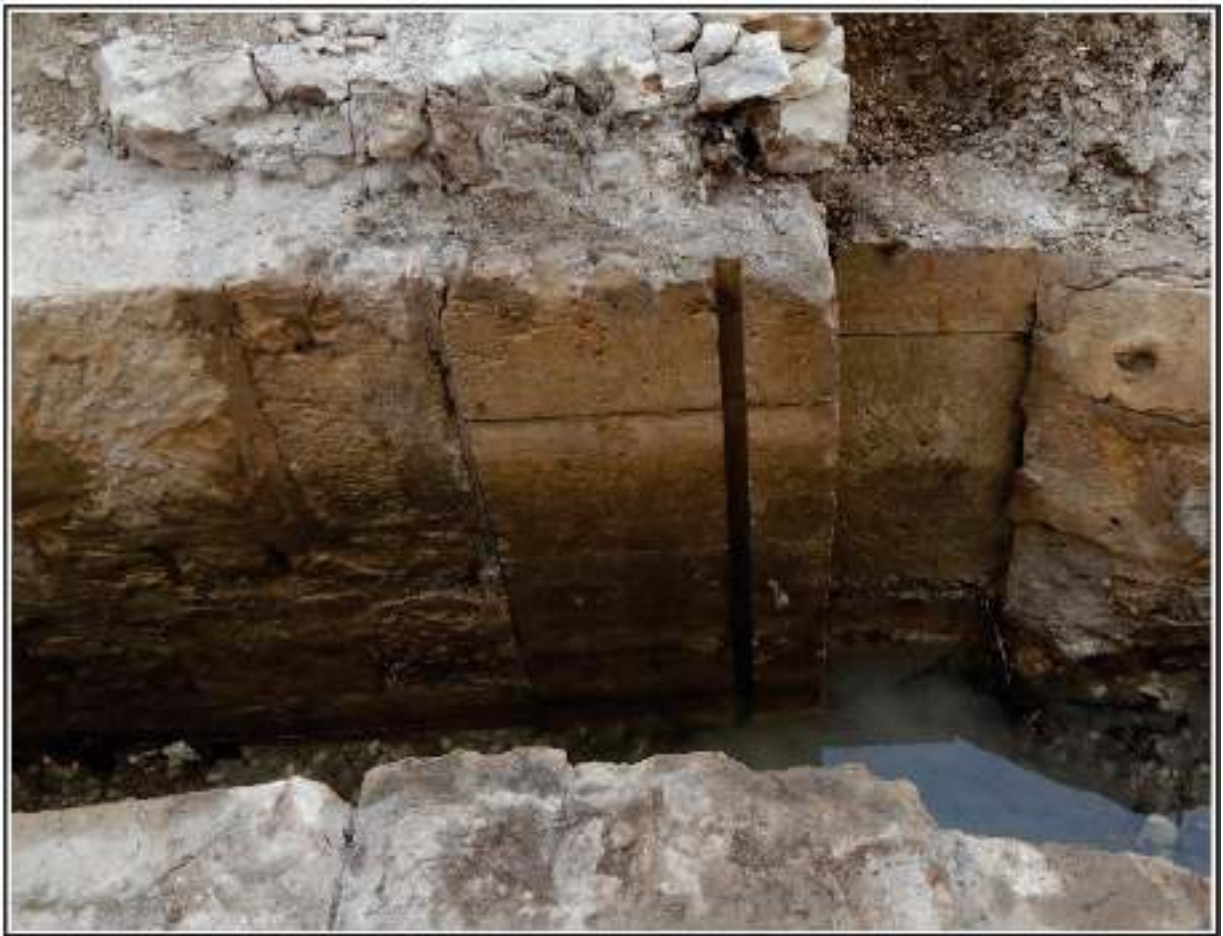
The mouth of the headgate has two finely carved vertical grooves, one on each side, cut into the stone (groove on west side shown in Figure 5-6). This pair of grooves allowed the headgate to be held in a fixed position and provided a means for lowering and raising the headgate to regulate water. In addition, a single, iron eye-bolt remains in place on the western side of the headgate, and it is 2.5 cm in advance (upstream) of the cut groove (Figure 5-7). While this is the only remaining eye-bolt, a single hole for an additional bolt is still extant, 2.5 cm behind the groove. There are no holes drilled into the east side of the headgate nor are there any remaining bolts on the upper western side as that portion of the upper block is no longer present. These eye-bolts may have acted as pivot hinges that could have supported additional gates or doors for closing the mouth of the channel to maintain, service, or replace the headgate.

Figure 5-6. West side of headgate exhibiting carved headgate groove and lower eye-bolt.

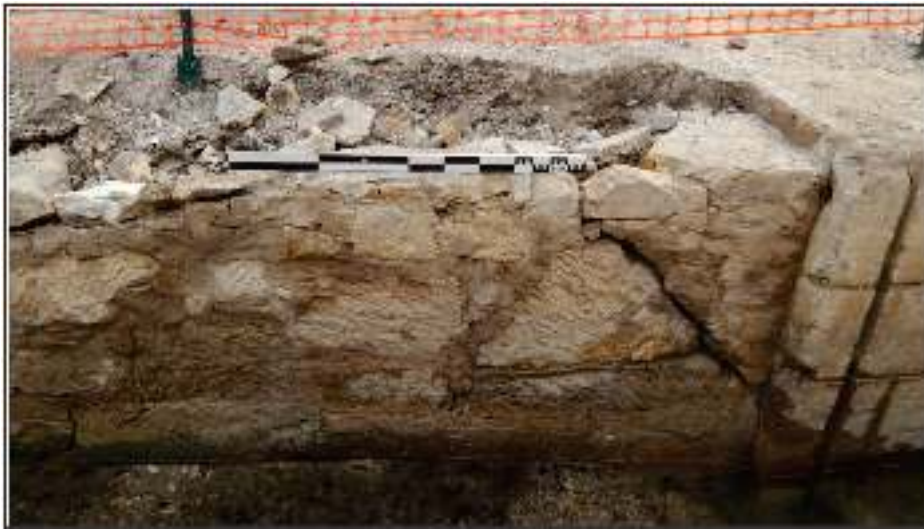
Figure 5-10. Upper channel wall (east) showing mixed construction and visible damage.

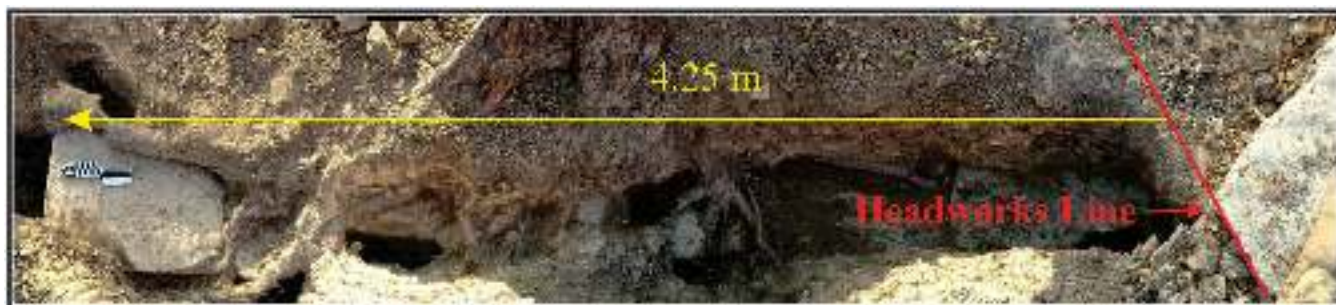
Although many details of the wall are obscured by tree roots, it is a minimum of three ashlar courses deep. The western end of the wall terminates on the east side of the headgate, which it directly abuts. A foundation of intermediate limestone rubble is beneath the blocks of the eastern leg. Limitations on excavation in the vicinity of the pecan tree prevented determination of the temporal affiliation of this lower limestone rubble mass. It is possible that it may be colonial in age, or it may simply be foundation material for the CSA walls. The eastern leg of F 5 must have engaged the

Figure 5-12. Top of F 5 wall between headgate and dam on east side of acequia.

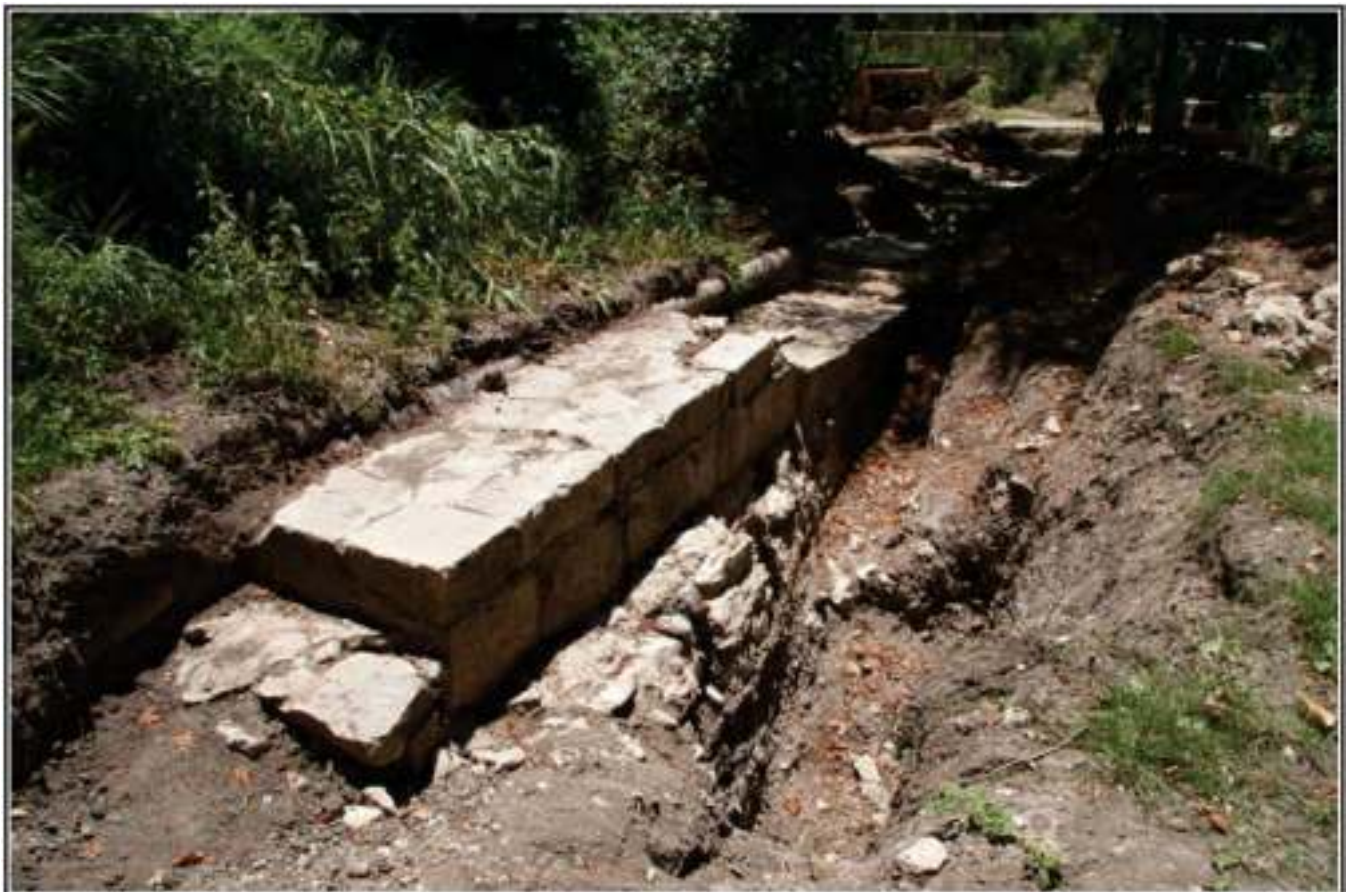
Figure 5-16. Northern terminus, west face. Nineteenth-century ashlars superimposed on eighteenth-century Spanish Colonial dam.

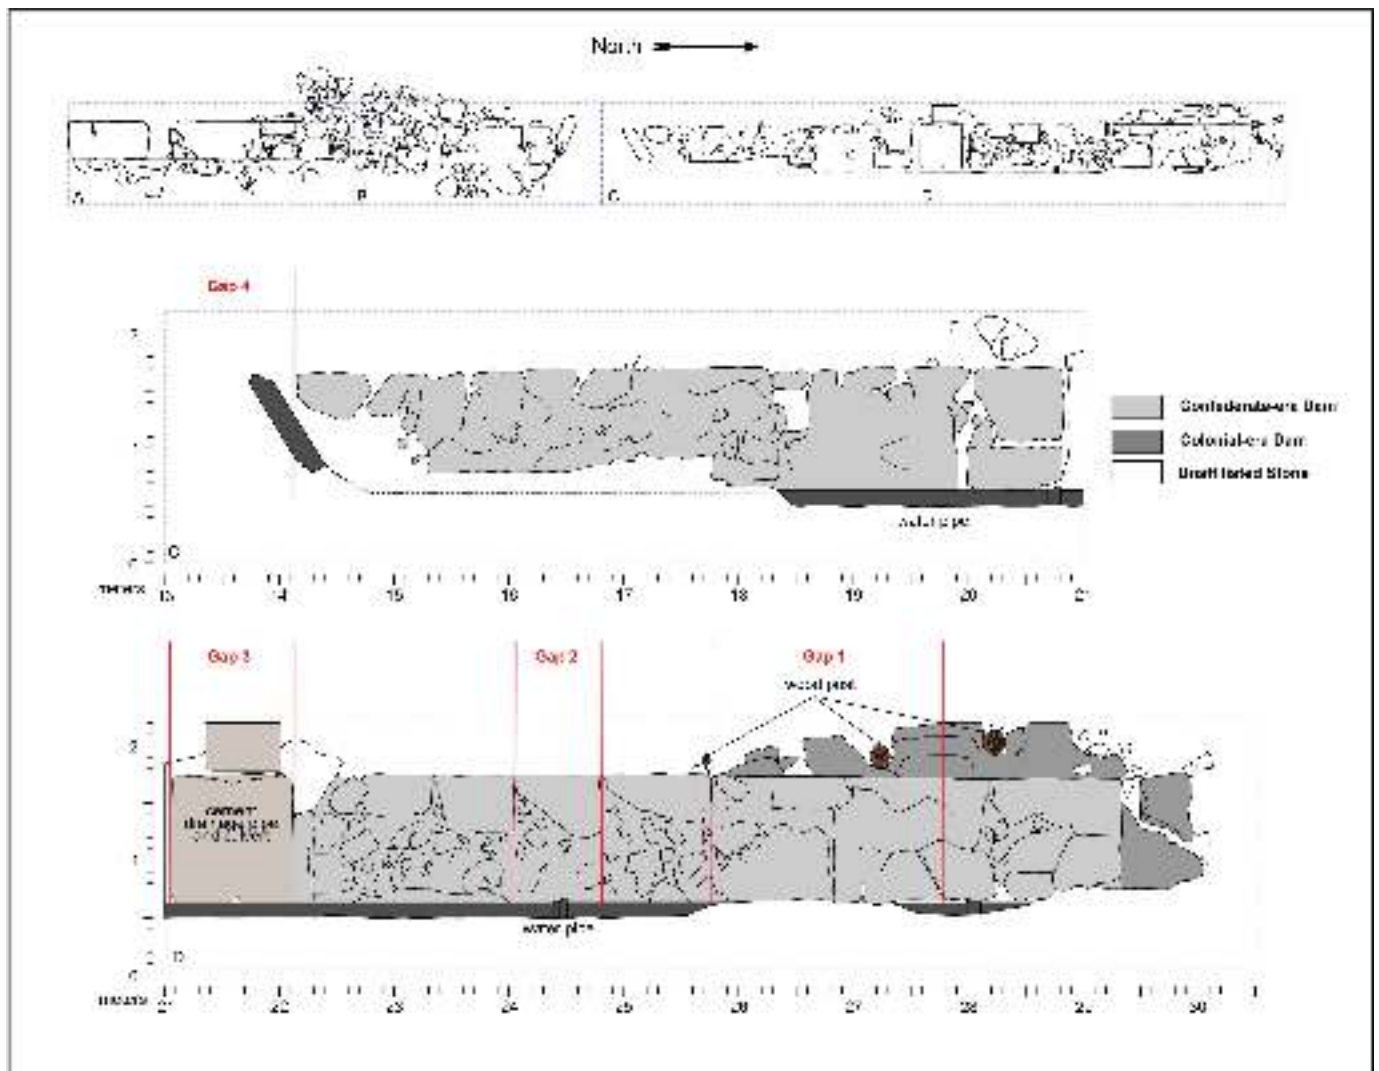
Gap 1 is a partial gap in the dam some 3 m from the northern end. This gap is 3.55-m wide and 20-cm deep. No attribution for the gap can be made.

Figure 5-17. Sequential plan view of north half of Upper Labor Dam showing Gaps 1, 2, 3, and 4.

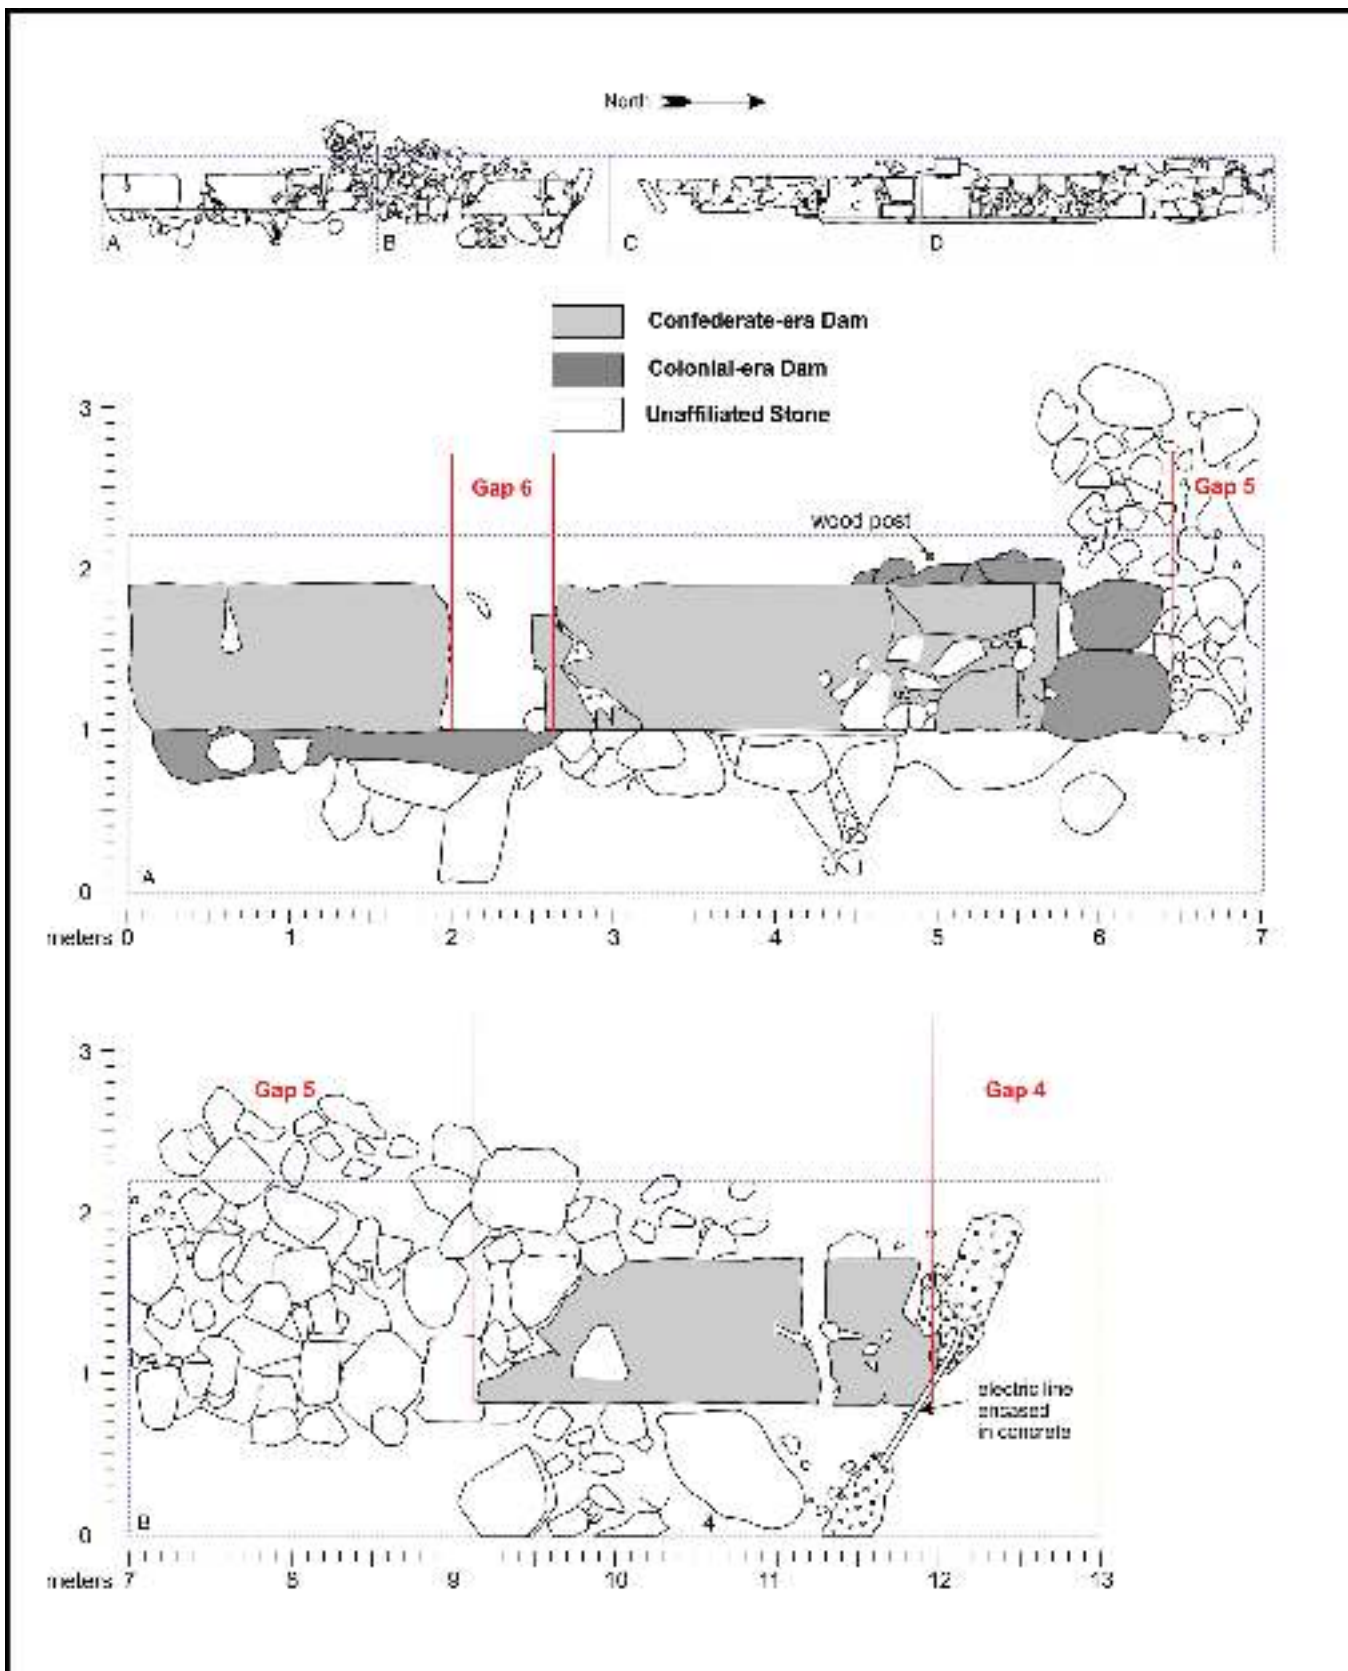
Gap 6 is a narrow, partial gap in the dam 28.6 m from the northern terminus and 1.65 m from the southern end. The gap is 80 cm in width and 40 cm in maximum depth. It appears to be related to a trench seen in the eastern profile of the excavation trench. Most likely this gap was for another utility line that was since removed or relocated.

Figure 5-18. Sequential plan view south half of Upper Labor Dam showing Gaps 4, 5, and 6.

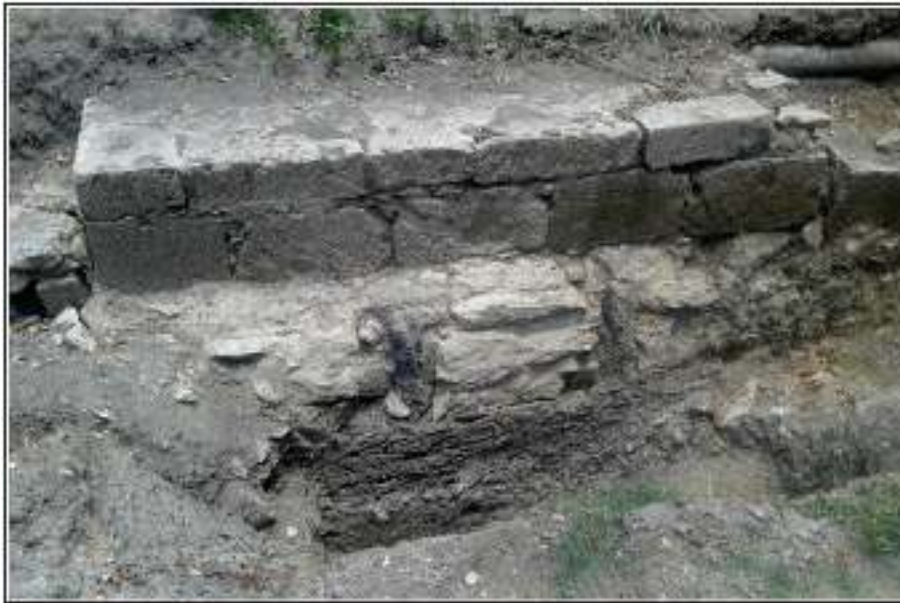
Figure 5-20. Spanish Colonial alignment with vertical wood posts and planking, north end of dam.

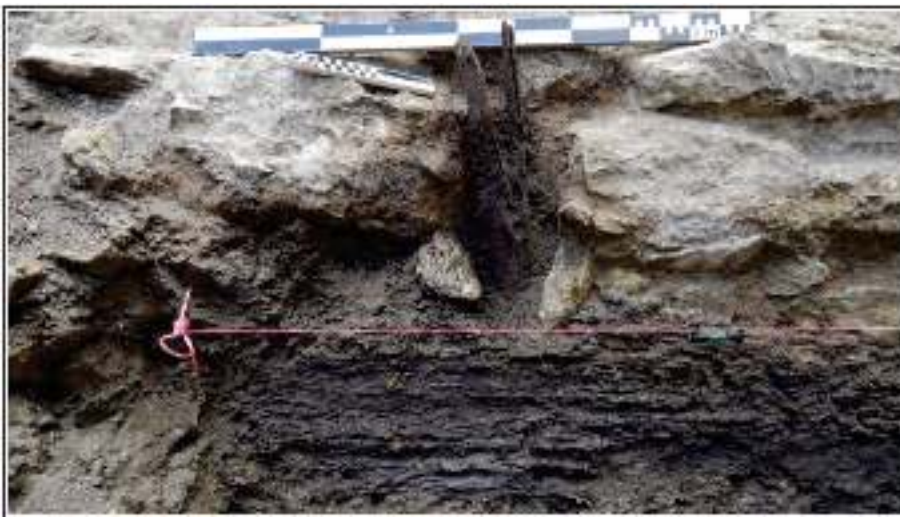
Figure 5-21. Close-up of posts and plank intruding/abutting the Spanish Colonial dam.

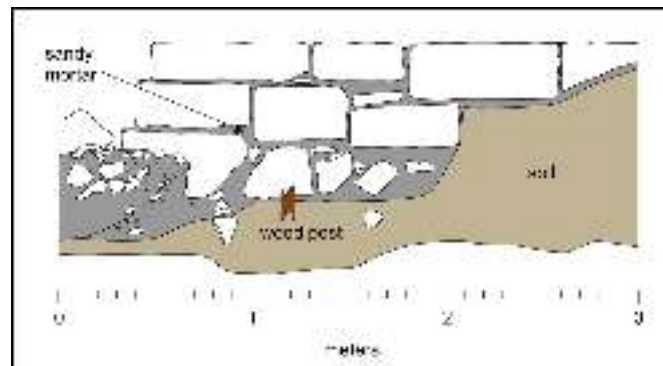
Figure 5-23. Profile of west face of southern end of dam showing wood post and Gap 6.

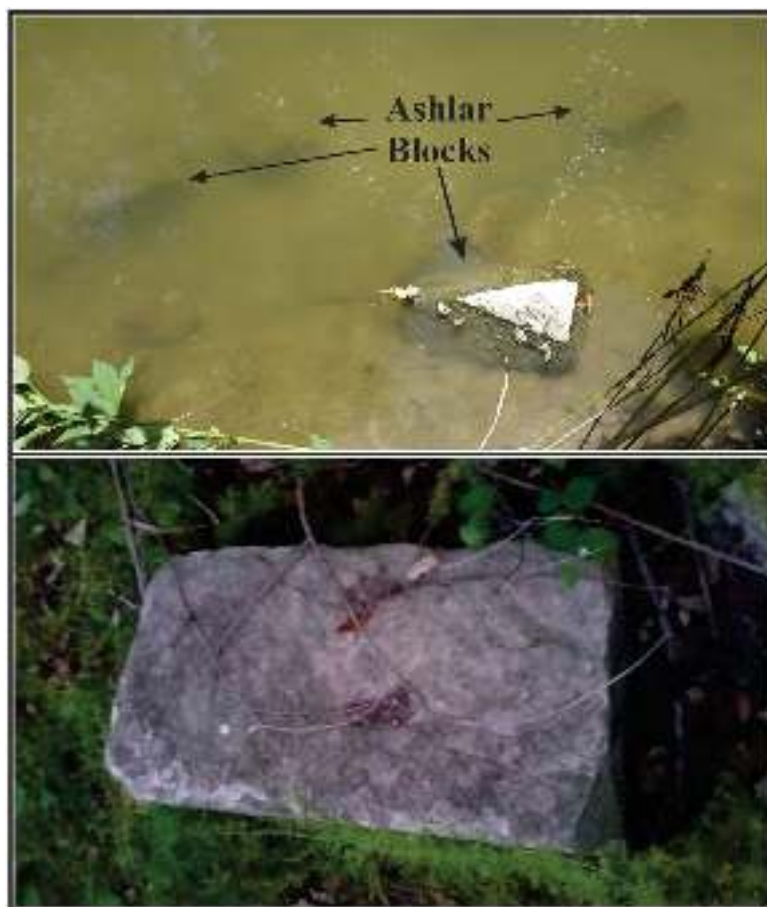
(Figure 5-25). These appear similar to the ashlar blocks of the headworks and are likely associated with the late nineteenth-century work in this area. The blocks at the northwest end of the Lily Pond may reflect ashlar blocks tumbled downslope from the continuation of the F 2 wall that formed the western side of the diversion pool during the Civil War through the late nineteenth century. Those blocks scattered in the river or partially buried along the river embankment likely represent portions of the CSA dam that were blown-out by whatever created Gaps 2, 4, and 5.

Figure 5-25. Ashlars in river (top) and on west bank of Lily Pond (bottom).
