Test Excavations at the Old Rock Store (41MC827), Tilden, McMullen County, Texas

Texas Antiquities Permit No. 8155

Prepared by:
Center for Archaeological Research
The University of Texas at San Antonio
One UTSA Circle
San Antonio, Texas 78249
Archaeological Report, No. 461

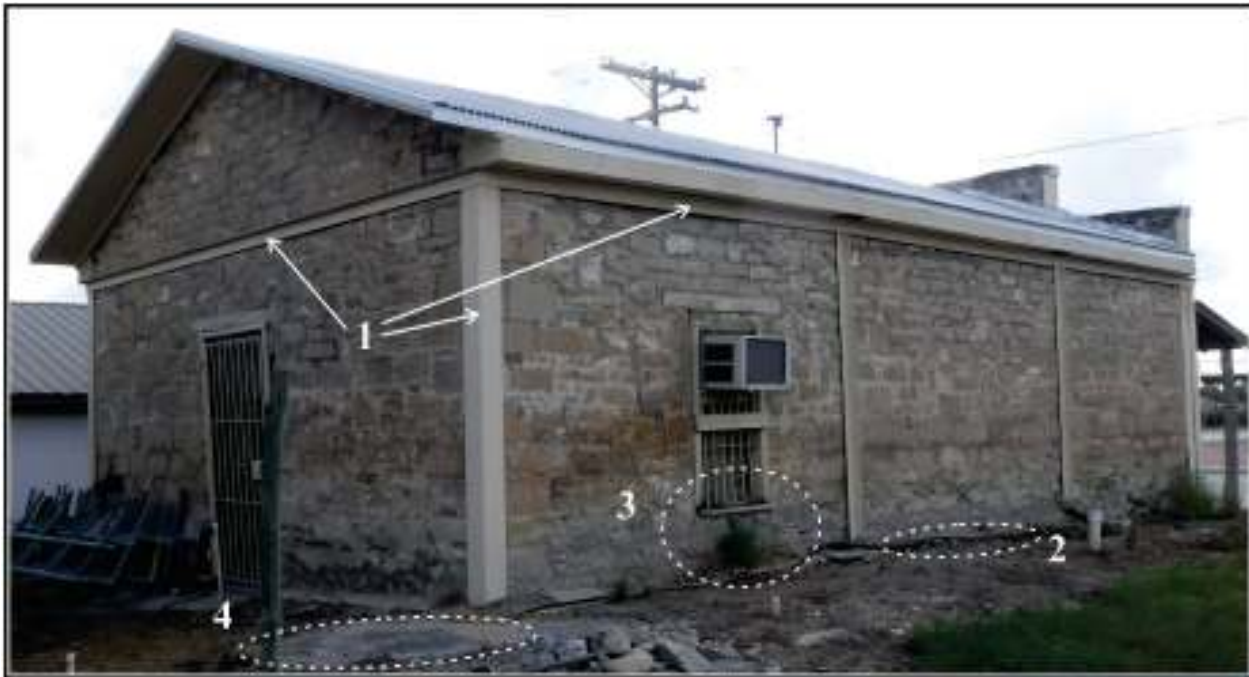
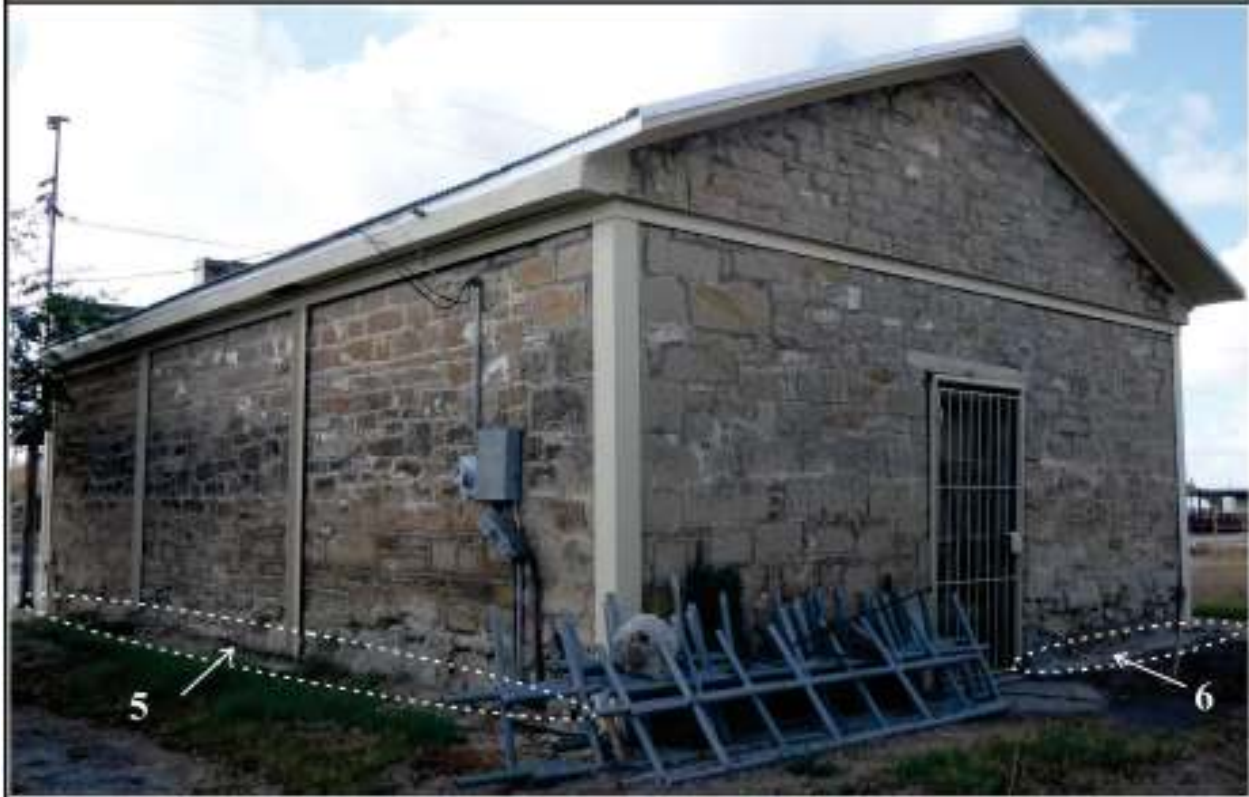
The east elevation of the store, facing State Highway 16, has a coat of stucco and a concrete porch, so the condition of the sandstone blocks, is unknown. There is extensive spalling along the surface course of sandstone blocks, and the problem is acute at the southwest corner. According to Jason Cooper, McMullen County Fire Chief (personal communication 2017), the stones at the southwest corner appeared to be failing about 15 years ago, and at that time, he and some other county employees excavated a pit, undercut the corner of the building and then filled it in with ready-mix concrete. He said the pit was about 4.5-m (15-ft.) deep and 1.8 m (6 ft.) in diameter with a 1.8 m (6 ft.) in diameter concrete pour off the southwest corner. CAR staff observed a backfilled cistern (cavity is evident) located opposite the concrete pour and on the adjoining lot. The south elevation, adjoining Lot 3, appears to be heavily impacted and littered with rock rubble. A narrow and shallow concrete buttress is poured up against the wall, and it continues around and along the west elevation. The roof trusses are held up by a series of vertical and horizontal heavy gauge angle irons. Soaker hoses were noted along the south, west, and north elevations. CAR staff was advised that several attempts to stabilize and otherwise arrest the deterioration of the walls have been made over the years. At one point, the MCHC was advised to keep the perimeter of the structure wet to prevent settling (Cecile Stanley, personal communication 2017). These series of exterior interventions are identified in Figure 4-1.

1. angle iron supports (horizontal and vertical); imbedded in concrete at base
2. spalling and soaker hose at south elevation
3. A/C condensation and rotting windowsill
4. concrete pour meant to support southwest corner; about 1.8 m (6 ft.) in diameter, 4.5-m (15-ft.) deep
5. spalling and soaker hose at north elevation
6. section of concrete buttress (narrow and shallow)

Figure 4-1. Old Rock Store showing areas of concern. Top: oblique view of west and south walls, facing northeast. Bottom: oblique view of north and west walls, facing southeast.

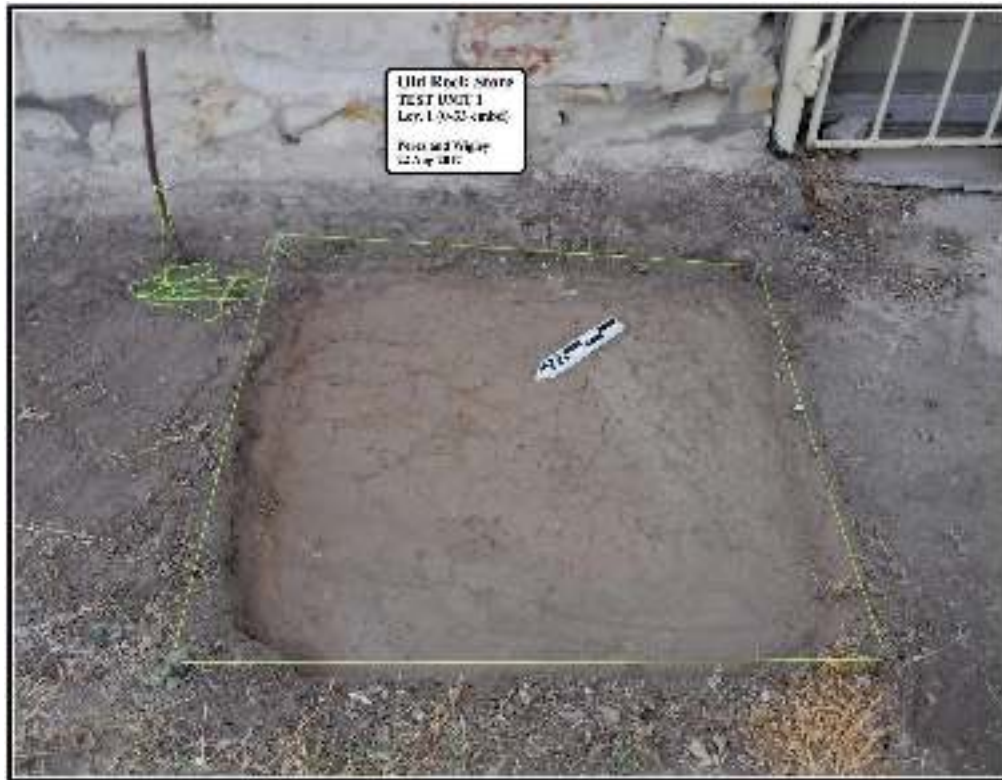
Figure 4-2. Test Unit 1, Level 1 (0-33 cmbd; 0-13 in.).

The Level 2 (33-43 cmbd; 13-17 in.) surface was a hard and dry layer of sand, with three different soil colors evident across the floor (see Table 4-1). The artifact density was low until the hard surface layer was broken through, exposing a less compact sandy loam. Excavation of this level fully exposed a narrow and shallow concrete buttress, meant to support the deteriorating sandstone blocks. Screening of the excavated soil produced mostly construction material, such as nails, window glass, and sandstone fragments, as well as modern trash from around the concrete buttress. This material was not collected. Excavation of TU 1 ceased because it became evident that the adjoining sandstone blocks were badly deteriorated. Excessive spalling of the sandstone blocks is extensive in this area, and additional excavation may aggravate the problem.

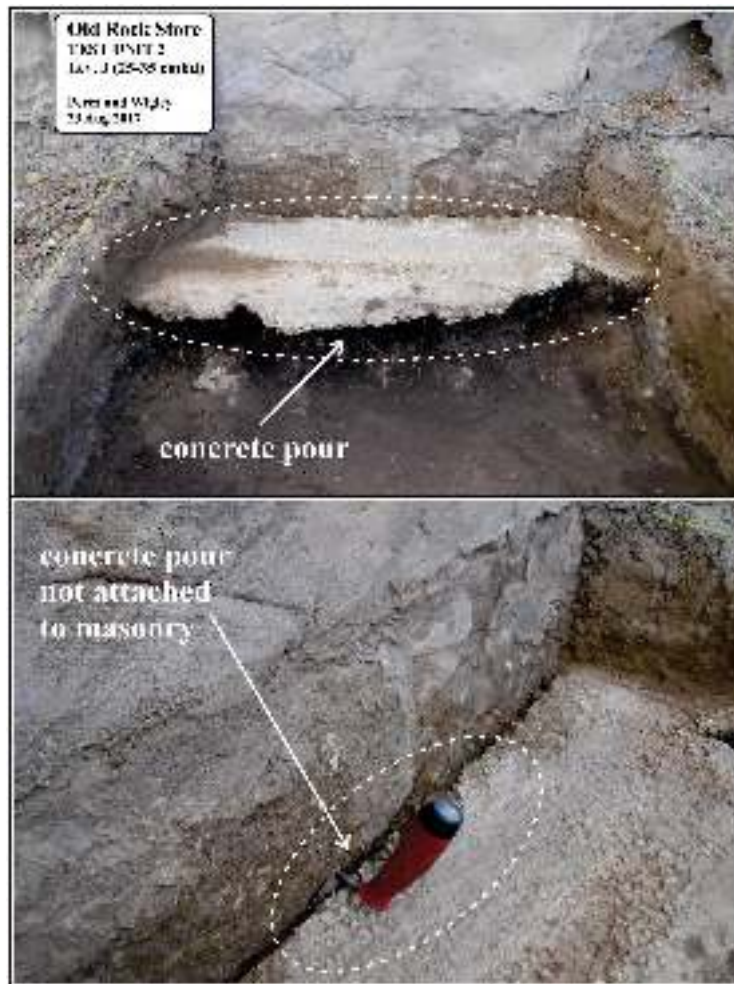
Figure 4-3. Close-up photos of TU 2; note concrete pour meant as a water barrier.

pour and the sandstone wall (Figure 4-3). After consulting with Cecile Stanley (personal communication 2017), it was decided to break off a 1-m (3.3-ft.) section of the buttress in order to continue excavating. The procedure was photo documented. The excavation then continued and exposed a 35 cm (13.7 in.) strip of light colored, silty textured sediment that abutted the sandstone wall. The screened soils produced a small number of artifacts (n=32), which included cut nails, bottle glass, and ceramic sherds.

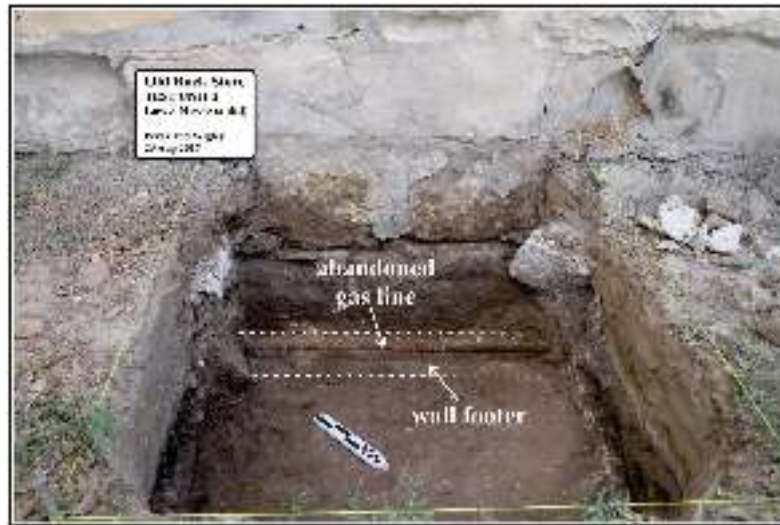
The wall footer was further defined in Level 5 (45-55 cmbd; 17.7-21.6 in.) and in the process exposed an abandoned 1-inch gas line at 47 cmbd (18.5 in.; Figure 4-4). The density of river cobbles decreased but was replaced by sandstone cobbles (probable construction debris). The types of artifacts recovered from this level were similar to those from Level 4, but the count decreased by 35 percent (n=192).

Figure 4-4. Close-up of TU 2 showing exposed gas line and wall footer.

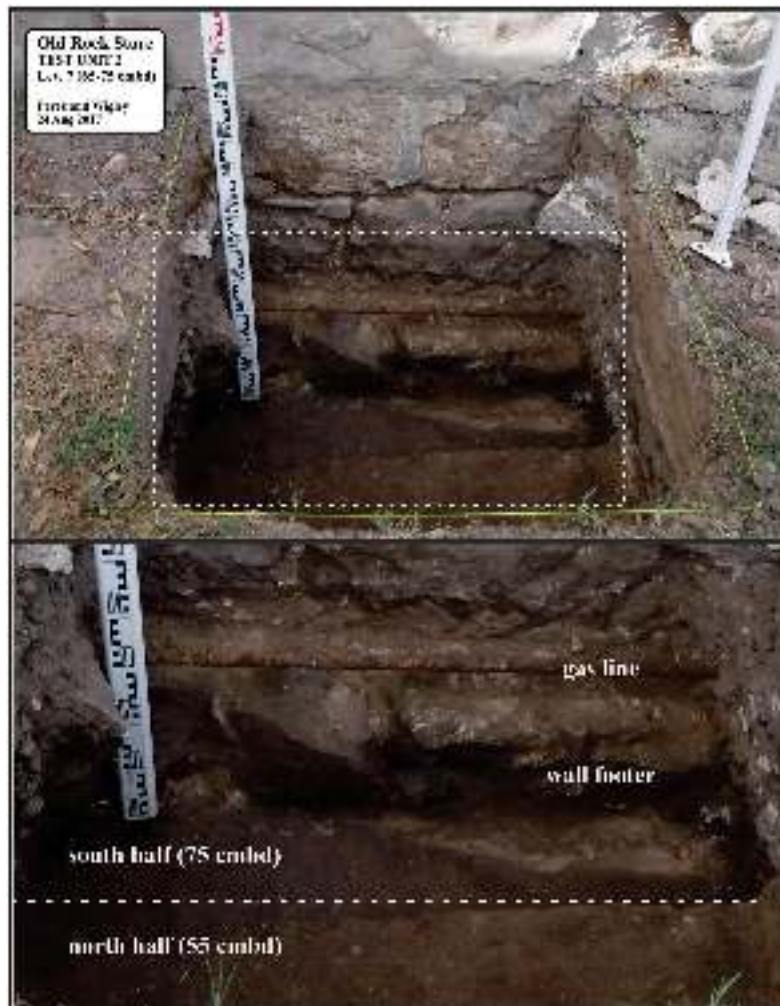
Figure 4-5. Test Unit 2 (view south) with close-up (bottom) of wall footer and wall setting trench.

Excavation of TU 2 ceased at 75 cmbd (29.5 in.), and the unit and wall footer were photo documented (Figures 4-5 and 4-6). Note that the abandoned gas line was not removed. A 20.3-cm (8-in.) long section of a 1/4-inch metal rod was used to probe beneath the exposed wall footer. The probe indicated the wall footer continued to an unknown depth. With the exception of Levels 8 and 9, the other levels are a mix of sandy loam, clay, and cobbles (Figure 4-7). These upper seven levels most likely represent fill episodes or disturbances caused by repeated attempts to remedy the rising damp problem.

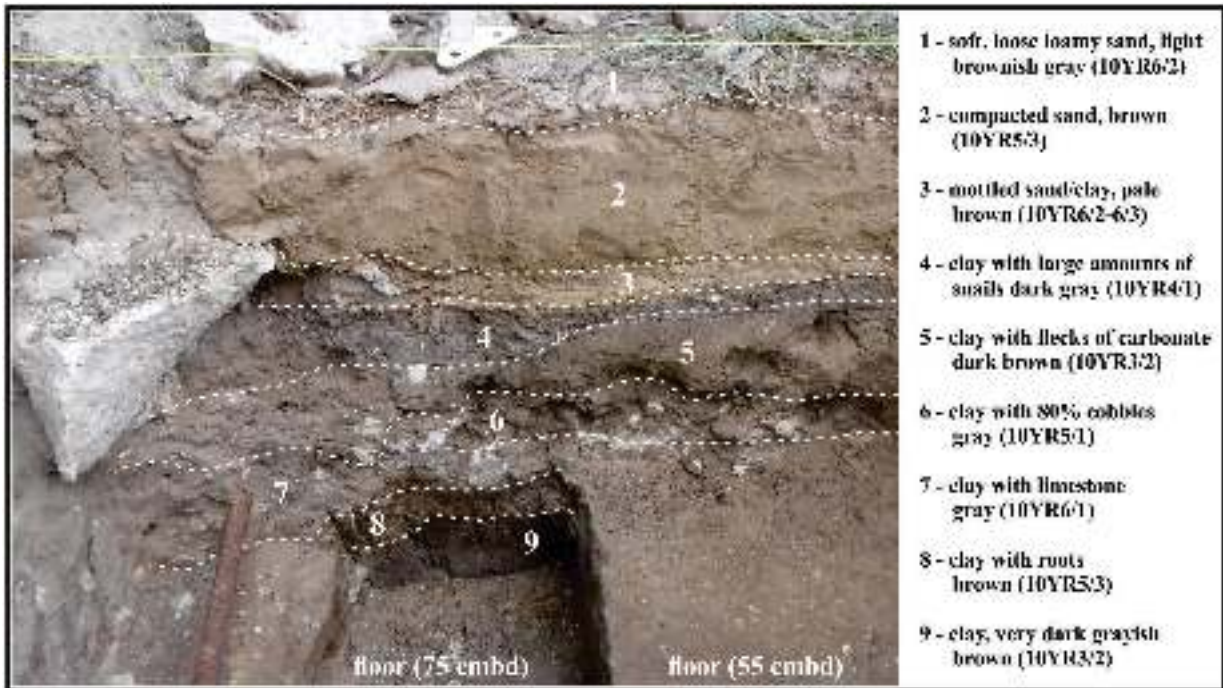
Figure 4-7. Test Unit 2 west wall profile; note assorted fill episodes.
