An Evaluation of 28 Historic Properties in the Socorro-San Elizario Area

David Kammer

©copyright 1998
Center for Archaeological Research
The University of Texas at San Antonio
Special Report, No. 23

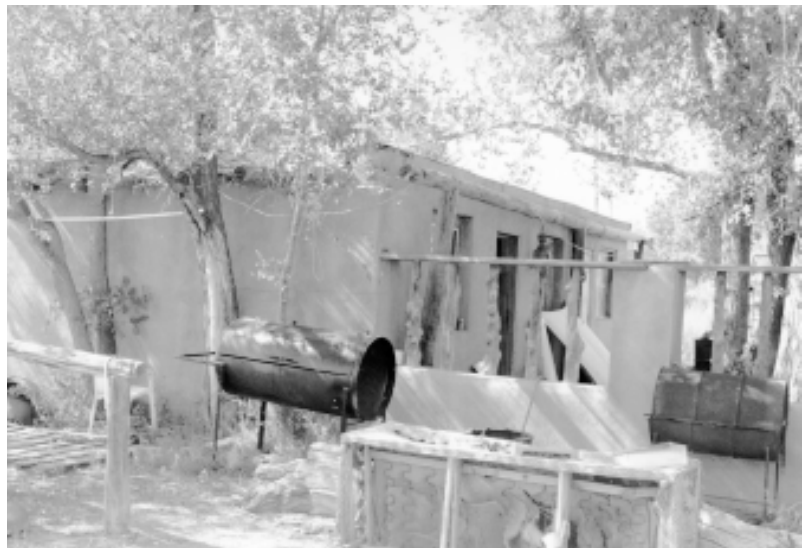
Figure 13. 12296 Cinnabar Road, southern building.

building (Figure 13) has a linear plan and is one story with a flat roof and slight parapet. Based on the relatively narrow jambs of the wood casement windows and two front entries, the walls appear to be wood frame with a brown stucco cement coating. In a departure from the common practice of vigas extending across the shorter lengths of a rectangular building, exposed unmilled vigas appear on the side walls, spanning the width of the building. Two wood panel doors face on a small courtyard bounded on the east side by a low stucco-coated wall topped with rustic log poles fixed to a milled rail.

Based on the location of its vigas and its wood frame construction, the former is probably a post-World War II building. Neither building possesses potential for individual listing in the NRHP or as a THL.

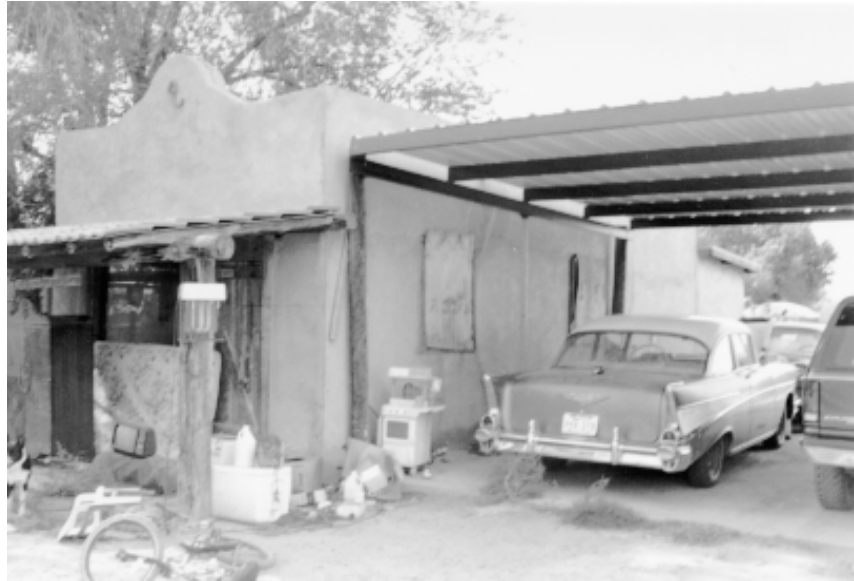
Figure 14. 12296 Cinnabar Road, northern building.

A previous report notes that the latter building once served as a residence and appears in aerial photographs taken in the 1930s but that it bears no architectural significance (Weedman et al. 1994a:185). The owner estimates that the latter was constructed around 1910.

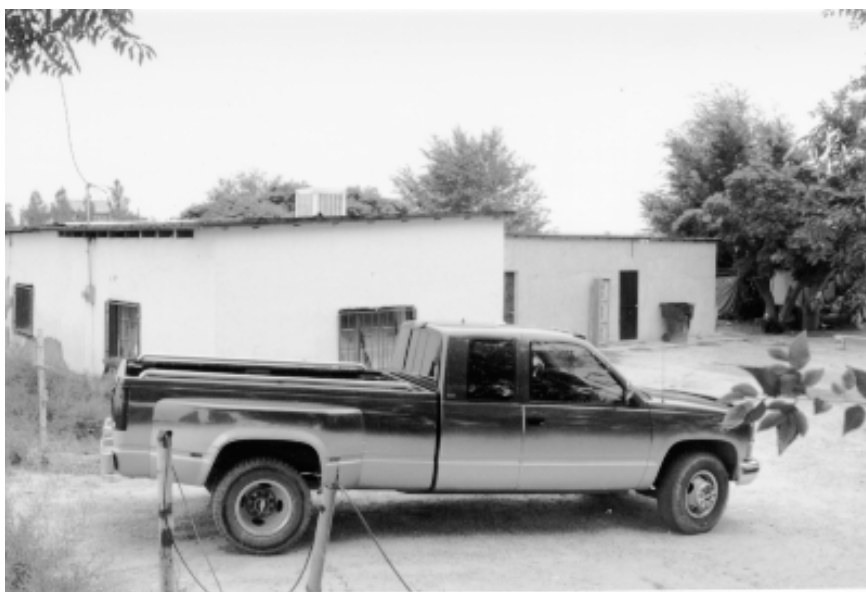
Figure 15. 12013 Glorieta Road.

Located just north of a spur of the San Elizario Lateral along Glorieta Road, the house (Figure 15) lies along a section of the road in which fields and a broken line of houses form a rural linear settlement pattern typical of older roadways in the outlying areas of Socorro and San Elizario. Siberian elms and cottonwoods line the lateral along the south side of the parcel and form a grove around the house. A concrete block pumphouse is located to the southeast of the building. The parcel is currently owned by Eugenio Elicon, and the house, now vacant, is a rental property.

The building has a linear plan with an L shape and is one story with an asphalt shingle shed roof with a slight overhang. Built incrementally, the portion paralleling the road is older and exhibits slight projecting

milled vigas in one portion. The foundation is concrete, and the walls are adobe brick with a white stucco cement coating. All of the windows are multi-light metal casement with thick concrete sills. Wood panel doors appear at each of the three entries, and the doors and entries have been covered with wrought iron security bars.

portion of the building it is estimated to have been constructed in the early 1930s. The building is not considered potentially eligible for individual listing in the NRHP or as a THL. Its location along an older roadway near an irrigation ditch with cotton fields nearby does suggest, however, the contribution the building makes to the rural cultural landscape associated with the area's cotton-based agriculture.

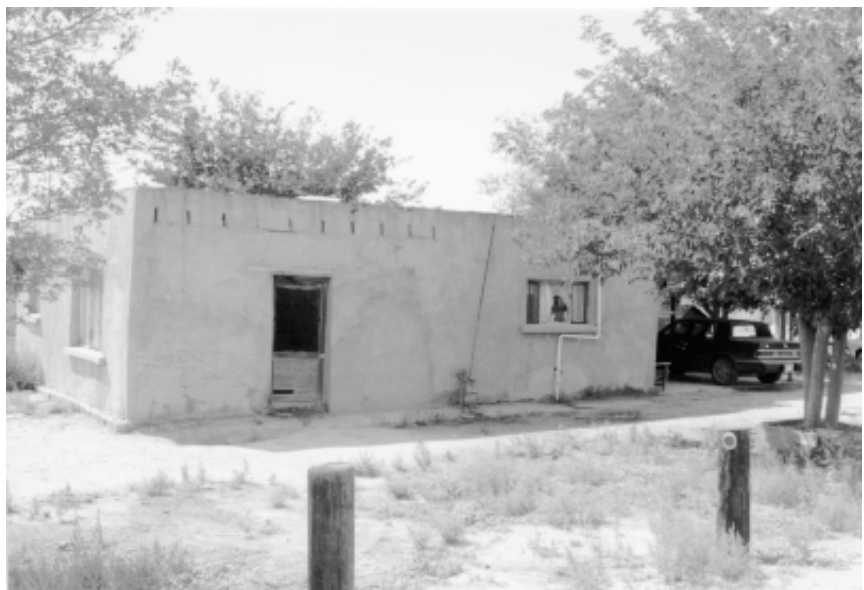
Figure 16. 12272 Glorieta Road.

Facing east onto Glorieta Road, the house (Figure 16) lies along a section of the road in which fields and a broken line of houses form a rural linear settlement pattern typical of older roadways in the outlying areas of Socorro and San Elizario. Siberian elms and cottonwoods form a grove around the house. To the rear of the house are a partially completed concrete block structure and a storage building with the River Drain just beyond the property to the west.

The building exhibits a variety of additions and changes typical of those that local builders have brought to the Mexican-American Rural Vernacular subtype as they seek adapt to their homes to modern needs. It has a square massed plan and is one story with a flat roof and a parapet broken by occasional metal drains. The foundation is unknown, but a protective concrete skirting now surrounds the building. The walls are adobe brick with a cement coating. The south half of the front facade has milled vigas cut flush with the wall. All of the windows are aluminum sliding of various sizes, and all have concrete sills. There are two entries, the front topped by a milled wood lintel. A carport and storage shed have been added at the north side.

A previous report notes that the building appears in aerial photographs taken in the 1930s and considers the property eligible for nomination to the NRHP (Weedman et al. 1994a:237). While the date of construction is unknown but estimated to be about 1910, the substantial alterations to the building lead to the conclusion that it lacks the architectural significance to be considered potentially eligible for individual listing in the NRHP or as a THL.

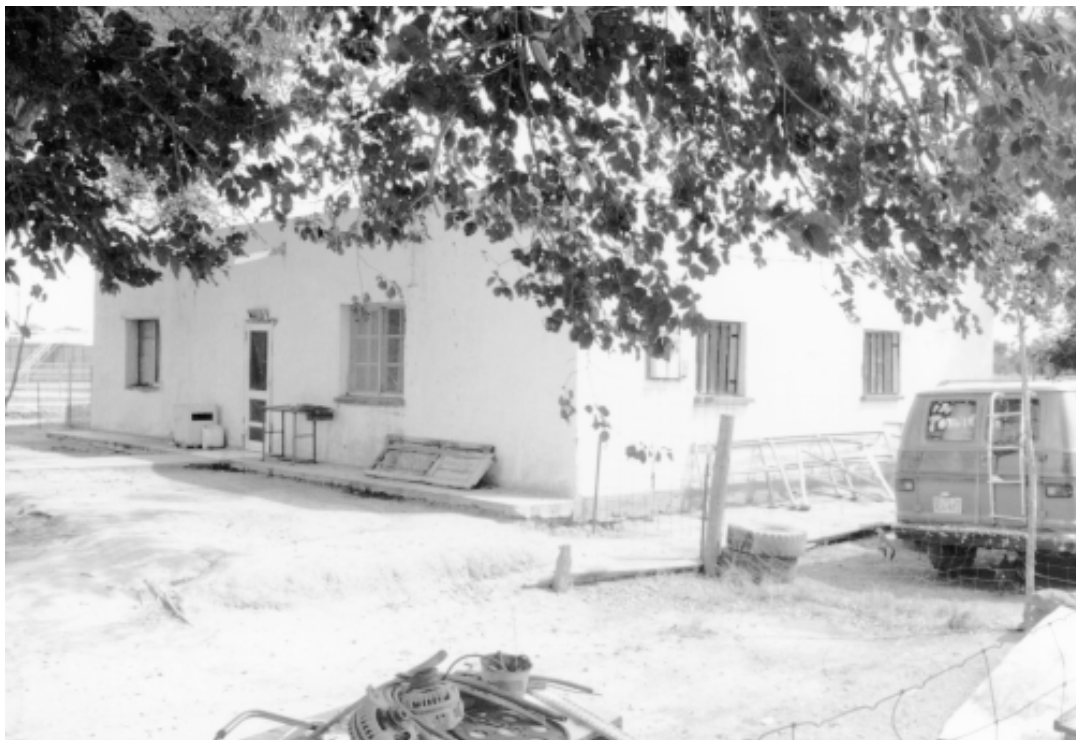
Figure 17. 12303 Glorieta Road.

a parapet broken by occasional metal drains. The foundation is concrete, and the house rests on a grade slightly higher than the surrounding land, suggesting its possible construction on the site of a previous building. The walls are adobe brick with a white stucco cement coating. Fenestration varies and includes aluminum sliding windows of various sizes and fixed windows with metal frames. All have concrete sills, and some have iron security bars. A single entry consists of a multi-panel wood door with a single large light fronted by a screen door.

A previous report describes the building as in poor shape with boarded windows. It also notes that the building appears in aerial photographs taken in the 1930s but does not consider the property eligible for nomination to the NRHP (Weedman et al. 1994a:229). Based on its materials and plan, the estimated date of construction is approximately 1930. The building has been refurbished since the previous survey. It is not considered potentially eligible for individual listing in the NRHP or as a THL. Its location along irrigation and drainage ditches with cotton fields nearby suggests, however, the contribution the building makes to the rural cultural landscape associated with the area's cotton-based agriculture.

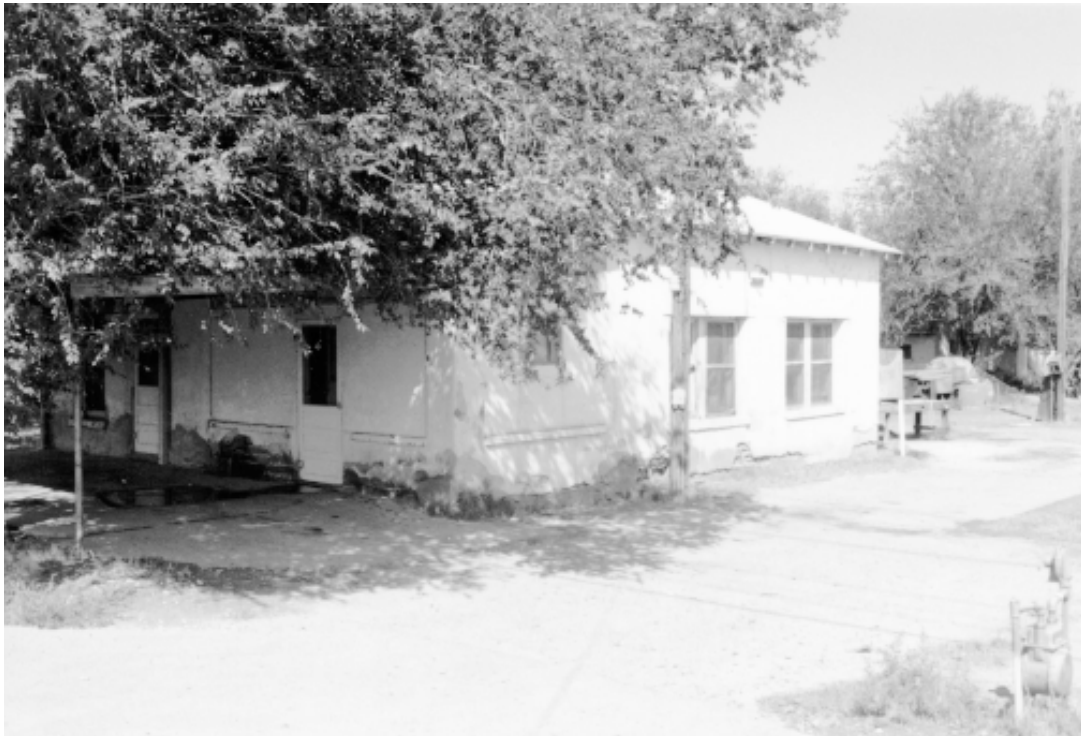
Figure 18. *12011 Socorro Road.*

A porch with a shed roof and metal support posts extends in front of the previous, now-enclosed front porch. The foundation is concrete, and the walls are adobe brick with a white stucco cement coating. The porch infill consists of plywood. Paired double-hung wood sash windows with 1/1 lights and concrete sills line the sides. Other fenestration includes metal casement and fixed wood-framed windows. The three entries have multi-panel wood doors, each with a large light.

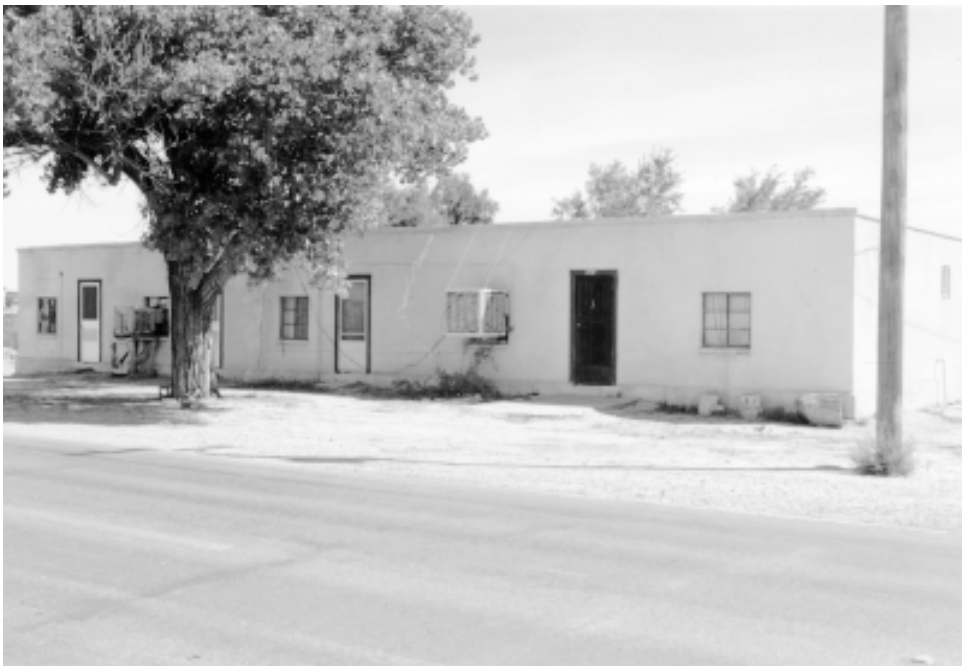
Figure 19. 250 Clint/San Elizario Road.

The rectangular building, a four-unit house for farm workers, exhibits a latter-day variation of the Mexican-American Rural Vernacular subtype (Figure 19). It has a linear plan and is one story with a flat roof and a parapet topped with a slight concrete coping. The foundation is concrete, and the walls are of concrete blocks with a white stucco cement coating. The windows and doors occur in a regular pattern. All of the windows are six-light metal casement with concrete sills. Each of the four housing units has a similar front and rear entry consisting of a multi-panel wood door with a large upper light.

A previous report notes that the building appears in aerial photographs taken in the 1930s and considers the property eligible for nomination to the NRHP (Weedman et al. 1994a:93). Based on its materials and plan, the building most likely dates to the 1950s or later and may stand on the site of a previous structure. It is not considered potentially eligible for individual listing in the NRHP or as a THL.

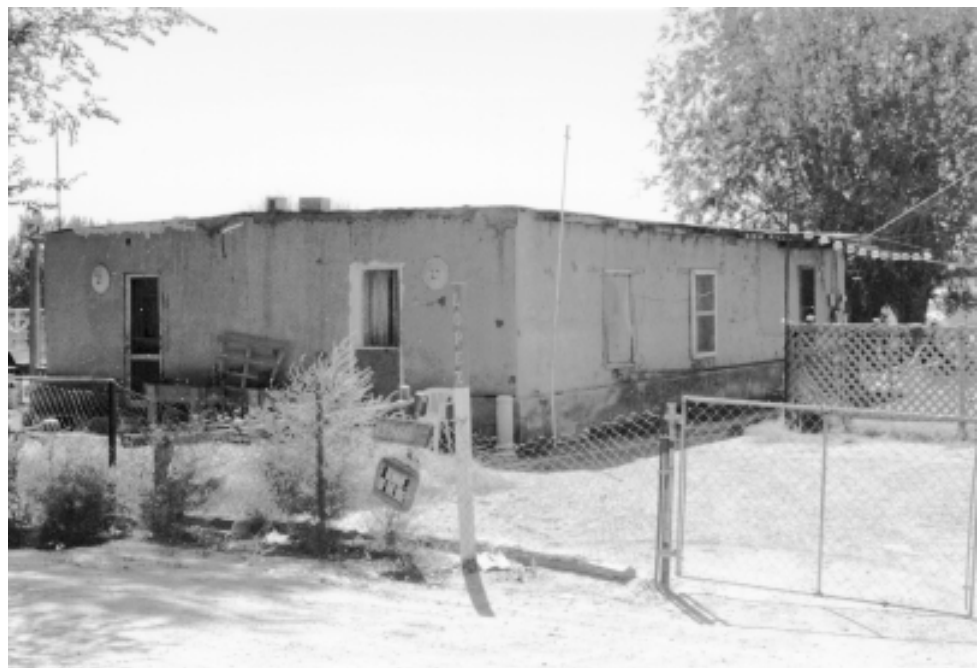
Figure 20. 13560 Chicken Ranch Road.

The building exhibits a variety of additions and changes typical of those that local builders have brought to the Mexican-American Rural Vernacular subtype as they seek to expand their homes and adapt them to current needs (Figure 20). It has a rectilinear massed plan and is one story with an almost imperceptibly pitched asphalt shingle roof with slight overhangs along the sides of the building. The foundation is concrete, and the walls of the original portion of the building are adobe brick with a cement coating. The windows are 4/4 double-hung wood sash. One of the two front entries has been infilled to create an additional window. The door is wood panel with a large upper light. An addition consisting of horizontal board walls appears at the southeast rear corner of the house.

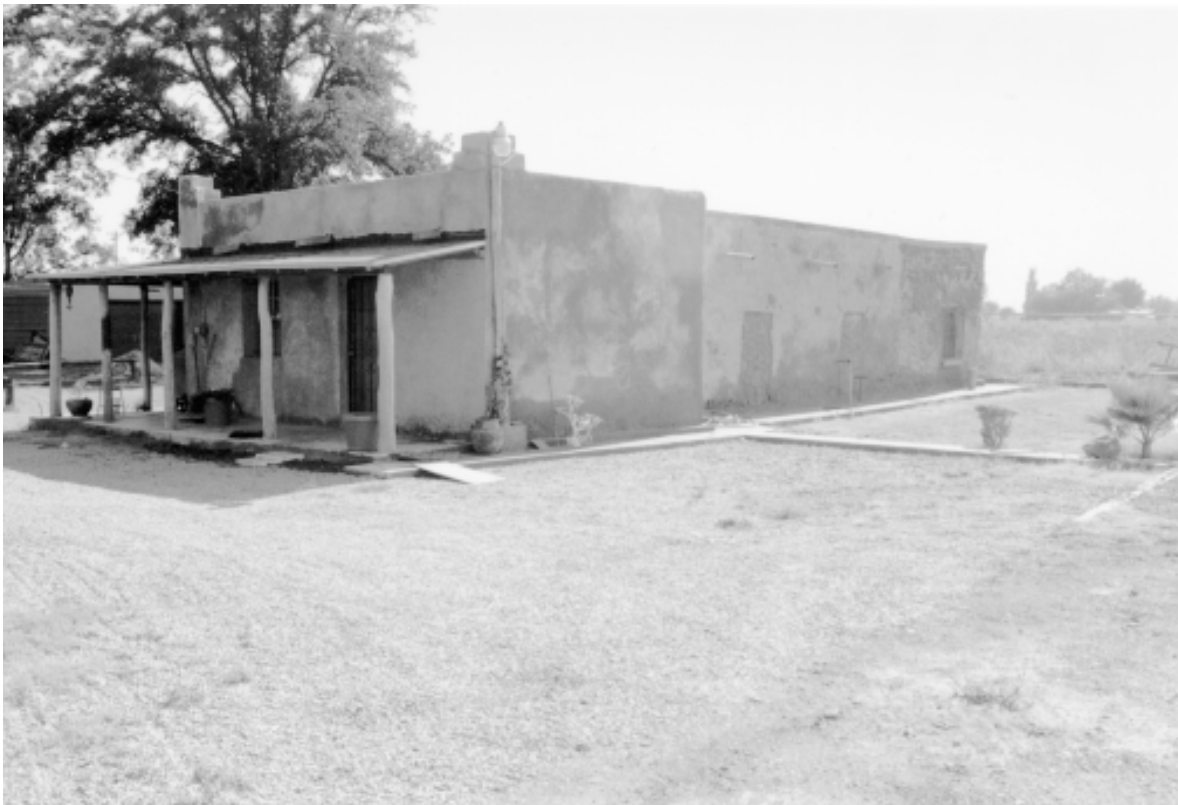
Figure 21. *12148 Socorro Road.*

and large log supports. The porch extends along the inner side of the L. Sections of the rear portion of the building where the stucco coating has been removed reveal adobe bricks and, at the rear parapet, concrete masonry blocks. A concrete coping has been added to rear portions of the parapet, and a concrete skirting surrounds the building. The exposed vigas noted in the earlier evaluation have been removed. Although the majority of windows have been filled in, those remaining are 6/6 double-hung with wood sashes and concrete sills. A wood panel door with iron security bars marks the front entry.

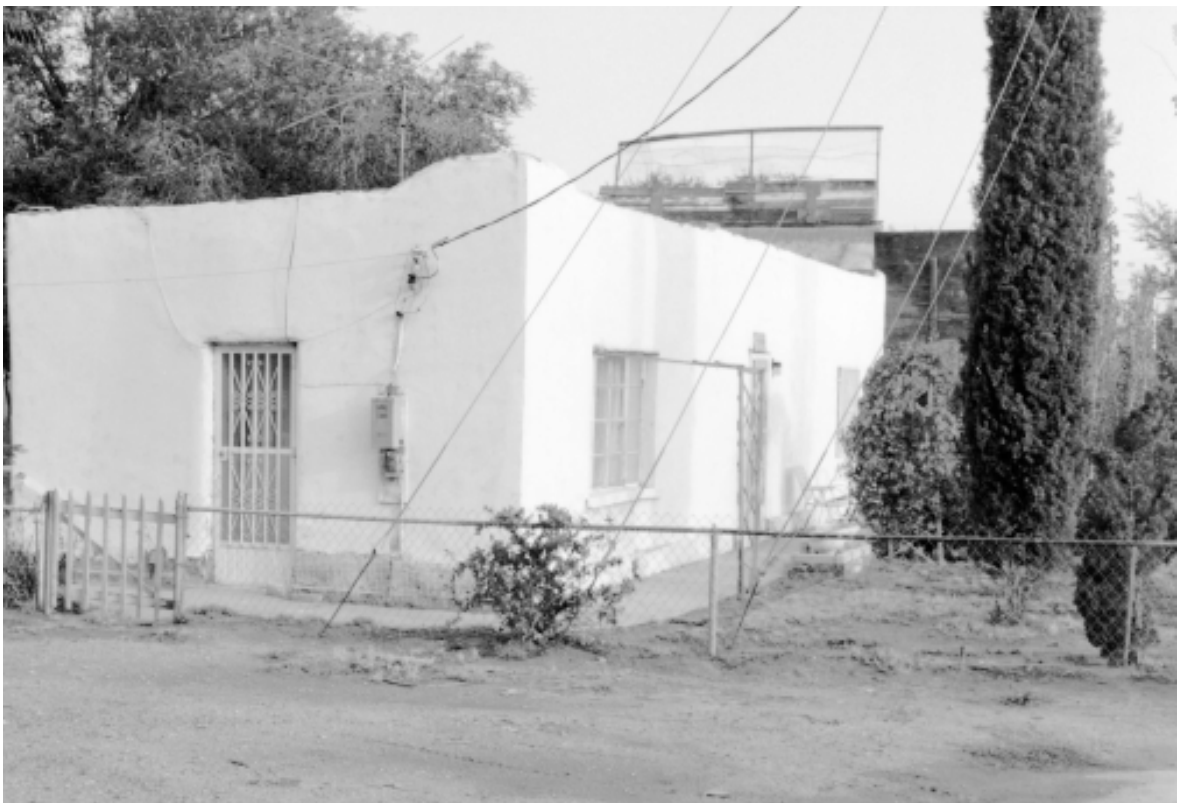
Figure 22. 12212 Socorro Road.

The building has a linear plan with an L shape. One story with a flat roof and a parapet with decorative stepping at the front corners, it exemplifies the Mexican-American Rural Vernacular subtype of housing (Figure 22). Although the foundation material is unknown, a concrete protective skirting extends around the perimeter of the house. The walls consist of adobe bricks with a white stucco cement coating. The front

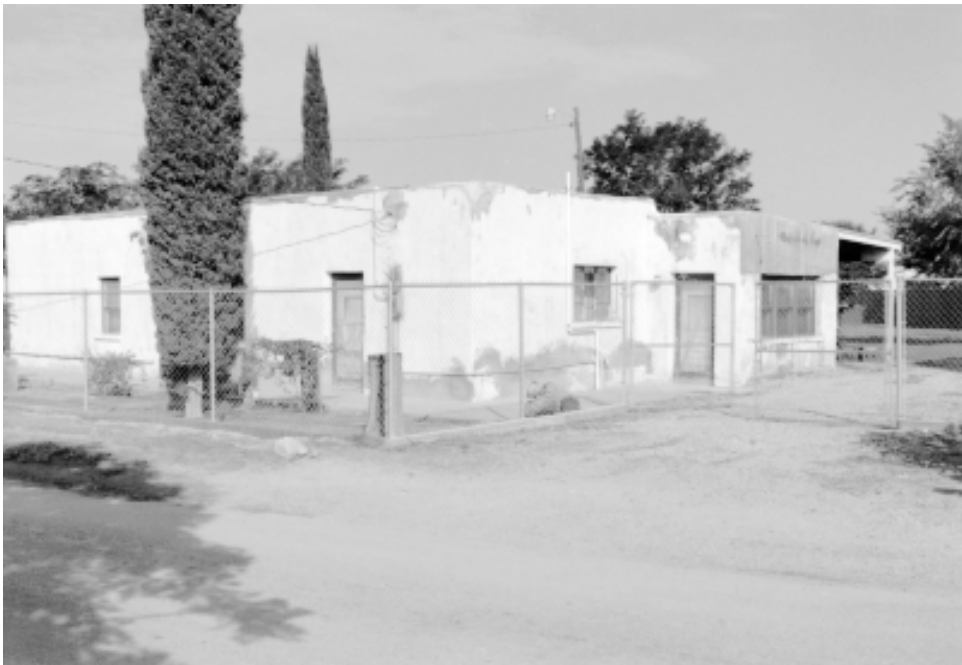
Figure 23. 865 Borrego Road.

The additions evident in the Panfilo Duran House illustrate how many residences built in the Mexican-American Rural Vernacular subtype have grown to meet the changing needs of their occupants (Figure 23). The building now has a rectilinear massed plan as subsequent additions to the rear of the house have augmented its former linear plan. The original linear core of the house, however, is evident at the front of the building. The building is one story with a flat roof; the stepping down of the parapet to the rear indicates the incremental growth of the house. Although the foundation material is unknown, the owner indicated that a protective concrete skirting had been added to

the perimeter of the house to reduce the wicking effect on the adobe bricks. The walls consist of adobe bricks with a white stucco cement coating. The windows of the original linear portion of the house have been replaced with metal casement windows with concrete sills; fenestration in the rear additions consists of grouped double-hung and aluminum sliding windows. The three entries have wood panel doors, each with a large square light. A porch with a shed roof and metal support posts is located at the northeast rear corner of the building.

Although the project team was unable to secure a copy of earlier evaluations of the property, its present owner, Angie Duran, noted that when her grandfather purchased the property from E.G. Maese in 1914 the linear core of the house served as the family's residence. She estimates that the house may have been built around 1900, a date consistent with its plan and materials. She also recalls that until after mid-century her grandfather farmed the land immediately around the house and that cotton fields surrounded his small farm. Earlier investigators had cut a small, 1-x-1-ft cross-section from the ceiling to examine the unmilled vigas and latillas that compose the original roof. The building is not considered potentially eligible for individual listing in the NRHP or as a THL.

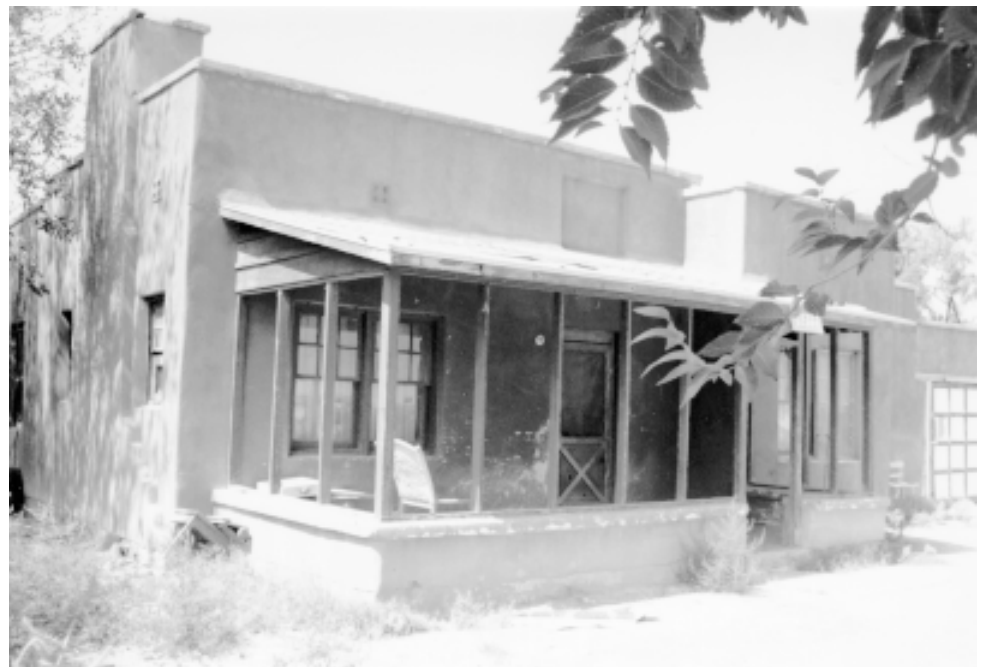
Figure 24. 12300
Camino de la
Rosa Road.

The building's details suggest a hybridization of the Bungalow and Spanish Colonial Revival subtypes (Figure 24). It has a massed plan with an attached garage added on the north side. The building is one story with a flat roof and a stepped parapet with a concrete coping. The foundation consists of brick and mortar, and the walls are adobe brick with a brown stucco cement coating. An exterior chimney flanked by small 4/4 double-hung wood sash windows and several paired 6/1 double-hung wood sash windows comprise the house's bungalow elements. Alterations include double-hung metal sash windows. The front

A previous report notes that Thomas Garcia owned the property from 1883 to 1920 and assigns his name to the house. It also notes that the building appears in aerial photographs taken in the 1930s but does not consider the property eligible for nomination to the NRHP (Weedman et al. 1994a:201). Based on its materials and plan, the estimated date of construction is the mid-1920s, when the property was owned by W. A. and Thelma Montgomery, the likely owners of the property when the house was constructed. With its additions, the building is not considered potentially eligible for individual listing in the NRHP or as a THL. Its locations in an area formerly used for cotton production, however, suggests the contribution the building makes to the rural cultural landscape associated with the area's cotton-based agriculture.

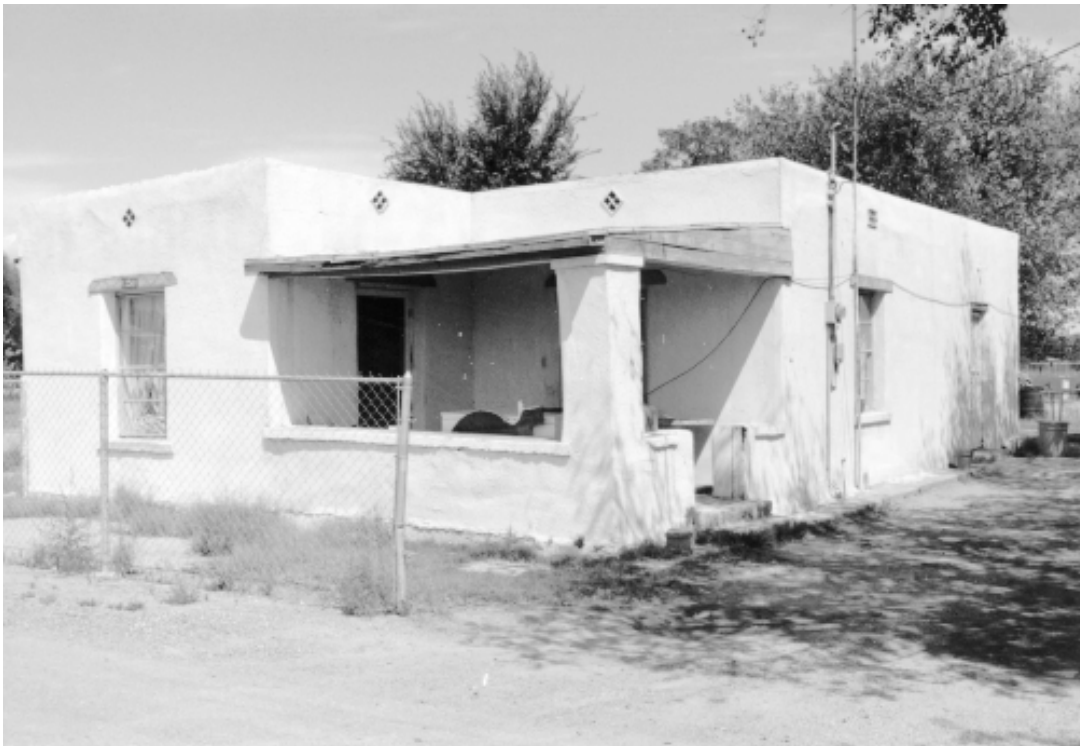
Figure 25. 12501 Caballero Road.

The building's details include a modest use of elements characteristic of the Spanish Colonial Revival subtype (Figure 25). It has a massed plan with a slight L shape and is one story with a flat roof. A parapet is punctuated with decorative hollow clay tile brick vents and with exposed milled vigas on the west side. The foundation is concrete, and the walls are adobe brick with a white stucco cement coating. Single windows are double-hung with metal sashes. Each window has a concrete sill and a wood lintel with a decorative zigzag carving

similar to those found on lintels at the house at 12337 Socorro Road. A wood panel door at the front entry faces on a large cut-out porch with a shed roof. The low porch wall topped with a concrete coping and a massive stucco-coated support post are analogous to porch supports found in the bungalow subtype popular in the 1910s and 1920s and suggest how local builders freely borrowed details from other subtypes as they worked.

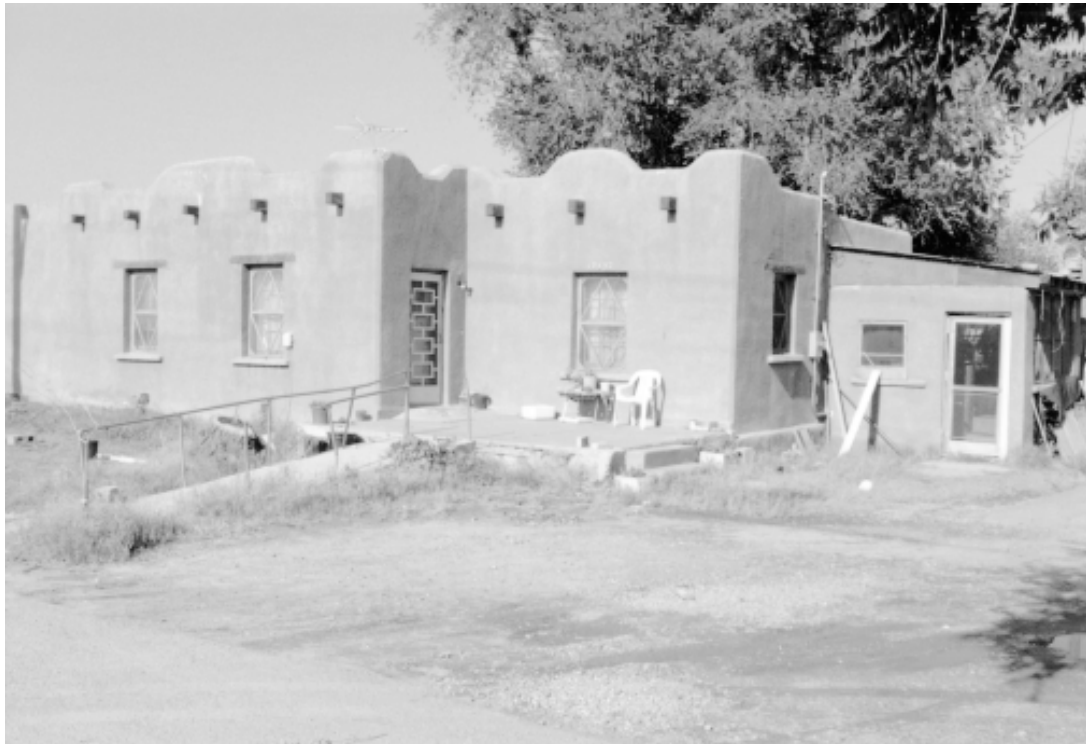
Figure 26. *12337 Socorro Road.*

The building's details include a modest use of elements characteristic of the Spanish Colonial Revival subtype, especially in the subtype's use of Pueblo Revival details, relatively rare in the area (Figure 26). It has a massed plan with a slight cutout along the main facade to create a concrete porch at the main entry. The building is one story with a flat roof and a curvilinear parapet stepped down at the porch marking the rear entry. Exposed milled vigas line the facade. The foundation is concrete, and the walls are adobe brick with a brown

stucco cement coating. Single windows are 6/6 double-hung with wood sashes and appear to have their original screen windows. Each window has a concrete sill and a wood lintel with a decorative zigzag carving similar to those found on lintels at the house at 12501 Caballero Road. A wood panel door with three small lights faces on the unenclosed front porch. A rear porch with an added storm door and shed roof leads to the rear yard. A small addition with a shed roof is located at the rear northwest corner of the house.

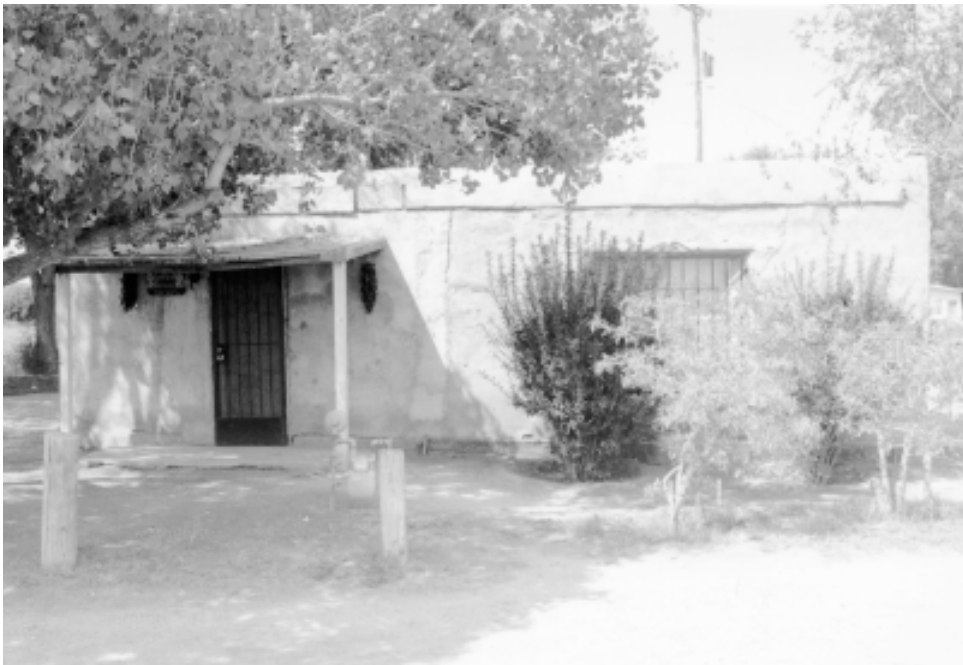
Figure 27. 12636 Camino de la Rosa.

The building has a linear plan with an approximate L shape. One story with a flat roof and a parapet with occasional projecting metal drainage pipes, it exemplifies the Mexican-American Rural Vernacular subtype of housing. The various materials and small setbacks marking different sections of the house suggest that it was built incrementally. The foundation is concrete, and an additional concrete skirting has been added as part of a recent refurbishing project. The entire house is of adobe brick with a cement coating. The front portion, a two-unit rectangle, has exposed milled vigas cut flush with the wall. Porches with concrete floors, shed roofs, and 4 x 4 wood support posts are located at both the front and rear entries.

Relatives of Dora Vargas who live nearby stated that the house had been deteriorating and was recently refurbished. The date of the construction of the house is listed as 1936 in a previous report (HHM 1994:151) The building has been altered considerably and is not considered potentially eligible for individual listing in the NRHP or as a THL.

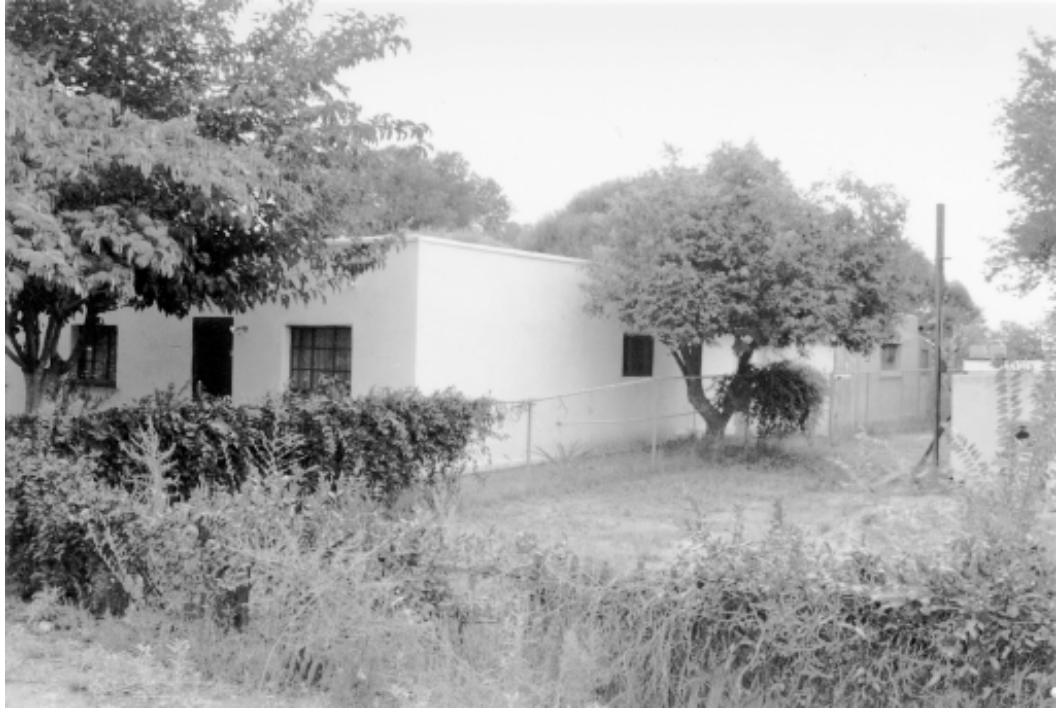
Figure 28. 1040 Sanchez Road.

Located on the southeast side of Sanchez Road and set back from the road about 20 feet, the Luis and Maria Nuñez House (Figure 28) lies in a rural agricultural area in which a loose line of residences are interspersed with large field parcels. A low chain-link fence separates the front yard from the road, and the surrounding yard is landscaped with low-lying bushes, flowerbeds, and mulberry and mimosa trees. The house is in good condition.

The additions evident to the rear of the house illustrate how many residences built in the Mexican-American Rural Vernacular subtype have grown to meet the changing needs of their occupants. The building now has a massed plan with irregularities as subsequent additions to the rear of the house have augmented its former linear plan. The original rectangular core of the house, however, is evident at the front of the building. The building is one story with a flat roof. A parapet with a concrete coping lines the original portion of the house and its first addition; it then steps down at subsequent additions. The foundation is concrete. The walls of the original section and first addition consist of adobe bricks with a white stucco cement coating. The walls of the rear addition are brown stucco cement over wood framing. Fenestration varies and includes paired 1/1 double-hung wood sash, fixed, metal casement and aluminum sliding windows, all with concrete sills. The front entry consists of a multi-panel wood door with an exterior wrought iron security door.

Although the project team was unable to secure a copy of earlier evaluations of the property, Cecelia Reyes, the daughter of its present owner, noted that when she first lived in the house in 1949 it consisted only of its two-room linear core. Based on her recollection of her father who grew up in the vicinity, she estimates

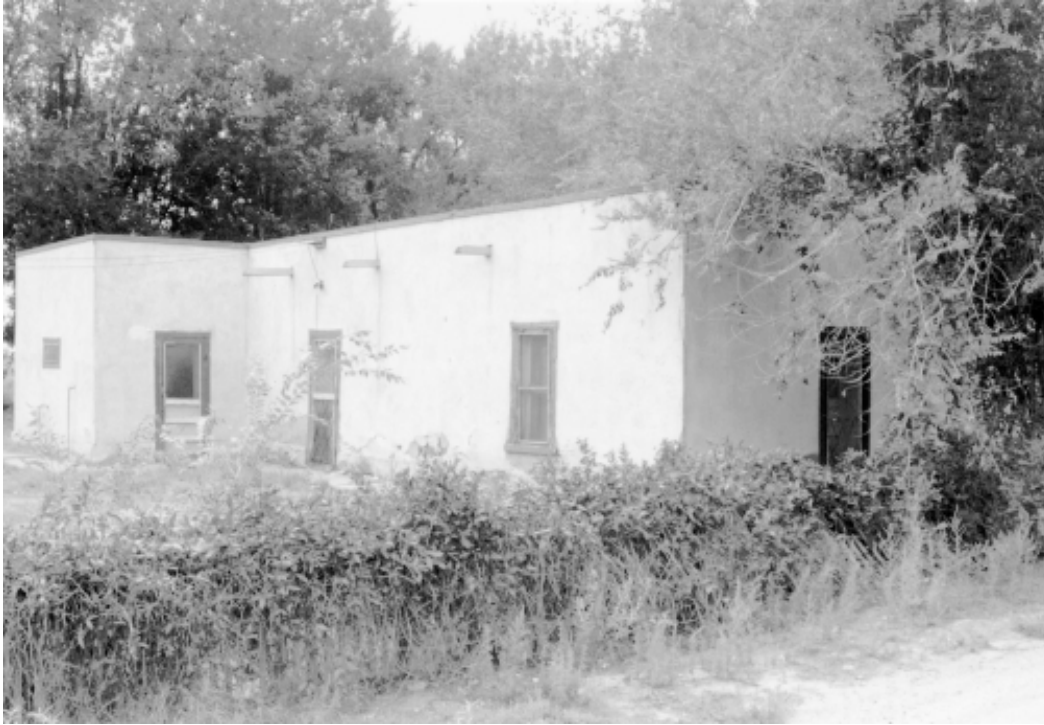
Figure 29. 1048 Sanchez Road.

Located on the southeast side of Sanchez Road and set back from the road about 20 feet, the Leonardo and Francisca Sanchez House (Figure 29) lies in a rural agricultural area in which a loose line of residences are interspersed with large field parcels. A low picket fence covered with vines separates the front yard from the road, and the surrounding yard, landscaped with occasional low-lying bushes, is set in a grove of Siberian elms. A small wood outbuilding is located to the rear of the house. Cecelia Reyes, the niece of the owner, noted that although the house continues to be occupied it is in need of repair.

The house is a good example of the Mexican-American Rural Vernacular subtype built around the turn of the century. It employs an irregular linear plan with multiple discreet entries. The building is one story with a flat

roof and a parapet with a concrete coping. Several metal drainage pipes project from the parapet. The foundation is earthen with a protective concrete skirting and sidewalk later added. The walls consist of adobe bricks with a white stucco cement coating. All of the windows are double-hung wood sash with 1/1 and 4/4 lights, and all have wood trim and concrete sills. The six doors are wood panel, each with a large square light.

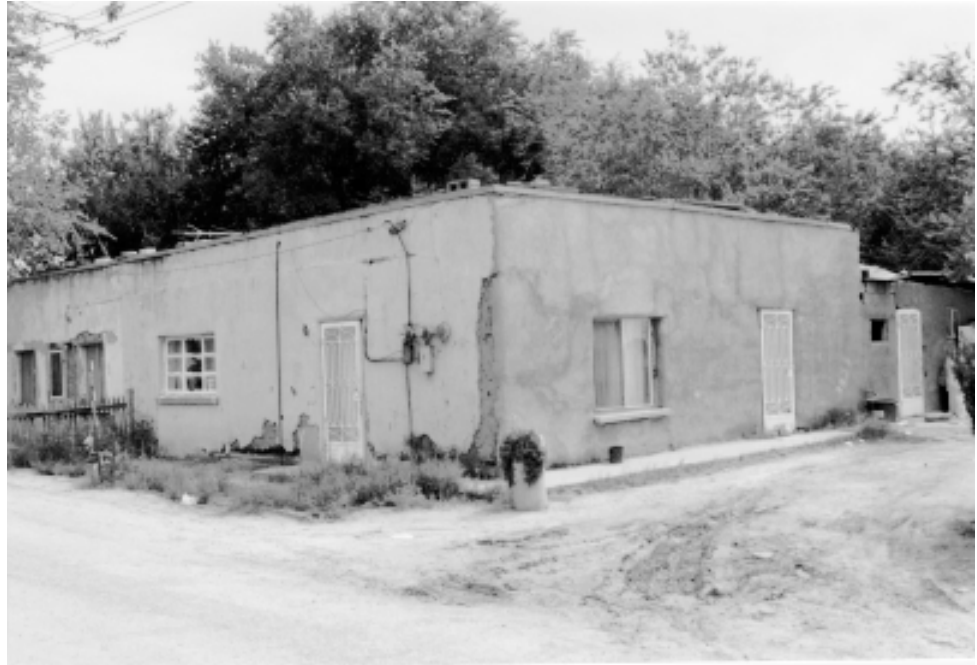
Figure 30. 1064 Sanchez Road.

protective concrete skirting has been added around the entire building. The walls of the original portions of the building are adobe brick with a cement coating; the walls of the northeast addition are adobe brick. Fenestration is varied and includes aluminum sliding, metal casement and double-hung metal frame windows, most of which have concrete sills. There are six entries, several with a multi-panel wood door with a single large light, and three with exterior metal security doors.

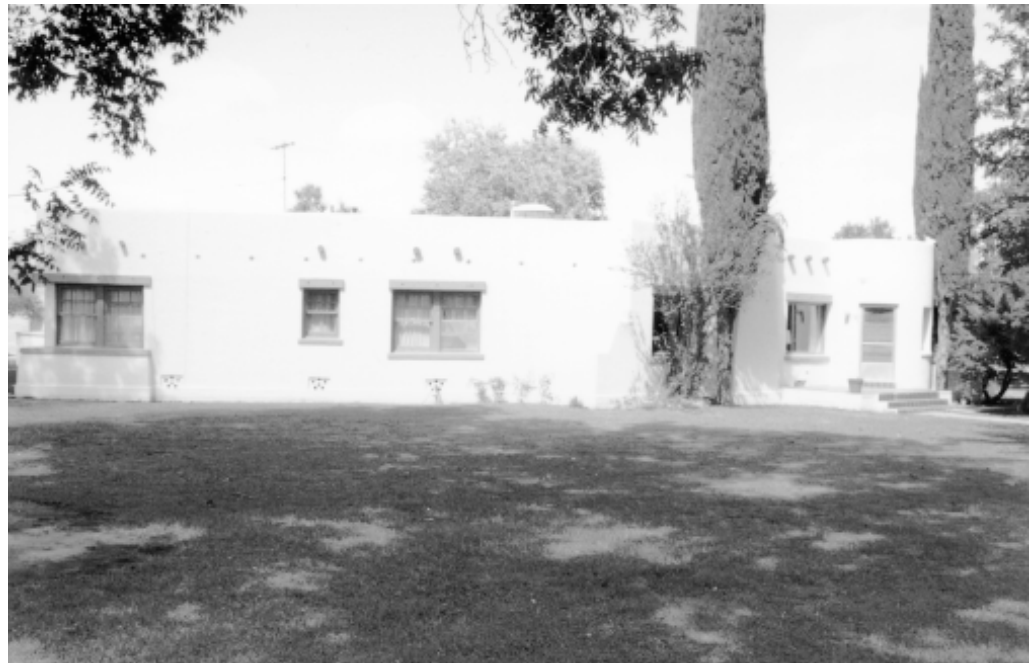
Figure 34. 10604 Sparks Circle.

The property was included in a previous survey of the silos associated with the former DeGroff Ranch when it was listed as SSE 78 A (Weedman and Brown 1993:63). The report noted that the DeGroff farmhouse was removed in the 1940s and that only the silos remain. According to the present owner, Peyton Sparks, the house was built in 1943 on the site of the former house. The building is an interesting example of an effort to adapt Pueblo Revival elements such as wood lintels and vigas as ornamental features to a local residence. The building retains a good deal of architectural integrity and would be eligible for listing in the NRHP or as a THL in a Multiple Property nomination treating the area's early twentieth-century agricultural history.

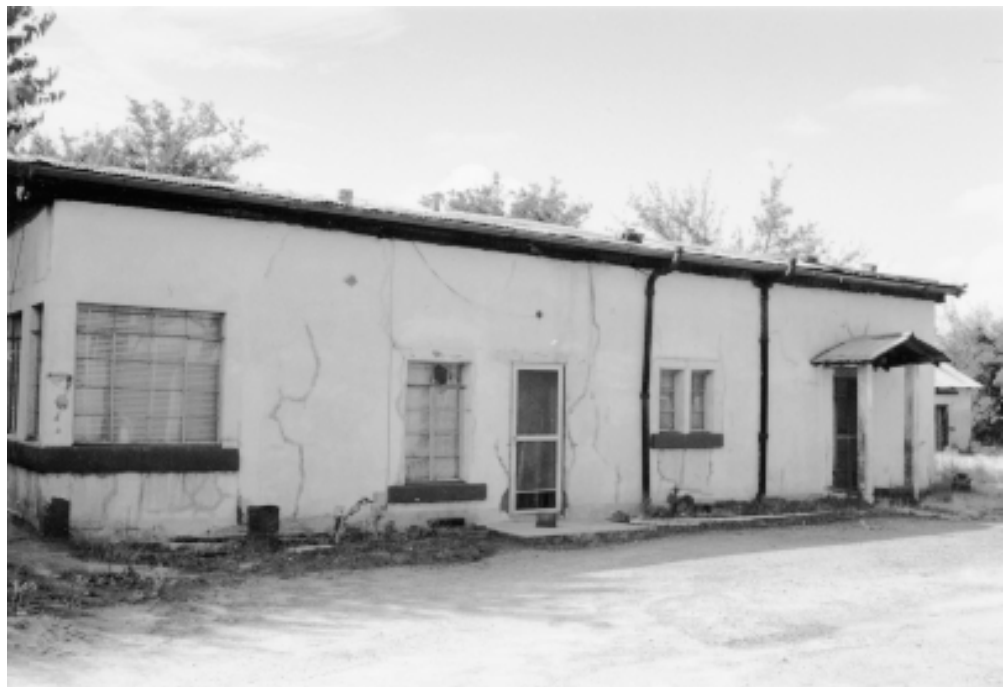
Figure 36. 9892
North Loop Road.

Earlier documentation of the property holds that the building was constructed about 1922 and employed a U plan in which the recessed portion was later filled in (HHM 1994:160). The report also notes that the residence was a part of a dairy farm, "the oldest such operation in the Socorro area." Madeline Burrus Boswell, the daughter of Louis J. Burrus, confirmed that her father constructed the residence about 1930 and that although the original wood frame windows have been replaced the building retains its original plan. She also clarified that her father was not specifically a dairy farmer but did keep a few milk cows, selling their milk locally. Although the building lacks the architectural significance to be considered potentially eligible for individual listing in the NRHP or as a THL, its role as an early farm residence and its location as a part of the linear settlement and field system pattern along North Loop Road suggests the contribution the building makes to the rural cultural landscape associated with the area's historic agriculture.
