Alamo Arbor Construction and Electrical Conduit Installation Monitoring, San Antonio, Bexar County, Texas

Texas Antiquities Permit No. 6738

Prepared by:
Center for Archaeological Research
The University of Texas at San Antonio
One UTSA Circle
San Antonio, Texas 78249-1644
Technical Report, No. 57

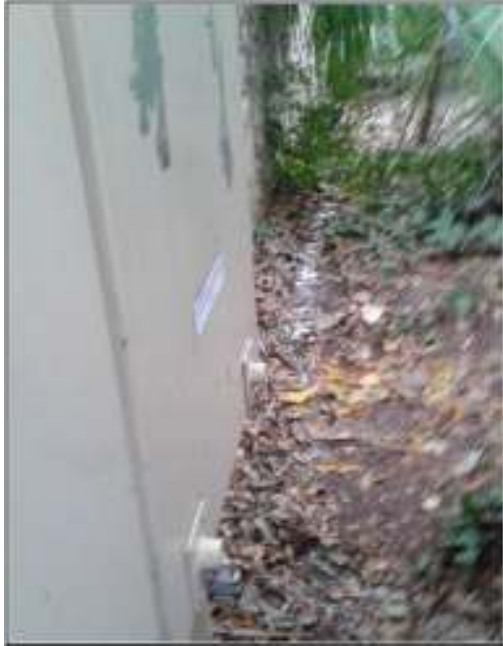
Figure 4-2. Existing circuit breaker box on north wall of complex and chalk-line indicating orientation of proposed trench.

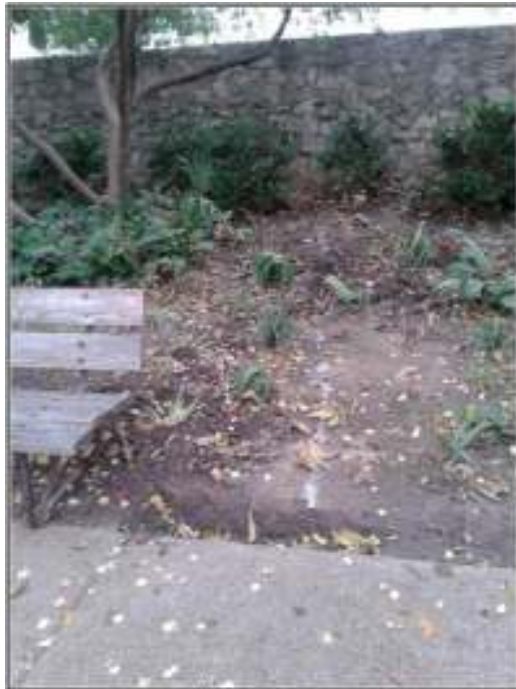
Figure 4-3. Orientation of proposed electrical line from north wall of complex to first sidewalk.

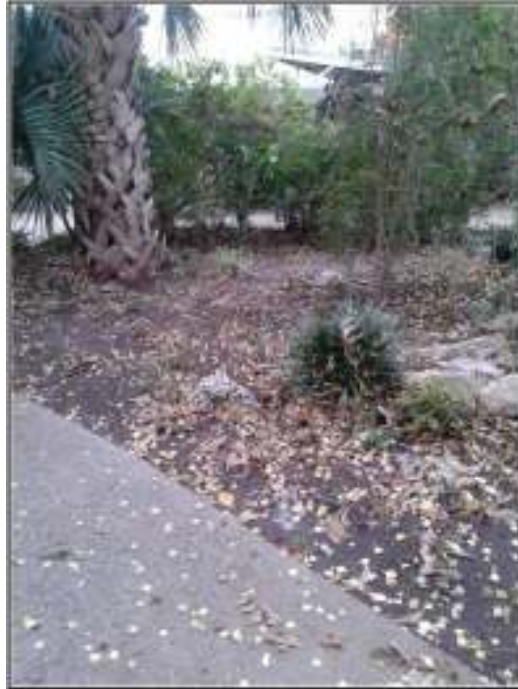
Figure 4-4. *Orientation of proposed electrical line across second flowerbed. Note the corner of the Arbor roof in the background.*

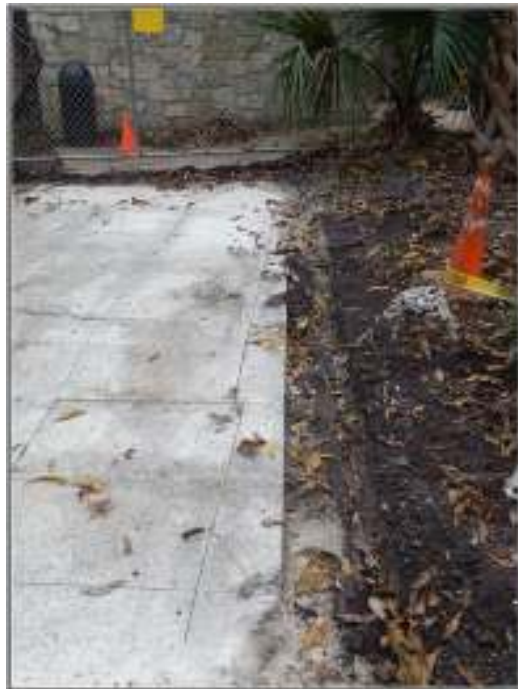
The trench extended from the eastern entrance along the north wall to the northern edge of the previously existing Arbor (Figure 4-1). The route for the trench followed alongside the north wall of the Alamo complex, turned east, and crossed the existing landscaping beds (Figures 4-2 and 4-3), the concrete sidewalk, an existing sidewalk, an additional area of landscaping (Figure 4-4), and a second sidewalk before it arrived at the northwest corner of the Arbor. Originally, plans called for the trench to be approximately 18 inches in depth. However, since this depth could have potentially reached below the depth of disturbance due to landscaping and fill, the contractor sought permission to install the electrical conduits at a shallower depth. At the recommendation of the Texas Historical Commission (THC), depth not exceeding 12 inches below the current surface was to be exempt from monitoring. The requested shallower depth was granted to the electrical contractor with the condition that the conduits be covered by concrete to prevent accidental damage. Therefore, the actual depth of the trenches was between 10 and 12 inches below the surface (Figure 4-5).

Figure 4-5. *Trench for electrical conduit along first sidewalk before it was removed.*

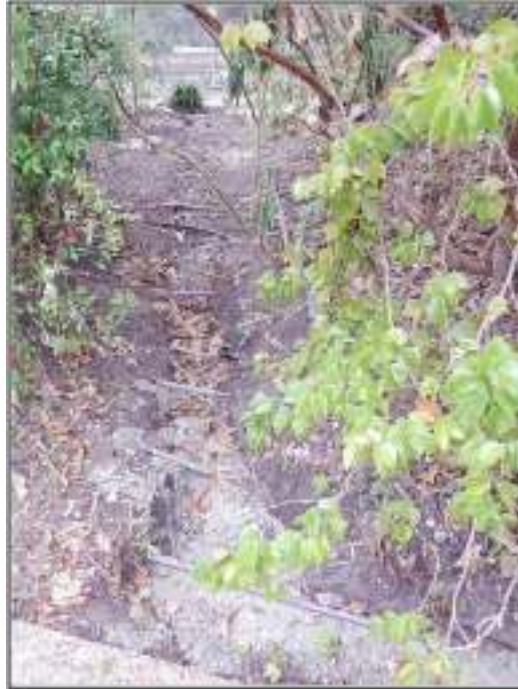
The initial excavation of the trench along the north wall and across the flowerbed was monitored to ensure that the contractor did not exceed the 12-inch depth. The monitoring halted when the trenching arrived to the first sidewalk since the contractor needed time to remove the concrete to continue the trench. The remaining portion of the trench was inspected after it had been excavated. No modern or historic artifacts were noted in the back dirt. The presence of numerous pre-existing electrical lines and plumbing pipes associated with the sprinkler system indicated that the area was heavily impacted prior to the present project. The proposed conduit was to run just beneath the existing utilities and irrigation lines (Figure 4-6).

Figure 4-6. *Conduit trench with pre-existing utility and irrigation lines, looking toward north wall of the complex.*

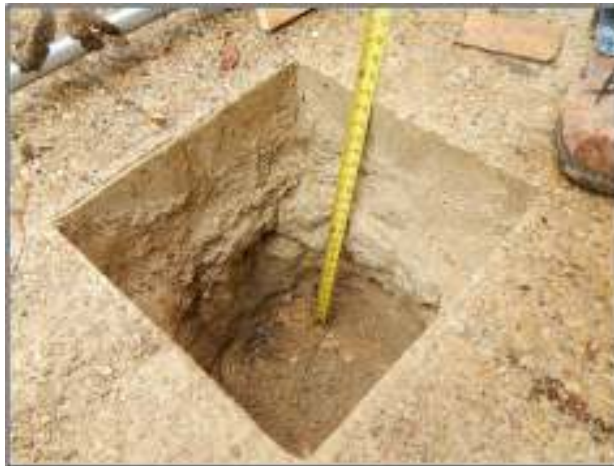
Prior to the excavations for the post holes, the concrete sidewalk was mechanically sawed. Each post hole had a 24-x-24-inch section of concrete removed (Figure 4-8). The concrete appeared to extend to approximately 5 inches below the surface. The base of the concrete was reinforced with rebar (Figure 4-9). Beneath the concrete was a layer of very light yellow caliche base. Below the base, the post holes encountered dark brown clay loam that represented the undisturbed soil of inside the Alamo complex (Figure 4-9). The excavators were instructed to halt the excavations at the top of this zone.

Figure 4.8. Post hole with scale showing depth of excavation. Note small area of dark brown soil along one edge of base.

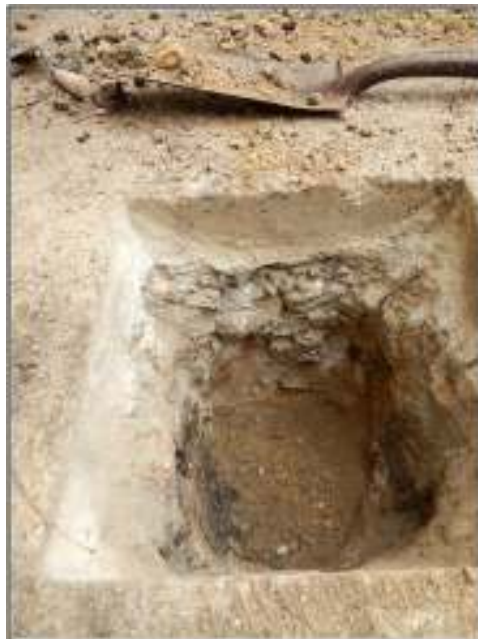
Figure 4-9. Reinforced concrete and fill in post hole. Note the small patch of dark brown clay loam in bottom of the unit.

During the monitoring, no significant cultural deposits were encountered. No artifacts were collected during the project. Because of the variance obtained by the electrical contractor to permit shallow conduit installation, the conduit trench excavation did not reach below the landscaping matrix. The excavation of the three post holes only penetrated to the base of the existing fill overlying the undisturbed clay loam found within the Alamo complex, therefore, the post holes did not impact undisturbed deposits.
