Archaeological Survey and Archival Research of the Naegelin Tract (41BX1600) in San Antonio, Bexar County, Texas

by
Jennifer L. Thompson
and
Antonia L. Figueroa

Center for Archaeological Research
The University of Texas at San Antonio
Archaeological Survey Report, No. 354
2005

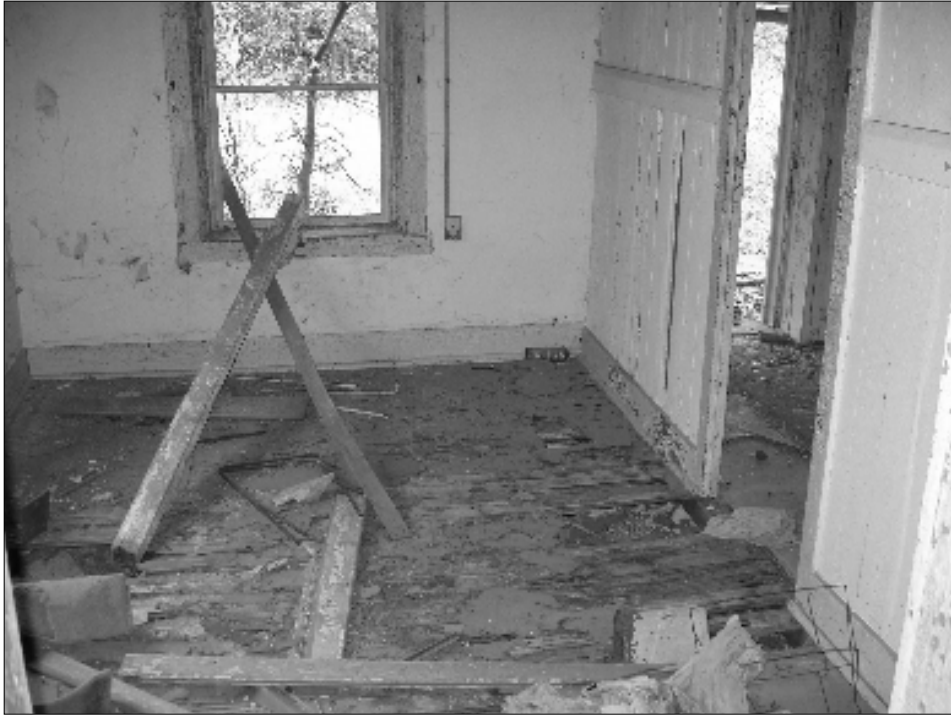
Figure 16. *Detail of room division and condition of flooring (Resource 1).*

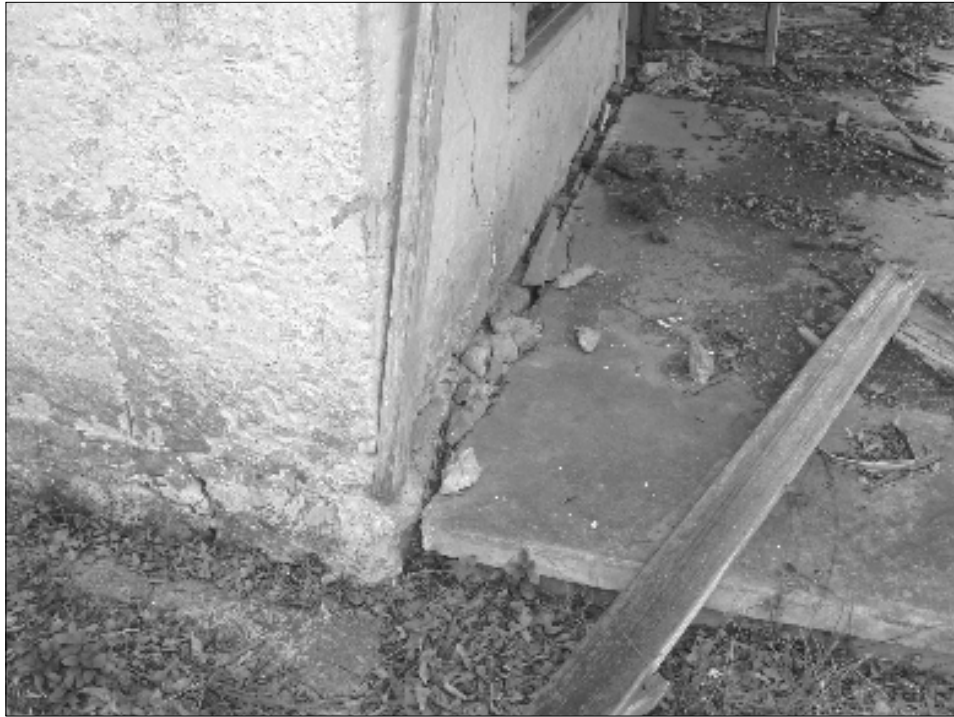
Figure 18. *Porch floor and house foundation (Resource 1).*

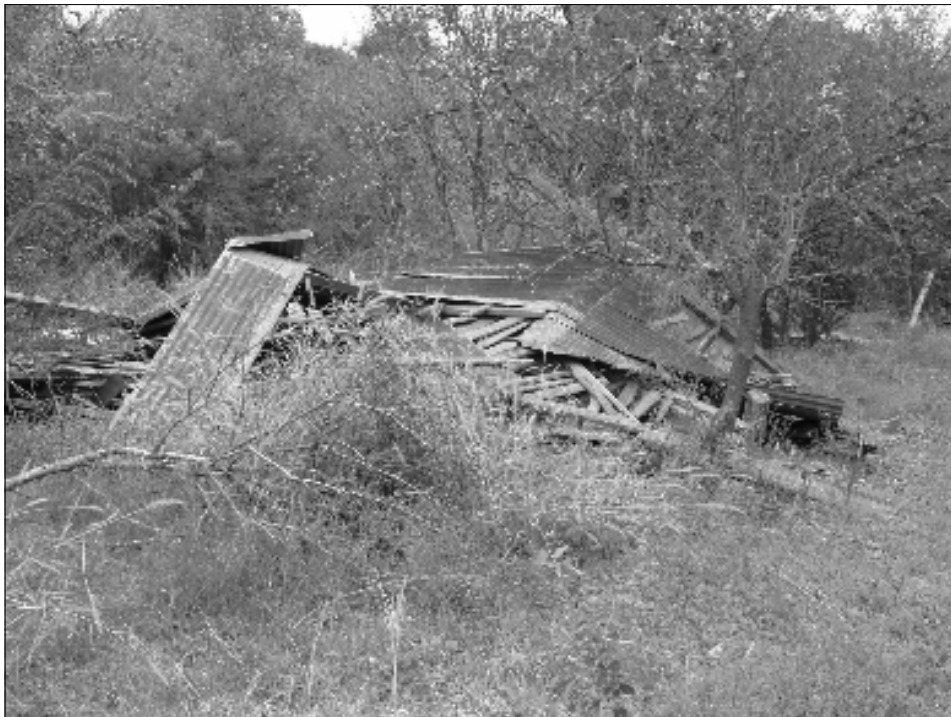
This is a third collapsed wood-frame structure with a corrugated metal roof. It is northwest of Outbuildings 1 and 2 (Figure 24). Resource 4 does not retain historic integrity.

Figure 24. *Outbuilding 3 (Resource 4).*

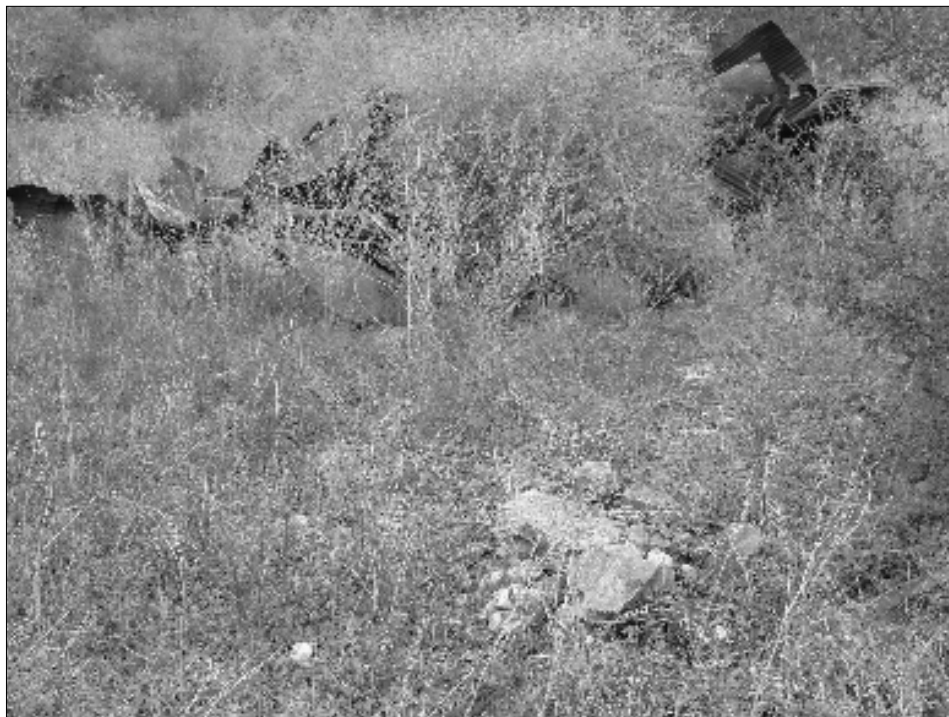
All that remains of Outbuilding 4 is a rock foundation (Figure 25). The remnant wood and metal were likely placed in one of the two trash heaps in the backyard of the house. The materials represent the remains of the main barn of the homestead. Resource 5 does not retain historic integrity. This outbuilding does appear on the 1939 aerial photo, therefore, it is likely that the foundation is minimally 50 years old.

Figure 25. *Outbuilding 4 (Resource 5)*.

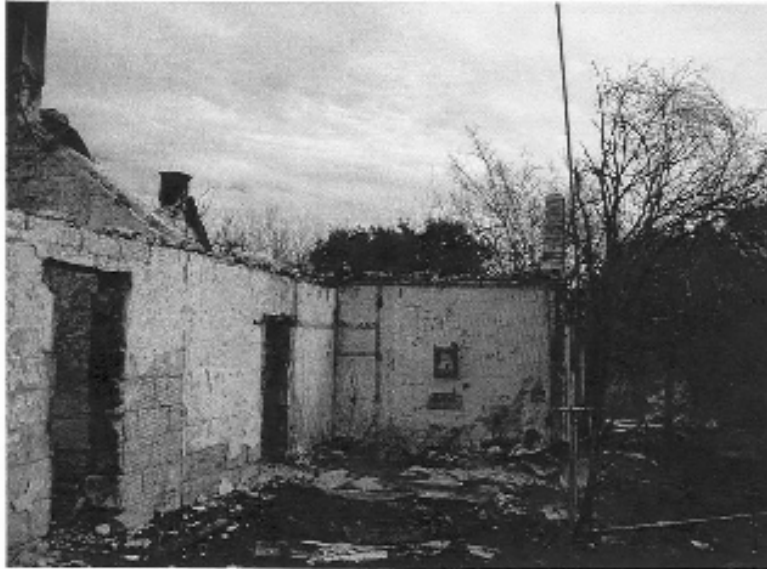
PHOTO 1: View of structure after the fire in January 2005.

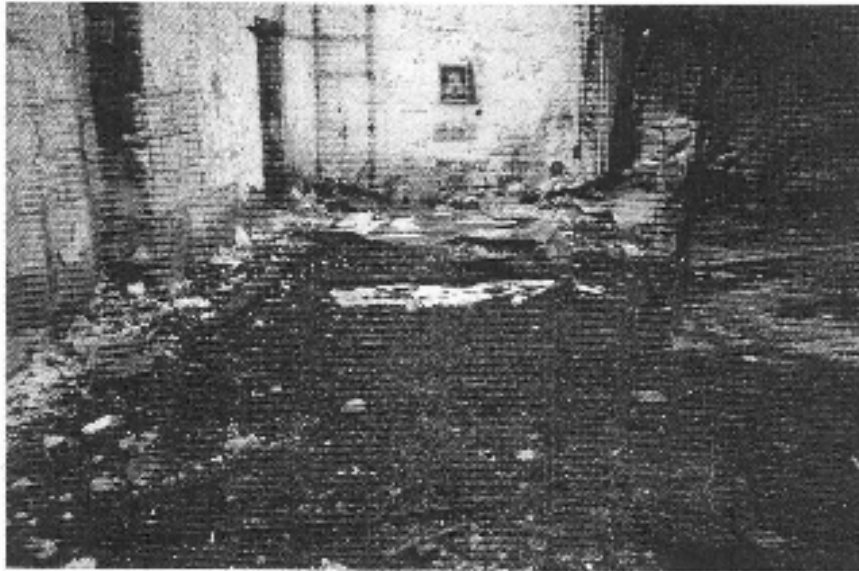
As a result of the fire, the asbestos containing materials was reduced to charred debris (See Photos 9, 10 and 11). Due to the historical significance, it was determined that it would be possible to shore the structure in order to complete the asbestos abatement if completed on a timely basis. If subjected to rain events, this option would not be possible due to the rain effects on the mortar of the limestone which would significantly reduce the structural integrity. On February 23, 2005 the structure was still in a condition to shore (See Photo 12).

PHOTO 9: View of asbestos containing debris present within the footprint of the structure after the fire.

It is strongly recommended that the remaining structure be demolished as soon as possible from the exterior under NESHAP's regulations governing structures containing asbestos. The debris will require disposal as asbestos containing material. This is recommended since this structure is now considered to represent a significant safety risk to the public since the area is not secure. It is suspected that vandals set the fire since the structure was also tagged with paint from the near by residential development. It is also suspected that vandals returned to cause the most recent destruction of the south wall. If vandals return again, they in fact would significantly endanger themselves if they attempt further destruction. In addition, if any homeless individuals seek shelter during inclement weather or strong winds, they would be at great risk due to not only the collapse of walls, but also exposure to asbestos. Therefore any delay in demolition is considered to greatly increase the safety risk present to the public and represents significant liability to the owner.

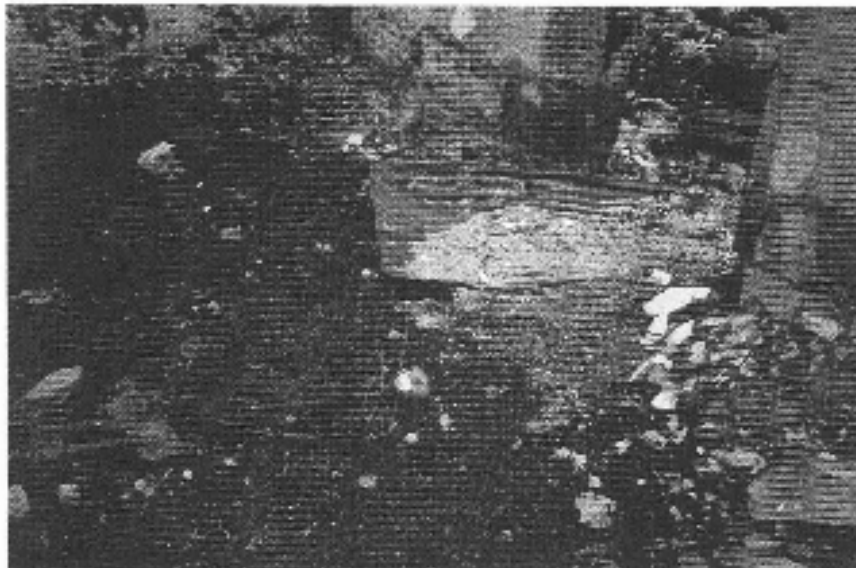
PHOTO 10: Additional view of asbestos containing debris present within the footprint of the structure.

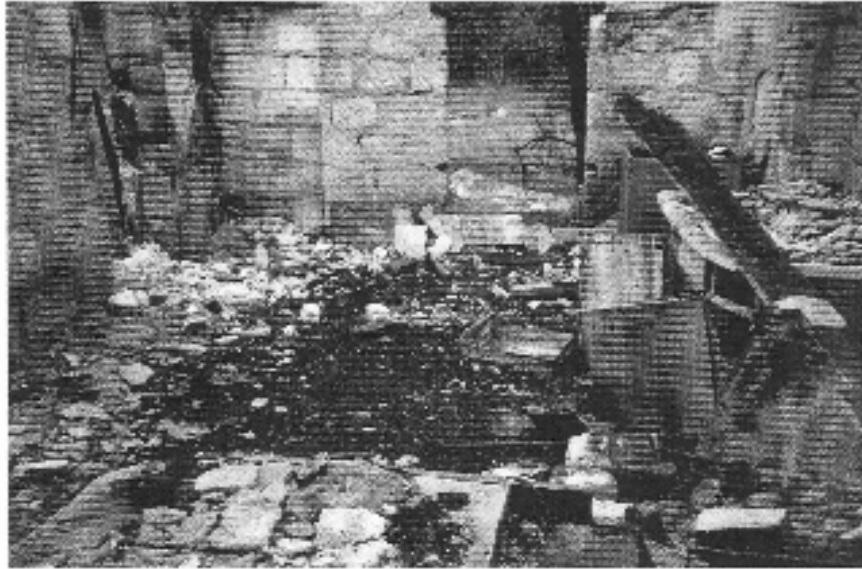
PHOTO 11: Additional view of asbestos containing debris present.

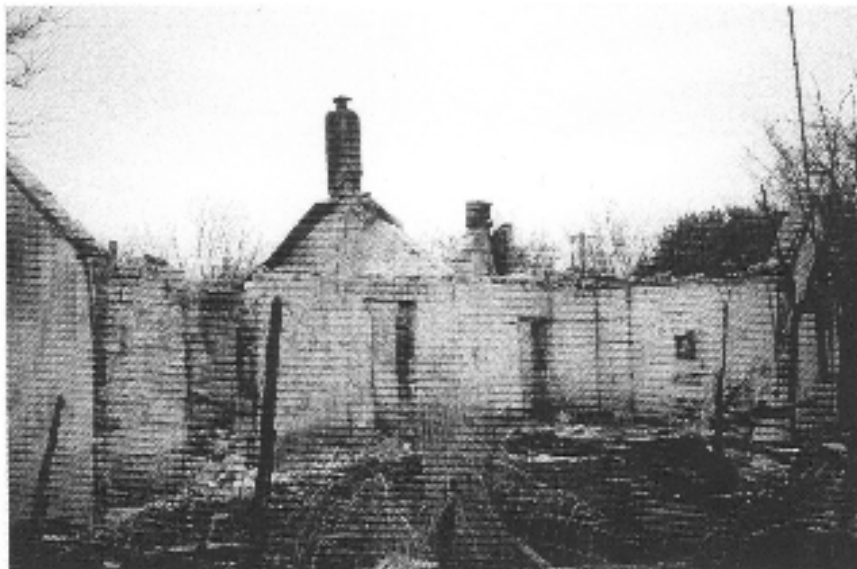
PHOTO 12: View of structure condition up to March 9, 2005.

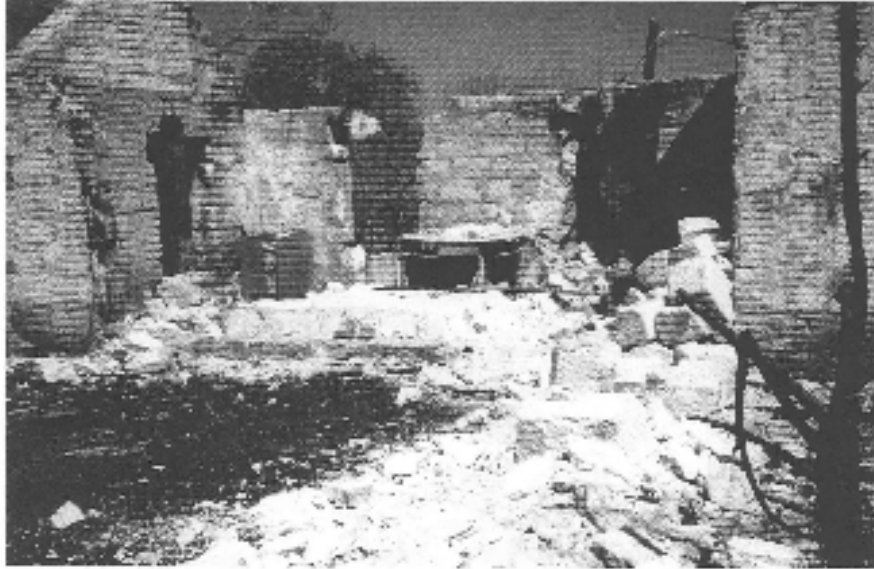
was still intact. However on March 11, 2005 when STC visited the site to design the required shoring, the south wall on the west end of the structure was laying on the ground (See Photo 13). It is suspected that vandals caused the destruction since a portion of the wall was lying inside the structure (See Photo 14) while another portion was lying outside the structure (See Photo 15 and 16). Weather had not been a factor since March 7, 2005 and the structure was still intact on March 9, 2005.

As a result of this wall destruction it is no longer considered feasible to shore the structure in order to complete the asbestos abatement. In fact the structure is now considered structurally unsafe and is considered to represent a **significant safety risk**. This has resulted since now the west wall is free standing with no support (See Photo 13). A strong wind with a cold front passing could bring this wall down. In addition, the center wall with the chimney also has lost the support of the south wall. This center wall has now become unstable (See Photos 17 and 18). A strong wind could topple the top of this wall. As a result, it is now considered unsafe to allow asbestos abatement activities to be conducted.

PHOTO 13: View of same wall in Photo 12 on March 11, 2005. Also shows west wall remaining as a free standing wall.

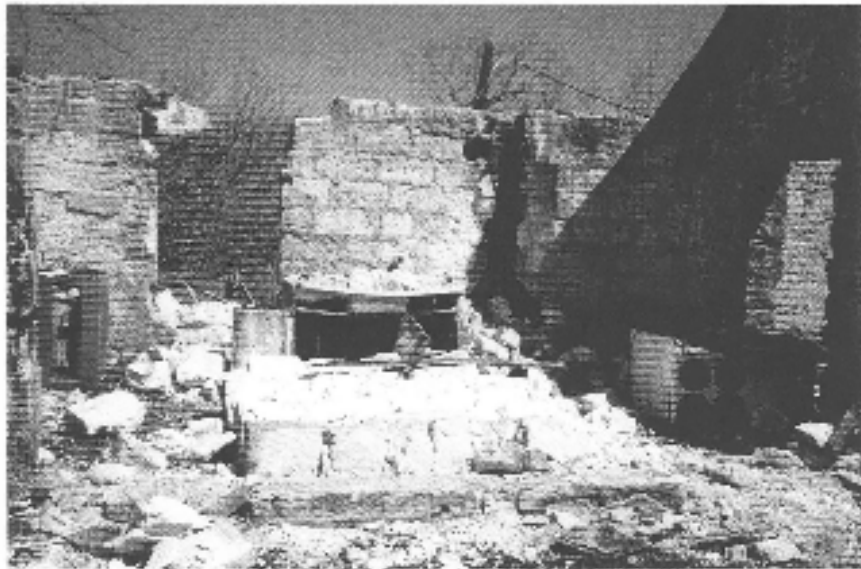
PHOTO 14: View of south wall section that collapsed inward.

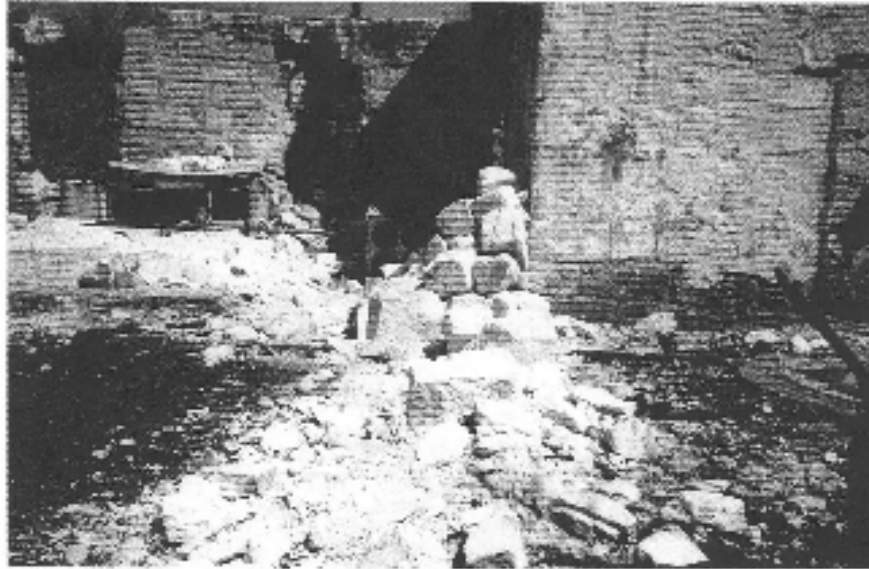
PHOTO 15: View depicting the extent of south wall outwards.

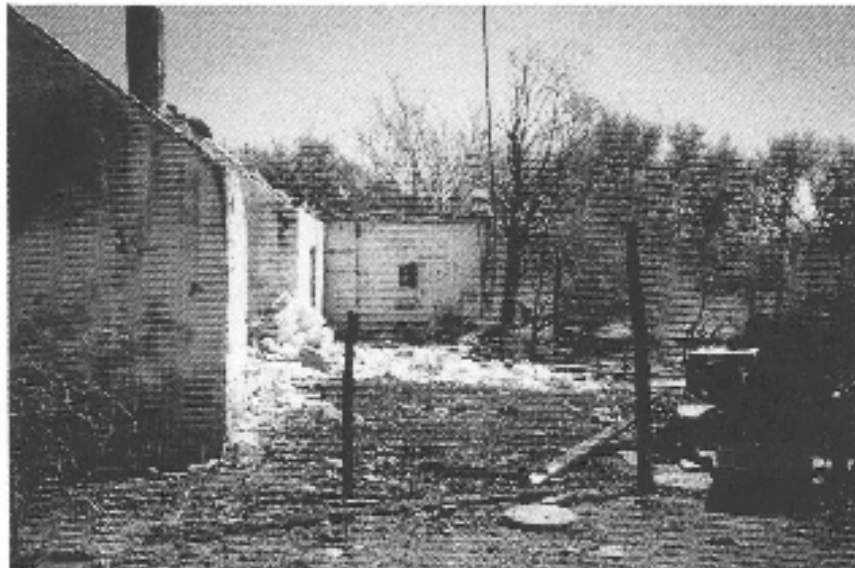
PHOTO 16: View depicting the extent of south wall outwards.

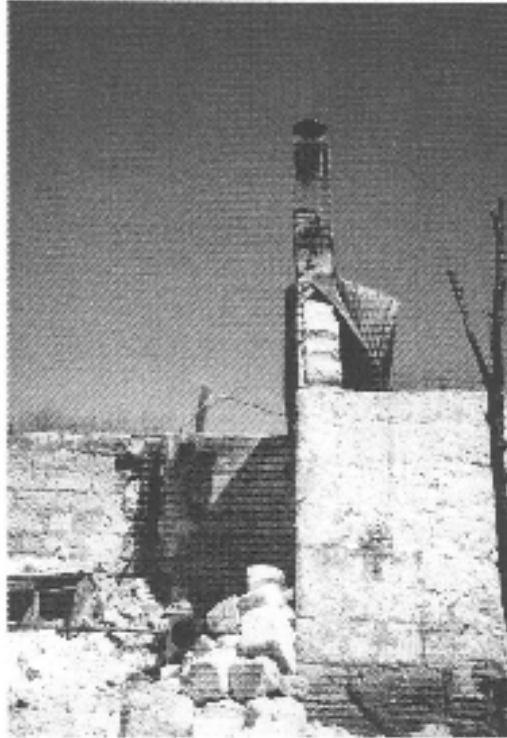
PHOTO 17: View of center wall with chimney now without the support of the south wall.

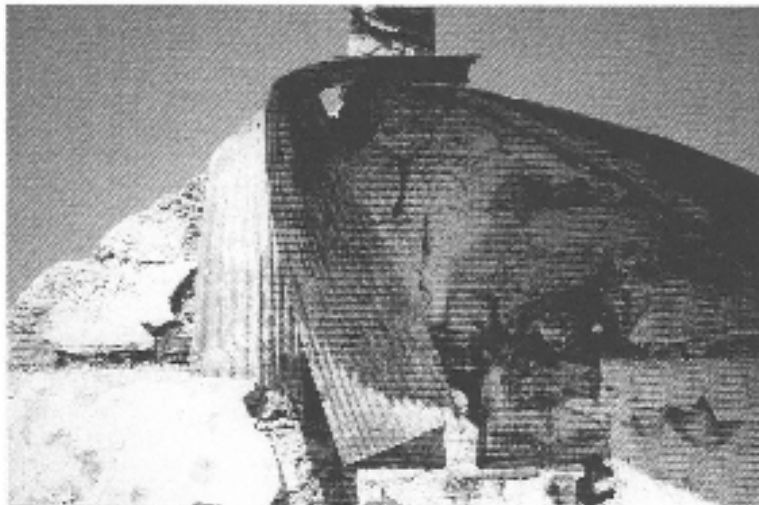
PHOTO 18: View of chimney base that has been weakened.
