Archaeological Monitoring and Limited Testing for Recent Development in Hemisfair Park, San Antonio, Bexar County, Texas

José E. Zapata, Antonia L. Figueroa, C. Stephen Smith, and Clinton M. M. McKenzie

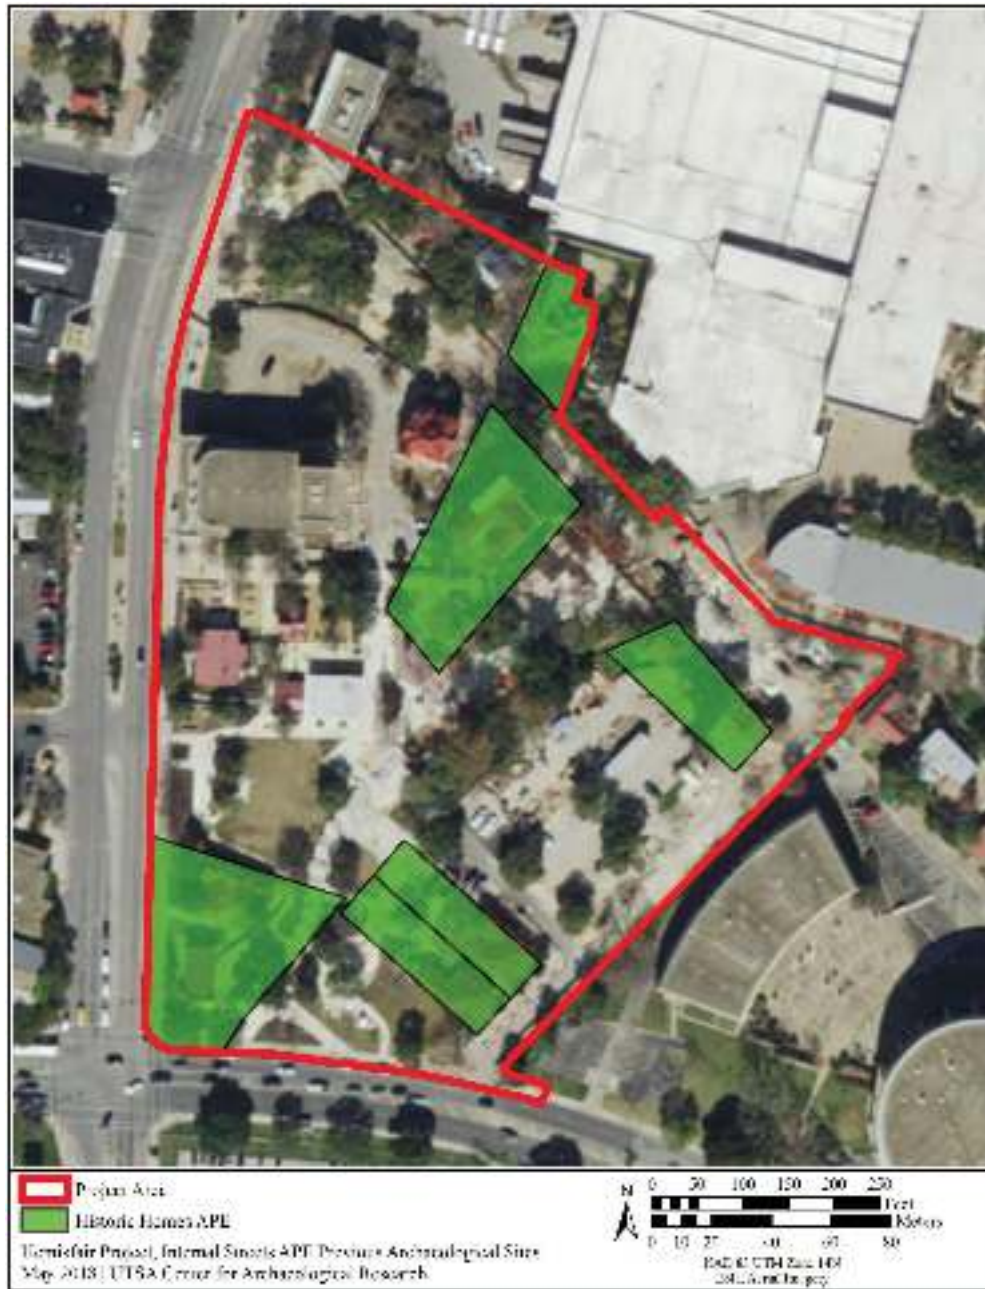
Figure 1-3. Historic Homes APE on Esri aerial imagery, NAD 83 UTM Zone 14N.

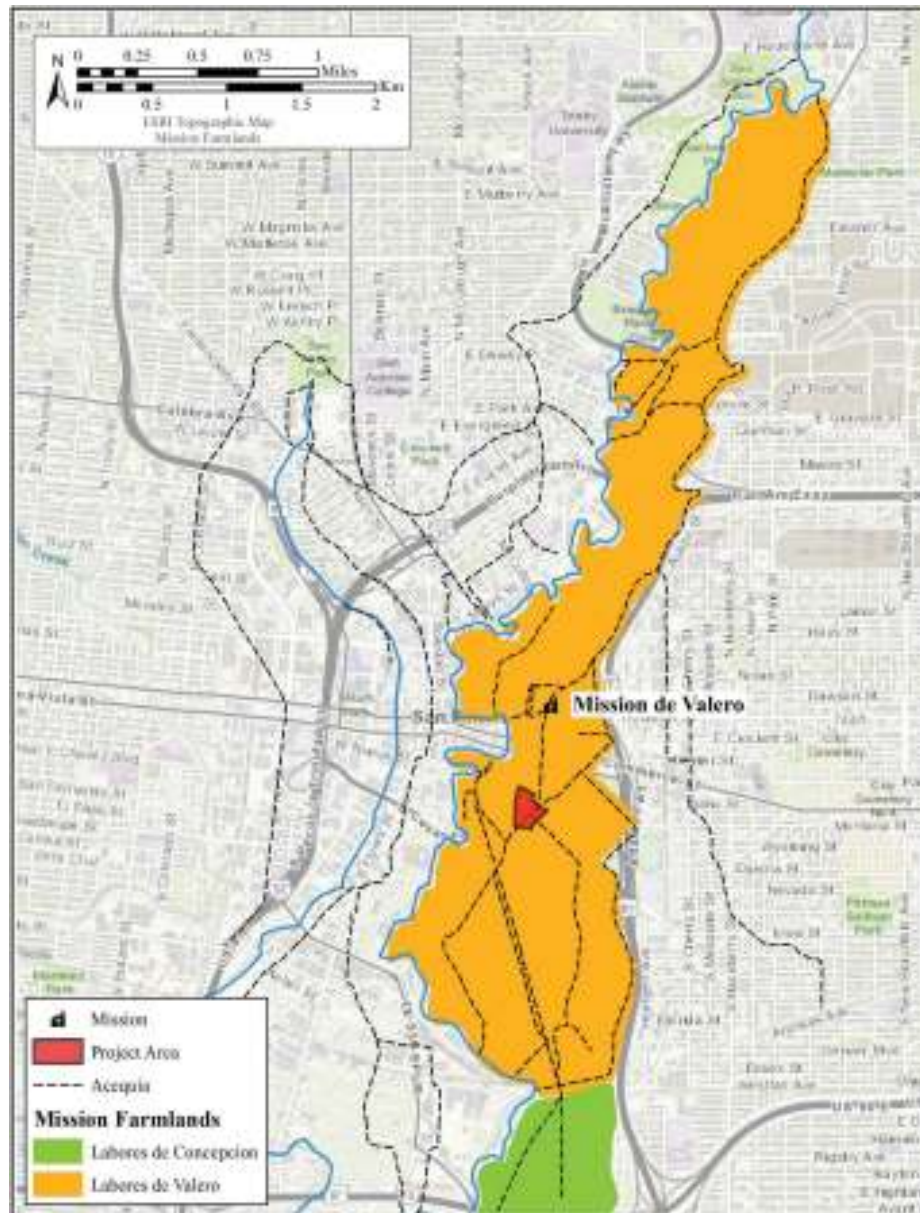
Figure 2-2. Extent of the Mission San Antonio de Valero farmlands and nearby acequias, 1719-1794. Adapted from the Historic Map of Old San Antonio de Bexar by Rullman 1912) shown on Esri topographical map.

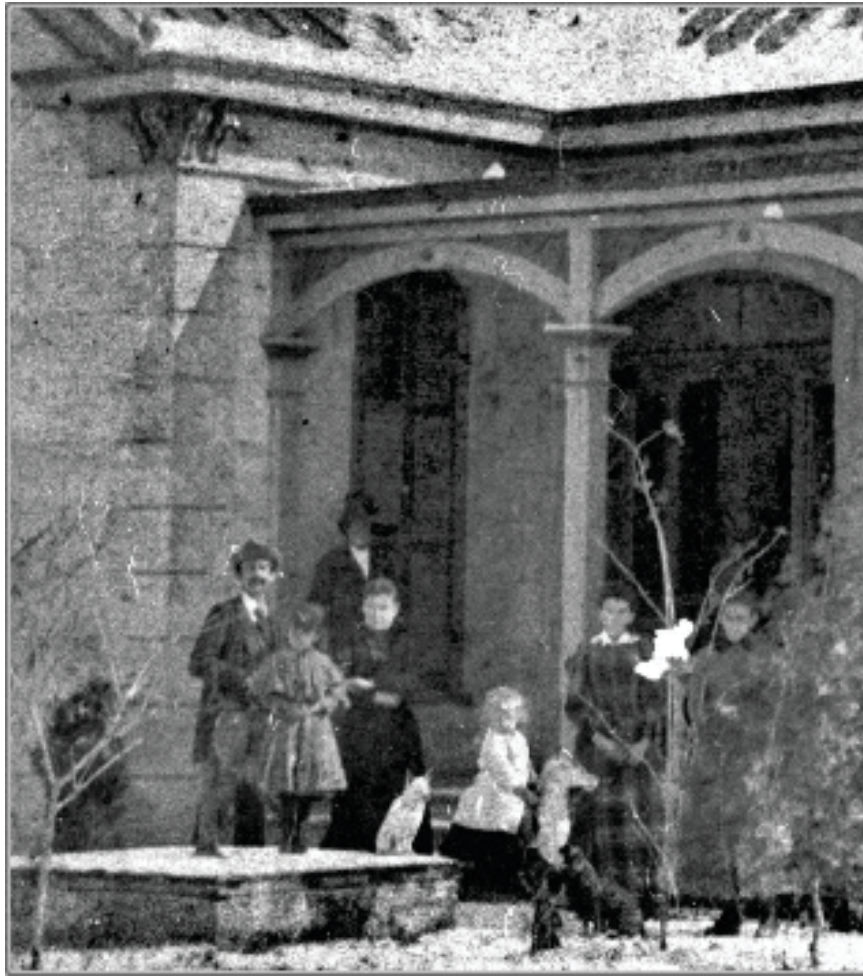
Figure 2-10. *Pereida Family circa 1895: Rafael Pereida at far left, Anne Schuetz Pereida to his left, Petrolina (8 years old) and Anita (2 years old), others not identified (photograph courtesy of UTSA Institute of Texan Cultures [ITC]).*

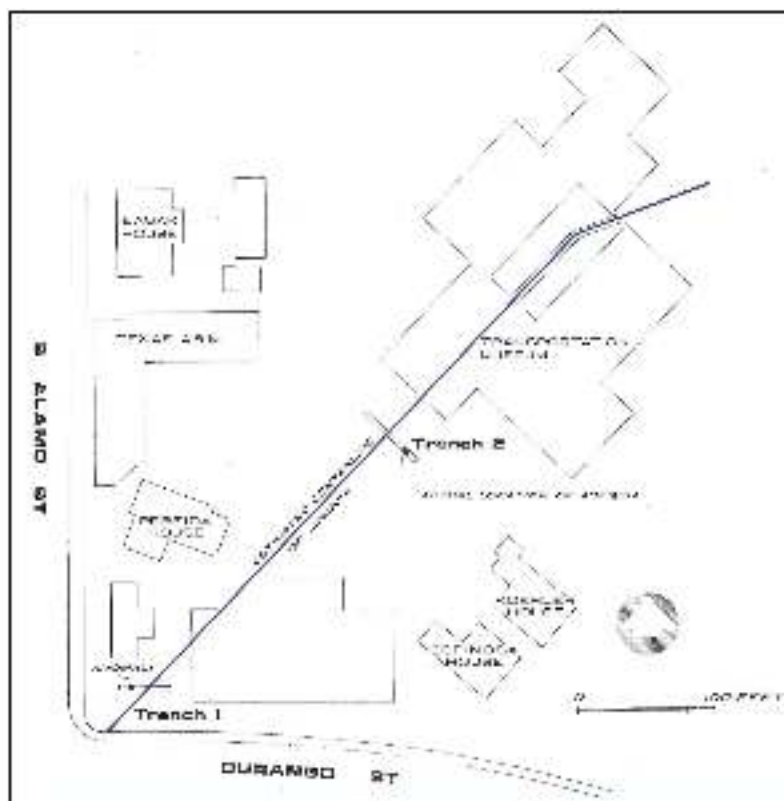
Figure 4-2. 1984 excavation map with projected route (blue) of Acequia Madre de Valero (Fox 1985:Figure 2).

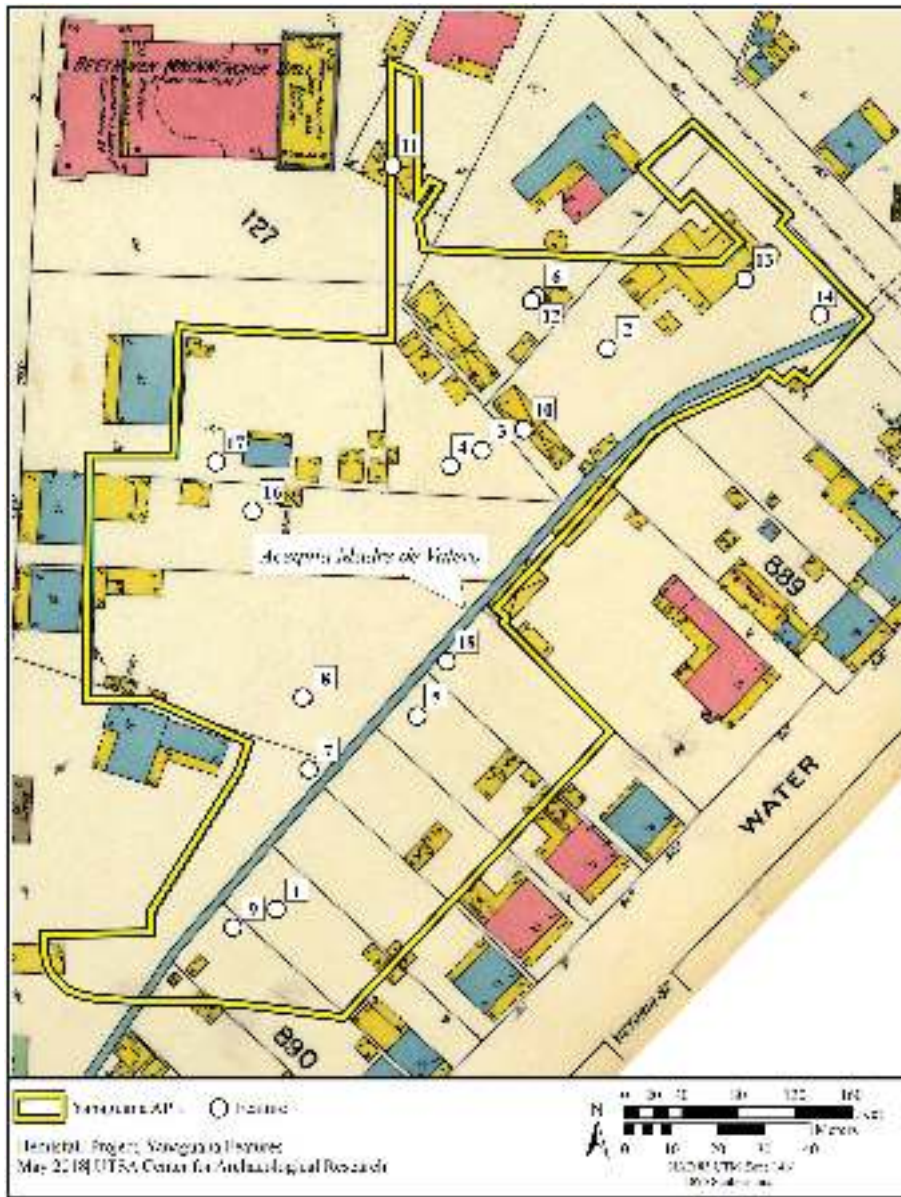
Figure 6-2. 1896 Sanborn Fire Insurance Map (Sanborn 1896) overlaid with features documented in the Yanaguana Garden APE; note the Acequia Madre de Valero in blue.

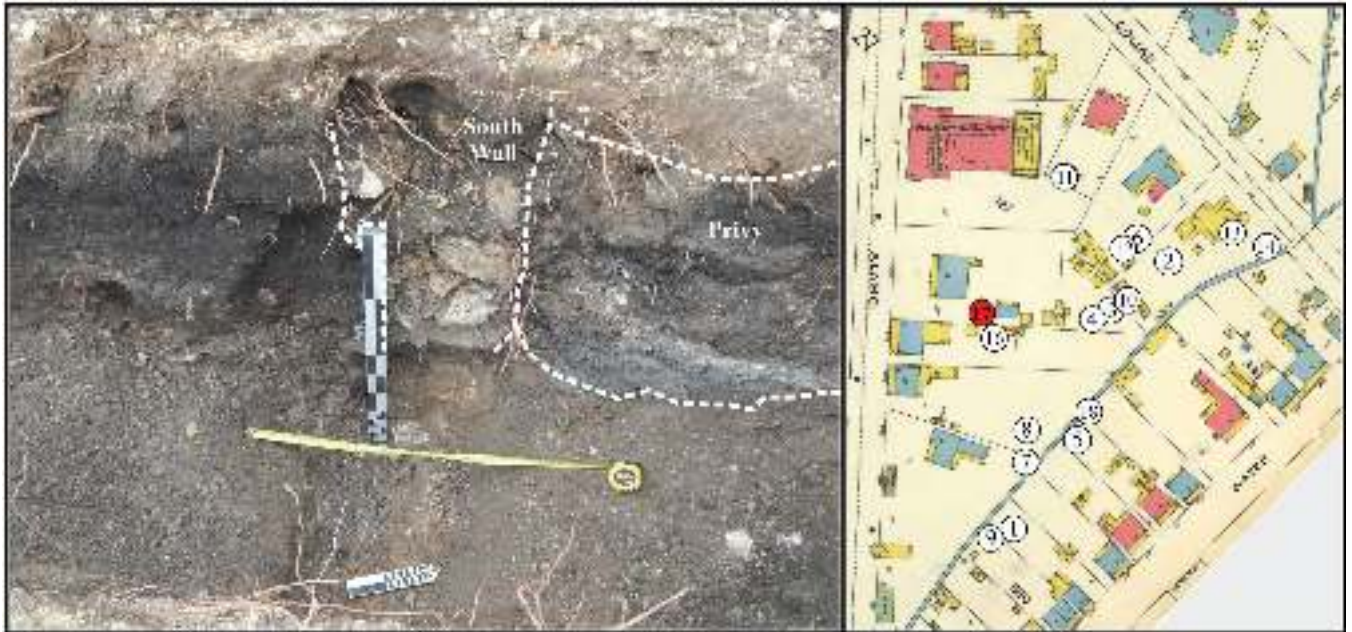
Figure 6-8. Left: Feature 17, nineteenth-century privy with stone wall (dashed lines indicated the interior). Right: location of Feature 17 on 1896 Sanborn Fire Insurance Map (Sanborn 1896). Scale is metric.

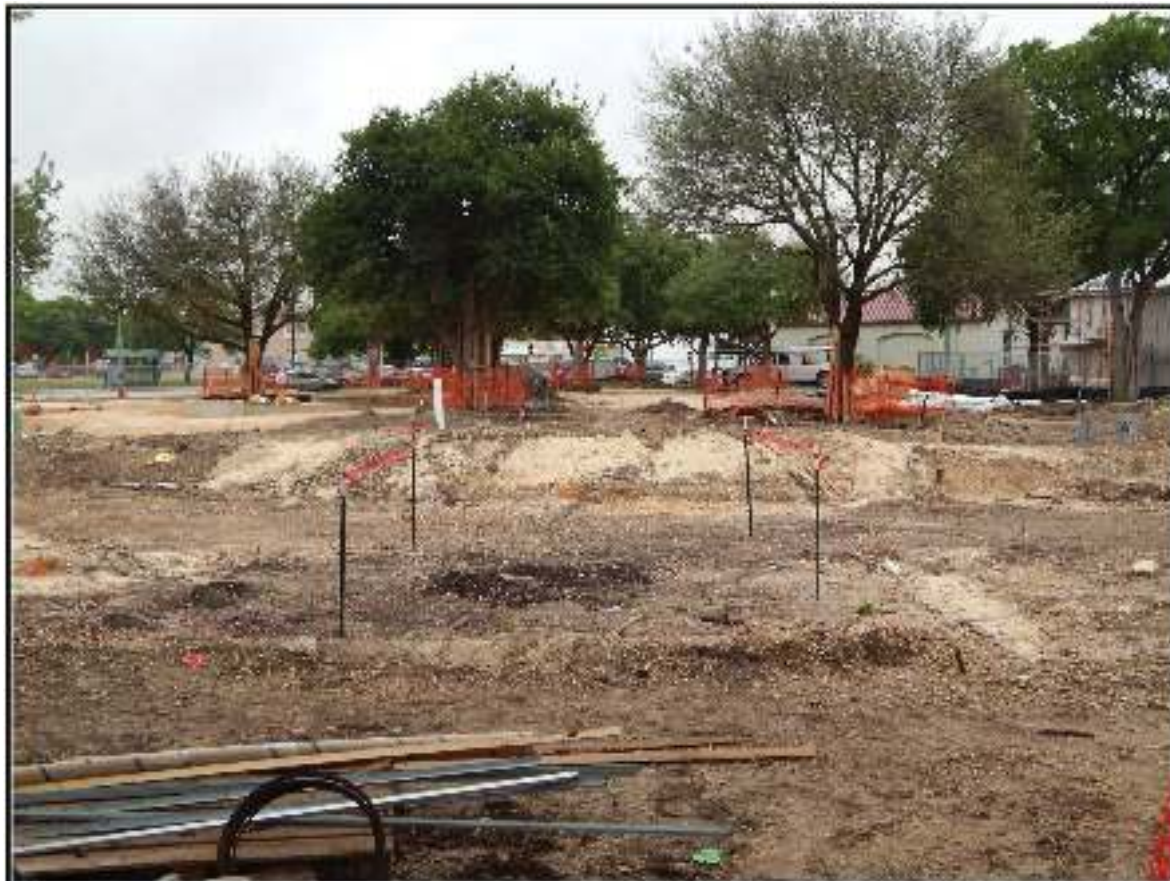
Figure 6-11. T-post barrier marking the pathway of the Acequia Madre de Valero (41BX8).

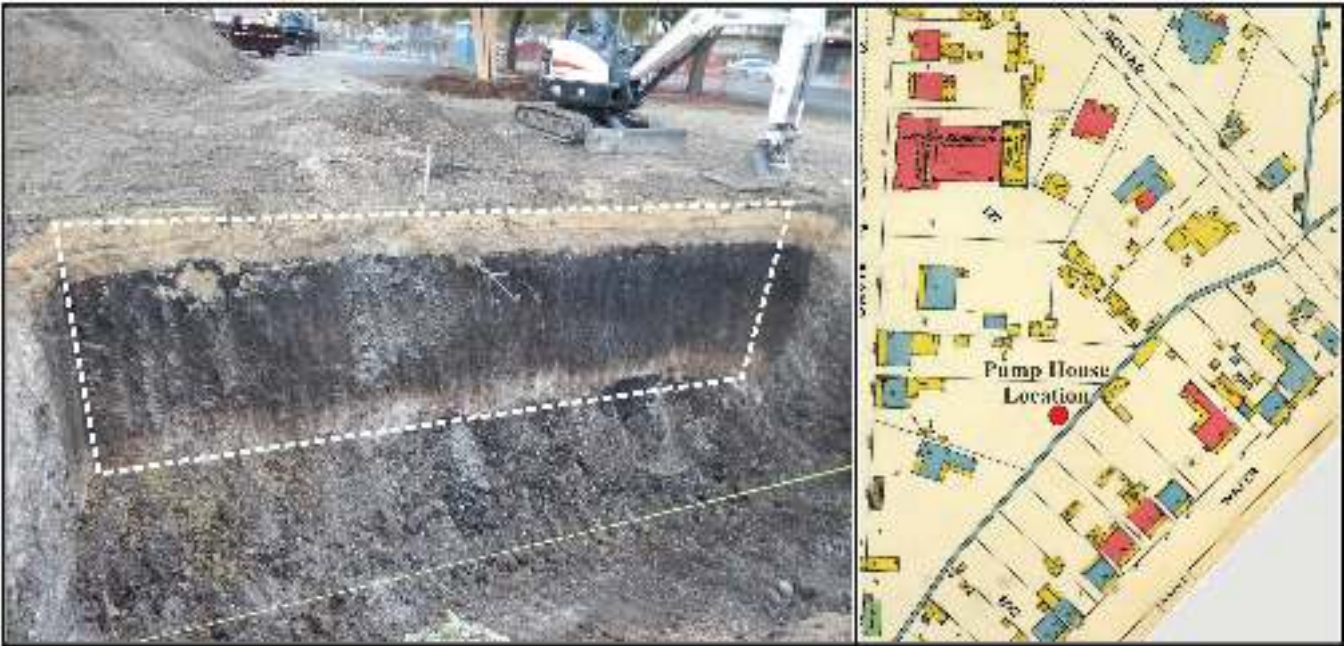
Figure 6-14. Left: soil profile (outlined in white) in Splash Pad pump house excavation. Right: location of pump house on 1896 Sanborn Fire Insurance Map (Sanborn 1896).

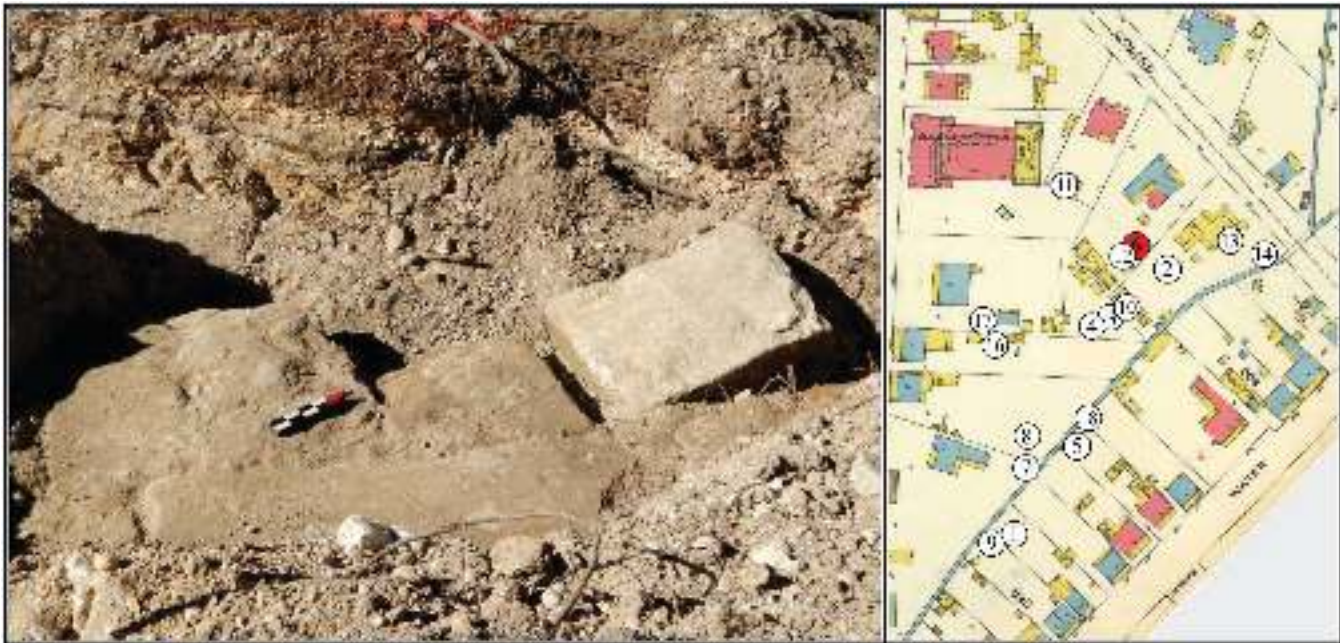
Figure 6-18. Left: Feature 6, stone foundation. Right: location of Feature 6 on 1896 Sanborn Fire Insurance Map (Sanborn 1896). Scale is metric.

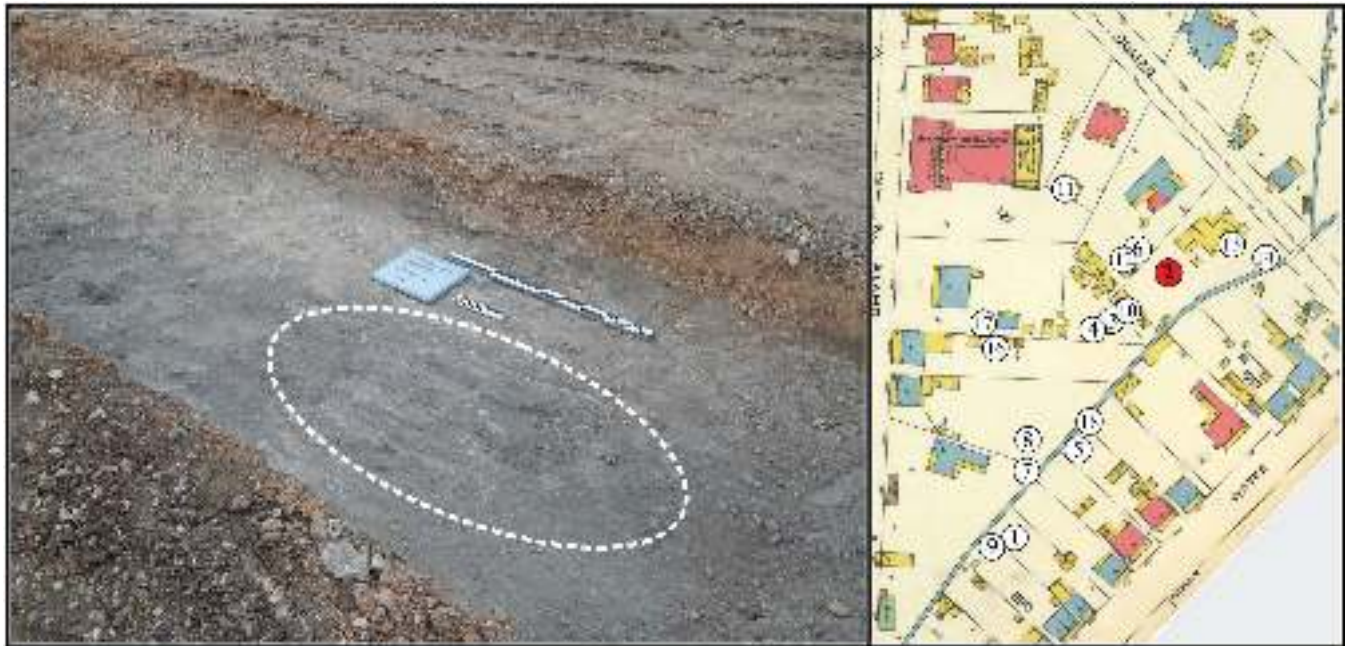
Figure 6-21. Left: Feature 2 (outlined in white), possible burned wooden floor joists. Right: location of Feature 2 on 1896 Sanborn Fire Insurance Map (Sanborn 1896). Scale is metric.

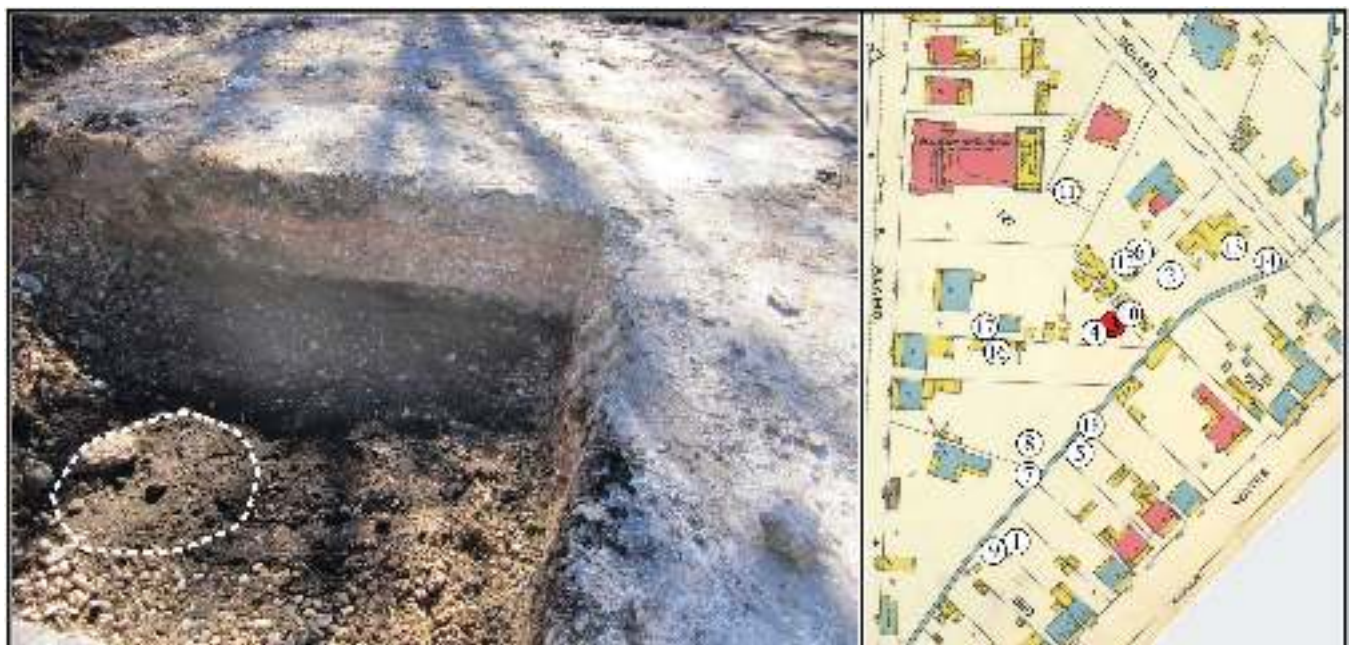
Figure 6-22. Left: Feature 3 (outlined in white), trash pit. Right: location of Feature 3 on 1896 Sanborn Fire Insurance Map (Sanborn 1896).

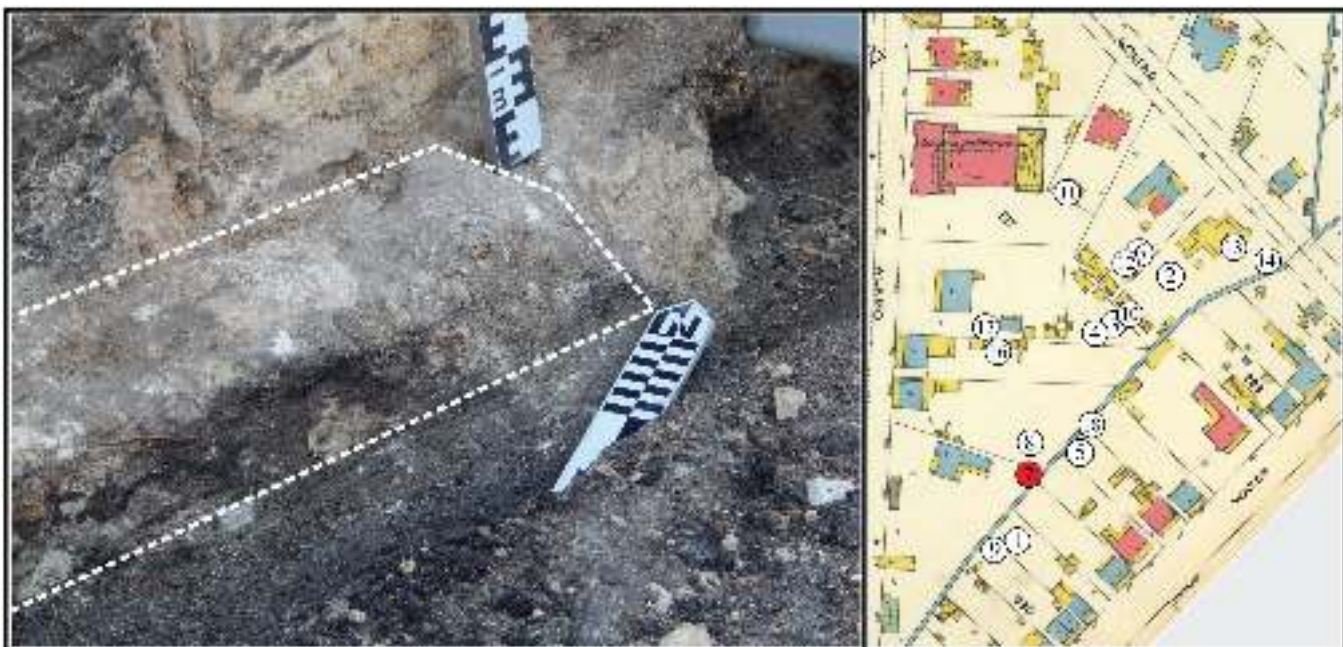
Figure 6-23. Left: Feature 7 (outlined in white), caliche blocks. Scale is metric. Right: location of Feature 7 on 1896 Sanborn Fire Insurance Map (Sanborn 1896).

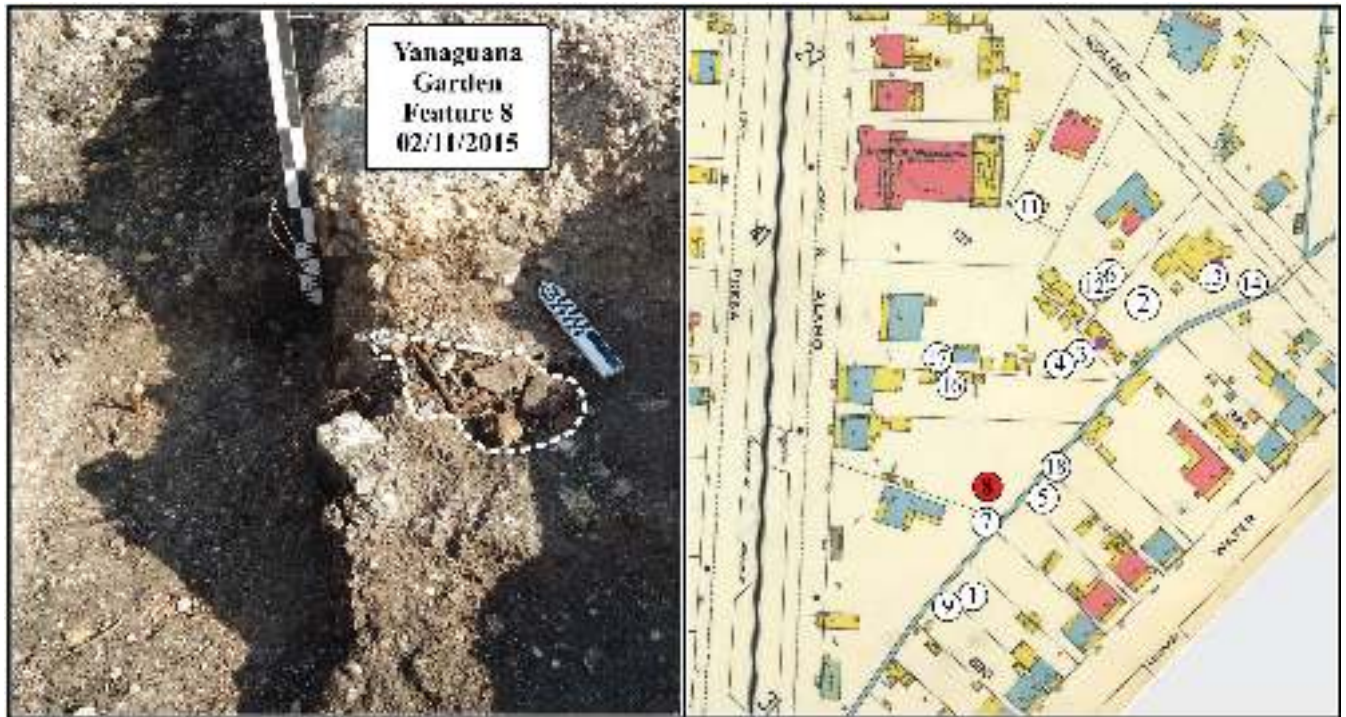
Figure 6-24. Left: Feature 8 (outlined in white), concentration of historic trash. Right: location of Feature 8 on 1896 Sanborn Fire Insurance Map (Sanborn 1896). Scale is metric.

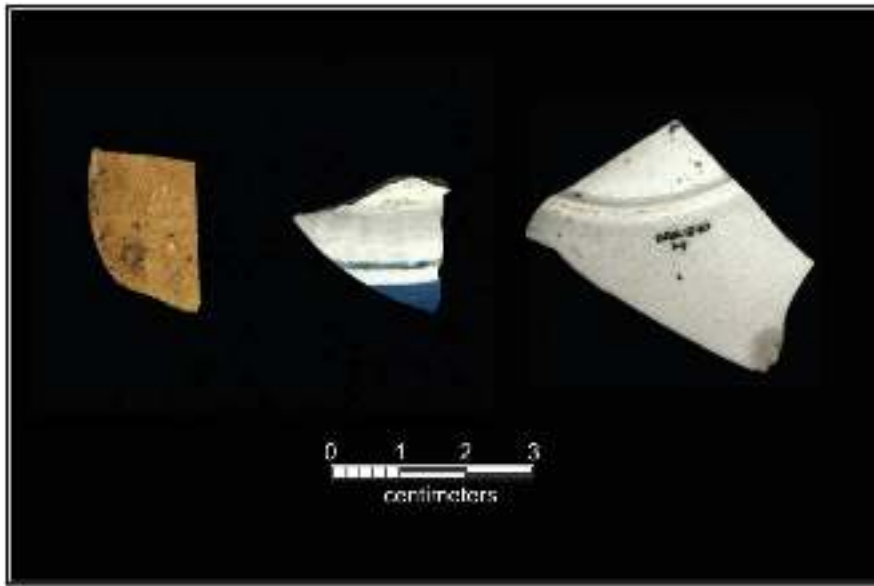
Figure 6-26. Photograph of earthenware sherds from Feature 3.

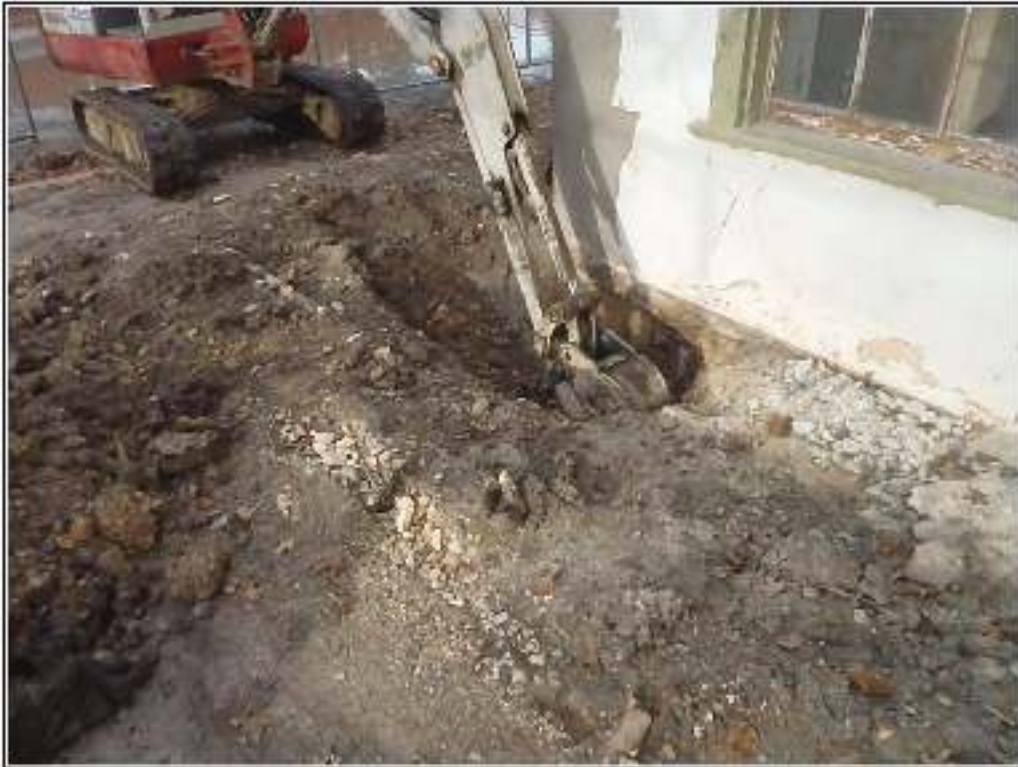
Figure 7-4. Mechanical excavations on the east corner of the Smith House (41BX589).

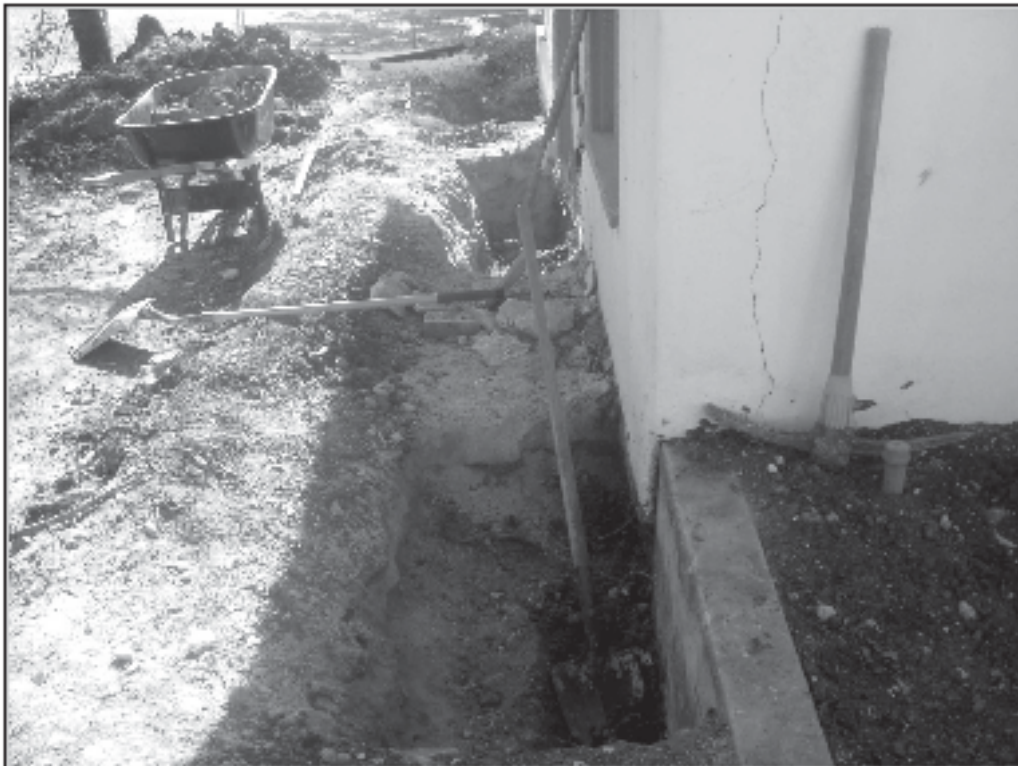
Figure 7-5. Hand excavations on east elevation of the Smith House (41BX589).

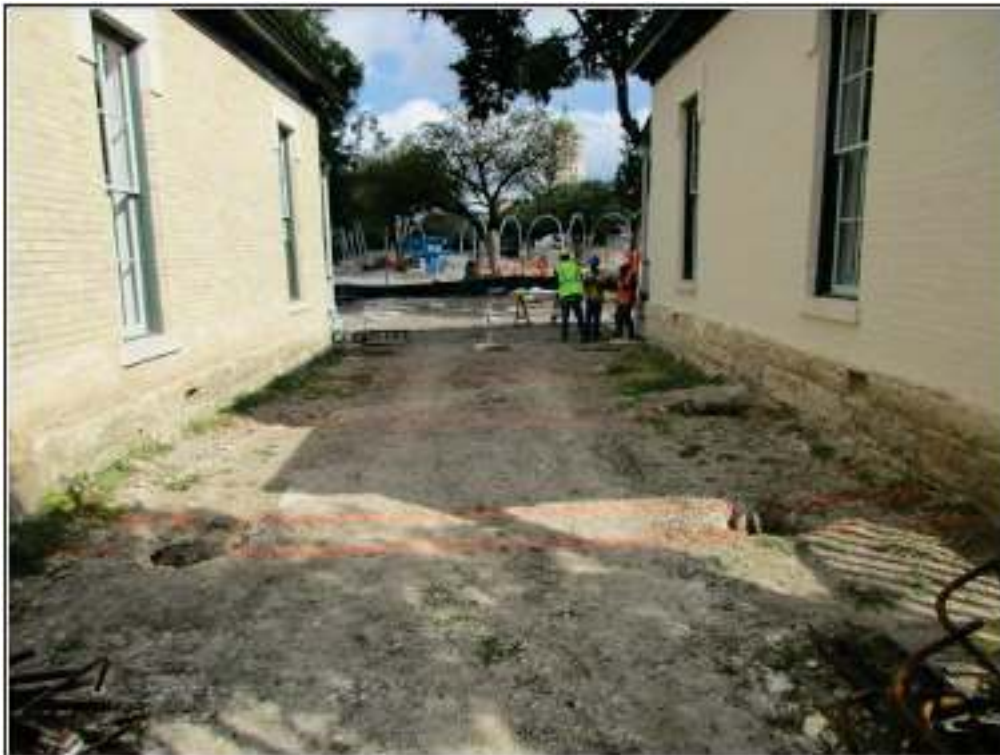
Figure 7-8. Four trenches excavated between the Koehler (41BX592) and Espinoza (41BX593) houses (facing east).

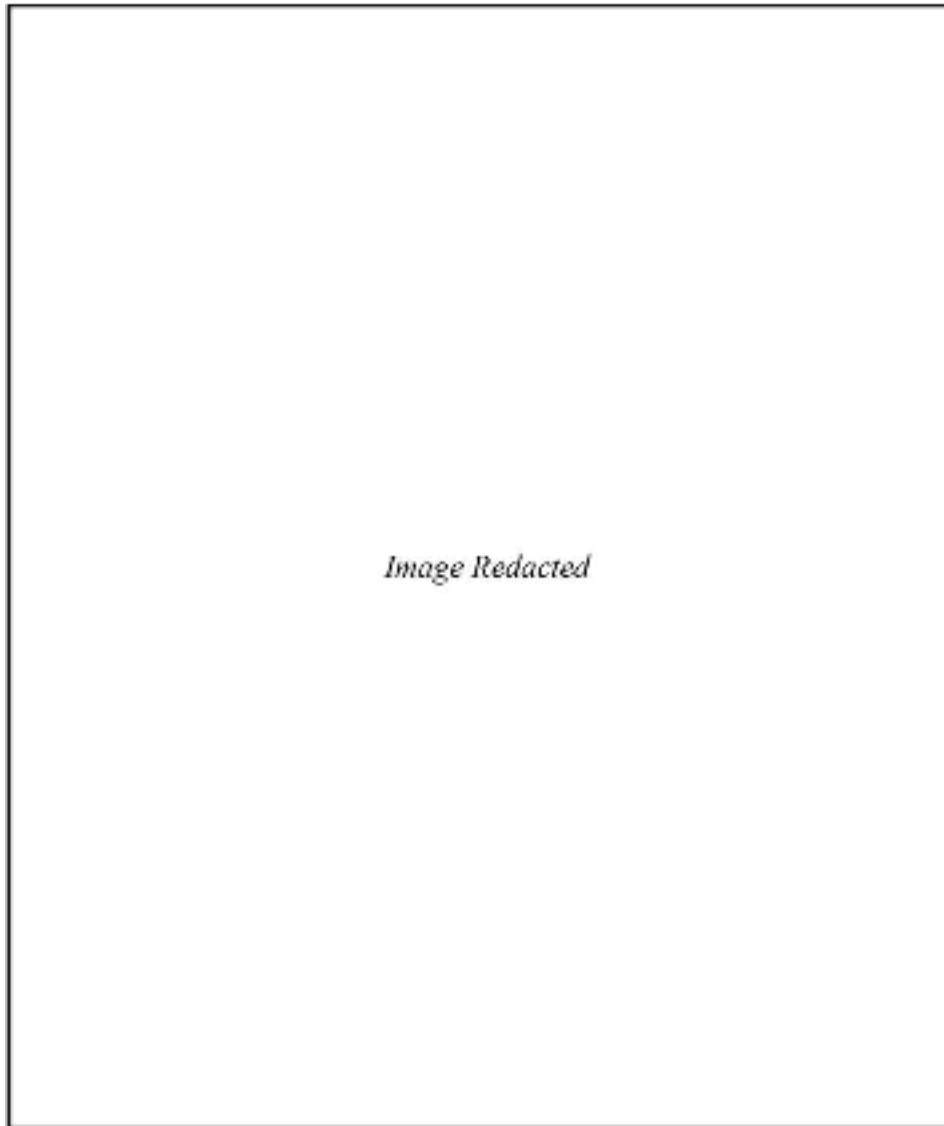
Figure 8-1. Internal Streets APE (blue) on Esri aerial imagery, NAD 83 UTM Zone 14N.

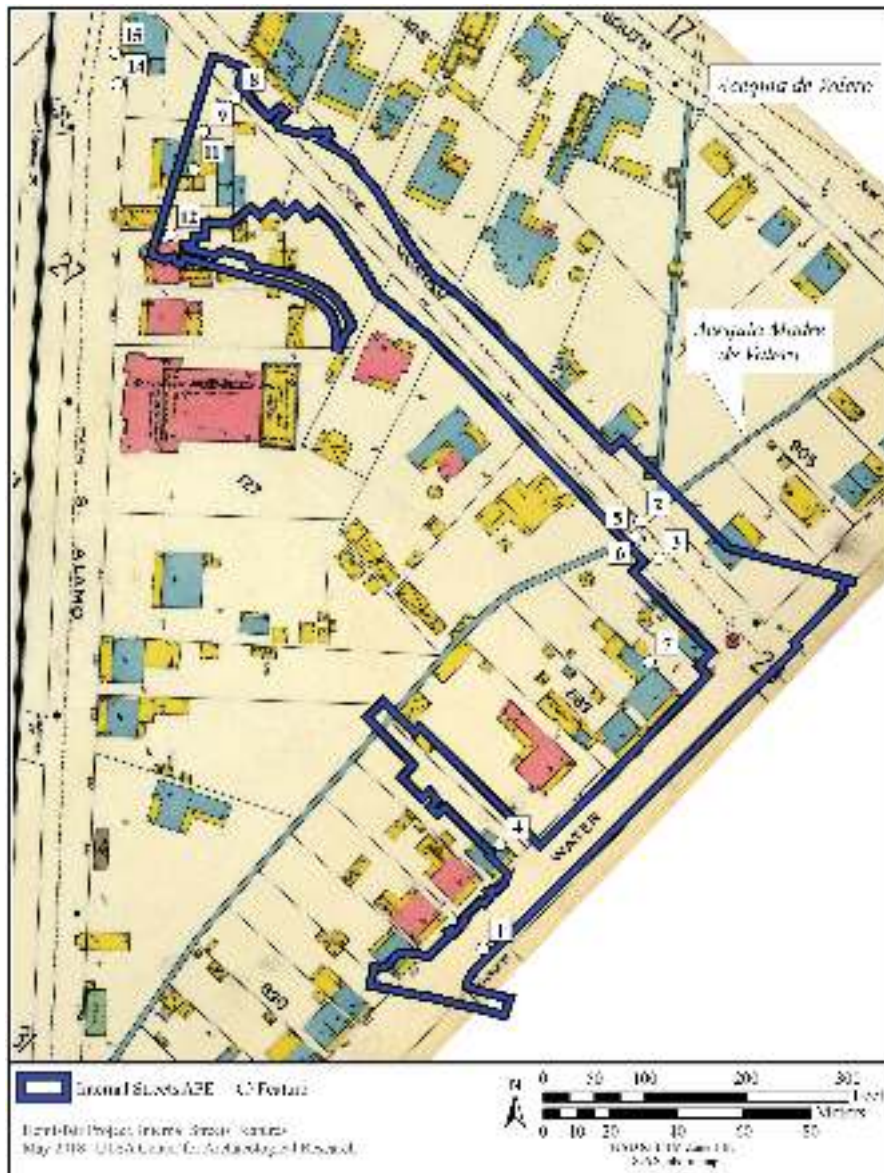
Figure 8-2. Recorded features from Internal Streets APE shown on georeferenced 1896 Sanborn Fire Insurance Map (Sanborn 1896).

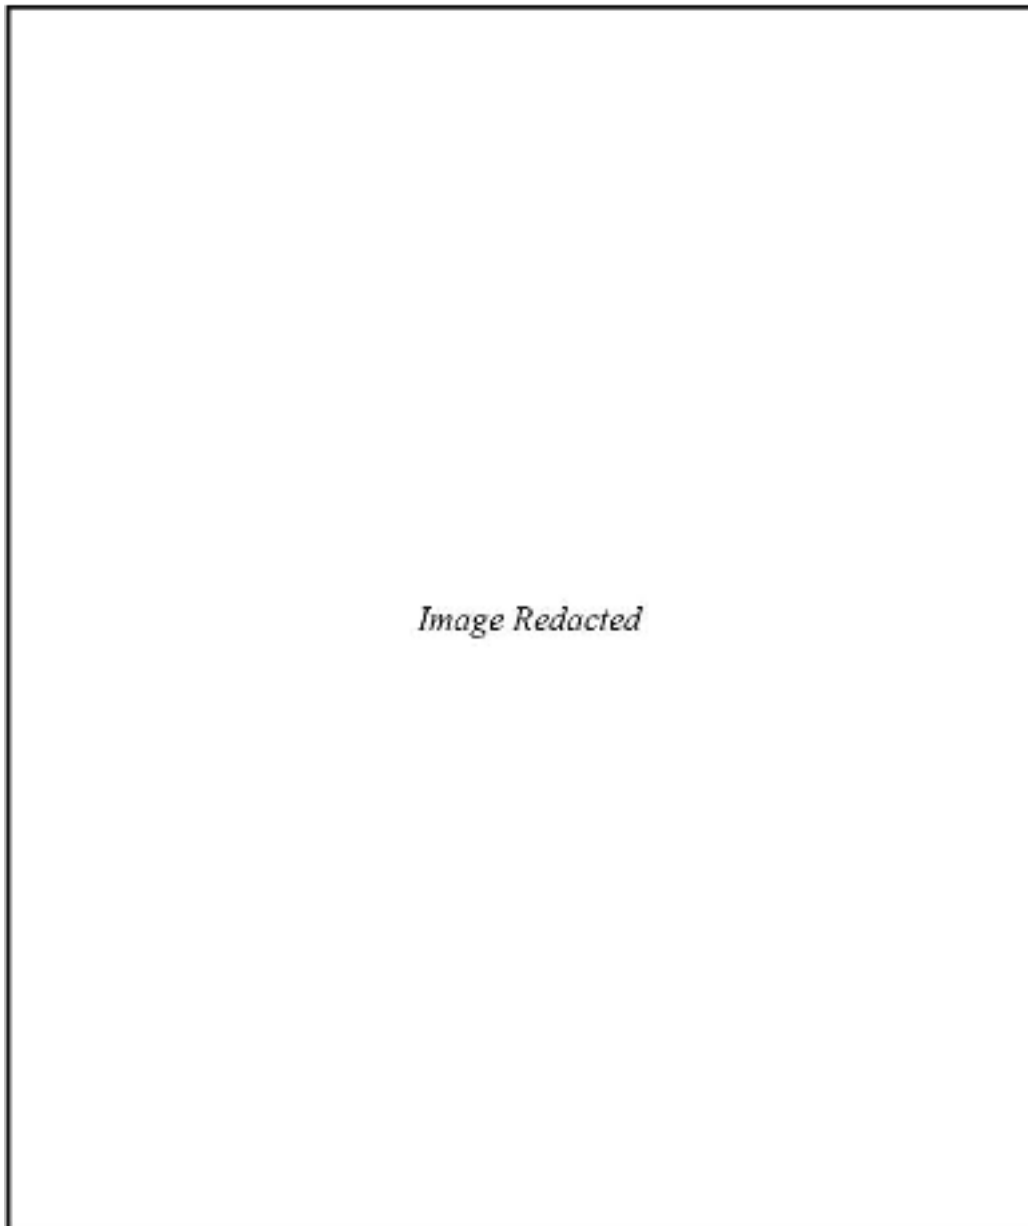
Figure 8-3. Newly recorded sites from the Internal Streets APE shown on Esri aerial imagery.

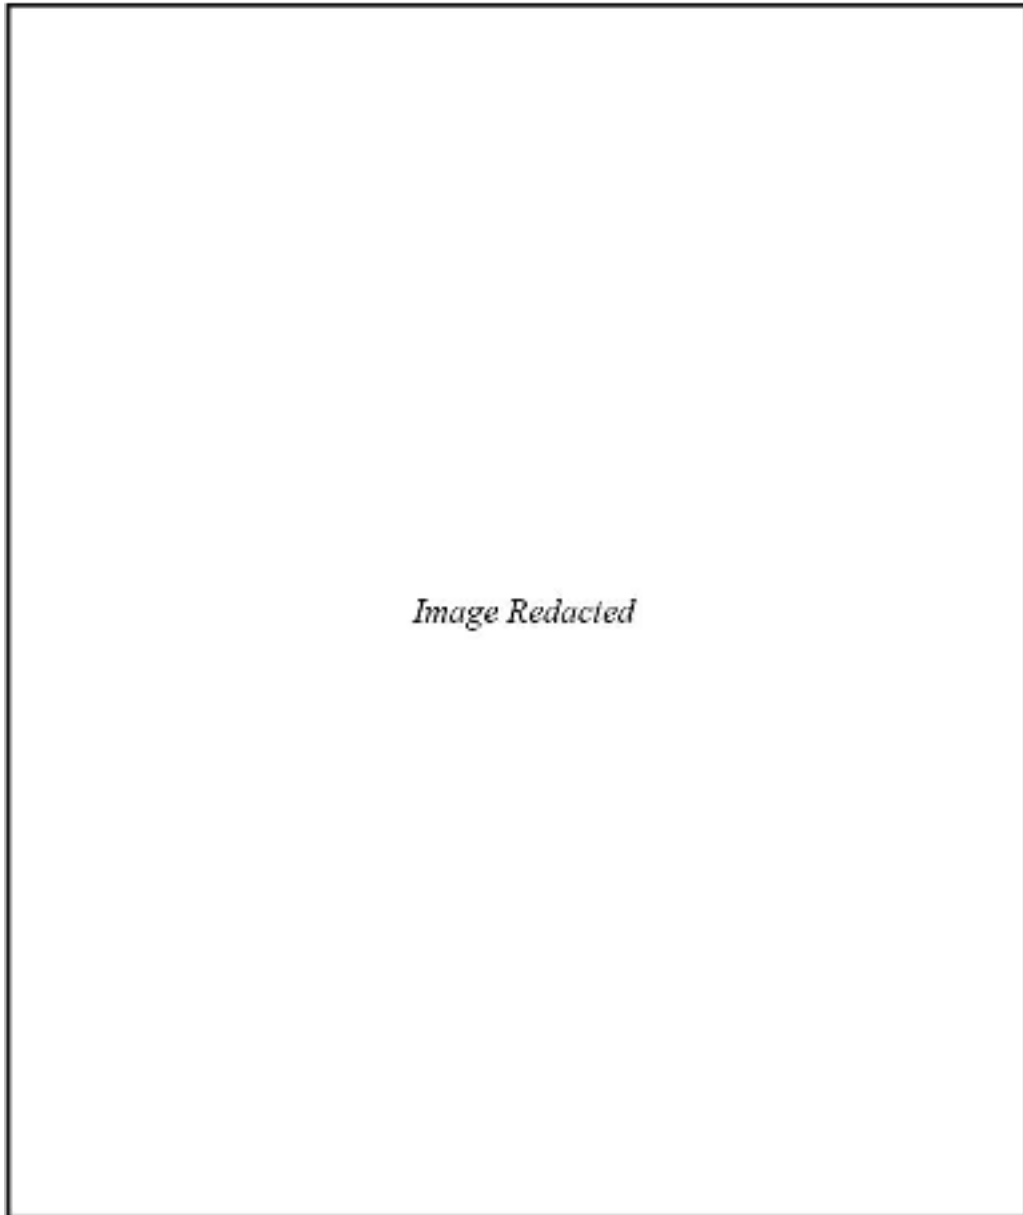
Figure 8-4. Newly recorded sites from the Internal Streets APE shown on satellite imagery georeferenced 1896 Sanborn Fire Insurance Map (Sanborn 1896).

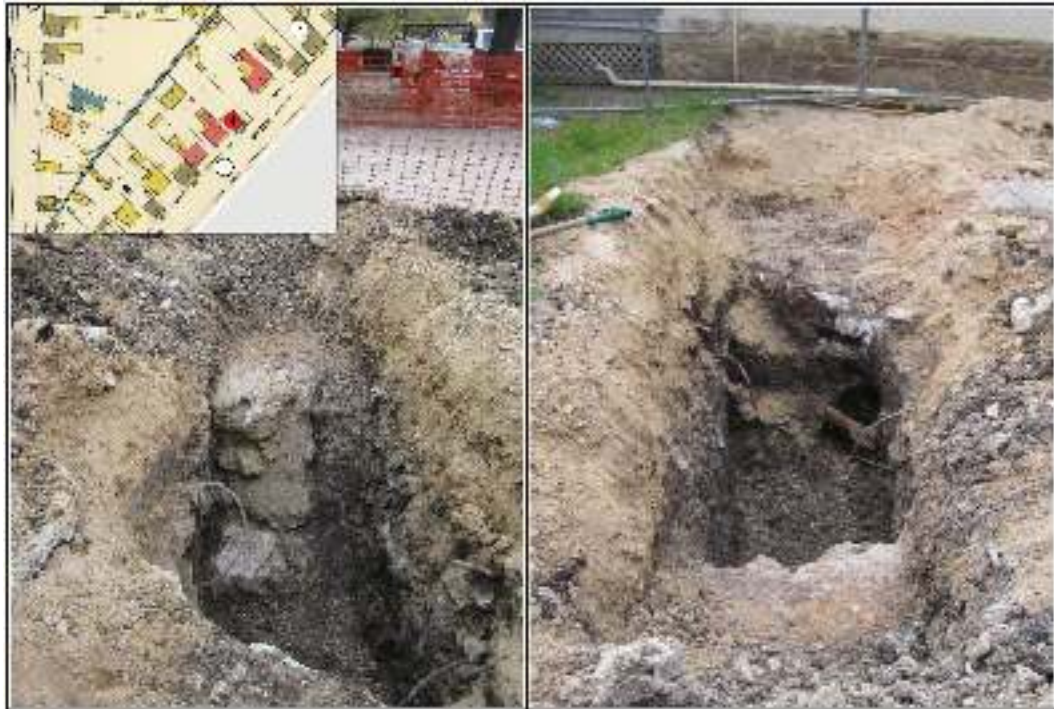
Figure 8-11. Feature 4, wall footer (41BX2123) facing north (left) and south (right). Inset: location of Feature 4 on 1896 Sanborn Fire Insurance Map (Sanborn 1896).

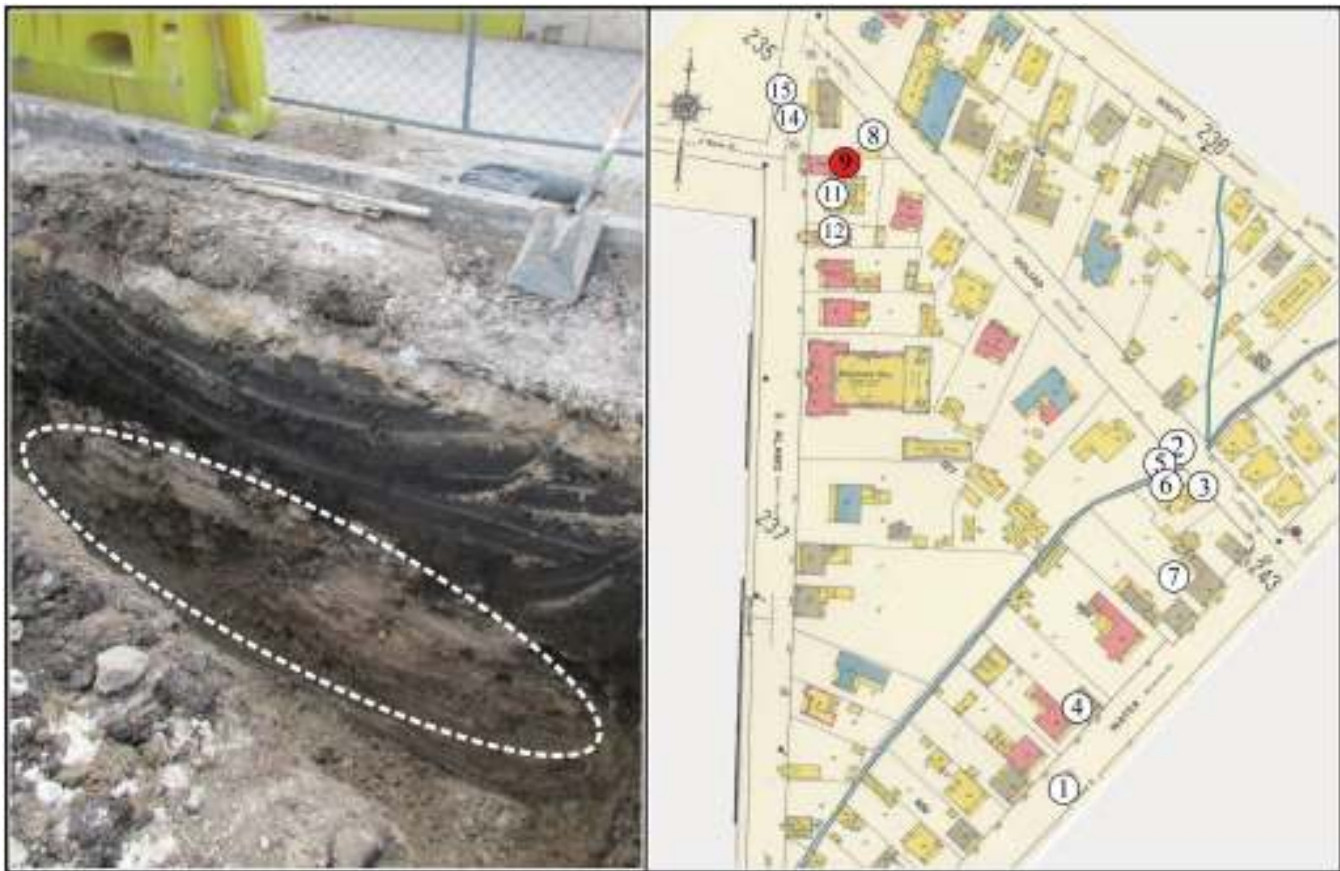
Figure 8-16. Left: Feature 9 (circled in white), stone alignment in duct bank trench, along east side of S. Alamo Street (facing southwest). Right: location of Feature 9 on 1896 Sanborn Fire Insurance Map (Sanborn 1896).

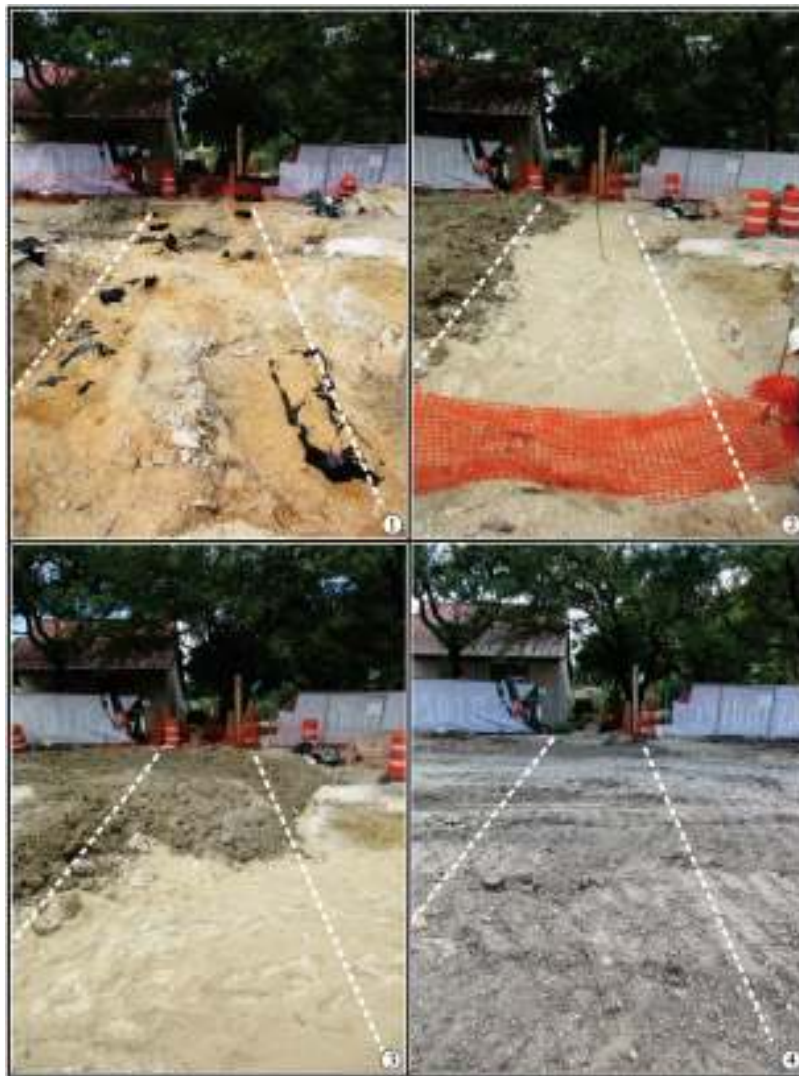
Figure 8-25. Acequia Madre de Valero (41BX8), backfilling stages: 1) landscape fabric and sand covering acequia walls; 2) additional layer of sand; 3) layer of clay fill; and 4) covering completed.
