Archaeological Monitoring and Limited Testing for Recent Development in Hemisfair Park, San Antonio, Bexar County, Texas

José E. Zapata, Antonia L. Figueroa, C. Stephen Smith, and Clinton M. M. McKenzie

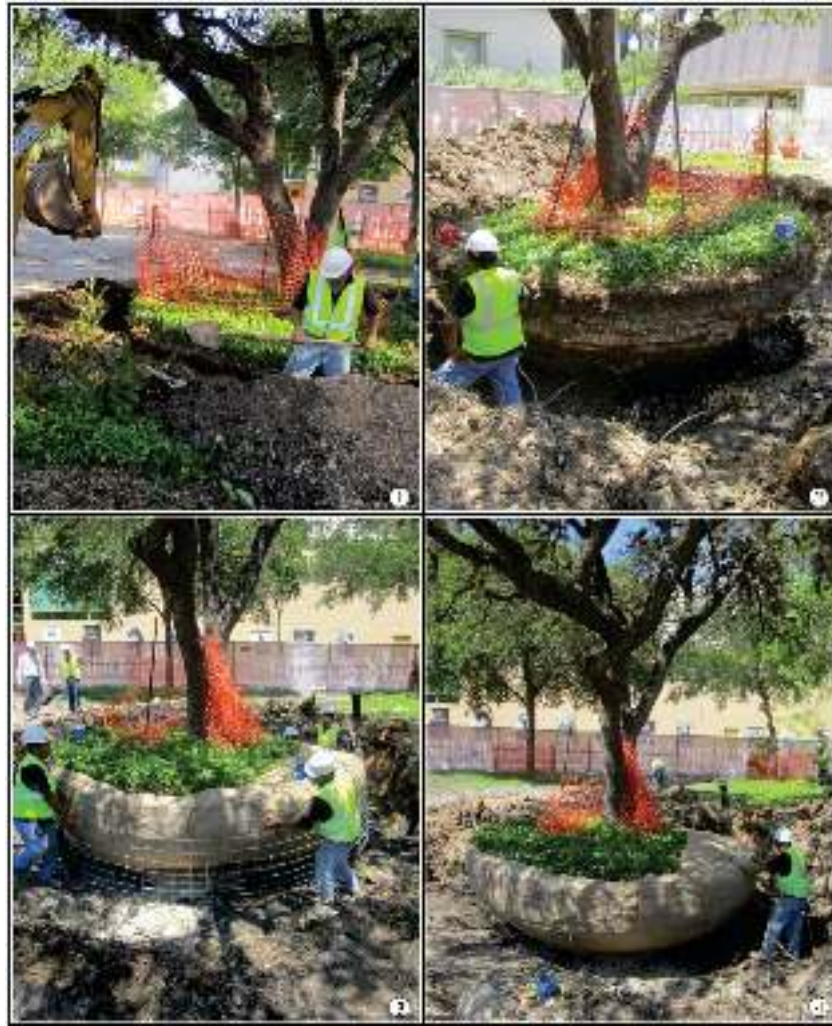
Figure 8-26. Typical tree transplanting: 1) trenched; 2) undercut; 3) balled; and 4) and burlaped (May 1, 2015).

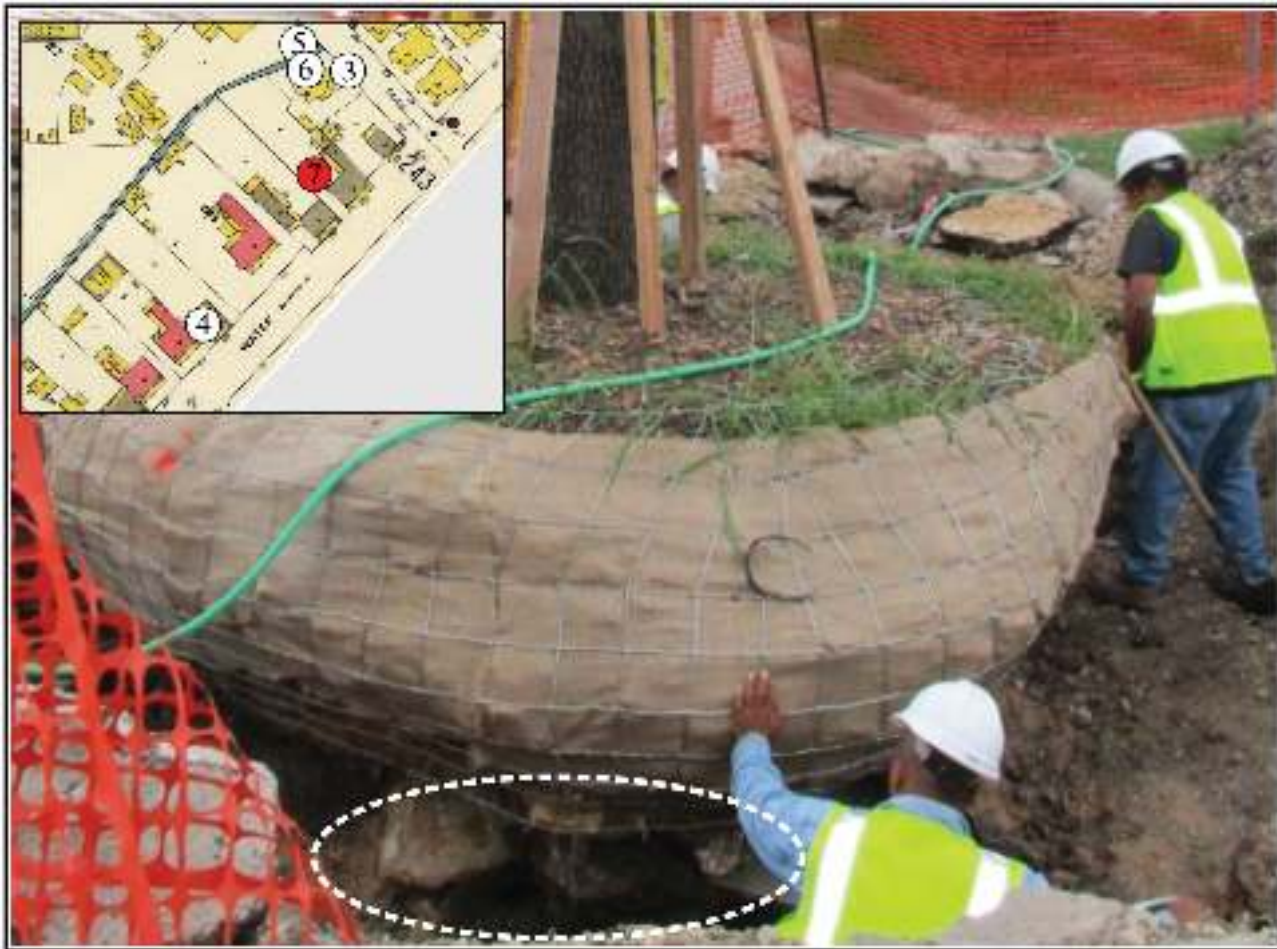
Figure 8-27. Feature 7, east-west stone alignment (circled); remnants of wall footers of early house at 505 Water Street (41BX2124), facing south. Inset shows location of Feature 7 on 1896 Sanborn Fire Insurance Map (Sanborn 1896).

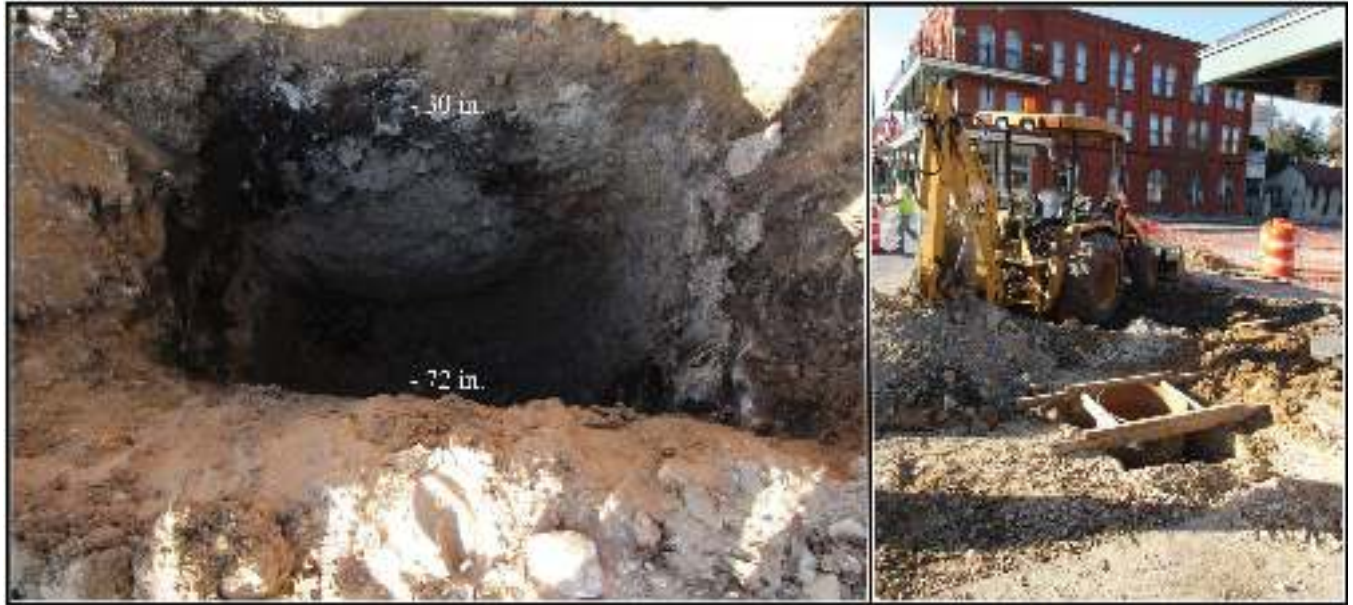
Figure 8-28. Left: Feature 14, wall foundation (facing north). Right: location of the northwest corner of S. Alamo Street and E. Nueva Street (facing south).

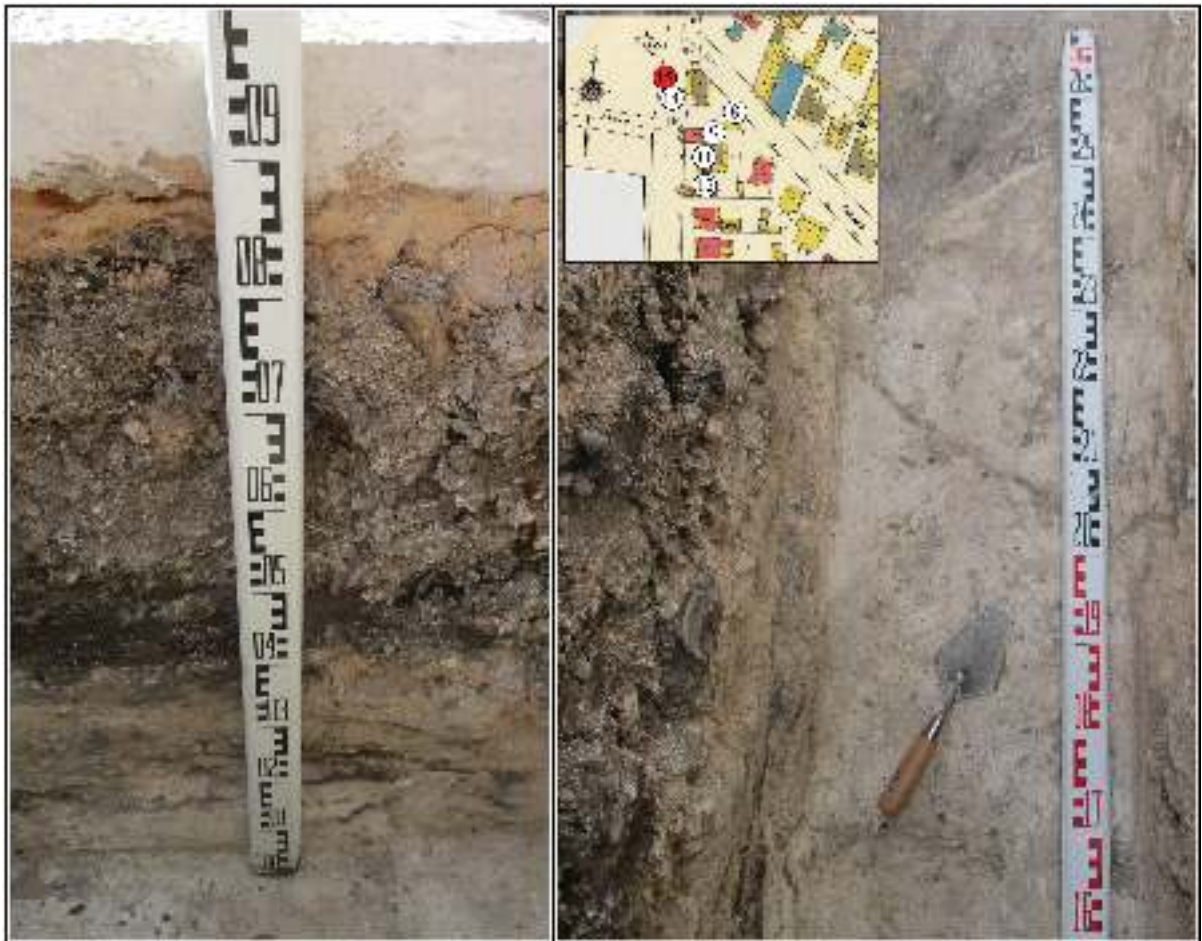
Figure 8-29. Feature 15. Left: Image shows Feature 15 between 30 and 36 in. (west wall profile of trench). Right: Feature 15 at floor of trench. Scale is metric. Inset shows location of Feature 15 on 1896 Sanborn Fire Insurance Map (Sanborn 1896).

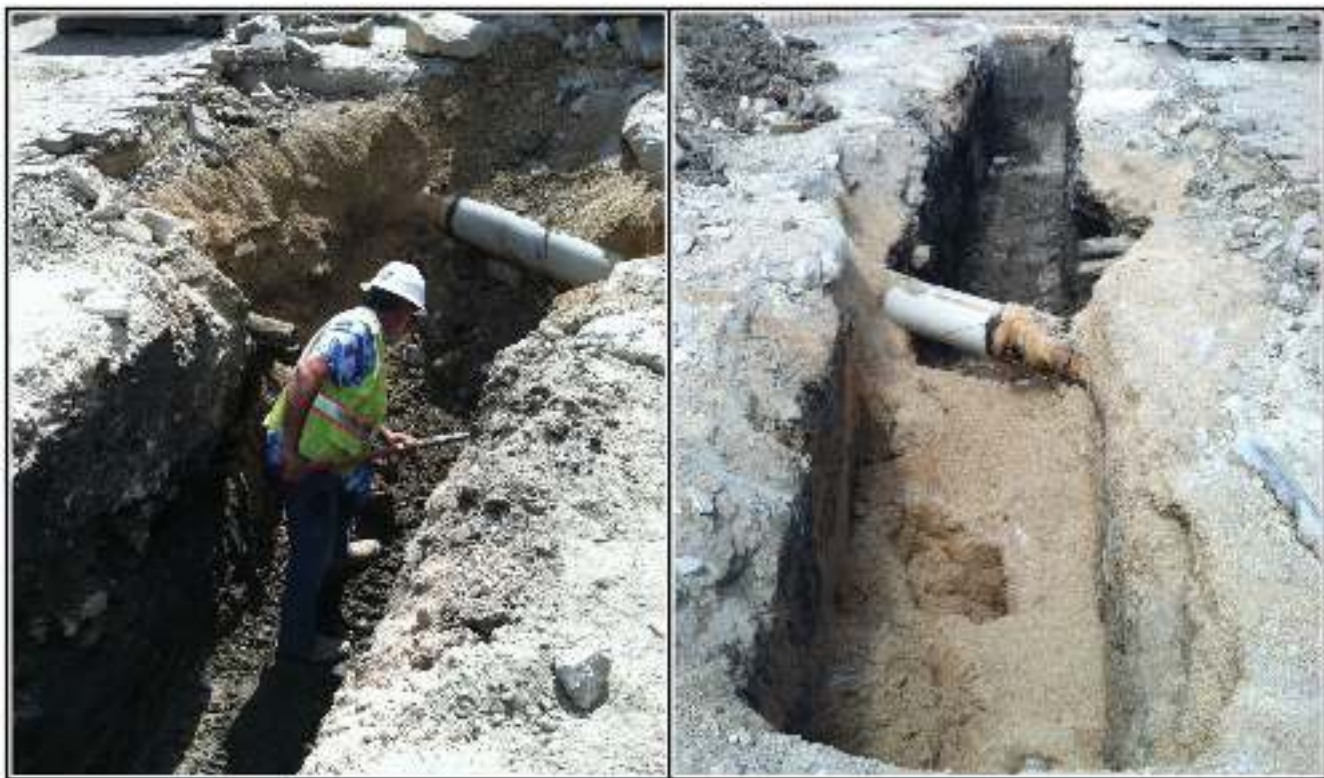
Figure 8-30. Gas line install, north side of E. Nueva Street at acequia crossing; note area is heavily impacted.
