**THE HERRERA GATE: AN ARCHITECTURAL, ARCHIVAL,  
AND CONSERVATION STUDY**

V. Kay Hinder

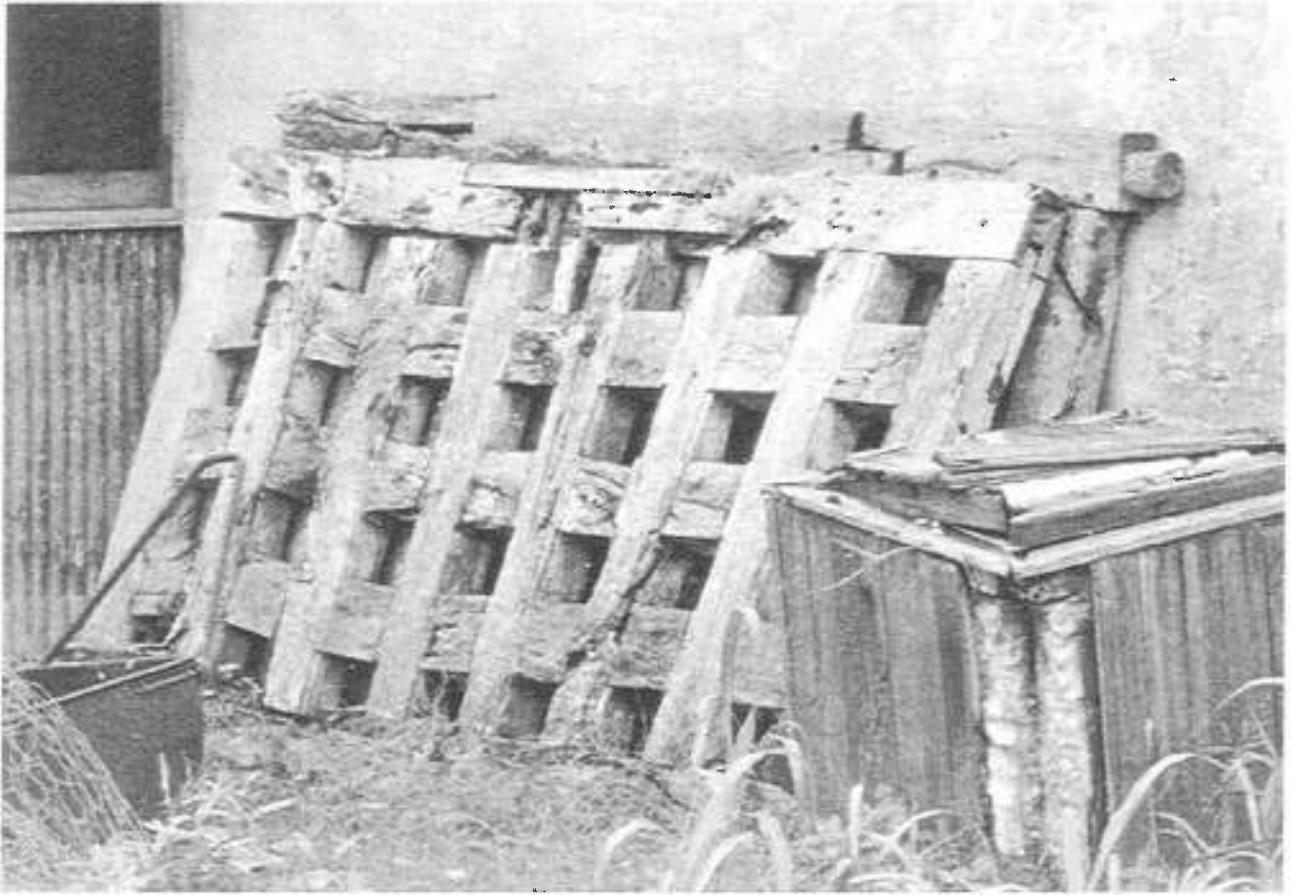
FIGURE 1. The Herrera Gate at 41BX672, November 1984.

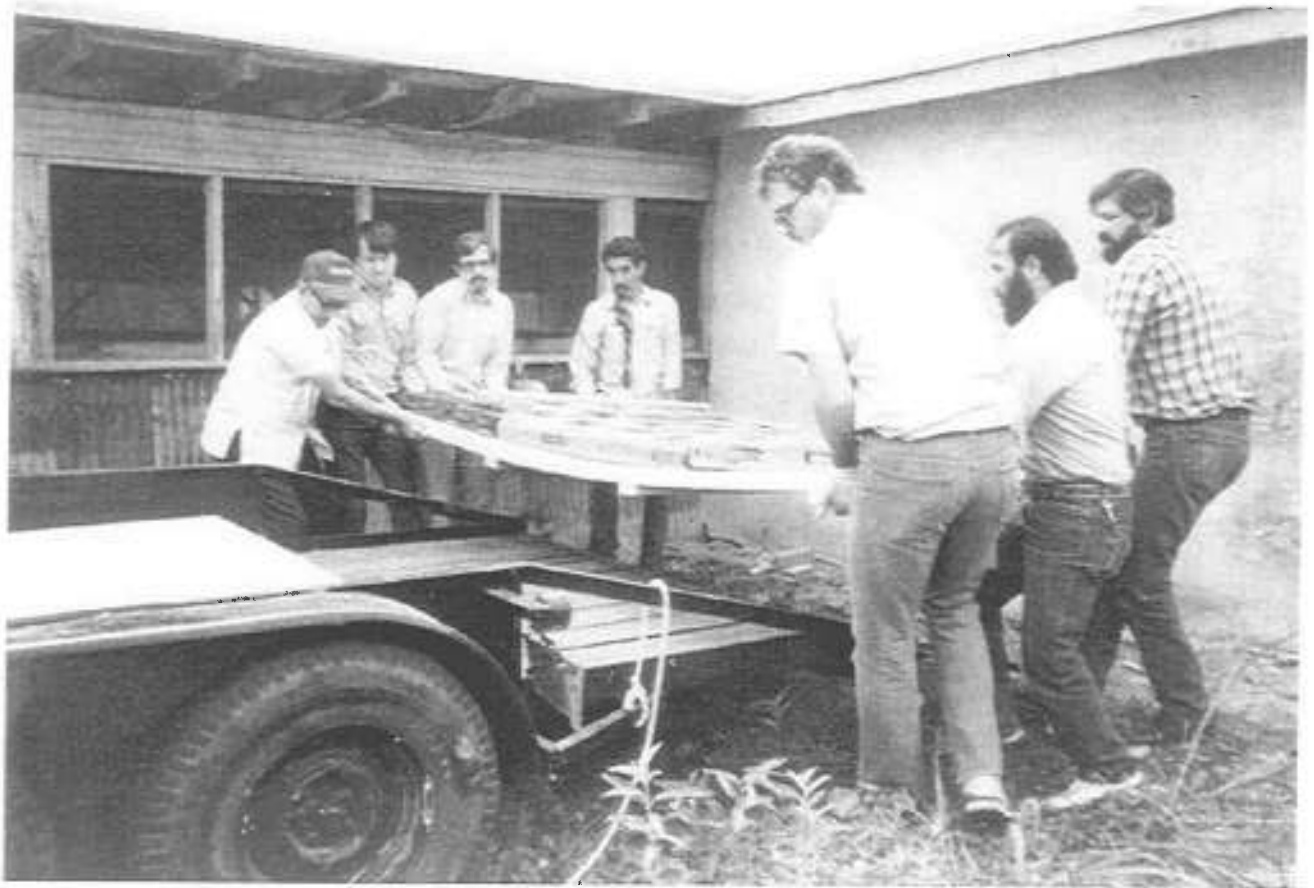
FIGURE 2. Removal of the Herrera Gate from 41BX672 to the Institute of Texan Cultures, April 16, 1986.

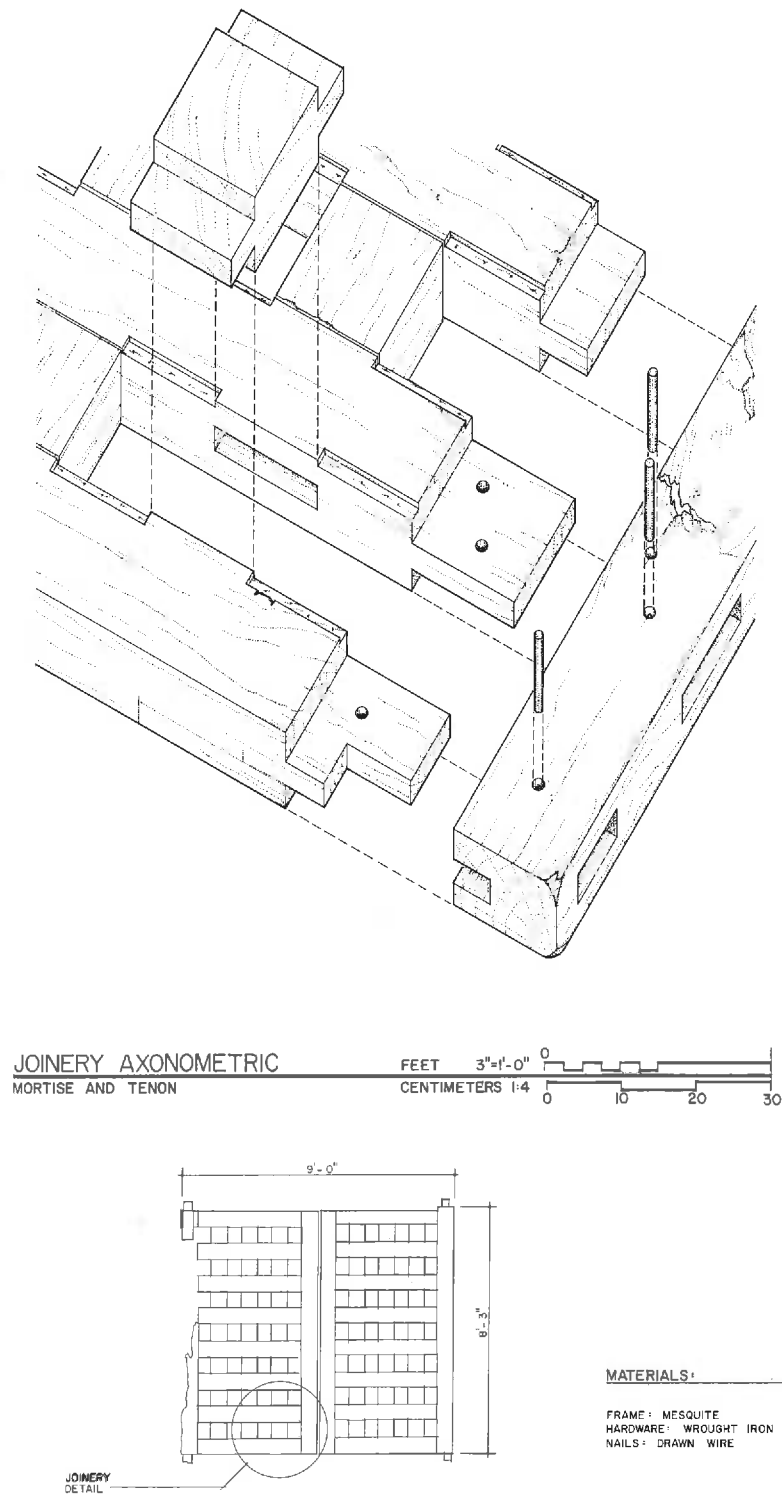
FIGURE 4. Joinery axonometric of mortise and tenon construction of muntins, cross beams, and side beams.

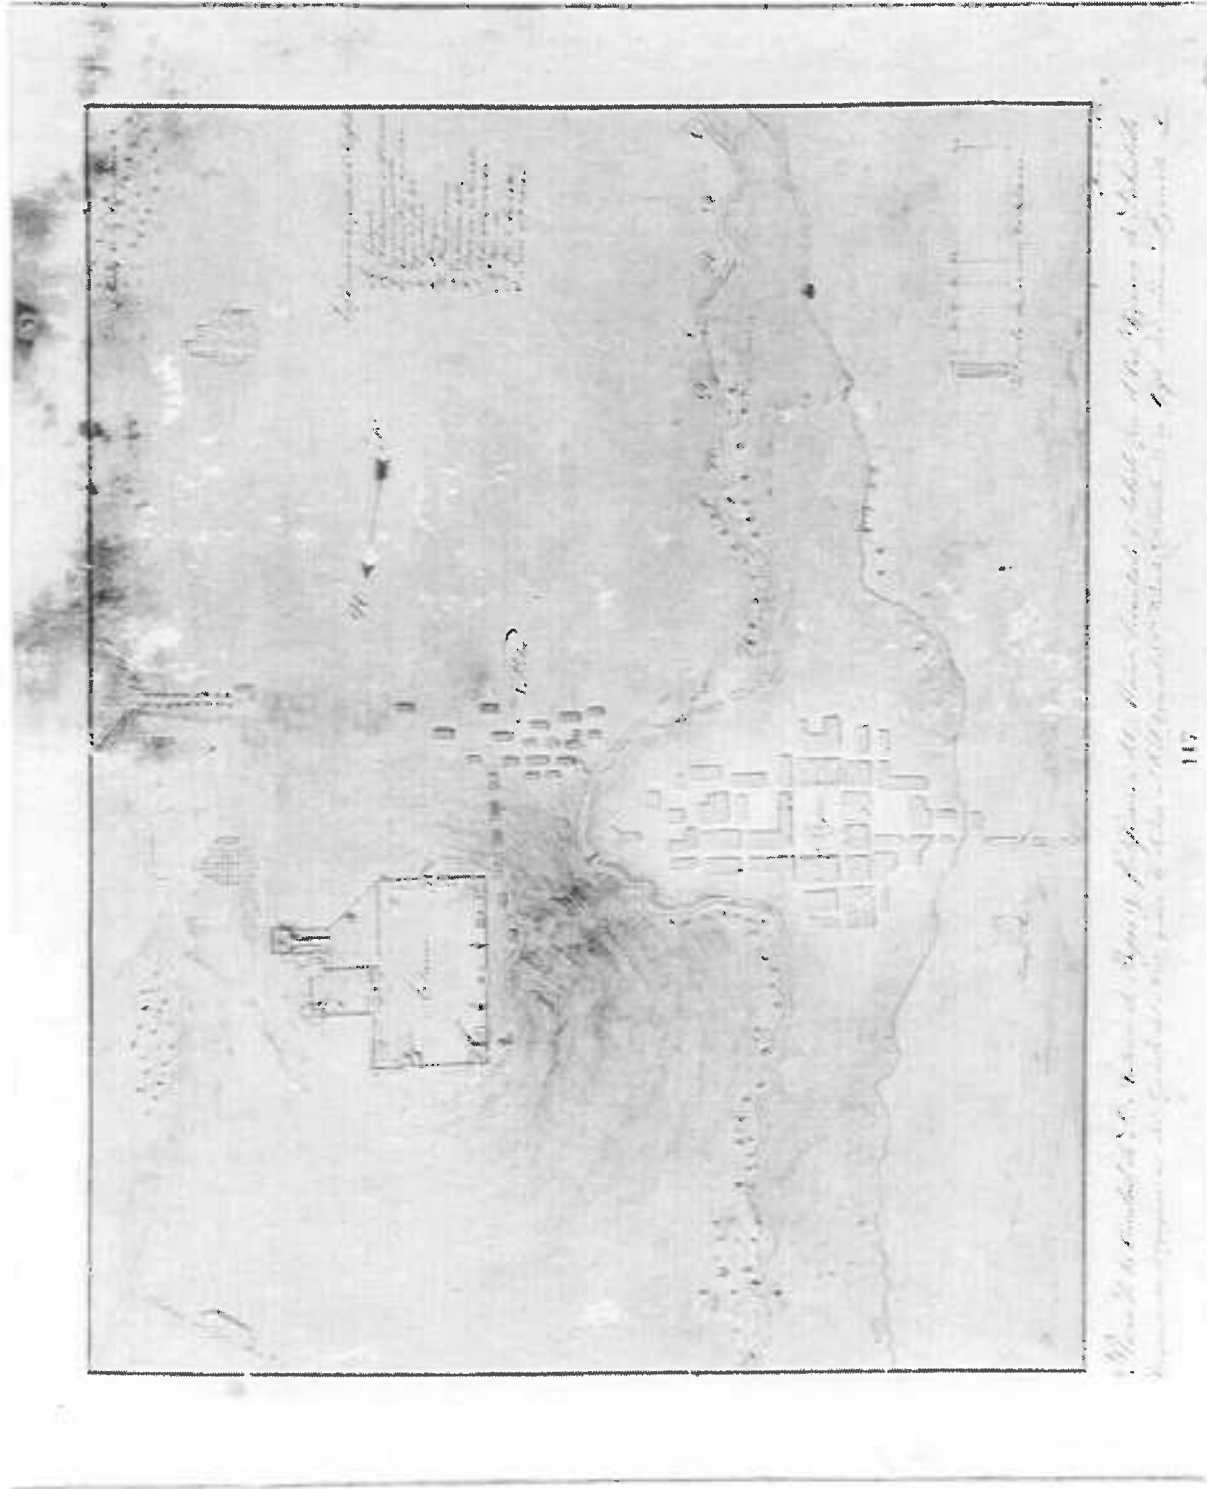
FIGURE 5. Plan of Mission San Antonio de Valero, 1836. *Plano de la Ciudad de San Antonio de...de Béxar y Fortificación del Alamo...* by Ignacio Labastida. Figure reproduced by permission of the Center for American History, The University of Texas at Austin.

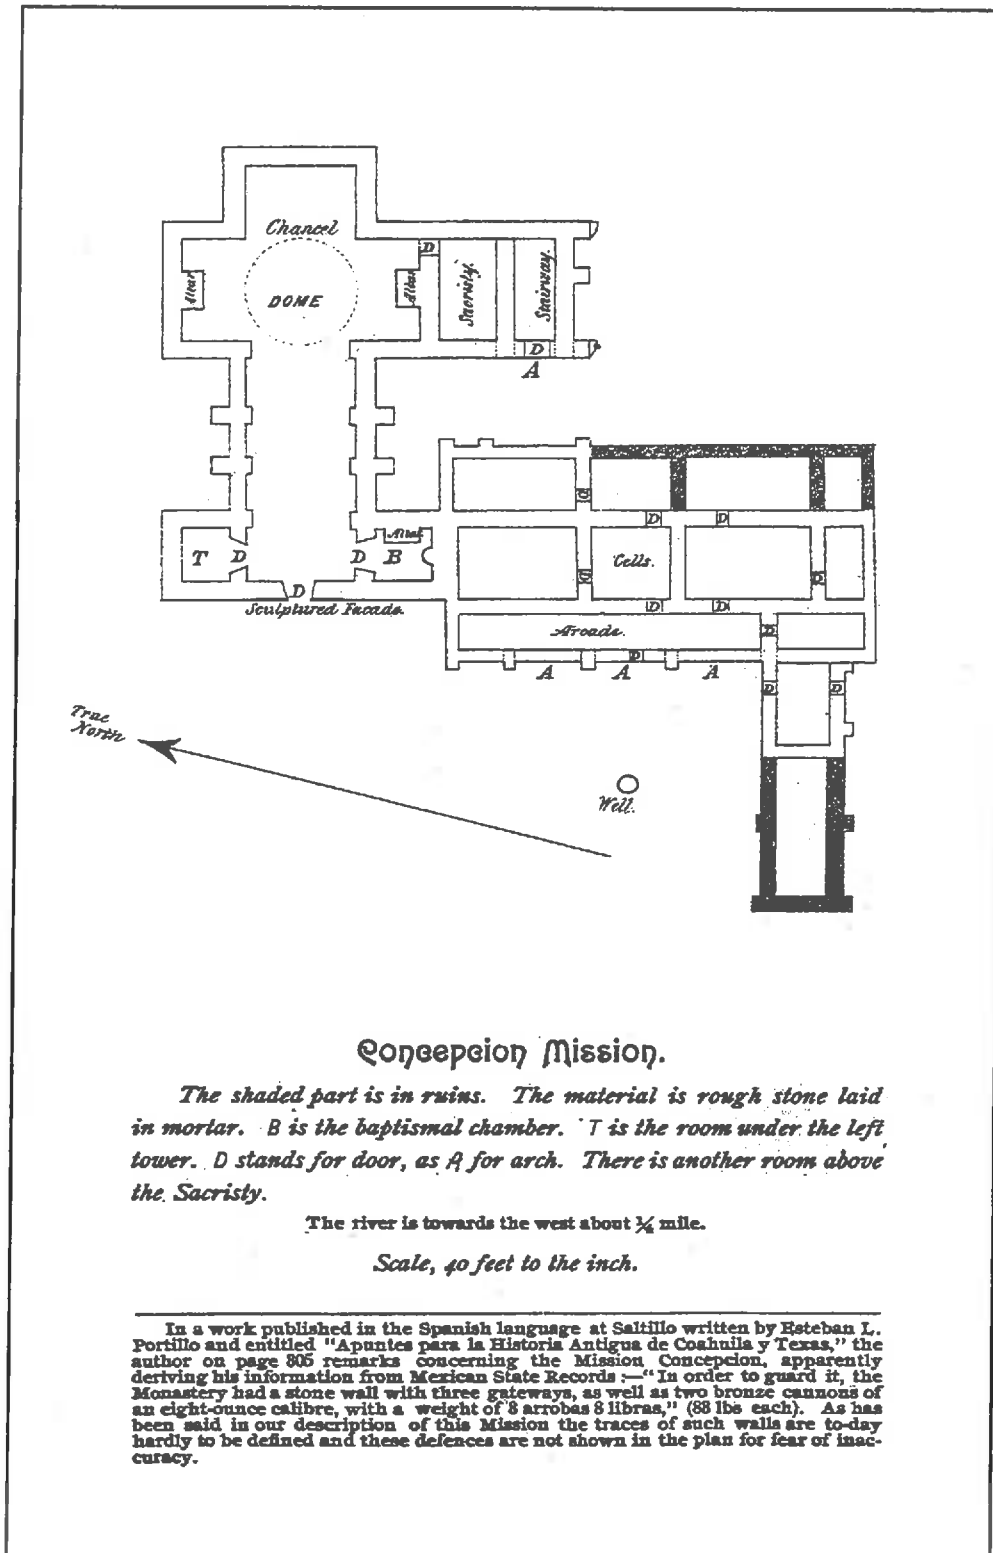
Figure 8. Plan of Mission Nuestra Señora de la Purísima Concepción (from Corner 1890, DRT Library).

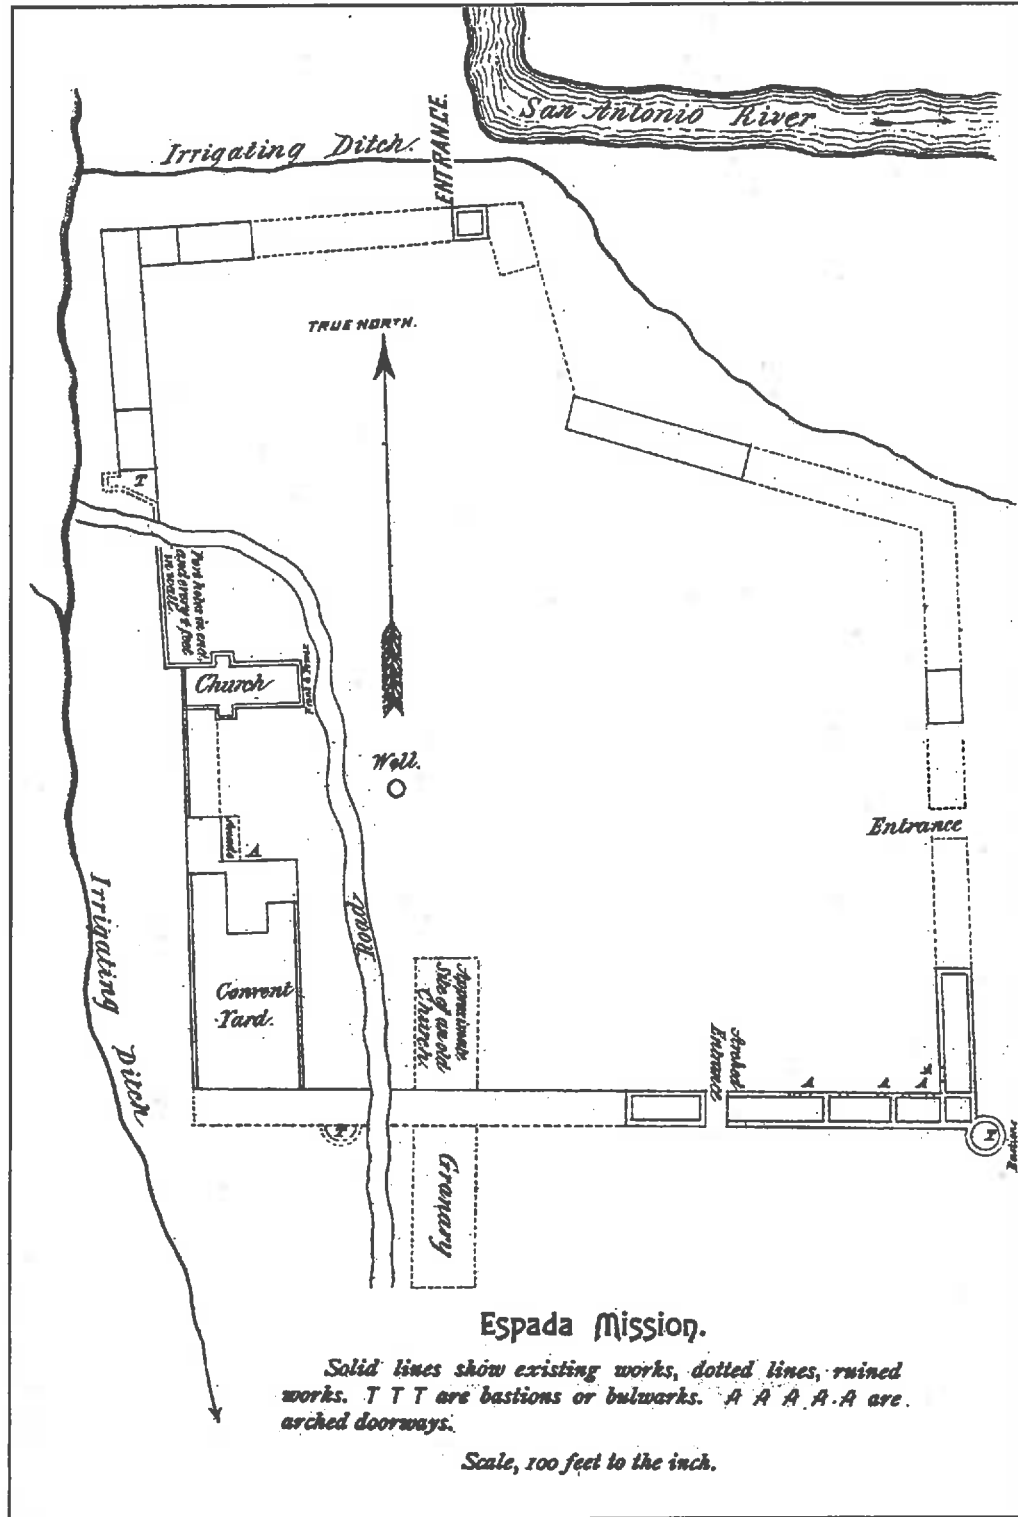
FIGURE 10. Plan of Mission San Francisco de la Espada (from Corner 1890).

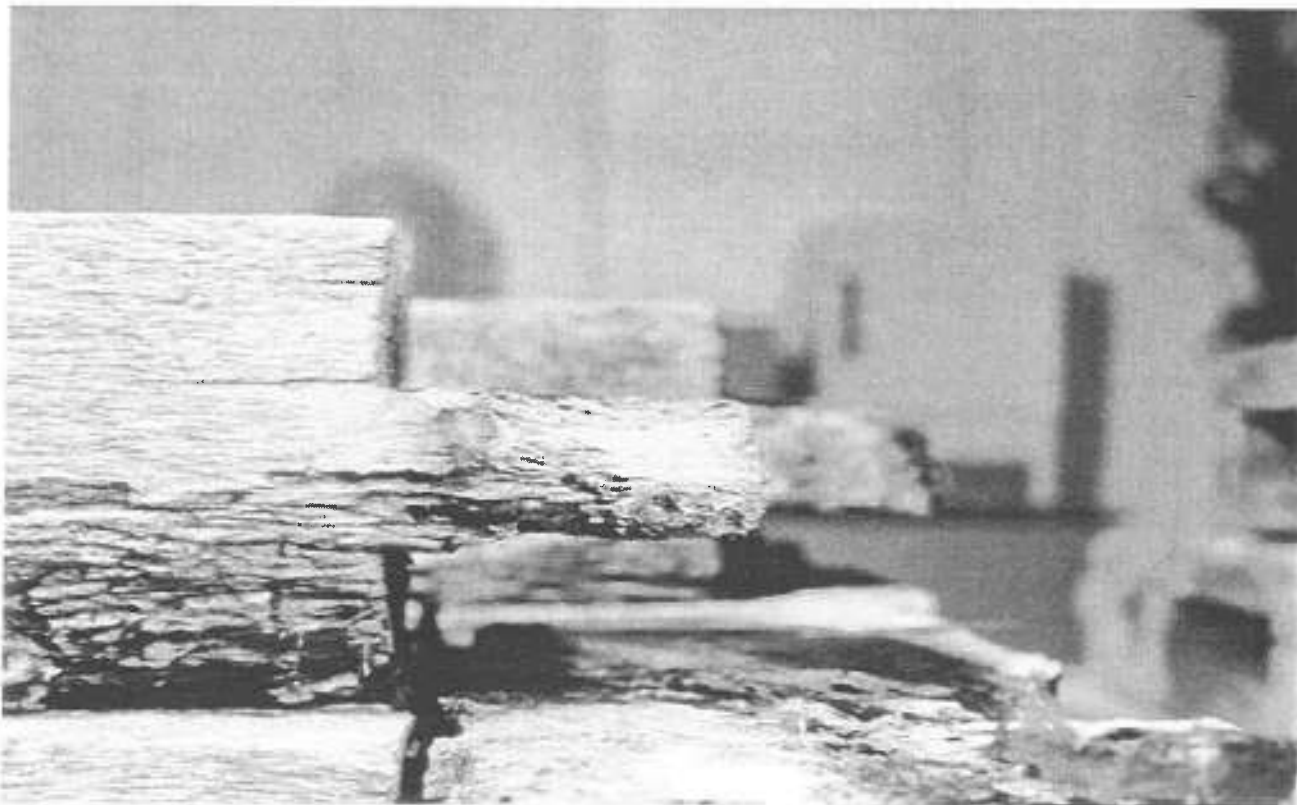
FIGURE 11. Muntin showing insect damage on the tenon. Casings from solitary bees were found in the mortise area into which this block was inserted.

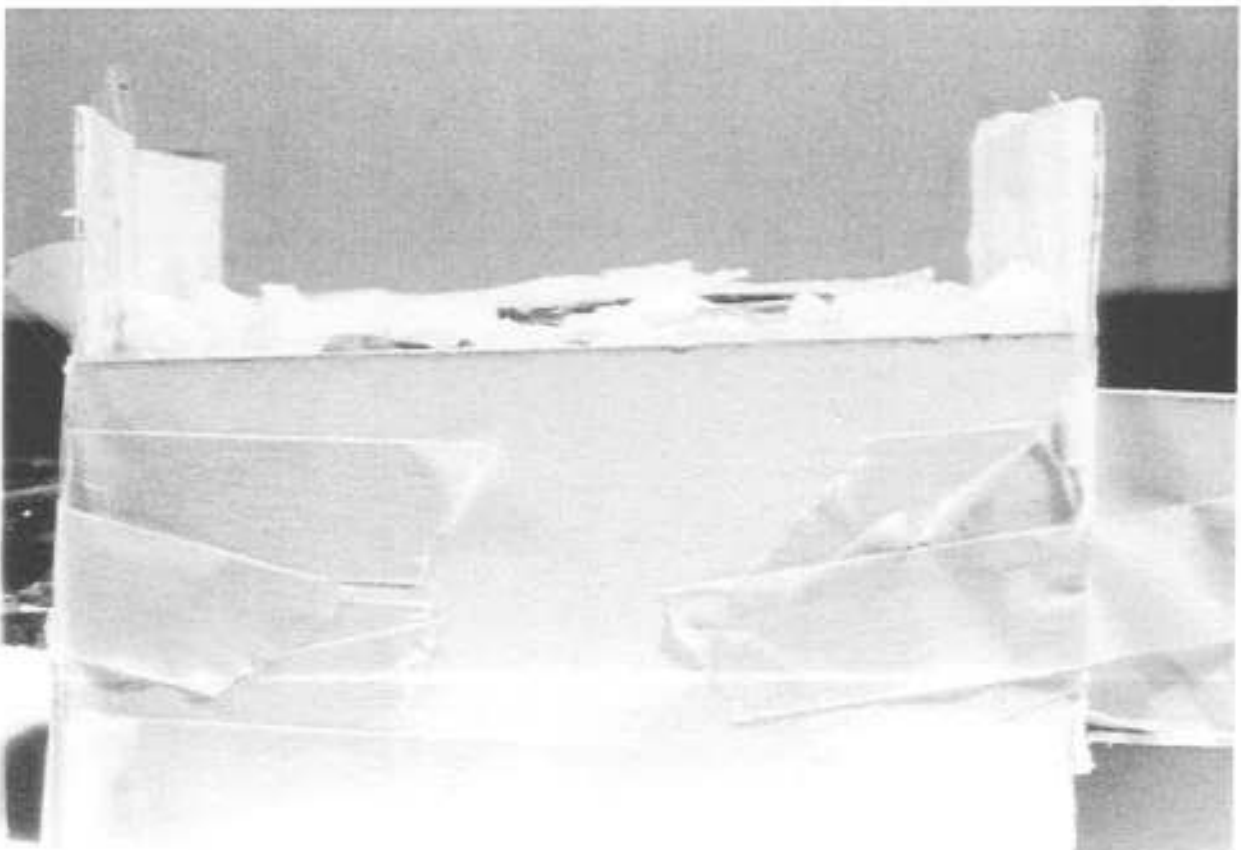
FIGURE 12. Mat board dike around the area to be filled on a muntin.

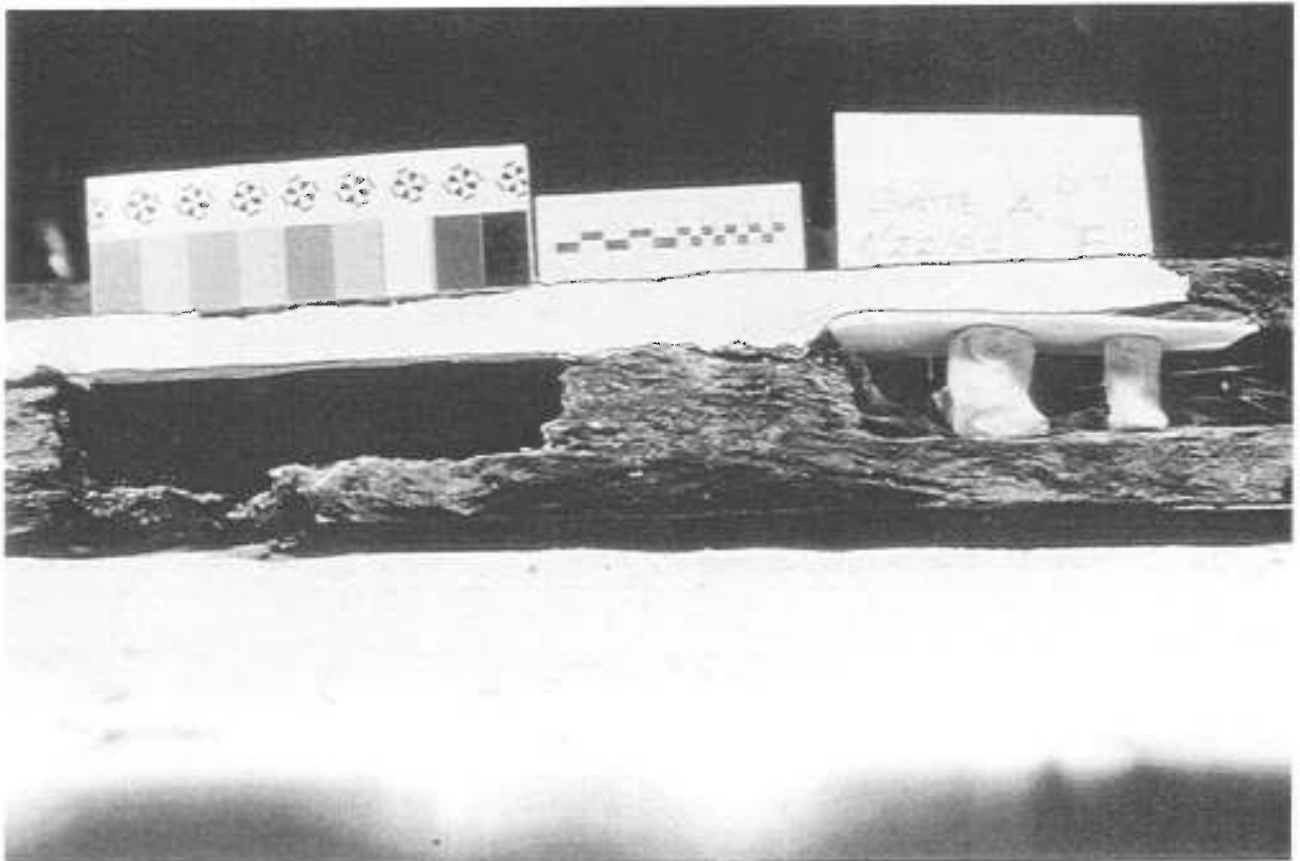
FIGURE 15. The broken mortise area being filled by the structural bridge fill method. The right mortise has a mat board support held up by plasticene pylons.

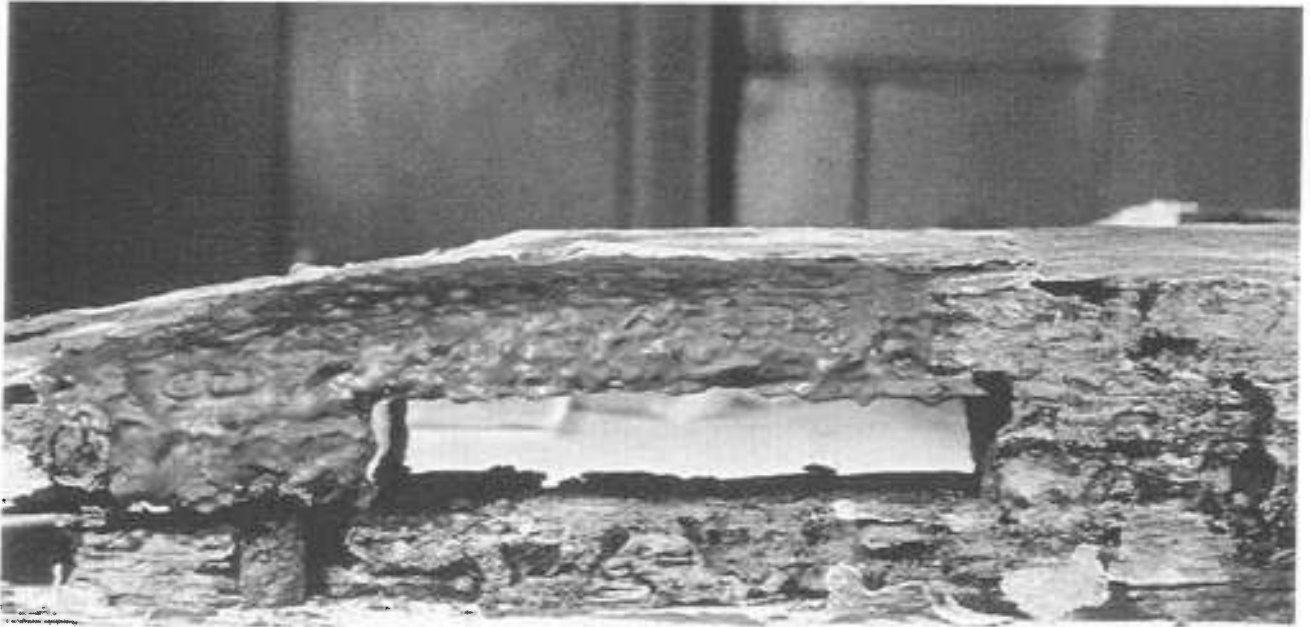
FIGURE 16. Intermediate stage in the reconstruction of a mortise on stile. The RTV has been colored with dry pigments.

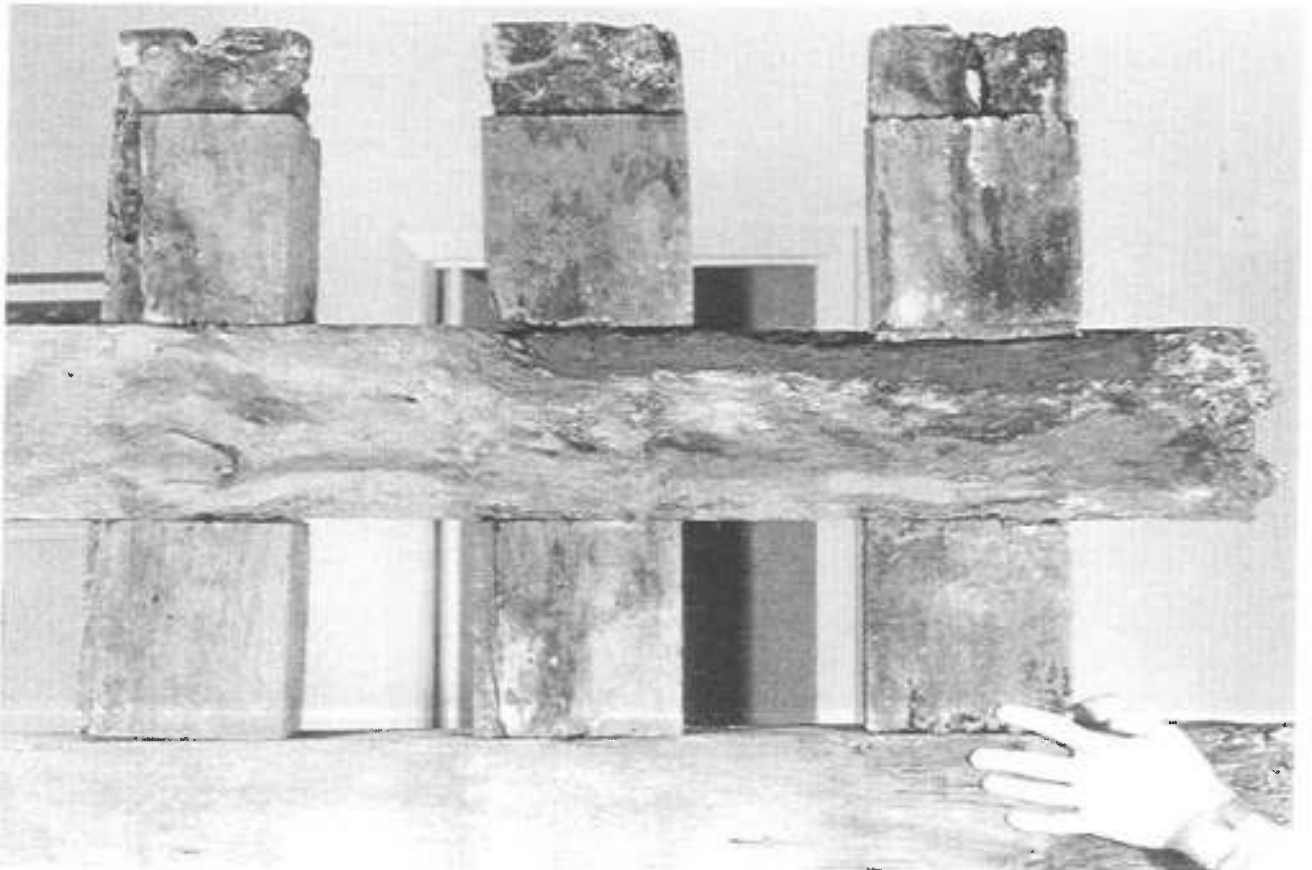
FIGURE 17. Completed reconstruction of broken mortise areas being tested for stability by placing the muntins back in them.

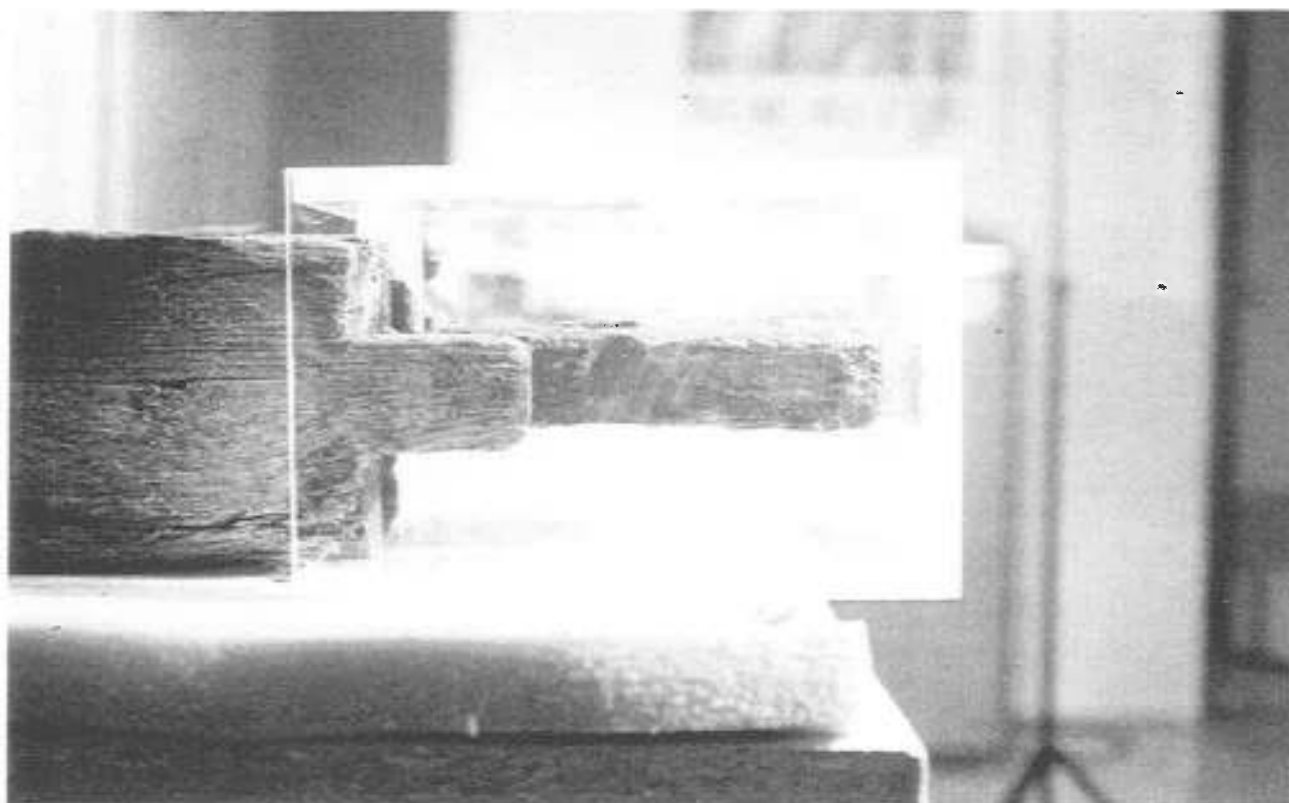
FIGURE 18. View of completed Acrylite beam on Gate A through the plastic beam.

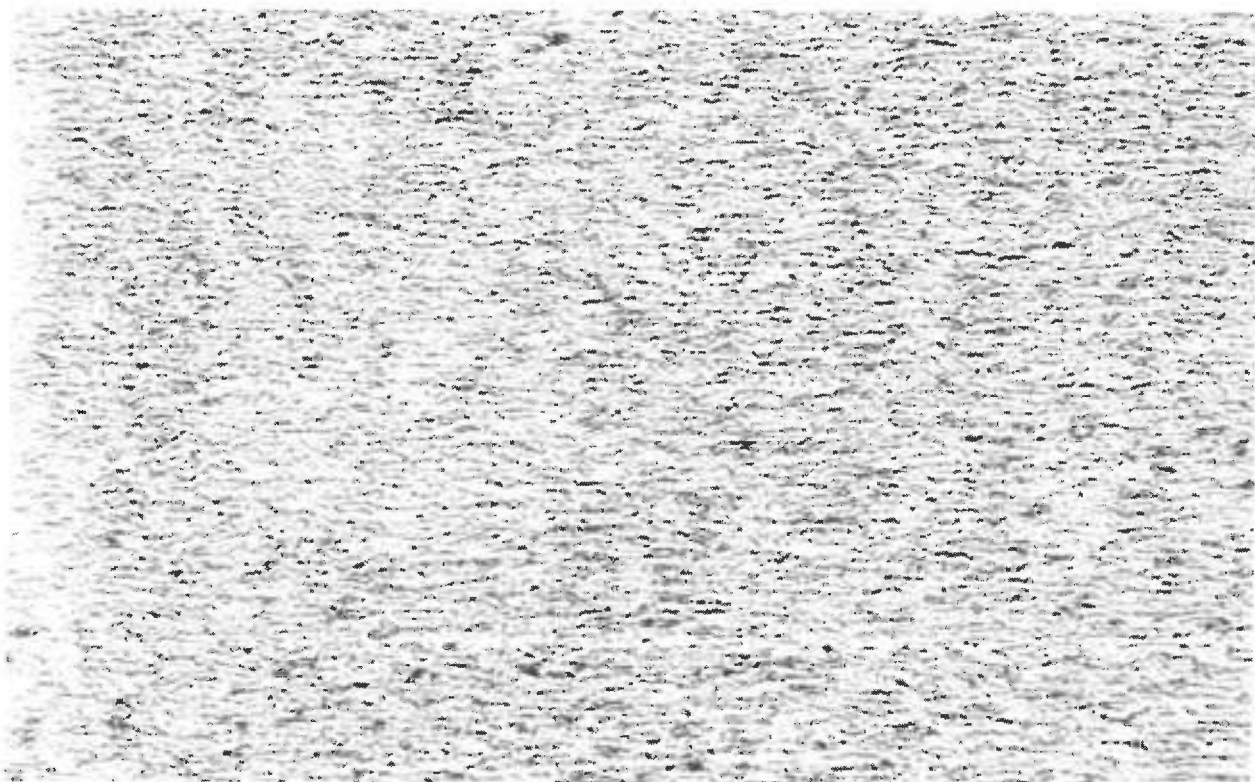
FIGURE 19. Metallographic cross section through a modern wire-drawn nail. Large grains have been compressed and are seen here as elongated areas of light and dark shades.

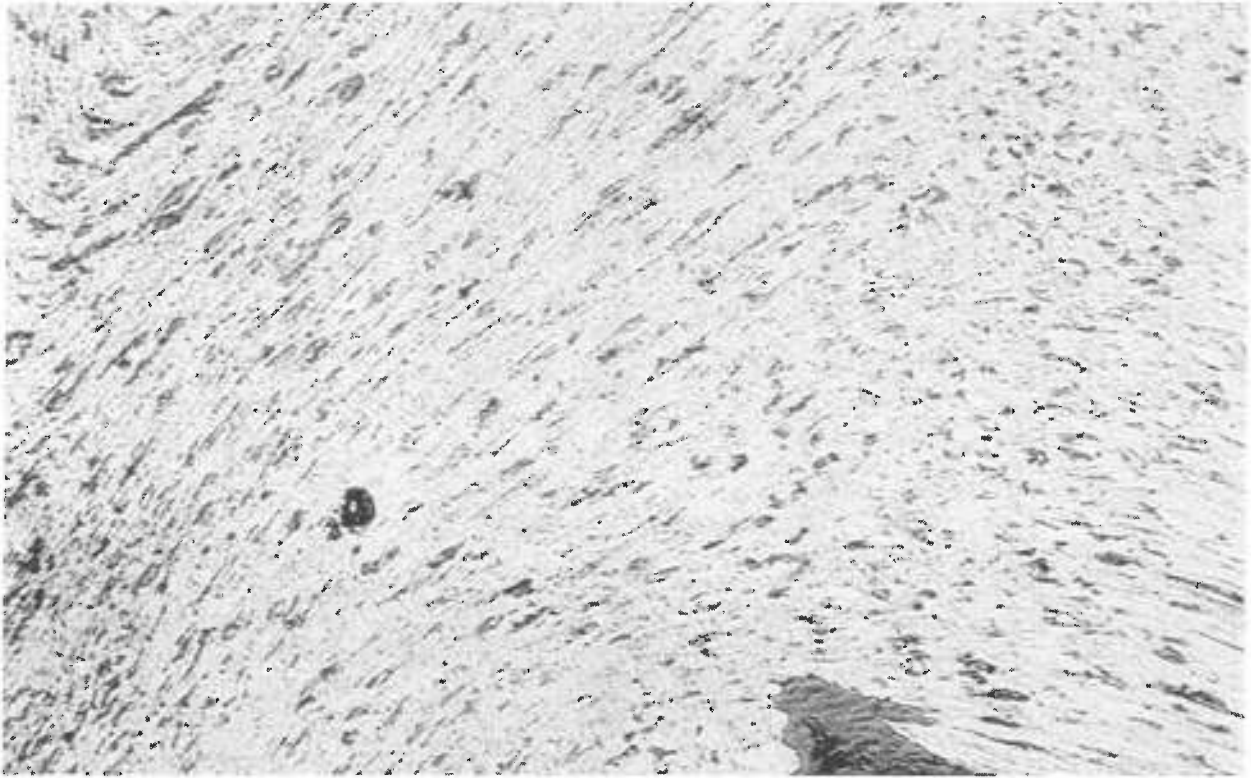
FIGURE 20. Metallographic cross section of a brad from one of the rabet cuts on Gate A. Notice the grain elongation, squeezing, and deformation due to wire drawing. The dark gray area at the bottom is ferric oxide corrosion.

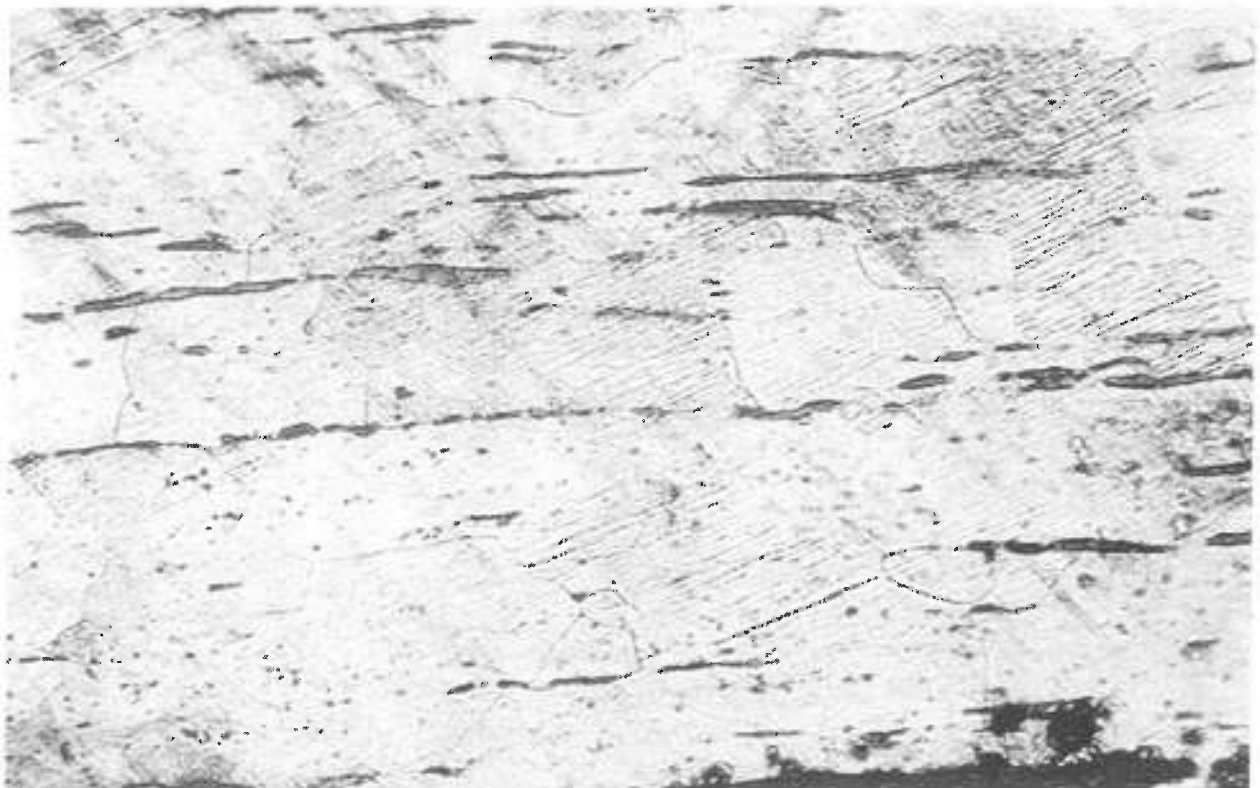
FIGURE 21. Metallographic cross section through a spike from Gate A. The ferrite grains are visible as faint outlines of irregularly shaped areas.
