Archaeological Monitoring of Drainage Pipe Trenching in the Vicinity of the San Pedro Playhouse, San Pedro Springs Park, San Antonio, Bexar County, Texas

Alexandria N. Wadley and Steve A. Tomka

Texas Antiquities Committee Permit No. 6359

Prepared by:
Center for Archaeological Research
The University of Texas at San Antonio
One UTSA Circle
San Antonio, Texas 78249
Technical Report, No. 52

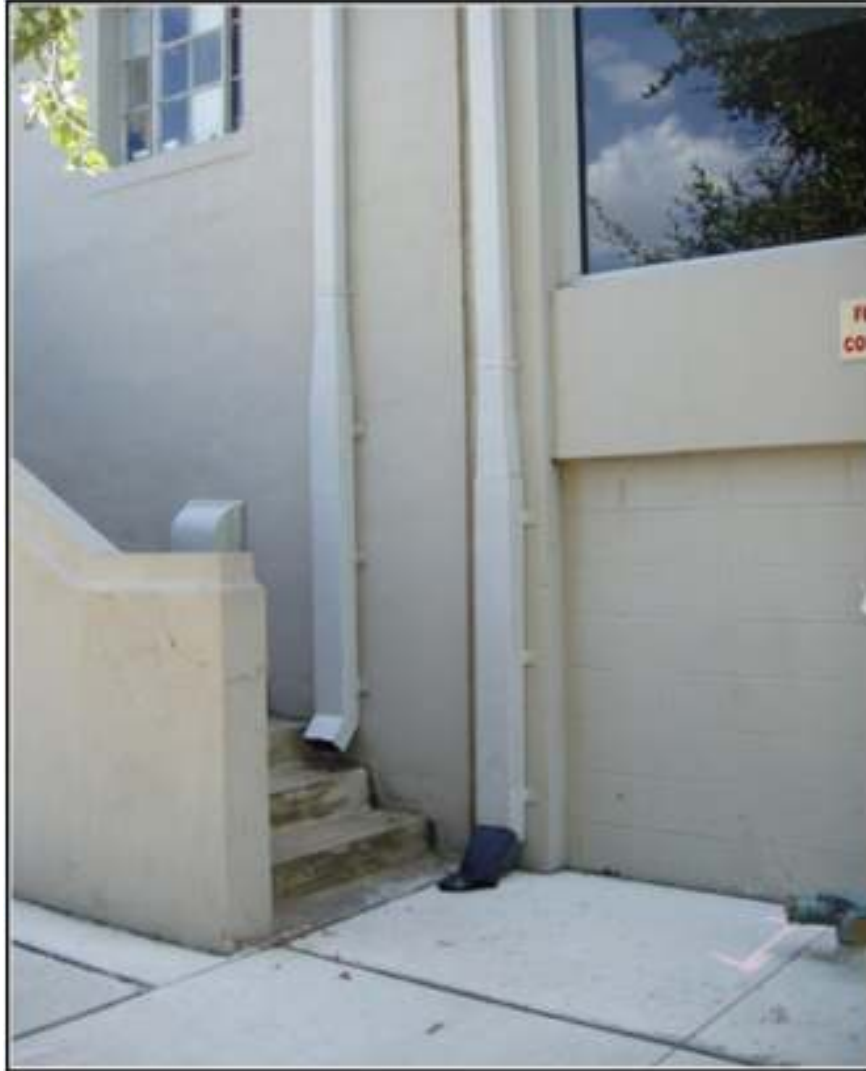
Figure 1-4. *Close-up of two downspouts at the base of the stairs.*

As a result of the reconfiguration, during severe weather rainwater typically drained directly against the base of the Playhouse building. The rainwater led to soil erosion below the sidewalks that endangered the foundation of the structure and also led to the flooding of the ground floor of the Playhouse.

To prevent further damage to the Playhouse, the San Antonio Parks and Recreation Department planned to improve drainage associated with three downspouts located on the northern face of the Playhouse building. Specifically, the entire existing concrete walkway extending along the northern wall between the downspouts would be demolished (Figure 1-5). Adhesive tar paper was to be placed along the 12-m wall to a depth of 1.5 m below the ground surface. Also, a 1.2-m tall concrete barrier would be constructed to further prevent water seepage. Two of the downspouts were to be connected to underground drainage pipes, which in turn would channel water to the north-northwest field and into an

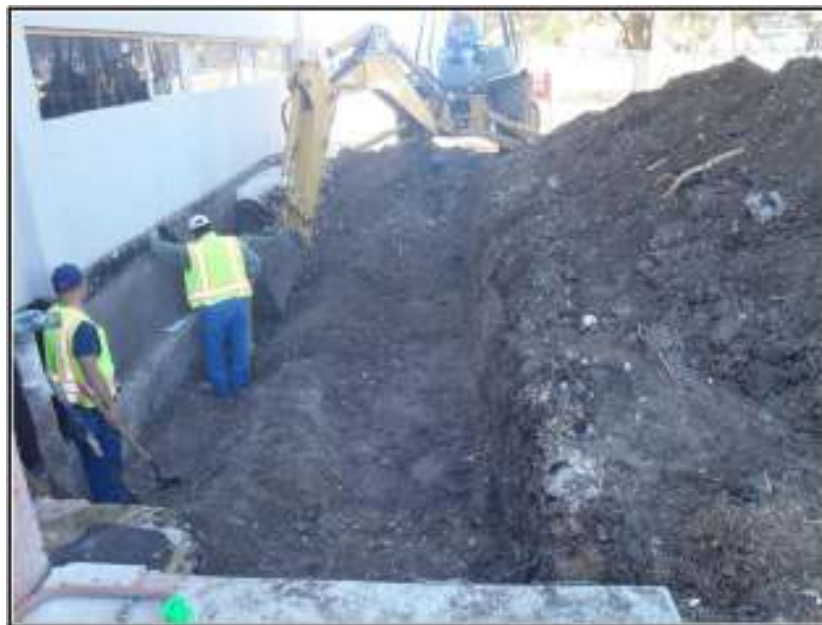
The soils in Trench 1 were disturbed as a result of previous construction activities adjacent to the base of the foundation. The stratigraphy consisted of a 13-cm thick caliche and gravel layer beneath the sidewalk and a light tan soil below the gravel layer averaging 15 cm in depth. Directly below the light tan soil was a dark brown, silty clay fill that continued to the base of the excavations.

Figure 4-3. Trench 1 being excavated by backhoe and shovels.

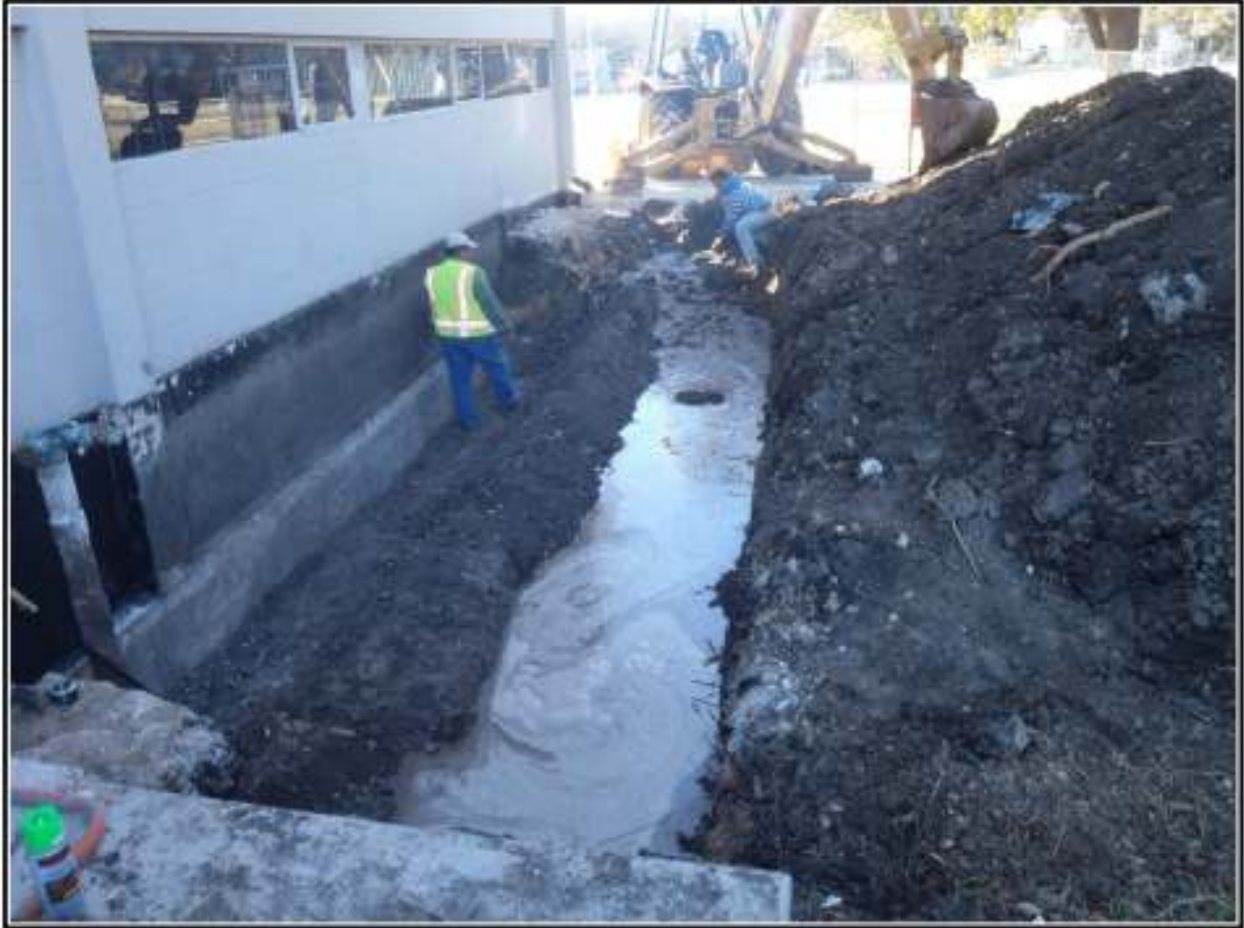
During the excavation of Trench 1, a PVC main waterline that connected to the Playhouse was damaged, flooding a portion of Trench 1 (Figure 4-4). The repair of the pipe necessitated additional excavations that were monitored by CAR staff. No artifacts were noted during the excavations around the broken PVC pipe.

Figure 4-4. Trench 1 flooded along the 1.2-m deep side.

Following the repairs, the north wall was covered with adhesive tar paper, and a row of sand bags was stacked against the northern portion of the trench. Reinforced rebar was placed along the trench, while the spaces between the stacked sandbags and the base of the wall was filled with matrix originally removed from the trench. The fill extended to approximately 41 cm from the eventual height of the sidewalk. At this point, the PVC drainage pipes connecting to the downspouts were positioned on top of the fill and secured in place with additional sandbags near the edge of the trench. Next, a layer of crushed limestone gravel was placed on top of the pipes (Figure 4-5). The two drainage lines were to intersect some 11 m from the base of the wall and to continue as a single line toward the culvert west of the building.

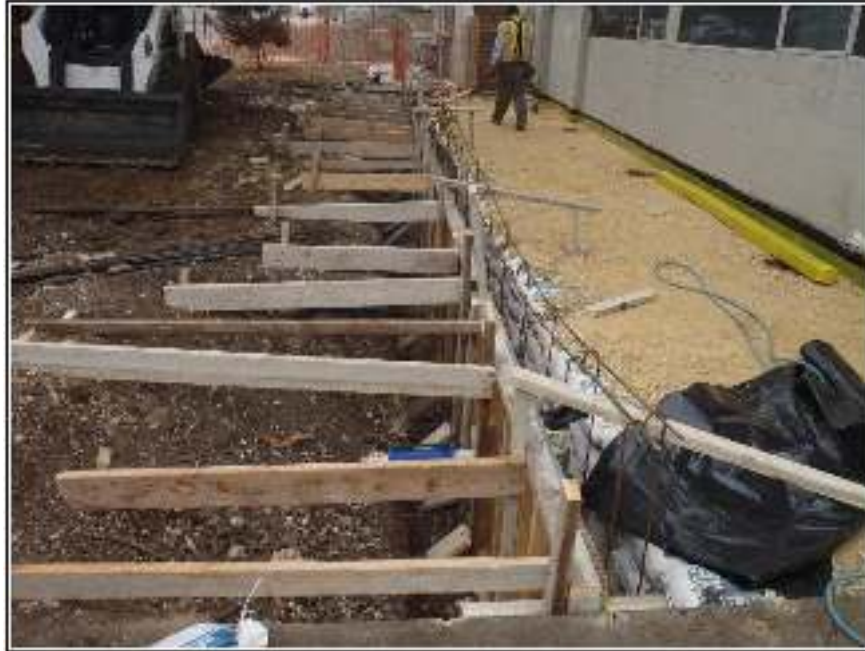
Figure 4-5. Stacked sand bags against the north wall of the Playhouse.

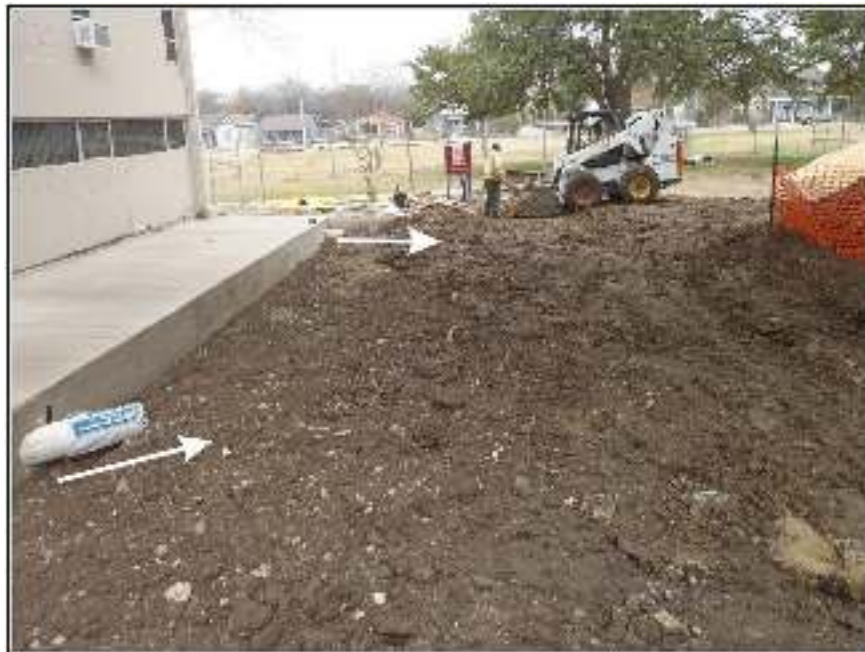
Figure 4-6. New sidewalk against north wall of Playhouse. Note drainage pipes extending from sidewalk.

Next, concrete was poured on top of the bags and fill, and the concrete was held in place by a temporary form placed along the north edge of the trench. The top of the concrete layer was to serve as the new sidewalk along the north wall of the Playhouse. The layer of concrete was approximately 46-cm thick and reached to the top of the moisture barrier installed on the north wall of the structure (Figure 4-6).

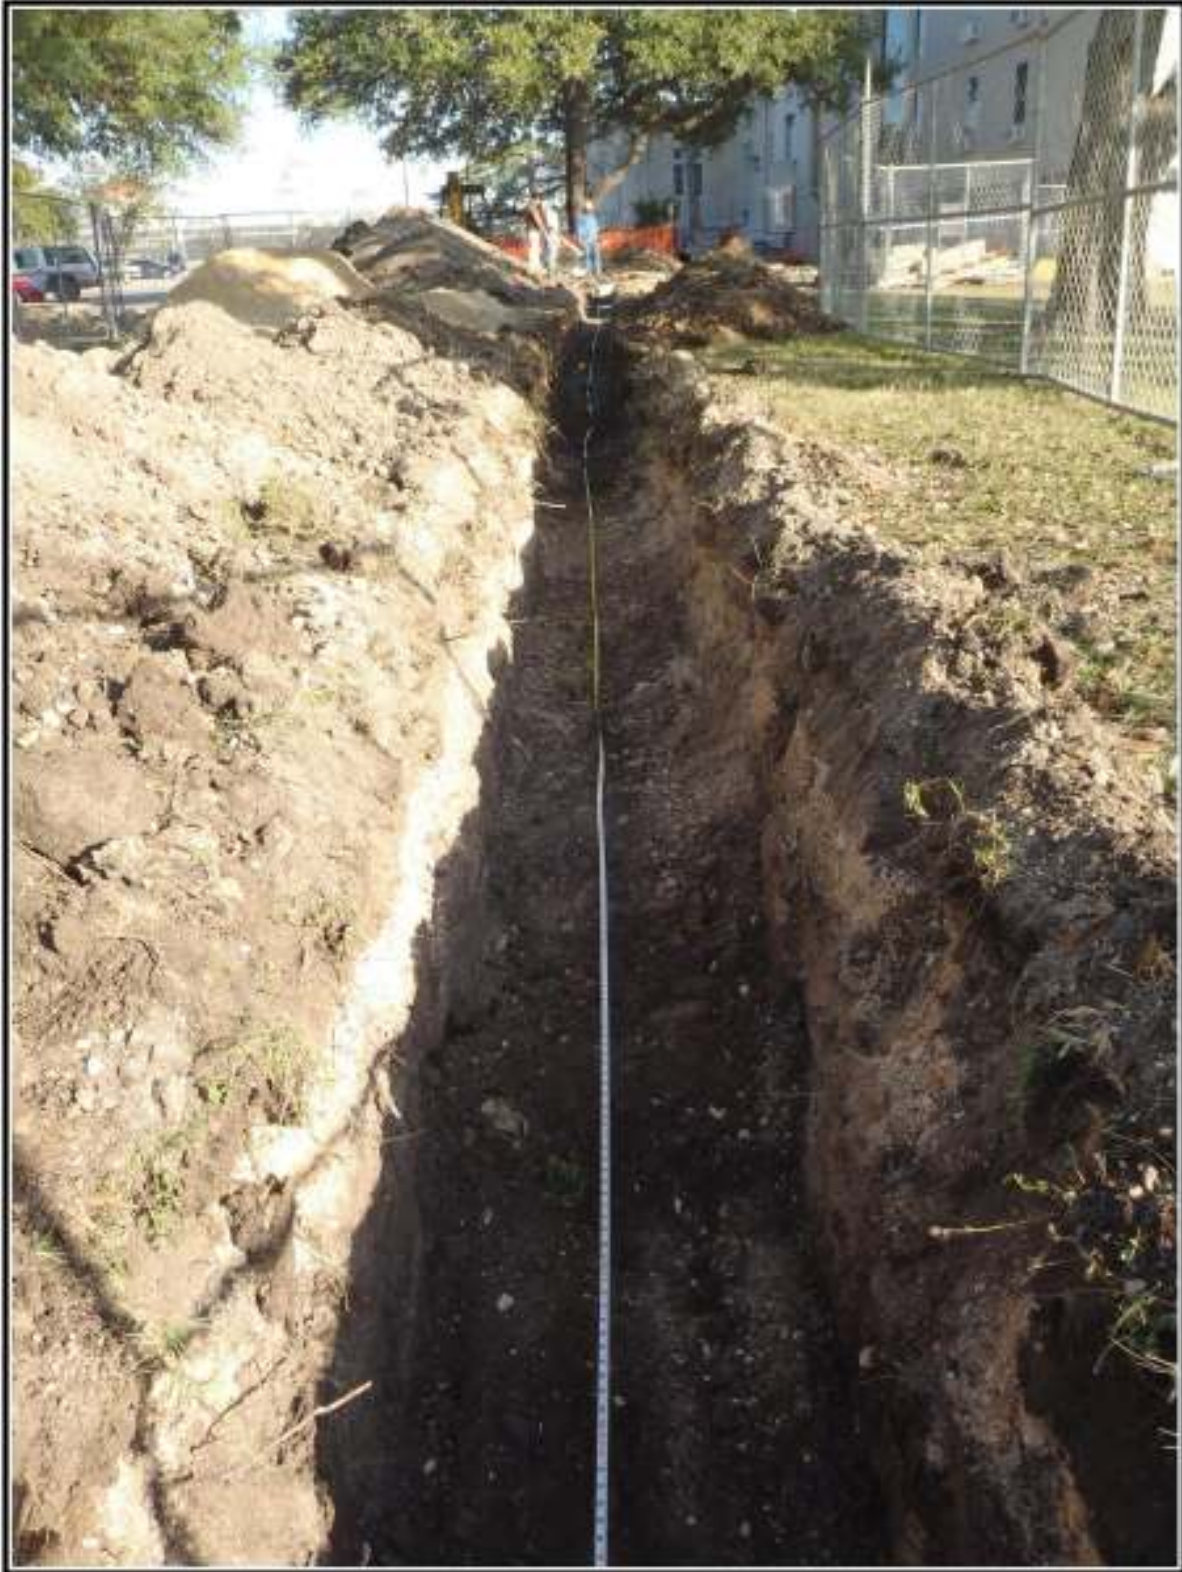
The excavations of the two trenches that started at the edge of the newly laid sidewalk and continued to the pipe intersections were not monitored since these areas had been previously disturbed. Beginning at the intersection of the two trenches to the culvert, the excavation of the trench was monitored by CAR staff. The stratigraphy revealed in the trench wall consisted of a 6-cm thick layer of dark brown, silty clay top soil (Figure 4-8). Below this layer was a 30-cm thick zone of mixed orange sand, crushed limestone gravels, and light tan, silty soil. At 40 cmbs was a homogeneous, 8-cm thick caliche layer throughout the trench. Beneath the caliche layer at 43 cmbs a brown, silty soil continued to the base of the trench (70 cmbs).

Figure 4-8. Trench 2 complete (facing east). View from grated drainage gutter towards the Playhouse.
