ARCHAEOLOGICAL INVESTIGATIONS AT FORT GRIFFIN STATE HISTORIC PARK  
SHACKELFORD COUNTY, TEXAS

Center for Archaeological Research  
The University of Texas at San Antonio  
Archaeological Survey Report, No. 23

1976

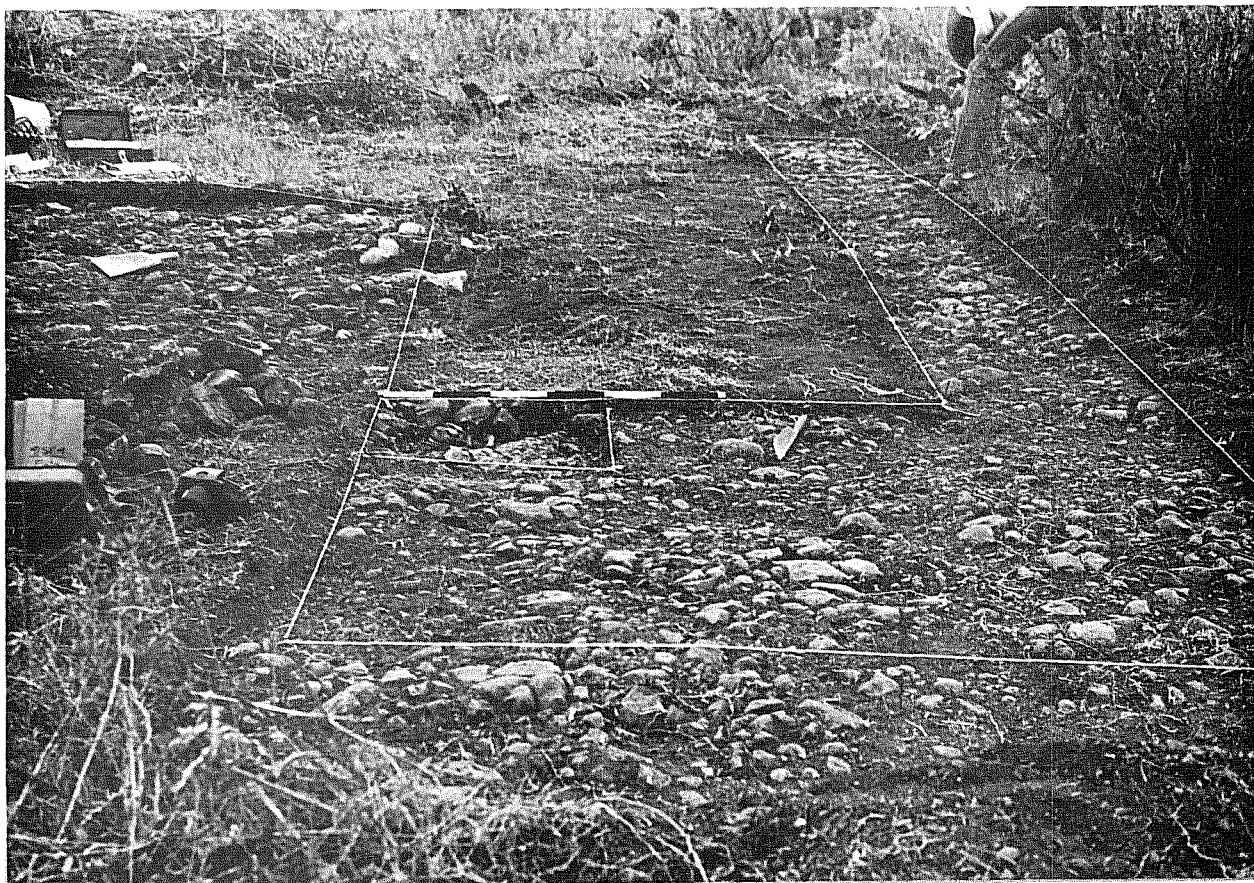
Figure 5. *Photographs of Excavations in Area A.*  
(upper) Chimney base at Kitchen-Mess Hall G4,  
looking west.

(lower) Excavations in area of Blacksmith Shop F,  
looking south.

Using information gained in the 1973 testing, another attempt was made to locate this structure, supposedly west of G3 (Fox 1973:27). An area 16' x 58' within which the building should be located was marked out using an alidade and plane table. A trench 2' x 26' located six feet east of the west end of this area was stripped of grass and weeds. Directly under the topsoil was a thin layer of gravel which overlay a pavement of larger gravel and small stones, inlaid with chunks of iron, square nails, and occasional glass fragments (Fig. 5). The cleared trench was expanded to the east and opened up into a 10-foot square over what appeared to be a concentration of larger rocks. The same combination of large gravel and artifacts appeared to extend over the entire area. Although great care was taken to examine all of the area cleared, no features were found which would indicate structure of any kind. All artifacts were left in place, then collected in a controlled grid in order to observe their distribution. No significant information was obtained from this exercise, however.

Judging from the artifacts recovered, (listed in Artifacts section) there is no question that the blacksmith, or at least a farrier, was located somewhere in the immediate vicinity. The fact that no evidence was found of a permanent forge, the base for an anvil or post holes for installation of other equipment, or trenches indicating picket construction probably indicates that the actual location has not yet been found.

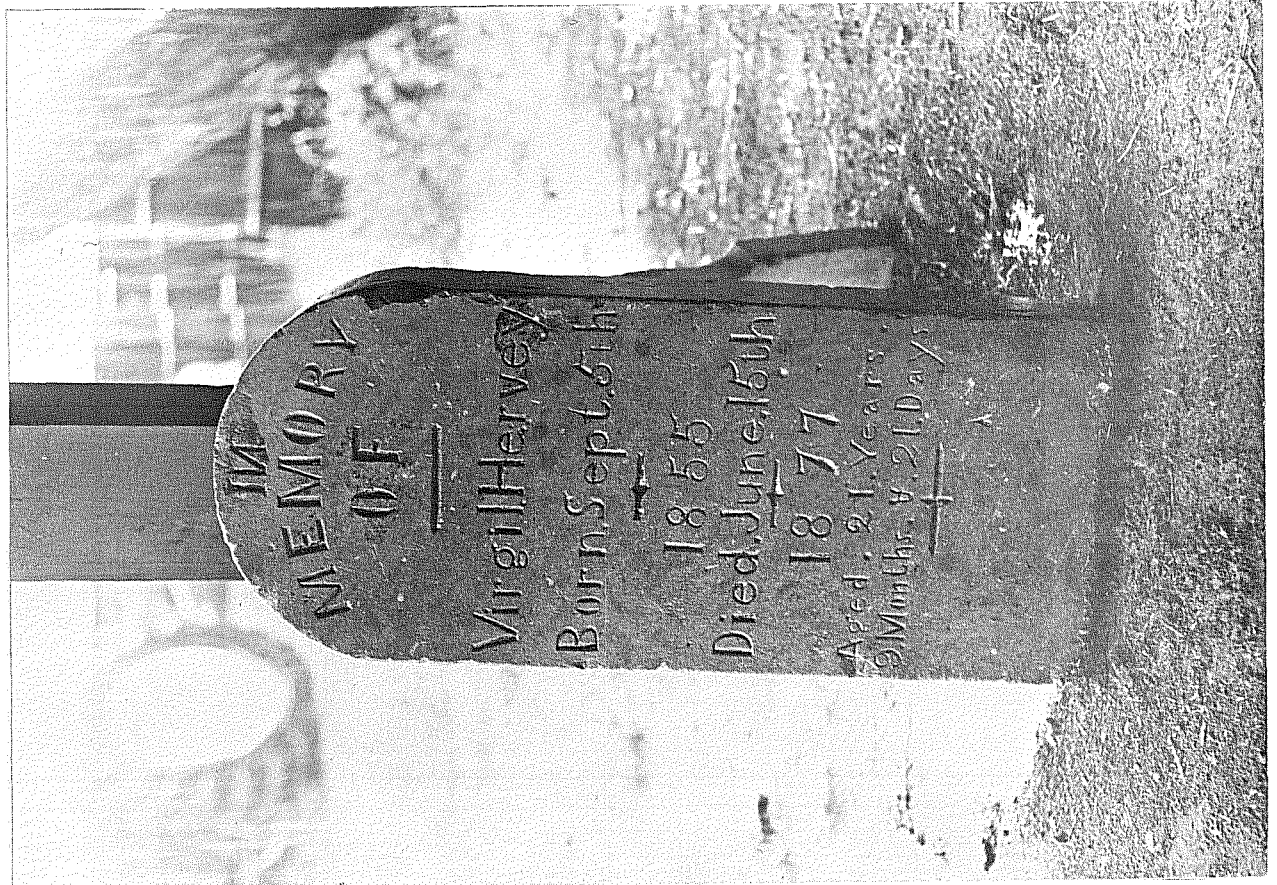
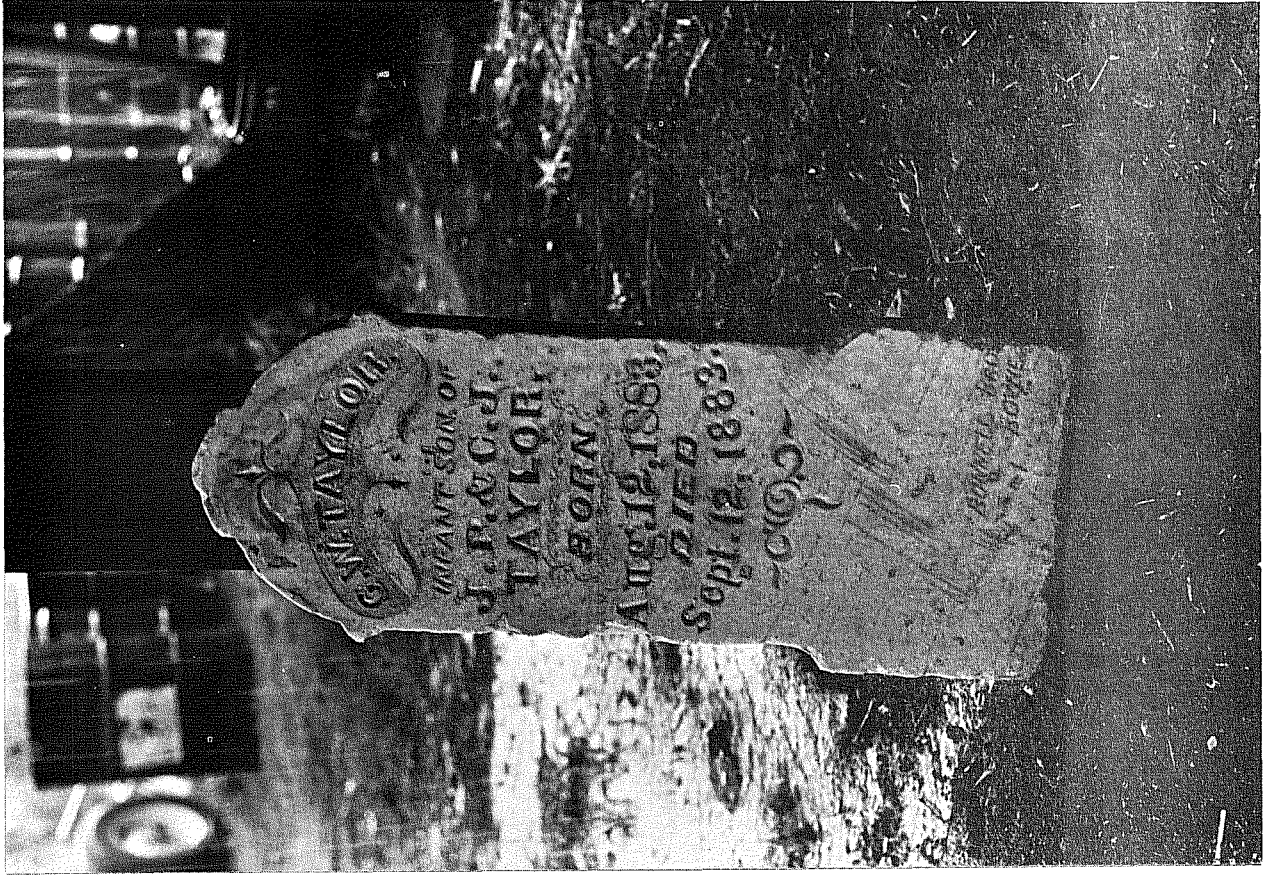
Figure 8. *Gravestones*. These were removed from the cemetery on Highway 283 and are now stored in the park.

In Memory  
of  
Virgil Hervey  
Born Sept. 5th  
1855  
Died June 15th  
1877  
Aged 21 Years  
9 Months & 21 Days

G. W. Taylor  
Infant Son of  
J. P. & C. J.  
Taylor  
Born  
Aug. 12, 1883  
Died  
Sept. 12, 1883

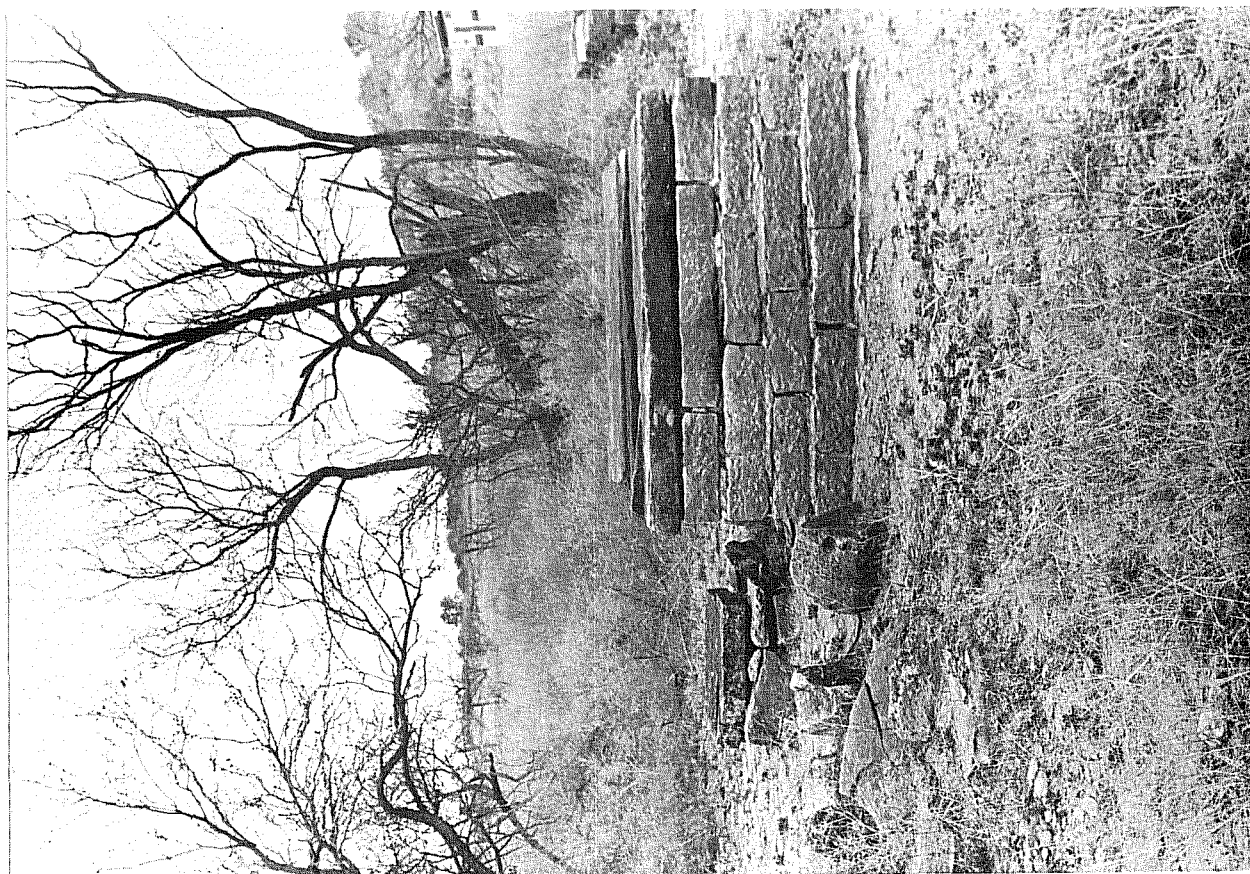
Figure 9. *Graves in Civilian Cemetery.*  
(left) Crypts of Little Lulu Hervey (45) and  
Virgil J. Hervey (44) taken from the east, with edge of  
Fort Griffin plateau visible in right rear.

(right) Typical grave with crude head and foot stones.

Most of the graves were marked only by a stone or two set upright in the ground, some by mounds of rock, and some merely by a depression in the ground. A few were surrounded by carefully constructed rock walls in a form of crypt (Fig. 9). Of the latter, two had large stone slabs laid across them marked as follows: "I.H.S./VIRGIL J. HERVEY" and "LITTLE LULU HERVEY". These were the only inscribed grave markers found in place. Park personnel pointed out two additional, more elaborate markers which had been found lying on the ground within the cemetery a number of years ago and stored behind a shed for safekeeping (Fig. 8). These contained more information:

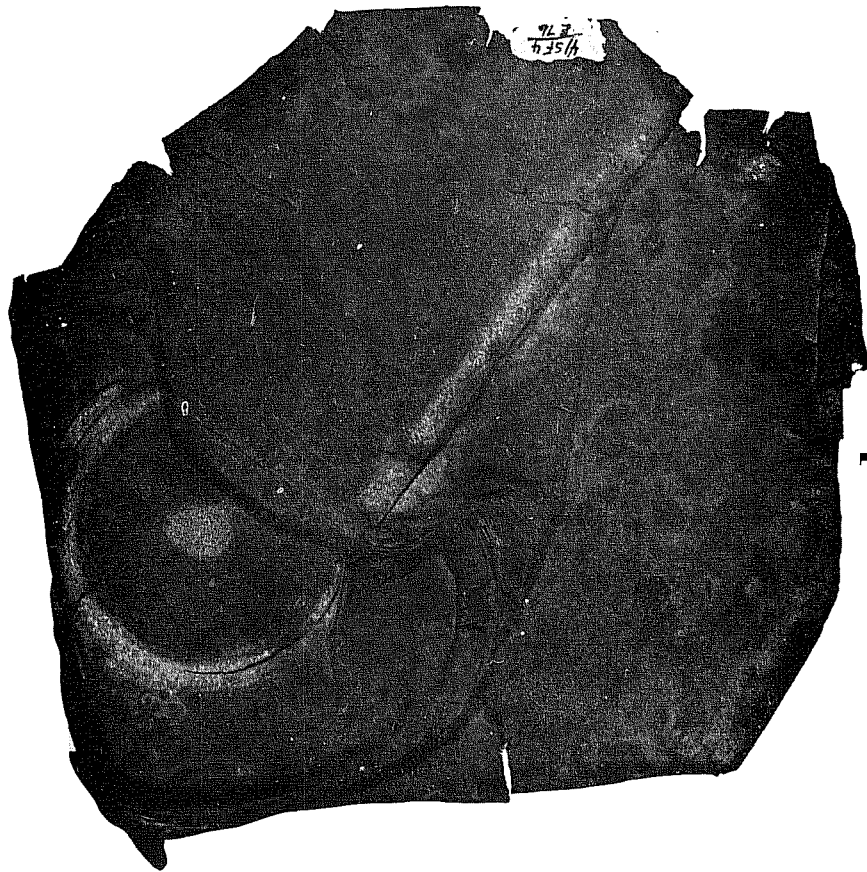
Figure 13. *Domestic Articles*

Provenience
a, white ironstone rim	Area C, trench E76
b, fragment of stoneware crock lid	Area C, trench E76
c, fragment of stoneware crock	Area C, trench B76
d, tin can with soldered seams	Area C, trench E76
e, cast iron kettle fragment	Area A, trench G1
