# ARCHAEOLOGICAL INVESTIGATIONS AT THE UNITED STATES ARSENAL SITE (41 BX 622), SAN ANTONIO, TEXAS

Center for Archaeological Research  
The University of Texas at San Antonio  
Archaeological Survey Report, No. 137

1986

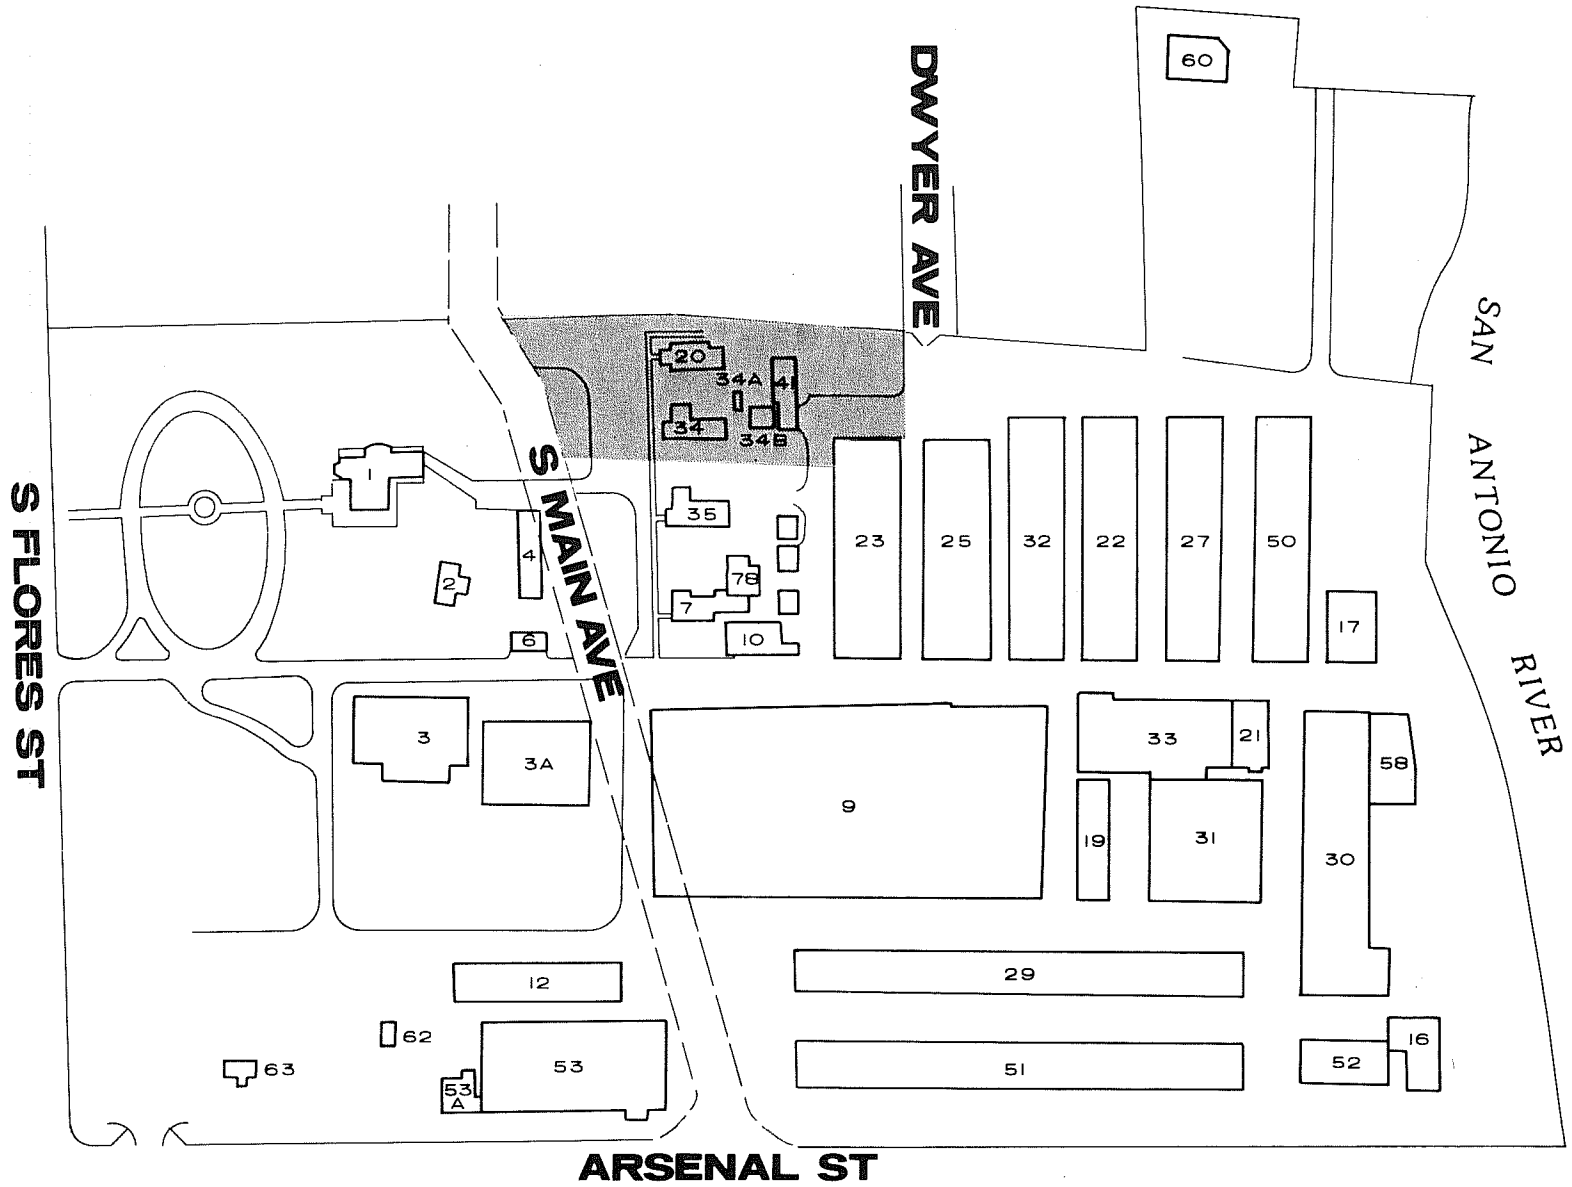
Figure 1. **Arsenal Site Plan.** Basic data and building identifications from 1946 road map (San Antonio Arsenal, Office of the Post Engineer 1946); location of South Main Avenue from 1961 site plan (General Services Administration 1961). The area investigated by trenching is indicated by darkened area.

- 1 Commanding Officer Quarters
- 2 Servants Quarters
- 3 Post Headquarters
- 3A Main Office
- 4 Hot House
- 6 C. O. Garage
- 7 Post Engineers
- 7B Engineers Carpenter Shop
- 9 Shops
- 10 Battery Charging Shed
- 12 Post Property
- 16 Loading Platform
- 17 Utilities Shop
- 19 Storehouse
- 20 Post Dispensary
- 21 Auto Repair Shop
- 22 Storehouse
- 23 Storehouse
- 25 Storehouse
- 27 Storehouse
- 29 Storehouse
- 30 Shop and Storage
- 31 Storehouse
- 32 Storehouse
- 33 Packaging Section
- 34 Inspection Division and Guard Station
- 34A Lavatory - Building 34
- 34B P. E. Blacksmith Shop
- 35 Plant Section and Safety Office
- 41 P. E. Paint Shop and Storage
- 50 Storehouse
- 51 Storehouse
- 52 Storehouse
- 53 Change House and Cafe
- 53A Cafe Store Room
- 58 Shop Area
- 60 Salvage Yard and Office
- 62 Motor Pool Office
- 63 Wash Rack, Motor Pool

In mid-February, the Center was requested to do additional testing at the south end of the old stone stable building (No. 21 in Fig. 1). It was hoped to determine if any indication remained of the location of an outside stairway providing access to the loft above the stable. A test pit measuring ca. 1-1/2 m x 3 m was excavated. The first level consisted of ca. 15 cm of gravel fill. A 1-m<sup>2</sup> concrete slab was found at the west end of the unit at this level, and a pipe trench at the opposite end. Excavation continued through several alternating layers of brown soil and gravel fill until a hard, cobble layer set into caliche at ca. 30 cm below the original ground surface was encountered in the area. No postholes or other traces of support for a stairway were found within this area. A profile of the south wall of this test unit is on file at the Center for Archaeological Research.

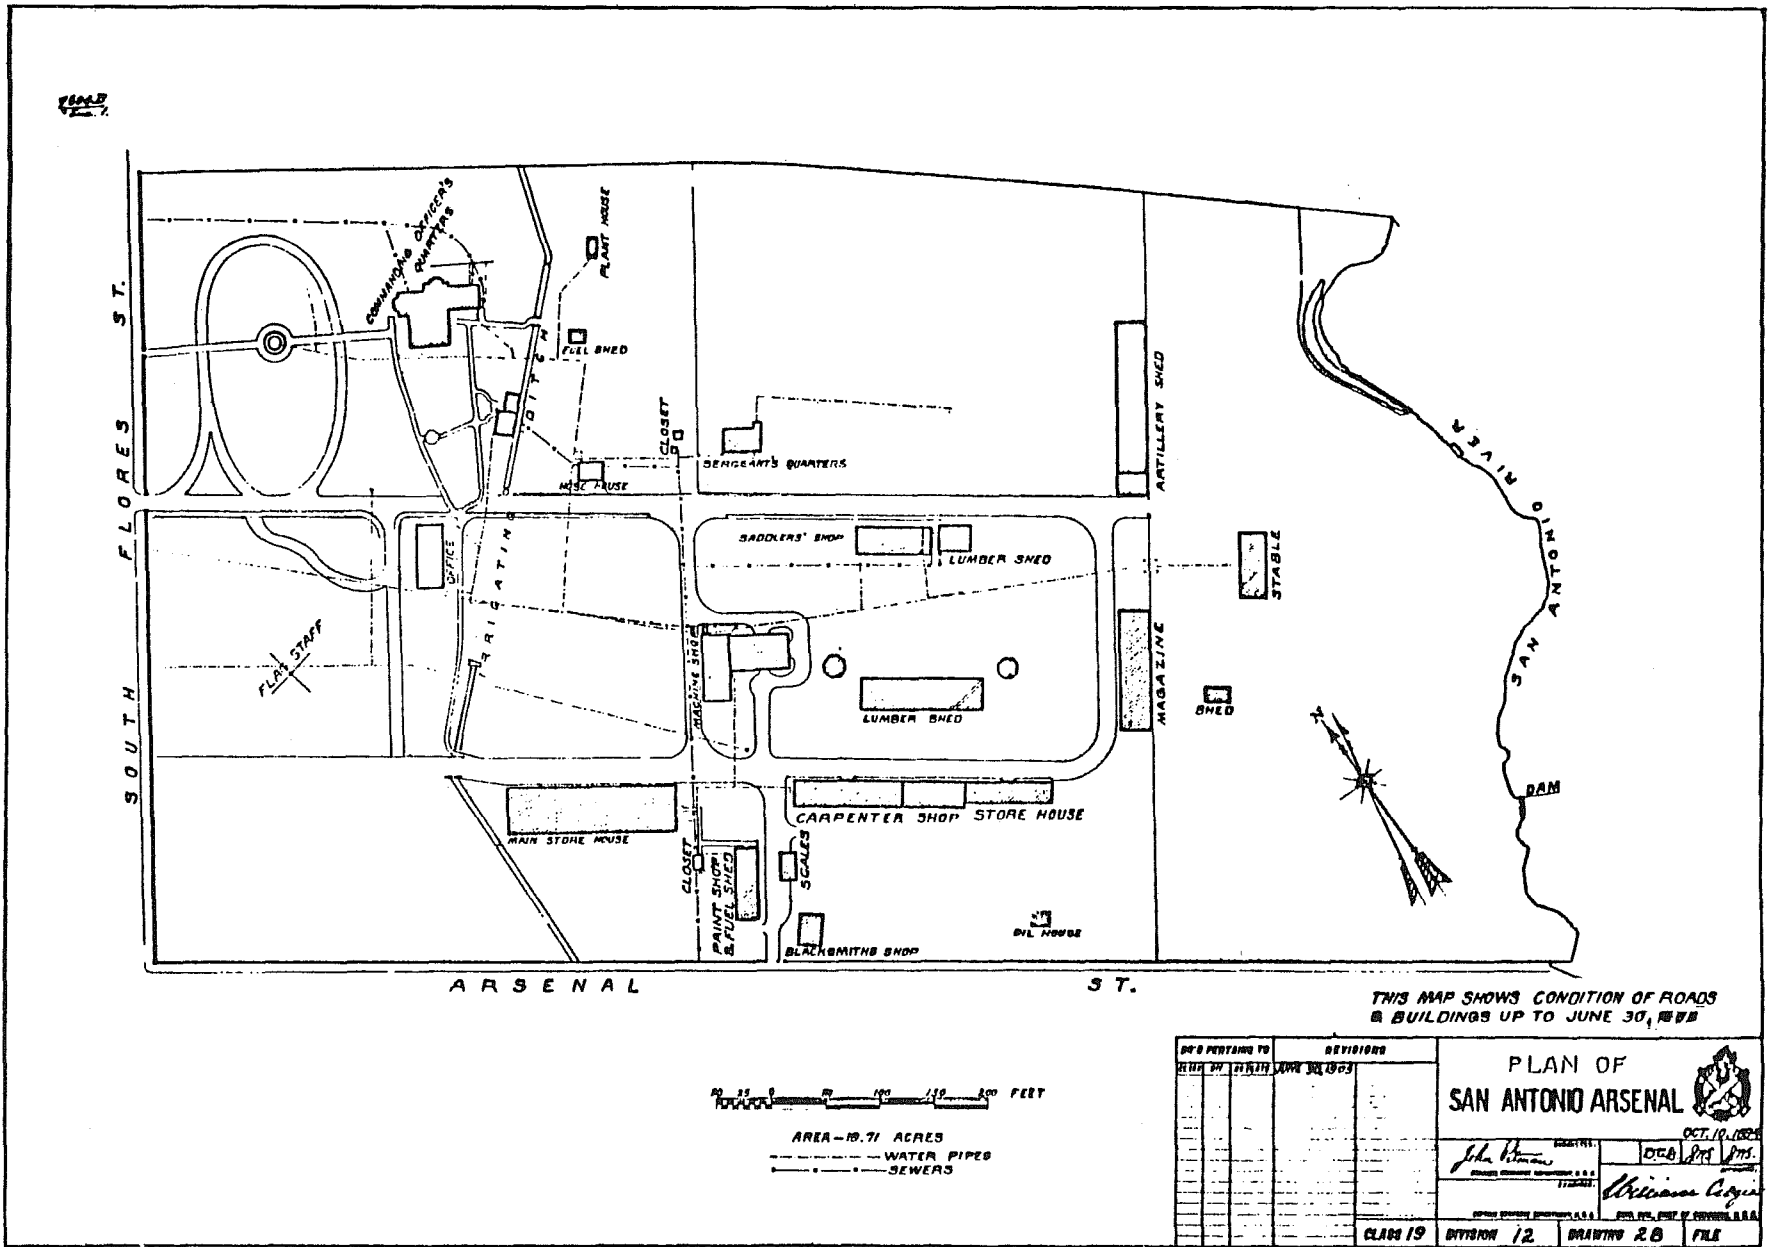
Figure 3. Plan of Arsenal from 1894-1905. From Department of the Army, Corps of Engineers (1905).

A stone storehouse was erected south of the administration building in 1883 (Fig. 3). This was the first permanent storehouse on the site, and served in that capacity until the deactivation of the Arsenal (Shank 1968; Garner 1969:6).

A plan of the Arsenal in 1894 (Fig. 3) shows the addition of a number of minor buildings and changes in the function of other buildings. However, it was not until 1919 to 1920 that another major building period occurred (**San Antonio Express** 1927). Three new storehouses, an oil house, a small arms shop, two magazines, a machine and equipment shop, barracks, and quarters eventually increased the number of buildings to 44 with a total value of \$900,000 (Garner 1969:6). The newest building on the grounds is the principal office structure, built in 1942 (Anonymous n.d.:2).

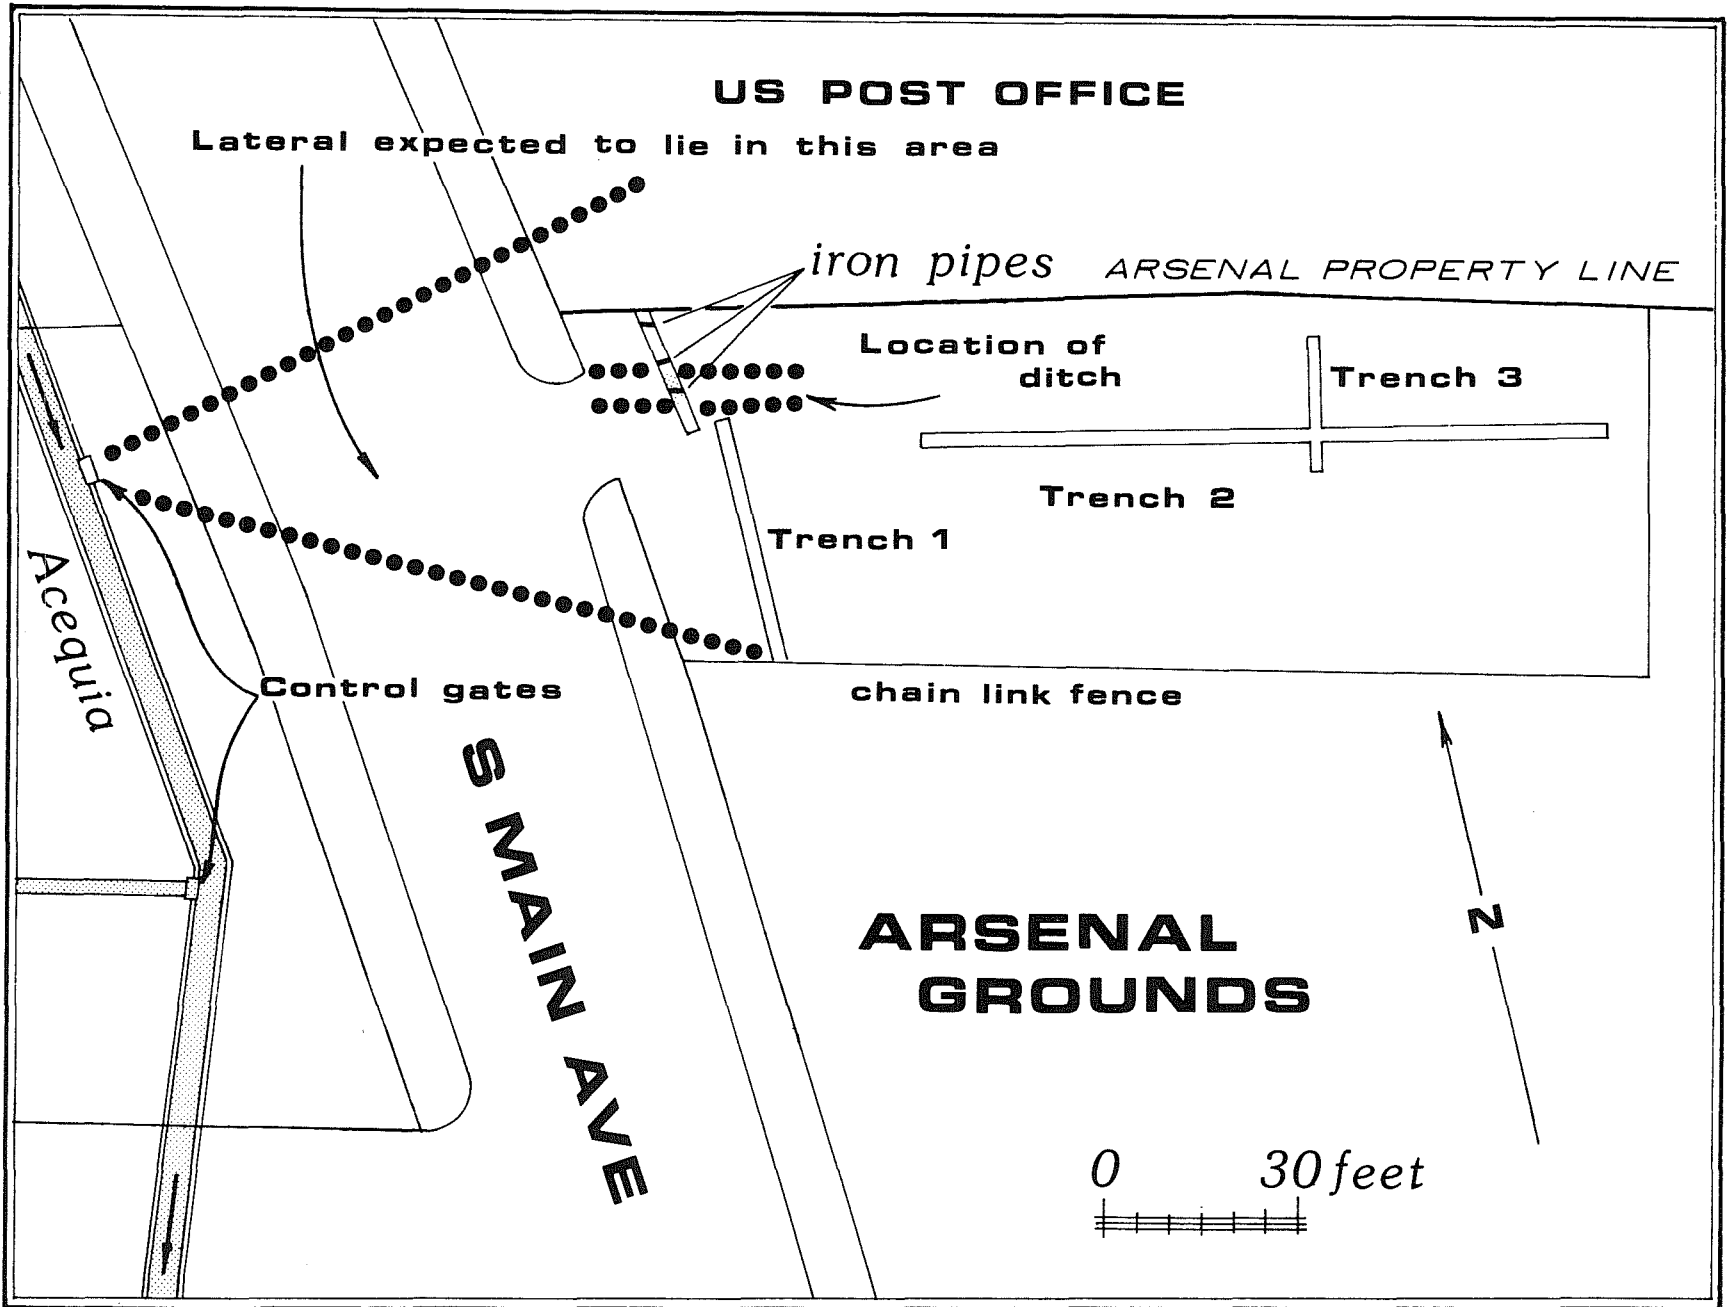
Figure 4. Plan of Backhoe Trenches.

On January 6, 1984, a series of backhoe trenches was excavated in the northwest corner of the development site, under the direction of the author and an assistant (Fig. 4). The first two trenches were positioned so as to determine whether the acequia lateral entered the area (Trench 1) or whether branches of the lateral intruded upon the site from the northern boundary (Trench 2).

In Trench 1, two gas lines were encountered which ran east-west across the area. A large disturbance six feet across was also found, which ran parallel to the gas line trenches. The trench was dug from the original ground level, which was beneath 10 inches of gravel fill laid for the asphalt paving on the western part of the lot. At first this disturbance was thought to be the acequia lateral, but a 5-1/2-inch iron pipe was found in a 15-inch trench in the bottom of the disturbance, at eight feet below the original surface.

Trench 2 ran east-west across most of the area under investigation. There were no signs of disturbance of any kind except for the presence of a number of two-foot-square concrete footing pads. These bore the marks of the 8- x 8-inch posts which once supported a temporary frame structure in this area (No. 20 in Fig. 1). Two small (2-1/2 inch) gas pipes and an electric line crossed (in a north-south direction) this trench. Caliche bedrock was found

in Trench 2 at ca. 30 inches below the present surface. The soil above is reddish brown loam with a medium clay content, grading to dark brown at the surface.

After the size and depth of the large disturbance in Trench 1 were noted, Trench 3 was excavated in order to determine if the deep pipe trench/disturbance could have preempted the original acequia lateral. If so, the lateral, with or without the pipe trench, might have continued toward a junction with the river to the east. Trench 3 revealed the same soil profile as that of Trench 2, with no disturbances.
