10TH STREET SUBSTATION EXCAVATION OF THE
ACEQUIA MADRE (41 BX 8), SAN ANTONIO, BEXAR COUNTY, TEXAS

Center for Archaeological Research
The University of Texas at San Antonio®
Archaeological Survey Report, No. 153

1985

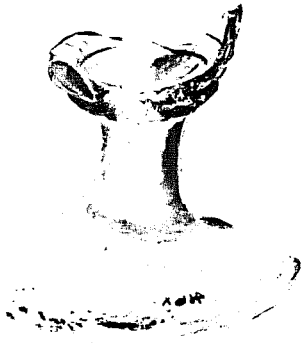
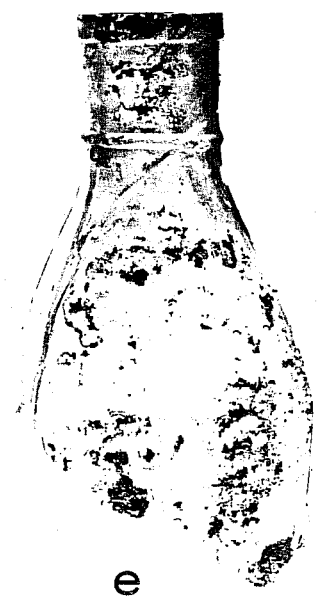
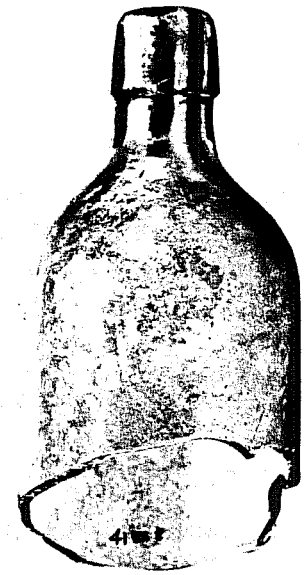
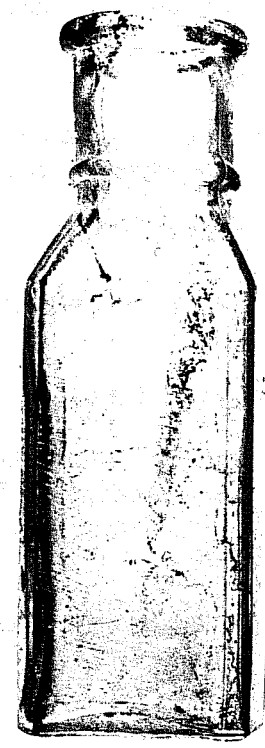
Figure 4. Selected Glass Artifacts from the Acequia Madre at the 10th Street Substation.

- a, goblet base;
- b, telephone pole insulator;
- c,d, molded bottles;
- e, clear bottle;
- f, short neck bottle with molded lip;
- g, condiment bottle;
- h, long neck bottle, produced in two-piece mold;
- i, long neck bottle, produced in turn mold;
- j, clear milk or cream bottle;
- k, brown square bottle with screw cap.

- 1 entire clear taper-sided condiment bottle 5-3/8 inches high
(Fig. 4,g).
- 1 entire extruding shoulder clear bottle with sides tapering to square
base 3-3/4 inches high (Fig. 4,e).

- 1 entire clear milk or cream bottle, square with truncated corners
6-3/4 inches high (probably post 1880s; Fig. 4,j).
- 1 brown-shouldered long neck bottle produced in two-piece mold, seam
extends only to base of lip, 11-1/2 inches high, bottom marked "C M
Co./F 28" (probably 1880-1900; Fig. 4,h).

- 1 entire brown-shouldered long neck bottle, machine made in turn mold
with crown cap, 11-1/2 inches high (probably 1892-1900; Fig. 4,i).
- 1 broken aqua-shouldered short neck bottle with molded lip, produced in
two-piece mold (probably 1880-1900; Fig. 4,f).

- 1 brown square bottle with screw cap, 4-1/2 inches high, marked
"P M/F S Co." on bottom (Fig. 4,k).
- 1 fragment round cobalt blue bottle.
- 1 fragment square aqua bottle produced in two-piece mold.

- 2 neck fragments of small molded bottles, 1 clear, 1 aqua (Fig. 4,c,d).
- 1 fragment ointment jar.
- 2 fragments lamp chimney.
- 2 fragments of pressed glass tumbler.

- 2 goblet base fragments, clear (Fig. 4,a).
- 1 fragment aqua telephone pole insulator (Fig. 4,b).
