**ADDITIONAL ARCHAEOLOGICAL  
AND  
HISTORICAL STUDIES FOR THE  
FAIRMOUNT HOTEL PROJECT IN  
SAN ANTONIO, TEXAS**

**Center for Archaeological Research  
The University of Texas at San Antonio  
Archaeological Survey Report, No.160  
1986**

1. Type of Investigation: Archaeological testing of the southern portion of New City Block 155, Lot 6, in downtown San Antonio, Texas;
2. Project Name: Fairmount II Project;
3. County: Bexar;
4. Principal Investigator, Thomas R. Hester; Co-Principal Investigator, Jack D. Eaton; Field Director and Author, Joseph H. Labadie;
5. Name and location of sponsoring agency: Alamo Architects and the Fairmount Hotel Company, San Antonio, Texas;
6. Texas Antiquities Committee Permit No. 505;
7. Published by the Center for Archaeological Research, The University of Texas at San Antonio 78285, 1986.

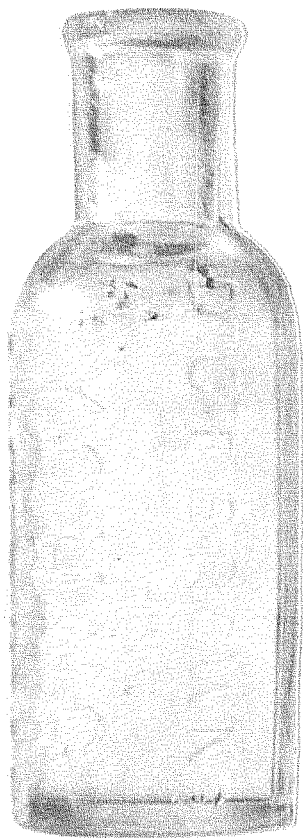
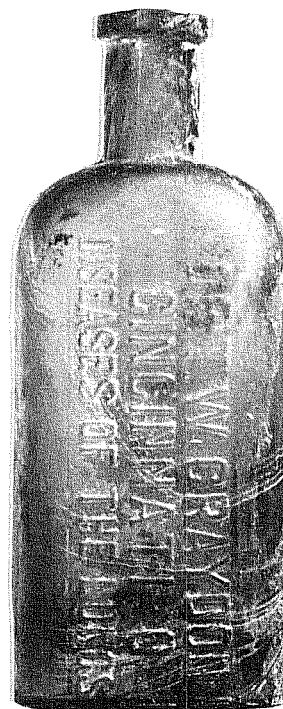
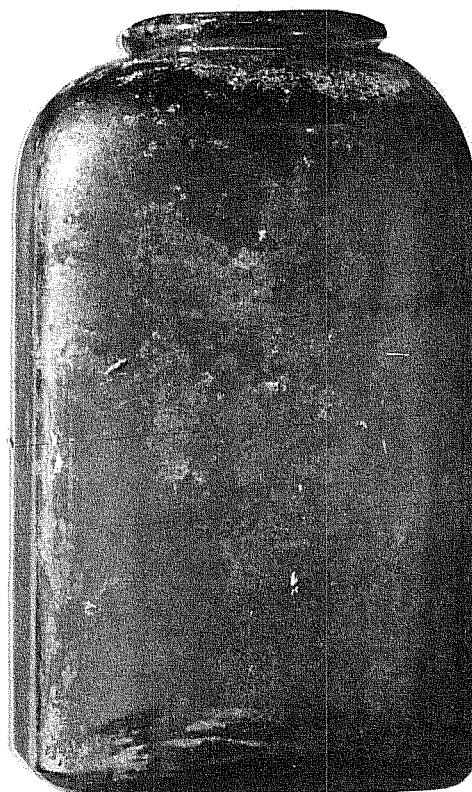
**Figure 9. Selected Late 19th-Century Glass Containers Recovered from Trench 6, Feature 1.**

- a, medicinal container with embossed lettering, "DT. C. F. BROWN'S YOUNG AMERICAN LINIMENT, NEW YORK";
- b, pharmaceutical container with embossed lettering, "SILVERTHORN & WAGNER, PRESCRIPTION DRUGGISTS, SAN ANTONIO, TEX";
- c, patent medicine bottle with embossed lettering, "DR. T. W. GRAYDON, CINCINNATI, OH, DISEASES OF THE LUNGS";
- d, Vaseline container with embossed lettering, "TRADE MARK VASELINE, CHESEBROUGH, NEW YORK";
- e, Levi-Garrett snuff bottle with hand-tooled lip.

The artifact sample recovered by the Fairmount II Project (Table 2) has no direct connection to the Mexican siege works (La Villita Earthworks site, 41 BX 677) found on the northern part of Lot 6. A few ceramic sherds (Fig. 6, a-n) of comparable age were found during the Fairmount II Project testing, but, in all cases, were recovered from disturbed contexts (e.g., Trench 7, Fig. 10). Only Feature 1, in Trench 6, had cultural materials (Fig. 9, a-e) that were still in a primary context; all of which date after 1880.
