ARCHAEOLOGICAL INVESTIGATIONS AT FORT MARTIN SCOTT (41 GL 52) IN GILLESPIE COUNTY, TEXAS

Center for Archaeological Research
The University of Texas at San Antonio
Archaeological Survey Report, No. 169

ARCHAEOLOGICAL INVESTIGATIONS AT
FORT MARTIN SCOTT (41 GL 52) IN
GILLESPIE COUNTY, TEXAS

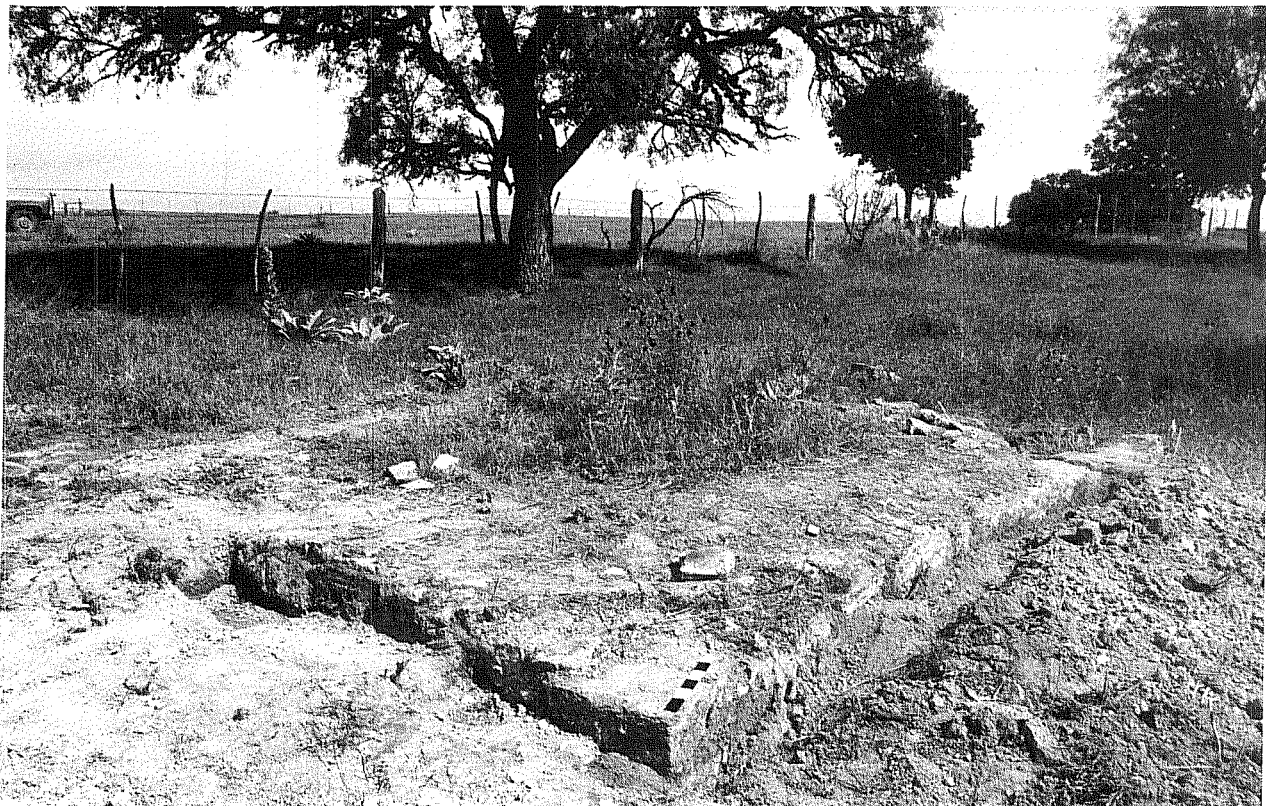
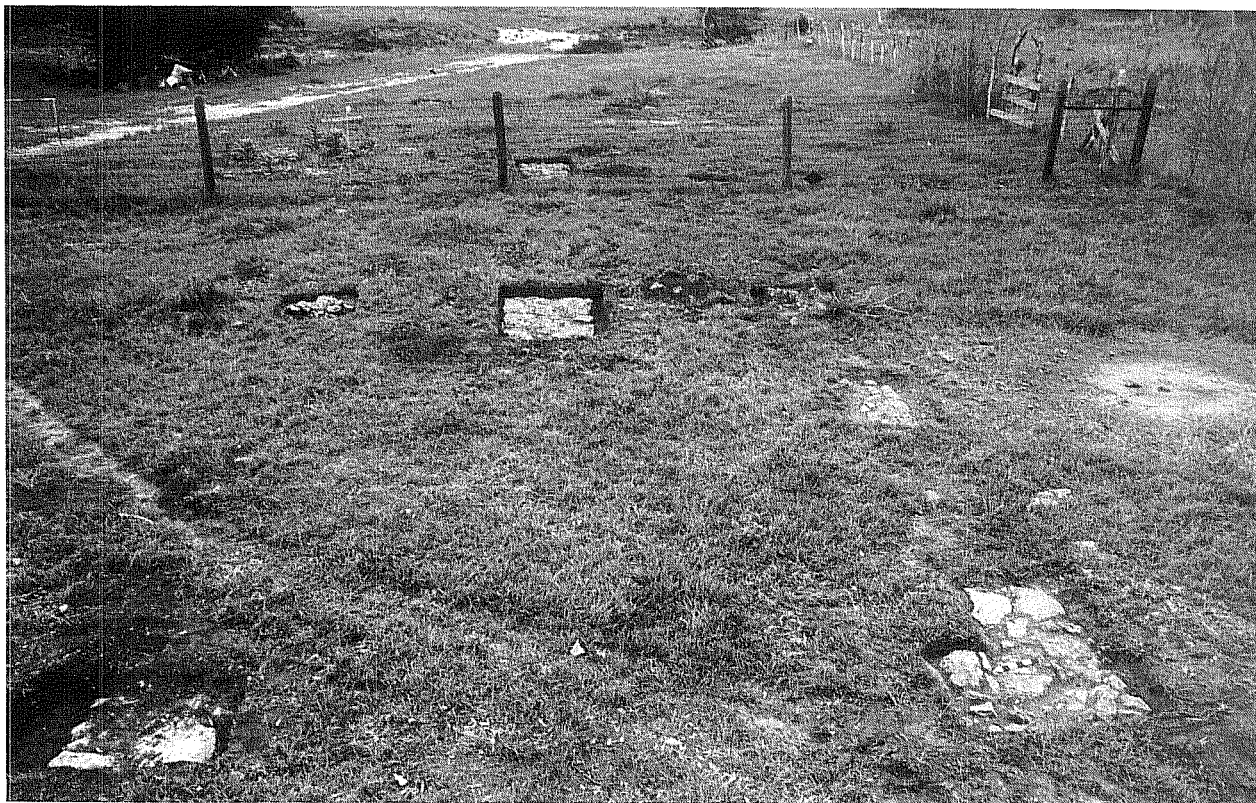
Figure 11. Foundation Remnants for Bake Oven and Structure 0. a, bake oven; b, Structure 0.

Structure M is located adjacent to Barons Creek and is ca. 50 feet south of the northeast corner of the property leased by the City to the Fredericksburg Heritage Federation (Fig. 4). The 1853 Freeman Inspection Report described the bake house as a log structure with dimensions of 14 x 20 feet (Fig. 2). The only remaining evidence for this structure is the remains of the foundation for a cut-stone bake oven (Fig. 11,a).
