*ARCHAEOLOGICAL INVESTIGATION TO LOCATE  
THE NORTHWEST CORNER OF  
MISSION CONCEPCIÓN  
SAN ANTONIO, BEXAR COUNTY, TEXAS*

*Anne A. Fox*

*Center for Archaeological Research  
The University of Texas at San Antonio  
Archaeological Survey Report, No. 212*

*1992*

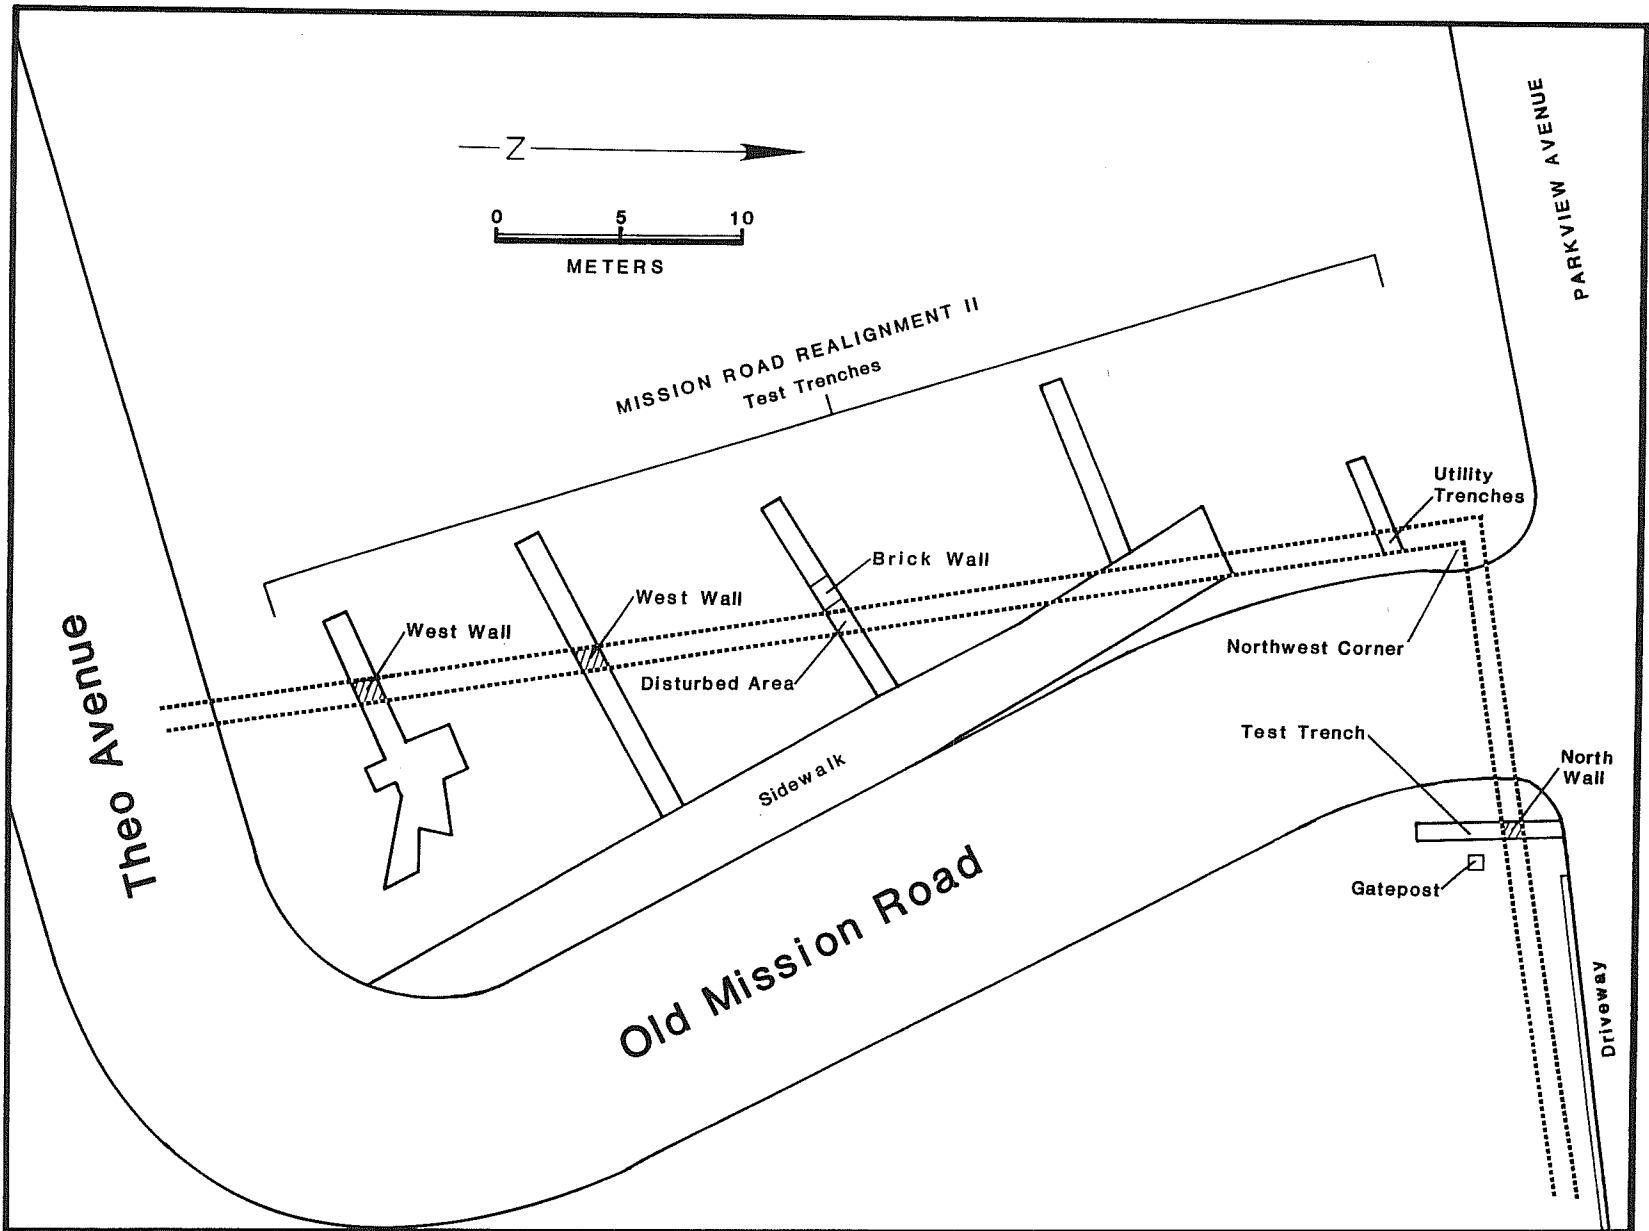
Figure 2. *Project Map*. Shown are previous and current test trenching that indicate the west and north wall alignments, and the projected northwest corner of the Mission Concepción quadrangle.

A backhoe trench 80 cm wide and approximately 5 m long was laid out 60 cm from the western face of the southernmost brick gatepost on the south side of the entrance drive to the St. John's Seminary buildings (Figure 2). The trench long axis was oriented to magnetic north. Approximately 1.25 m north of the gatepost, at ca. 75 cm below the surface, the top of the north wall of the compound was found. The wall was found to measure approximately 75 cm in thickness. The depth to the bottom of the wall was not determined, but it continued more than 1 m below the surface, where the trenching stopped.

The location of the northwest corner of the mission compound can be determined by projecting the lines of the west and north walls until they meet (Figure 2). This bit of information can now be added to the accumulated data about the outlines of the mission recovered by previous archaeological investigations. It can also be used in the future to relocate the northwest corner on the ground when the time comes to suitably indicate the mission walls on or above the ground surface.
