Investigations of the Southeast Gateway at Mission San José, Bexar County, Texas

Cynthia L. Tennis

Texas Antiquities Permit No. 1649

©copyright
Center for Archaeological Research
The University of Texas at San Antonio
Archaeological Survey Report, No. 252
1998

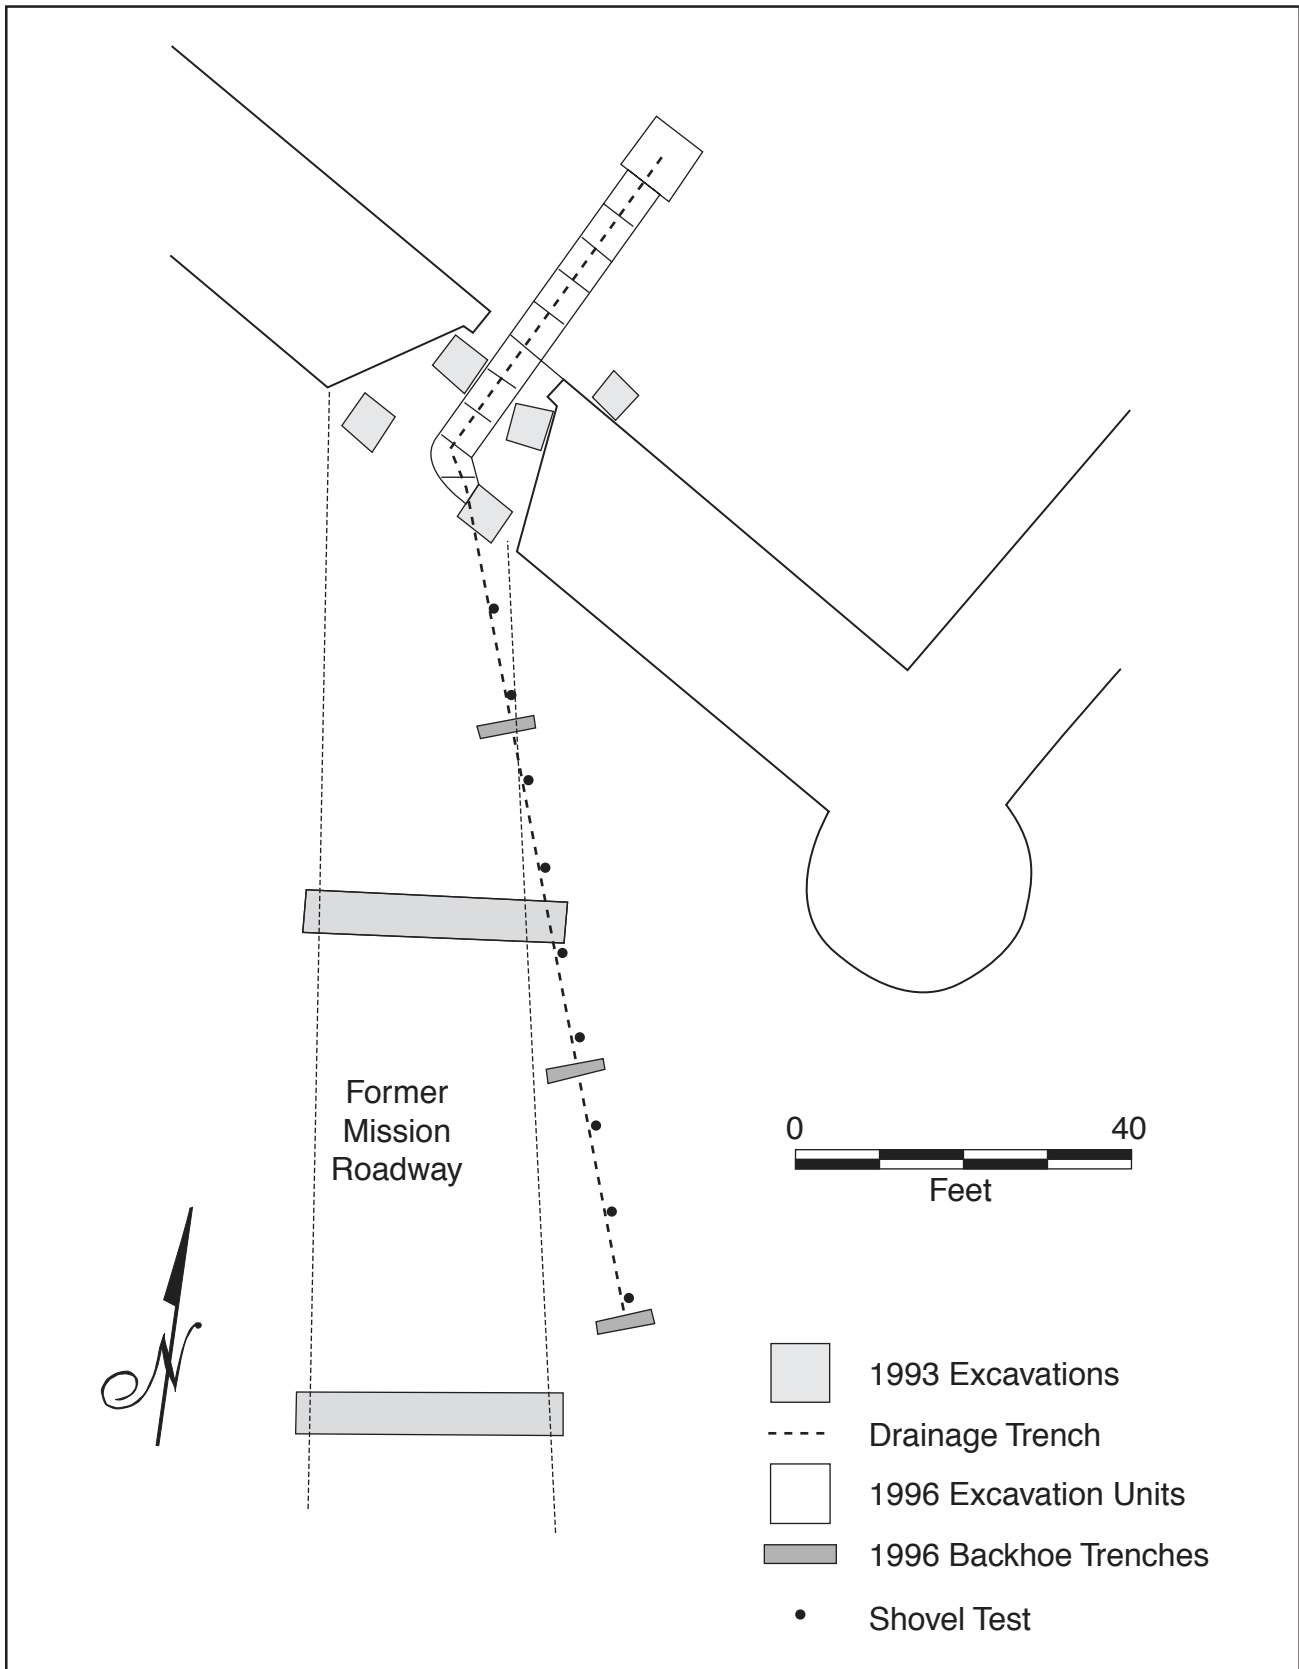
Figure 1. Areas of investigation in the southeast gateway.

placed along the portion of the drainage trench extending beyond the compound walls (Figure 1).

Based on the 1993 CAR investigations, a data recovery program was designed for the trench impact area within the compound and gateway. Because the impact area outside the compound walls had previously been disturbed by construction of Mission Road and the presence of commercial buildings and private residences, a testing and monitoring program was designed for this section of the drainage route. The fieldwork completed in 1996 consisted of the excavation of nine shovel tests and three backhoe trenches outside the mission compound. One 6-x-6-ft test unit, eight 4-x-4-ft test units, and two irregularly shaped units were excavated within the southeast gateway and southern section of the mission compound (Figure 1).

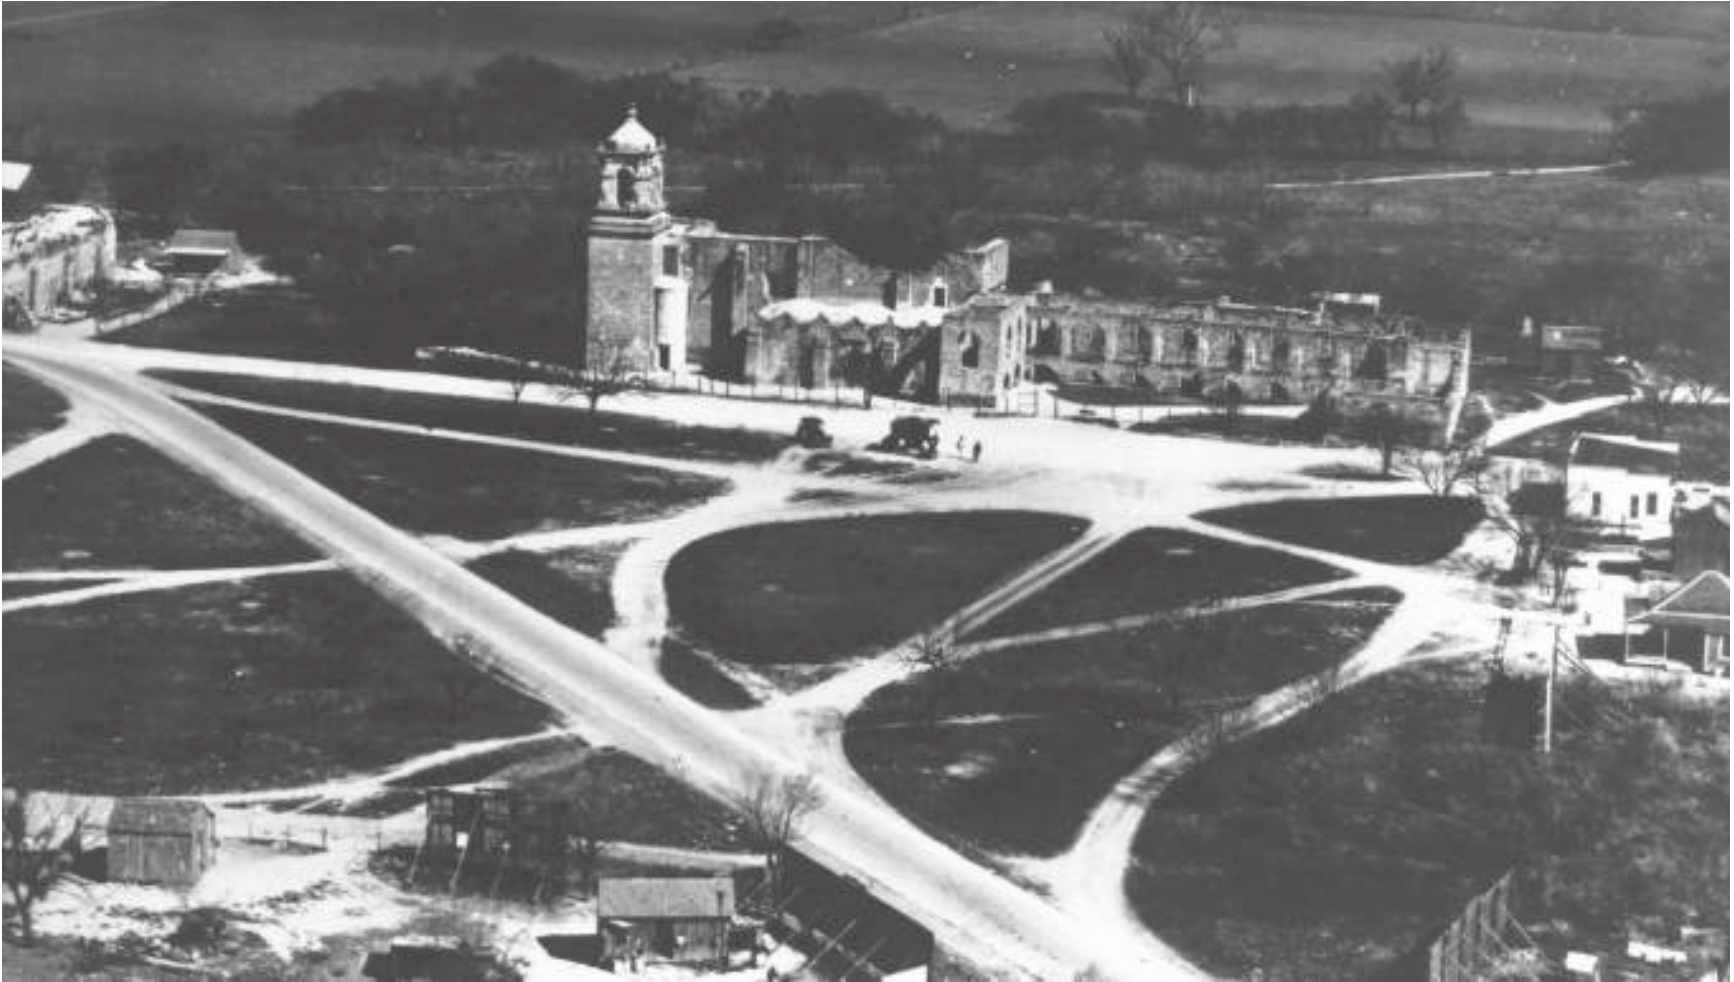
Figure 2. *Aerial photograph of Mission San José, ca. 1920, prior to reconstruction.* In this view, looking north, Mission Road runs diagonally across the courtyard. From the collection of the San Antonio Missions National Historical Park, San Antonio.

The mission compound was reconstructed in its present configuration in the 1930s–1940s based on research and designs by architect Harvey P. Smith, Sr. As early as 1918, Smith noted that huts had been built upon the ruins and that any remaining wall foundations would probably disappear within a few years (Clark 1978). Aerial photos of the mission from 1920 and 1932, prior to the Smith reconstruction, show the enclosing walls had entirely collapsed by this time and Mission Road is clearly visible running diagonally across the compound from what would have been the southeast corner to the front of the granary (Figures 2 and 3).

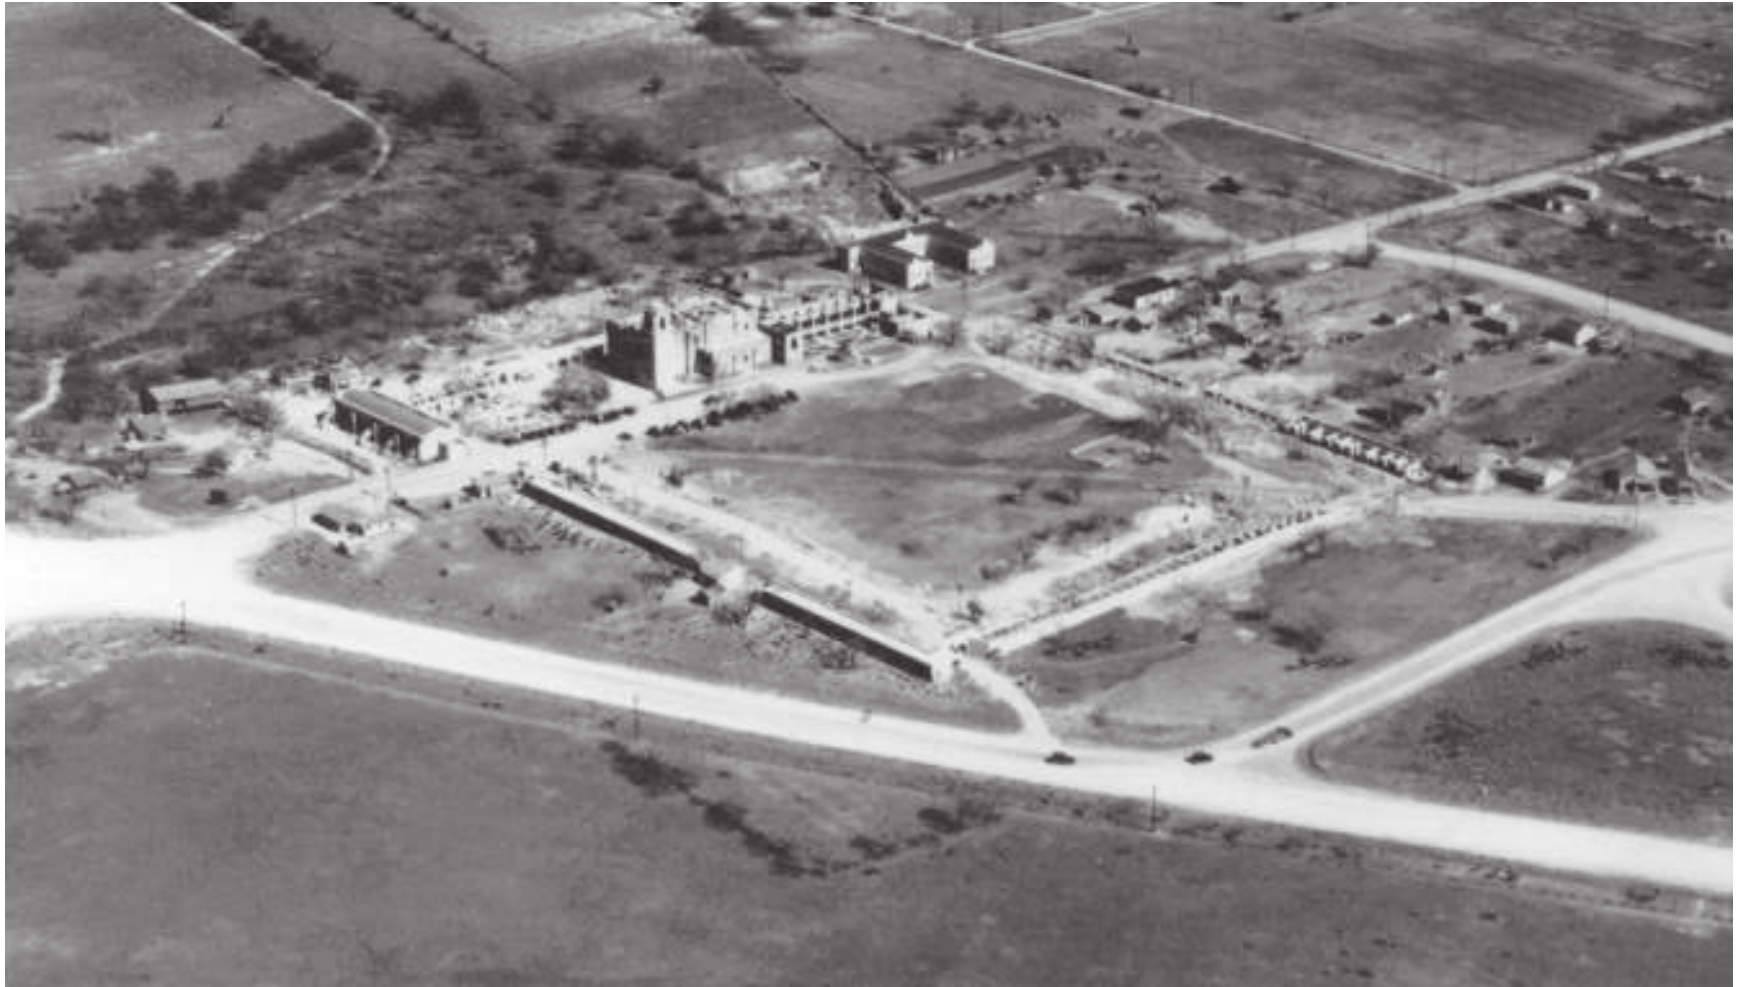
Figure 3. *Aerial photograph of Mission San José, ca. 1935, during reconstruction.* Mission Road can be seen running diagonally across the compound from what is now the southeast gateway on the right, to the granary on the left. From the collection of the San Antonio Missions National Historical Park, San Antonio.

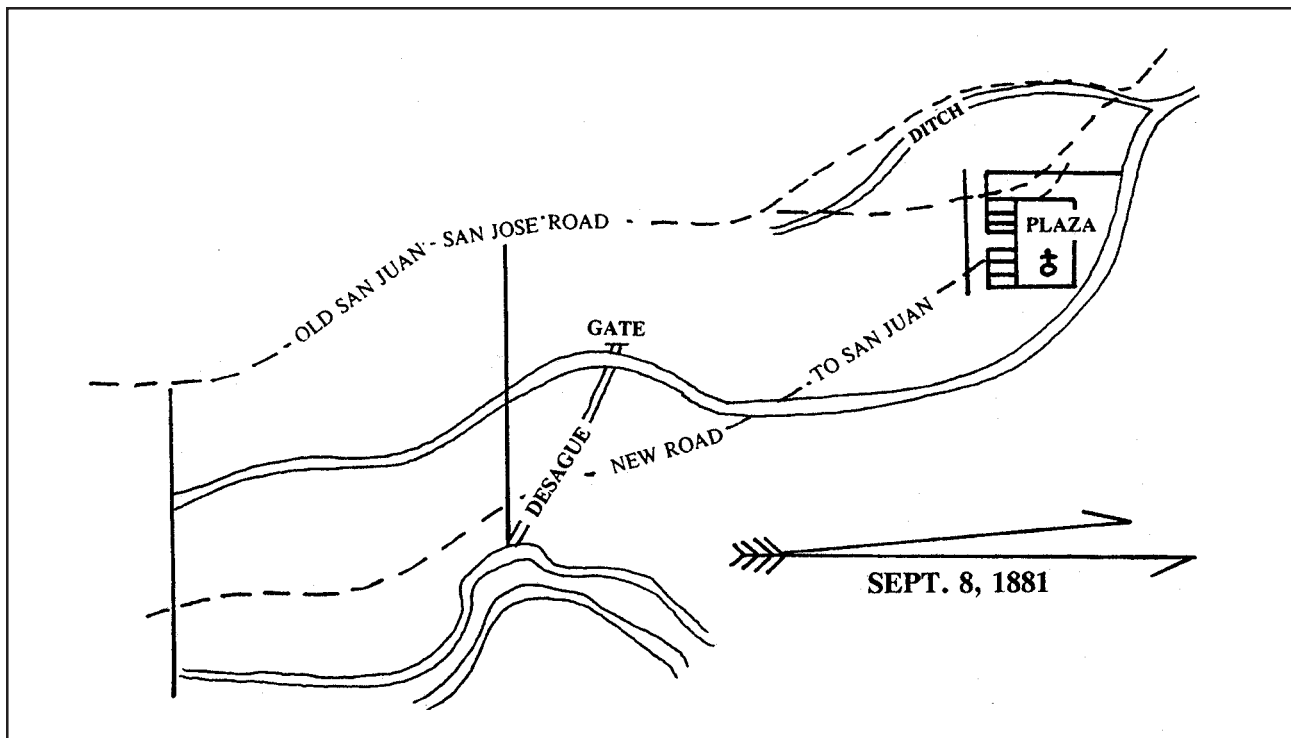
Figure 4. *Early location of New Road through Mission San José.* Adapted from the 1881 M. W. Merrich survey of the Lazzeler tract. DCR K:103.

A road into the mission appears on the 1881 Lazzeler tract map (Figure 4) labeled as the “new road to San Juan” (District Court Records [DCR], Office of the District Clerk, Bexar County Courthouse, San Antonio, Volume K:103). This “new” road appears to enter the mission compound through an opening close to the center of the south wall as suggested by Ivey et

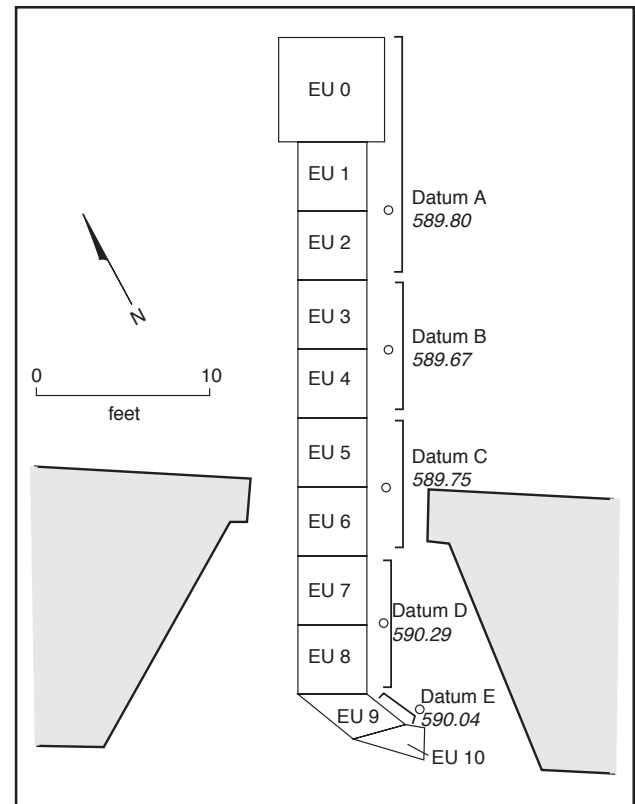
Figure 7. Layout of 1996 excavation units within the southeast gateway. Datum elevations (amsl) are given in italics.

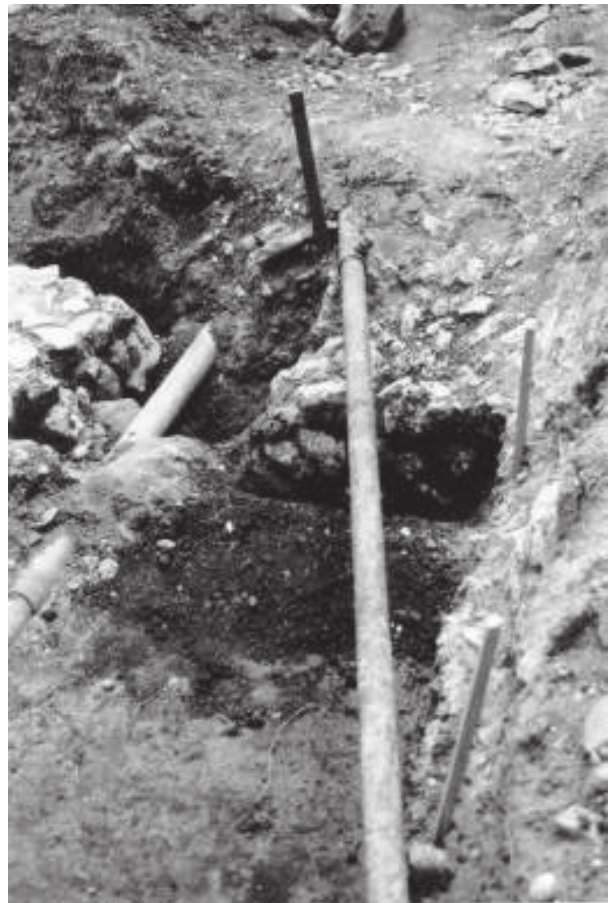
Figure 9. Exposed portion of the original exterior foundation. Looking south.

The exterior wall foundation identified during the 1993 CAR testing was relocated and an additional portion was exposed (Figure 9). This portion of the exterior foundation was exposed 19 inches below the surface at the southern limits of the project trench in EUs 9 and 10. It extends to a depth 35 inches below the surface and is approximately 35 inches wide. The foundation is composed of uncut sandstone and limestone held together by lime and sand mortar. Approximately 15 inches of this foundation had been removed during the installation of the four-inch main water line now serving the mission. Removal of the fill from the water-pipe trench provided a cross-section view of the foundation which shows the outline of the two-inch thick trench dug for construction of the original foundation (Figure 10).

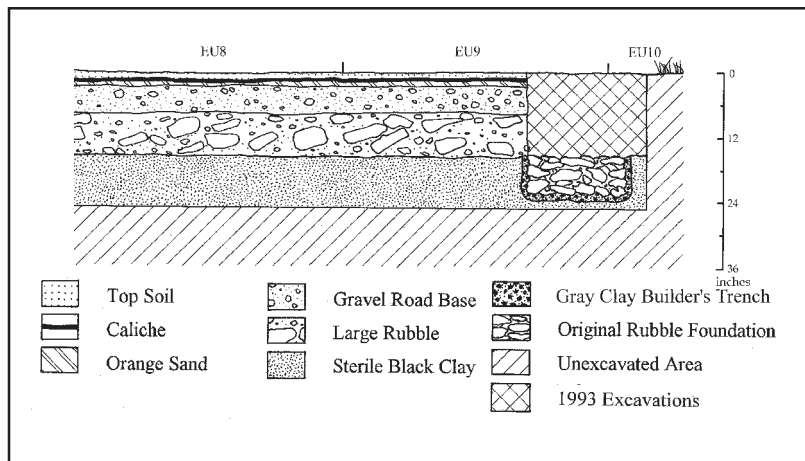
Figure 10. Profile of the east walls of EUs 8–10 within the gateway.

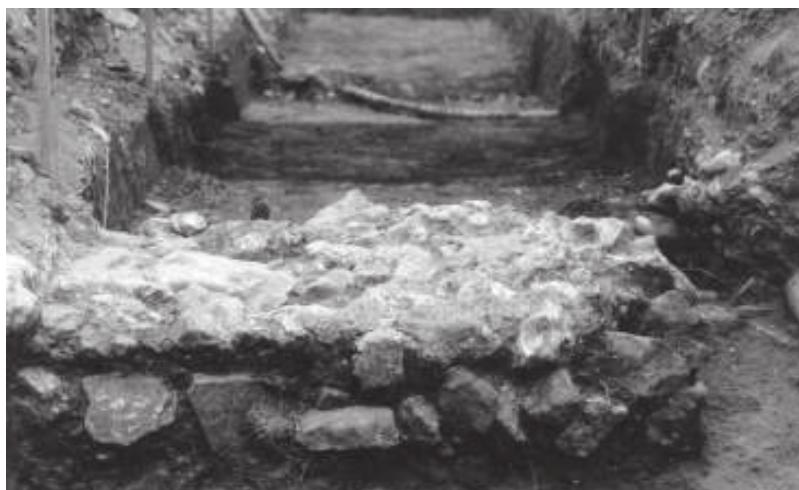
Figure 11. Exposed portion of the original interior wall foundation. Looking north.

A section of the interior wall foundation was also discovered 12 inches below the modern surface, in EUs 5 and 6, in line with the existing reconstructed interior wall of the compound (Figures 11 and 12). This foundation extends to a depth 25 inches below the surface and is 27 inches wide. The foundation is

composed of uncut pieces of sandstone and limestone that do not appear to have been laid systematically for the foundation. These stones are held together by uneven layers of fine-grained, lime and sand mortar. No evidence of a construction trench was found with the interior foundation.

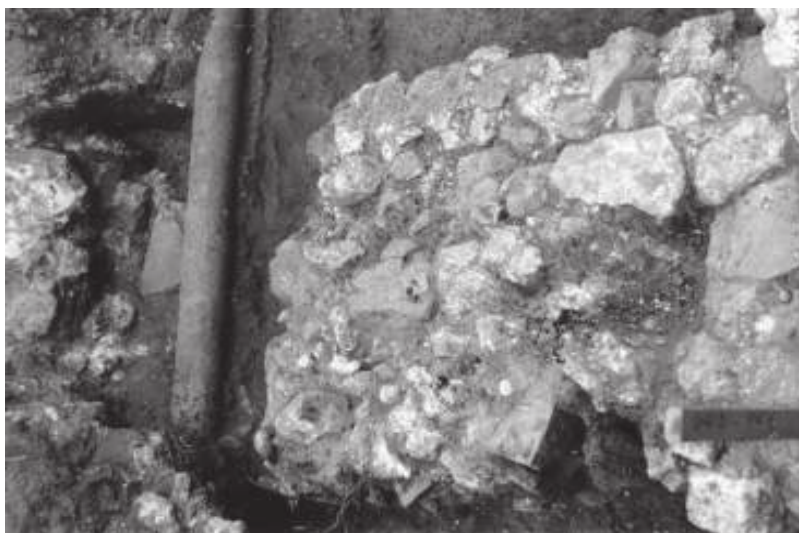
Figure 12. Exposed portion of interior wall foundation, top view.

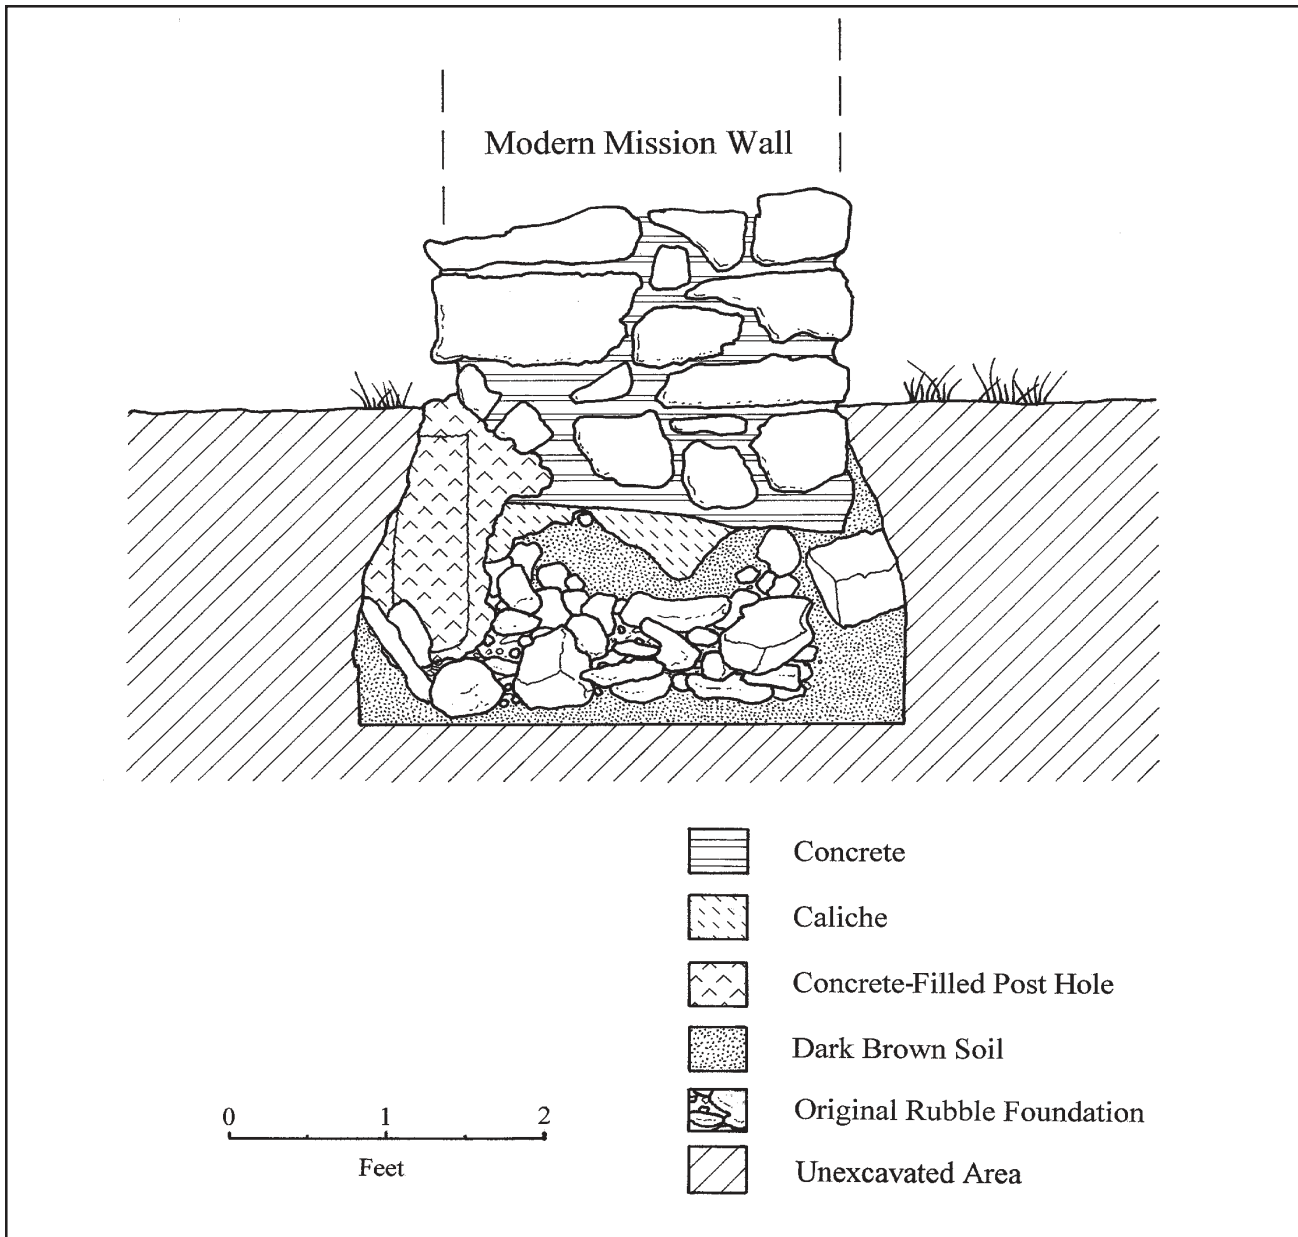
Figure 13. Profile of eastern gate archway showing connection of reconstructed and original portions of interior wall.

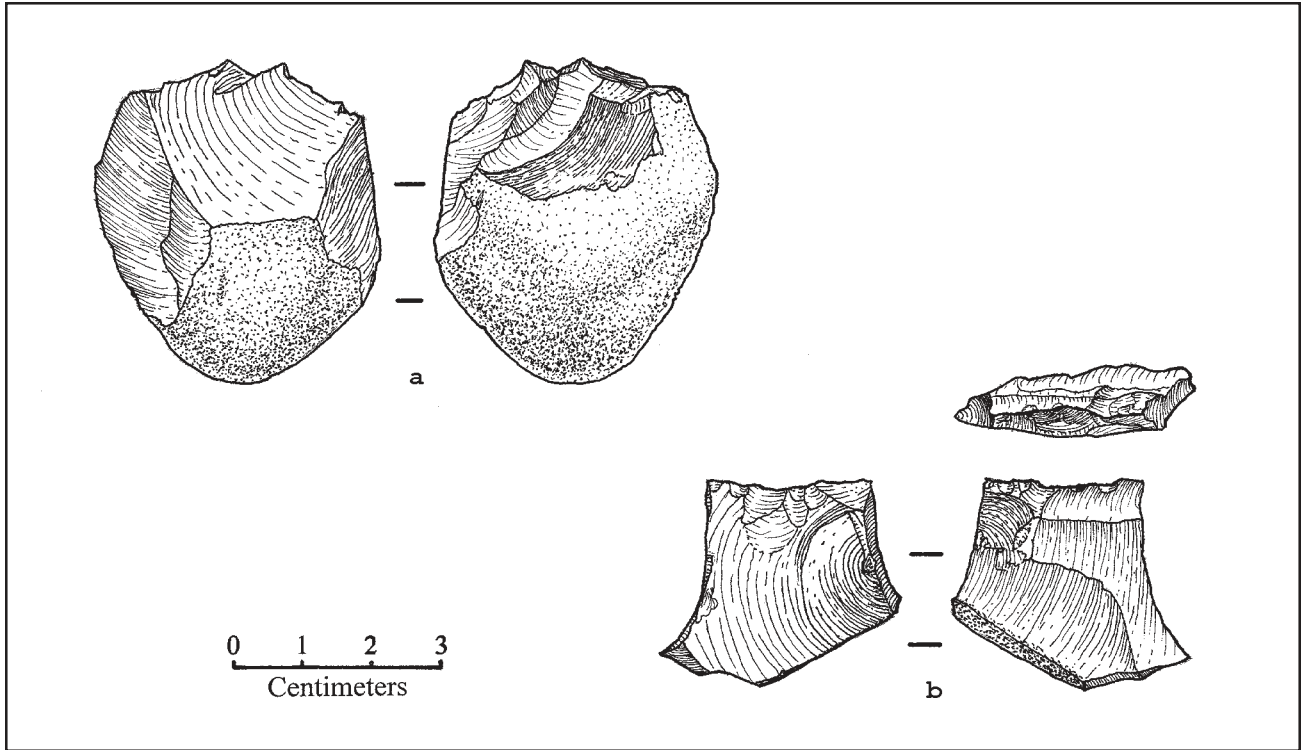
Figure 15. *Lithic tools: a. trimmed flake; b. small utilized cobble.*

EU 0: A flake (Figure 15a) which has been trimmed along one edge. This edge also exhibits some use-wear.

EU 0: A very small core (Figure 15b). Use-wear is present along one edge, but the raggedness of this edge suggests that the core was not originally intended for direct use, but rather picked up and used as an expedient tool. The frequent use of such small cobbles in Colonial-period sites has been noted (Hard et al. 1995:57).

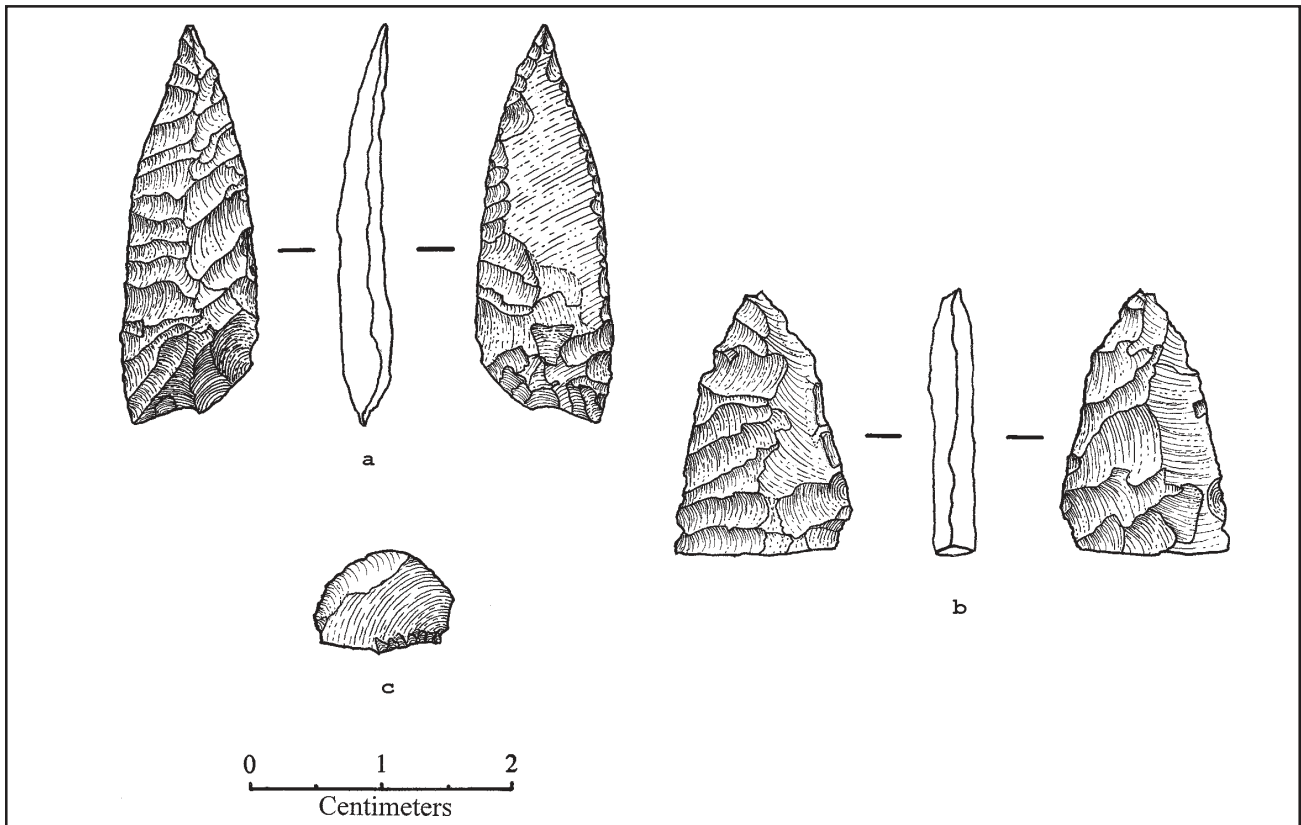
Figure 16. *Lithic tools: a. distal tip of biface; b. Guerrero projectile point; c. very small trimmed flake. Note: shown larger than actual size.*

EU 2: A Guerrero projectile point (Figure 16b). The point was clearly made on a flake, but is bifacially finished. It exhibits the typical fine workmanship and parallel flaking of the Guerrero point (Turner and Hester 1993:216). One corner of the base of this point was broken and carefully reworked.
