## Archaeological Testing and Monitoring for a Proposed Drainage Channel at Mission San Juan Capistrano, San Antonio, Texas

Texas Antiquities Permit No. 1748

2. Project name: San Juan Drainage

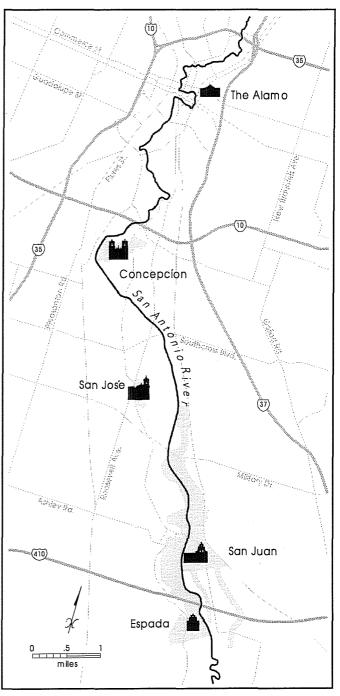
Figure 1. San Antonio's five missions. Shaded areas indicate the San Antonio Missions National Historical Park

In October 1996, the Center for Archaeological Research (CAR) of The University of Texas at San Antonio (UTSA) completed archaeological investigations south of Mission San Juan Capistrano, one of the chain of Spanish colonial missions that make up the San Antonio Missions National Historical Park (Figure 1). Shovel tests were excavated at 5-m intervals in areas specified for a proposed 800-ft drainage channel to direct rain water away from the mission (Figure 2). The investigations revealed this area contains a limited amount of Colonial period and modern artifacts in a mixed context.

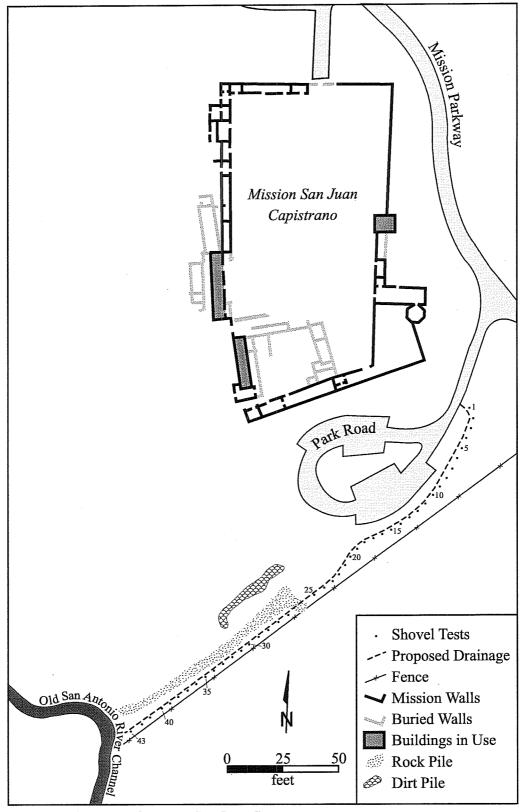
Figure 2. Plan view of Mission San Juan Capistrano.

Forty-three shovel tests (STs) were excavated at five-meter intervals along the route of the drainage channel (Figure 2). STs 26 and 27 were not excavated because of a large amount of gravel and caliche stockpiled on the surface of this portion of the route. The tests were excavated in 15-cm levels to a maximum depth of 60 cm below the surface. Soils were screened through ¼-inch wire mesh. Shovel-test locations were plotted on a site map generated from the engineering plan provided by NPS.
