# Archaeological Testing at the Selma Stagecoach Stop and Post Office (41BX1409), Bexar County, Texas

Center for Archaeological Research  
The University of Texas at San Antonio  
Archaeological Survey Report, No. 307  
2005

Texas Antiquities Permit No. 2395

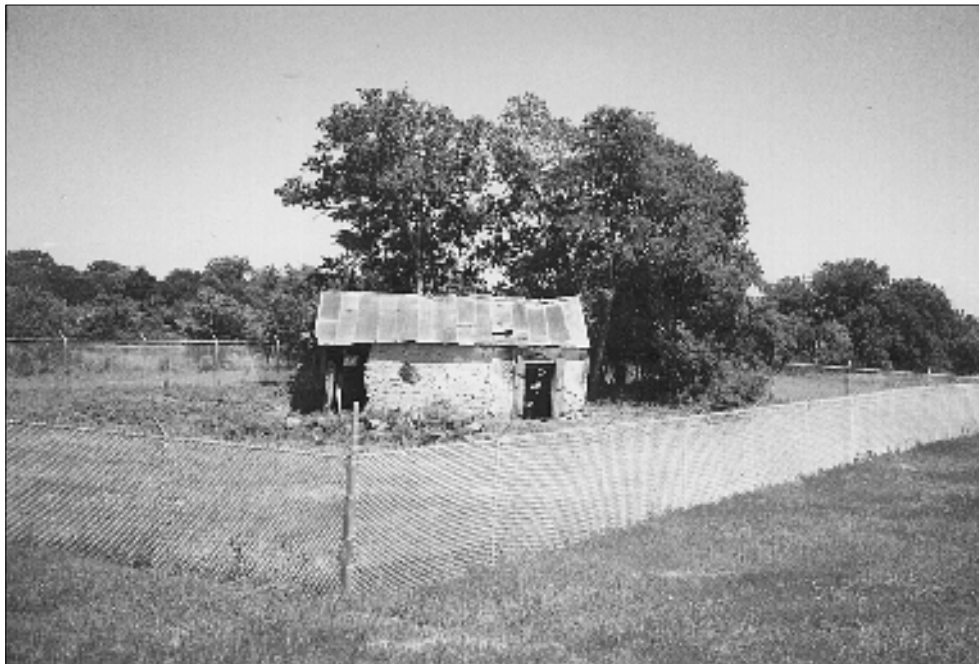
Figure 2. *Photograph of western elevation of the Selma Stagecoach Stop and Post Office in 2000.*

At the time of the May 2000 archaeological investigations, the City of Selma had installed a chain-link fence around the structure (Figure 2). A grid was superimposed over a sketch map of the area inside the fence and pin flags, representing the placement of 39 shovel tests (STs), were placed in the ground. Near the structure, the shovel tests

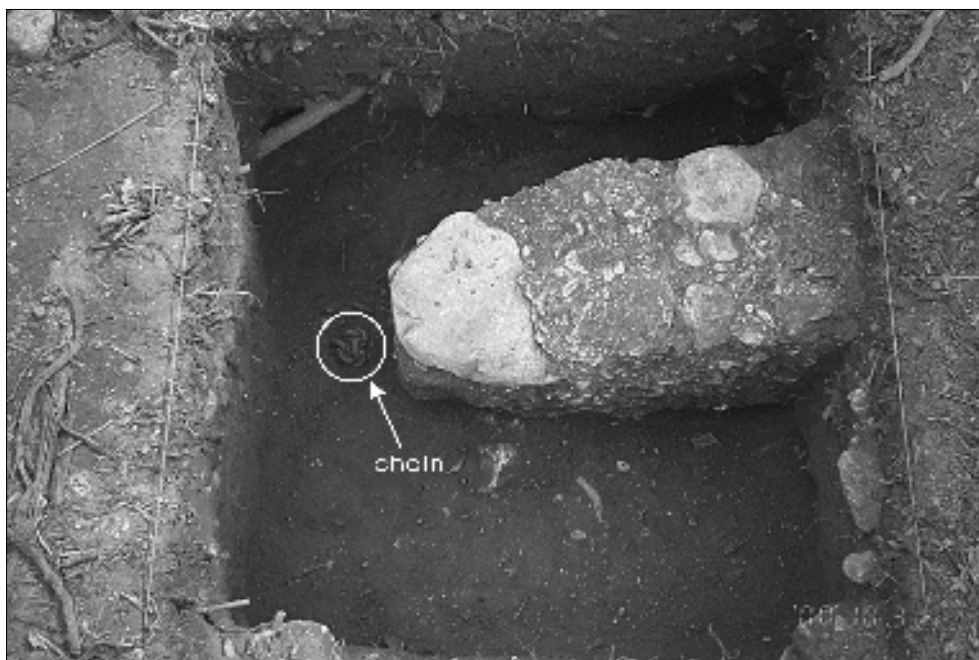
Figure 5. North end of wall footer in Unit 1. Note location of post hole and associated chain.

The unit was excavated in 10-cm levels to a final depth of 60 cmbs (ca. 23½ in.). The first level was comprised of a loose, humus-rich sandy loam with a scatter of modern debris. The next two levels (Levels 2 and 3; 10–30 cmbs) were fairly similar and also consisted of a sandy loam, but with less humus and a lot of root disturbance. About 30% of the soil inclusions consisted of small gravels. The cultural material consisted of mixed deposits of chipped stone, fragments of animal bone, assorted bottle glass, undecorated whiteware, and fragments of unidentifiable metal. The wall footer (foundation) was exposed between 14 and 18 cmbs (5½ and 7 in.), and was oriented north-south (Figure 5).

Although the root disturbance continued into the fourth level (30–40 cmbs), this level was intact. The recovered cultural material consisted of fire-cracked rock, undecorated whiteware, cut nails, lamp glass, ochre, and fragments of unidentified metal. The last two levels excavated (40–60 cmbs) were fairly similar to the fourth level, although there were noticeably fewer artifacts. The wall footer was fully exposed in Level 6 and extended 15–54 cmbs (6–21¼ in.). The far north end of the footer was 10.9 m (36 ft.) from the structure's northwest corner. The footer was in good condition and showed no signs of deterioration. There was no indication that the footer would have extended to the east, in order to support a north elevation, tabby-constructed wall. The possibility that there may have been a gate at this end was suggested by the location of a 31-inch chain imbedded in a shallow posthole at the north end of the wall footer (Figure 5).

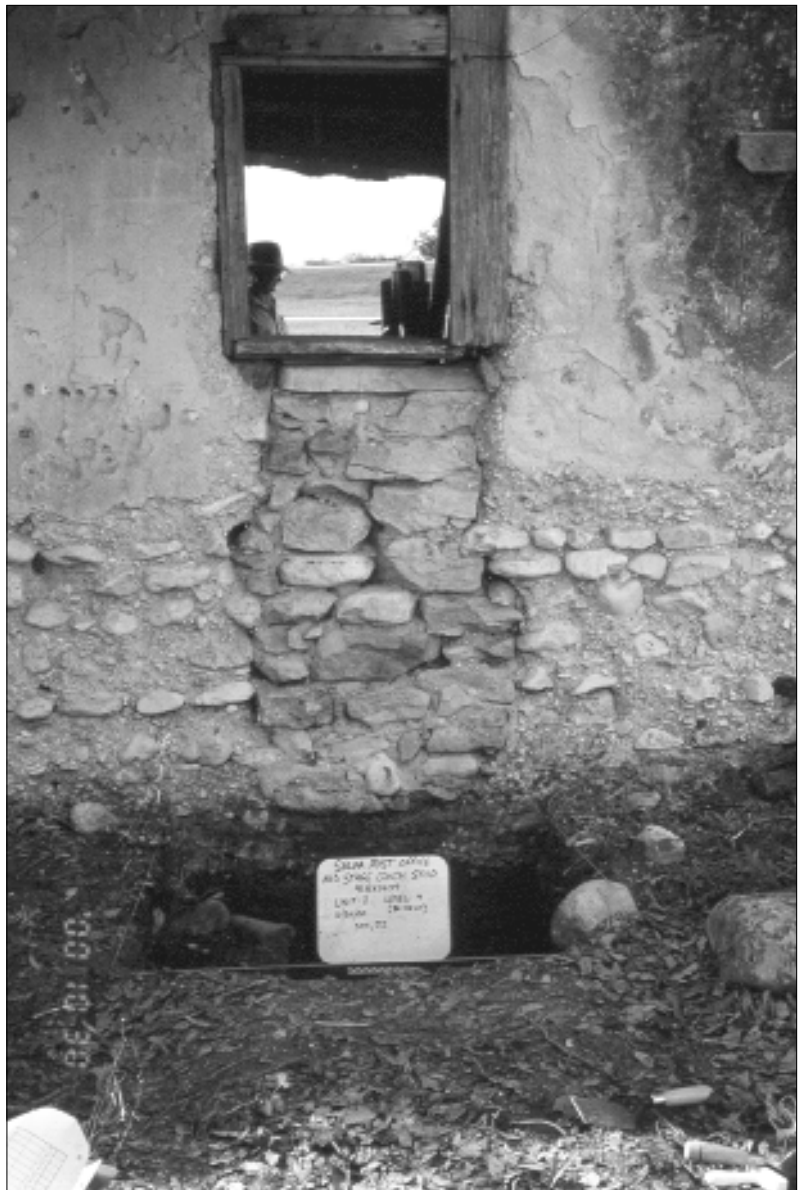
Figure 6. Location of Unit 2. Note repaired wall under window opening.

Unit 2 was located 6.6 m (22 ft.) north of the structure's southeast corner, and along the east elevation wall (Figure 4). This unit was situated directly beneath a window opening that showed signs of having been altered or repaired (i.e., stone rubble construction below the opening; Figure 6). The unit was located in this area in an effort to determine the function of this opening (i.e., window or door), the mode of construction, and the extent and condition of the wall footer.

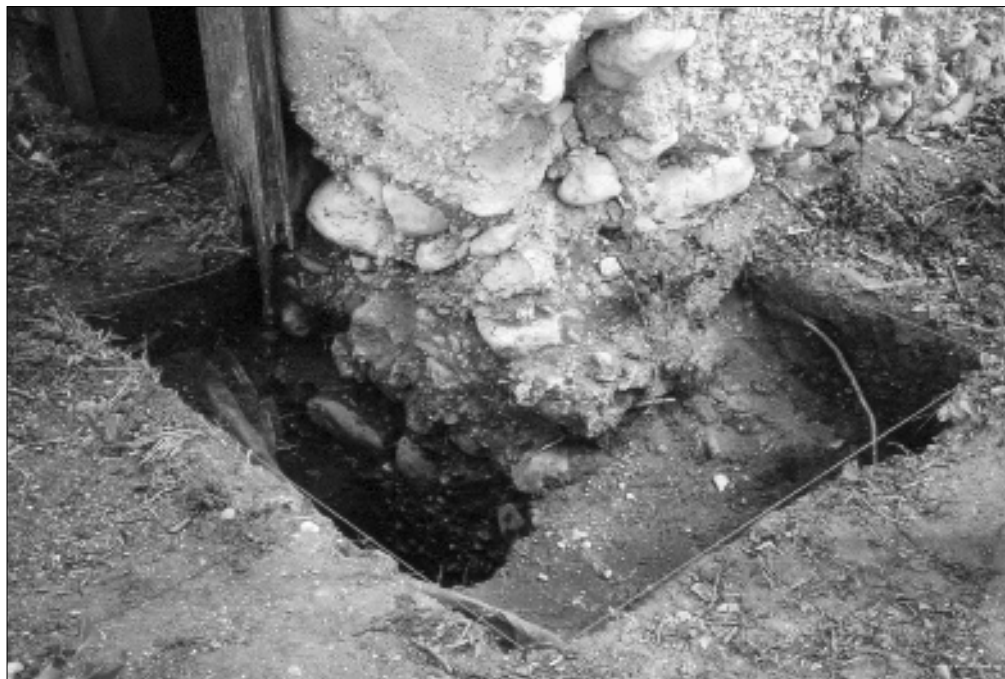
Figure 9. Base of wall and footing exposed in Unit 3 adjacent the southwest corner of the structure.

extreme coving in Figures 8 and 9), the wall footer was in very good condition and showed no signs of deterioration.

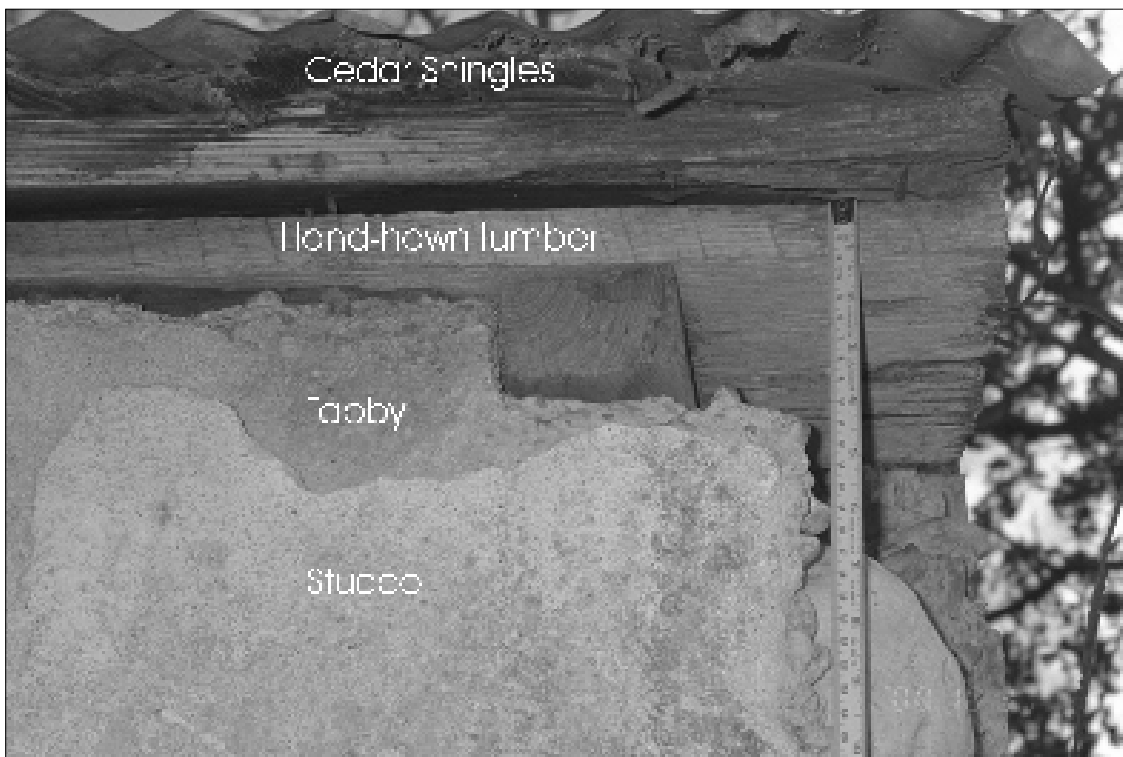
Figure 11. Construction detail of the southwest corner of the stage stop/post office structure, above Unit 3.

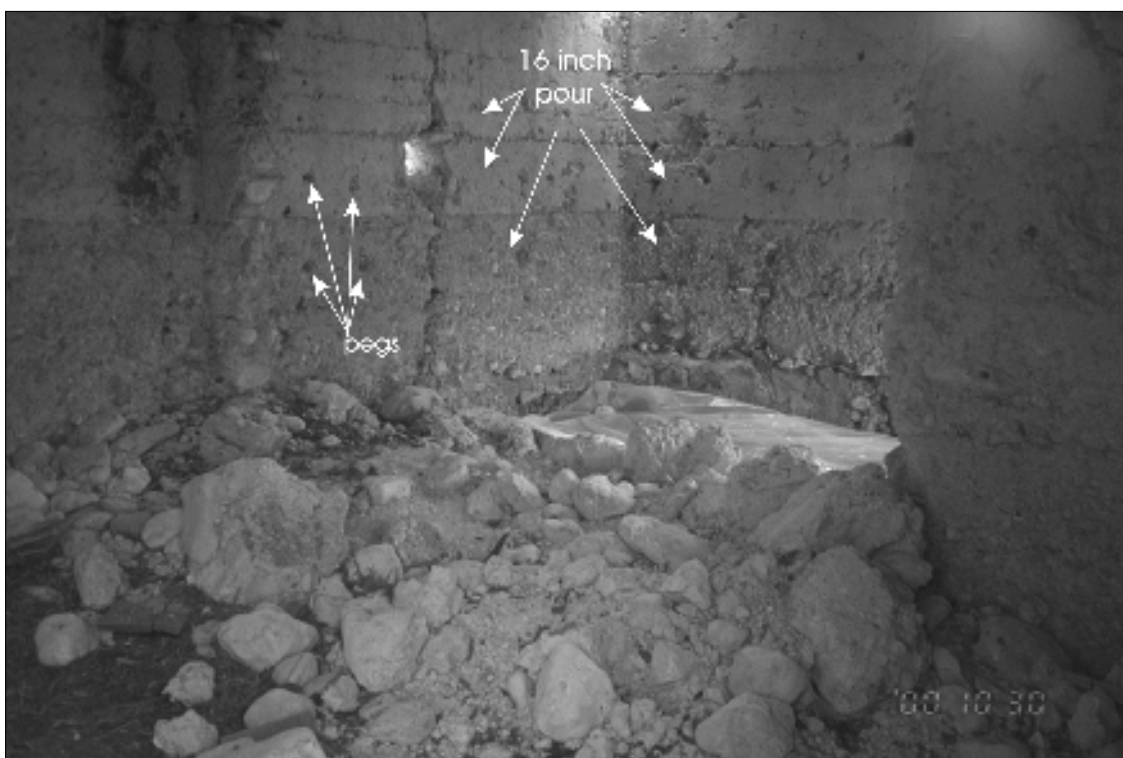
Figure 12. View of interior wall fall and tabby-related features (pours and pegs).
