Archeological Survey Report of FM 536 Improvements Project near Floresville, Wilson County, Texas

Archaeological Report, No. 363
Center for Archaeological Research
The University of Texas at San Antonio
©2006

Texas Historical Commission Permit No. 3914

CSJ 1009-01-033

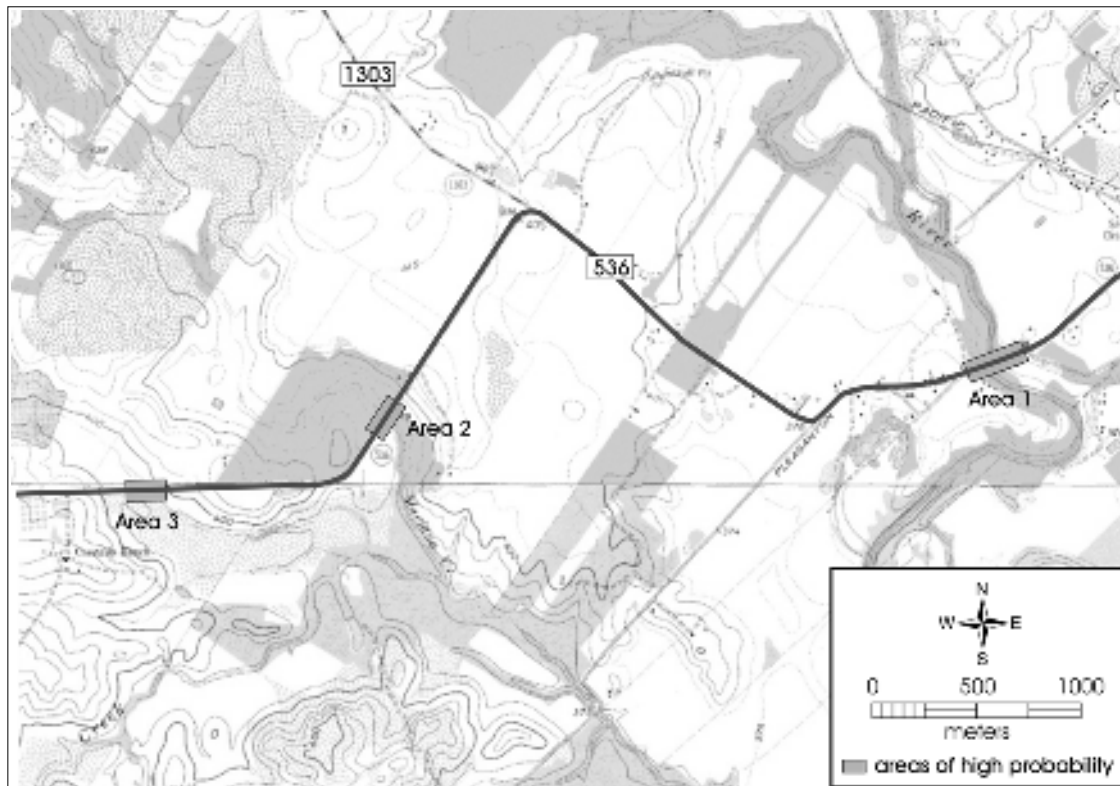
Figure 1-2. Project area showing high probability areas.

The areas to be examined consisted of three high probability localities within the boundaries of the APE discussed above; all other areas will have been impacted by previous construction within the existing ROW. Areas in proximity to existing drainages where the deposition of alluvium could have buried cultural deposits were designated as high probability. In such contexts, the size of the drainage and water discharge during rain and flood events would determine how much sediment could be laid down and how deep previously exposed surfaces would be buried. High probability areas represent approximately 710 m along the ROW, all these are within the rural section of the ROW. The areas where subsurface inspection occurred (Areas 1, 2 and 3) are highlighted in Figure 1-2.

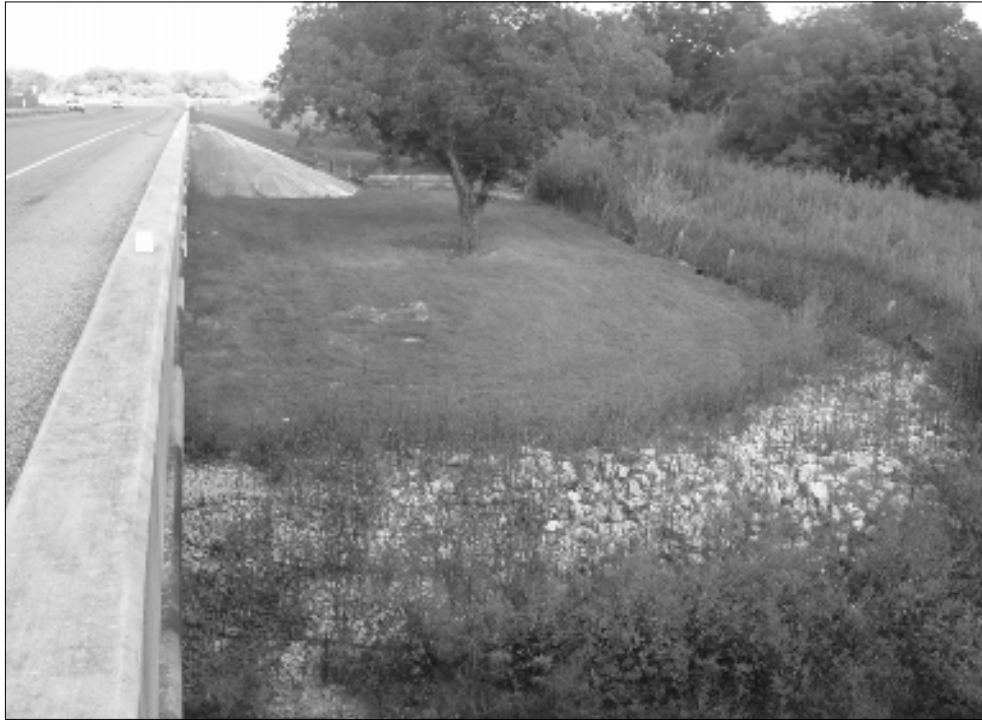
Figure 1-3. Photo overlooking Area 1.

Area 1 crosses the San Antonio River approximately 1310 m west of the beginning of the project area in Floresville. The area spans the river from an upland terrace on the east side of the San Antonio River to an upland terrace on the west side, and is approximately 292 m long (Figure 1-3).

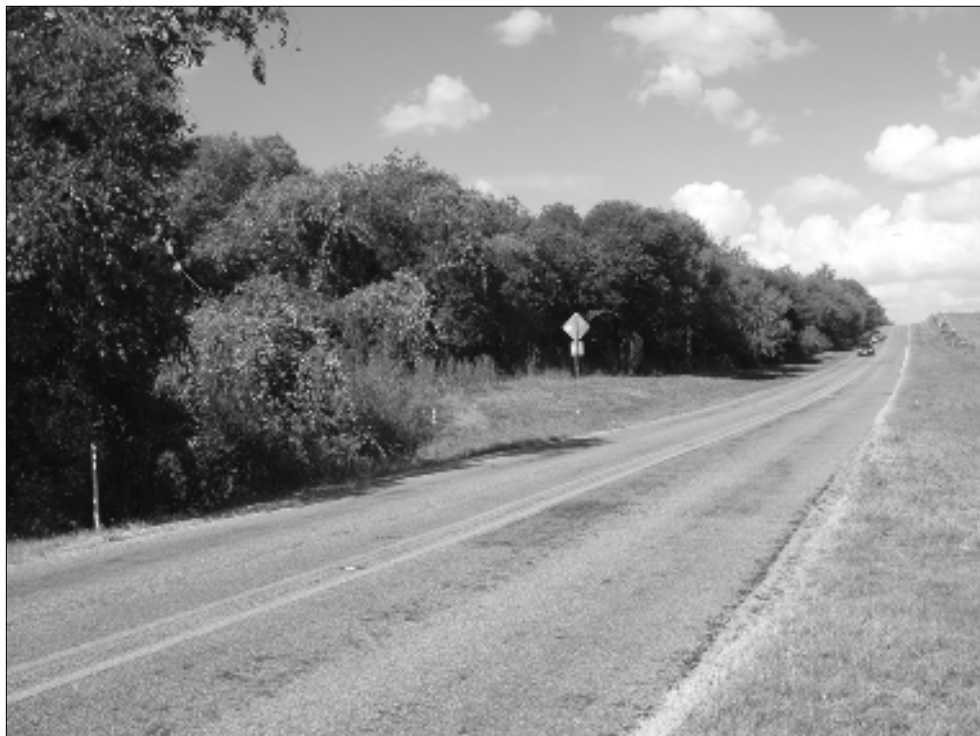
Figure 1-4. Photo overlooking Area 2.

Area 2 crosses Mariana Creek approximately 3680 m from the San Antonio River. This area spanning Mariana Creek is approximately 210 m long (Figure 1-4). It also lies in the rural portion of the ROW.

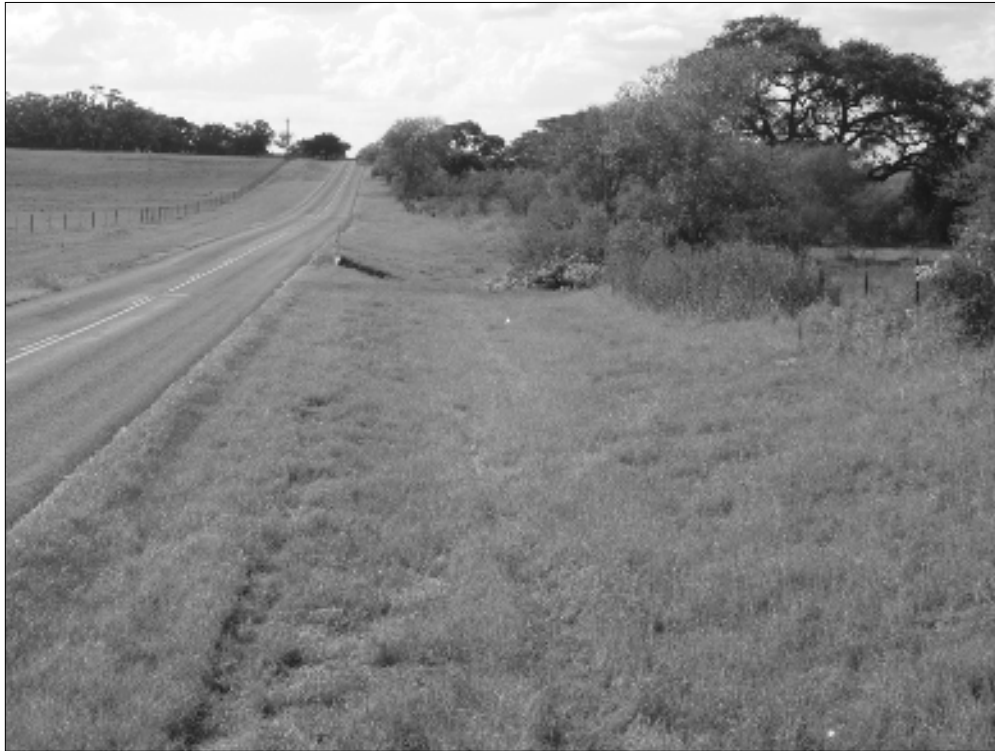
Figure 1-5. Photo overlooking Area 3.

Area 3 crosses an unnamed tributary of Mariana Creek 1165 m from the Mariana Creek crossing (Figure 1-5). This area spans the drainage and the terraces on each side for 210 m.

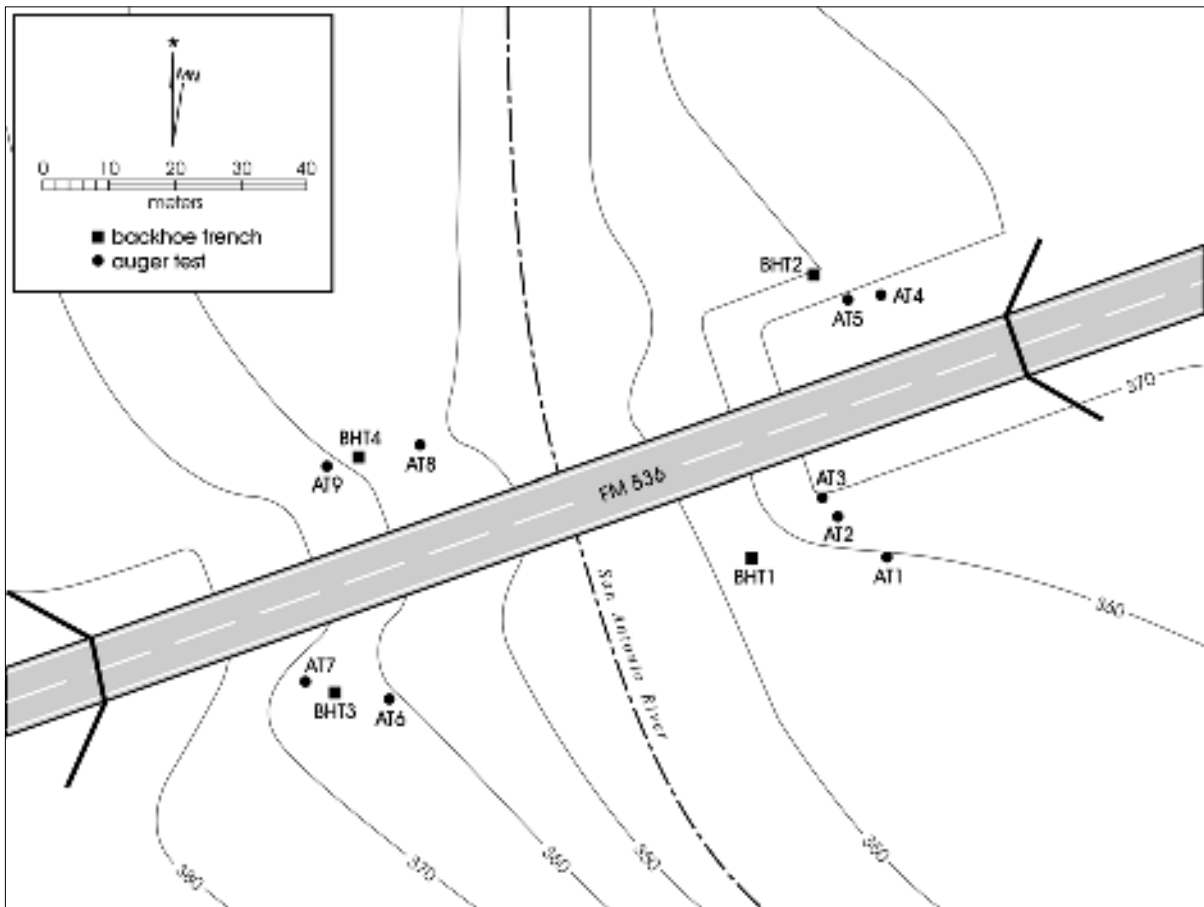
Figure 3-1a. Map showing location of auger tests and backhoe trenches in Area 1.

A total of 23 auger tests were excavated within the three high probability areas (refer to Figures 3-1a-c) to a depth of 120 cm. Nine of these were excavated at Area 1 all of which showed evidence of modern disturbances (AT 1-9; Table 4-1). Eight auger tests were excavated at Area 2 (AT 10-17). Six (75 percent) presented evidence of modern disturbances. Finally, six auger tests were excavated at Area 3 (AT 18-23), four of which (67 percent) showed clear evidence of modern disturbances. No auger tests were excavated in the vicinity of BHT 10 located north of FM 536 on the western bank of the creek due to the major disturbances present in the area. No cultural materials were found on any of the excavated auger tests. Table 4-1 summarizes the results of the auger testing in more detail.

A total of 10 backhoe trenches were also excavated within the three high probability areas (refer to Figures 3-1a-c) to a depth of 150-175 cm. Four backhoe trenches were located in Area 1, two in Area 2, and four in Area 3. Only two trenches were excavated in Area 2 due to the presence of utility lines within the narrow ROW as evidenced in the dirt berm used to cover the utility excavations (Figure 4-1). All the backhoe trenches excavated showed evidence of disturbed deposits. No cultural materials were found in any of the excavated backhoe trenches. Table 4-2 summarizes the results of the backhoe trenching in more detail. Appendix A (Figures A1-A7) shows the profiles for the excavated backhoe trenches. No profile was drawn for BHT 4 as the deposits resembled those of BHT 1. Also, the deposits observed at BHTs 8 and 10 were very similar to those present in BHT 9.

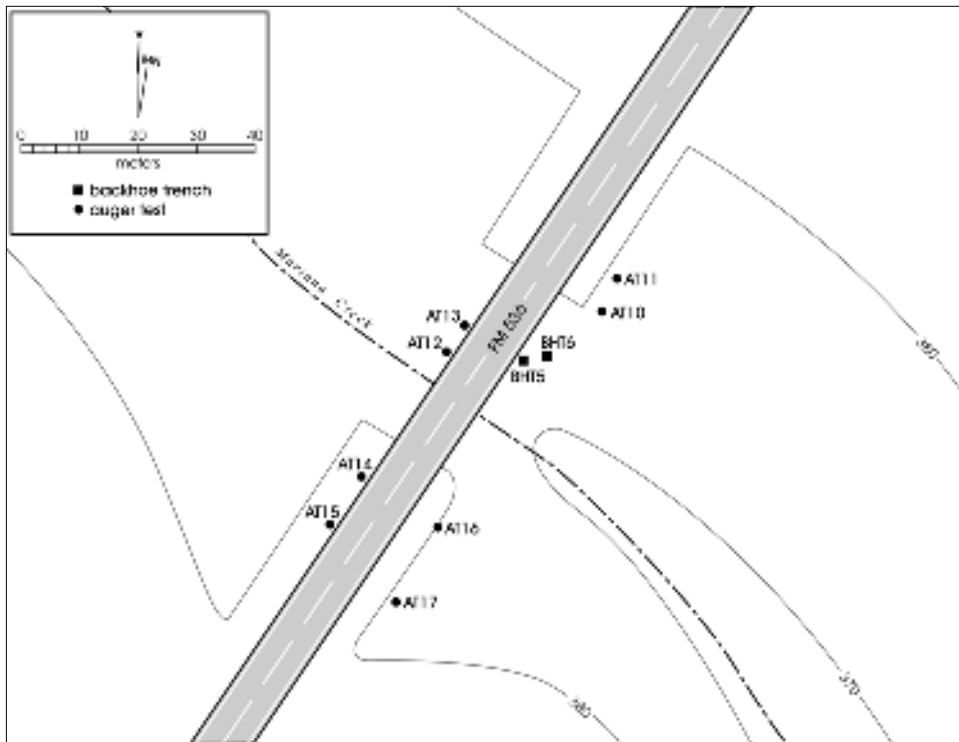
Figure 3-1b. Map showing location of auger tests and backhoe trenches in Area 2.

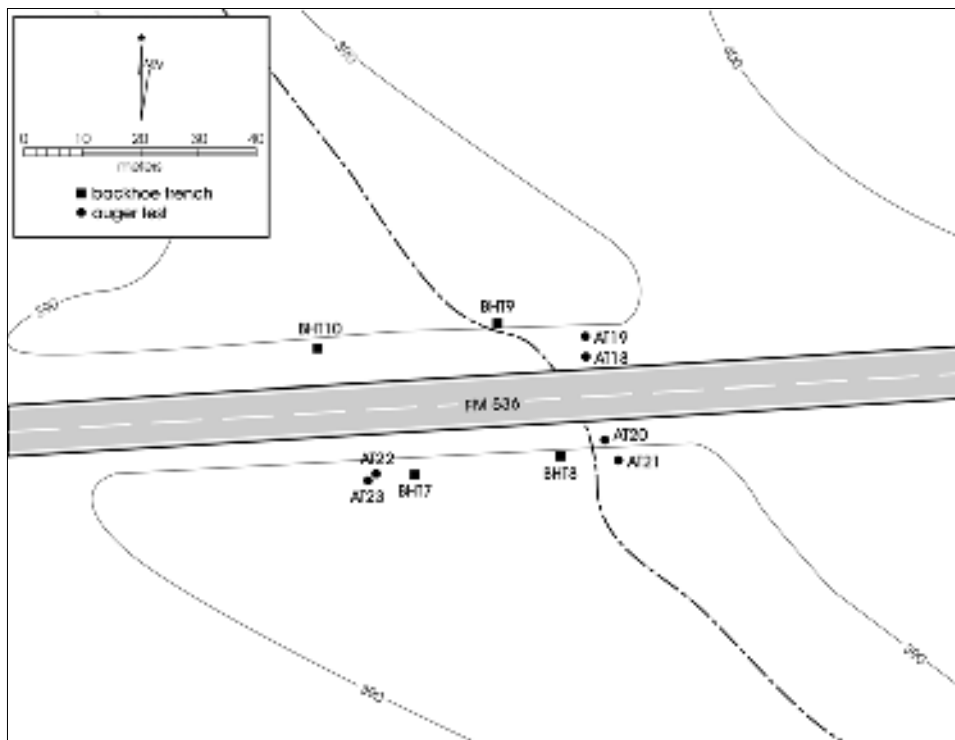
Figure 3-1c. Map showing location of auger tests and backhoe trenches in Area 3.

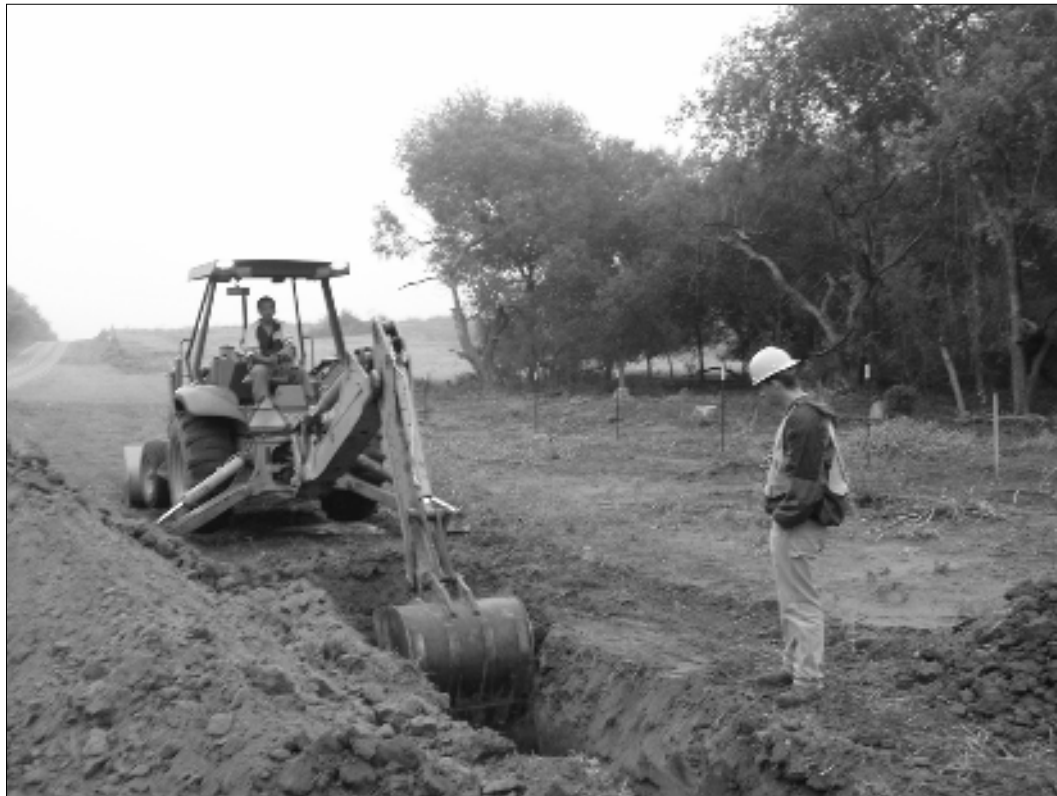
Figure 3-2. Backhoe trenching at FM 536.

Two backhoe trenches were to be placed on each bank of the three drainages within the ROW (Figure 3-2). However, disturbances in some areas did not justify the excavation of a backhoe trench at specific locations (Figures 3-1a-c). Each backhoe trench reached a depth of 1.75 m below surface and extended 5.0 m in length. No soils were screened from these trenches but notes on the stratigraphy were taken on standardized forms. A representative segment of one wall of each backhoe trench was profiled unless it reflected a great degree of homogeneity, in which case only those trenches reflecting different depositional processes were documented. The locations of all backhoe trenches were plotted with GPS units and on the topographic quadrangle and/or aerial photographs. Digital color photographs were taken of all backhoe trench profiles.

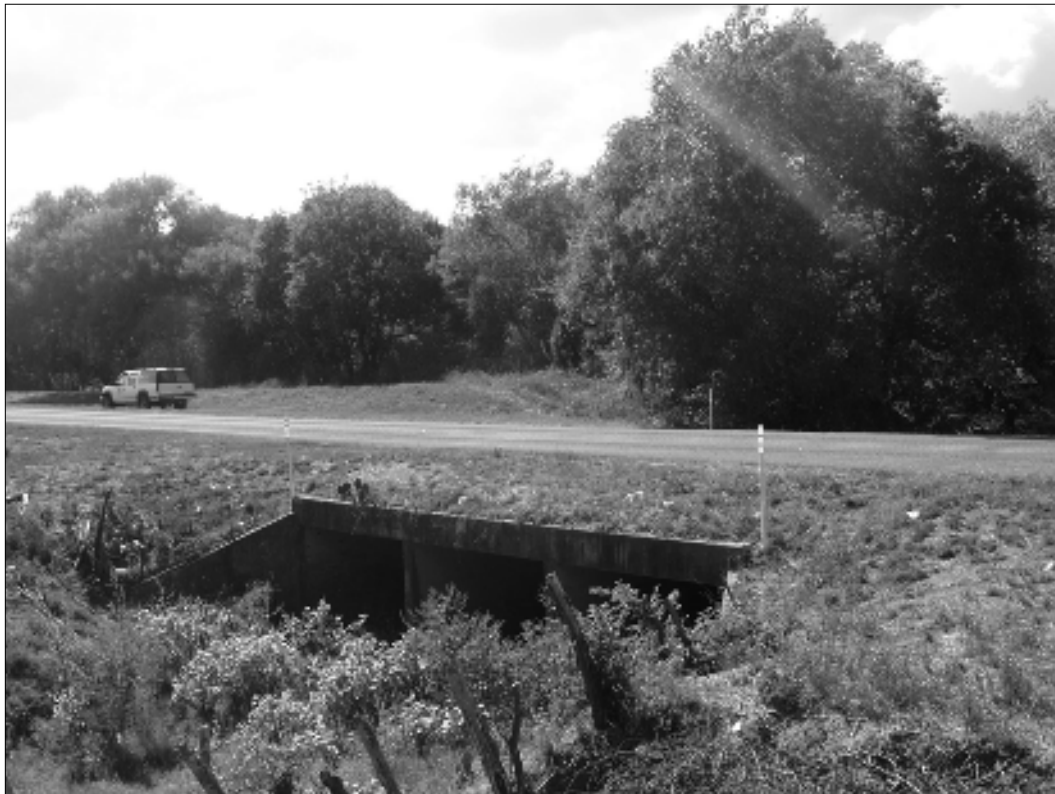
Figure 4-1. Area 2 right-of-way showing evidence of disturbances.

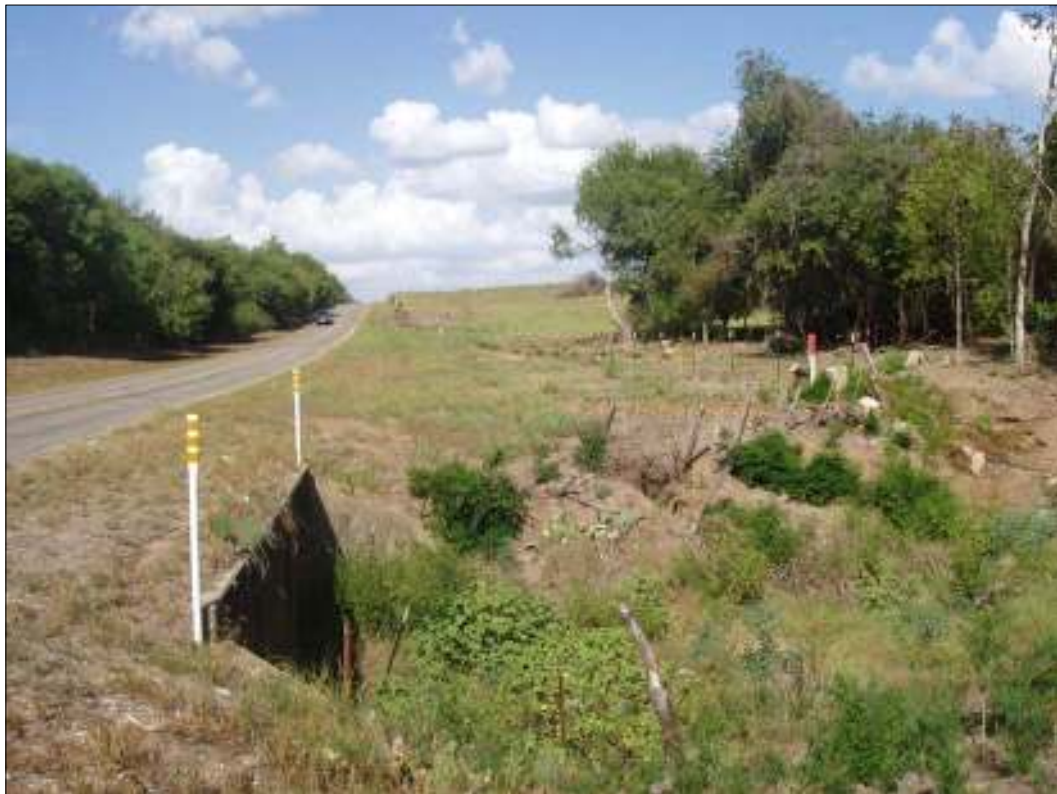
Figure 4-2. Project area photo showing disturbances caused by utilities and road construction.

The FM 536 survey corridor has been heavily disturbed by road construction and utilities installation (Figure 4-2).

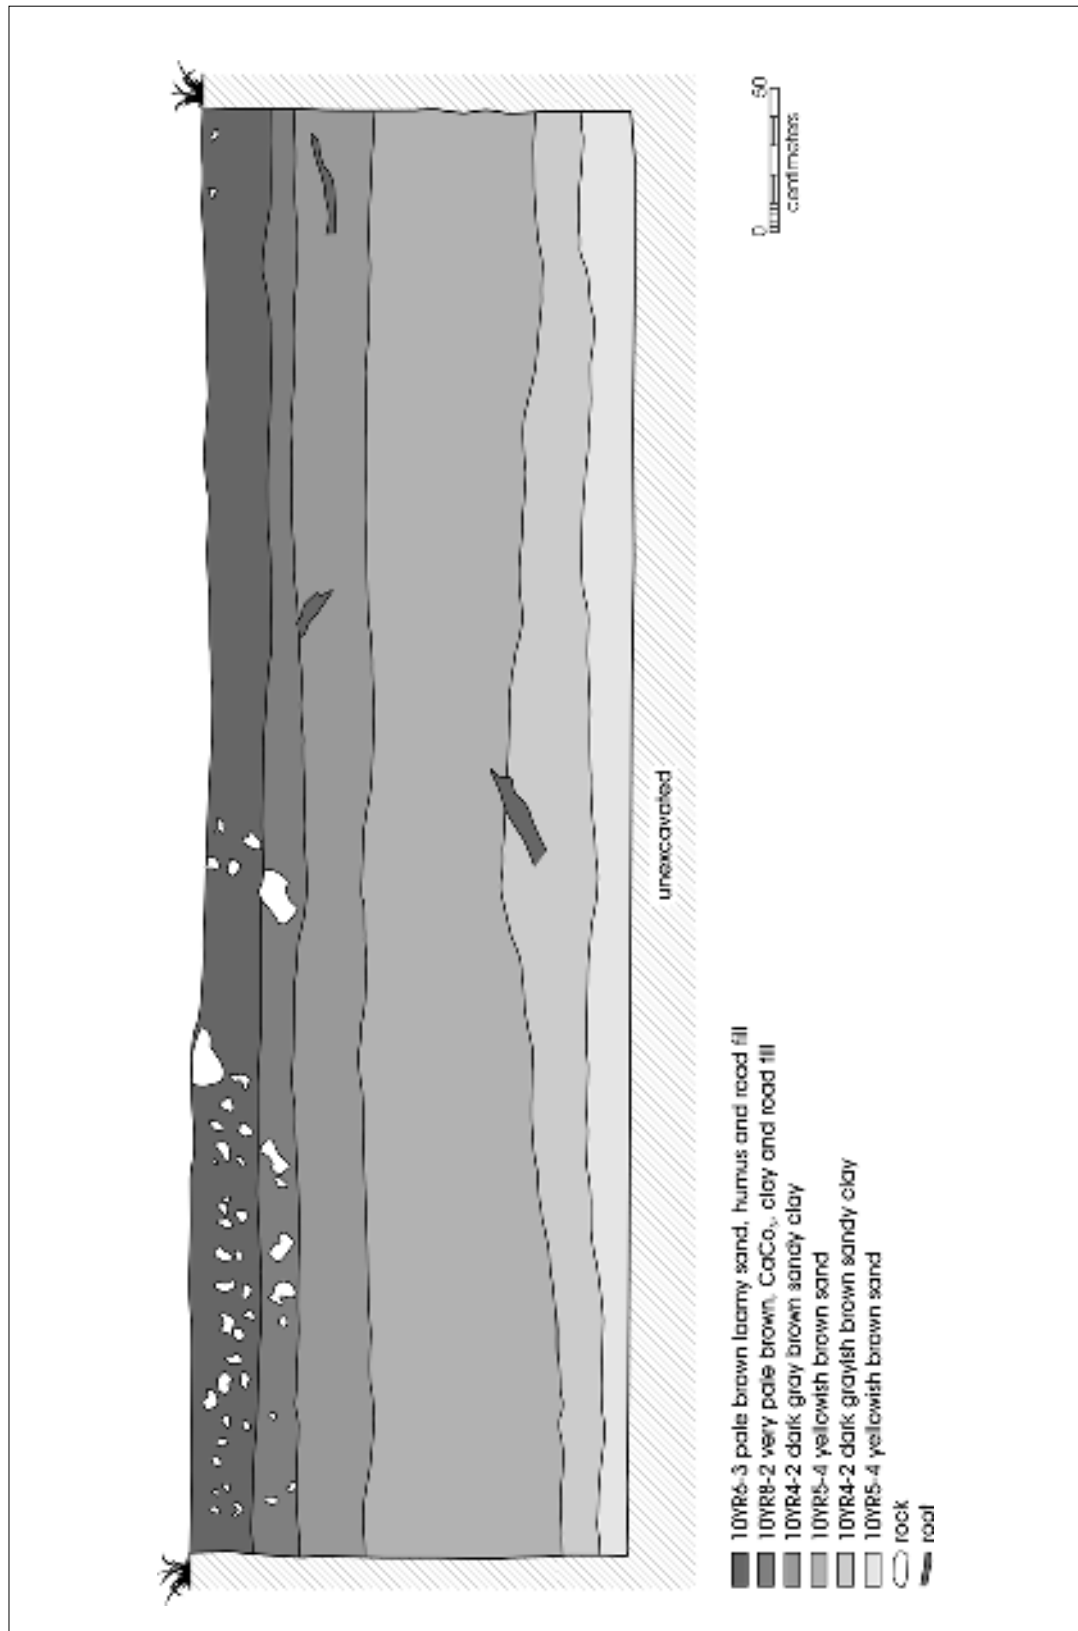
Figure A-1. Backhoe Trench 1, North Wall profile.

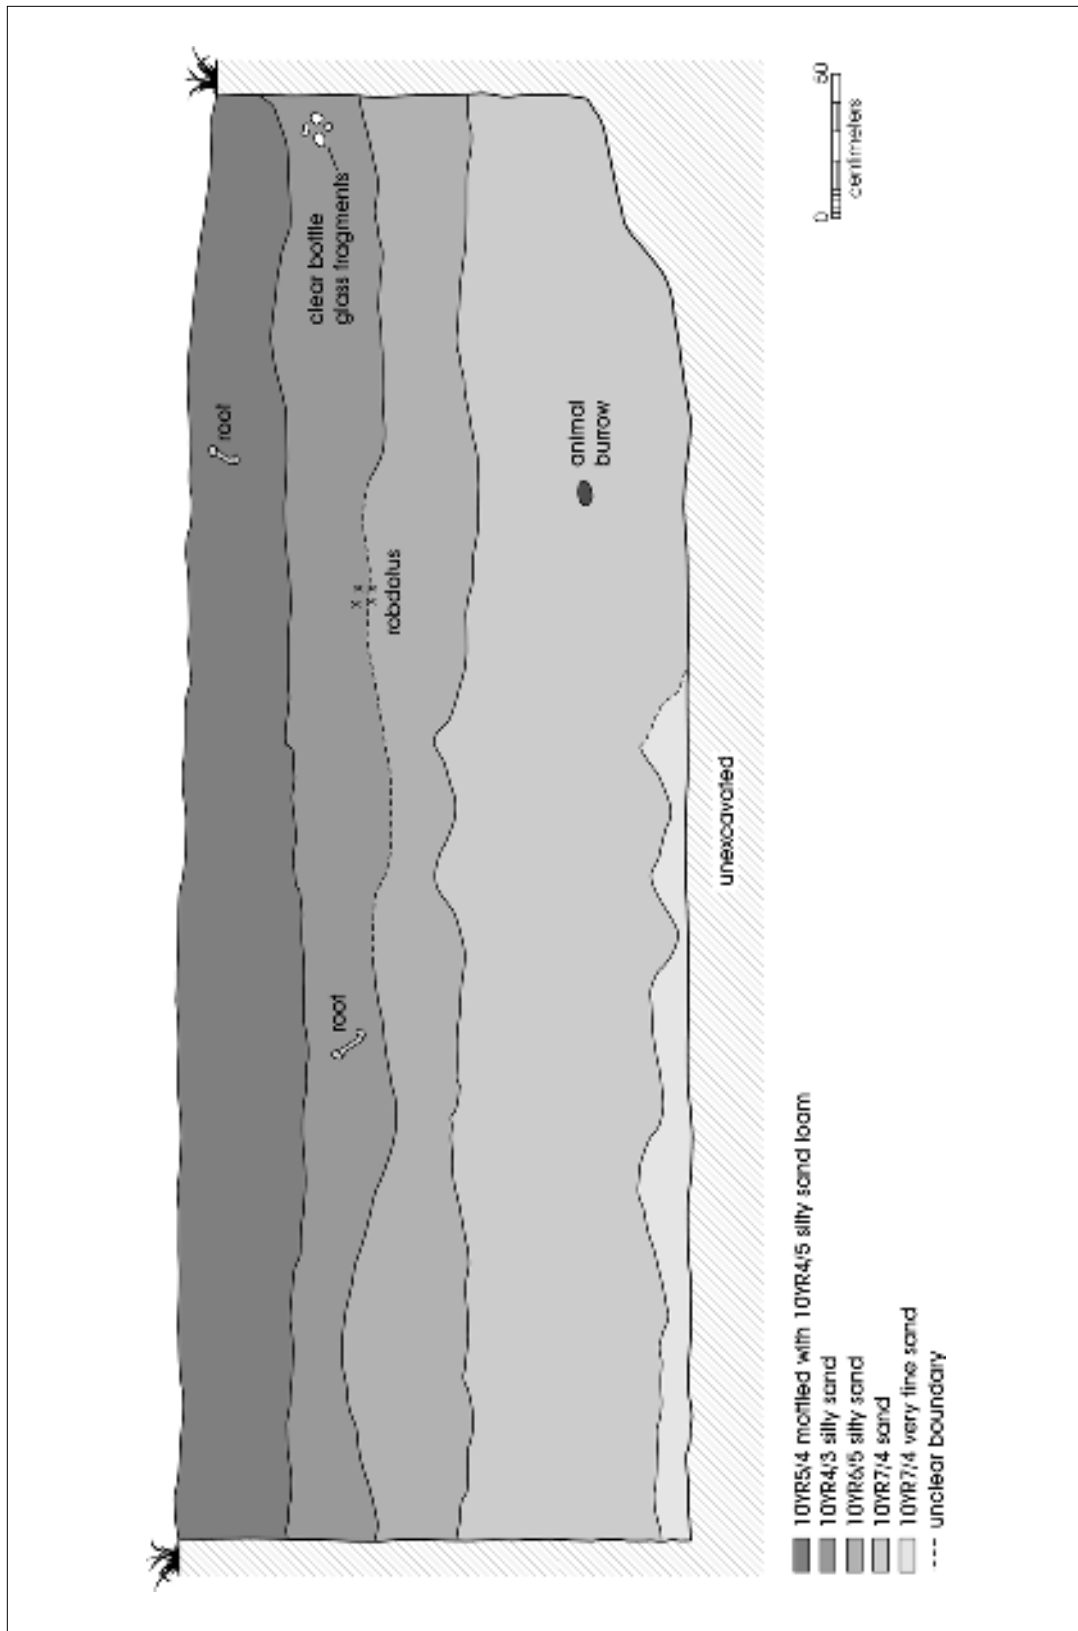
Figure A-2. Backhoe Trench 2, North Wall profile.

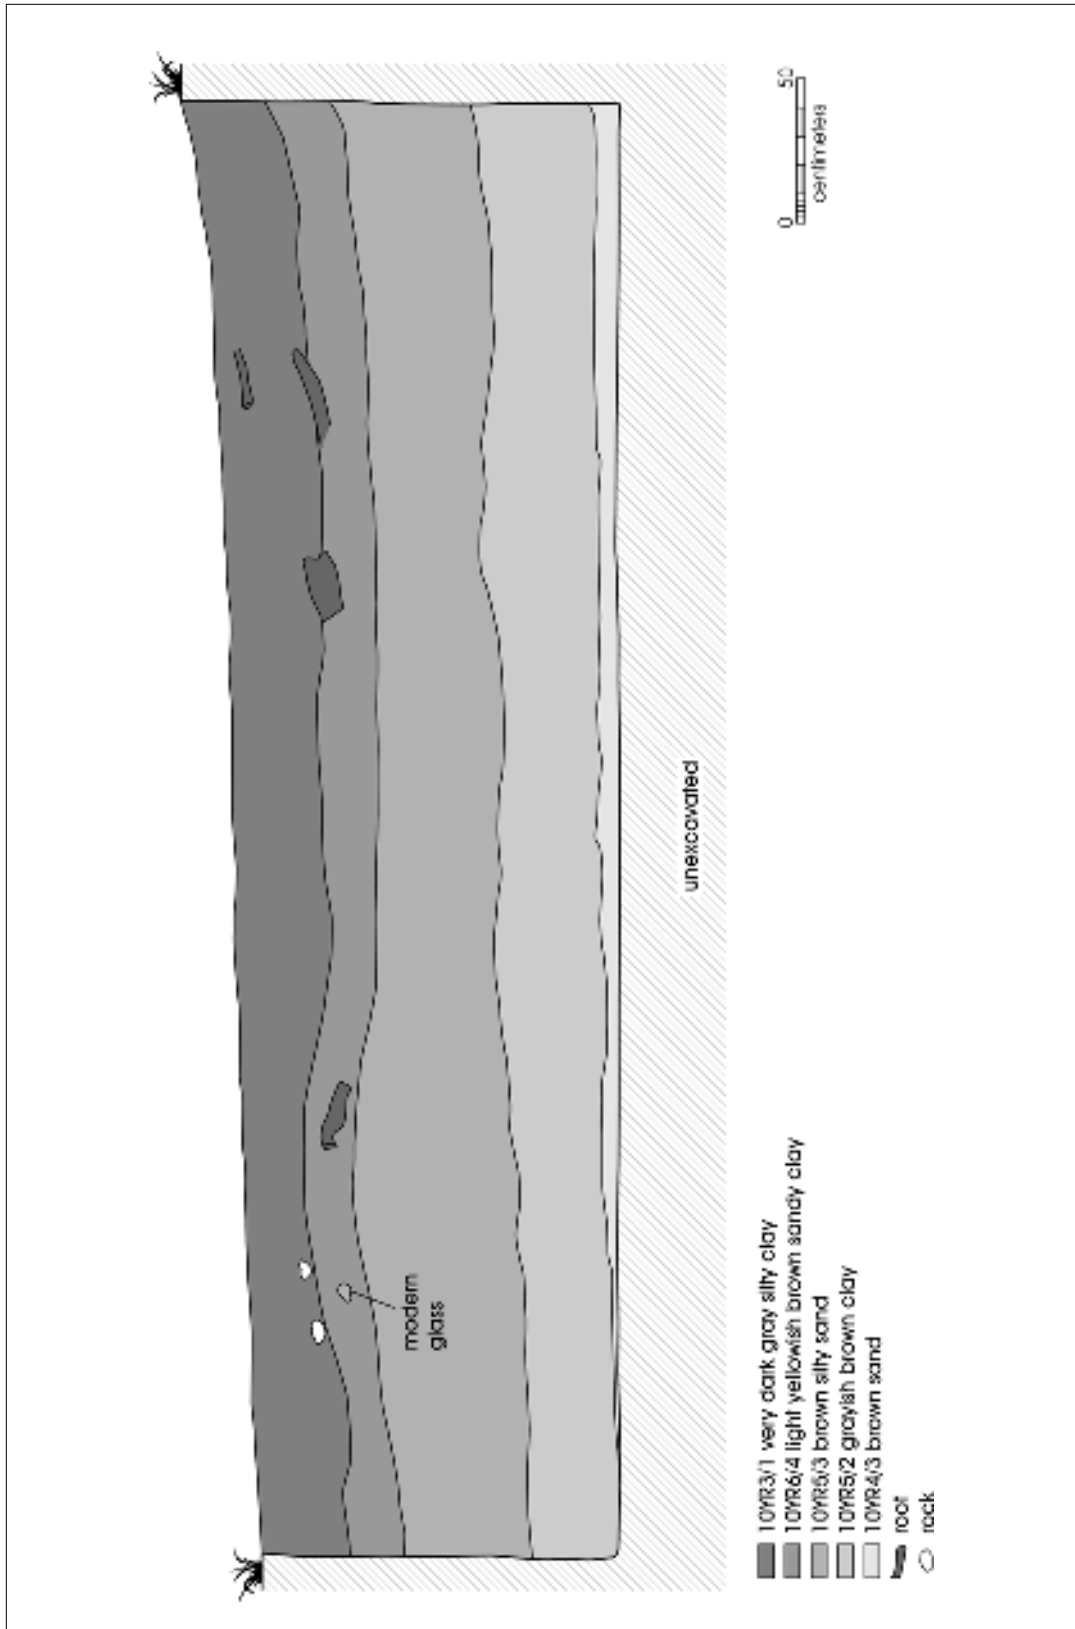
Figure A-3. Backhoe Trench 3, South Wall profile.

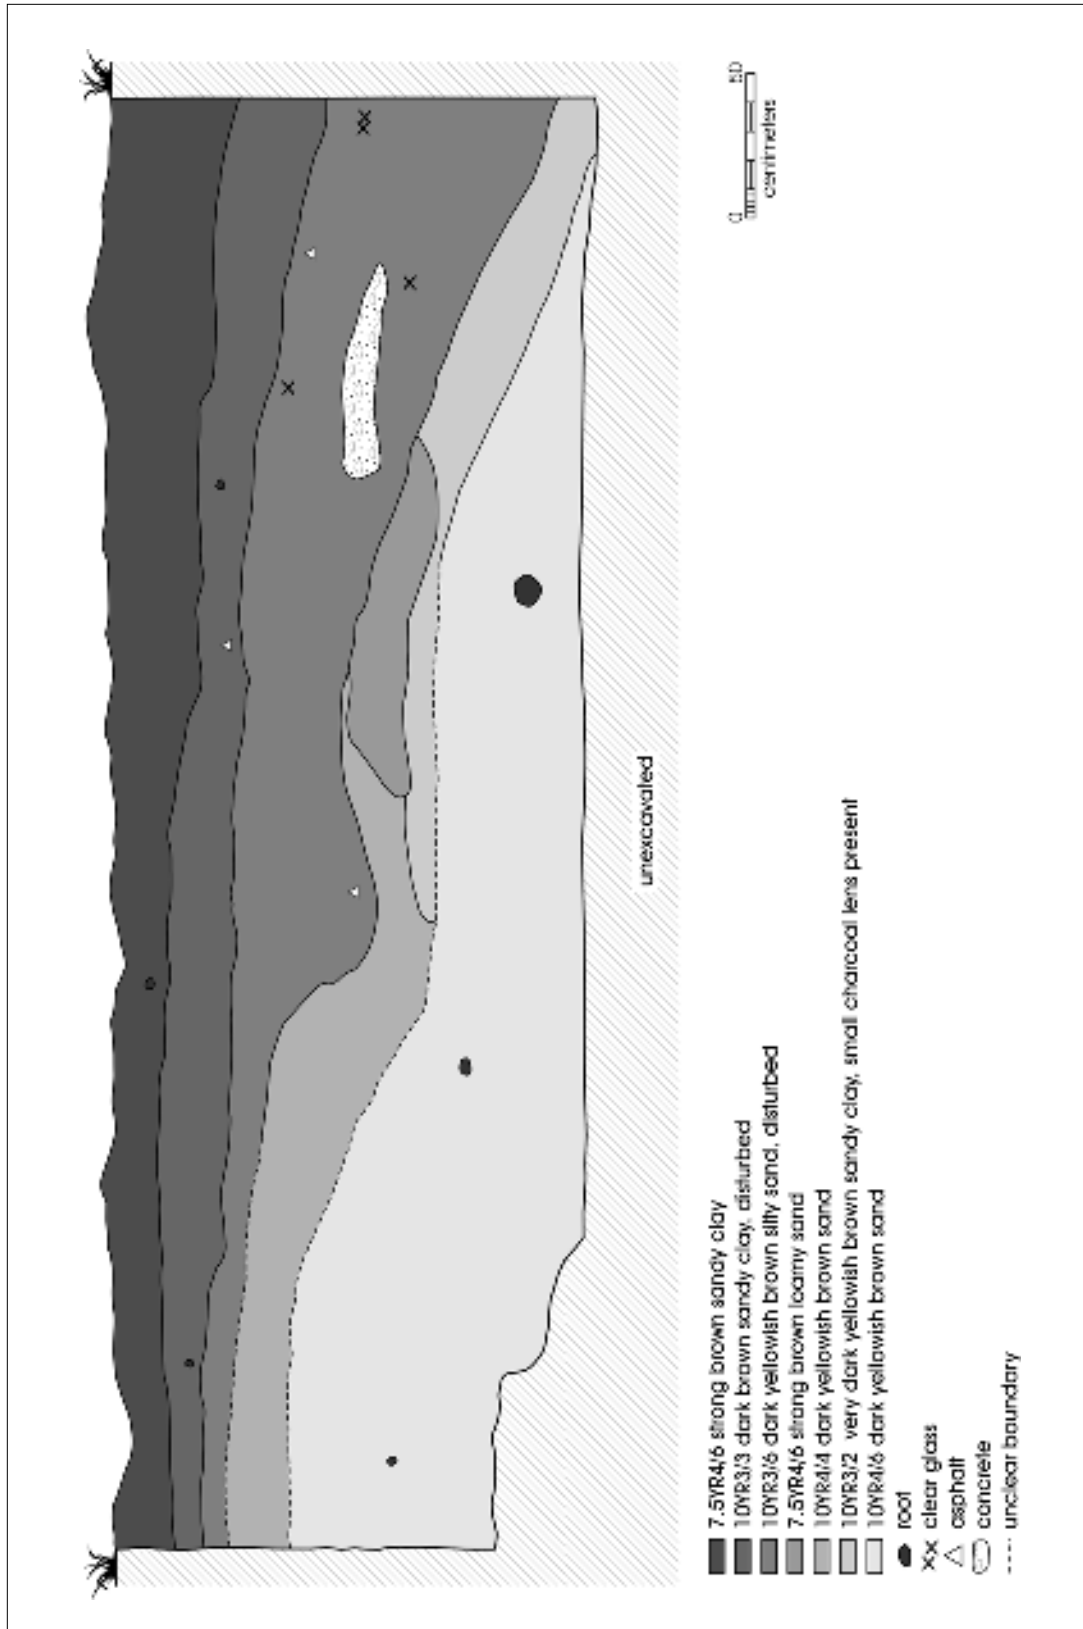
Figure A-4. Backhoe Trench 5, East Wall profile.

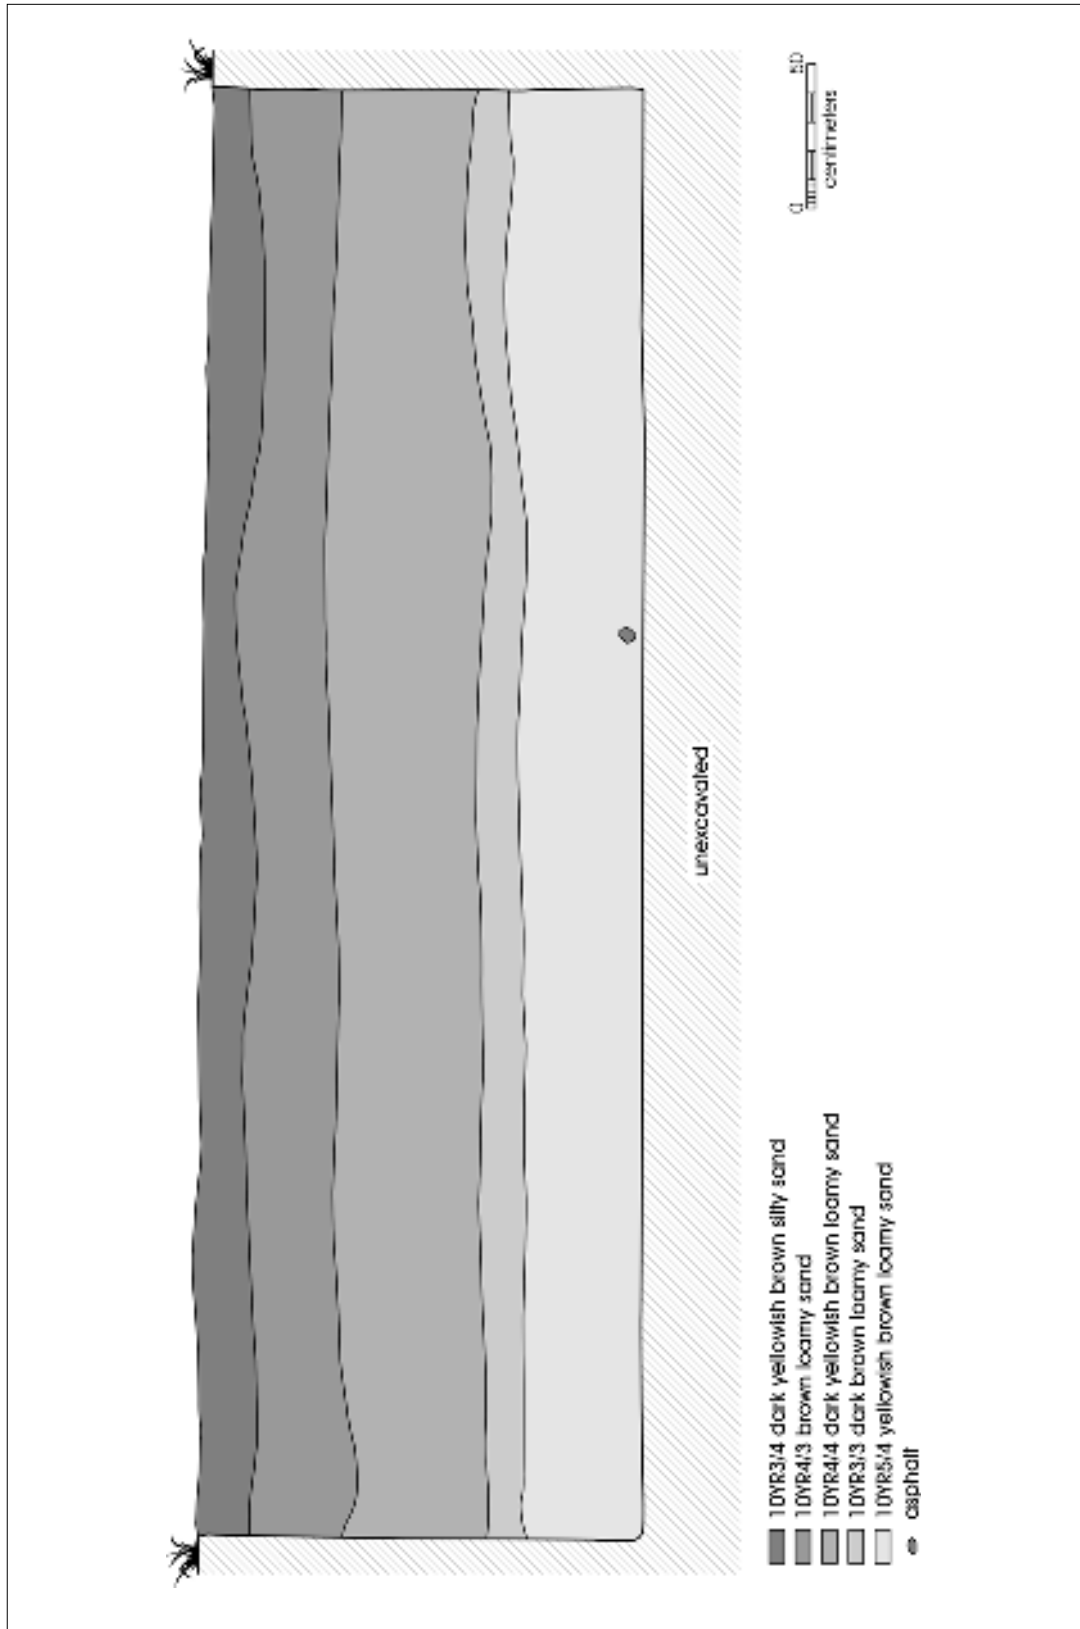
Figure A-5. Backhoe Trench 6, East Wall profile.

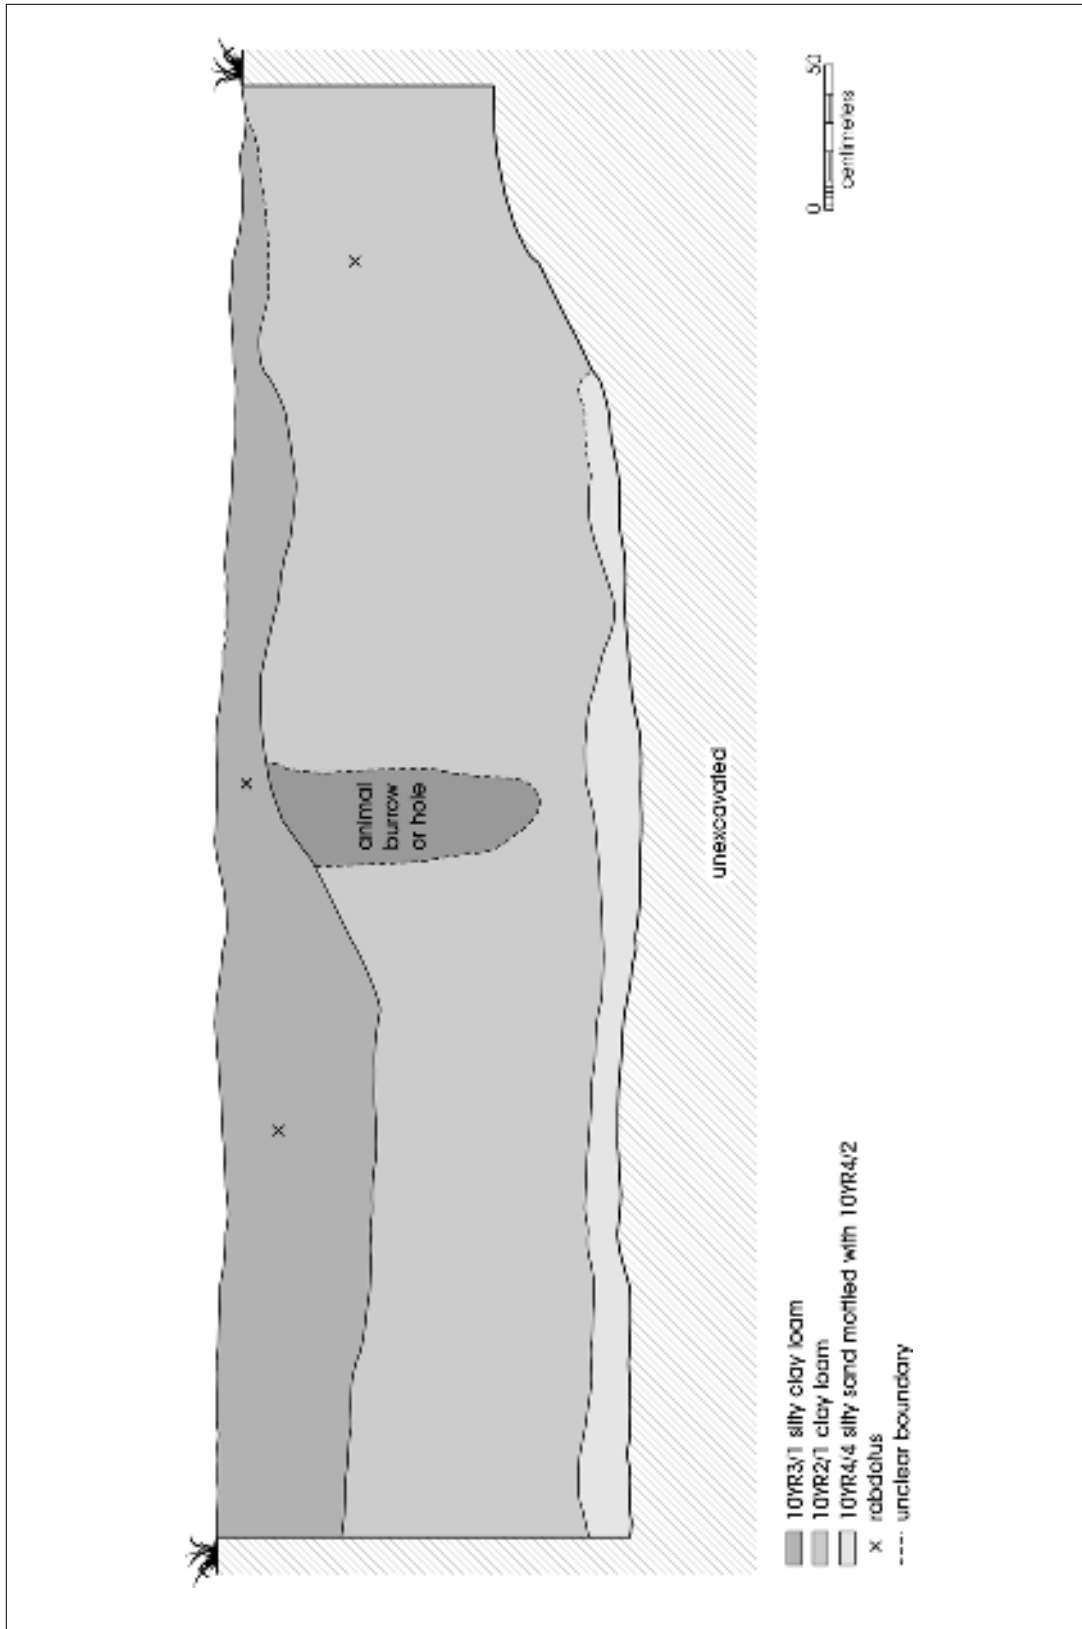
Figure A-6. Backhoe Trench 7, South Wall profile.

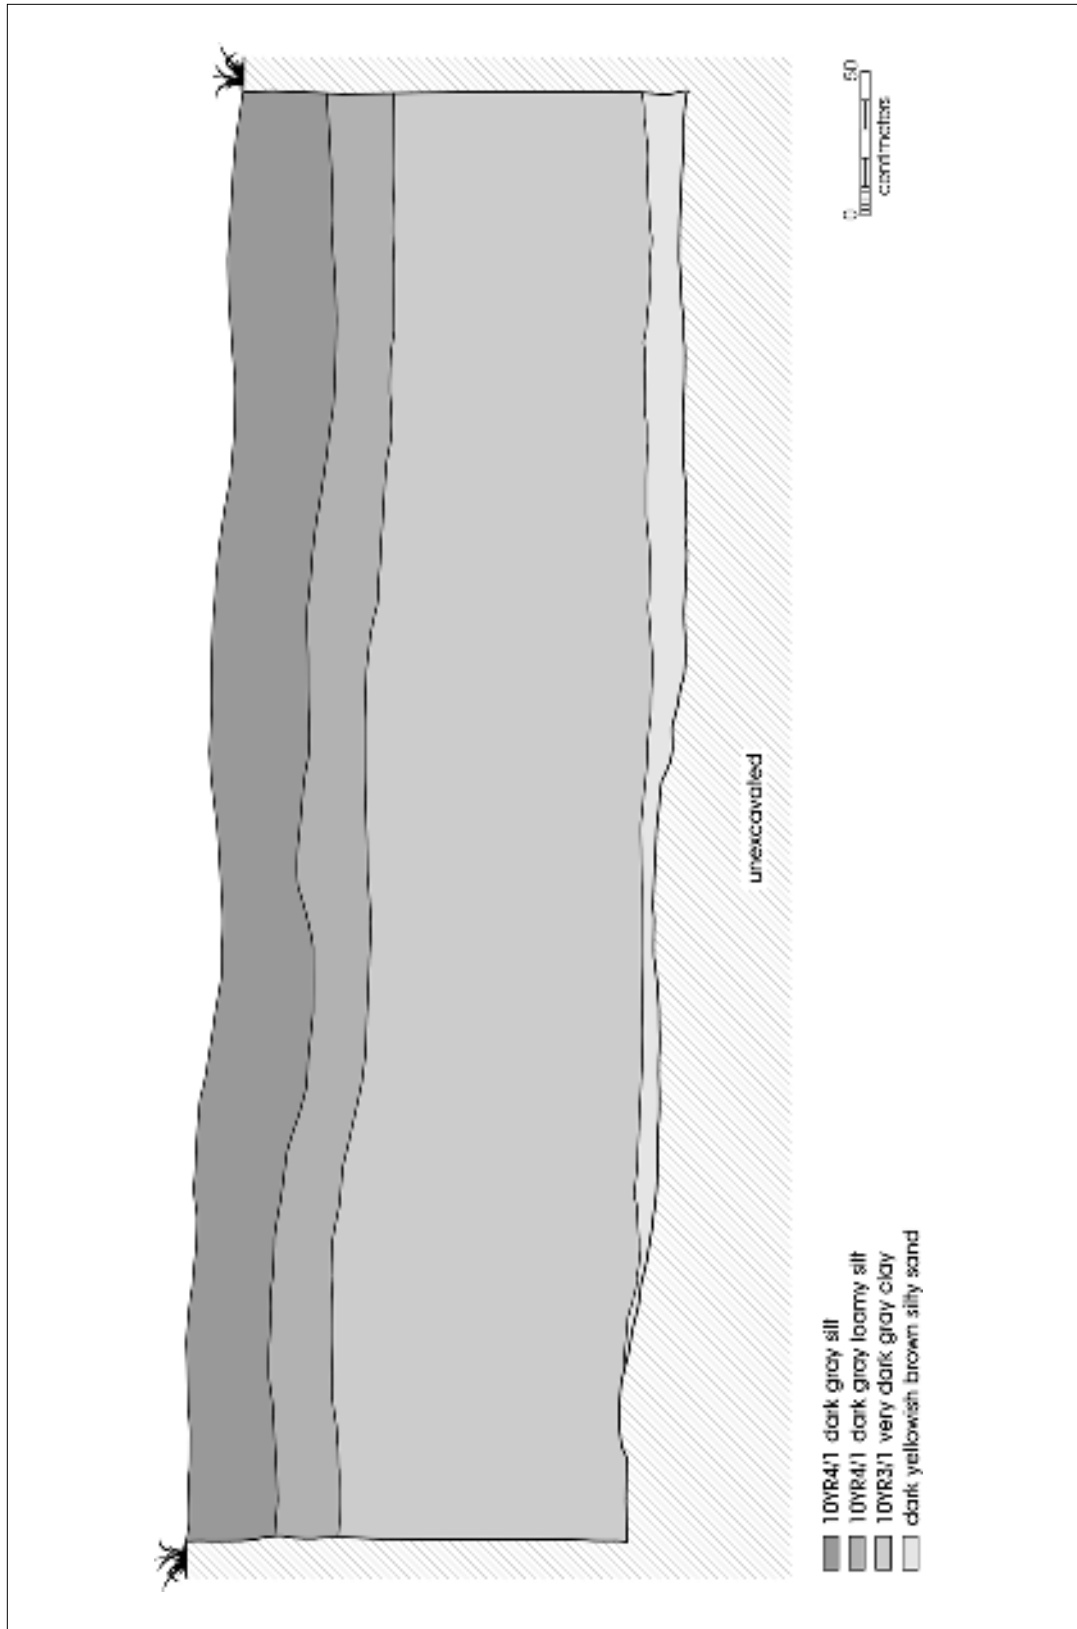
Figure A-7. Backhoe Trench 9, South Wall profile.
