Intensive Pedestrian Survey along the Banks of the San Antonio River: Museum “Urban” Reach Section of the San Antonio River Improvements Project, Bexar County, Texas

by
Antonia L. Figueroa, Kristi M. Ulrich, S. Christopher Caran,
and Charles A. Speer

Texas Antiquities Permit No. 3852

Prepared by
Center for Archaeological Research
The University of Texas at San Antonio
Archaeological Report, No. 371

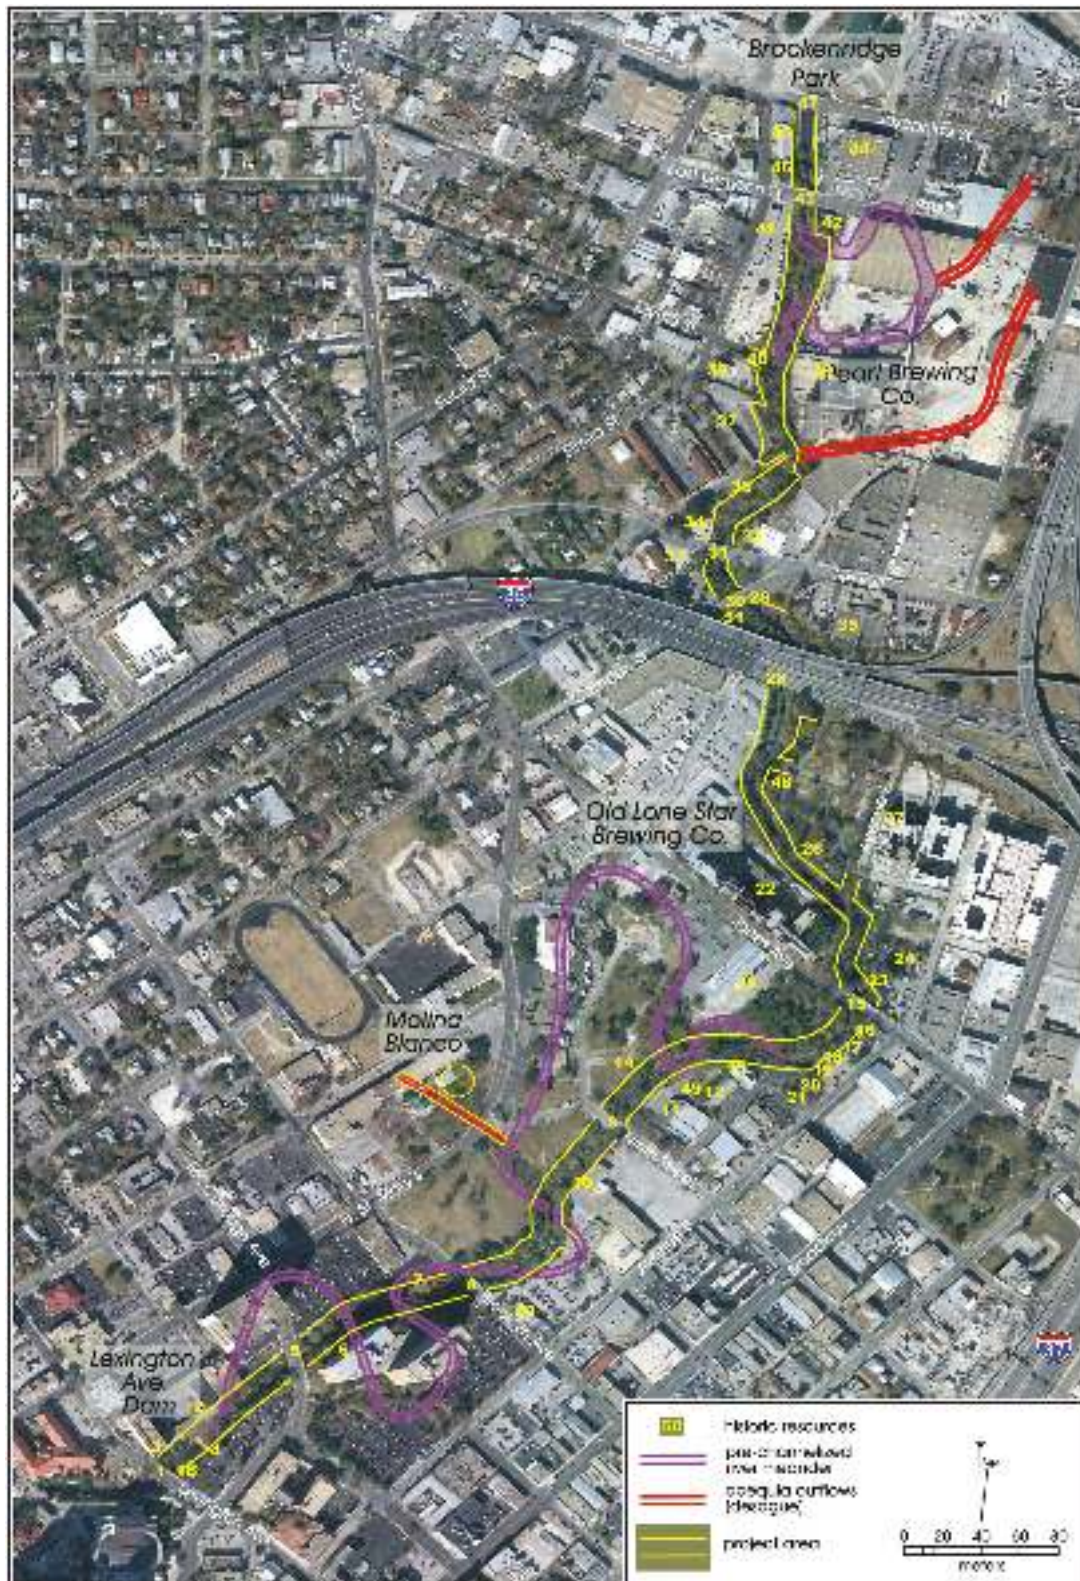
Figure 2-1. Museum "Urban" Reach project area, showing locations of historic resources by inventory number, and original meander of the San Antonio River.

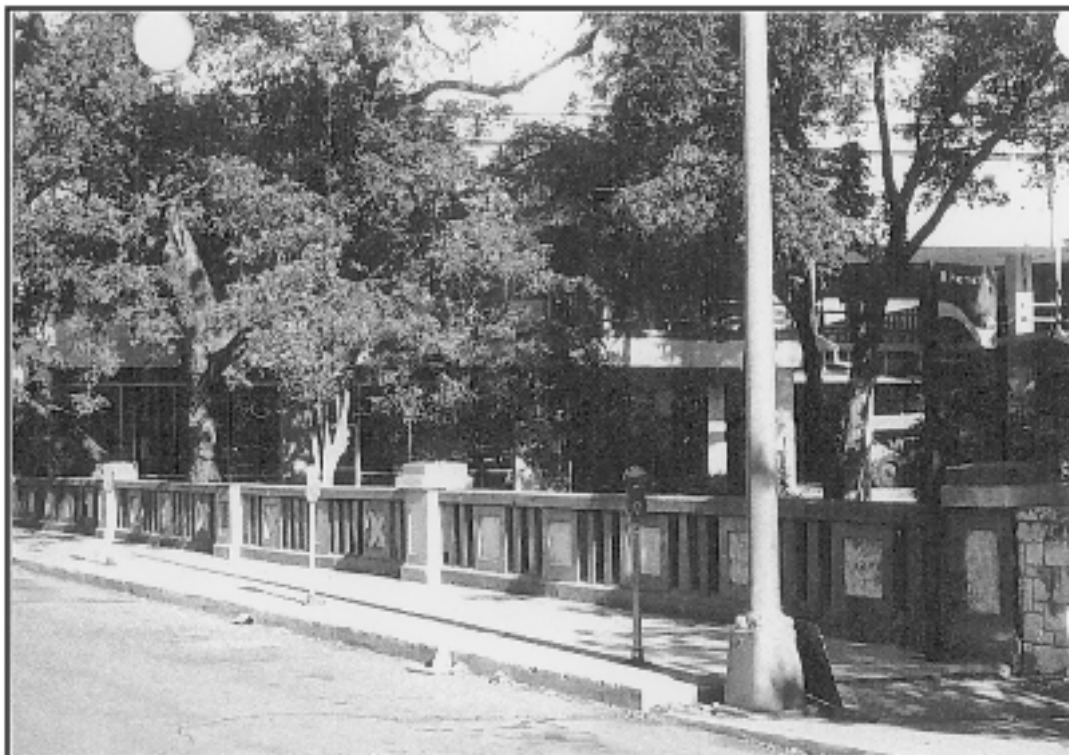
Figure 2-2. The Fourth Street Bridge located on Lexington Avenue (Historic Resource #1).

There are six bridges along the project corridor that are historically significant. These bridges were constructed as a result of river improvements authorized and funded under the administration of Mayor Chambers who served from 1927 to 1933. The Fourth Street Bridge, also known as the Lexington Avenue Bridge, is located in the 100 block of Lexington Avenue (Figure 2-2; Table 2-1:Historic Resource #1). The bridge was constructed during river improvements between 1940 and 1941. It is a reinforced concrete bridge for vehicular traffic, with two load-bearing walls supporting the road deck. It has concrete sidewalks and concrete railings on both sides of the bridge’s deck. The railings have five pillars each, of which two display plaques denoting the historical context of the bridge.

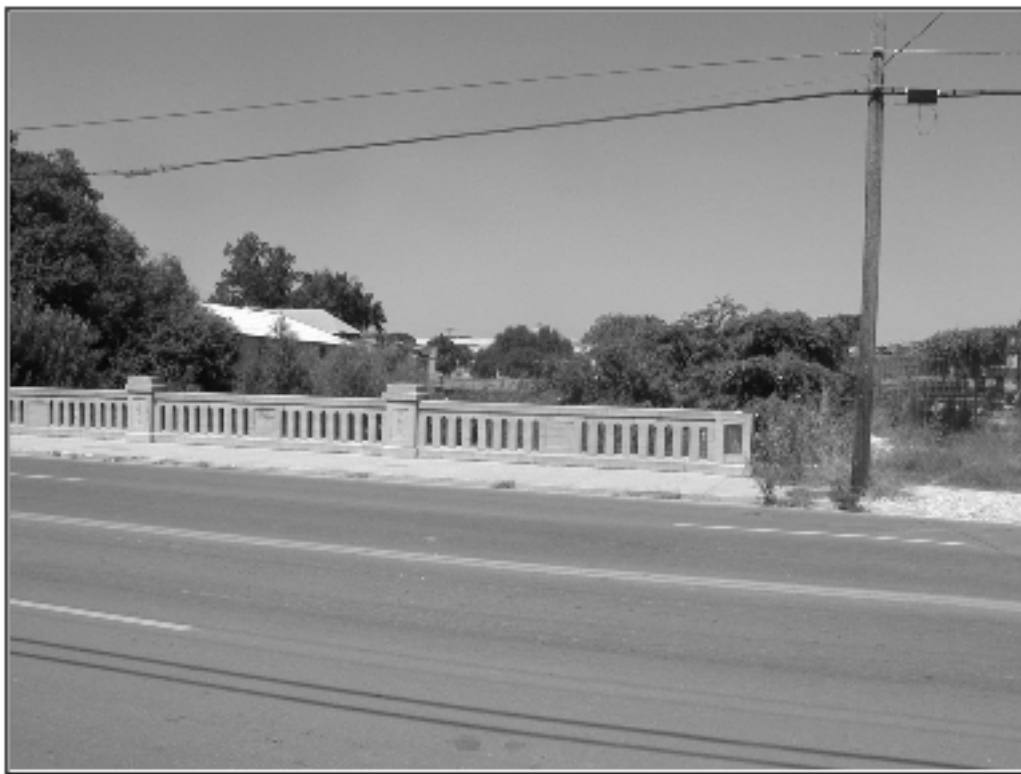
Figure 2-4. *The Grayson Street Bridge located on Grayson Street (Historic Resource #43).*

The Grayson Street Bridge, or Grand Avenue Bridge, located in the 100 block of Grayson Street, was constructed in 1929 (Figure 2-4; Historic Resource #43). It is a reinforced concrete bridge for vehicular traffic. It has concrete sidewalks and concrete railings on both sides of the bridge’s deck. The concrete railings each have six concrete, square rail columns.

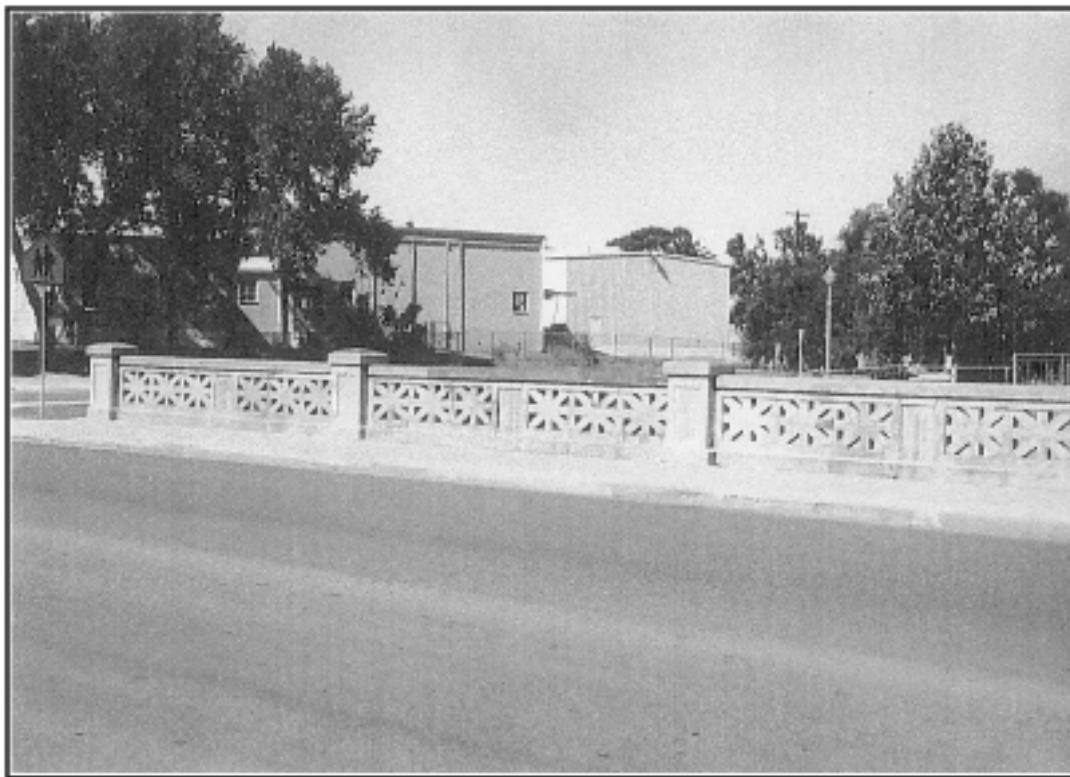
Figure 2-5. *The Josephine Street Bridge located on Josephine Street (Historic Resource #47).*

The Josephine Street Bridge, located in the 100 block of Josephine Street, was constructed in 1929 (Figure 2-5; Historic Resource #47). The bridge is a reinforced concrete bridge for vehicular traffic. It has concrete sidewalks and concrete railings on both sides of the bridge’s deck. It has concrete railings, each with six small, concrete, square rail columns. The Josephine Street Bridge was constructed as part of the river improvements occurring during the administration of Mayor Chambers.

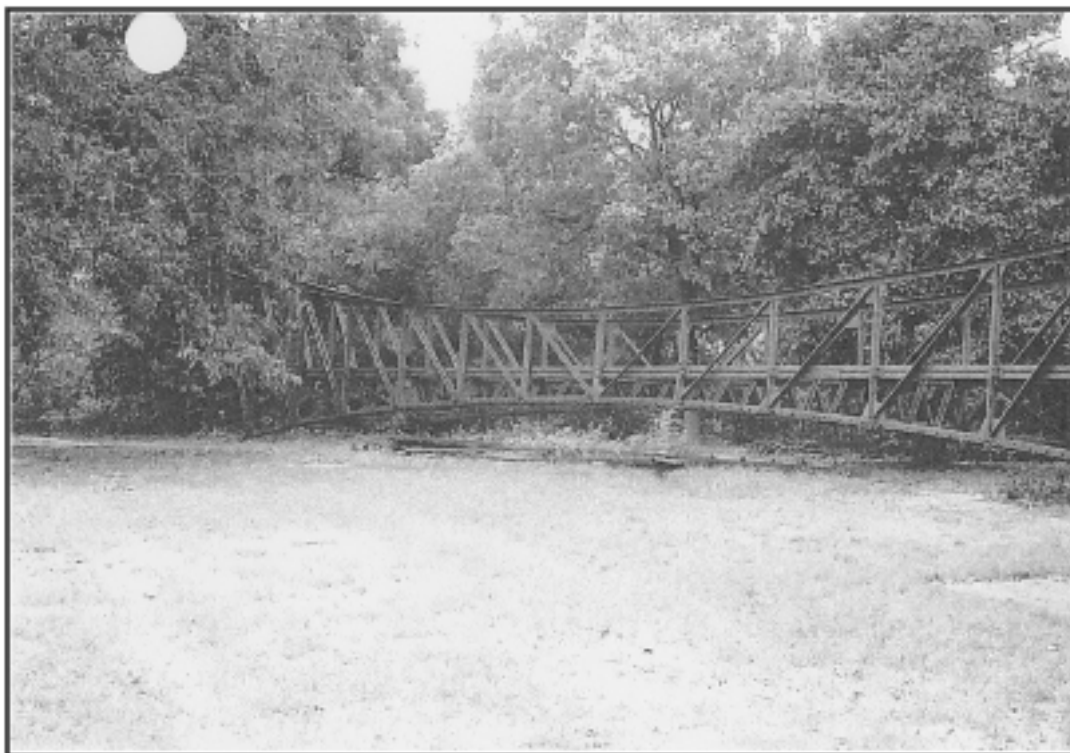
Figure 2-6. The iron bridge from Lone Star Brewery located on Roy Smith (Historic Resource #48).

Historic Resource #48 is the iron bridge from the Lone Star Brewery and it was constructed 1901–1904 (Figure 2-6). The bridge served as pedestrian path between the two towers of the Lone Star Brewery. The bridge is a flat Pratt truss-bridge structure. The bridge was temporarily located at 102 Roy Smith (where it still stands) when the brewery became the San Antonio Museum of Art. The Lorenzo Ochs and George Aschbacher Brewery is depicted in a 1904 Sanborn map on the same property (Figure 2-7). This small San Antonio brewery only functioned from 1890 to 1904 (Texas Historical Commission [THC] 2006). According to deed records the land was conveyed to Ochs and Aschbacher in 1901 by W. Dobrowolski (BCC 2006a).

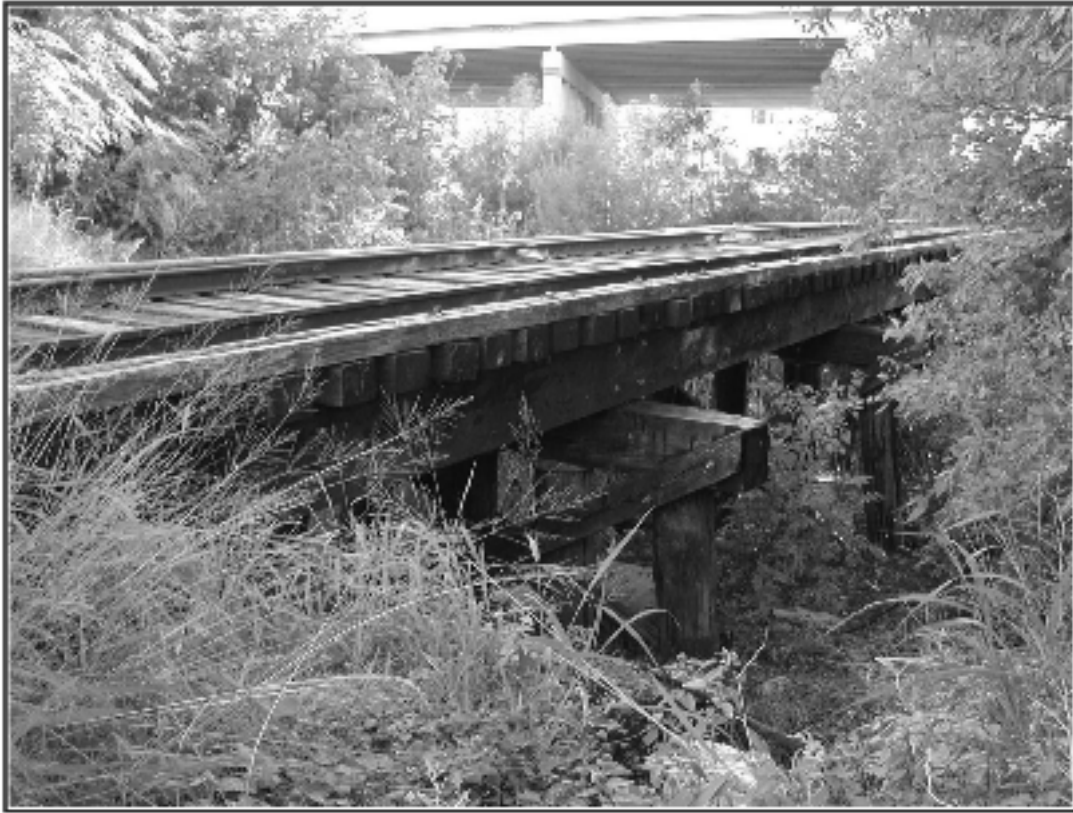
Figure 2-8. *Wooden trestle bridge located between Camden Street and IH-35.*

A wooden trestle bridge is located between Camden Street and IH-35 (Figure 2-8). It served the Texas Transportation Company and the date of construction is not known. The terminal railway company was chartered in 1897 and ran between the Galveston, Harrisburg, and San Antonio Railroad tracks and Pearl Brewery. This structure was not documented during the standing structure survey.

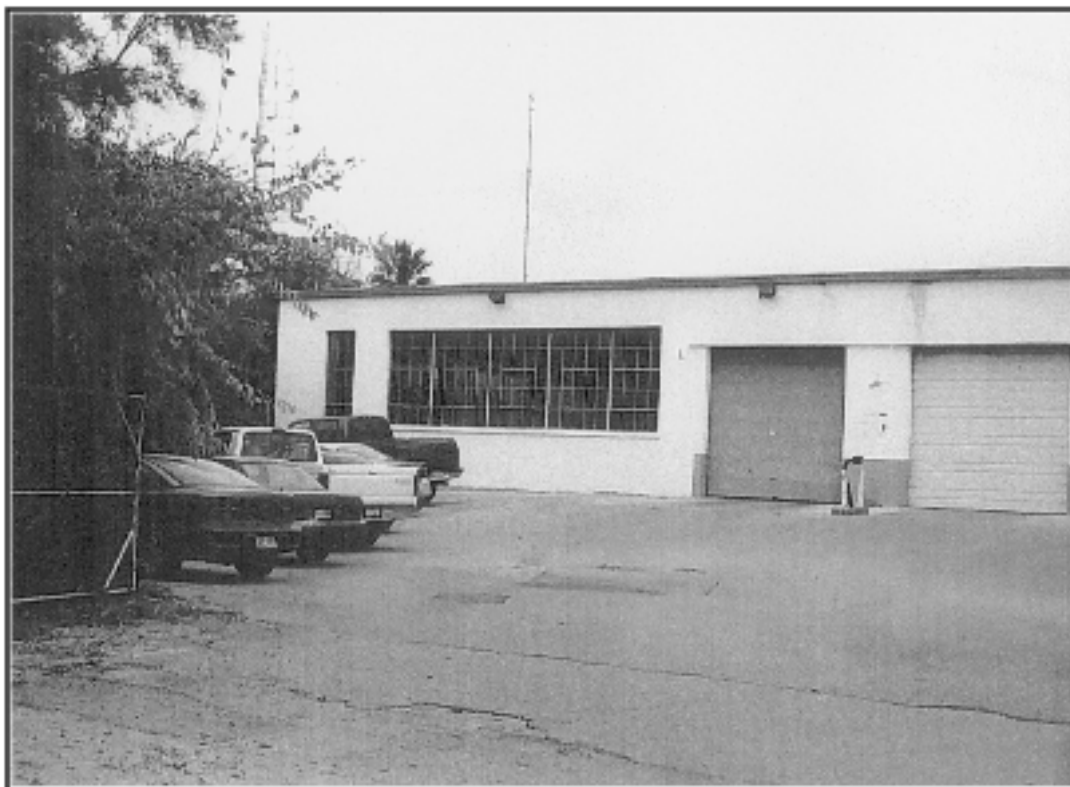
Figure 2-12. Historic Resource #10 located on Avenue B (southwest façade).

Historic Resource #10 is located at 815 Avenue B and was constructed in 1935 (Figure 2-12). Currently, the building is used as covered parking for the AT&T building. Deed

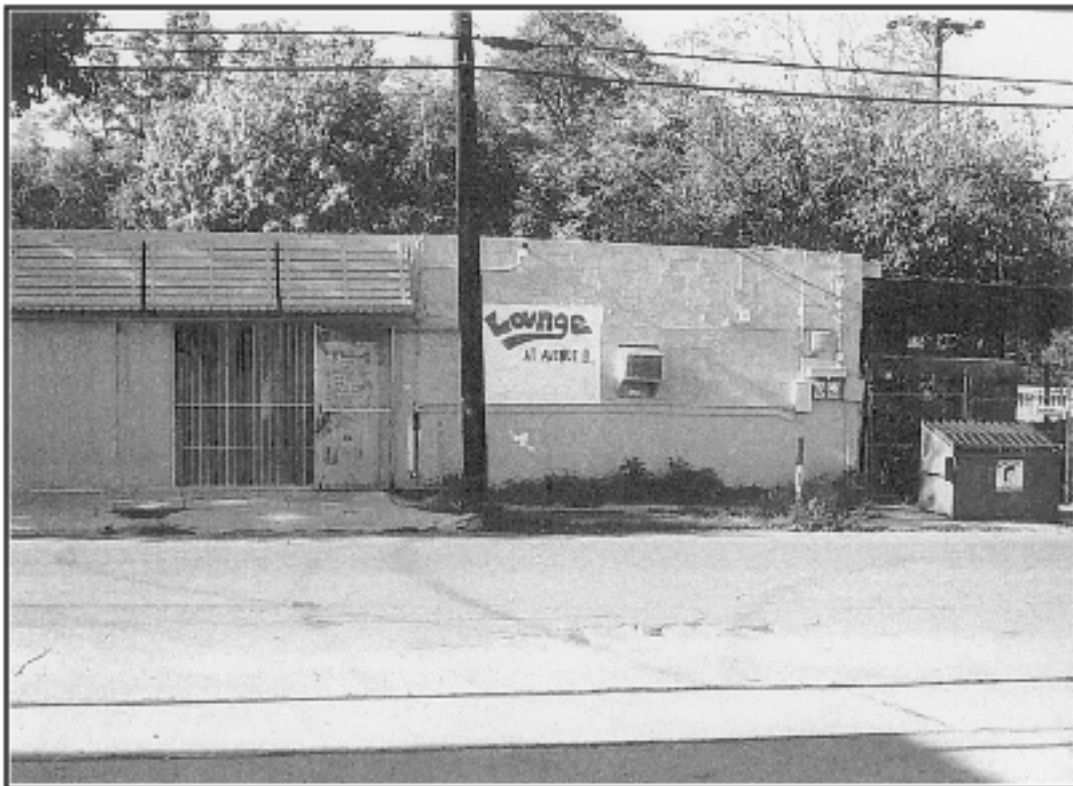
Figure 2-18. Historic Resource #16 located on Avenue B (southeast façade).

Historic Resource #16 is located at 1033 Avenue B and was constructed ca. 1945 (Figure 2-18). It is a single-story, rectangular, commercial building of concrete block construction with a low slope, built-up roof with parapet

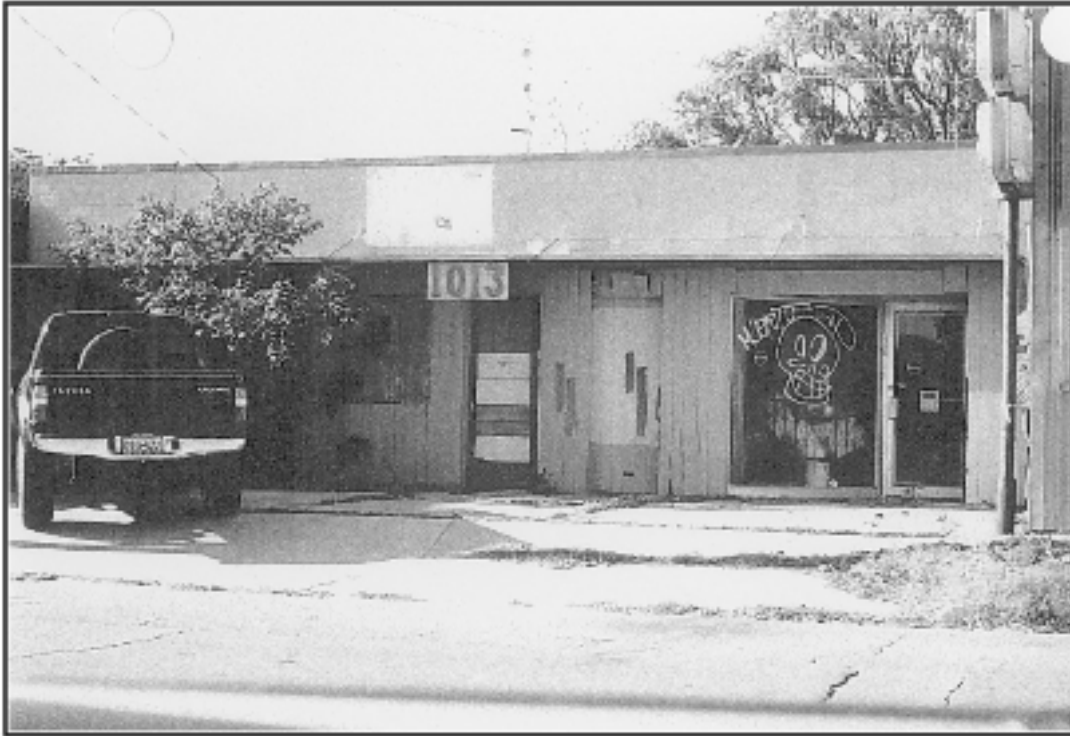
Figure 2-19. Historic Resource #18 located on Avenue B (southeast façade).

Historic Resource #18 is located at 1013 Avenue B and was constructed ca. 1945 (Figure 2-19). The deed search of the property revealed that the building would have been built when L. K. and Elma Hamm owned the property (BCC 2006t). The structure is a single-story commercial building with a rectangular plan. It is clad with grooved plywood panels over unknown original material. It has an aluminum and glass storefront that is recessed from the front façade.

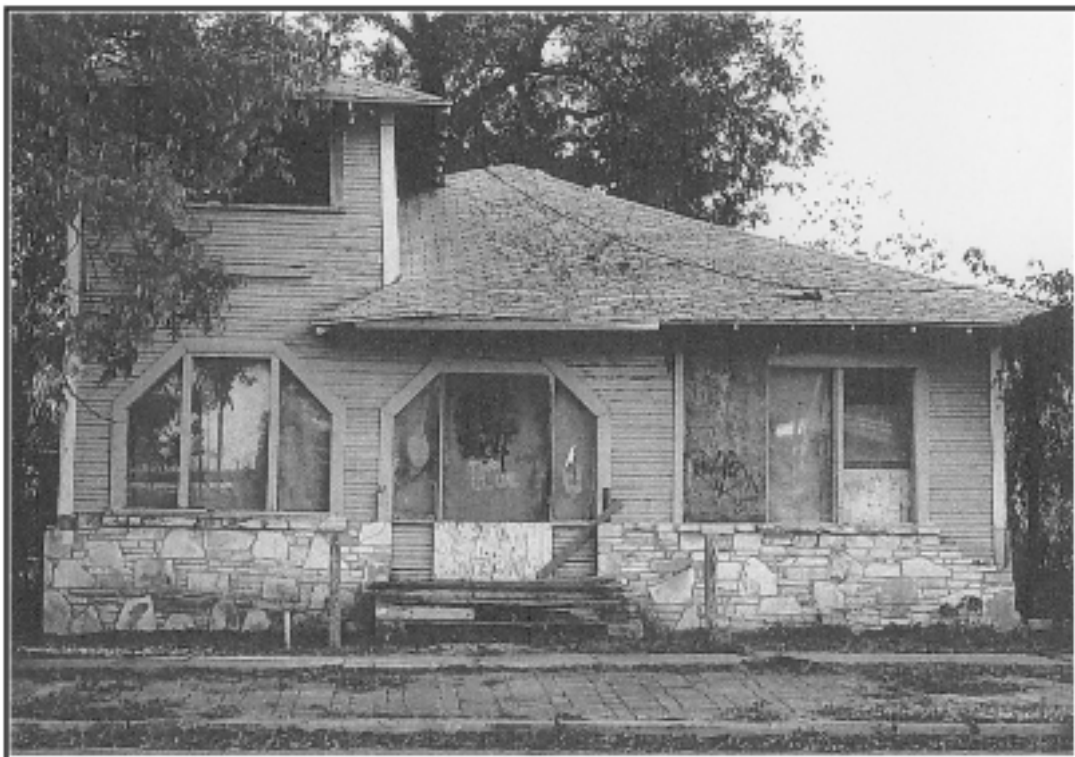
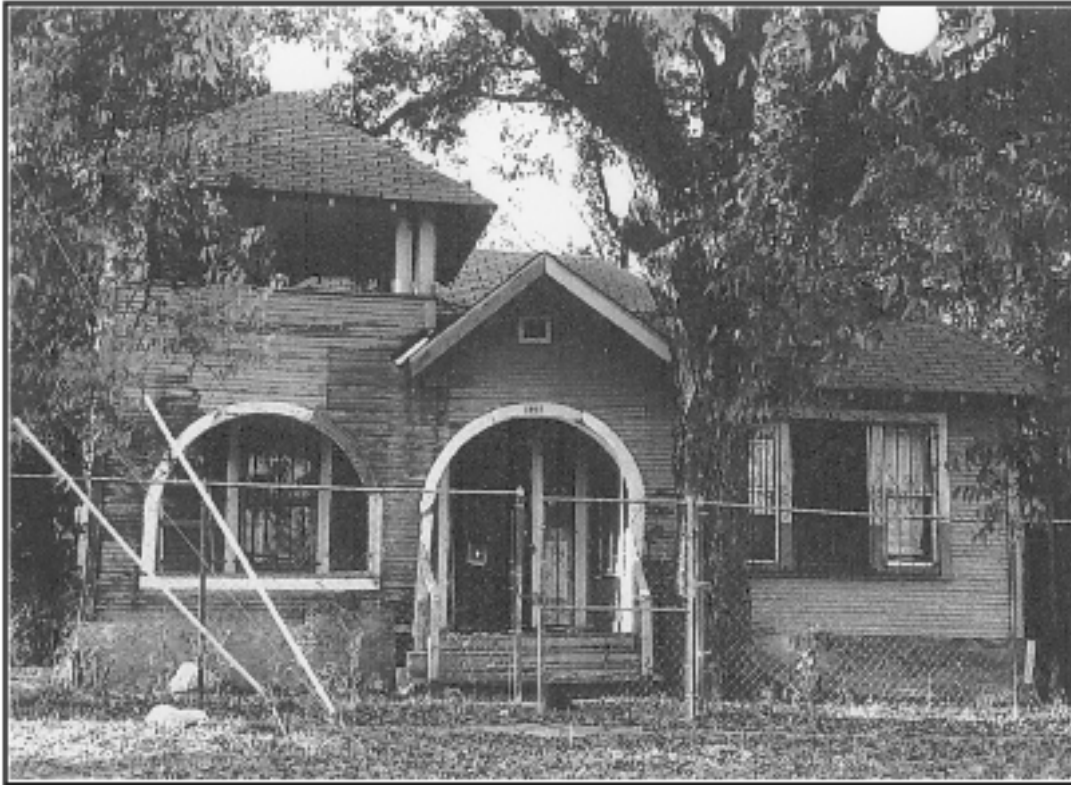
Figure 2-21. Historic Resource #20 located on Avenue B (southeast façade).

Historic Resource #20 is located at 1005 Avenue B and was constructed ca. 1900 (Figure 2-21). Historic Resource #21 is located at 1001 Avenue B and was also constructed ca. 1900 (Figure 2-22). It appears that Historic Resources #20 and #21 were owned by Francis Smith prior to 1901 (BCC 2006v). David Logan was the property owner from 1901 to 1910 (BCC 2006v). Both houses have a single-story, square plan with a front porch and a two-story tower on the left side. The architectural elements are executed in a Craftsman bungalow style. This style was prevalent during the early 1900s. The buildings are wood-framed with pier and beam foundations. The façades are composed of wood drop siding. There is an imitation limestone veneer approximately 3.3 ft. high.

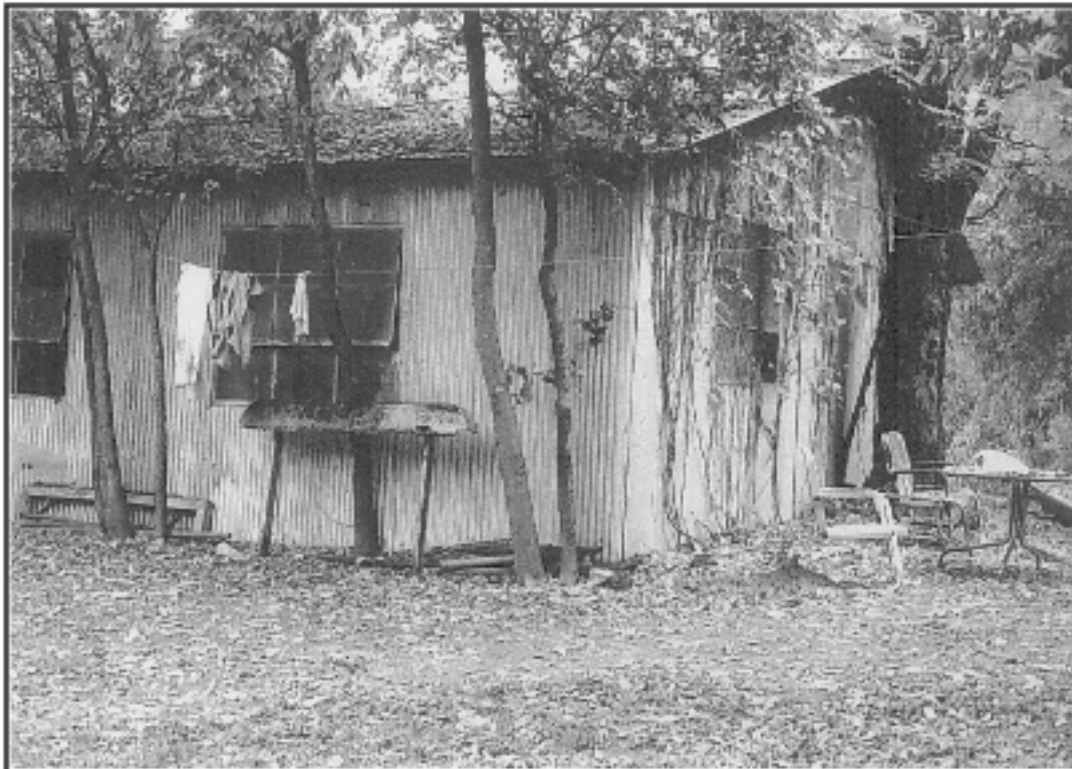
Figure 2-23. Historic Resource #26 located on Avenue A (southeast façade).

Historic Resource #26 is located at 201 Avenue A and was constructed ca. 1945 (Figure 2-23). The property has three freestanding buildings arranged in a clustered pattern. In the Bexar County Appraisal District records, two improvements were recorded: One improvement was added in 1945 and is described as a wood warehouse; the other improvement was dated 1955 and consisted of a masonry warehouse. The Mainstreet Architects inventory form for this historic resource only included the metal buildings, not the masonry or wooden resources. In 1945, the property belonged to Dabney Petty (BCC 2006w). The property was conveyed to Earl Denson in 1947 (BCC 2006x) and thereafter to F. P. Elizondo (BCC 2006y). Elizondo may have been the owner of the property in 1955 when the masonry warehouse was constructed.

Building #1 is a single-story, rectangular metal building with a corrugated metal gable roof with a slight overhang. It has a fixed metal frame with six- and nine-pane sash windows and large sliding wood doors. Building #2 is a metal rectangular mobile home. Building #3 is a metal Quonset hut with a block false front and an arched, corrugated metal roof and elevated concrete slab foundation.

There is a dock area with a large overhead wooden door with visors. Currently, the property is used for storage but was used as a bookbinding facility in the past.

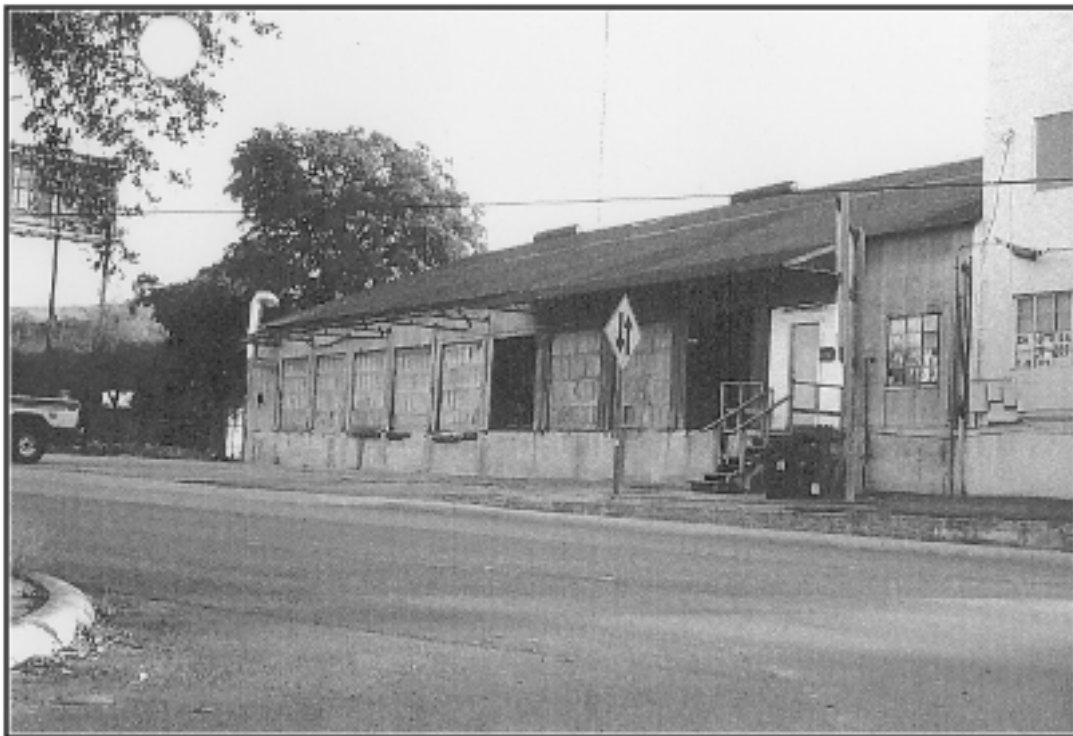
Figure 2-24. Historic Resource #32 located on East Quincy Street (north façade).

Historic Resource #32 is located at 1126 E. Quincy Street and was constructed ca. 1945 (Figure 2-24). The property was owned by Julia M. Brogden until 1948 when she sold the property to D. R. Semmes (BCC 2006z). Currently, the building serves as an auto repair shop. There are four freestanding buildings arranged in an "L" configuration on the property. Building #1 is a two-story, rectangular brick building. The building has a metal frame, industrial windows (eight and 16 pane), wood doors and an elevated concrete slab foundation. Building #2 is a single-story, rectangular metal building on an elevated concrete slab foundation used as a loading dock. It has a corrugated metal gable roof with overhangs. Building #3 is a small, single-story, rectangular metal building with a corrugated metal gable roof. Building #4 is a small, rectangular, metal-clad mobile office with a corrugated metal gable roof, metal doors, and windows.

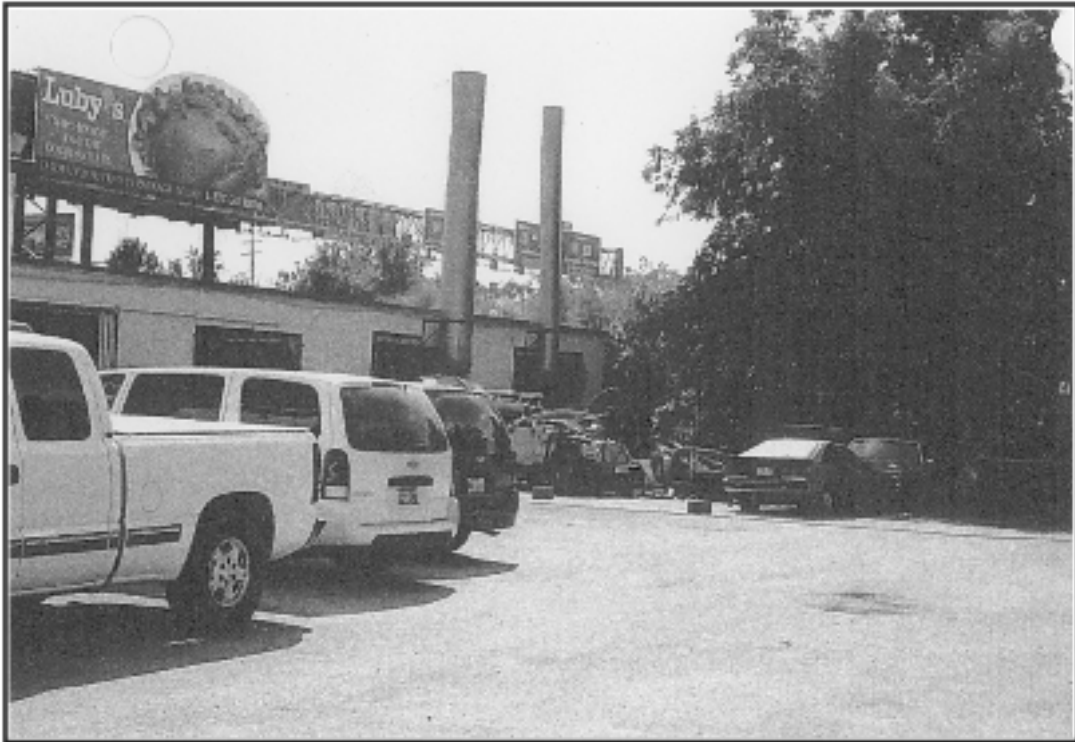
Figure 2-26. Historic Resource #35 located on Newell Avenue (west façade).

Historic Resource #35 is located at 212 Newell Avenue and was constructed ca. 1945 (Figure 2-26). Mitchell Motors, Inc. sold the property to Elwood Cluck in 1978 (BCC 2006aa). The Yellow Cab and Baggage Company purchased the property in May of 1948 from J. M. and Emma Harris. J. M. Harris contracted with G. W. Mitchell in April of 1940 to build a structure on the premises (BCC 2006bb). This historic resource is a single-story building composed of concrete block with a flat roof and concrete foundation. There are variety of window types, configurations and materials (steel, aluminum and wood). The building is currently used as an auto repair shop but was a taxicab company in the past.

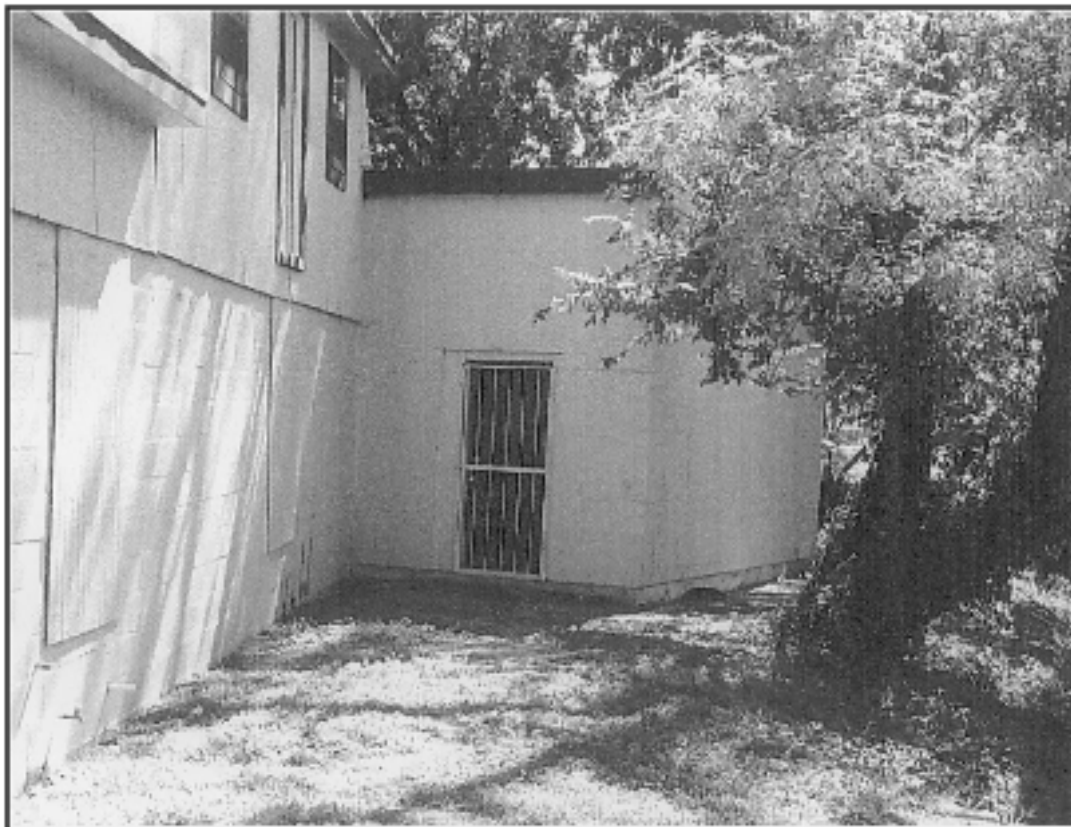
Figure 2-28. *Historic Resource #42 located on Grayson Street (west façade).*

Historic Resource #42 is located at 100 Grayson Street and was constructed ca. 1945 (Figure 2-28). The deed for this property was only traced back to 1994 when it was owned by William W. Atwell. Dead records prior to 1994 were not located. This historic resource is a two-story building that has a “T” plan configuration, described in three zones. At the north façade is a rectangular, single-story building with a metal low-pitch roof (Zone 1). Zone 2 is a half wood, two-story building with a slightly sloped roof of corrugated metal. The southern end (Zone 3) is a single-story block structure that forms the “T” of the building. The building is currently vacant.

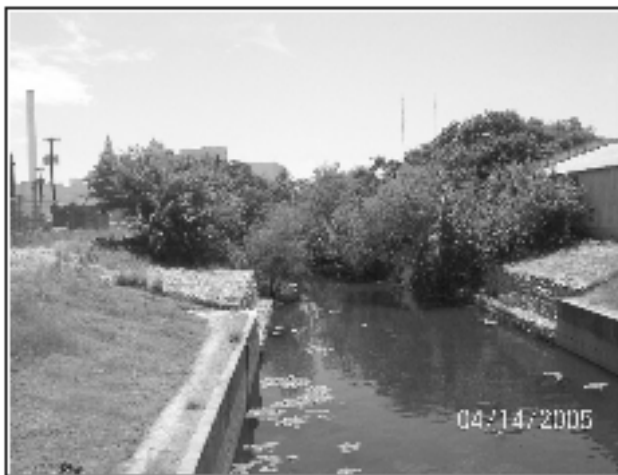
Figure 4-1. Concrete embankments near the northern end of project area, looking south from E. Josephine Street Bridge.

Portions of the project ROW have been heavily impacted by modern alterations of the banks of the river including concrete embankments (Figure 4-1), bridge construction (Figure 4-2), and landscape-related sculpting (Figure 4-3). The reconnaissance indicated that there are two river channel profiles predominate within the project area. The most common channel profile is characterized by narrow stretches of high banks just inside of the project ROW dropping rapidly and steeply to lower terraces sitting 4–6 ft. above water level immediately adjacent the active channel of the river (Figure 4-4). While the active, water-carrying channel is usually 8–10 ft. in width, the adjacent, lower terrace varies from 5–15 ft. on each bank of the stream. The higher, upper terrace sits 8–10 ft. above the lower terrace and only in a few places is it more than 3–6 ft. wide along the project ROW.

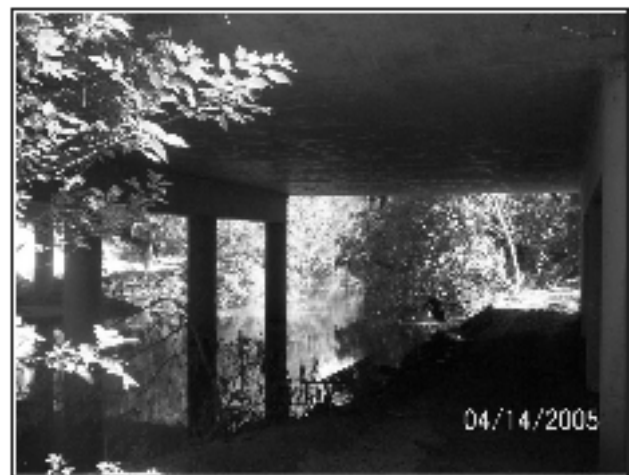
Figure 4-2. West bank of San Antonio River under the Newell Street Bridge.

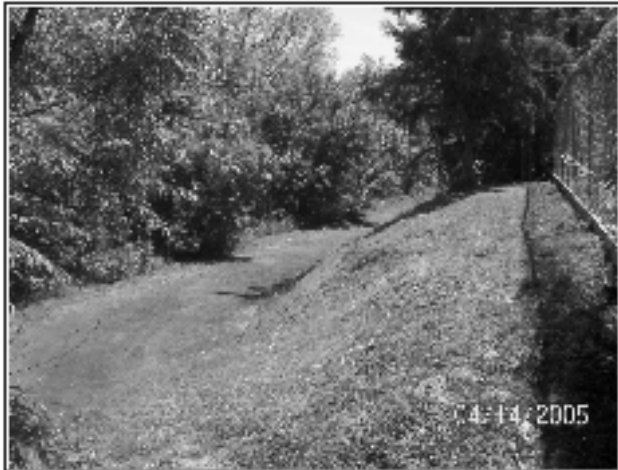
Figure 4-3. Cleared portion of west bank of the San Antonio River near the IH-35 overpass.

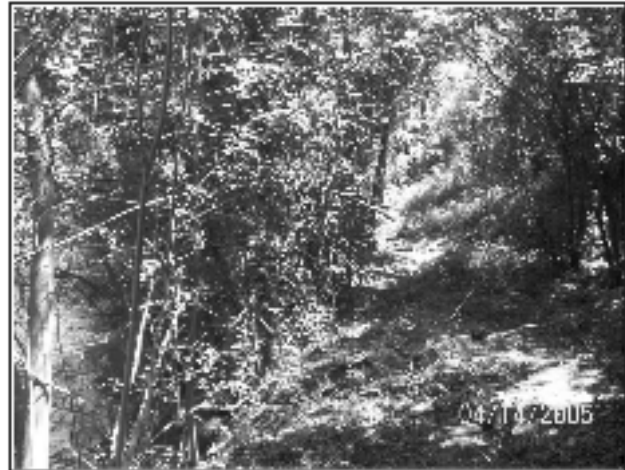
Figure 4-4. Lower terrace immediately adjacent to active channel of the San Antonio River.

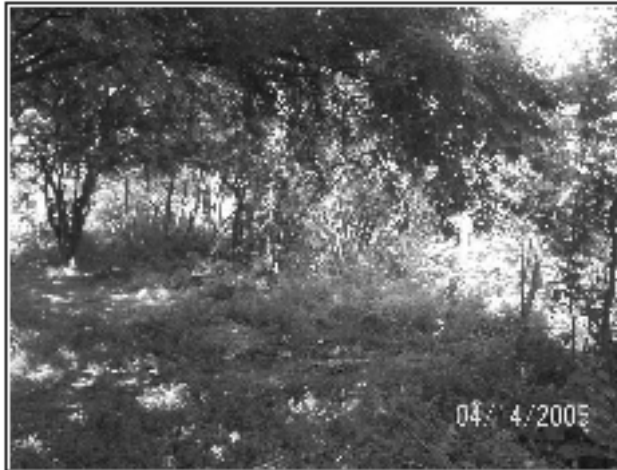
Figure 4-5. Northern segment of the upper terrace available for backhoe trenching along project area just east of Schiller Street.

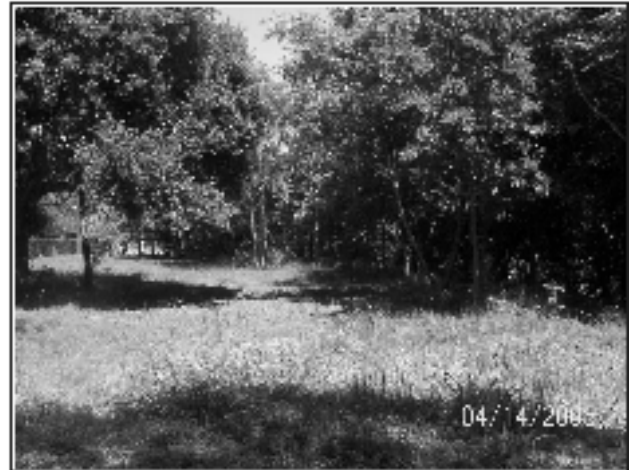
Figure 4-6. Segment of upper terrace available for backhoe trenching just south of W. Jones Avenue Bridge.

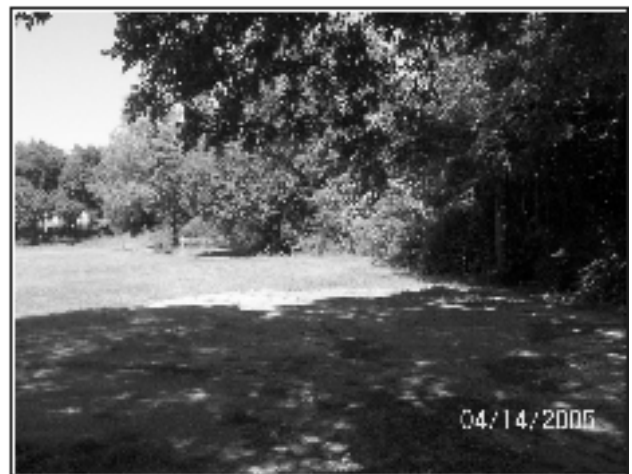
Figure 4-7. Southern segment of upper terrace on west bank of river, just north of Ninth Street Bridge.

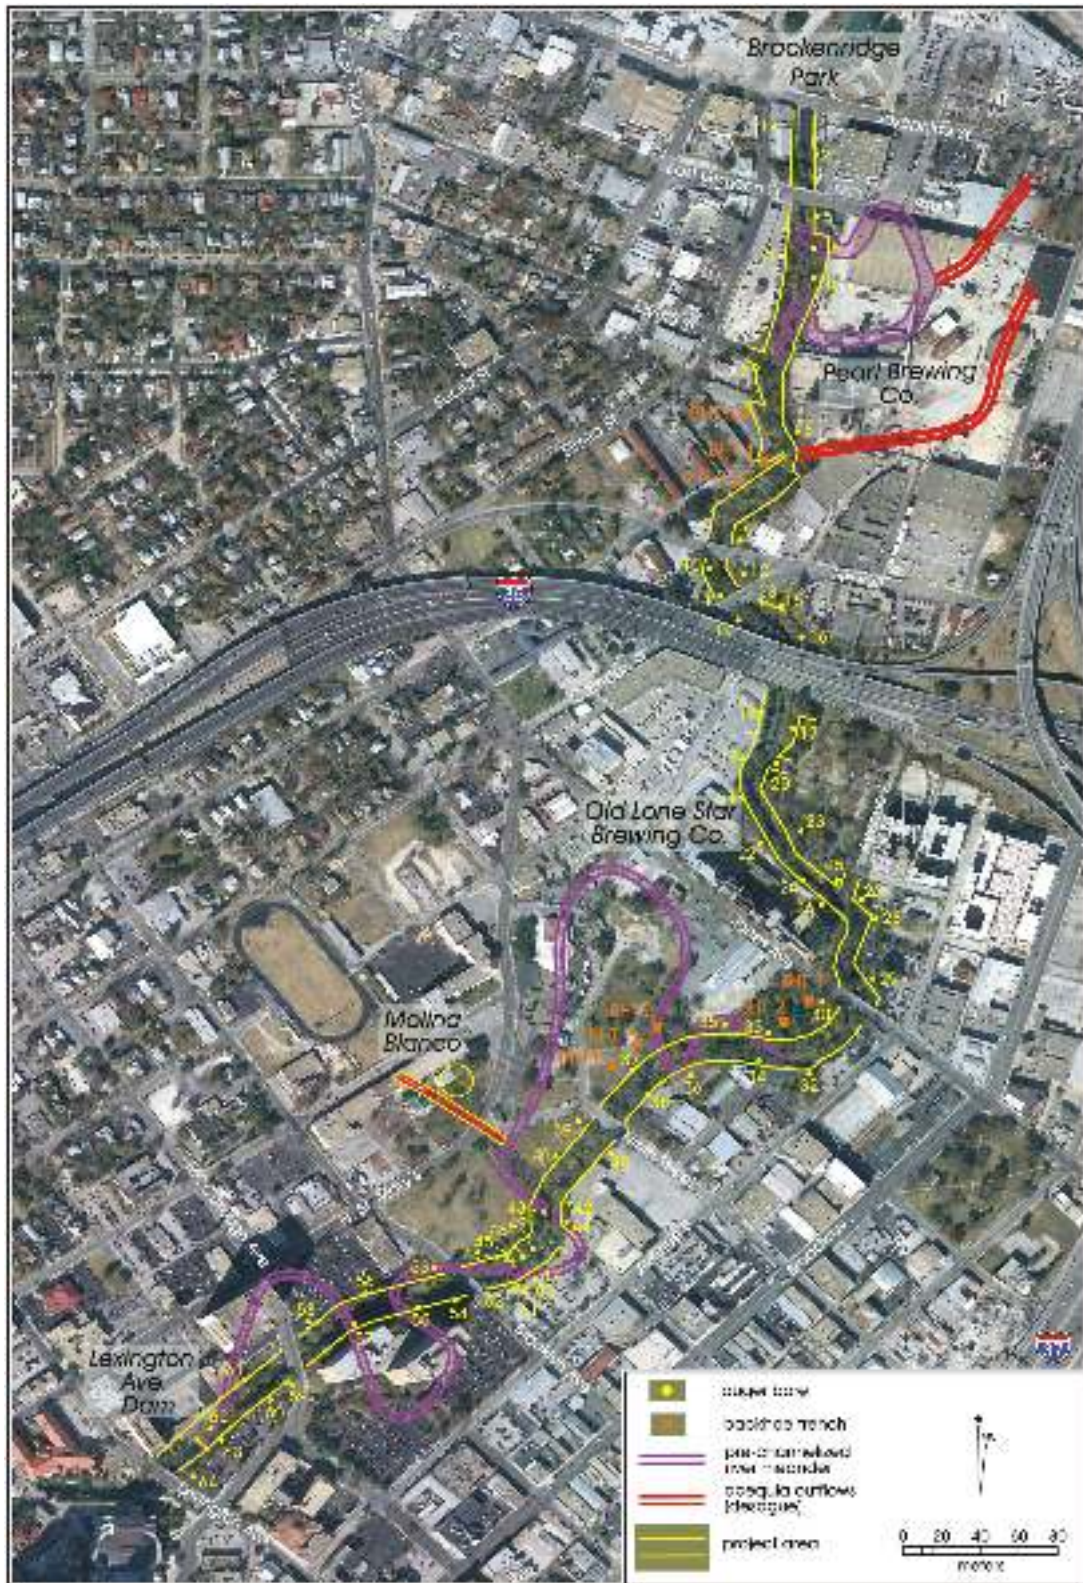
Figure 4-8. Locations of backhoe trenches and auger bores in the project area.

The present investigators examined stratigraphic profiles at three locations, in a total of eight backhoe trenches (Figure 4-8). Seven of the trenches exposed as much as 2.6 m of historical and modern fill materials, but no natural deposits. Pre-modern, non-anthropogenic strata were found in only one trench, beneath 65 cm of fill. S. C. Caran described the local geomorphic setting and stratigraphy of each trench profile and collected a limited number of sediment samples for laboratory analyses. C. A. Speer recovered and identified a number of historical and modern artifacts and collected selected items for further study and use in the teaching collection at the Center for Archaeological Research. All profiles and their landscape contexts were photographed.

Arias and Associates, Inc. drilled 63 boreholes (B-1 through B-30 and B-32 through B-64) throughout the Museum Reach, on both the right and left banks of the San Antonio River (Bacon 2005). In general, the boreholes were numbered from north to south, i.e., downstream. Maximum

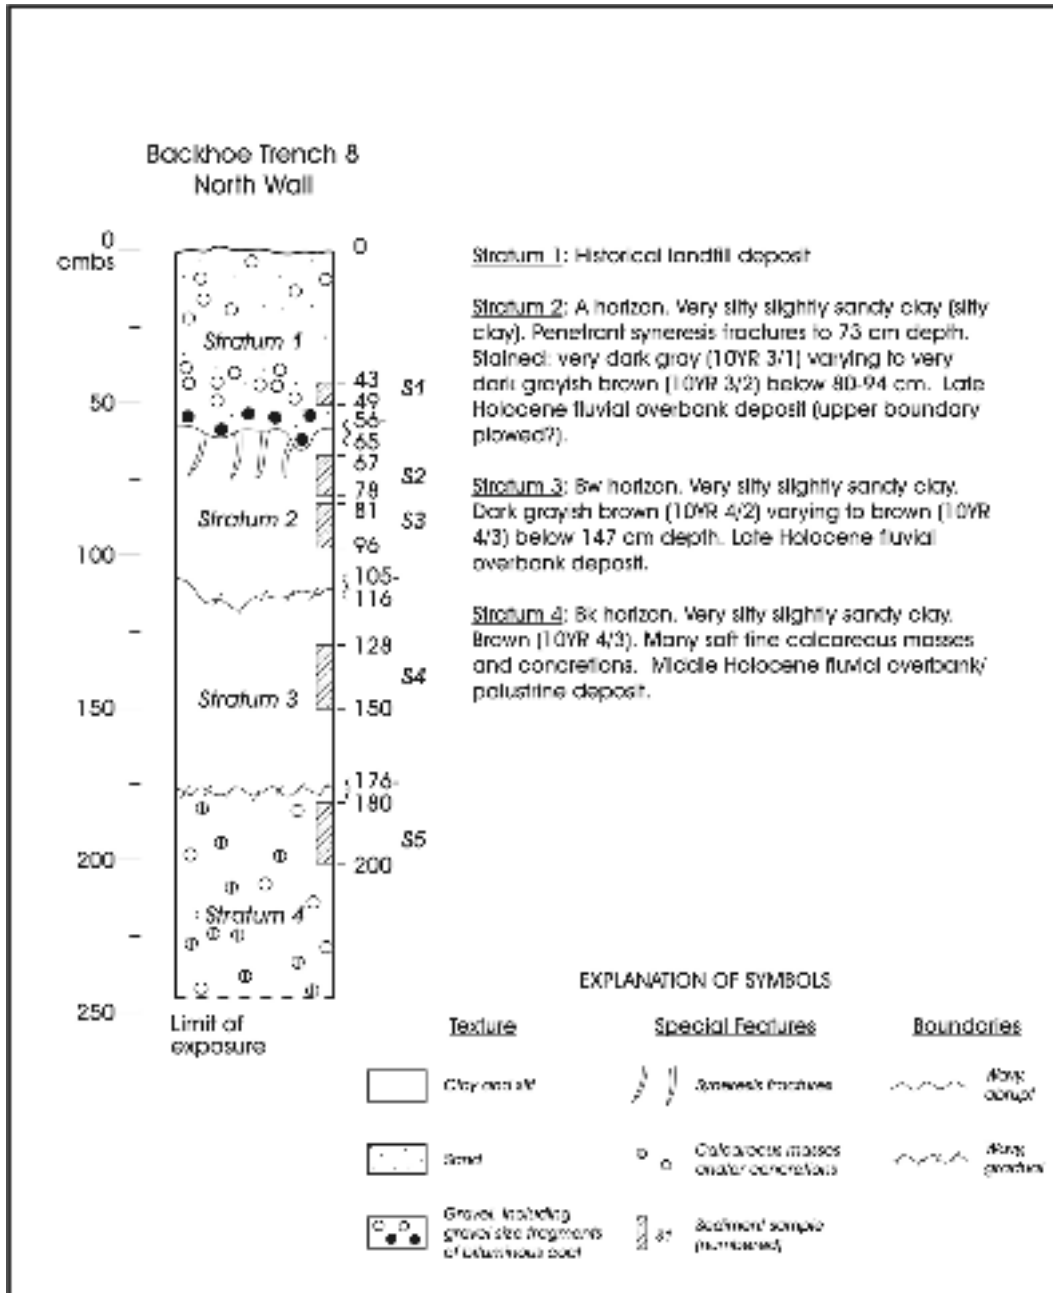
Figure 4-9. Stratigraphic profile exposed in northern wall of Backhoe Trench 8 (see Tables A-1, A-2, and B-1).
