Intensive Pedestrian Survey along the Banks of the San Antonio River: Museum “Urban” Reach Section of the San Antonio River Improvements Project, Bexar County, Texas

by
Antonia L. Figueroa, Kristi M. Ulrich, S. Christopher Caran,
and Charles A. Speer

Texas Antiquities Permit No. 3852

Prepared by
Center for Archaeological Research
The University of Texas at San Antonio
Archaeological Report, No. 371

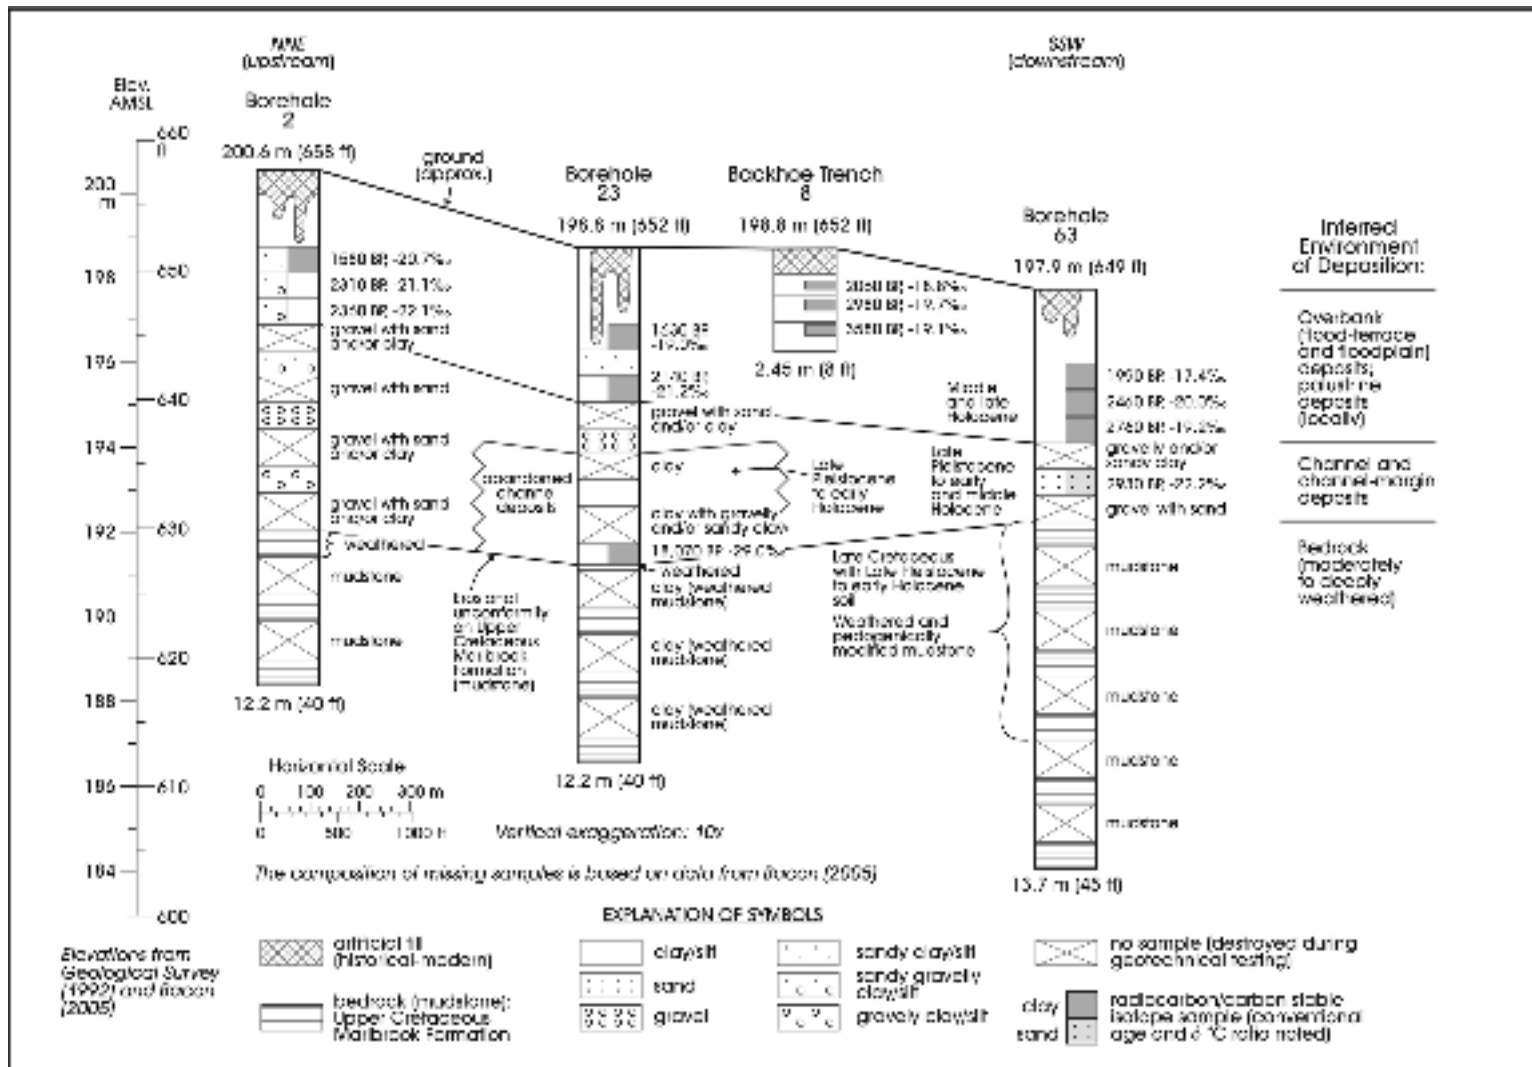
Figure 4-10. Down-valley stratigraphic cross-section showing representative sample profiles through Museum Reach.

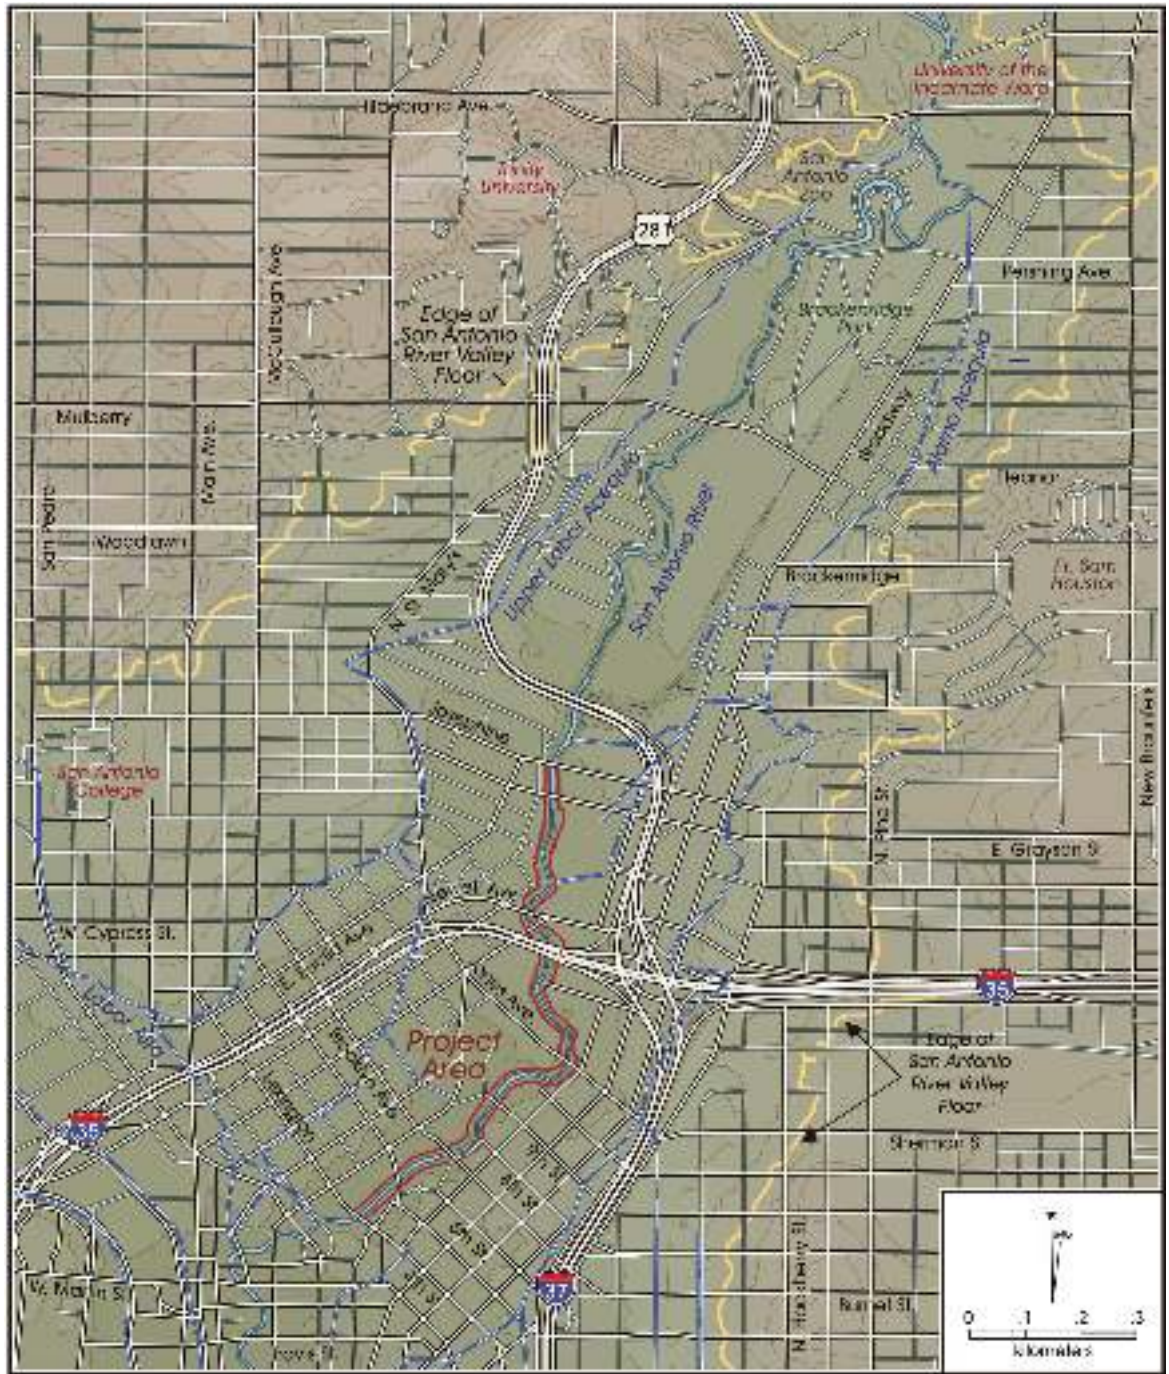
Figure 4-11. Road alignments reflecting Spanish water-distribution network.

The original alignment of the *acequias* corresponded to the natural topography and locations of arable lands within the valley. Once established, however, this essential water infrastructure defined or controlled property boundaries, roadways, and later, utilities. Even today, "the enduring impress of Spanish design on the American city" is clearly evident upon examination of any local street map (Cox 2005:viii). Roads outside of the valley floor primarily form a rectilinear grid corresponding to the cardinal directions. In contrast, the bottomlands are marked by a complex network of streets with orientations mirroring the former flow diversions, tailwater returns, and distributary ditches, which typically bifurcated in the downstream direction (Figure 4-11). For example, see the mostly unnamed roads between Josephine Street and Lexington Avenue on the right bank on the river in Figure 4-11. Although we were aware of the locations of some *acequias* and suspected others based on the road pattern, we were unable to find any direct evidence of them. The thickness of the historical fill prevented exposure of the natural landform and underlying deposits in all but one backhoe trench. In addition, repeated modification of the river channel has undoubtedly destroyed some canal segments and related structures. Nonetheless, future systematic investigation of the *acequias* could prove informative.

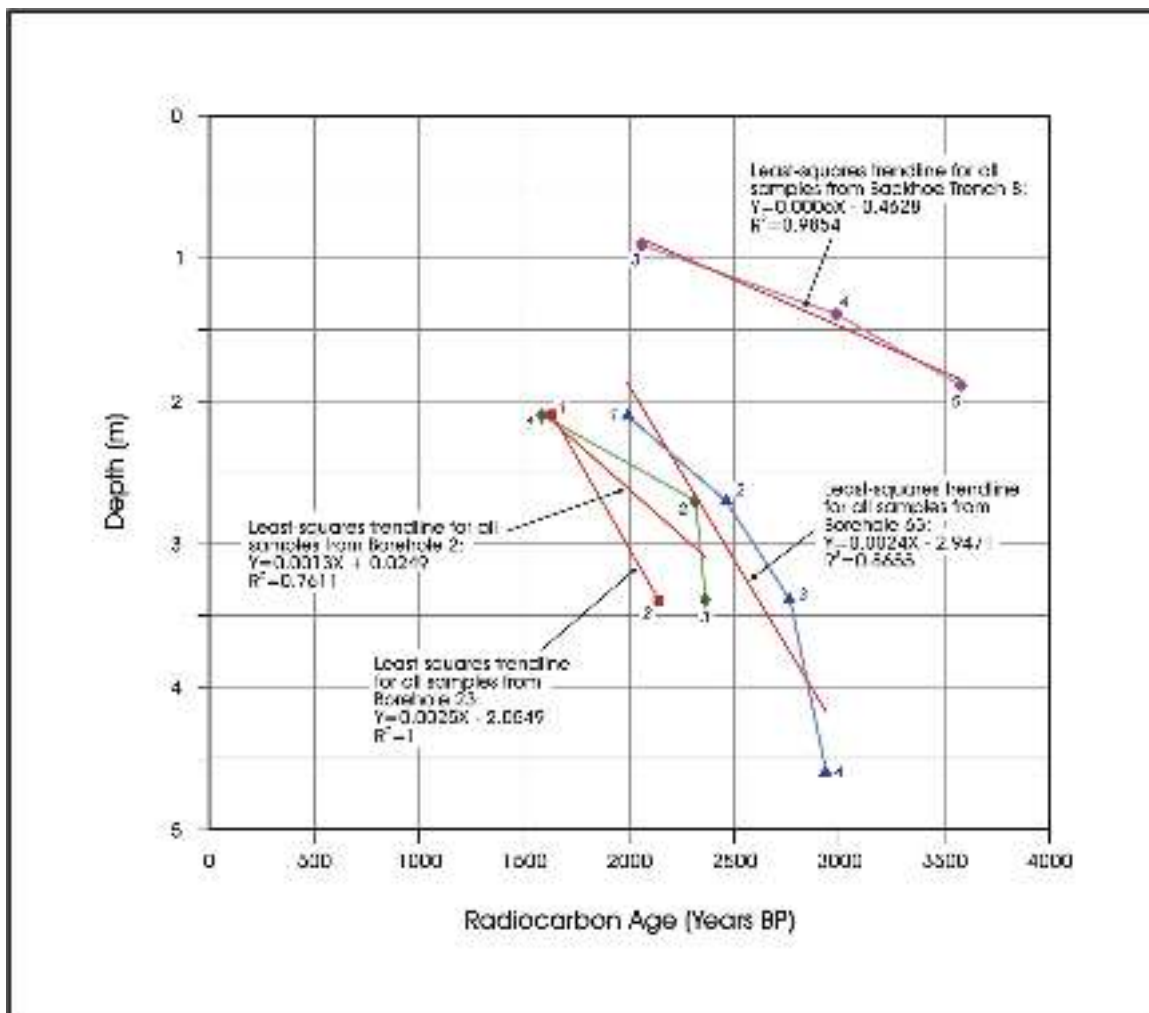
Figure 4-12. Age:depth relationships, Boreholes 2, 23, and 63, and Backhoe Trench 8.

radiocarbon age in years before present (YBP), and **a** is the Y-intercept. An additional, calculated factor, the coefficient of determination, **R²**, expresses the degree of scatter among the data, where 1.0 is perfect. The trendline for samples from B-23 (excluding Sample 3) had an R² of 1.0 because there were only two samples and two points always define a straight line. Samples from BHT8 had an R² of 0.9854, which is very close to 1.0. The Y-intercept for this line, -0.4628, is also nearly ideal, indicating continuous deposition at an essentially constant rate from 3580 years ago to the present (point 0.0, 0.0). Because the upper 65 cm of deposits at BHT8 are artificial fill (not covered by the trendline), the similarity between its average rate of aggradation and the natural rate of overbank sedimentation must be considered fortuitous. In this kind of graph, a negative Y-intercept and steep slope mean that the samples

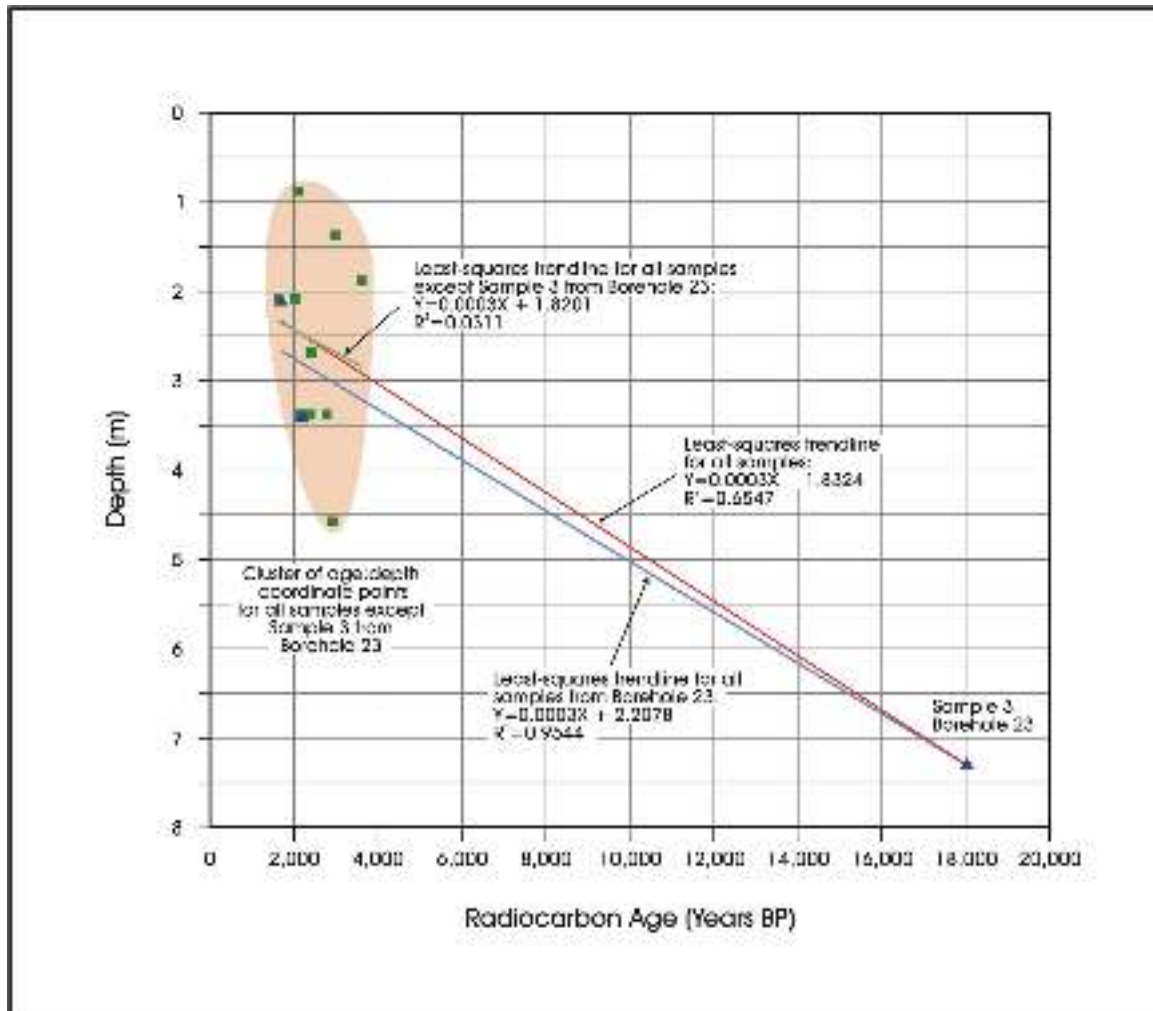
Figure 4-13. Age:depth relationships, all samples.

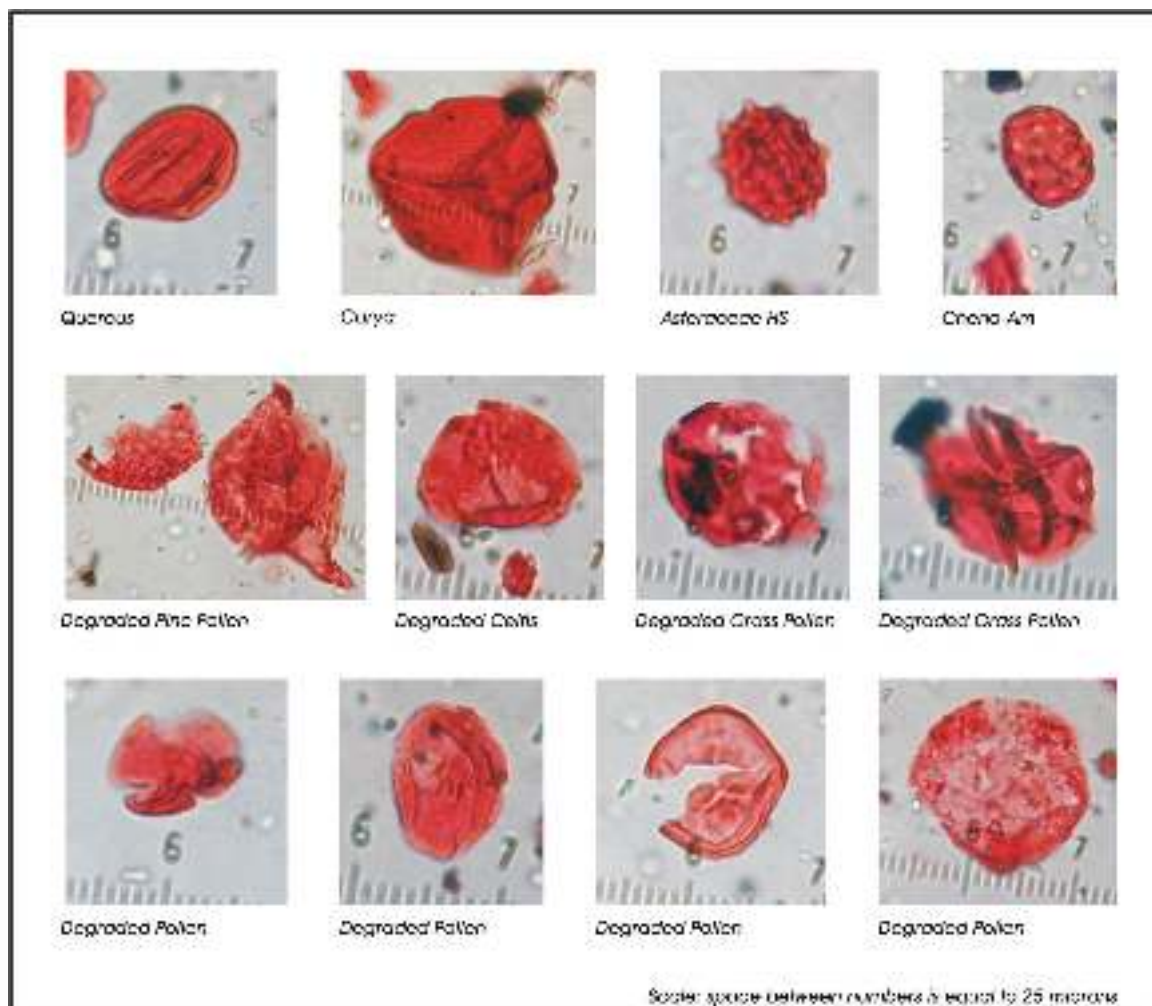
Figure C-1. Selected pollen types from site samples.
