**INTENSIVE LINEAR PEDESTRIAN SURVEY OF CALLAGHAN
ROAD BETWEEN INGRAM AND BANDERA ROADS
AND ALONG ZARZAMORA CREEK,
SAN ANTONIO, BEXAR COUNTY, TEXAS**

ARCHAEOLOGICAL REPORT, No. 372
CENTER FOR ARCHAEOLOGICAL RESEARCH
THE UNIVERSITY OF TEXAS AT SAN ANTONIO
©2007

Texas Antiquities Permit No. 4320

CSJ#s 0915-12-154 and 0915-12-266

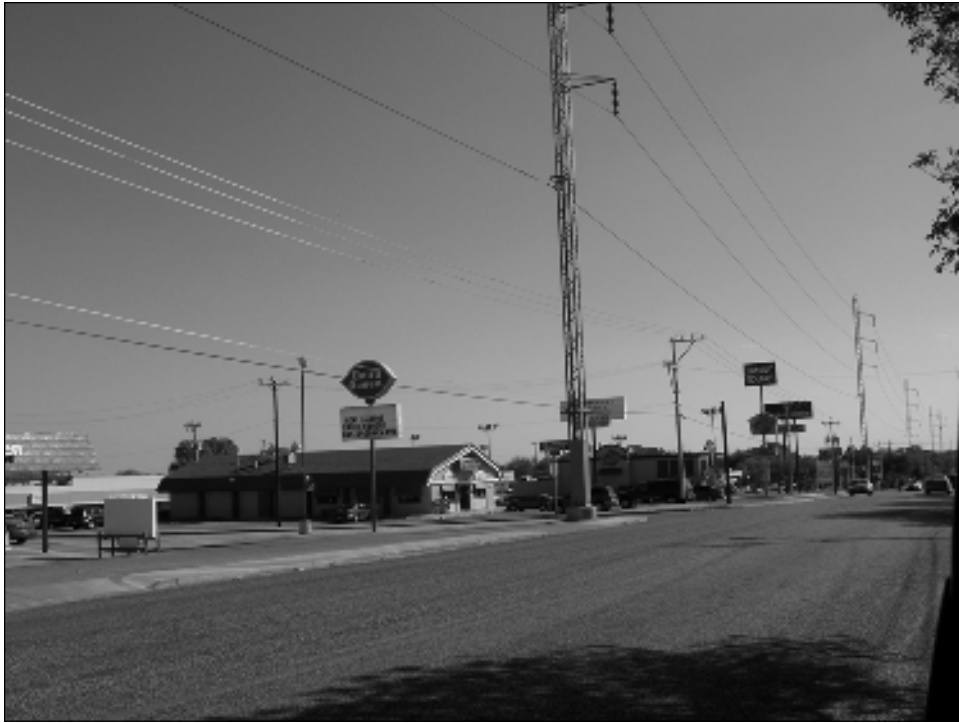
Figure 2. *Between Ingram and Oak Knoll, Callaghan Road is commercially developed and retains little potential for encountering intact cultural or buried deposits.*

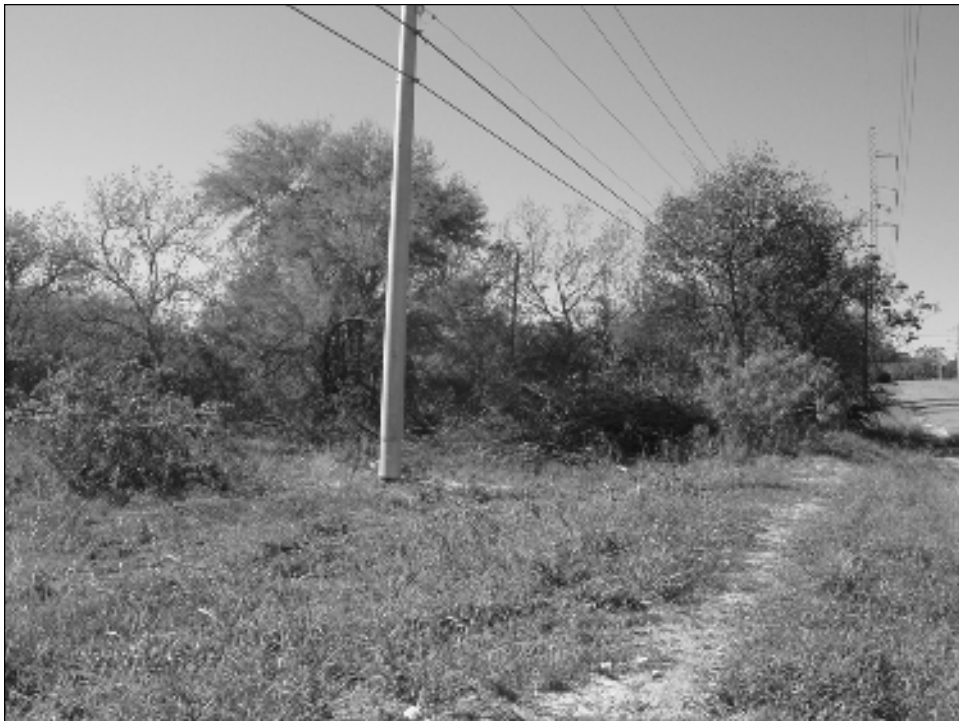
Figure 3. *Sections between Horseshoe Bend East and Oak Knoll have mixed commercial and residential development with more areas available for shovel testing and therefore a greater chance of encountering intact archaeological deposits exists.*

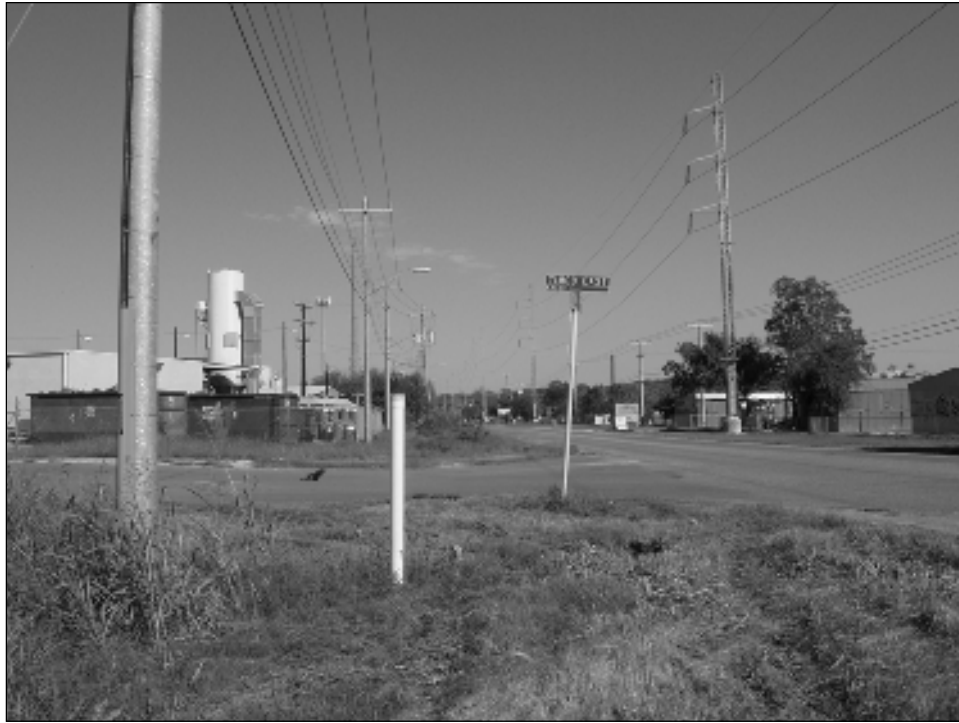
Figure 4. *The eastern end of the APE between Horseshoe Bend East and Bandera Roads has also seen commercial development and retains little potential for encountering intact archaeological deposits due to the amount of paved ground surface.*

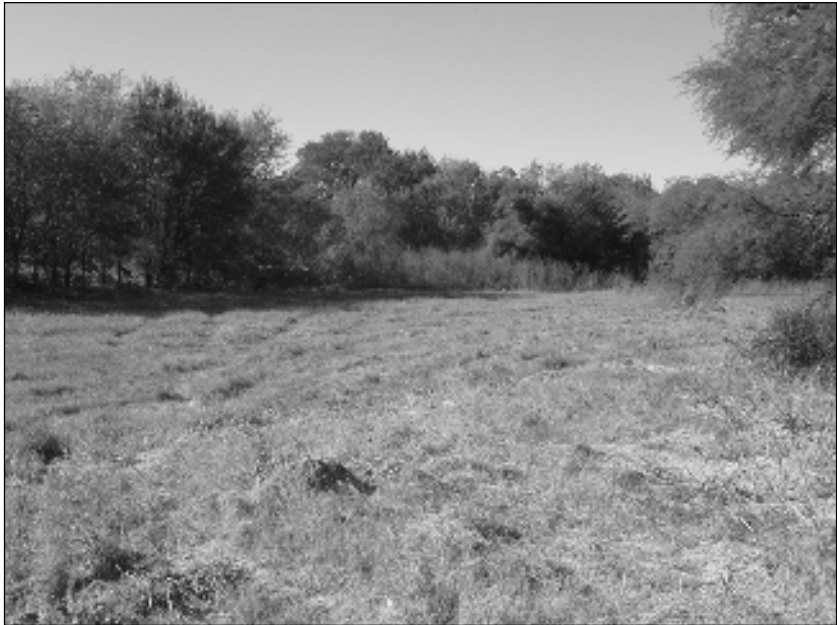
Figure 5. The APE includes areas east of the current location of Zarzamora Creek, encompassing 2.31 acres of floodplain and flood terrace that have the greatest potential for containing archeological deposits.

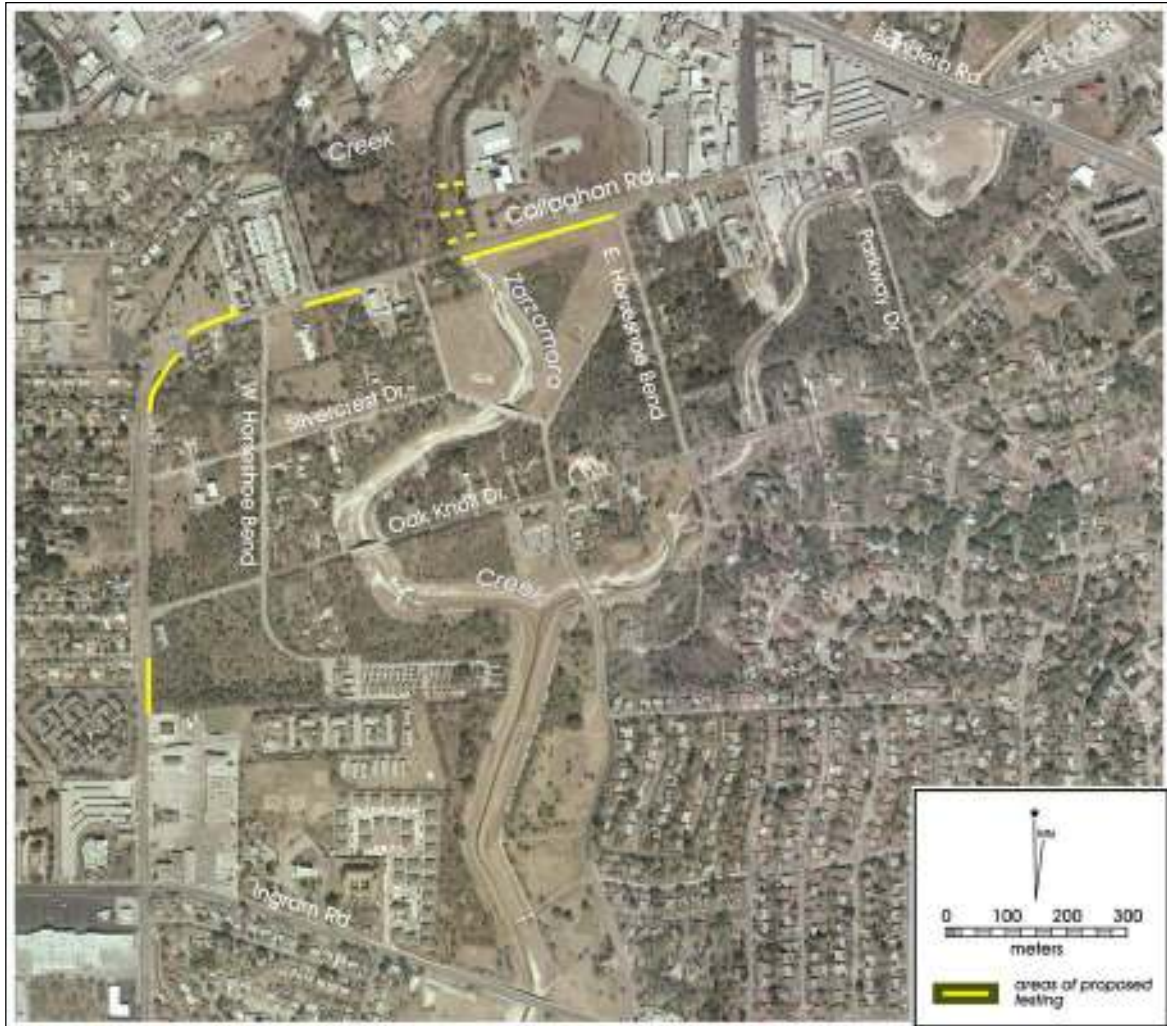
Figure 7. 2006 aerial photograph showing sections along Callaghan proposed for subsurface testing.

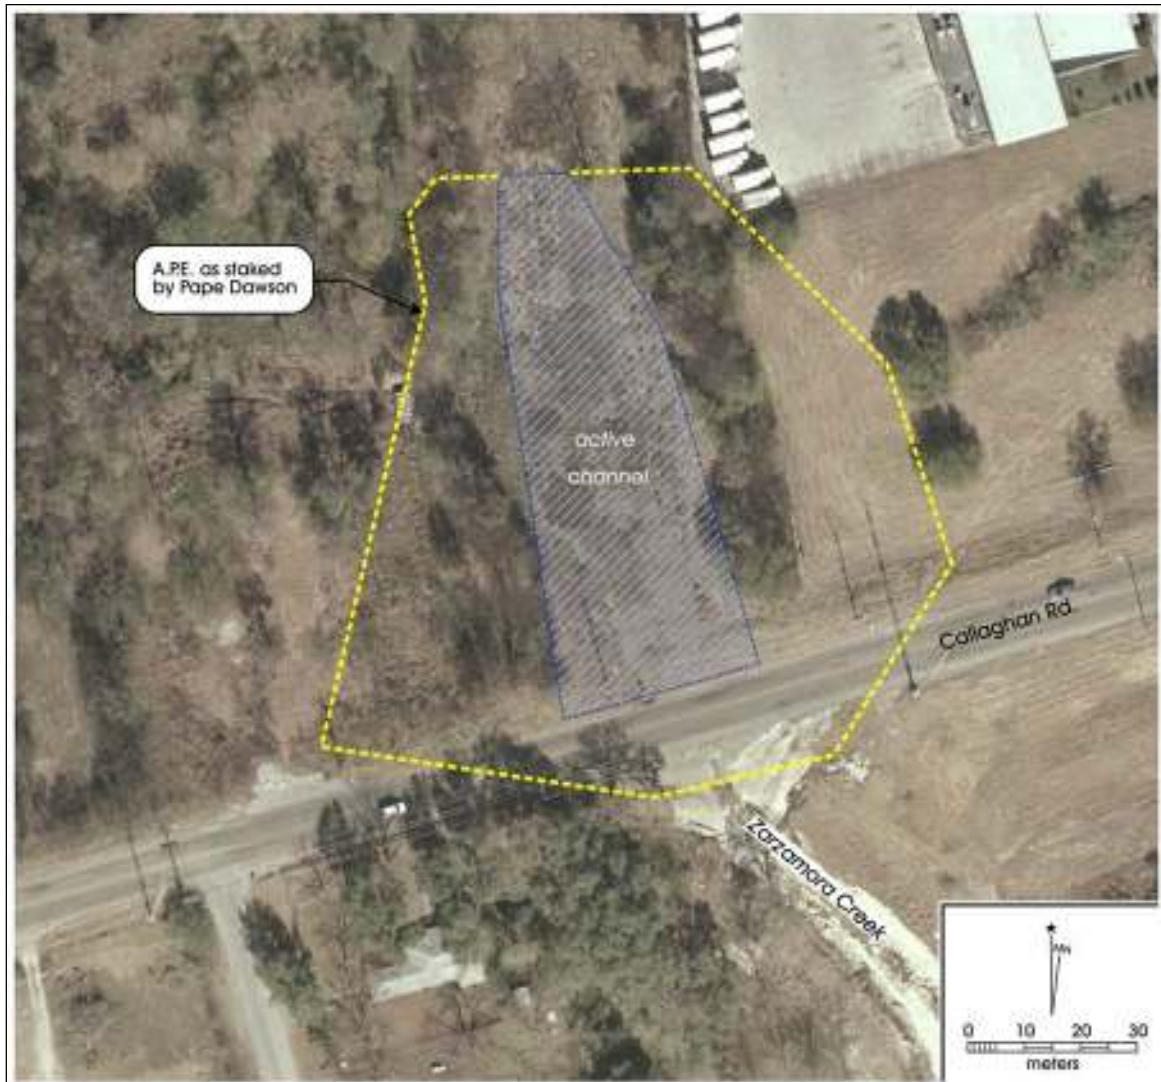
Figure 8. 2006 aerial photograph showing locations of the channel limits as staked by Pape Dawson, Inc. and the originally proposed areas for backhoe trenching.

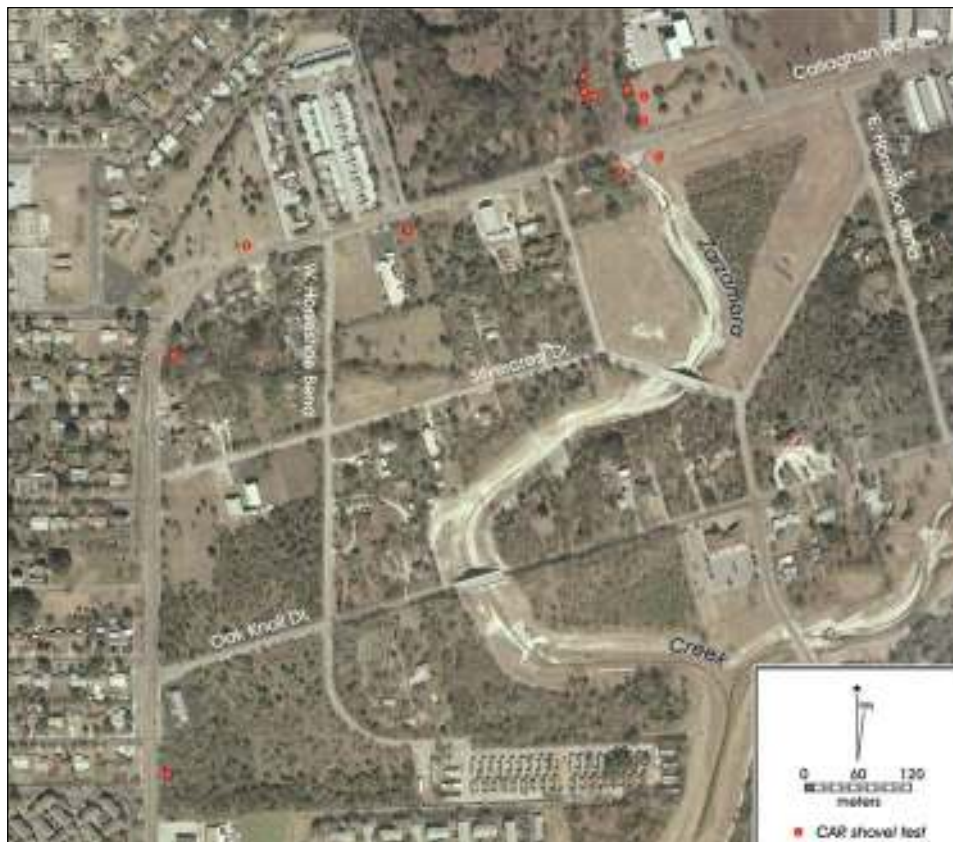
Subsurface shovel testing occurred in five locales along Callaghan Road (Figure 9). Two shovel tests were excavated between East Horseshoe Bend and Zarzamora Creek and one at each of the following locations: between West Horseshoe Bend and Woodside Drive, between Silvercrest

CAR personnel found no artifacts within the project area along Callaghan Road. Shovel tests revealed shallow bedrock between 30 and 62 cm below surface (cmbs) in the western end of the survey area and a construction dump at the eastern end (Figure 10). A large lot between East Horseshoe Bend and Zarzamora Creek proposed for shovel testing was actually quite disturbed upon closer examination. The eastern edge of the lot is paved and the entire lot littered with construction debris (Figure 11). The landform appears artificially raised. We assume that this is part of the construction dump documented previously by the City of San Antonio Environmental Services Department mentioned above. Our assessment, based on the landform, aerial photographs, and the degree of construction material scattered across the lot inside the APE, is that the construction dump spans 43,138 m² (10.73 acres). All attempts

Figure 9. 2006 aerial showing locations of shovel tests along Callaghan Road.

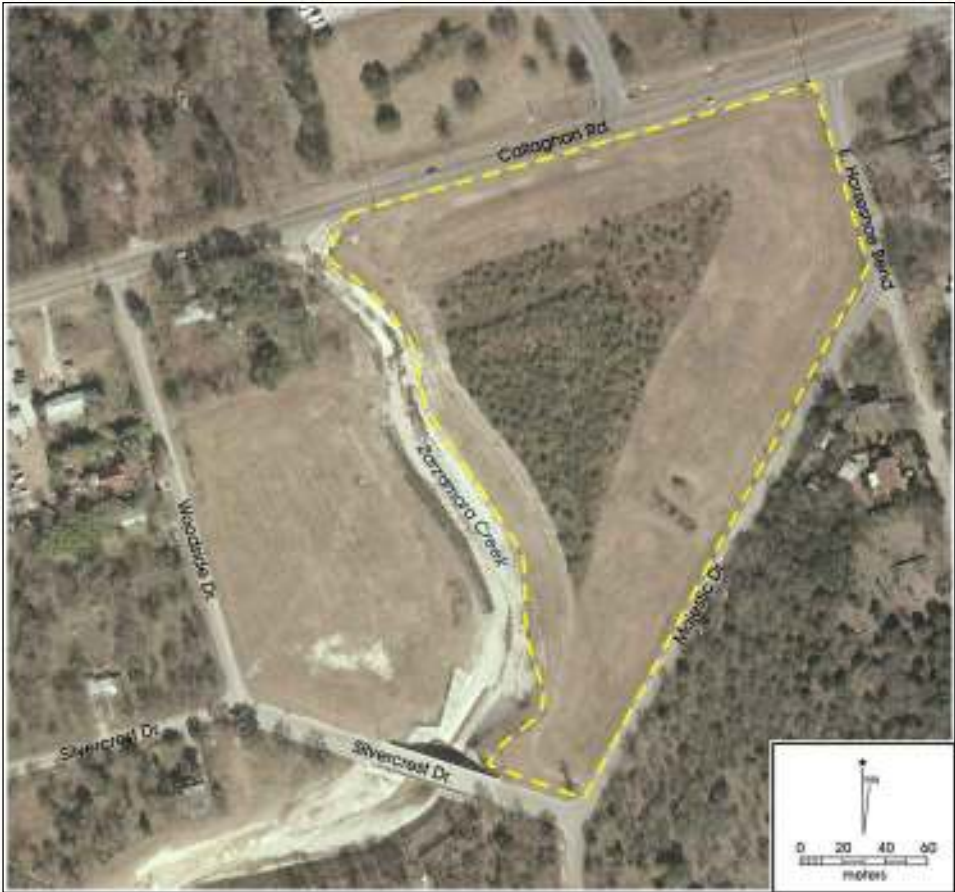
Figure 10. Aerial photograph showing the estimated location of construction dump south of Callaghan between Zarzamora Creek and Horseshoe Bend East.

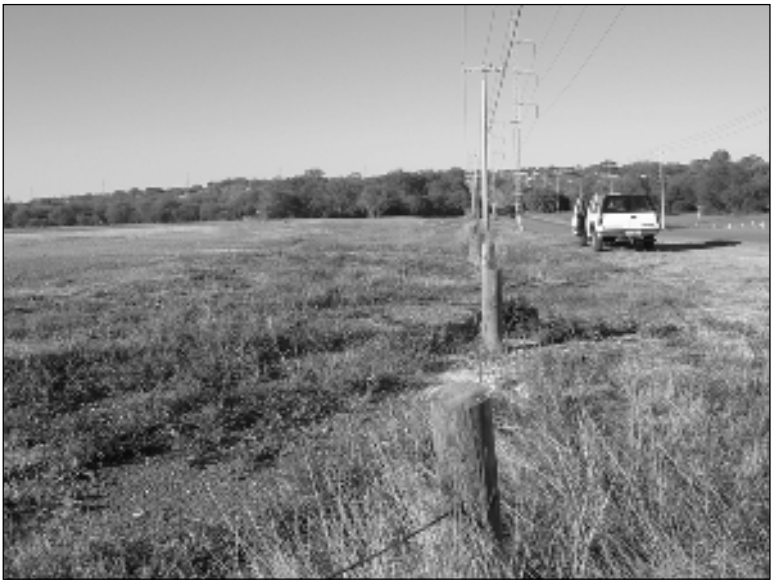
Figure 11. The eastern edge of the lot east of Zarzamora Creek south of Callaghan is paved and the entire lot is littered with construction debris.

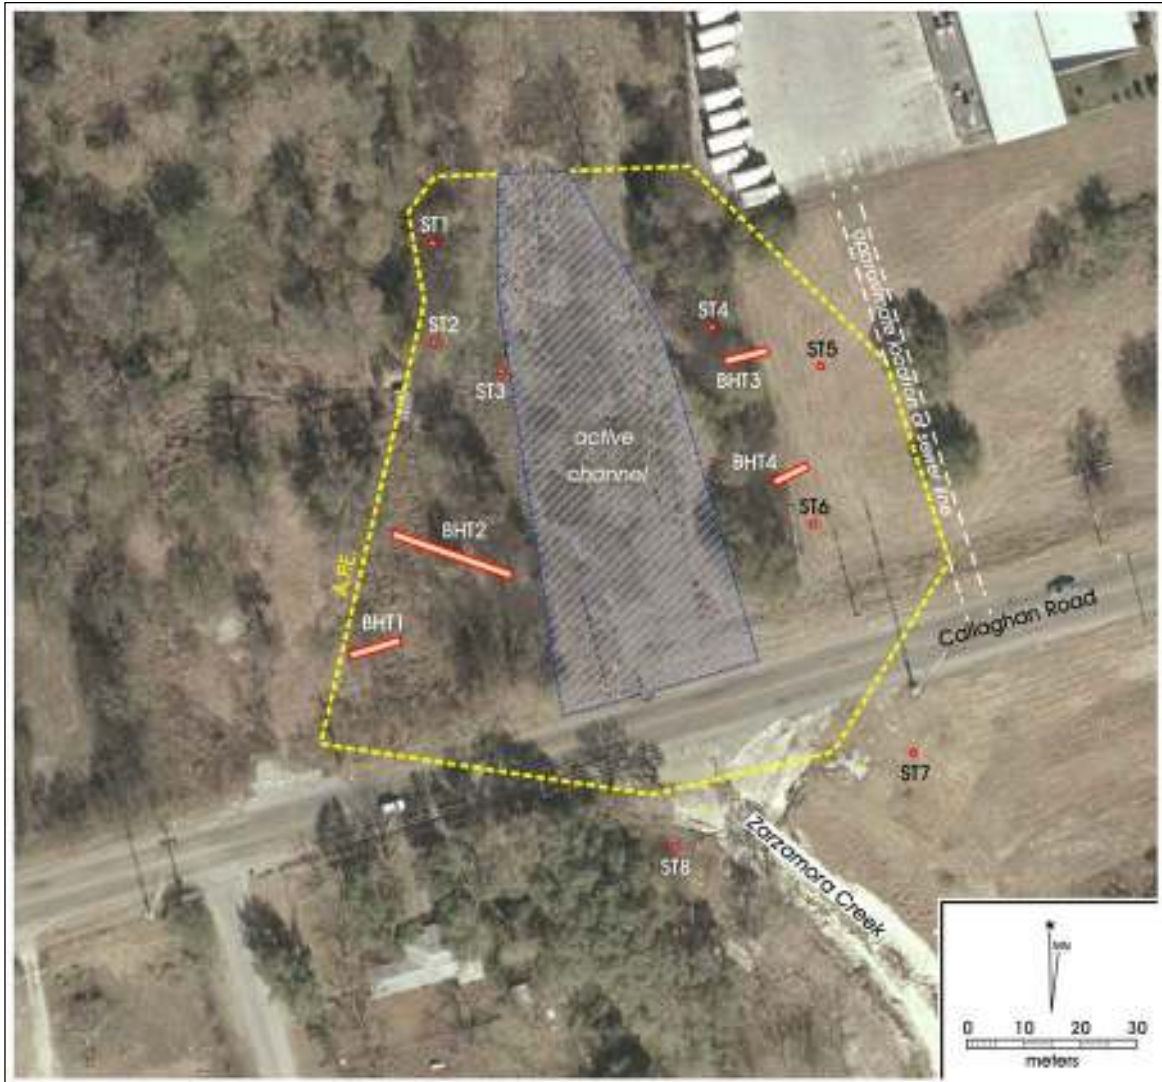
Excavations performed at Zarzamora Creek included four backhoe trenches and six shovel tests (Figure 12). The west side of this area is filled by construction dumps as previously

Figure 12. Aerial photograph showing the placement of backhoe trenches and shovel tests near Zarzamora Creek.

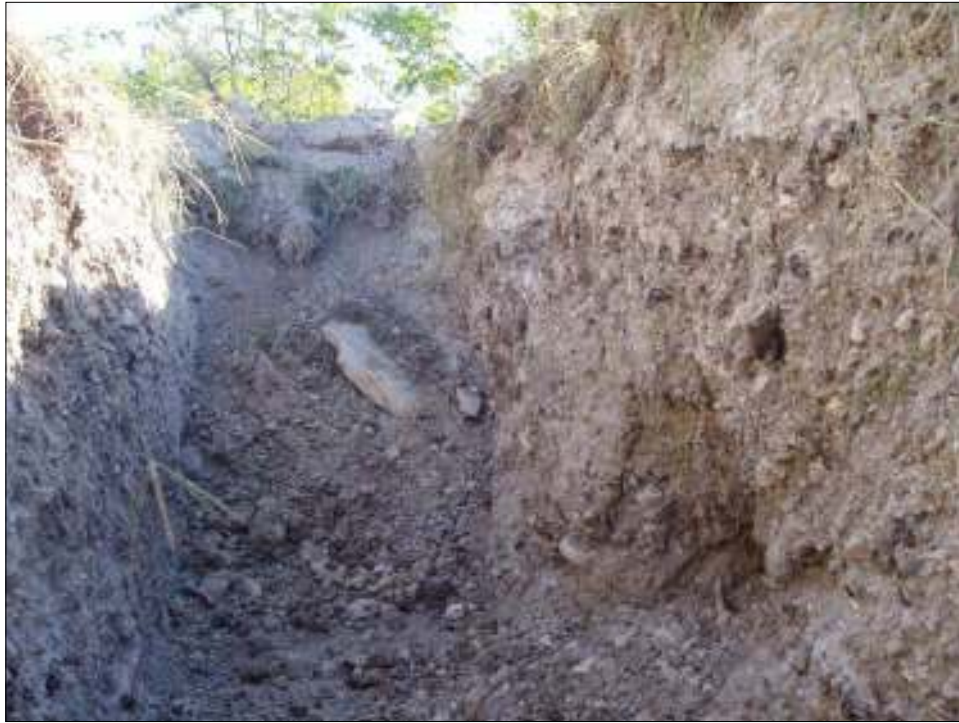
Backhoe Trench 1 was excavated on the west side of the creek on a rise above the current floodplain. Excavation occurred entirely within construction fill and revealed no significant archeological deposits (Figure 13). To determine the extent of this construction fill, we excavated a long trench from closer to the active channel west in an attempt to locate the eastern edge of the dump. Backhoe Trench 2 showed the most informative profile spanning 20 m long (Figure 14). The center of the trench exposed the following profile (Figure 15). The top 10 cm of silty loam over 60 cm of fill and gravels likely brought in by owners. Below the modern fill lies 80 cm of alluvial clay with creek gravels and pebbles. Creek channel

Figure 13. *Photograph of Trench 1 excavated entirely in construction fill.*

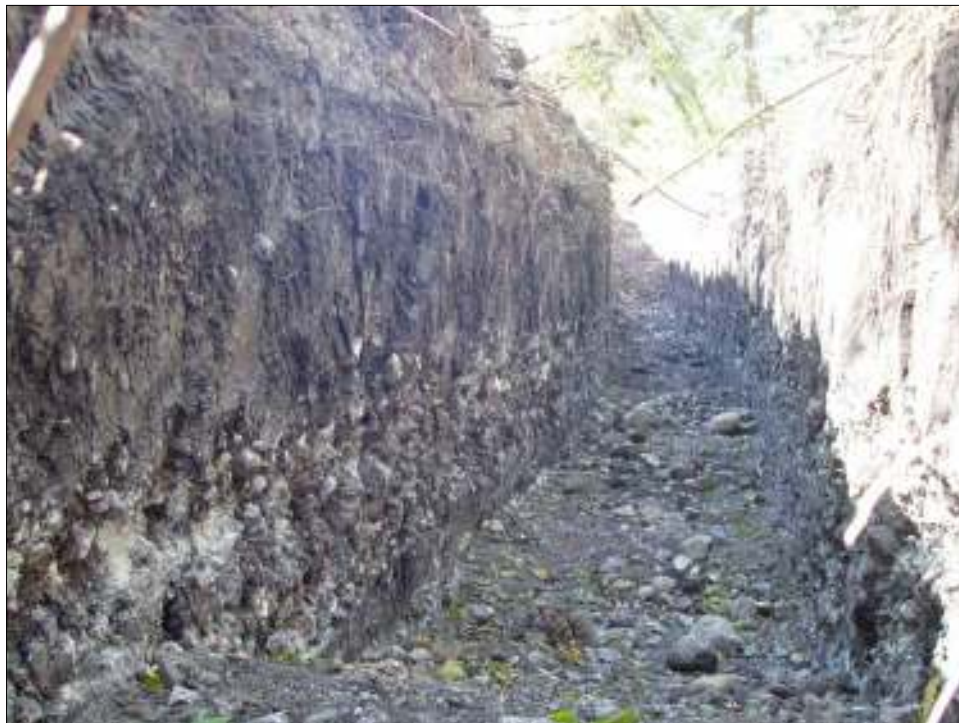
Figure 14. *Photograph of Backhoe Trench 2.*

Backhoe Trench 2 revealed the best profile and encountered alternating strata of silty clay and creek channel gravels up to 2.0 mbs. A single chipped stone tool was excavated from the trench and seen in the backdirt. This is a bifacially flaked expedient tool 15 cm in length with approximately 50 percent cortex remaining. The provenience of this tool is unknown and is the only example of cultural material in the trench. No other cultural items or archaeological deposits were seen in the profile wall. This artifact does not represent a significant archaeological deposit or exhibit any research potential. Fire-cracked rock was recorded from shovel tests on the west side of Zarzamora Creek but these were from the upper levels and associated with modern trash and construction materials. East of the creek, fire-cracked rock was seen above creek gravels in Backhoe Trench 4. This artifact was likely carried in with flood deposits and not in its primary location.

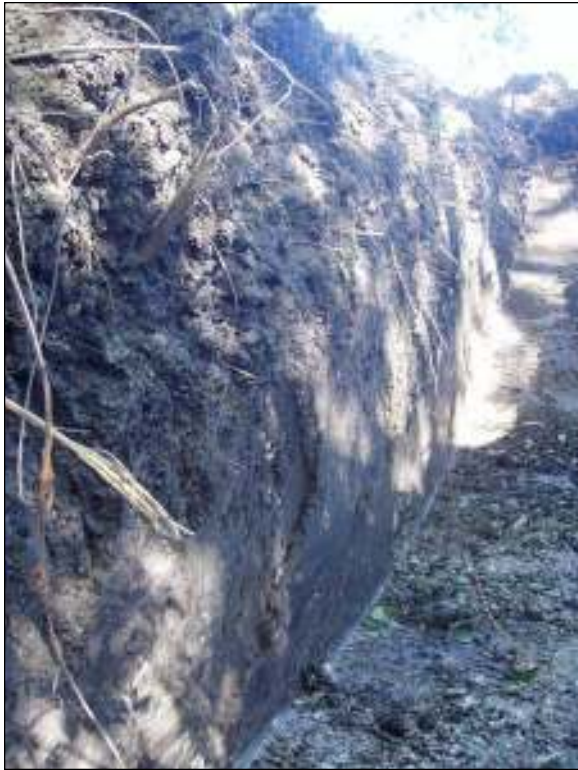
Backhoe Trenches 3 and 4 were placed on the eastern side of the Zarzamora Creek flood zone near the sewer line and the Blue Bell Creameries building. Both trenches exposed silty clays. Backhoe Trench 3 exposed silty clay with some gravel inclusions to 150 cmbs (Figure 16). Backhoe Trench 4 reached decomposing bedrock at 125 cmbs (Figure 17). The upper 25 cm showed silty clay loam with roots. Beneath this upper stratum lay compact silty clay with sparse, fine roots. One piece of fire-cracked rock observed in the trench wall lay within this silty clay deposit 25 cm above a stratum of creek gravels. The stratum of creek gravels was approximately 25 cm thick sitting on weathered bedrock in this exposure. Soils in Backhoe Trenches 3 and 4 appear to be unaltered by fill or construction dumps, though the area has seen disturbance with the installation of a 22-in. forced sewer line. We made every effort to place backhoe trenches in undisturbed areas of the APE.

Figure 16. Photograph of Backhoe Trench 3 showing 1.25 meters of silty clay.

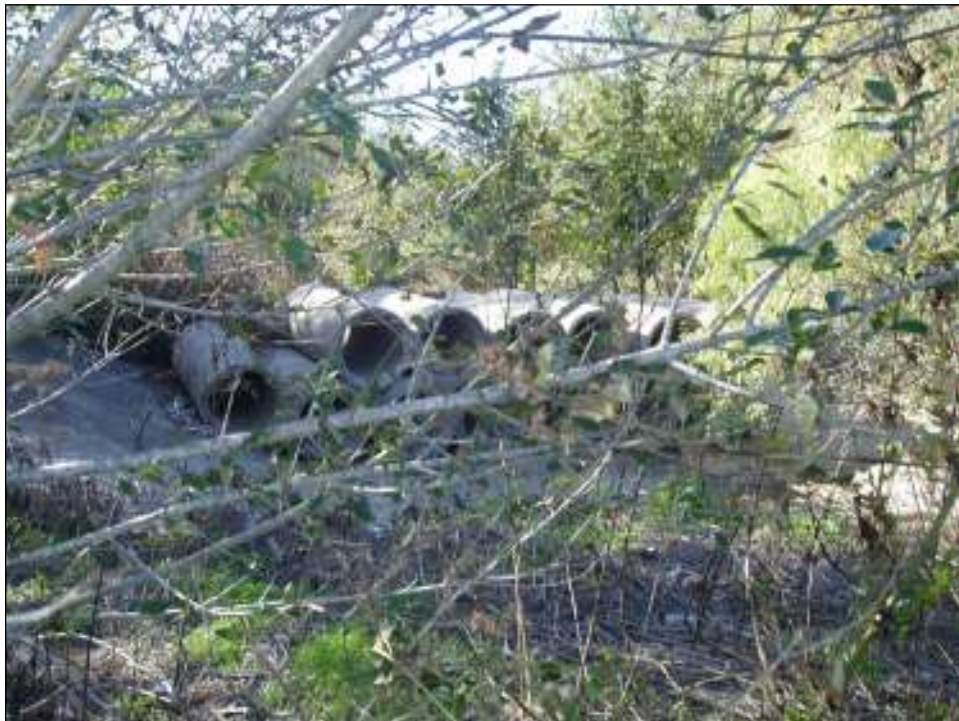
Shovel tests around Zarzamora Creek tested areas inaccessible with the backhoe. These included places crossed by fences or near a culvert barrier on a concrete pad (Figure 18). Shovel tests showed disturbed soils with trash up to 40 cmbs on the west side of the creek. Gravels begin to increase at 30-40 cmbs with no other discernable change in soil texture. The upper 20 cm are soft silty loam and the lower 40 cm are compact silty clays with pebbles. Burned rock was identified in the 30 cm of Shovel Test 1 along with recent trash (plastic grocery bags, machine cut nails, concrete).

Figure 18. *Culverts were stacked to allow floodwaters to drain while also serving to keep horses out of the creek, according to a former horse caretaker on the property.*
