Archaeological Investigations and Construction Monitoring at the Bexar County Justice Center Expansion Project, San Antonio, Bexar County, Texas

Texas Antiquities Committee Permit No. 4853

Prepared by:
Center for Archaeological Research
The University of Texas at San Antonio
One UTSA Circle
San Antonio, Texas 78249
Archaeological Report, No. 392

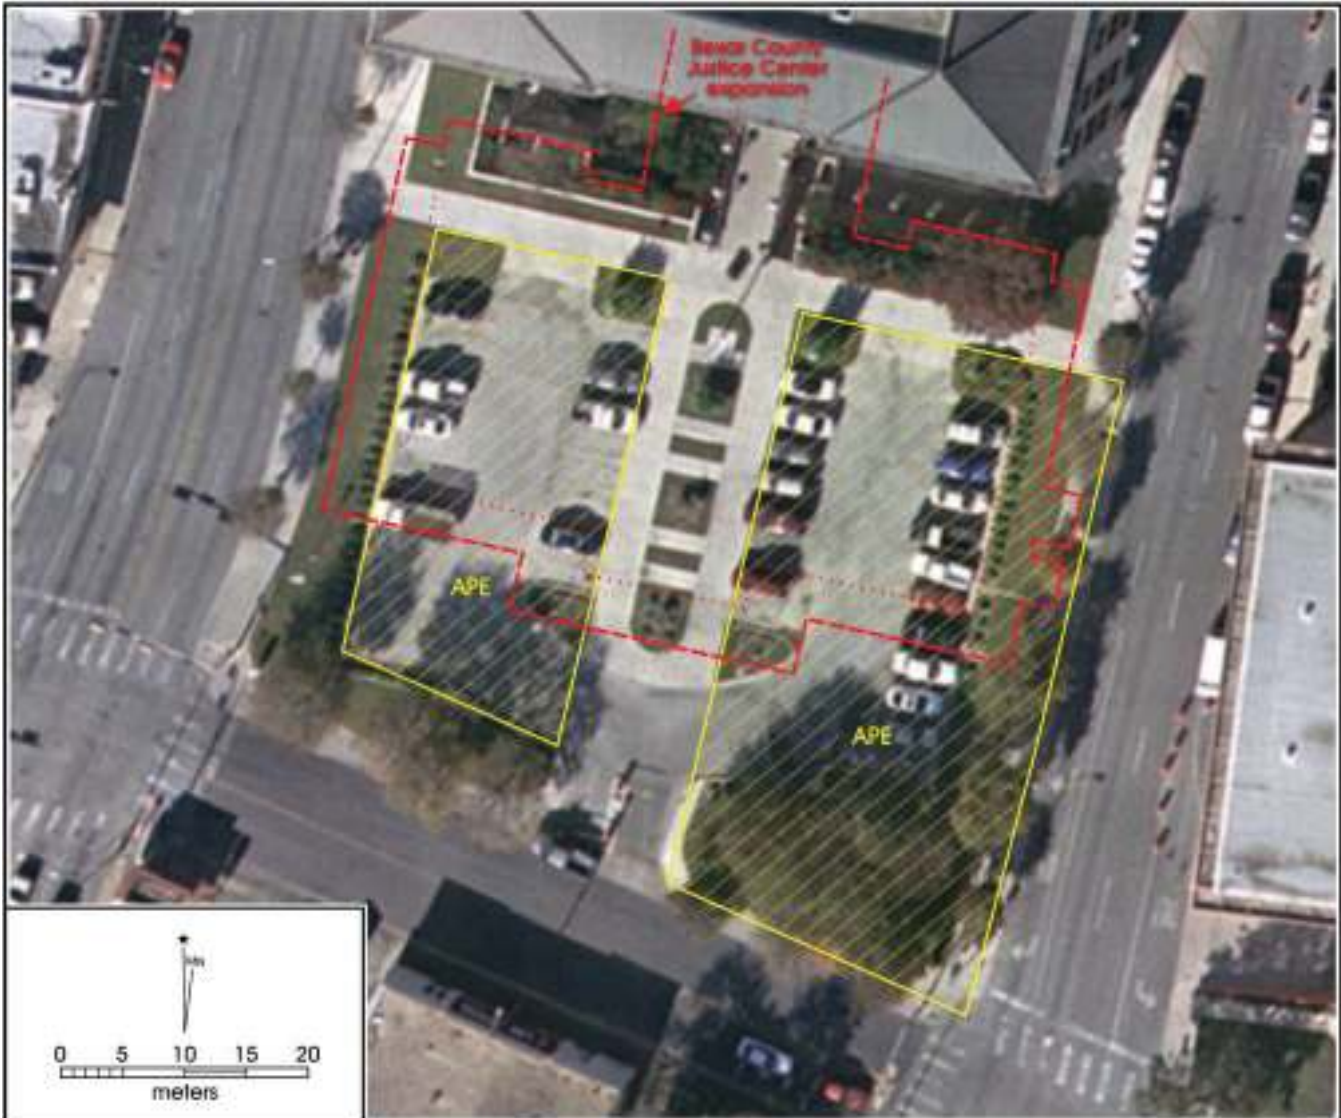
Figure 1-2. The project area and Area of Potential Effect (APE).

The project area is located within New City Block 100 (NCB 100). The impacts associated with the Bexar County Expansion include the construction of buildings south of the existing Bexar County Justice Center (Figure 1-2). The Area of Potential Effect (APE) is an existing paved parking lot located at the intersection of South Flores Street and

Nueva Street in downtown San Antonio. At the inception of the project, the edges of the parking lot were landscaped with shrubbery and mature trees. The northern section of the APE was within the proposed building footprint, while anticipated impacts in the southern section consisted of landscaping and utility installation. Impacts from proposed construction were to include deep excavations for a basement and support columns.

Prior to the beginning of archaeological investigation, the APE was divided into eastern and western sections. Previous investigations had occurred in the eastern portion of the APE, but none had been conducted in the western section. The APE measures 0.5 acres (2050 m²). Both the western and eastern sections will be impacted by the proposed building construction.

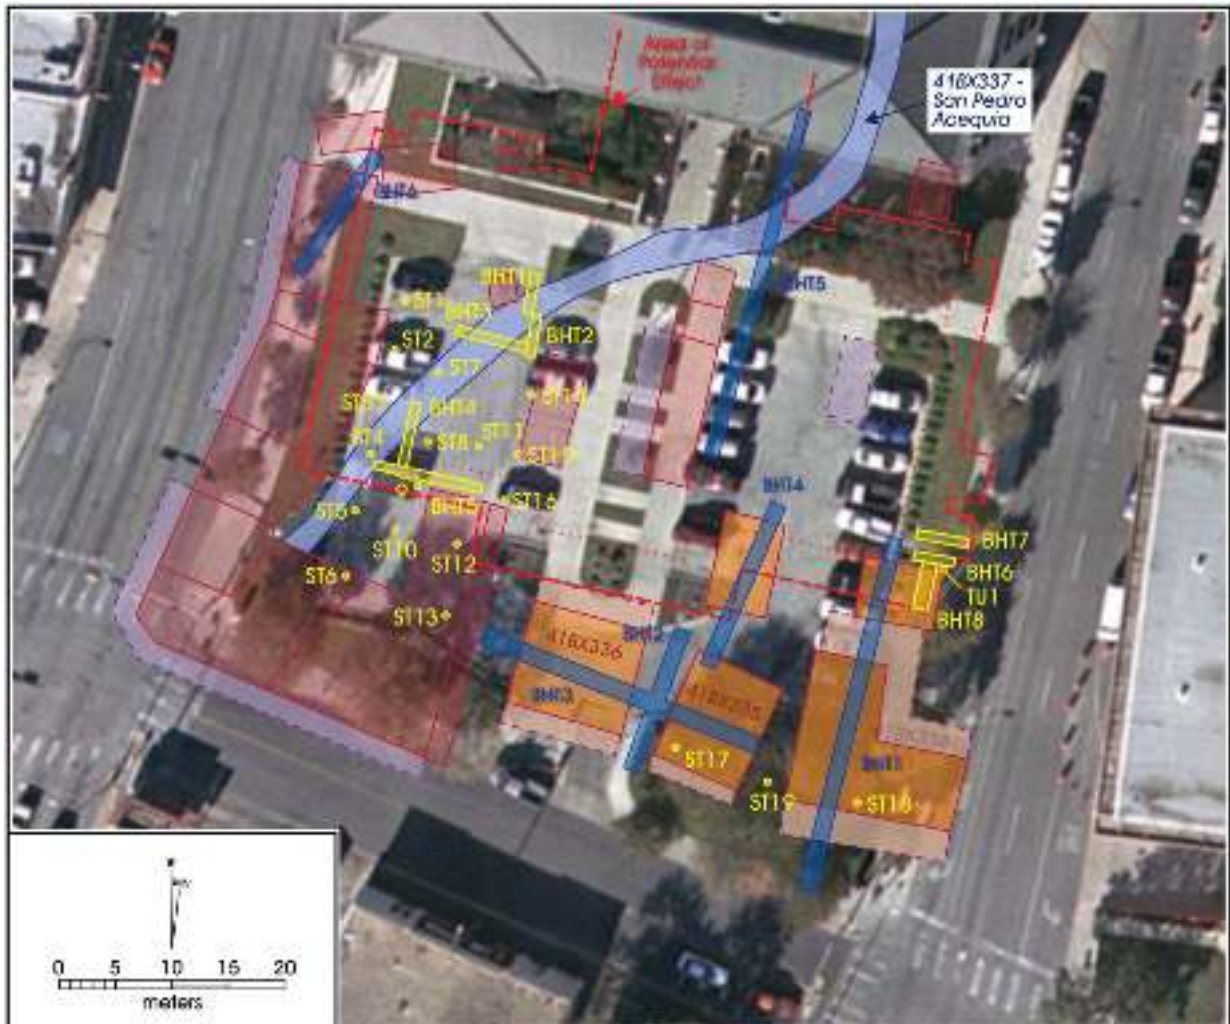
Figure 4-1. Map showing the current archaeological investigations.

In the western portion of the APE, sixteen areas were mechanically stripped for shovel testing, and five backhoe trenches were excavated (see Figure 4-1). The aim of the investigations was to locate and document the *San Pedro Acequia* and any cultural resources in the area. The *acequia* had been previously documented in 1978 (Fox et al.1989), north of the APE. The *acequia* was encountered during current backhoe excavations (BHT 5). Nine architectural features were encountered during shovel testing and backhoe trenching of the western portion of the APE and designated as site 41BX1775.

Feature 1 was located in ST6 and consisted of four red bricks that appear to be the remnants of an old sidewalk (see Figure 4-1). The feature was found at 30 cmbs underneath the caliche base of the parking lot. The bricks measured approximately 30cm-x-30cm. Although this feature is within the lot that J. Dullnig owned from 1878 to 1944 (see Property History section in Chapter 2) it is not thought to date to that time. Artifacts were not observed during the exposure of Feature 1. Furthermore, it is unlikely that the brick feature dates to when Dullnig occupied the area.

(refer to Figure 4-1). Backhoe Trench 1 (BHT 1) consisted of asphalt that measured 8 cm thick, followed by concrete and fill material that reached 1.5 meters below surface (mbs) in its northern portion. In the southern portion of BHT 1, Feature 6 was encountered and recorded (Figure 4-8). Feature 6 was a yellow brick wall that was encountered at 60 cmbs and was situated perpendicular to the trench. The feature was 80 cm wide (the width of the trench) and measured 1.5 m in depth, the terminal depth of the trench. The northern face of the wall was plastered. A small structure is depicted in this area of the APE on an 1895 Sanborn map and it is possible that the wall is part of the structure. Artifacts were not recovered during the excavation of this backhoe trench.

Backhoe Trench 3 (BHT 3) and Feature 8 was excavated southwest of BHT's 1 and 2 (refer to Figure 4-1). The trench was 5 m long and 80 cm wide. The terminal depth of the trench was 110 cmbs. The first 40 cm of the trench consisted of asphalt and caliche fill. Feature 8 was revealed in this trench and consisted of a yellow brick wall that spanned perpendicular (east-west) to the trench. The feature was

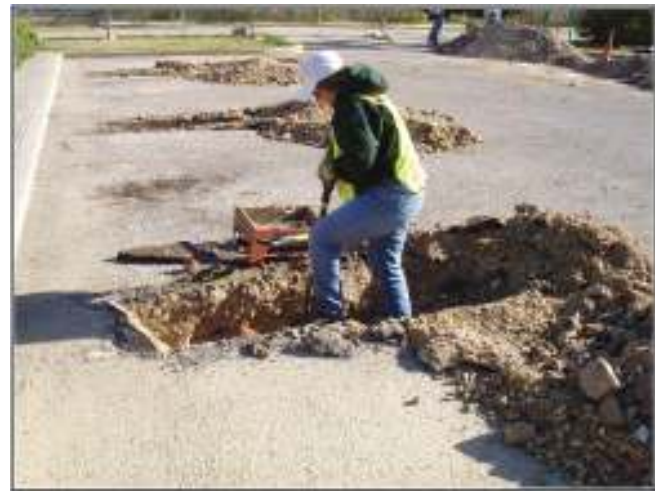
Figure 4-2. The excavation of Shovel Test 3.

In Shovel Test Areas 3, 4, 5, 9, and 13, standard shovel tests were excavated to a depth of 60 cmbs below the asphalt and caliche base (Figure 4-2). The artifacts recovered from shovel tests are listed in Table 4-1. Shovel Tests 3, 4 and 5 contained dark brown clay. There was a low density of artifacts, consisting mostly of construction material, glass, metal and faunal remains.

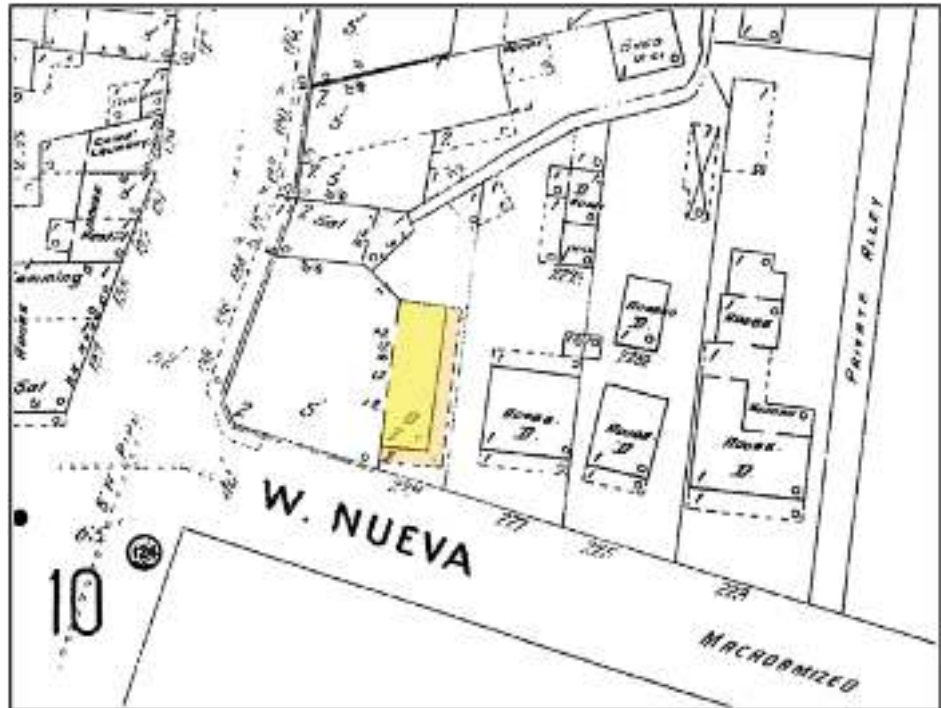
Figure 4-4. 1904 Sanborn. Note that the highlighted dwelling is in the vicinity of Feature 3.

Feature 3 consists of a plaster floor uncovered in ST10. The plaster floor was encountered at 40 cmbs, just below the caliche base. It measured 70cm-x-50cm. This feature appears to match the location of a structure labeled “Boarding” that is depicted on an 1885 Sanborn’s map. The structure is labeled as a dwelling on a 1904 dated version of the Sanborn map (Figure 4-4).

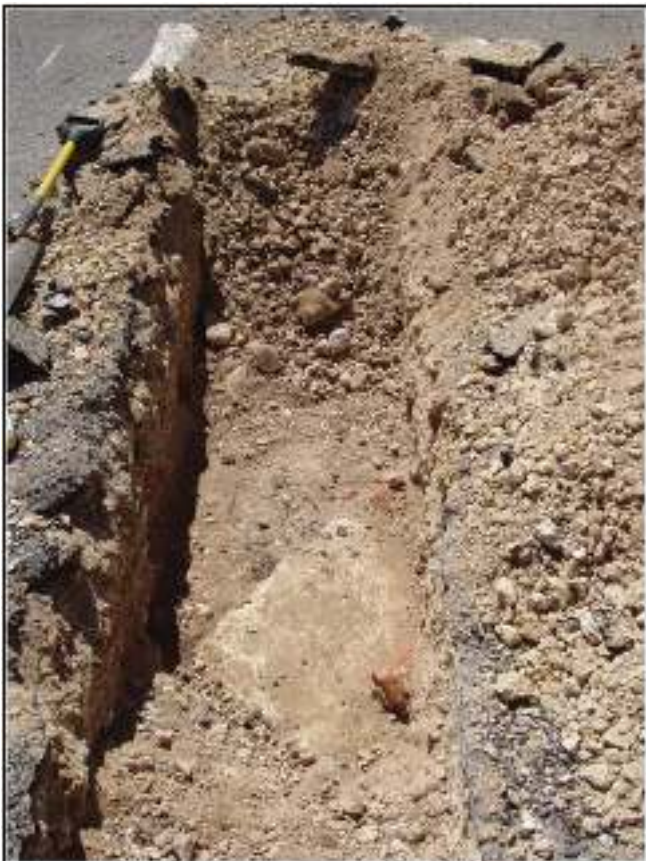
This feature was on the property once owned by J. Dullnig. Three pieces of glass (cobalt, olive and clear) and two fragments of ceramic sewer pipe were collected during the mechanical removal of the asphalt and caliche base. The caliche base was located just above the feature (Figure 4-5).

Figure 4-5. Feature 3, a plaster floor uncovered in Shovel Test 10.

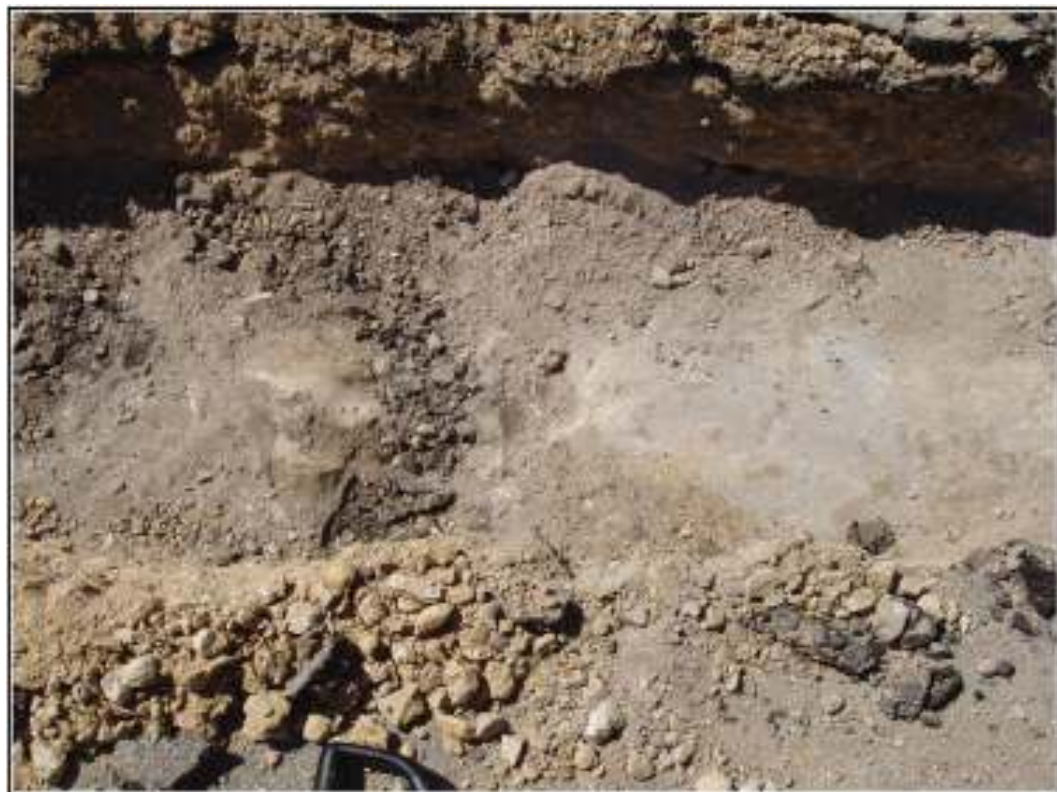
Feature 5 was uncovered in the ST14, 40 cm below the asphalt. The feature consisted of two limestone blocks that measured an area 1 m by 70 cm. The feature may be related to a structure labeled as “shed” on the 1885 Sanborn map (Figure 4-6). Feature 5 may be associated with the dwelling structure (41BX336) uncovered by previous investigations in BHT 5 (Fox et. al., 1989). Cultural material was not observed within the feature during excavations (Figure 4-7).

Figure 4-7. Feature 5, limestone blocks recovered in Shovel Test 14.

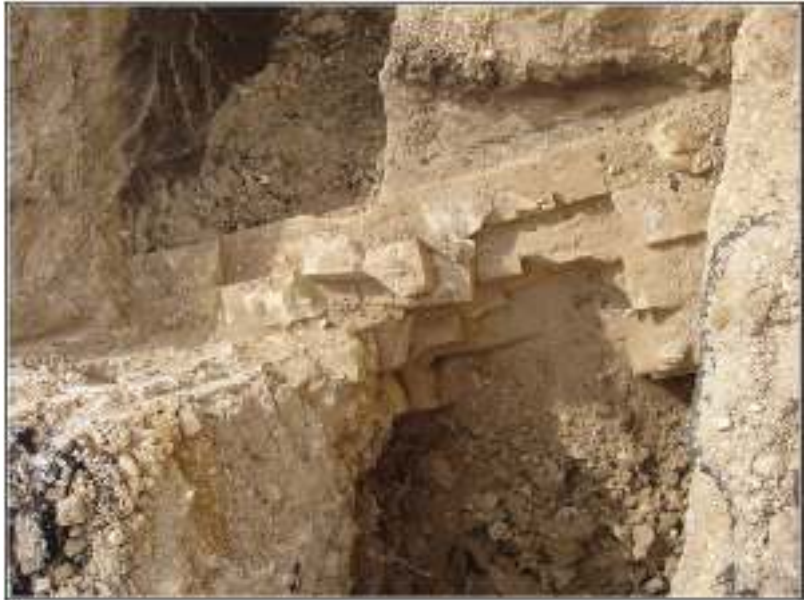
Figure 4-8. Feature 6, yellow brick wall encountered in BHT 1.

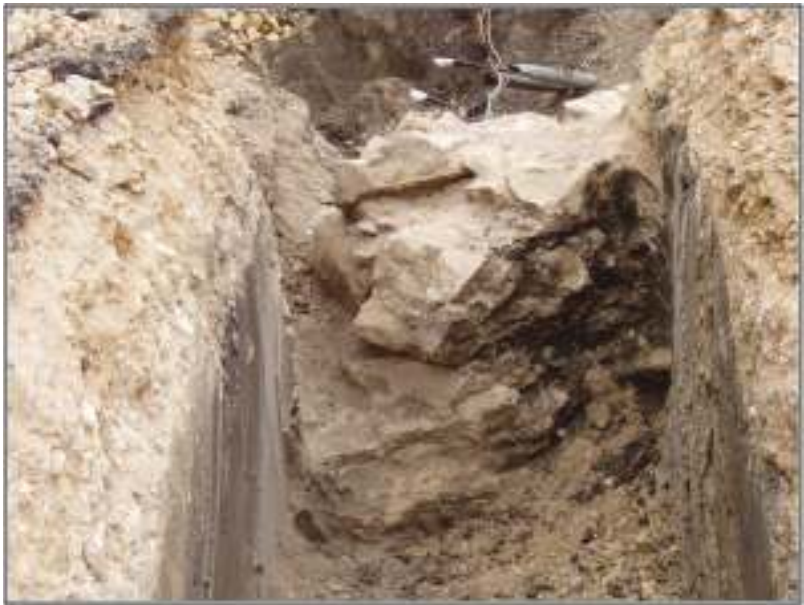
Backhoe Trench 2 (BHT 2) and Feature 7 was excavated immediately south (orientated north-south) of the brick wall that was in BHT 1. BHT 2 measured 230 cm long and 65 cm wide. Soil in BHT 2 consisted of 46 cm of asphalt (being 8 cm thick) and caliche base sitting atop dark brown silty clay. In the southern portion of BHT 2 (approximately 1.8 meters south of the brick wall), Feature 7, a limestone alignment was uncovered at 40 cmbs (Figure 4-9). The limestone feature appeared to run perpendicular to the trench. It was 30 cm wide and it was surmised that the eastern portion had been disturbed by a utilities installation. Excavations south of the limestone alignment were halted due to a utility line encountered in the trench.

Figure 4-9. Feature 7, a limestone alignment uncovered in BHT 2.

Feature 7 may be part of a shed that was associated with 41BX336, the same as in Feature 5. The two were given different feature numbers because the structure was not fully exposed. In addition, it had not been recorded during previous investigations. During the excavation of this backhoe trench, no artifacts were observed or collected.

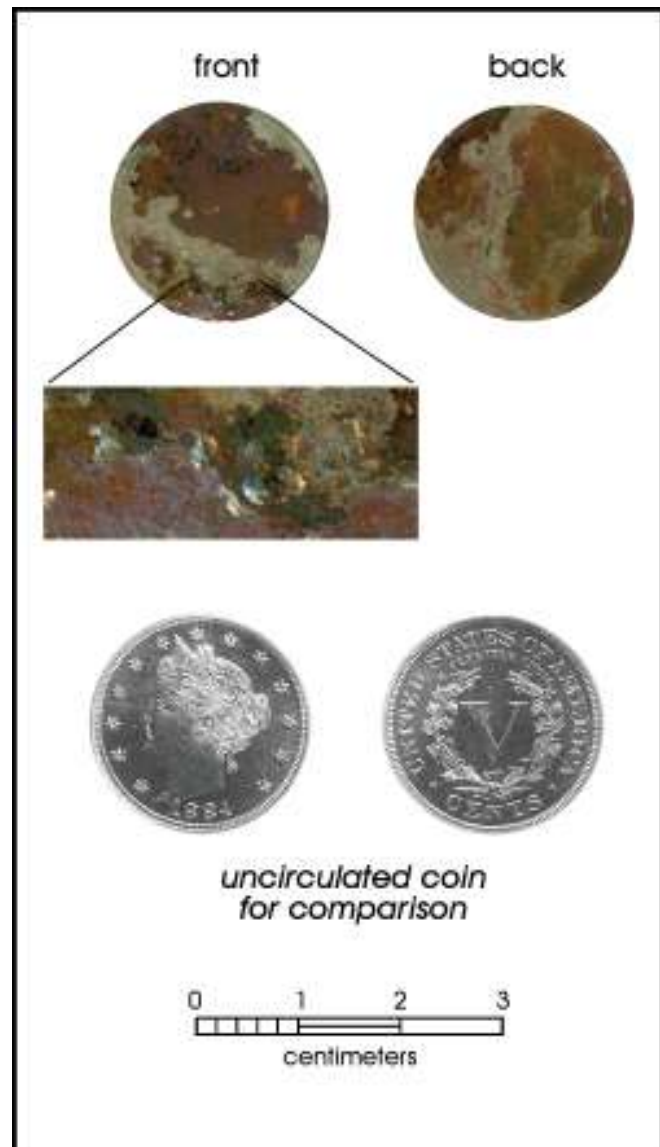
Figure 4-12. 1884 Liberty Head five cent coin.

The majority of the materials recovered from the *acequia* fill ranged in date from 1884 to the early 1900s. An 1884 nickel (Figure 4-12) was retrieved, as well as several medicinal and soda bottles. Table 4-3 lists bottles retrieved from the *acequia* that could be dated. The majority range in date between 1885 and 1920. The earliest dated item was the 1884 nickel. Material evidence indicated that the *acequia* at this location started to be filled in between 1884 and 1900. The official closing of the *acequia* was not until 1899. It seems that the use of this portion of the *acequia* began to dwindle prior to its official closing in 1899. The dwellings and businesses on the property probably contributed to most of the waste found in the *acequia*.

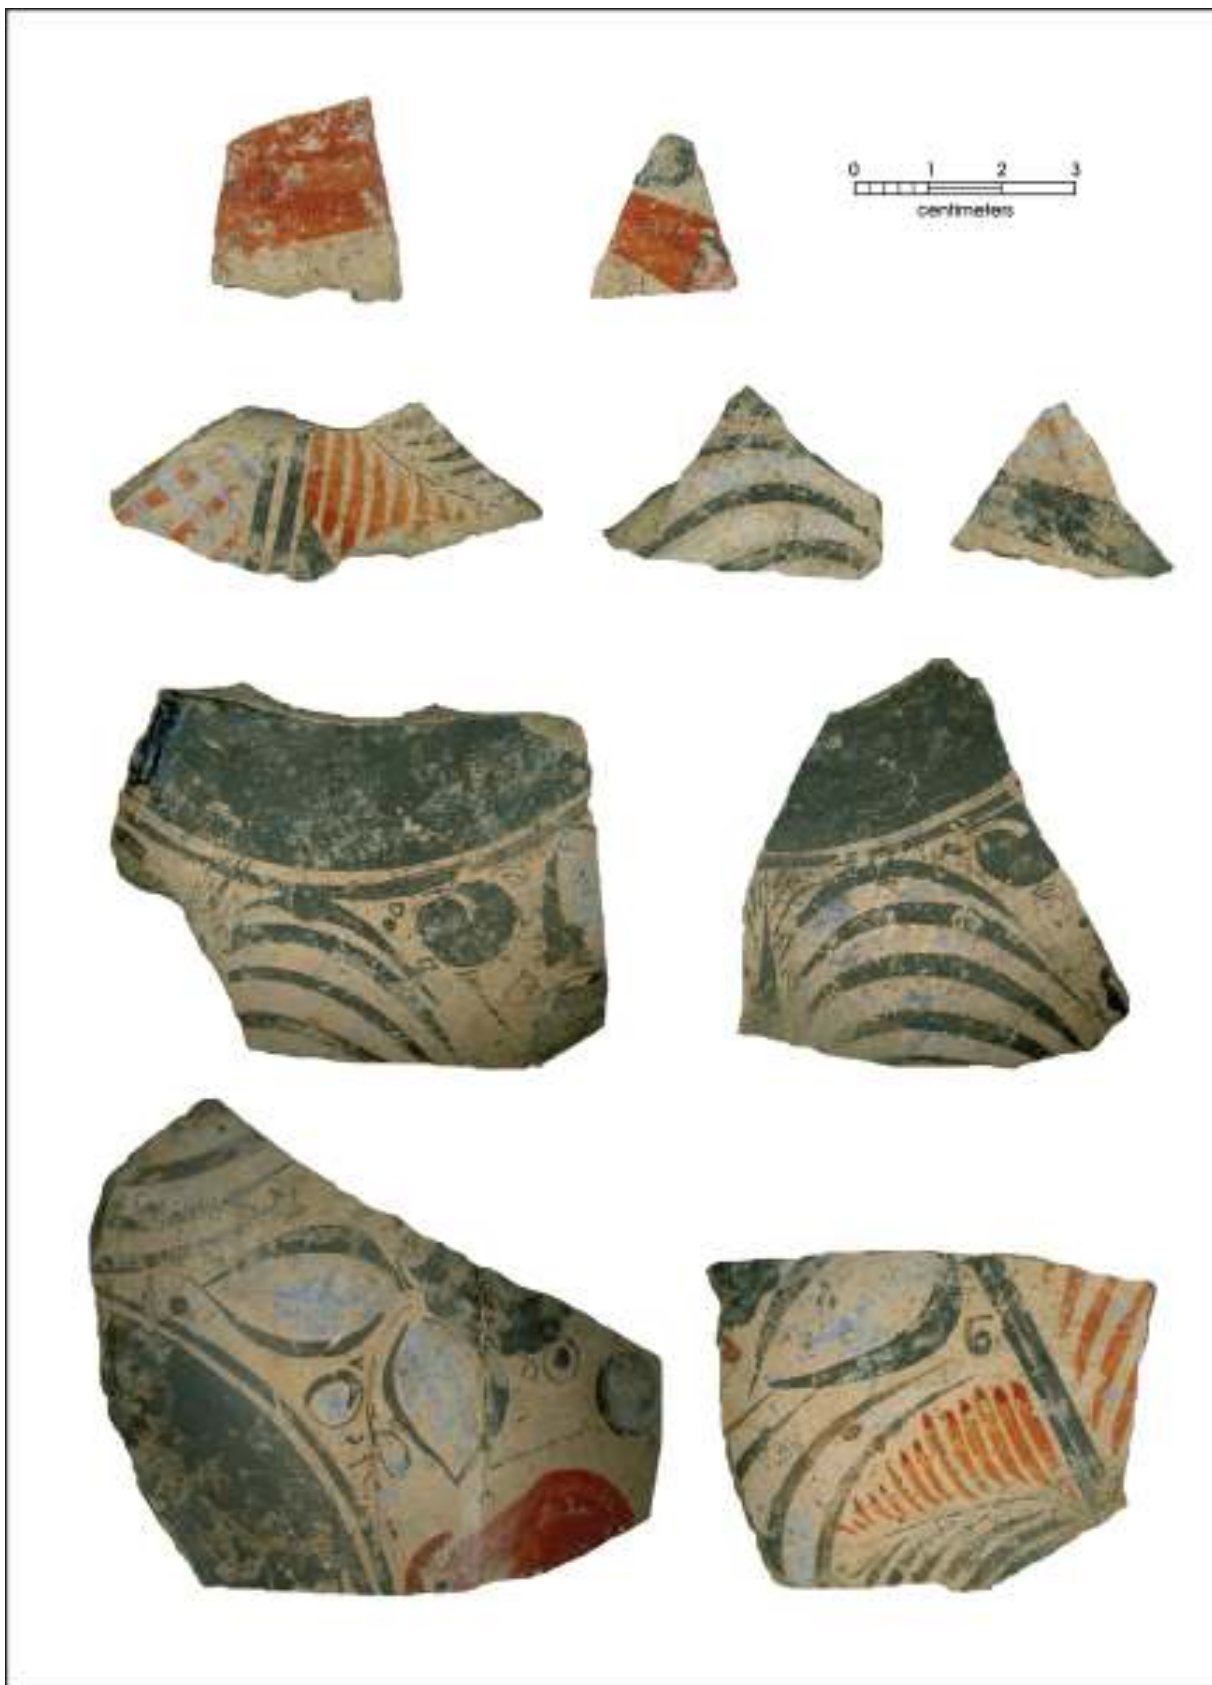
Figure 4-14. *Fragments of Tonalá jar.*

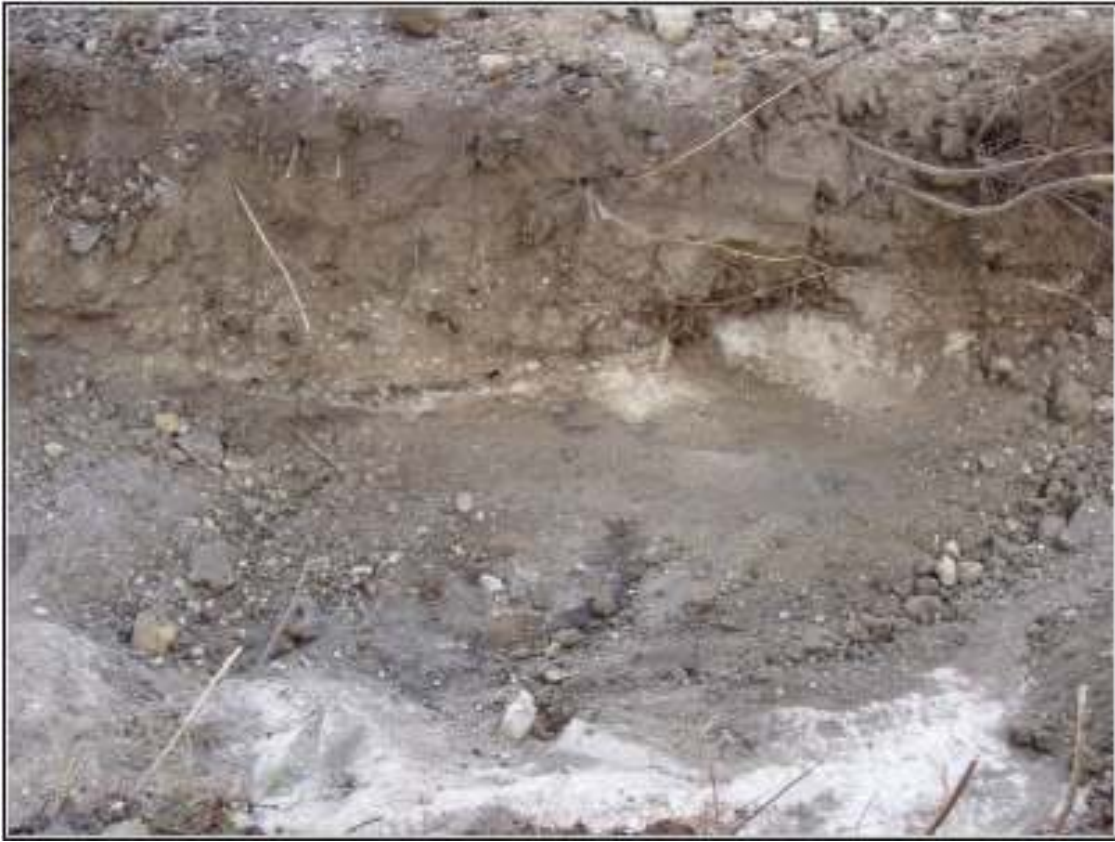
Figure 4-15. West profile of BHT 8.

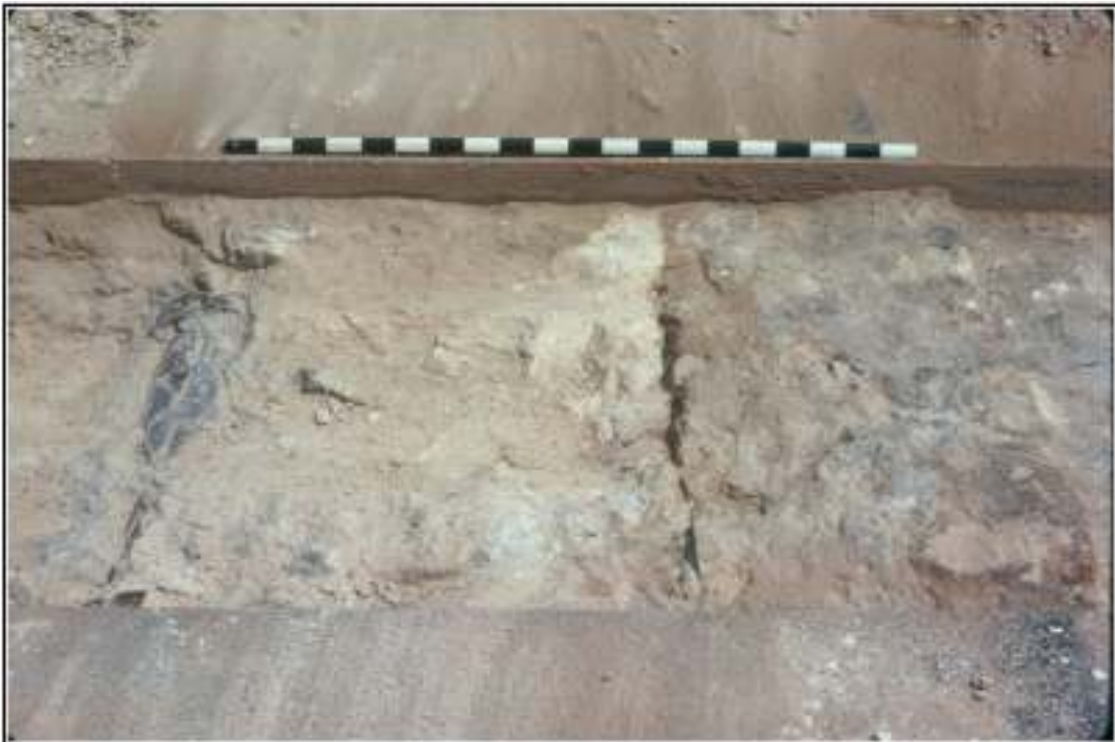
Figure 4-16. Kitchen structure associated with 41BX334 documented in previous investigations.

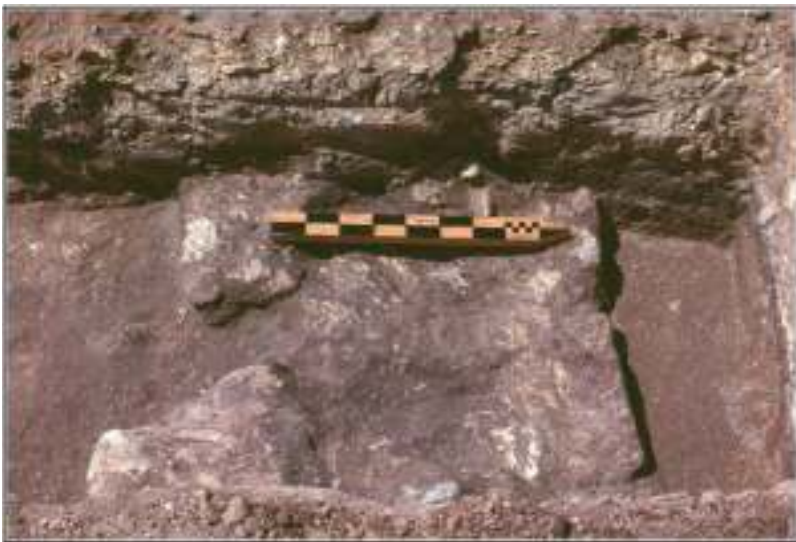
It was suspected that the kitchen associated with 41BX335 would be present under the existing parking lot. Figure 4-18 depicts a photograph of the kitchen structure associated with 41BX335 taken during previous investigations (Fox et al. 1989). Previous investigations postulated that the original ground surface level between the house and the kitchen was at 40 cm below the parking lot, and the foundation trenches were excavated from that level (Fox et al. 1989:21). Although the structures associated with 41BX335 were not as shallow as the kitchen structure associated with 41BX334, it too may have been disturbed during the construction of the current parking lot.

Figure 4-18. North kitchen wall associated with 41BX335 documented in previous investigations.

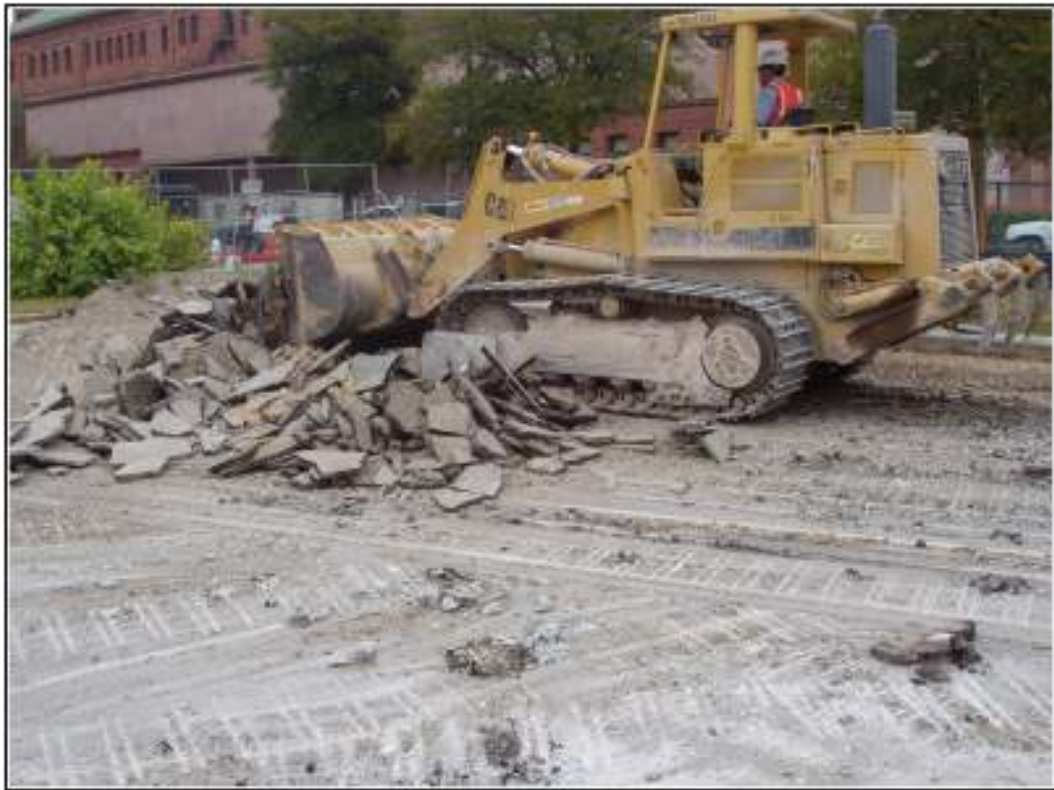
Figure 4-19. Asphalt removal in the eastern portion of the APE.

Monitoring for the construction of the building and entrance ramps began in November of 2008. Excavations took place on the eastern portions of the parking lot, starting at the place where the black top asphalt was removed (Figure 4-19). Evidence of SAL's was not noted during the removal of asphalt and curbs from the eastern portion of the APE.

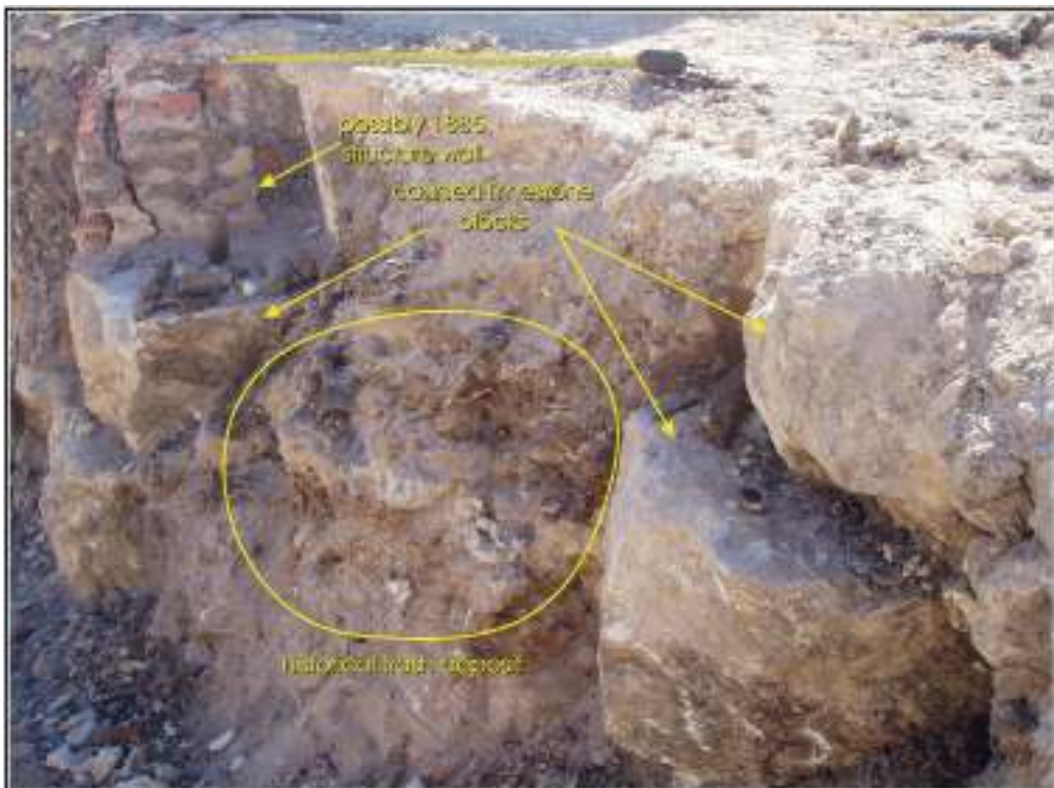
Figure 4-20. Possible acequia remnants and foundation remains associated with 41BX1775.

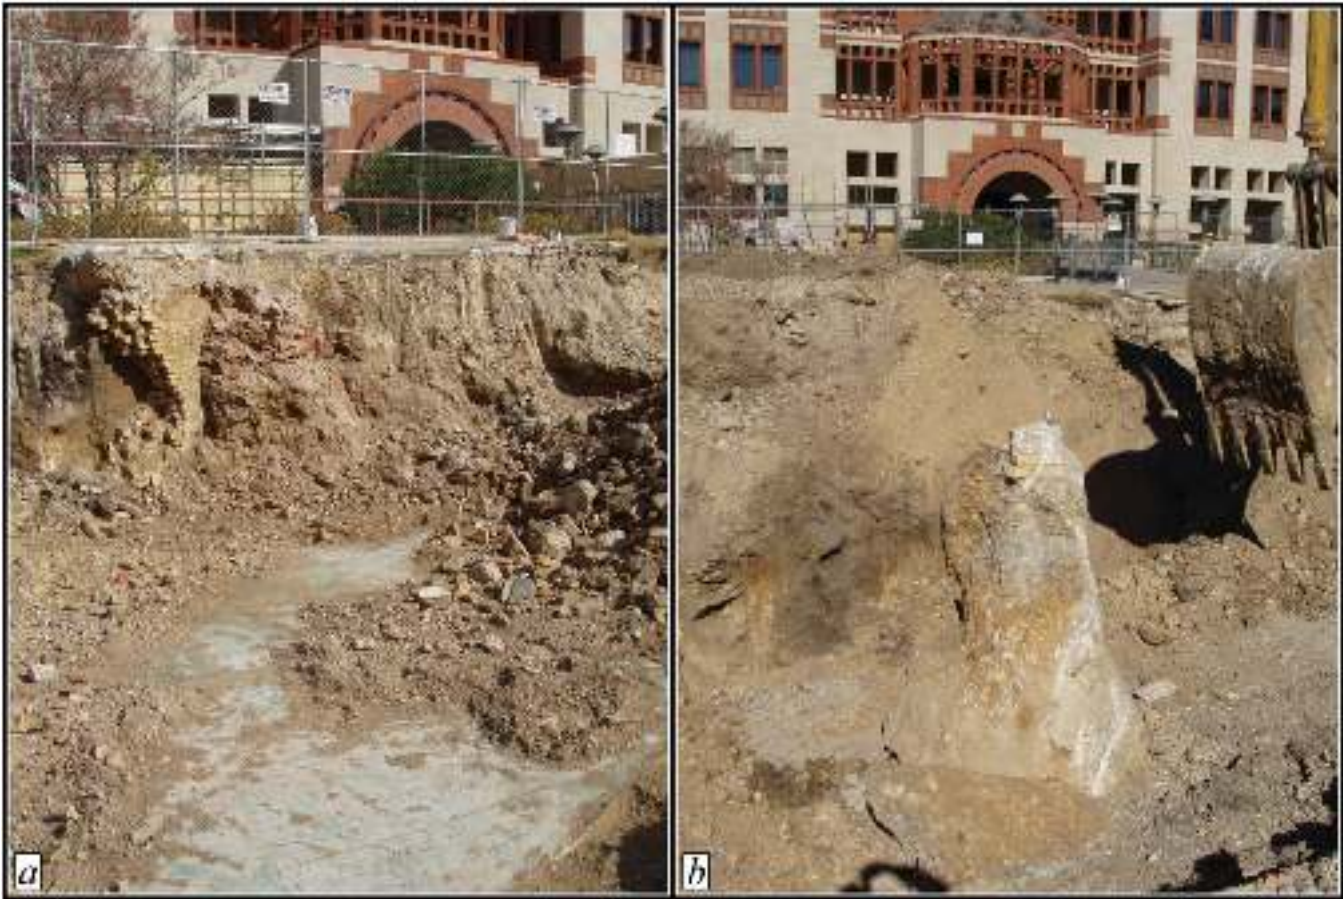
Figure 4-21. *a) Evidence of deep impacts to the western portion of the APE (note concrete floor) b) Evidence of deep impacts to western portion of the APE (note the concrete bell-footers).*

During monitoring efforts it became evident that the northern and central portions of the APE had been disturbed substantially by 1900s construction. Figure 4-21a shows the deep impacts that occurred in the project area (note the concrete floor that might have been part of a basement). Large concrete bell-footers were extracted during deeper excavations (Figure 4-21b).

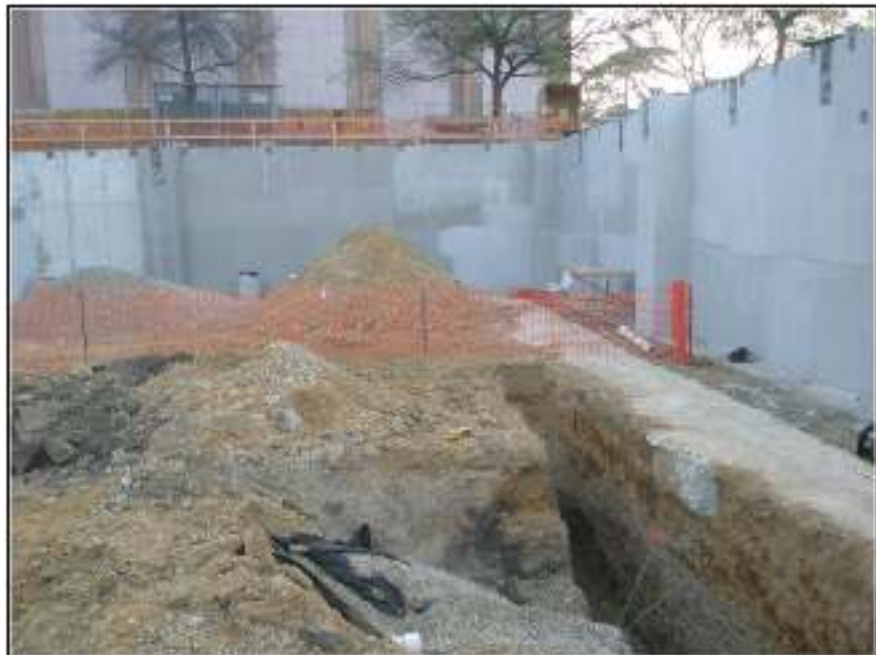
Feature 10 was uncovered during excavations within the building footprint associated with a sump pit (Figure 4-22 and 4-23). When the deposit was encountered, excavations were halted, and CAR was contacted. The excavations associated with the sump tank began at approximately 12 feet below the ground surface. The feature started about 14 to 15 feet below the ground surface and 2.25 ft below the graded surface. The feature

Figure 4-22. *Feature 10 encountered during sump pit excavations.*

was irregular in shape, and is 1-x-.60 meters in dimension. The feature concluded at a depth of 6 feet. The feature was located seven to eight meters north of the southern edge of

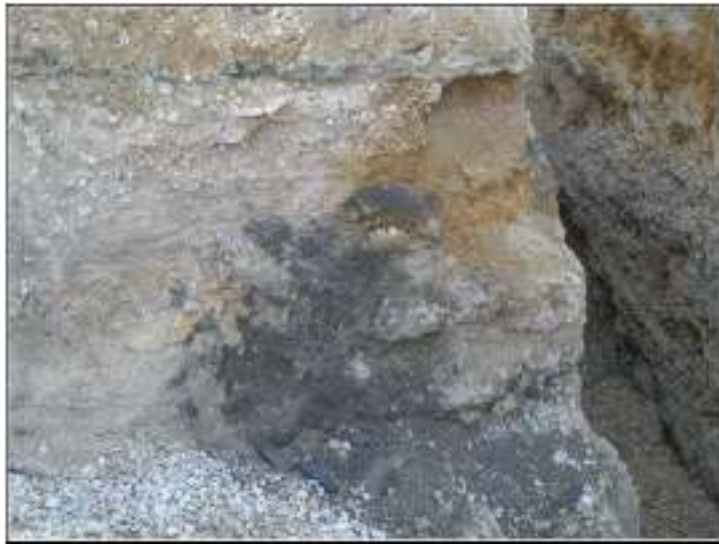
Figure 4-23. *Feature 10 (dark stain) in east wall profile of sump pit excavation.*
