Archaeological Investigations in the Courtyard of Mission Nuestra Señora de la Purisima Concepción Acuña (41BX12)

by
Antonia L. Figueroa and Steve A. Tomka

Prepared by:
Center for Archaeological Research
The University of Texas at San Antonio
Archaeological Report, No. 403

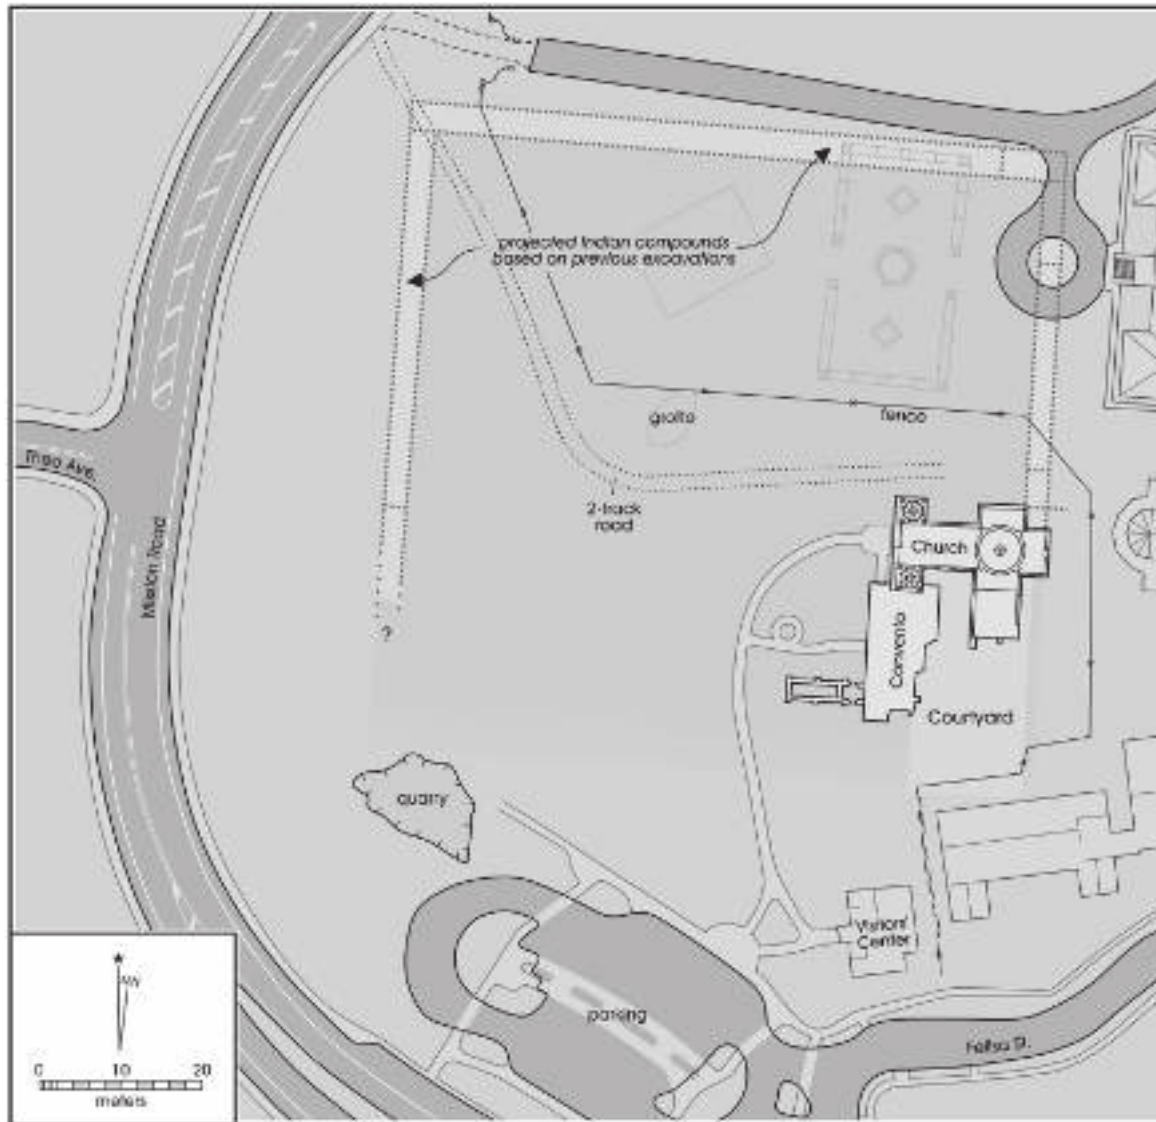
Figure 1-2. *The layout of Mission Concepción.*

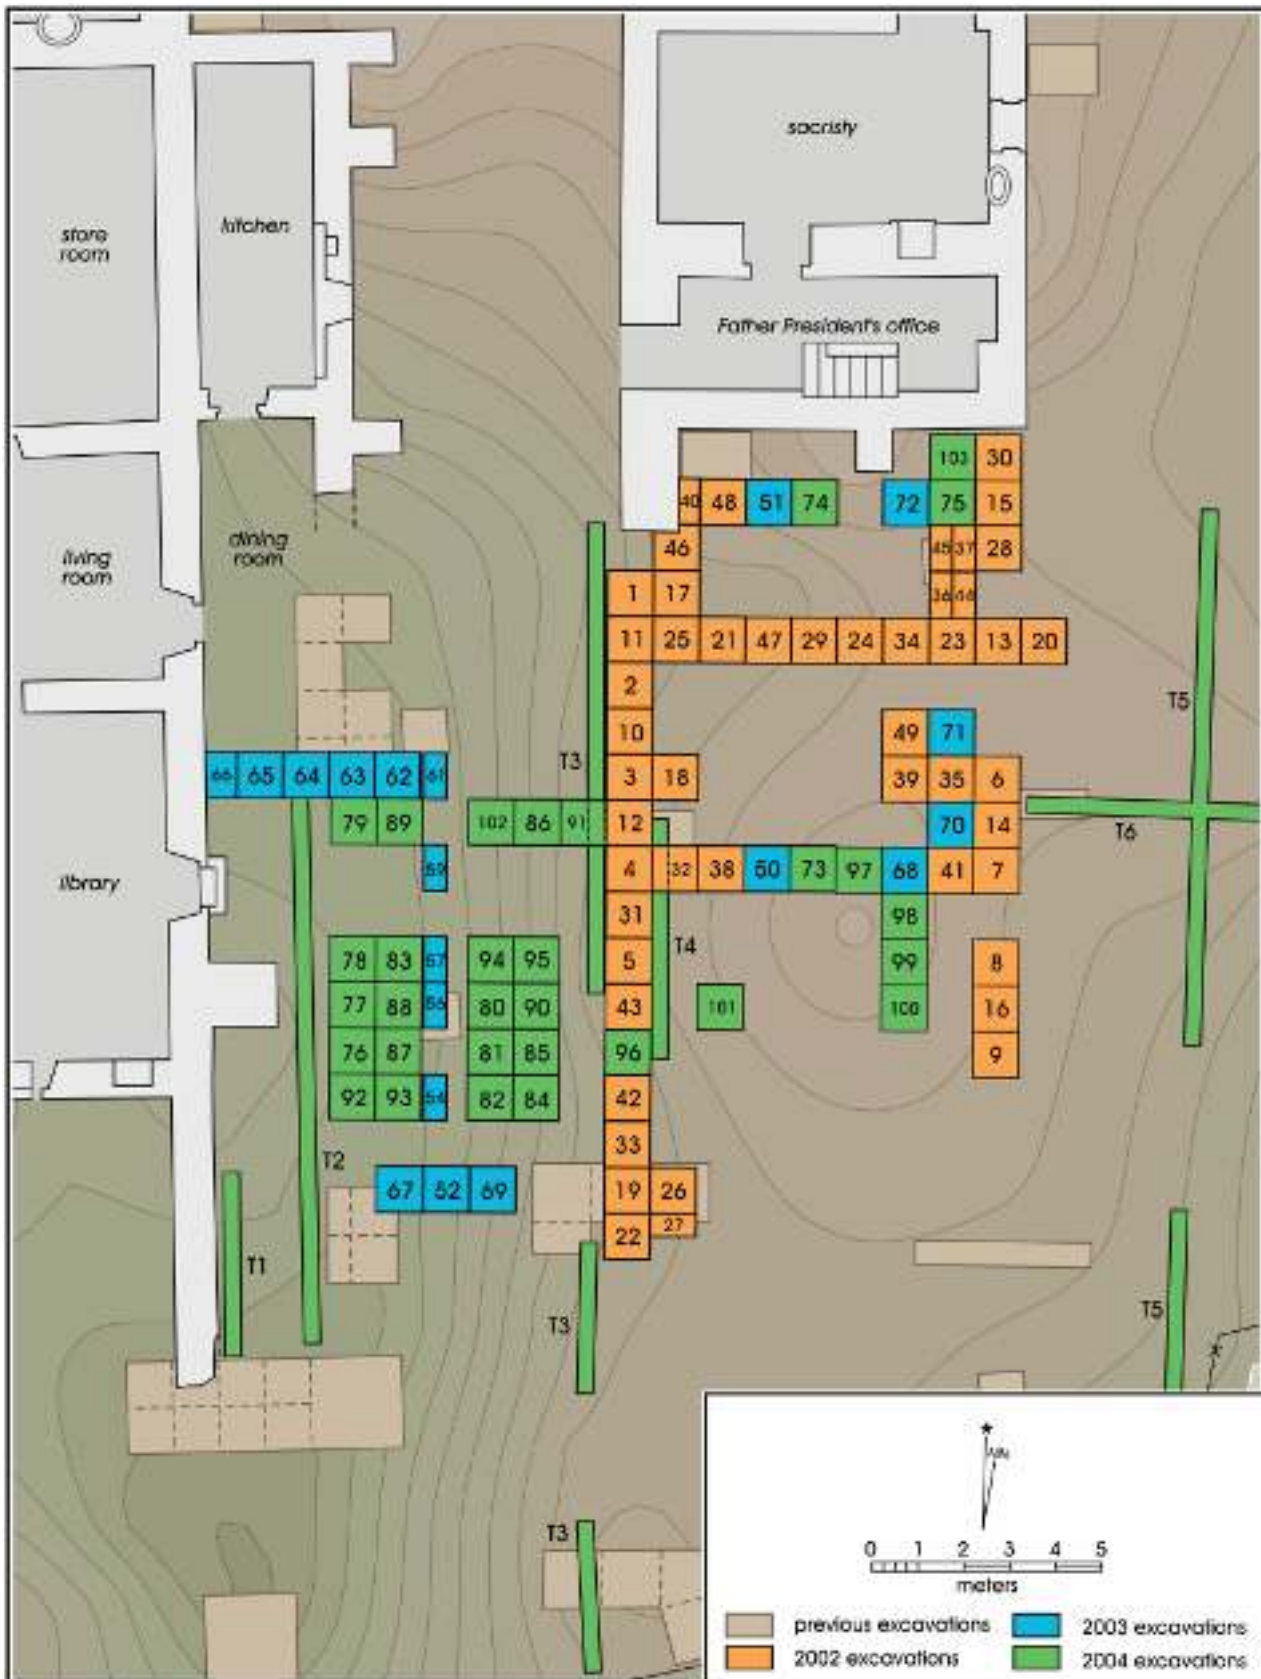
Figure 4-2. Map of test units and trench excavations conducted from 2002 to 2004.

The 2002 excavation units were positioned immediately south of the Father President's Office (FPO, Figure 4-2). Two N-S running lines were placed in line with the east and west corners for the office hoping to expose presumed foundations located in the area. Only after consulting the WPA map produced by H.P. Smith, was it realized that the eastern

A majority of test units excavated during 2003 were located along the western portion of the courtyard (Figure 4-2). Six adjoining test units were placed perpendicular to the east wall of the *convento* to expose the foundation of the wall and also more fully expose the N-S running alignment in line with the east wall of the kitchen. Five 1x.5 meter test units (TU's 54, 56, 57, 59 and 61) were positioned parallel the east wall of the *convento* approximately 6 meters from the wall. The goals of these units were to cross-cut and/or expose any potential E-W running intersecting walls in this area. Unfortunately, these units were placed directly within an existing trench used for the installation of electric conduits within the area (Figure 3-3). Only two levels were excavated in each unit prior to the discovery of the disturbed context. Nonetheless, no architectural alignments were noted in the walls of these units suggesting that no E-W running walls were present in the area. In addition, six 1x1 meter units excavated during volunteer Saturdays were dispersed south of the sacristy to explore architectural features partially exposed during previous excavations. The volume of matrix excavated from the 2003 test units is approximately 6.2 m³.

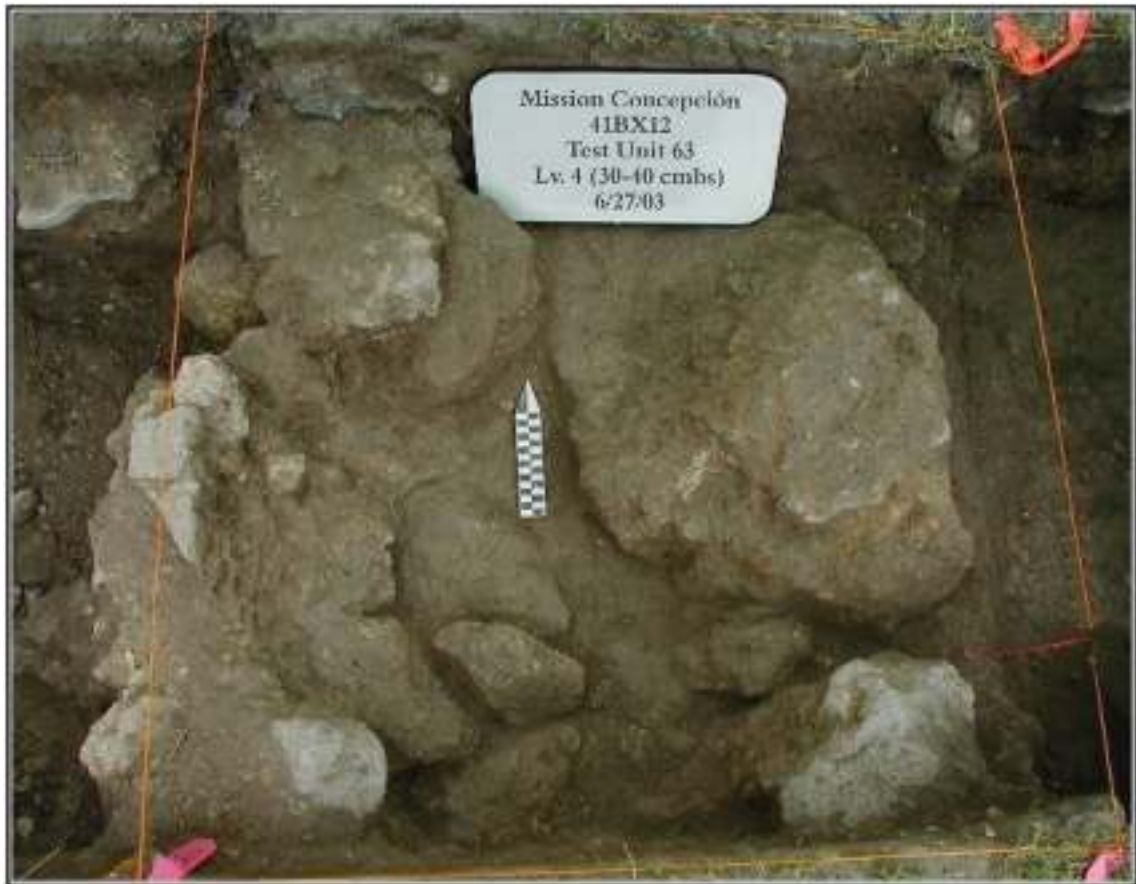
Figure 5-2. Alignment 1 uncovered in Test Unit 63.

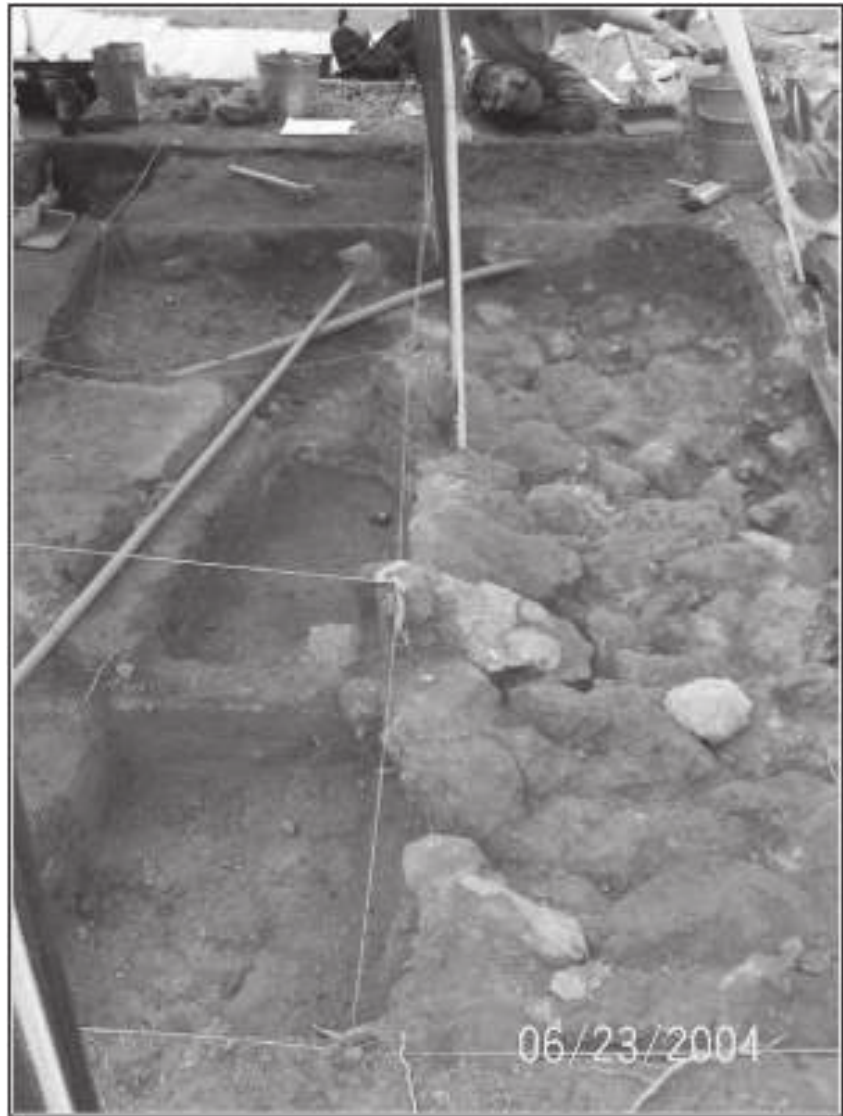
Figure 5-3. Alignment 1 in Test Units 78 through 92.

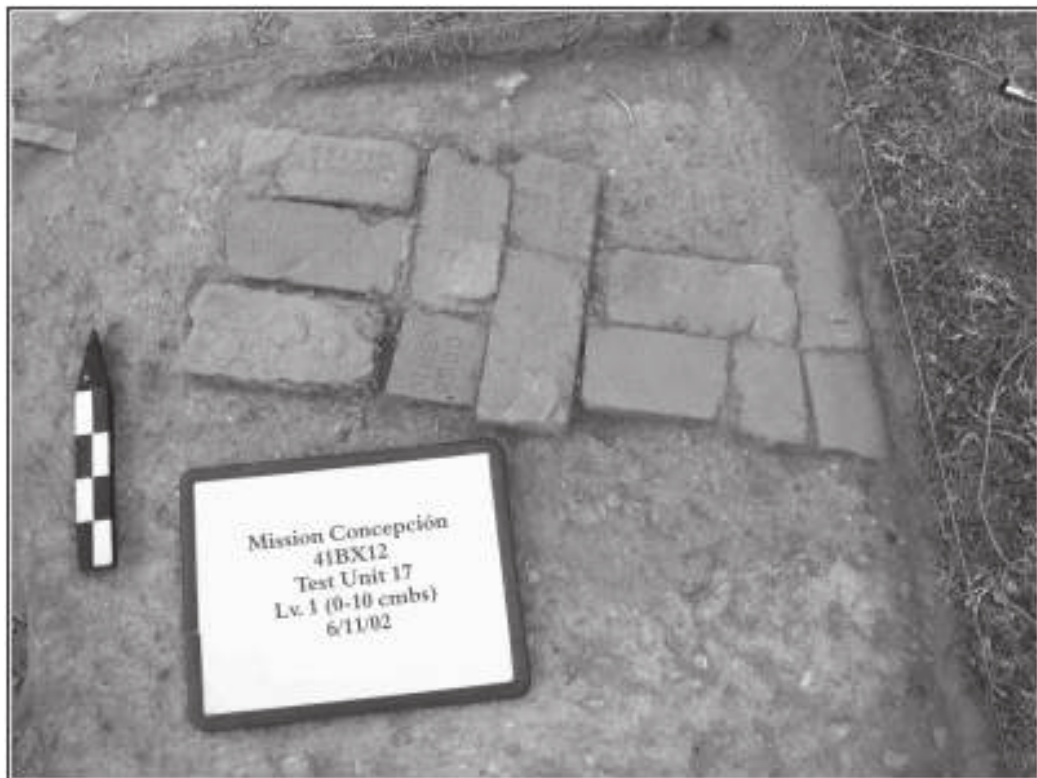
Figure 5-4. Partial layer of bricks forming sidewalk in Test Unit 17.

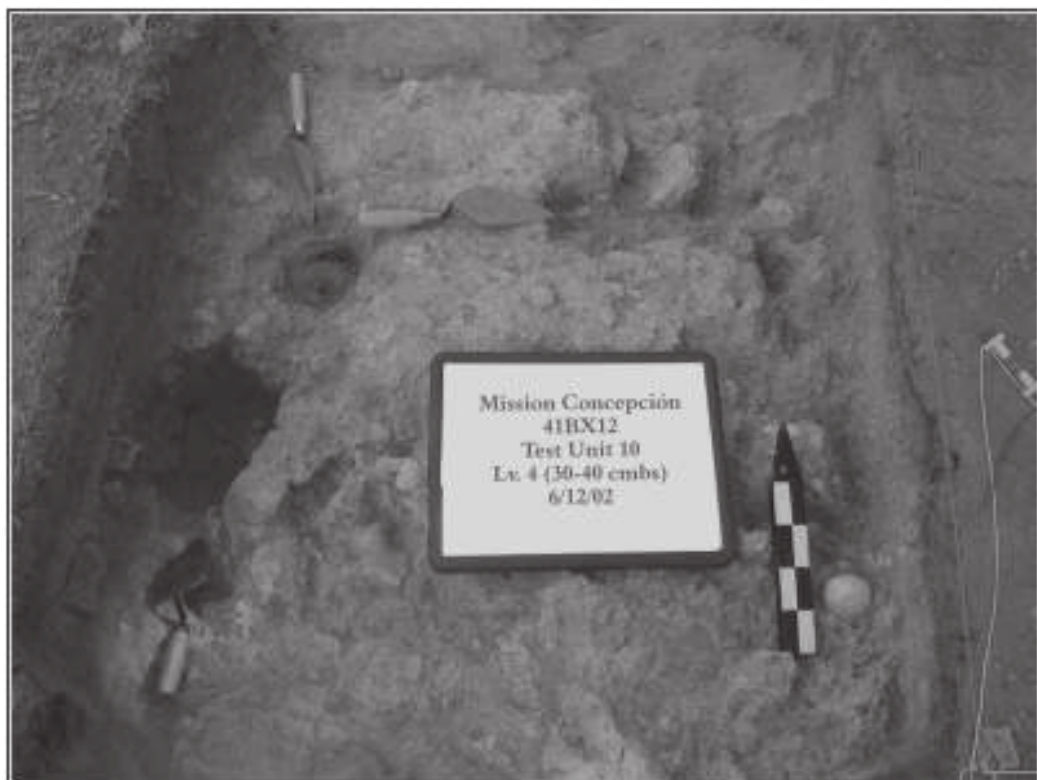
Figure 5-5. An intact portion of Alignment 2 uncovered in Test Unit 10 (note the possible posthole in northwest corner of the unit).

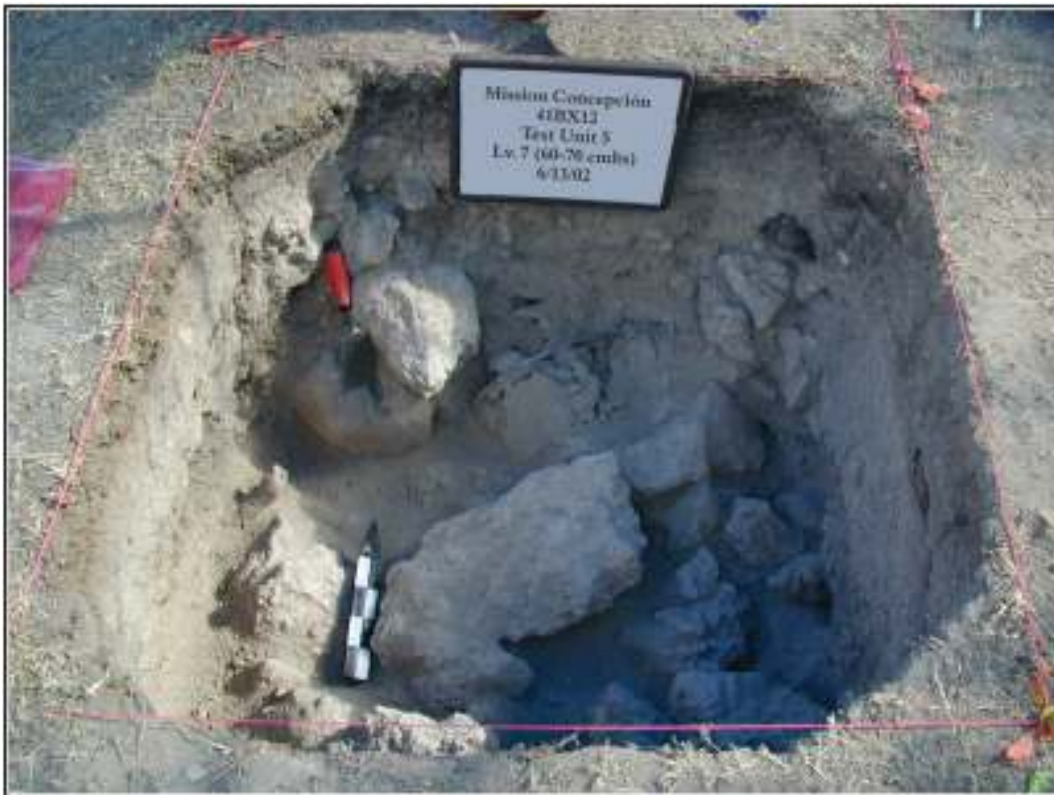
Figure 5-6. Disturbed portion of Alignment 2 uncovered in Test Unit 5.

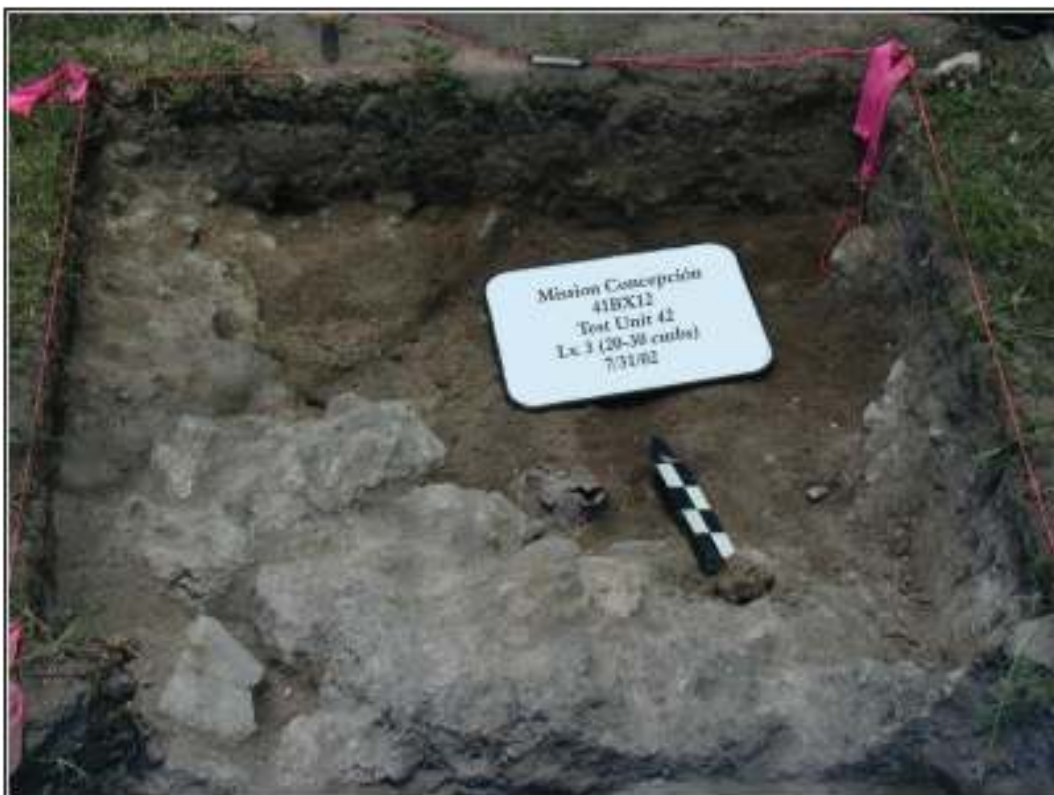
Figure 5-7. Portion of Alignment 2 uncovered in Test Unit 42.

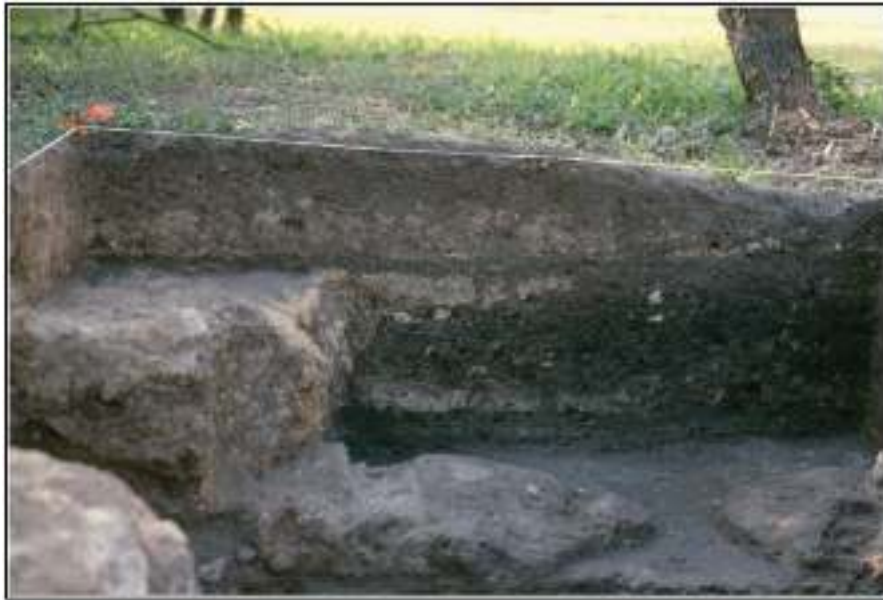
Figure 5-8. Ivey and Fox (1999) excavations, Block I, probable southwest corner of structure represented by Alignment 2.

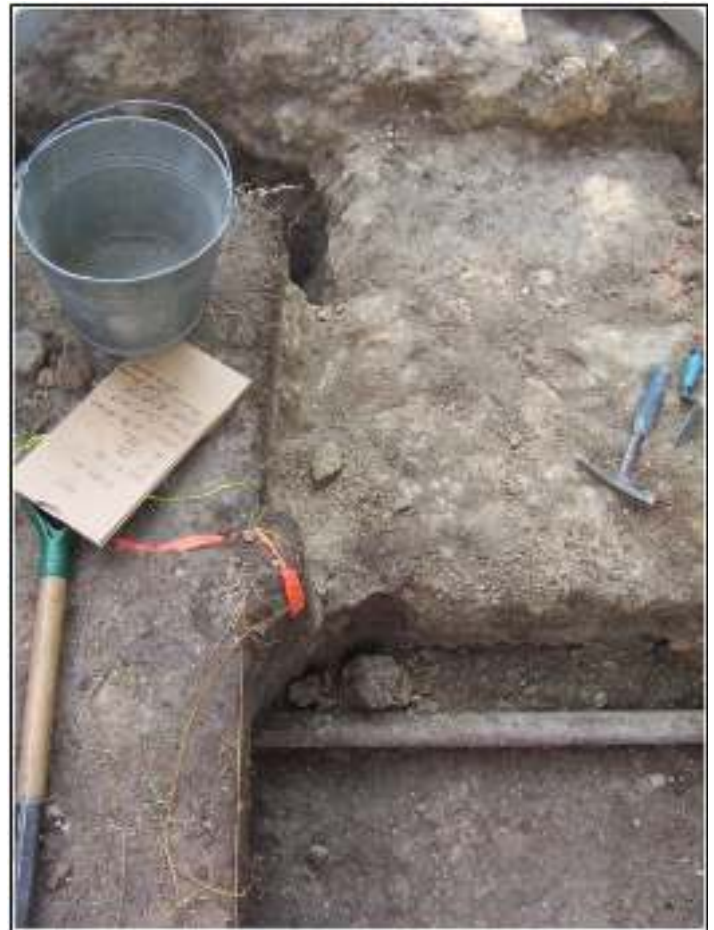
Figure 5-9. Alignment 2 (at top of photo) and Buttress 1 (center of photo) in Test Unit 91.

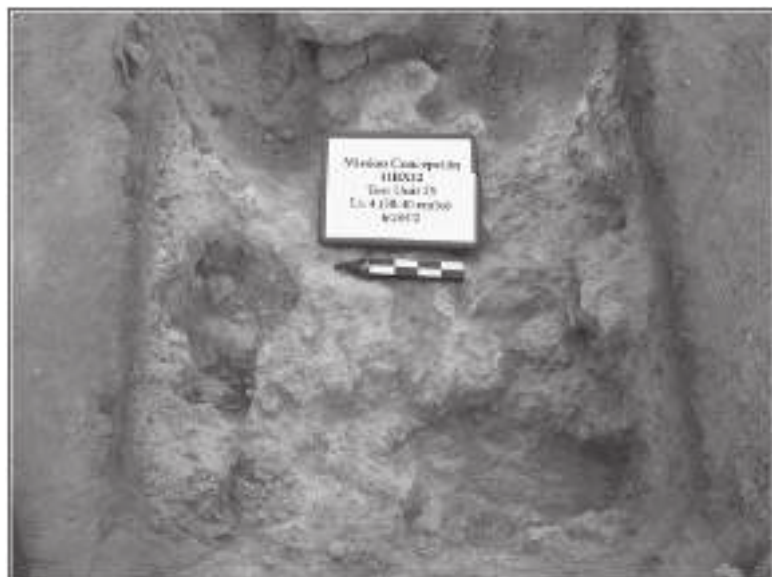
Figure 5-10. Intact portion of Alignment 3 revealed in Test Unit 23.

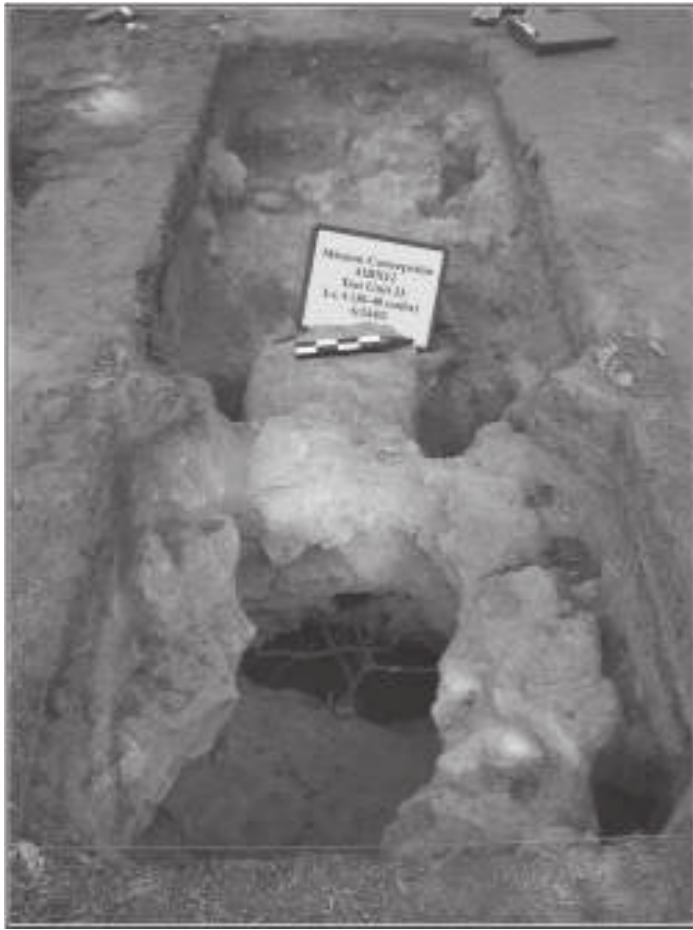
Figure 5-11. *Alignment 3 uncovered in Test Units 23, along with wall fall present in adjacent Test Units 13 and 20.*

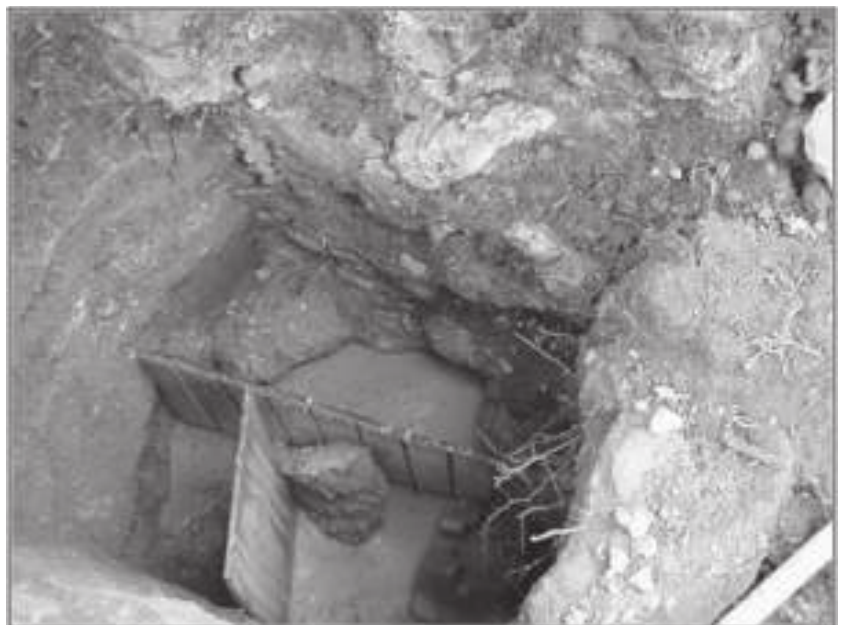
Figure 5-12. *Cement slurry at bottom of Test Unit 30.*

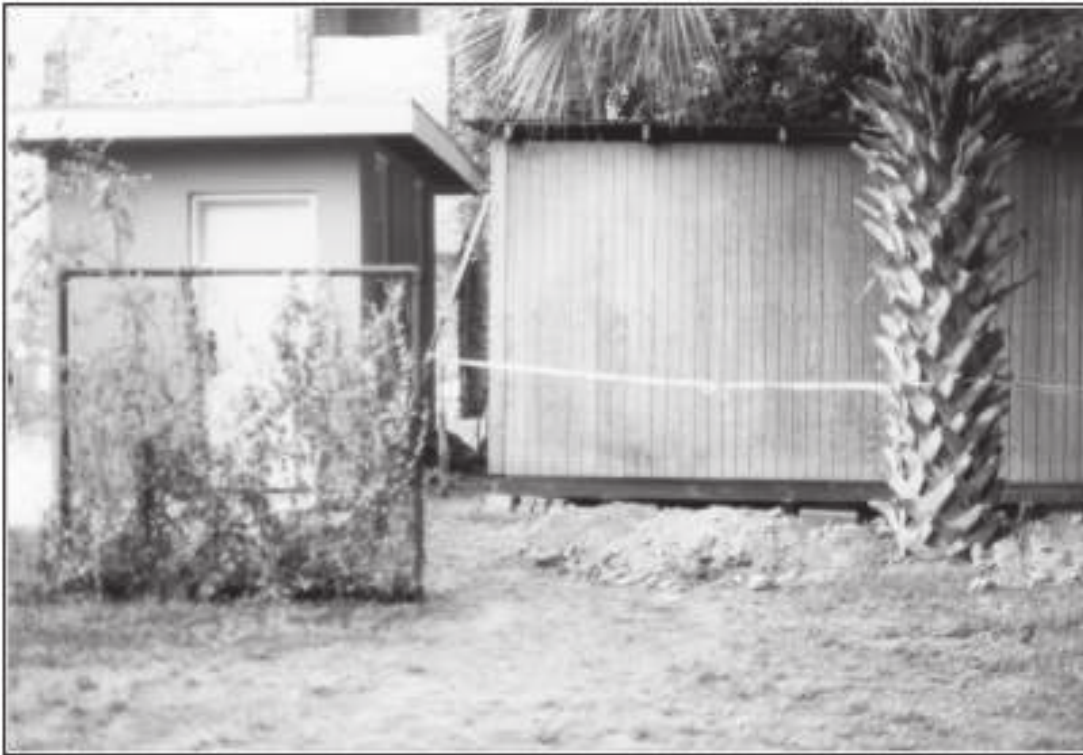
Figure 5-13. Restroom facilities and storage shed in courtyard installed in the late 1940s and removed in the late 1980s.

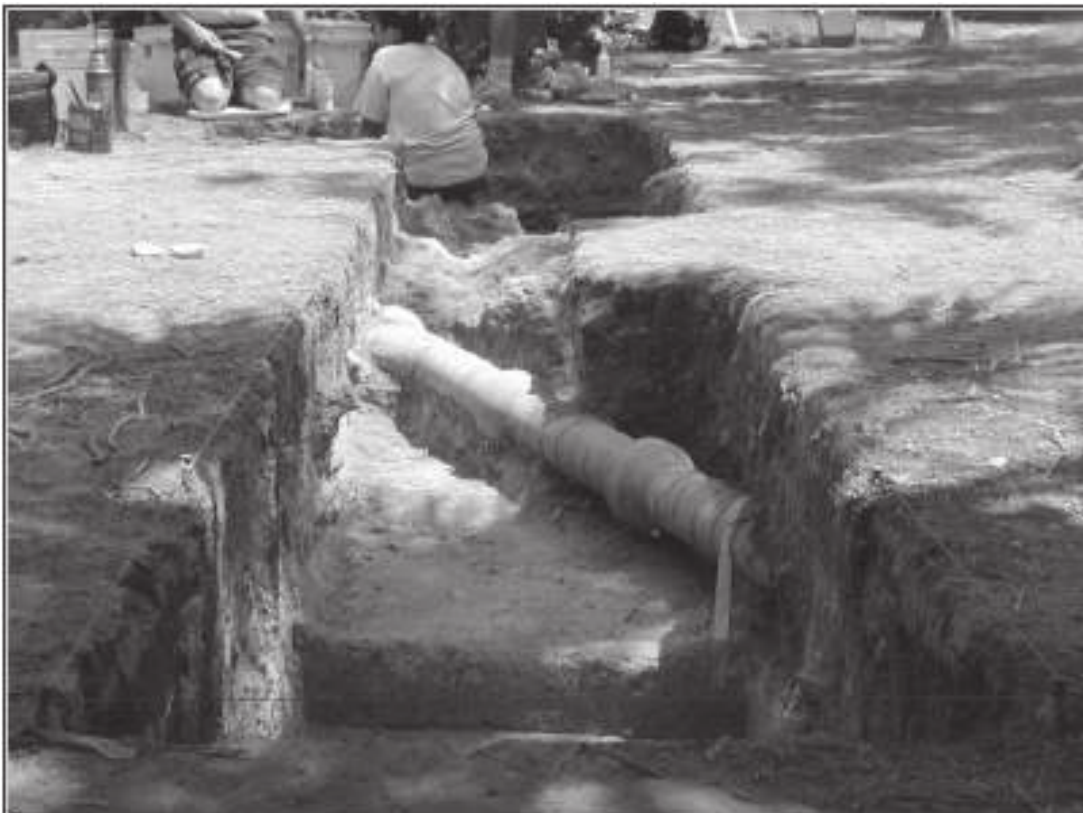
Figure 5-14. Concrete sewer pipe south of remnants of possible buttress in Test Units 8, 16 and 9.

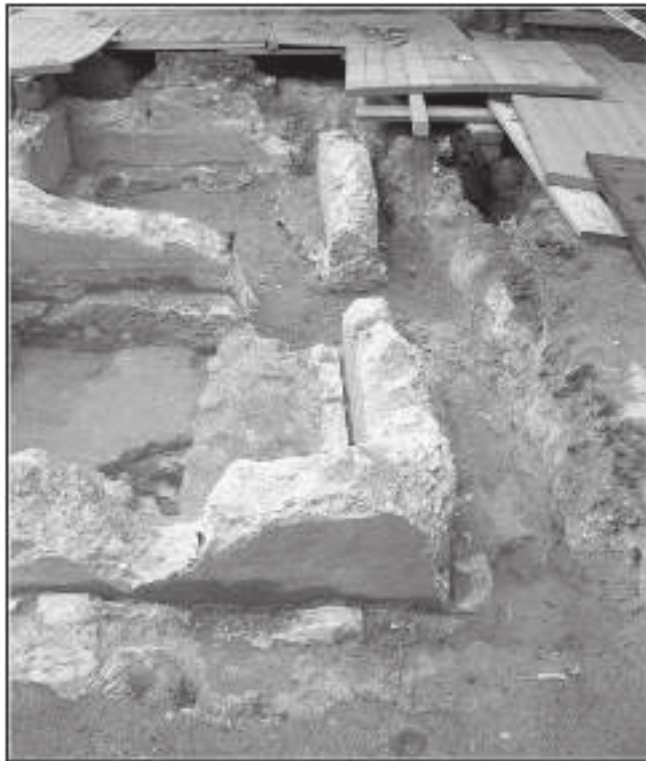
Figure 5-15. Foundation remnants of restroom facility.

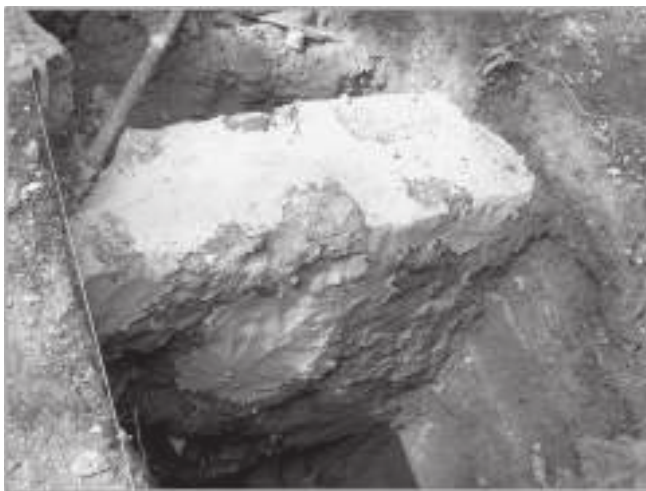
Figure 5-16. Cement-reinforced stone wall identified in Test Unit 15.

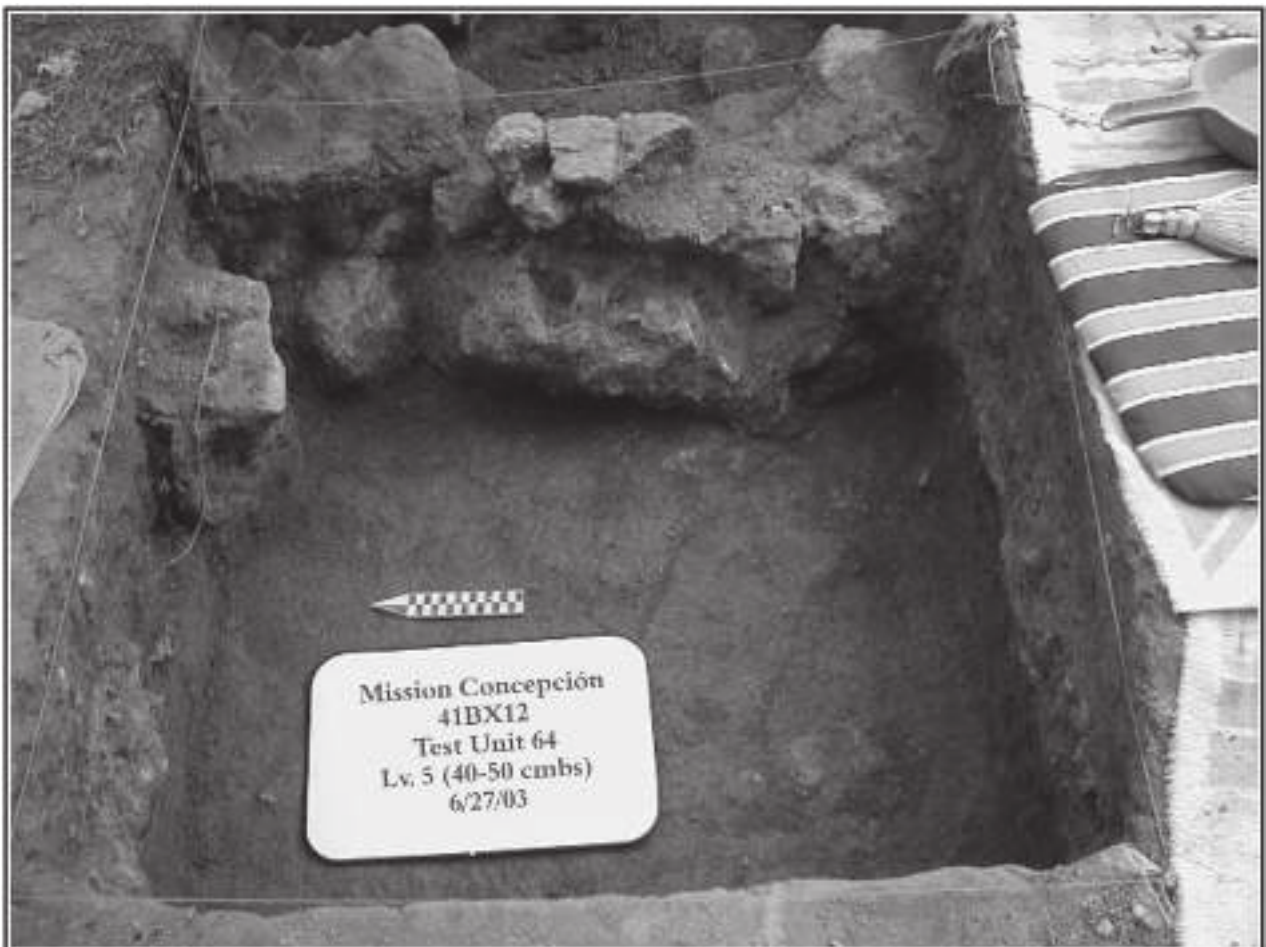
Figure 5-18. Eastern face of Alignment 1 as seen in Test Unit 64.

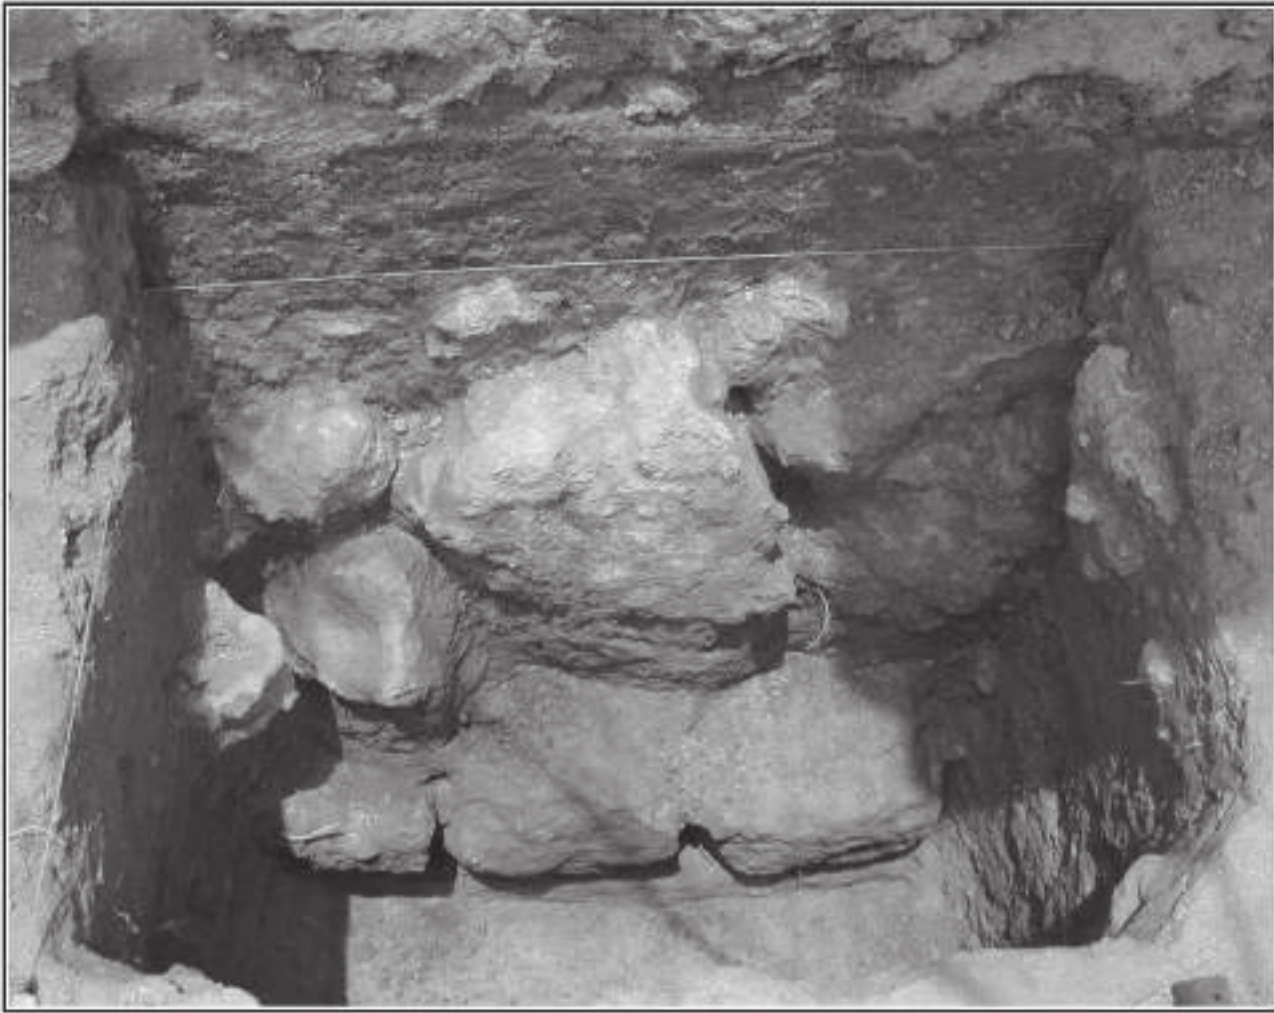
Figure 5-19. Foundation of Convento wall exposed in Test Unit 66.

The principal goal of these units was to determine the depth of the foundation of the east wall of the *convento* and examine the foundation itself. The top of the foundation began roughly 20 cmbs. The foundation consisted of large boulders of limestone that expanded toward the base creating a trapezoidal appearance. The rocks are held in place by what appears to be mortar. The outline of a trench that would have been dug for the foundation rocks could not be discerned in the north or south walls of TU 66. The large rocks that form the foundation and its trapezoidal shape are different from architectural Alignments 2 and 3. The difference may reflect

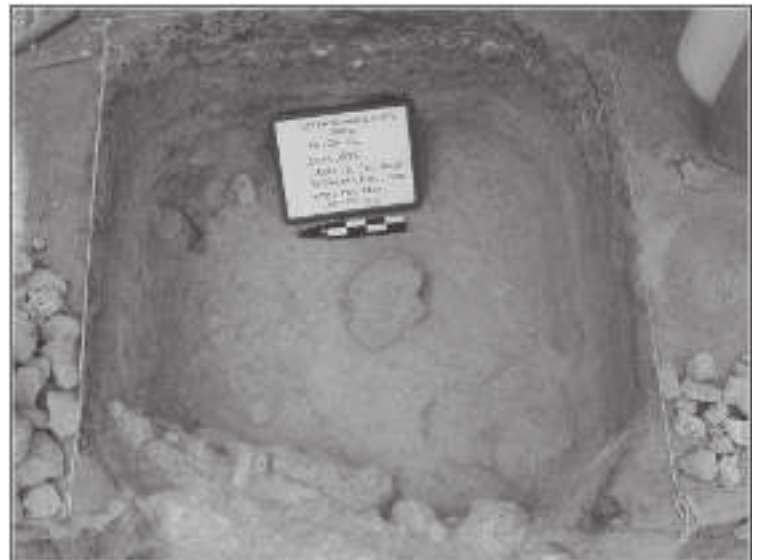
Figure 5-20. Layer of red sand that formed surface of foot path within courtyard.

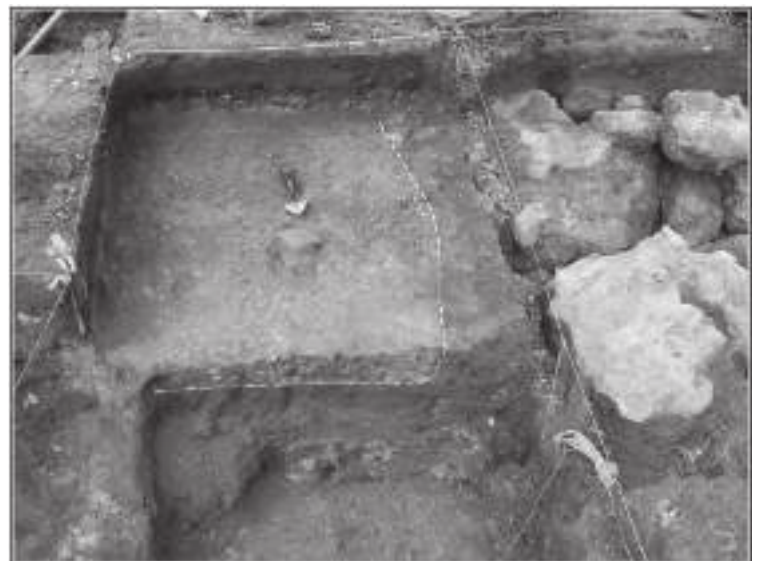
Figure 5-21. Test Unit 89 (Area 2, Block I) excavation with hard-packed gravel surface (Feature 3) exposed.

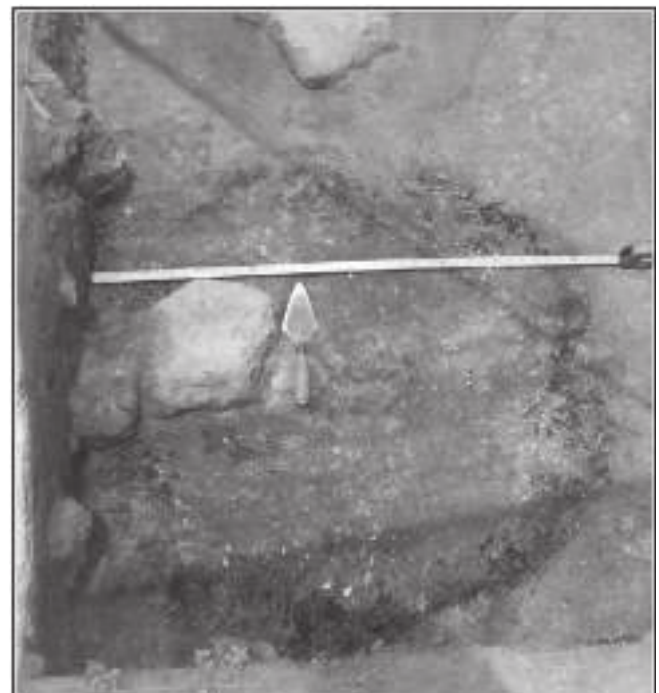
Figure 5-22. Feature 1, Test Unit 82.

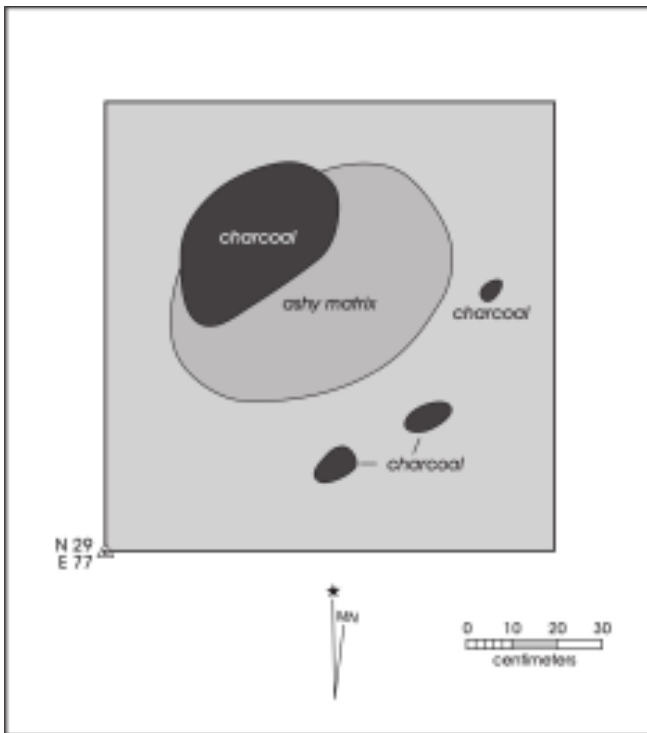
Figure 5-23. Planview of Feature 2, Test Unit 80, at 40 cmbd.

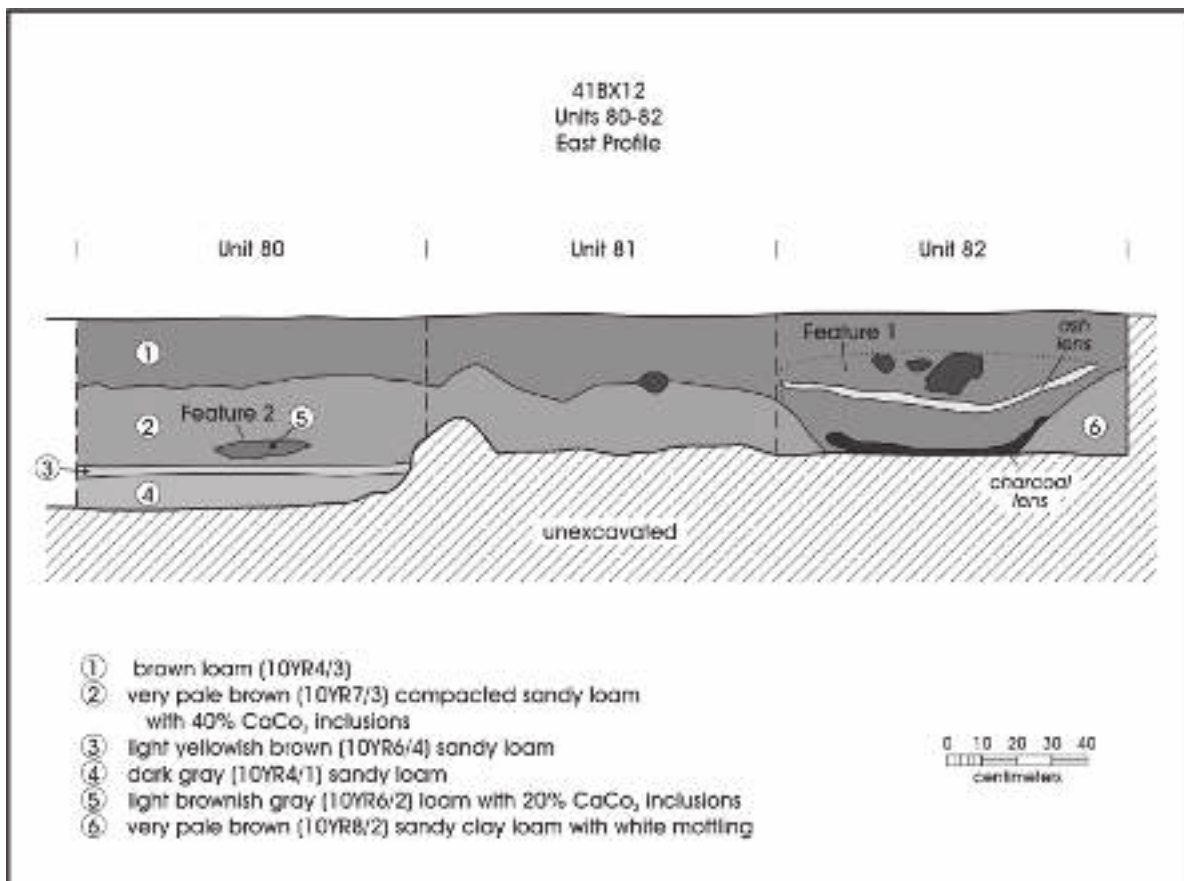
Figure 5-24. Profile of east wall of Test Units 80-82.

The profile drawing of Test Units 80, 81 and 82 indicate there are no disturbances in the block, with the exception of the utility line crossing TU's 80 and 95 (Figure 5-24). This profile was drawn prior to the termination of test unit excavations and it does not show at least two excavated levels. The profile of the east wall of these three units showed evidence of three distinct stratigraphic zones. Zone I was present in all three units but varied in color, ranging from a grayish brown to a brown (10YR 4/3), two thin lens of ash and charcoal are

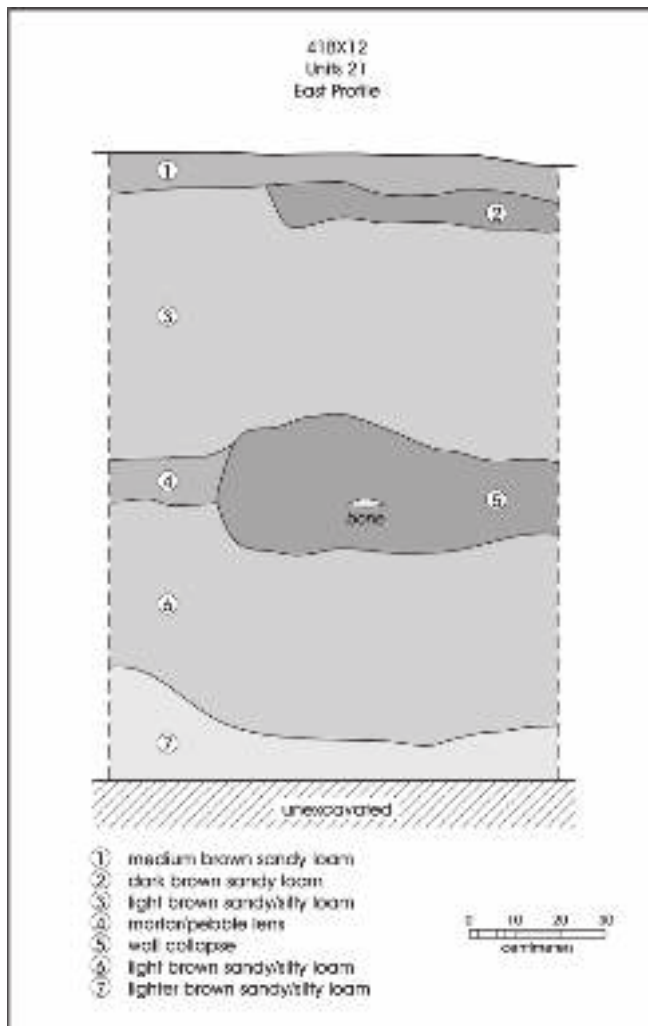
Figure 5-25. Profile of south wall of Test Unit 21.

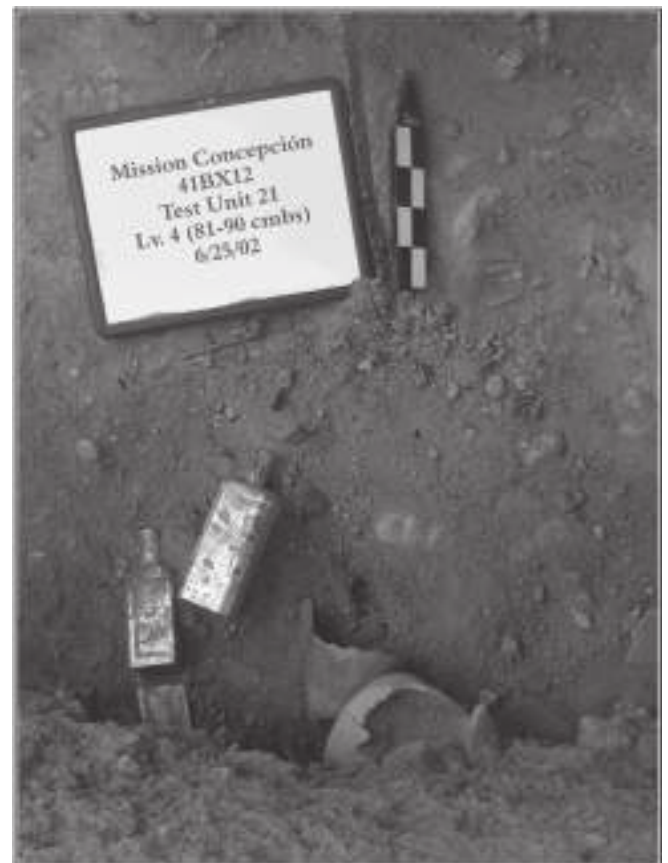
Figure 5-26. Garbage in Feature 5, Test Unit 21.

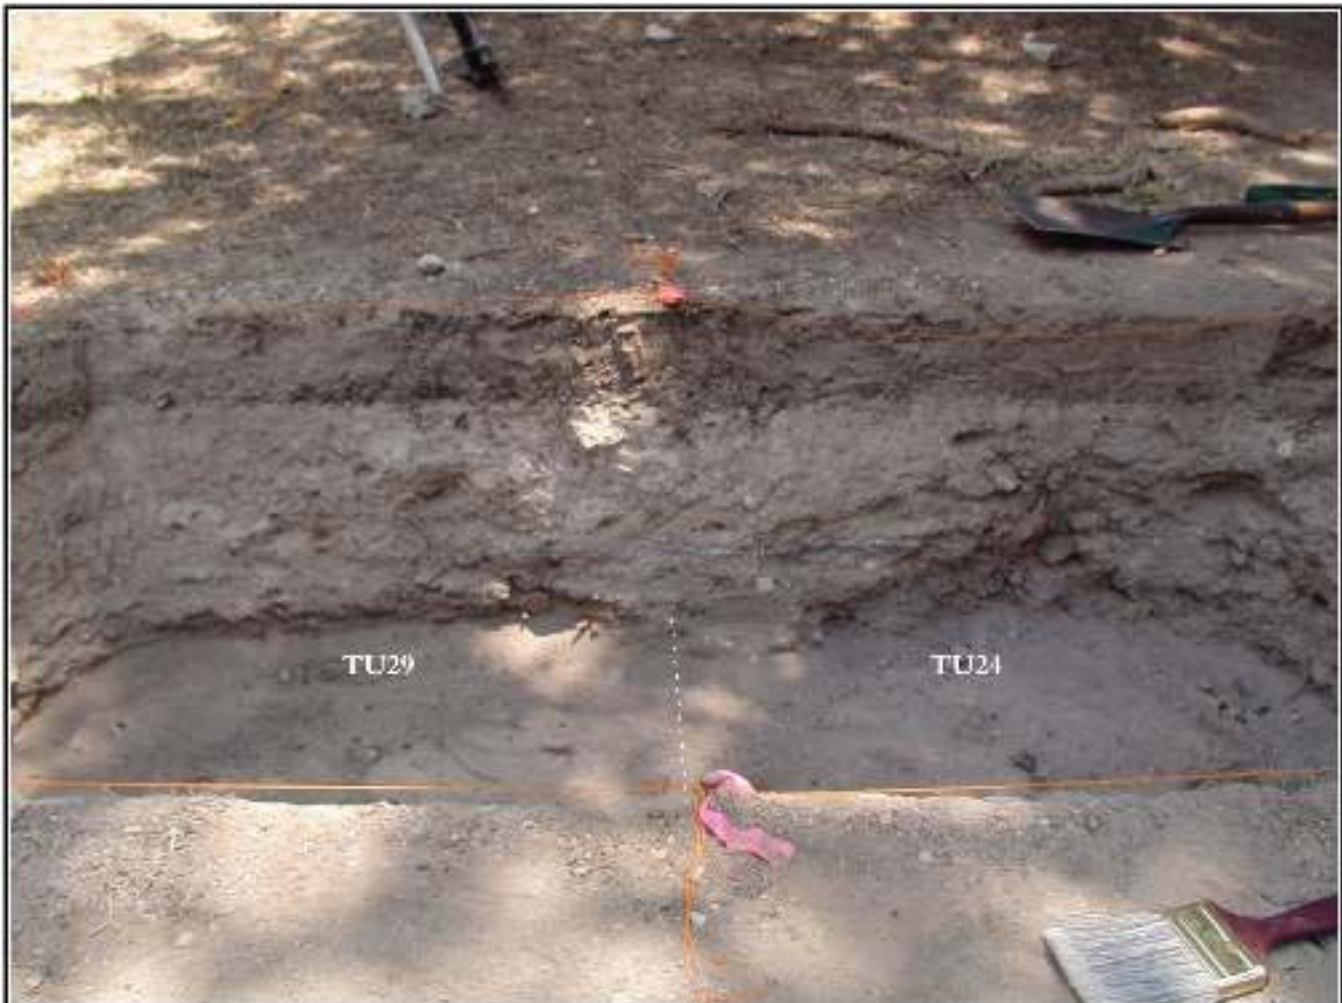
Figure 5-27. Hard-packed level surface below top soil in Test Units 24 and 29.
