Archaeological Investigations in the Courtyard of Mission Nuestra Señora de la Purisima Concepción Acuña (41BX12)

by
Antonia L. Figueroa and Steve A. Tomka

Prepared by:
Center for Archaeological Research
The University of Texas at San Antonio
Archaeological Report, No. 403

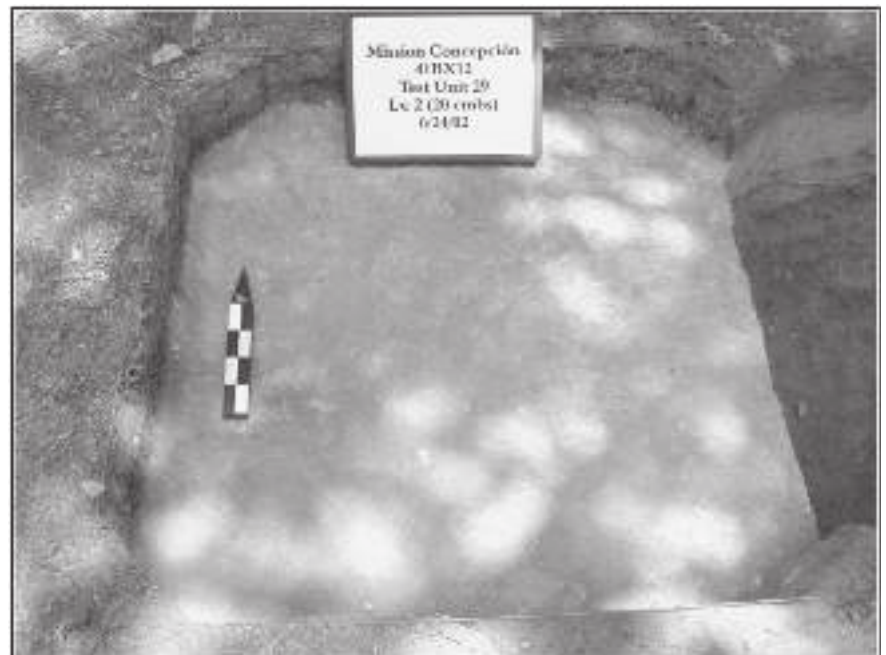
Figure 5-28. Top of hard-packed surface in Test Unit 29.

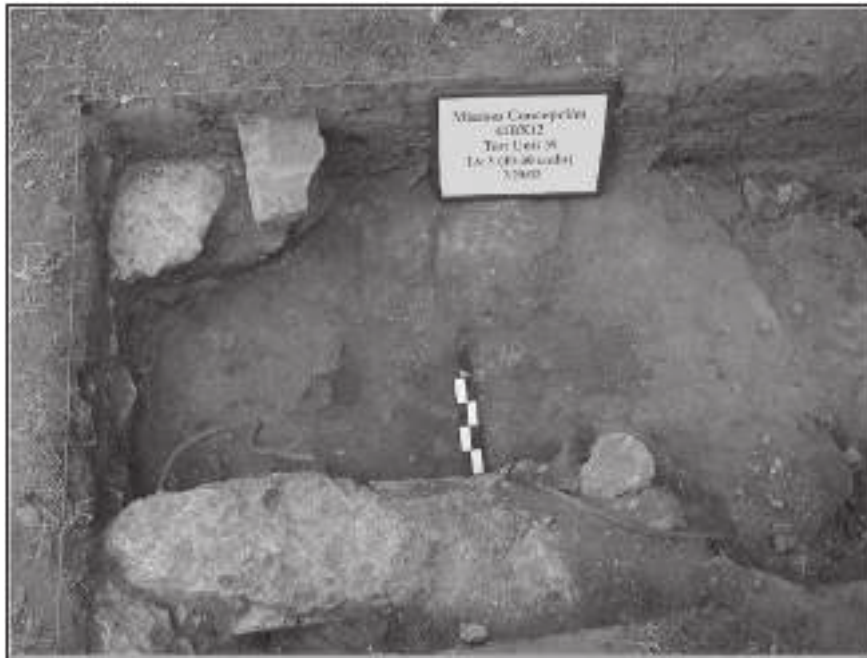
Figure 5-29. Remnant of concrete foundation of restroom facility in Test Unit 39.

associated with this facility were exposed at the bottom of Level 2 (10-20 cmbs) in each of the test units (39, 73, 68, 98, and 99). Spanish colonial foundation remains were identified beneath the 1940s bathroom when the bathroom was removed.

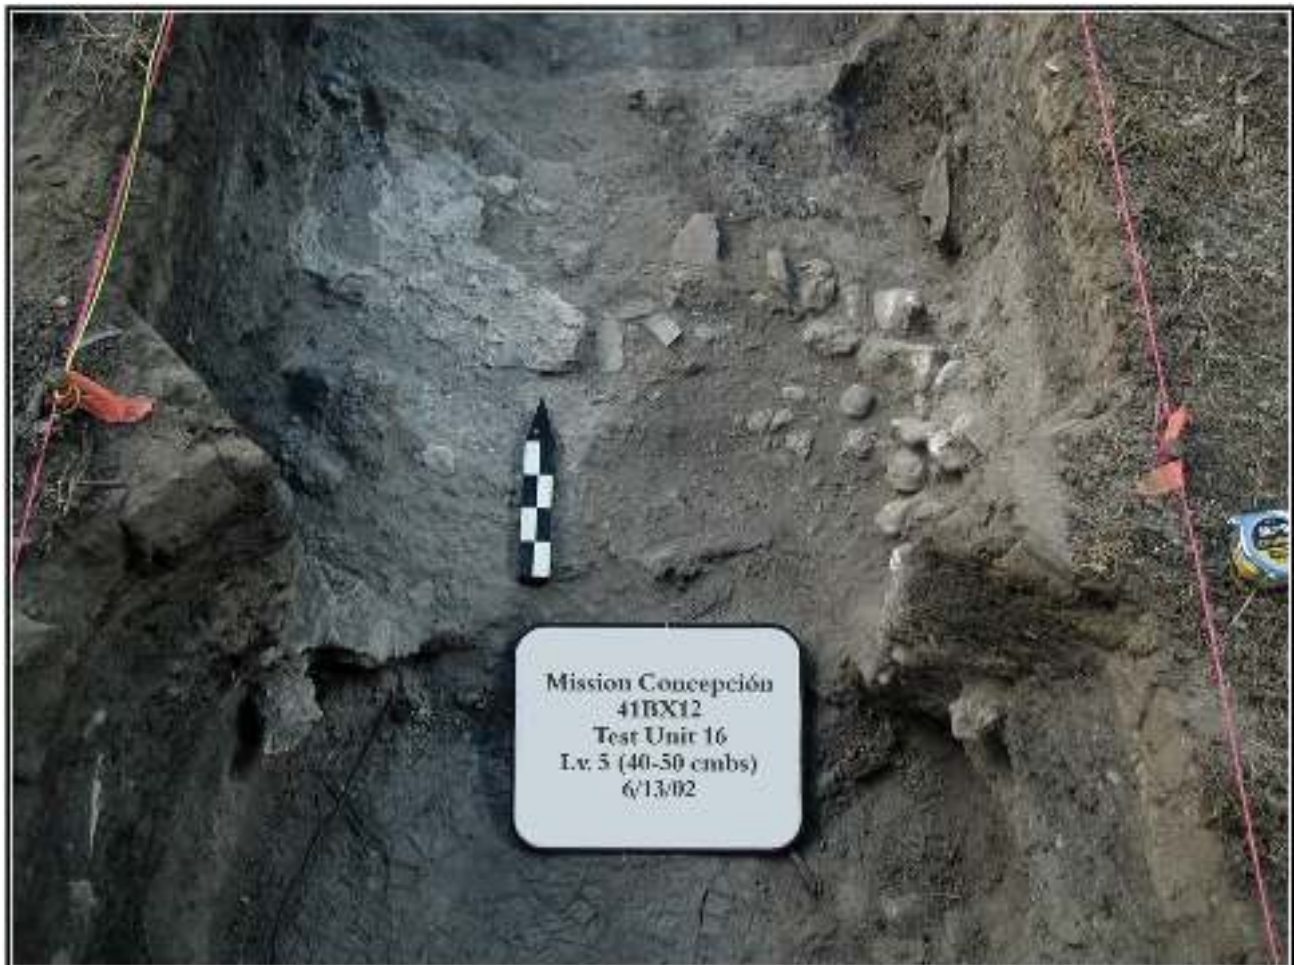
Figure 5-30. Plaster surface exposed in Test Unit 16, Area 5.

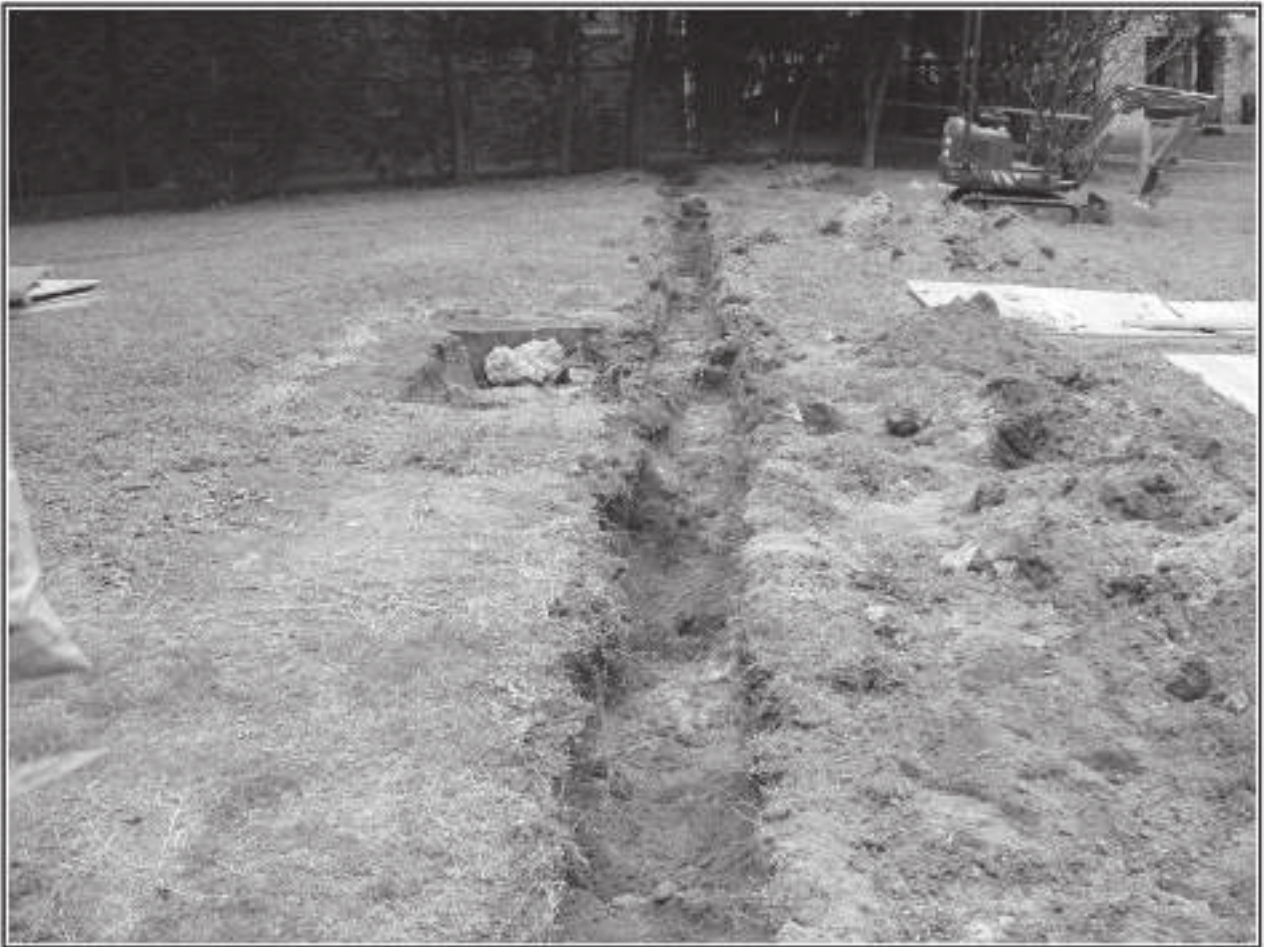
Figure 5-32. Southern portion of Trench 3 excavated by small trackhoe.

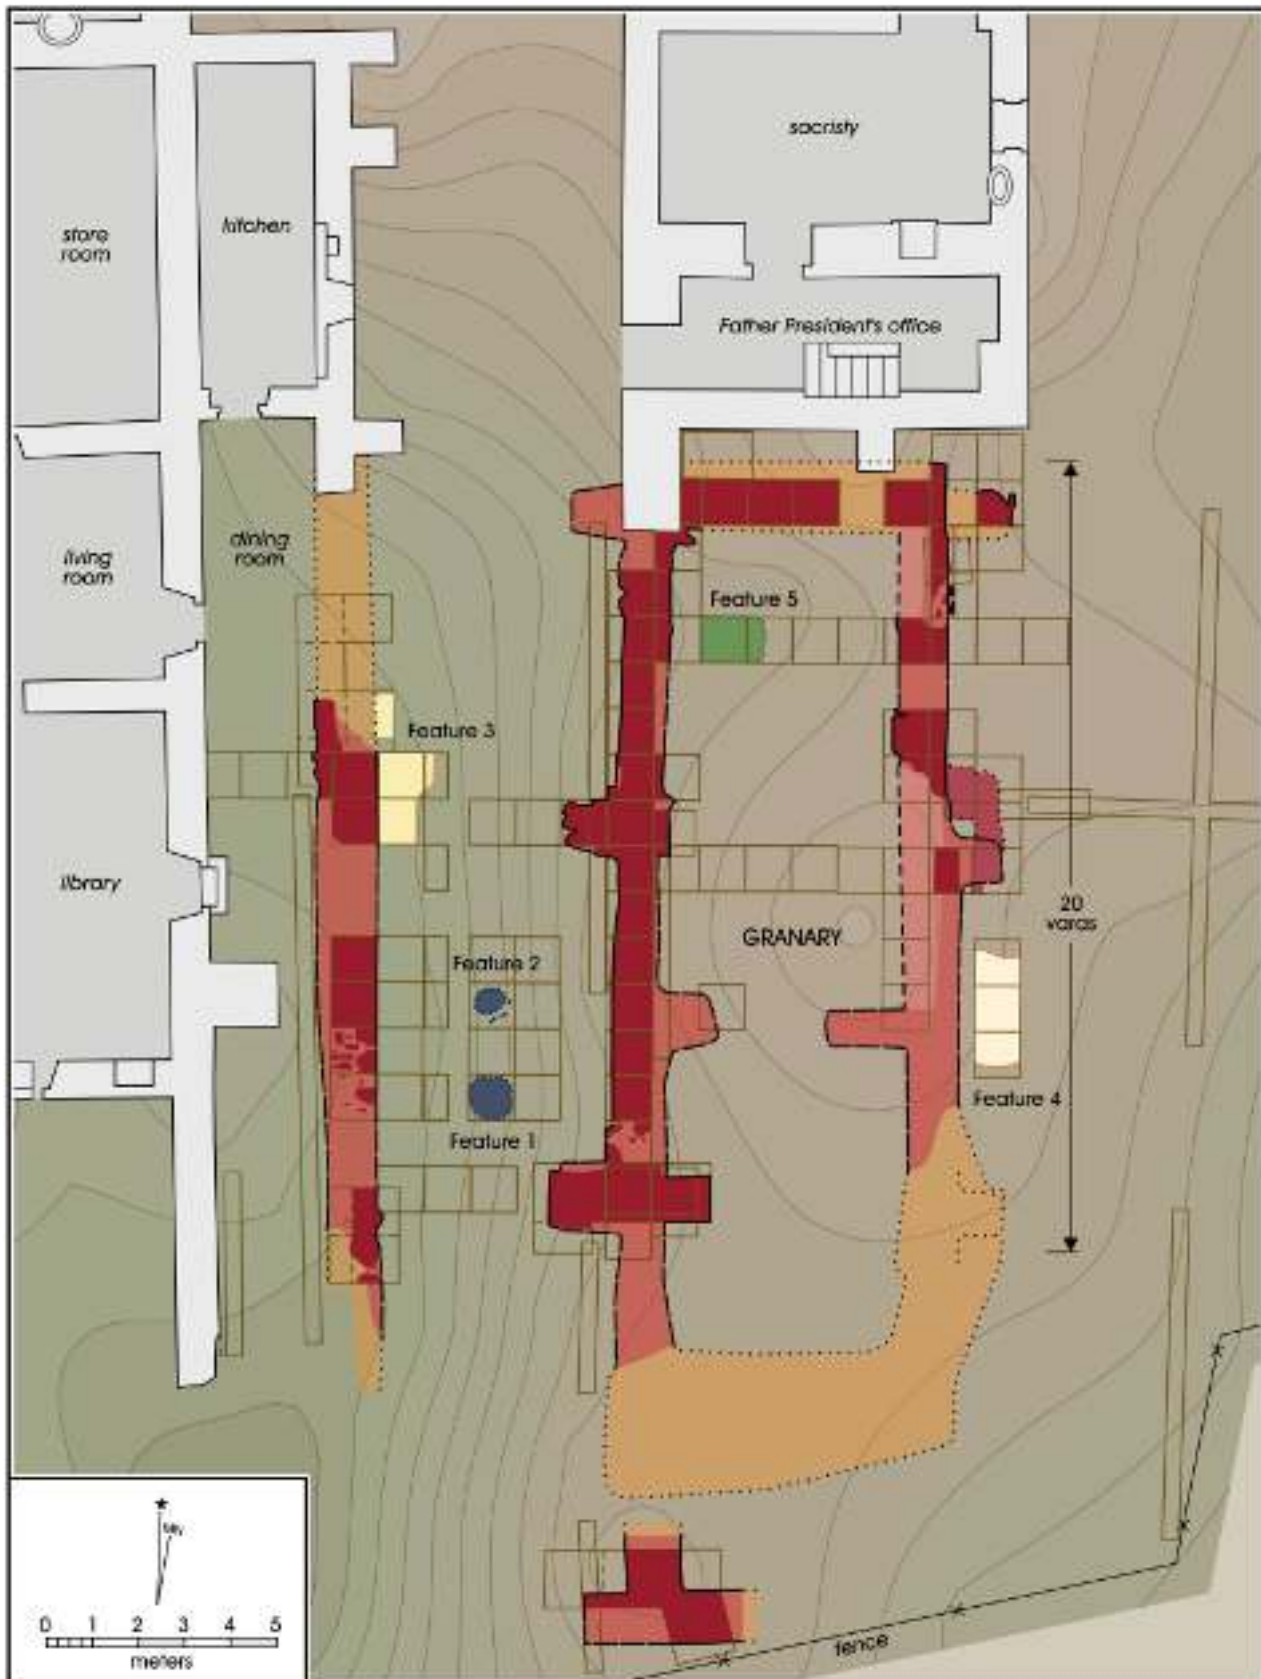
Figure 7-1. Structural remains, conjectured alignments of the granary and features exposed during excavations.
