Testing and Data Recovery at the Pérez Ranch (41BX274), San Antonio, Bexar County, Texas

Texas Antiquities Committee Permit No. 4770

Prepared by:
Center for Archaeological Research
The University of Texas at San Antonio
One UTSA Circle
San Antonio, Texas 78249
Archaeological Report No. 404

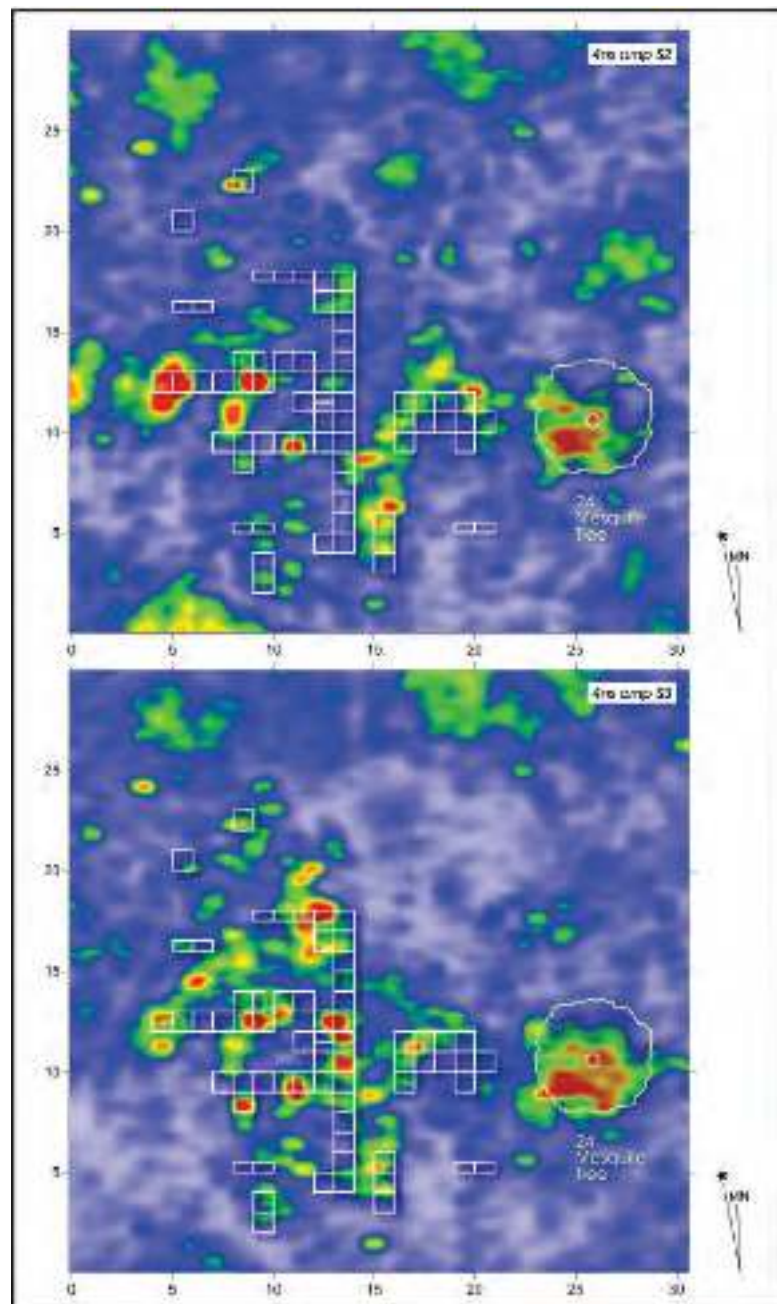
Figure 5-1. Placement of excavation units over the results of Ground Penetrating Radar (GPR) survey.

Prior to the archaeological services conducted by CAR, THC volunteered to conduct a Ground Penetrating Radar and magnetometer survey of an area of the site where the foundation to the stone house was believed to be. The THC set up a 40-x-30 meter grid and systematically walked the grid to obtain the shots for the magnetometer survey. The GPR survey was done within the same grid, though the entire grid was not examined. The GPR survey consisted of a 30-x-30 meter portion of the grid. The grid was orientated to the magnetic North. The information gathered during the GPR and magnetometer survey was analyzed to find any anomalies that would indicate buried features. The results of the GPR and magnetometer survey influenced the placement of the units in the area of the stone foundation.

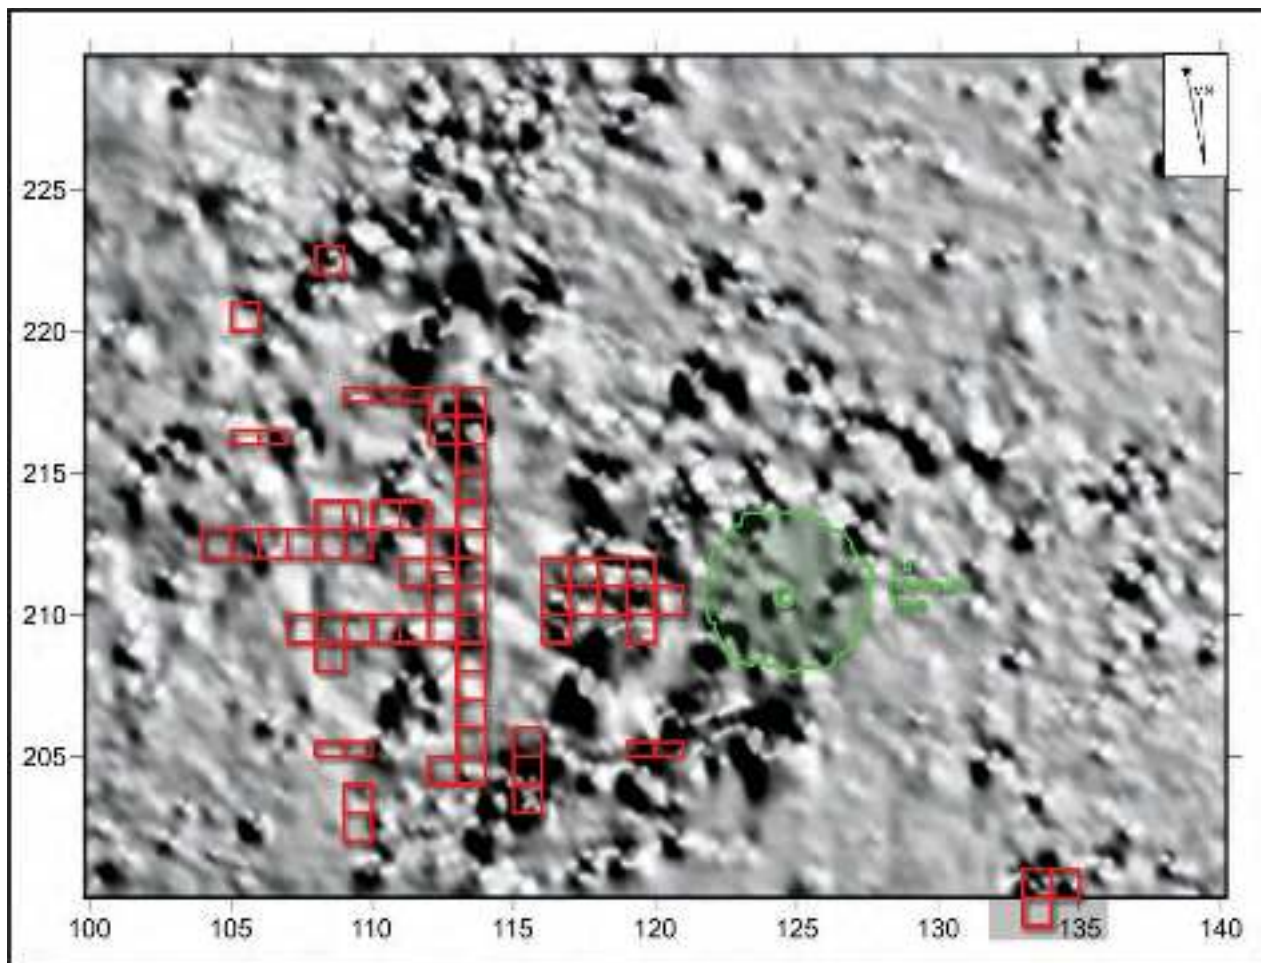
Figure 5-2. Location of excavation units over the results of the Magnetometer survey.

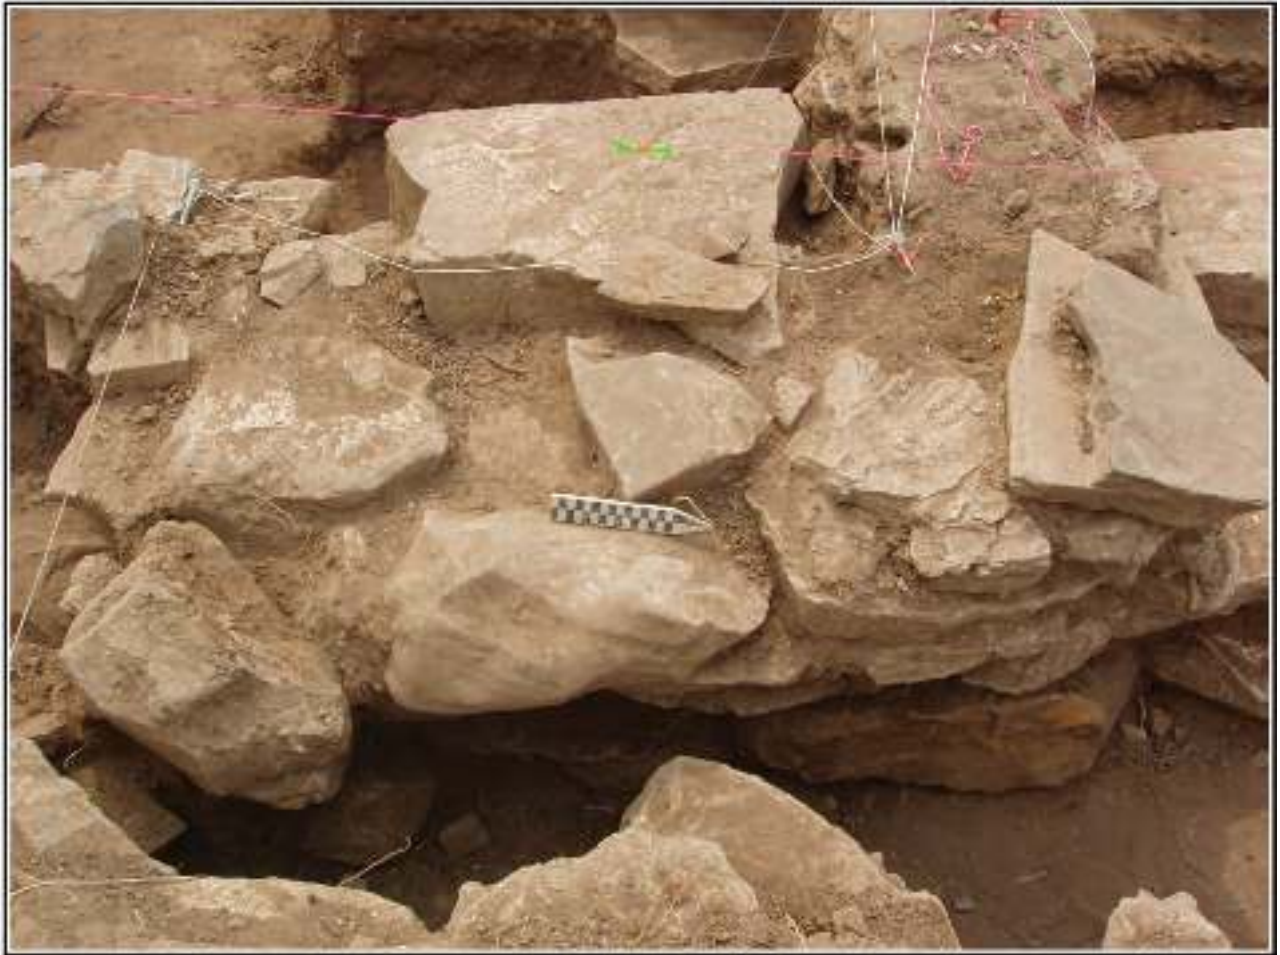
Figure 5-9. Stone foundation in Unit 6.

Unit 7 also contained a large quantity of rock. Initially, only the eastern half of the unit could be excavated due to what appeared to be *in situ* foundation stones occupying the rest of the unit. Later, the northwest corner of the unit was excavated. In Levels 2-4 (20-50 cmbd), additional rocks were uncovered and any that appeared to be at an angle were removed. These levels produced very few artifacts. Level 5 (50-60 cmbd) saw an increase in the density of

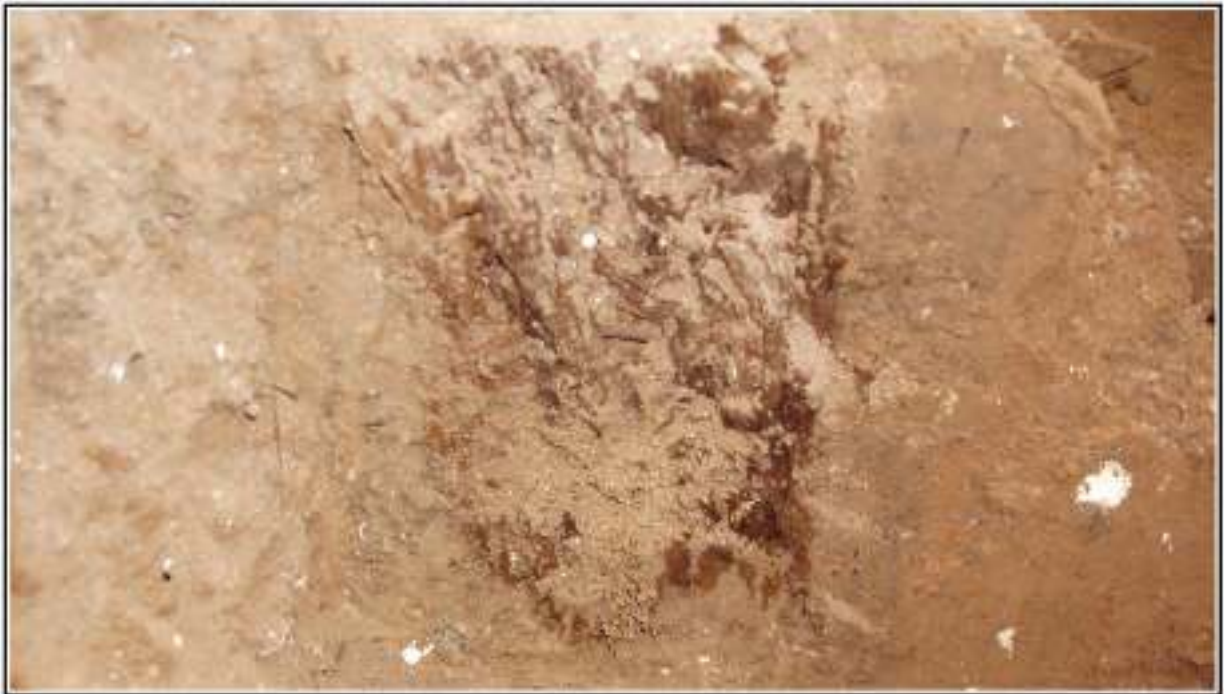
Figure 5-11. *Post hole with portions of post, Feature 2.*

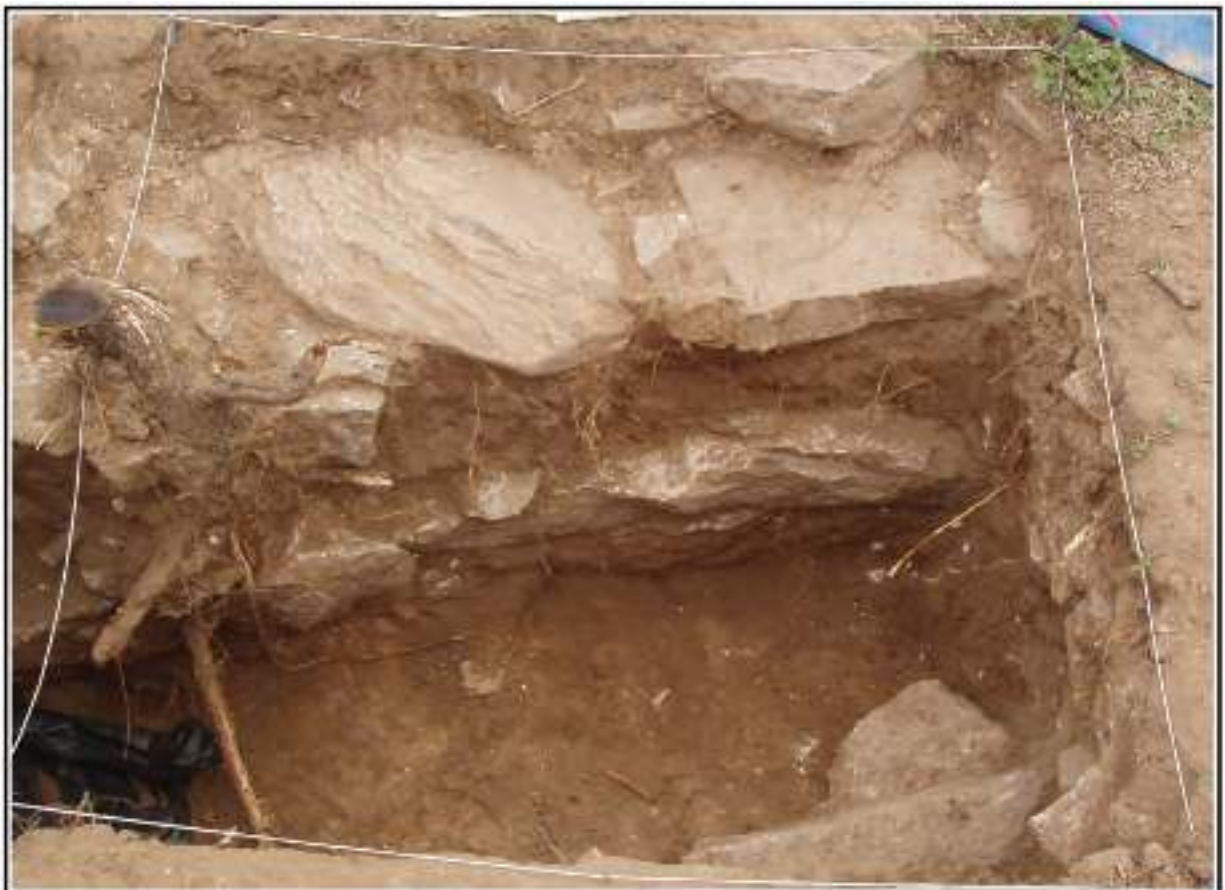
Figure 5-12. *Foundation exposed in the east wall of Unit 64.*

Unit 64 was excavated just to the south of Unit 63. The foundation was exposed in the eastern half of the unit (Figure 5-12). The western portion of the unit represents the interior of the structure; it was excavated to 100 cmbd. Unit 64 lacked the abundance of cut nails (n=5) in comparison to Unit 63 (n=20). Mortar (25.8 g) was only present in Level 5 (70-80 cmbd). Prehistoric or non-European materials were most

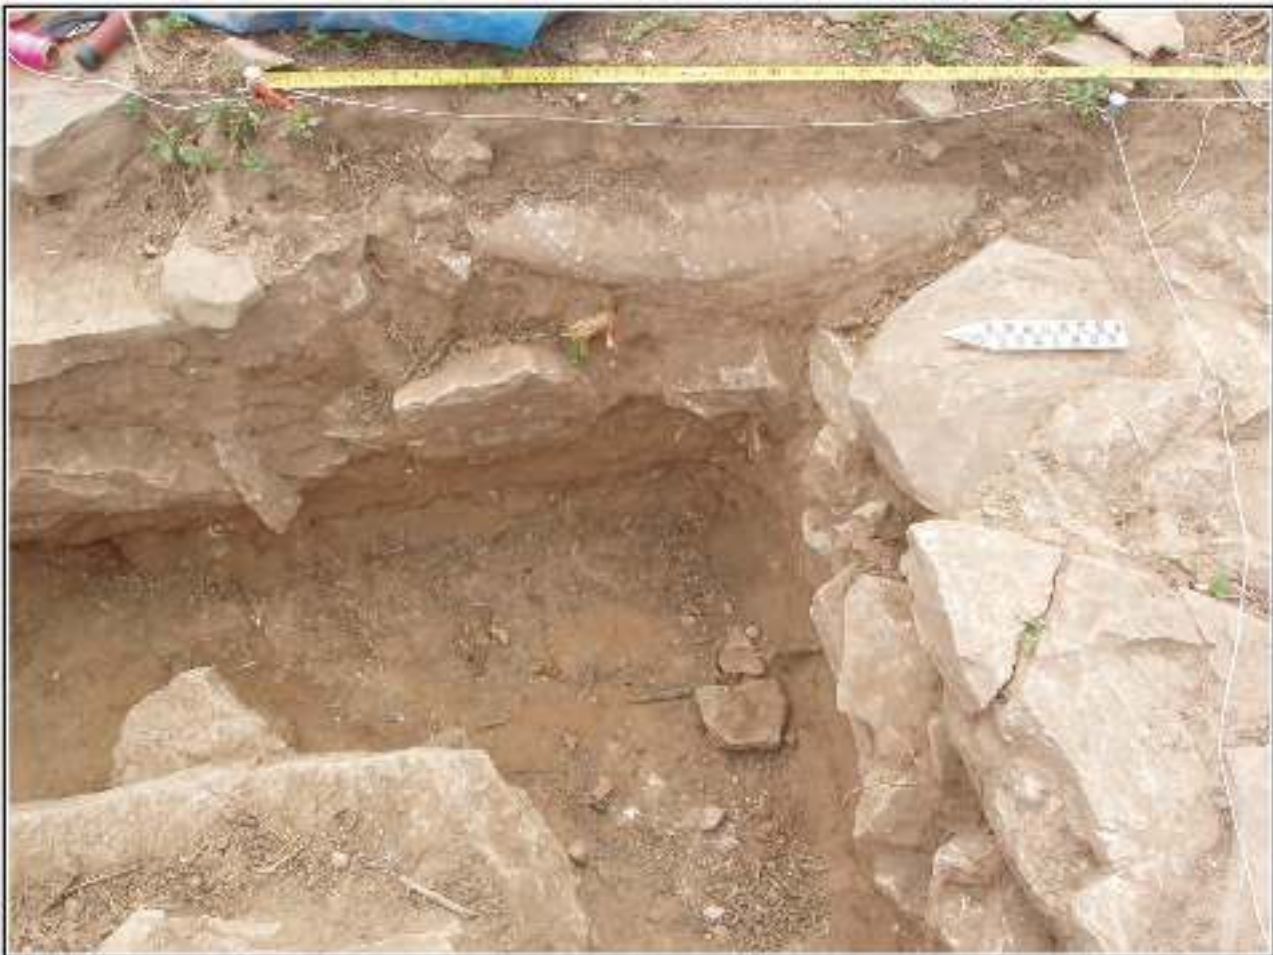
Figure 5-13. The interior of the southwest corner of the stone foundation.

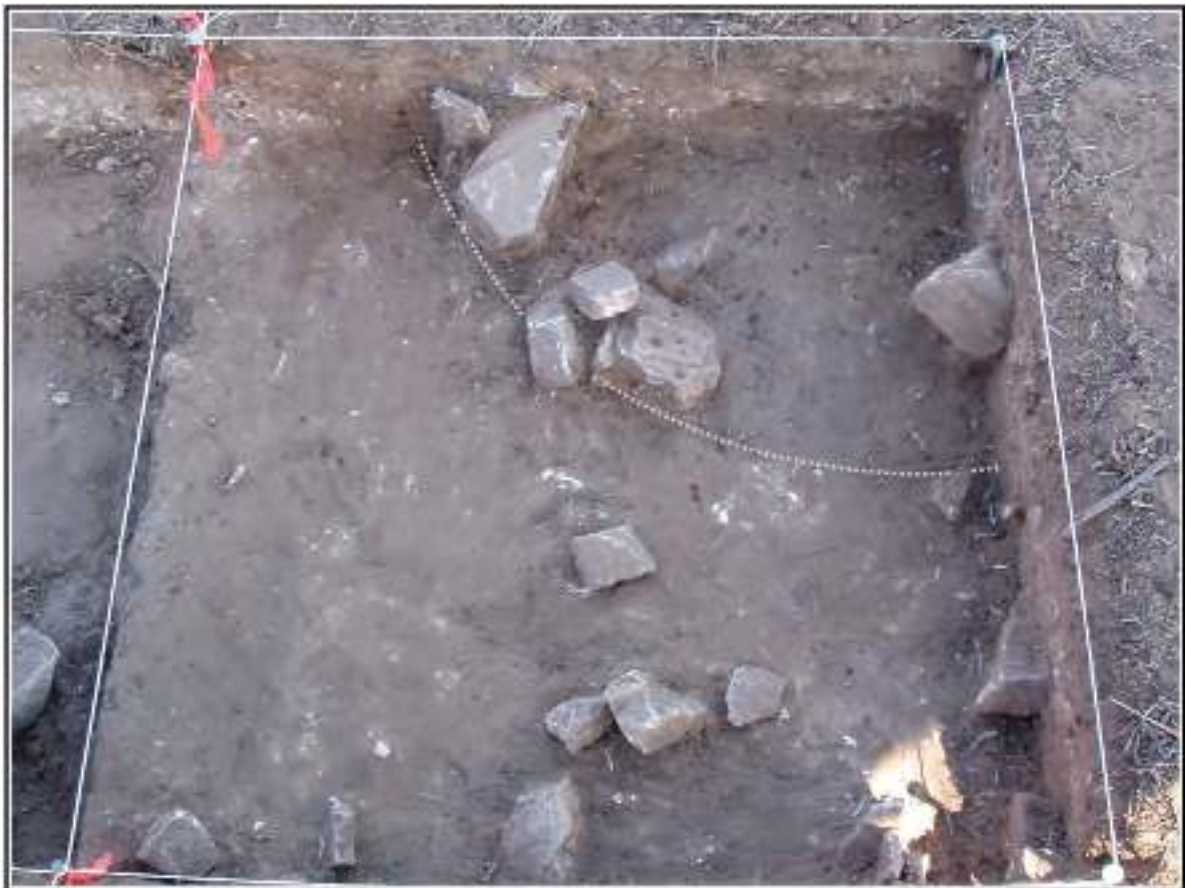
Figure 5-21. Feature 1 in the northeast quadrant of Unit 13, Level 3.

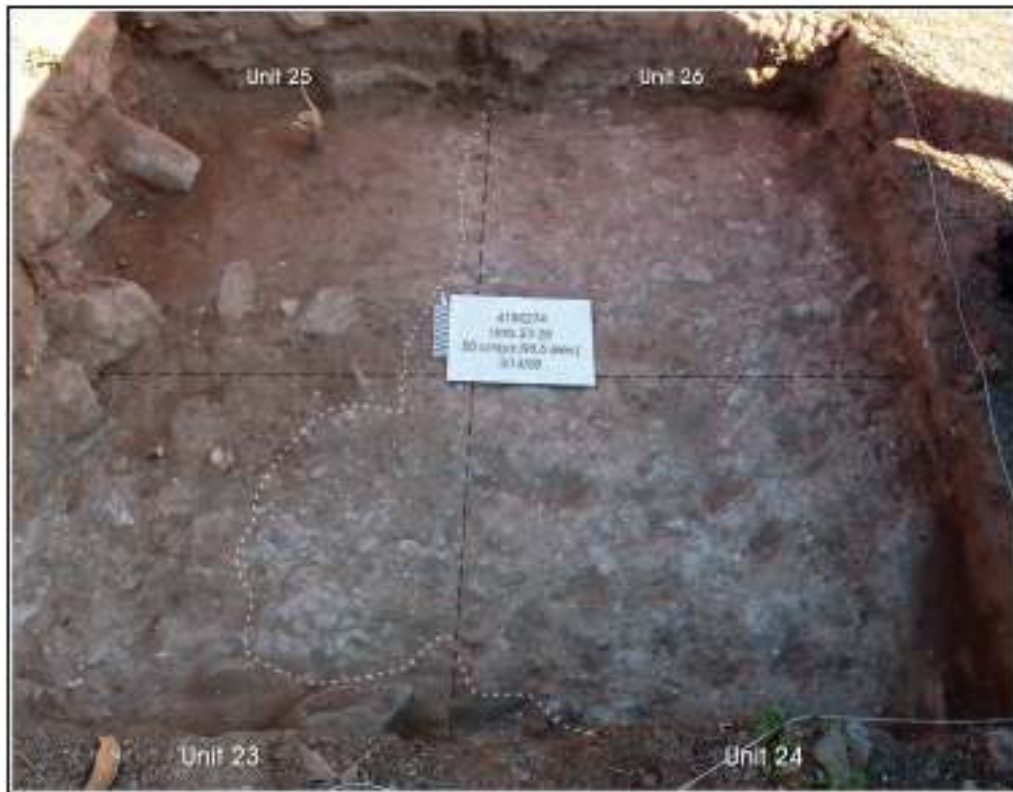
Figure 5-23. Mortar surface (Feature 6) encountered across the eastern portions of the block composed by Units 23-26.

Units 23-26 and 57-58 in Area D also appear to be a case of a wall falling away from the structure. The plaster is

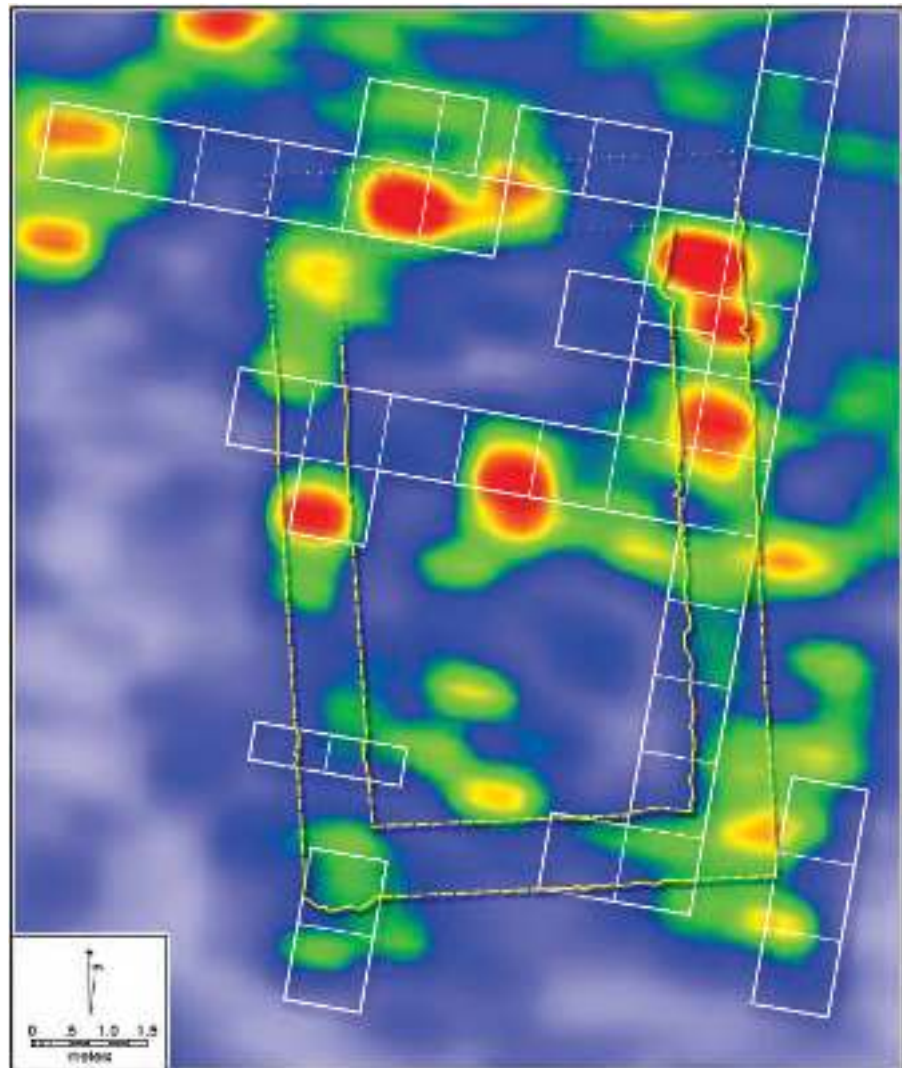
Figure 7-6. Plan view of the stone foundation projected onto the 4ns amp 3s GPR map.

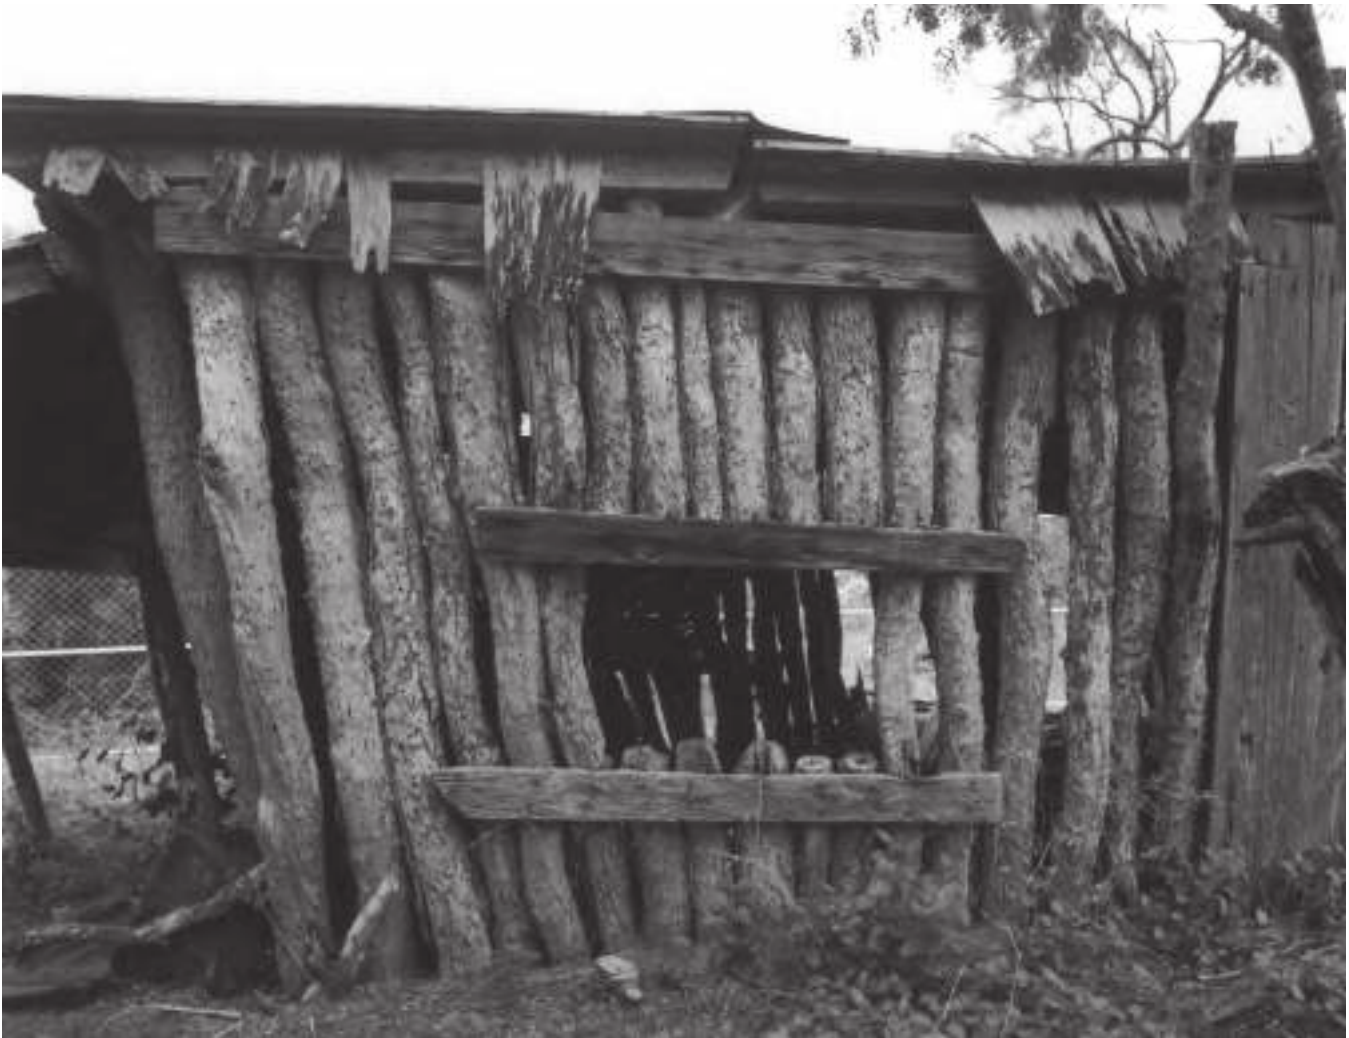
Figure C-7. View of jacal showing window detail and construction elements, looking west (TX-3539-A-5).

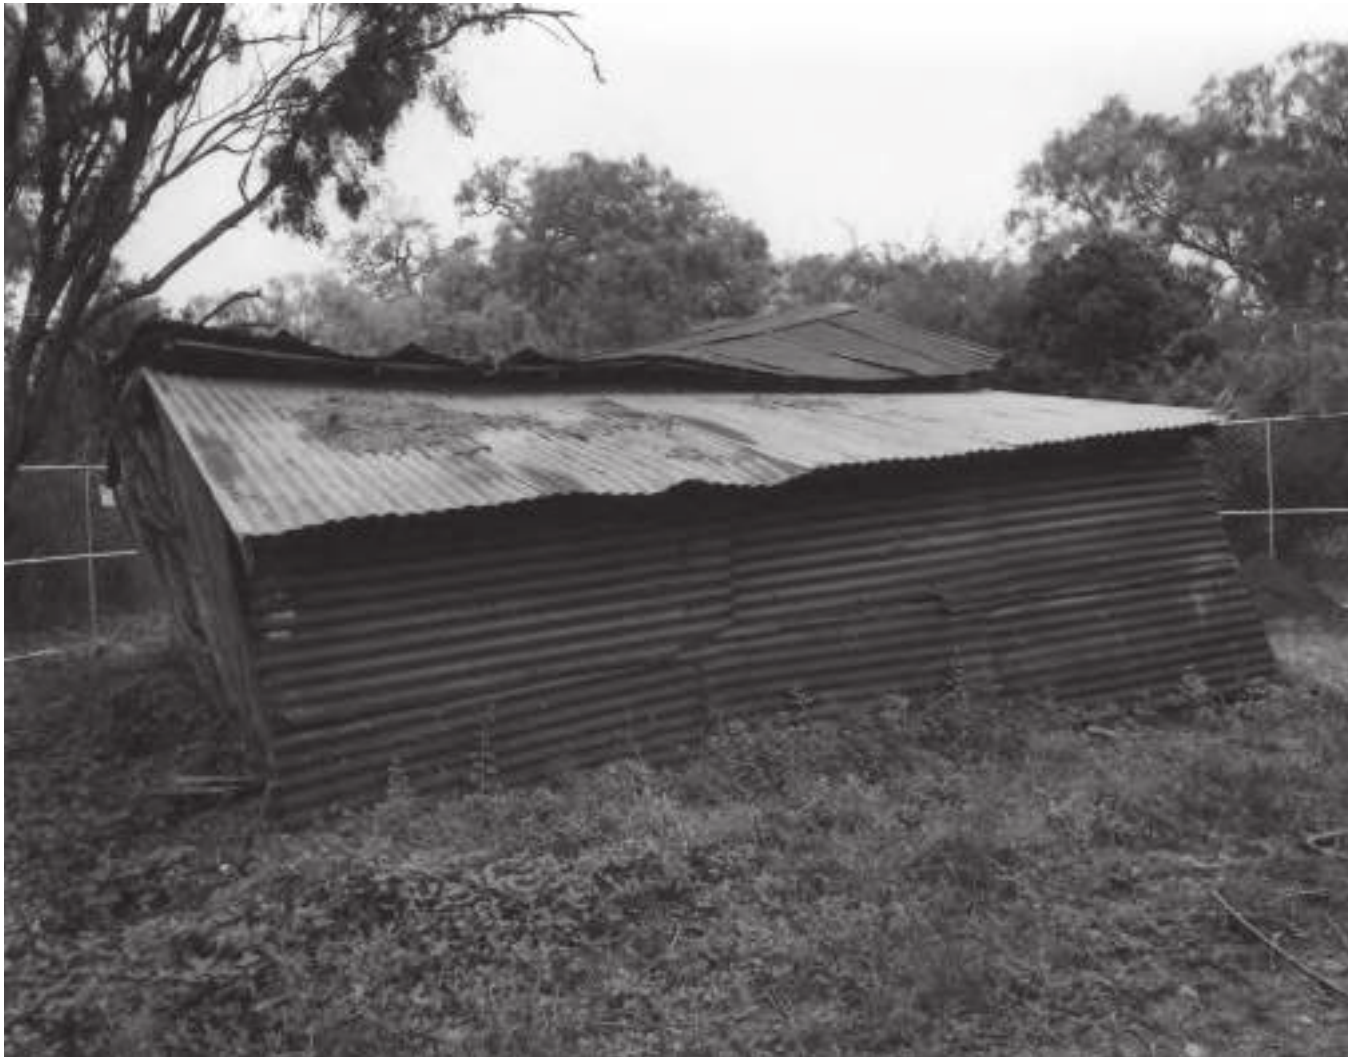
Figure C-8. View of jacal showing rear construction materials and roof, looking south (TX-3539-A-6).

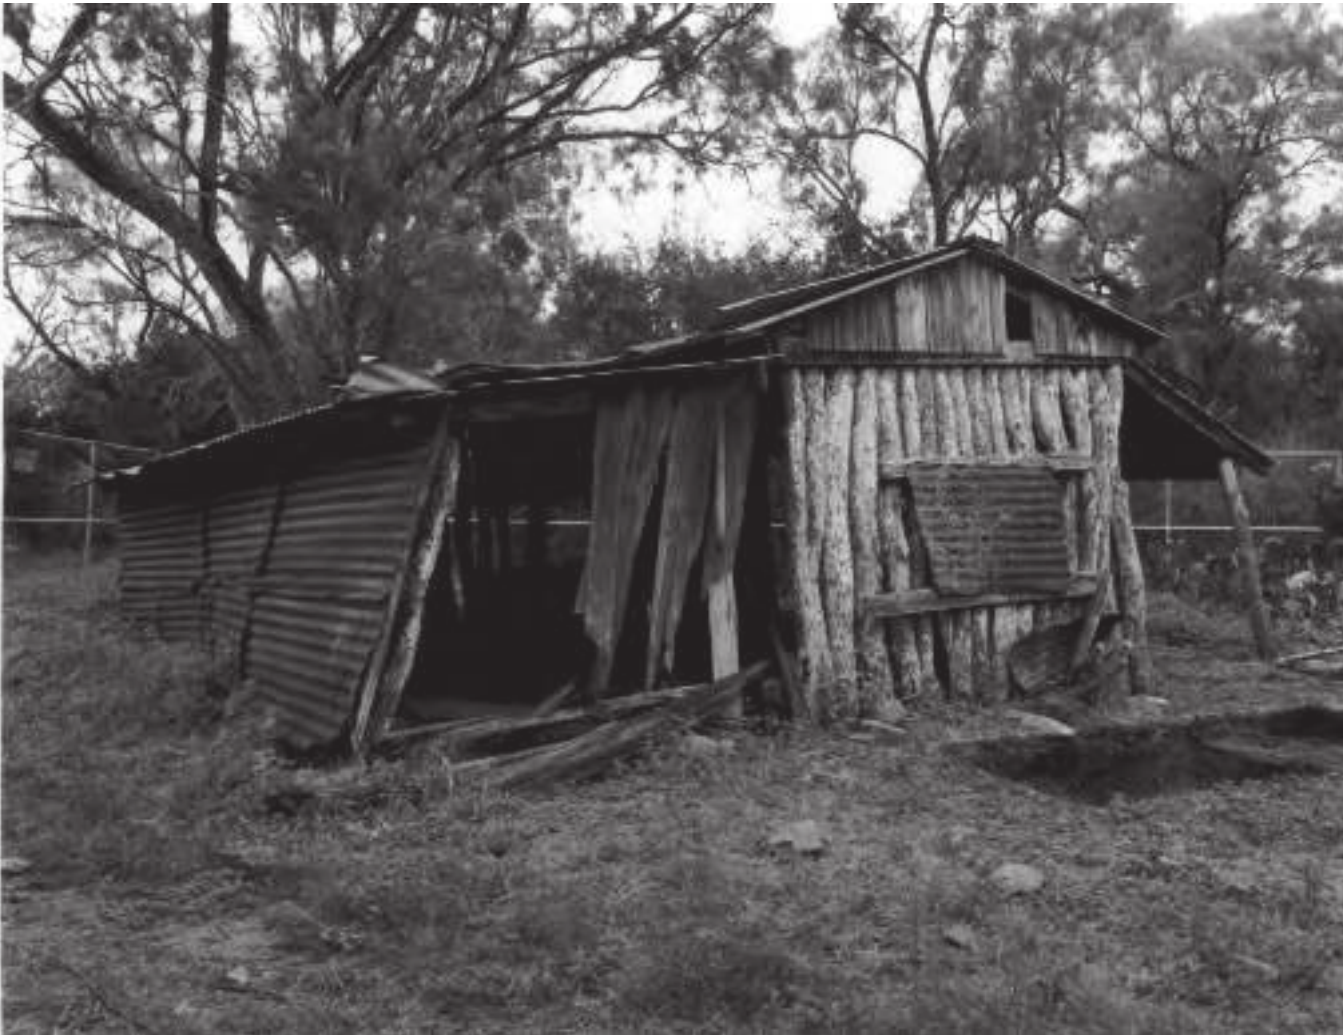
Figure C-9. View of jacal showing commercial and historic construction materials and damage, looking southeast (TX-3539-A-7).

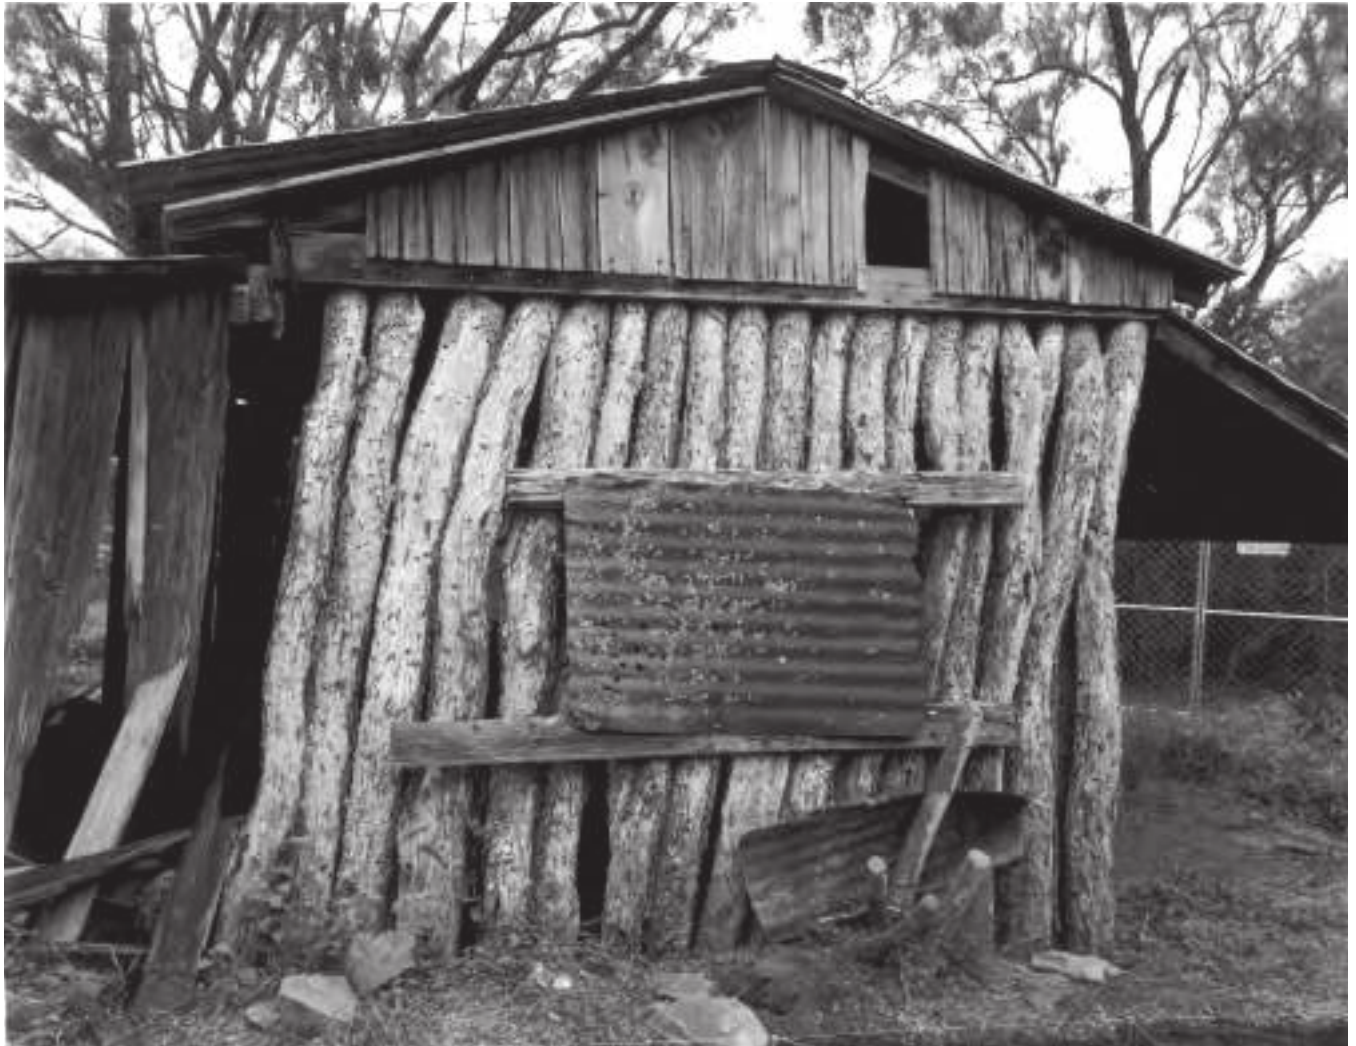
Figure C-10. View of jacal window and gable detail with modern and historic construction material, looking east (TX-3539-A-8).

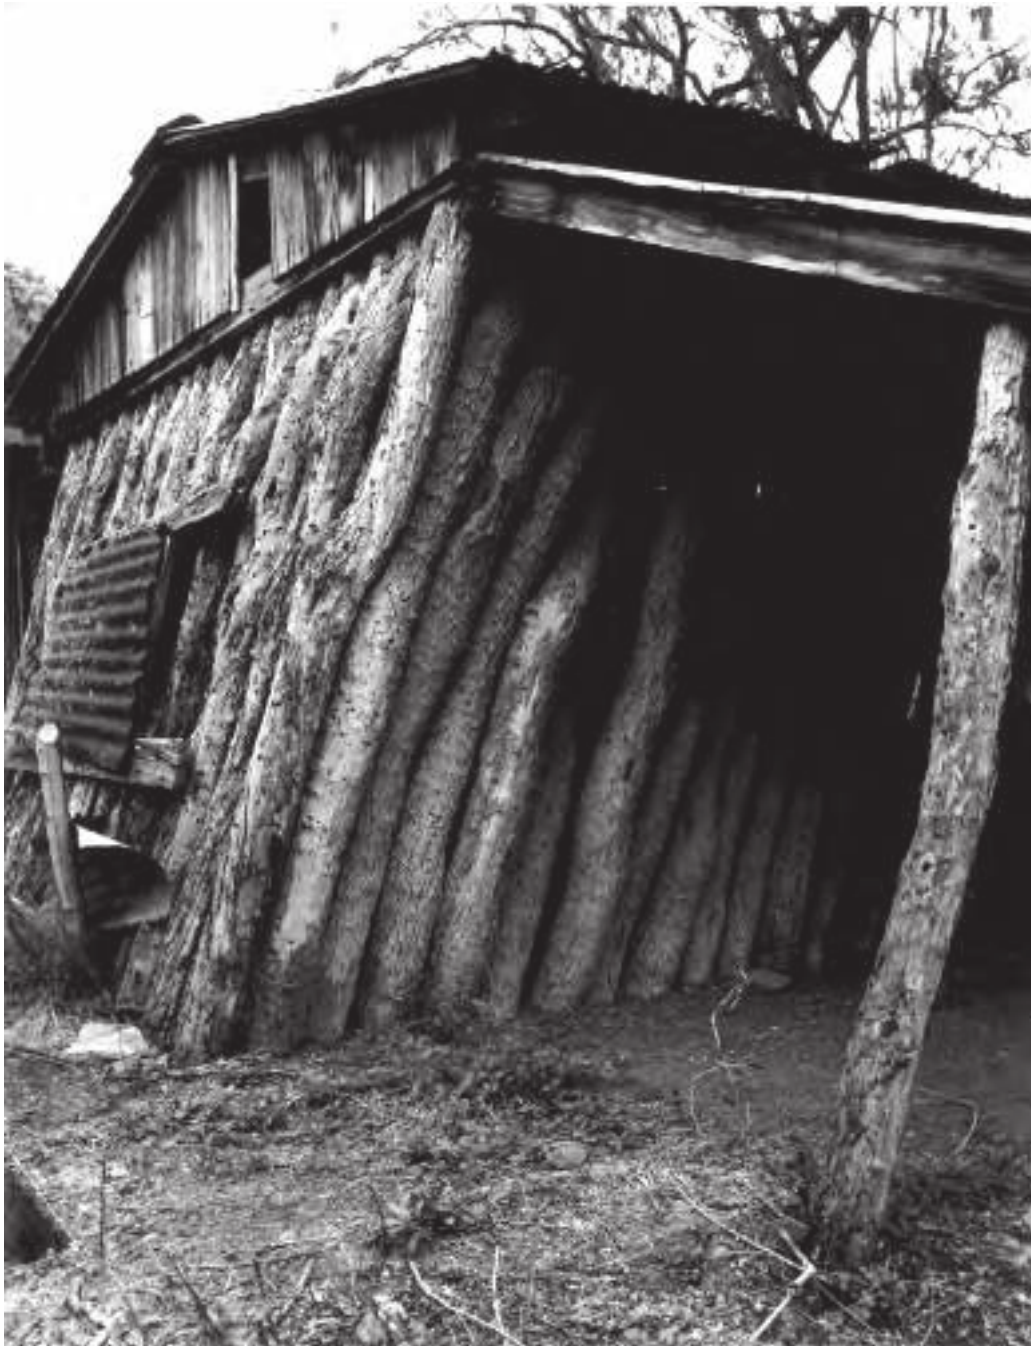
Figure C-11. View of jacal showing detail of overall tilt at southwest corner, looking northeast (TX-3539-A-9).
