# Intensive Survey and Testing Associated with the Rediscovery of the Acequia Madre and Alamo Dam, San Antonio, Bexar County, Texas

Prepared by:  
Center for Archaeological Research  
The University of Texas at San Antonio  
One UTSA Circle  
San Antonio, Texas 78249  
Archaeological Report, No. 417

**Intensive Survey and Testing  
Associated with the Rediscovery of  
the Acequia Madre (41BX8) and Alamo Dam,  
San Antonio, Bexar County, Texas**

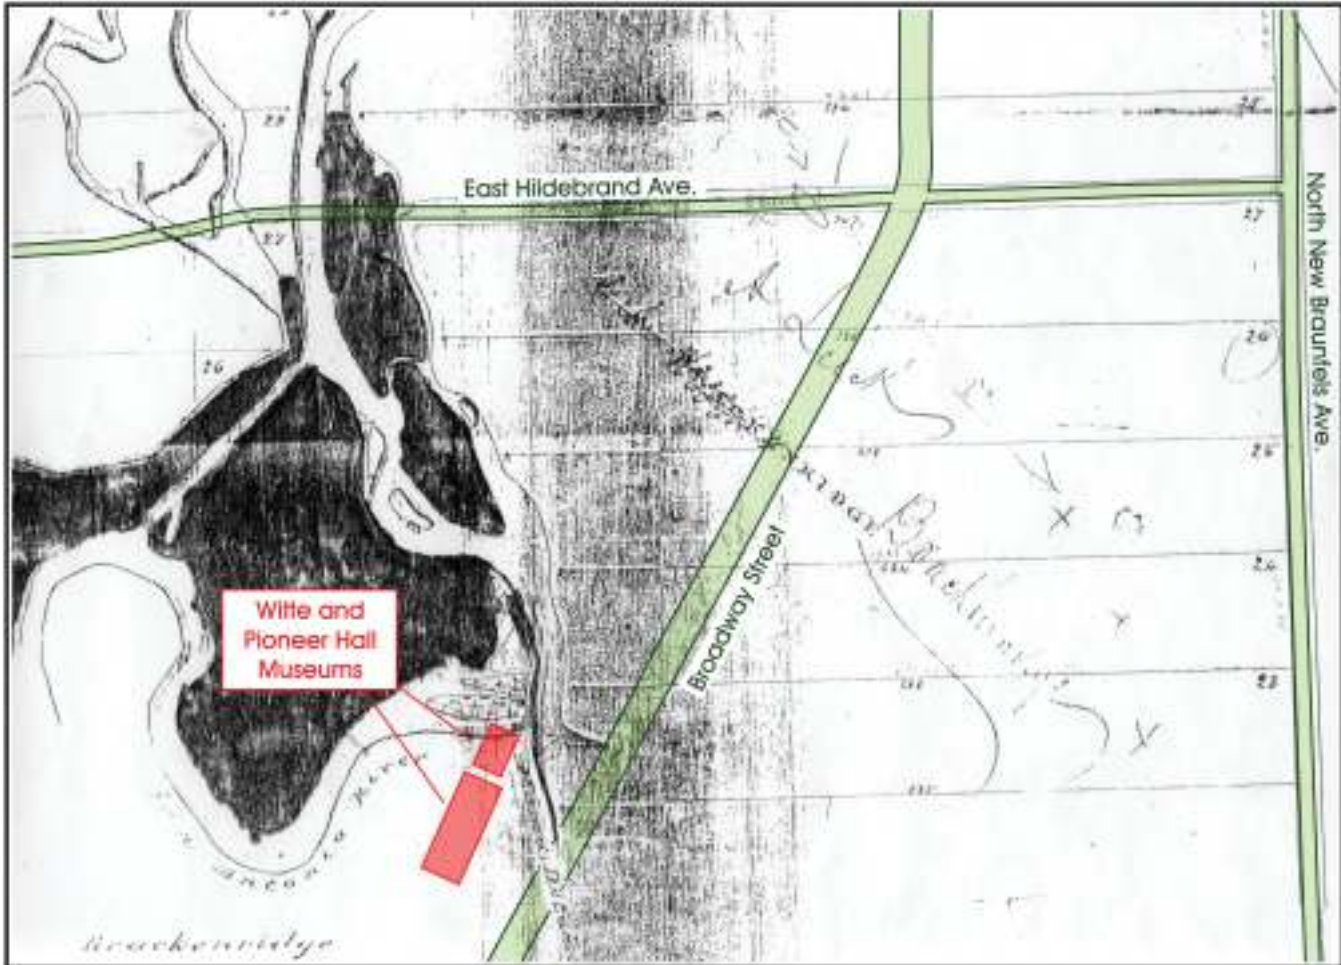
San Antonio River to the west. Historic maps, such as Louis Giraud's 1879 drawing (Figure 1-2), indicate that the head of the *Acequia Madre*, also known as the *Alamo Acequia*, was located at the bend in the San Antonio River just north of the Witte Museum. The *acequia* began on the east bank

Figure 1-2. Map of the project area drawn by City Engineer Louis Giraud 1879 showing the San Antonio River and alignment of the *Alamo Acequia* and dam. Museum Complex and selected streets added for reference.

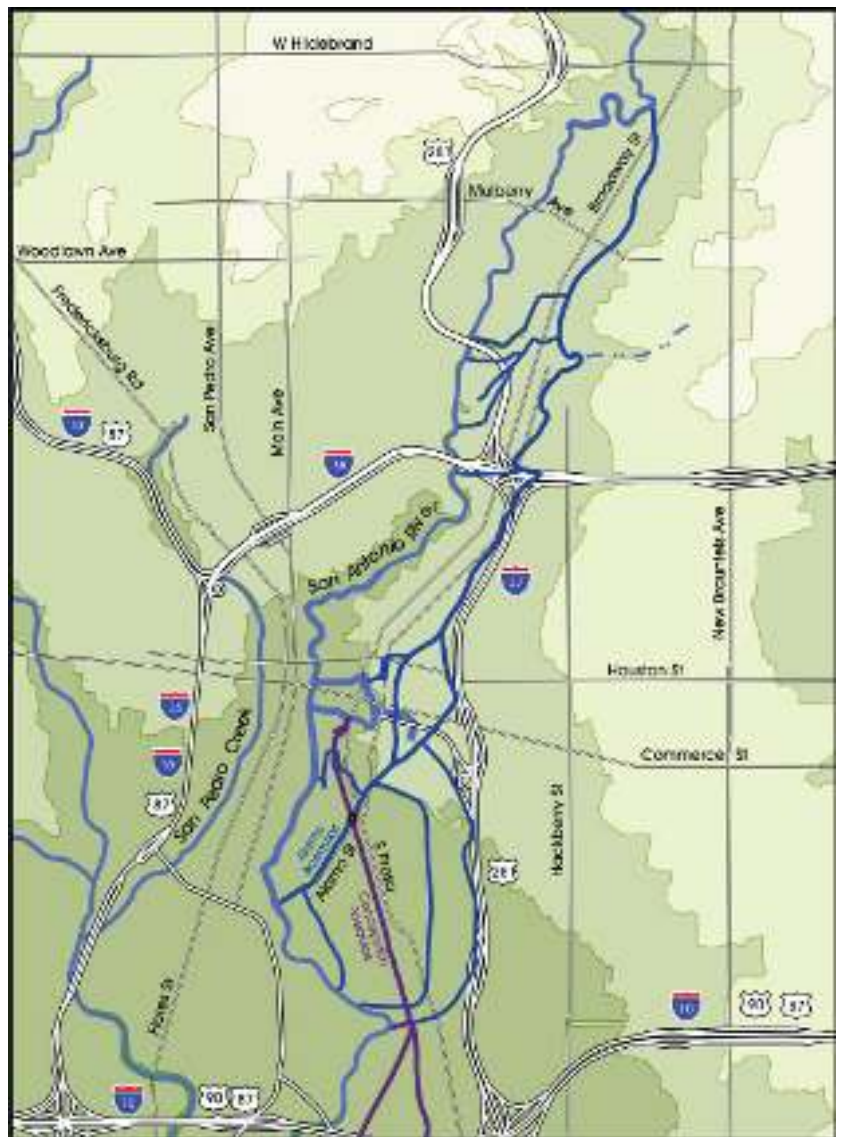
The *Acequia Madre* (1719-20) originated on the river's east bank just above today's Pioneer Hall, ran south to water the lands of Mission San Antonio de Valero, and returned to the river below the mission (Figure 3-1). It had numerous returns ("desagues") along this path where water returned to the main channel of the river. The land between the river and the main ditch was controlled by the mission. It was not until after the mission's secularization in 1793 that these fields were granted to individual owners, notably the Adaesanos who had relocated to San Antonio when the Presidio de los Adaes was abandoned in 1773.

Figure 3-1. General map showing the relationship of the San Antonio River and the Alamo Acequia (*Acequia Madre*) along with its recorded desagues.

At the time of the arrival of the Spaniards, the area would likely still have been an important resource to Native Americans. Though the Spanish missionaries chose locations to the south of the current project area for their mission sites and residences, the need for irrigation compelled them to alter the landscape to the north of the main portion of town. In 1719, construction commenced on the *Acequia Madre*, later also referred to as the Alamo Ditch. The irrigation ditch started at a bend in the river south of the headwaters of the San Antonio River. The path of the *acequia* headed to the south, running parallel to present day Broadway Street. The *acequia* passed by Mission San Antonio de Valero, and continued in several branches until it re-entered with the River north of its juncture with San Pedro Creek. Several *desaguas* were present north of the final re-entry into the River. Some of these were later additions while others were changes to the original channel that started near the Witte Museum (Figure 3-1).

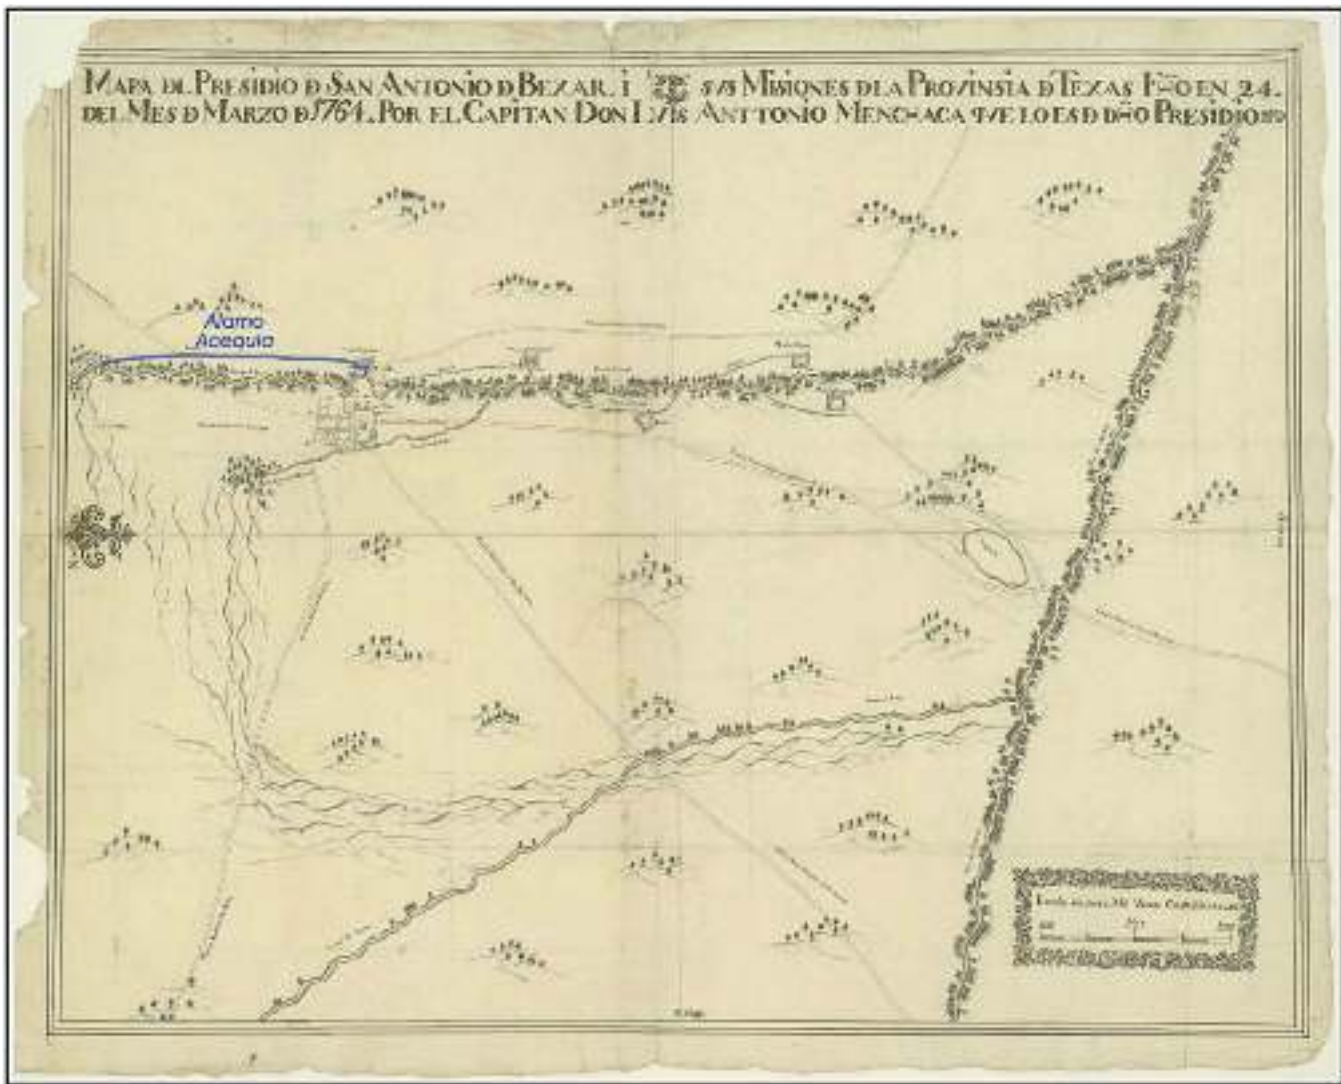
The 1764 map drawn by Menchaca (Figure 3-3) shows that the *Acequia Madre* lead to Mission Valero, but the path south of the mission was depicted with a dotted line (Schuetz 1970).

Figure 3-3. *The Menchaca Map showing San Antonio de Bexar in 1764.*

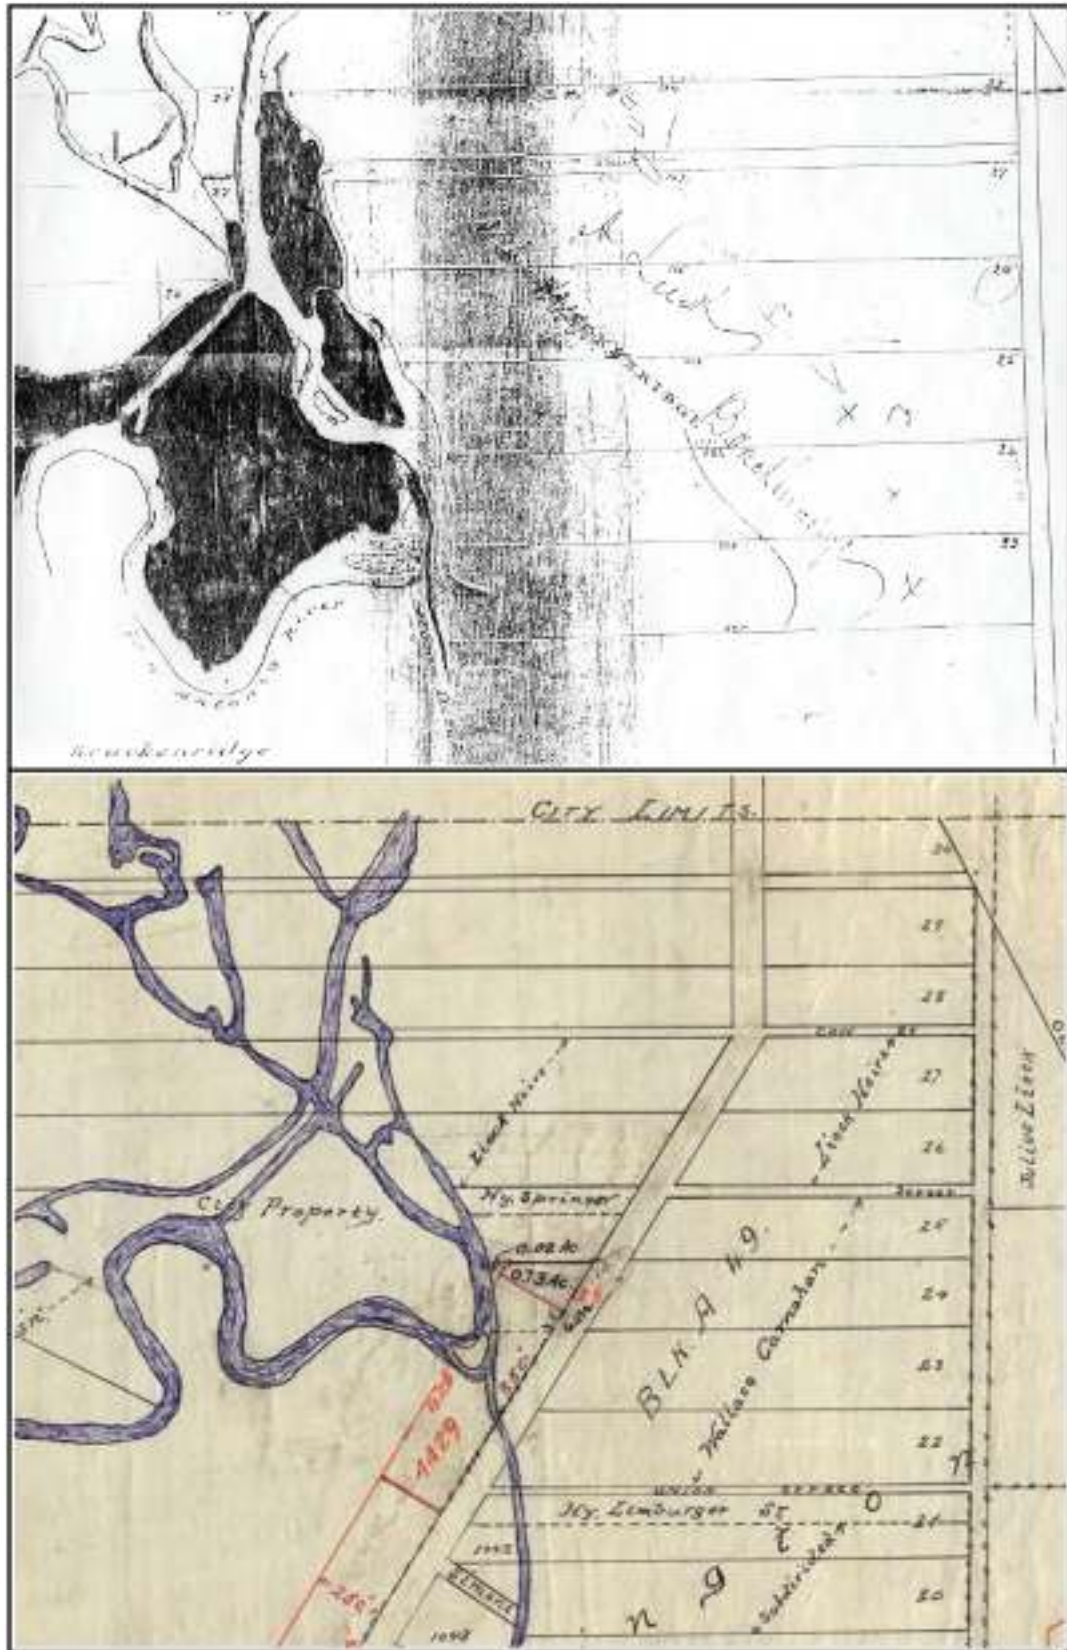
Figure 3-4. The 1879 Giraud map (top) compared to the 1908 City Engineer map (bottom) showing the area of the headwaters of the Acequia Madre.

In 1905, the *Acequia Madre* was ordered to be closed once more. It was estimated that it would cost approximately \$2,000 to fill the ditch, but an alderman at the time came up with a different plan. He suggested that the ditch be filled with street sweepings which would dramatically reduce the cost to close the ditch. By mid-1905, the *Acequia Madre* was closed for the final time (Cox 2005). Though the *acequia* was closed, the path of the ditch was noted on several maps of the area that were drawn after 1905. These maps, plus ones that were drawn in the mid to late 1800s, were used to help determine the path of the *acequia* on the Witte grounds (Figure 3-4).

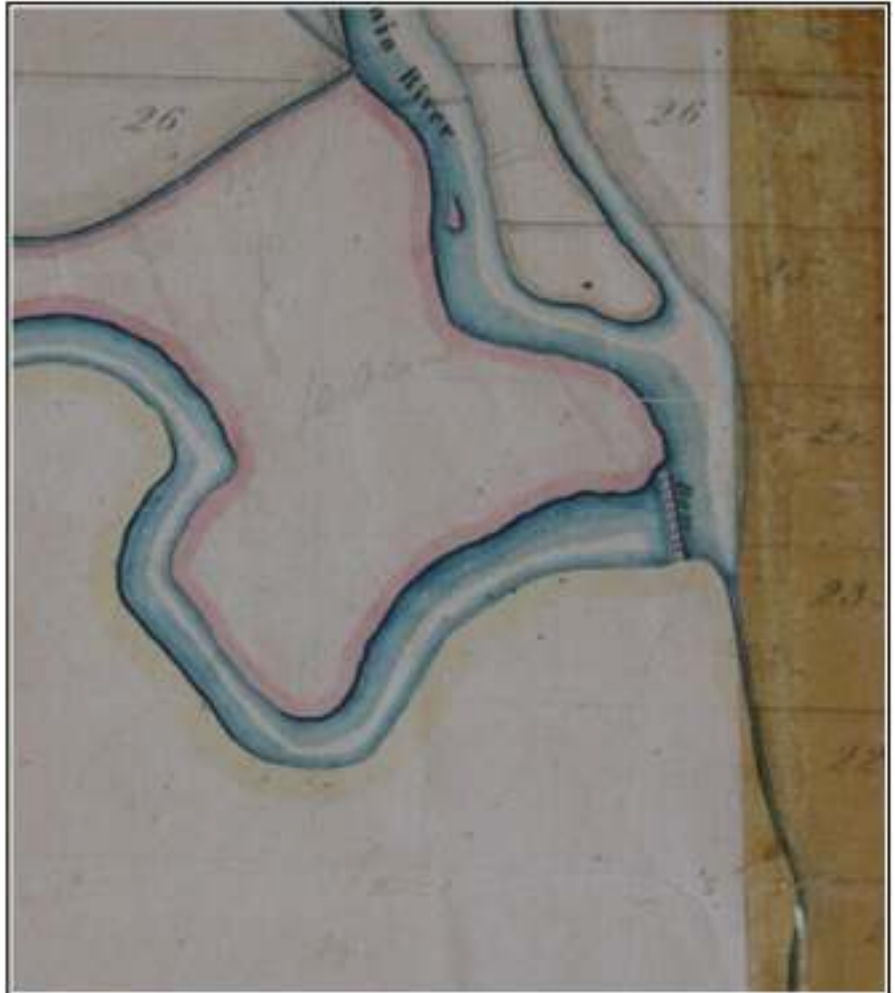
One of the earliest relatively detailed maps showing the *acequia* was drawn by Louis Giraud in 1875 (Figure 4-1). It depicts the dam at its very northernmost portion in location to the meander of the river. The *acequia* begins immediately east of the dam as a narrow channel.

Figure 4-1. *The Acequia Madre and Alamo Dam as drawn by Louis Giraud in 1875.*

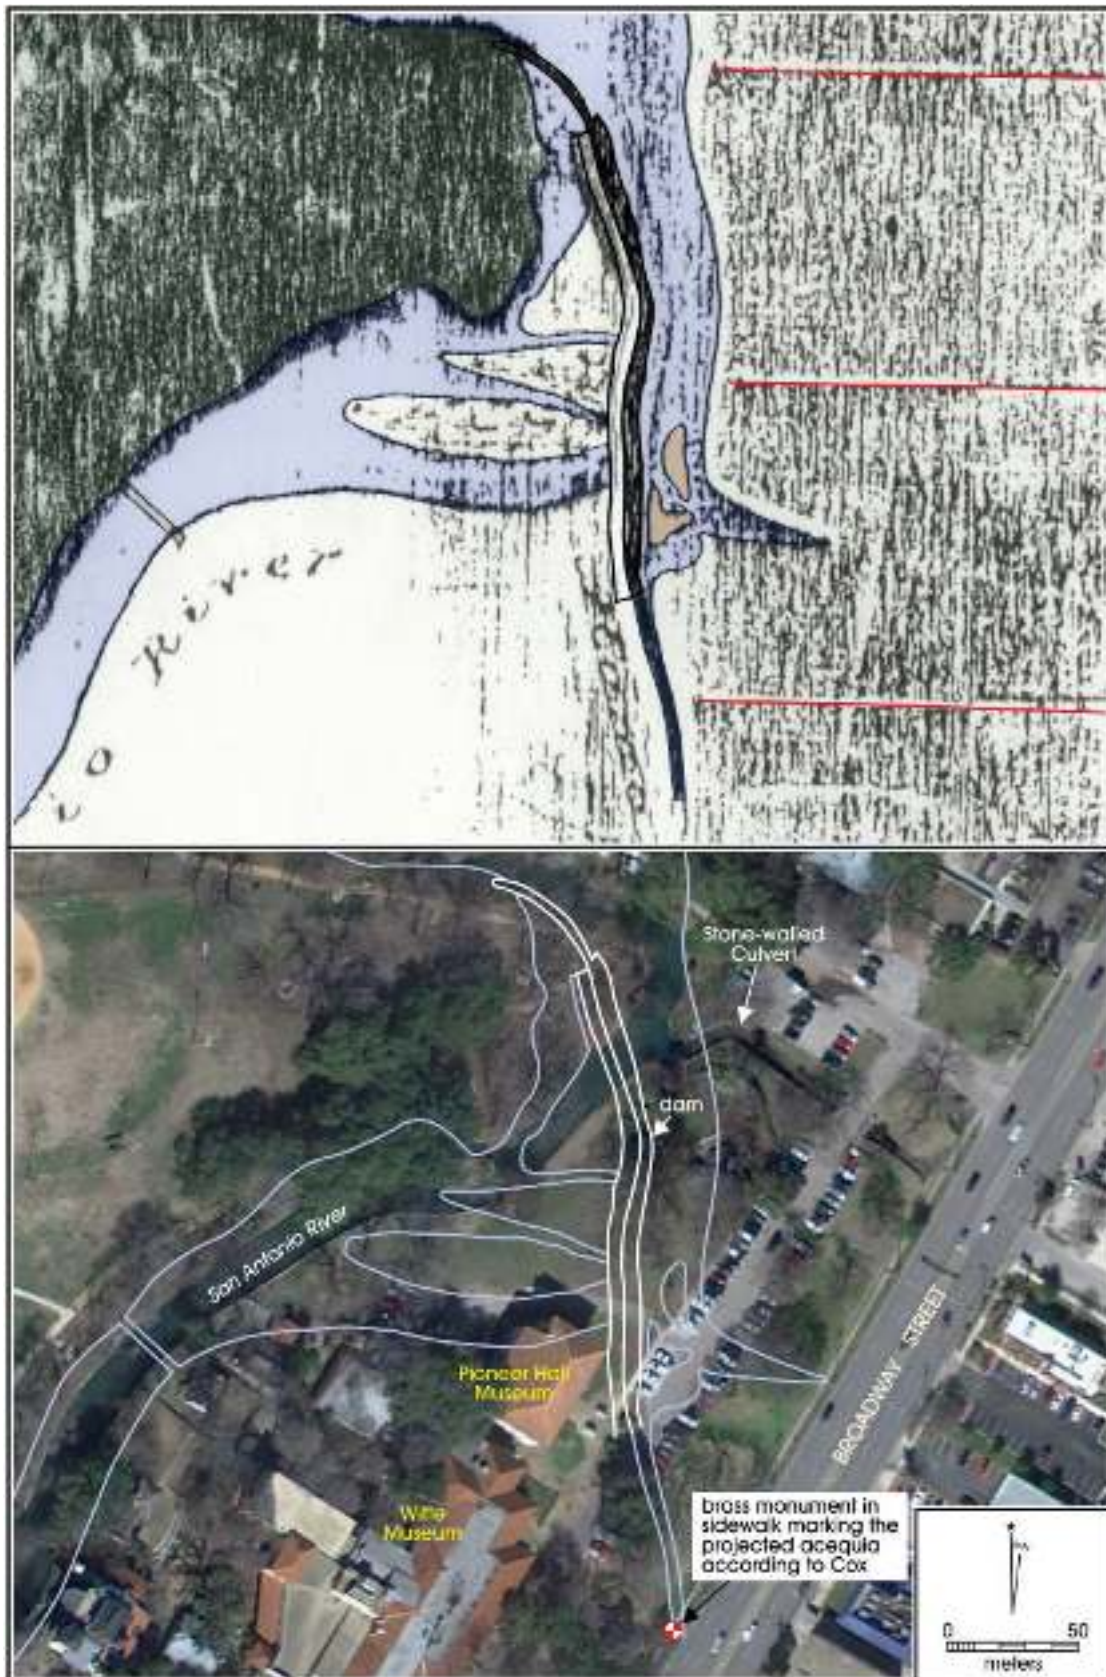
Figure 4-2. The Acequia Madre as drawn by Giraud in 1789 overlaid on a current aerial of the APE.

The CAR staff overlaid Louis Giraud's 1879 map onto a current aerial map of the APE (Figure 4-2). Assuming that the scaling needed to produce this overlay is accurate in relation to the modern aerial, this conjunctive map indicates that the land area adjacent to the dam was marshy. It also suggests that the main channel of the *acequia* did not appear to be clearly defined until well into the southeast of the dam. According to this overlay, the dam and *acequia* fall under the proposed Changing exhibit Gallery as seen in Figure 4-3.

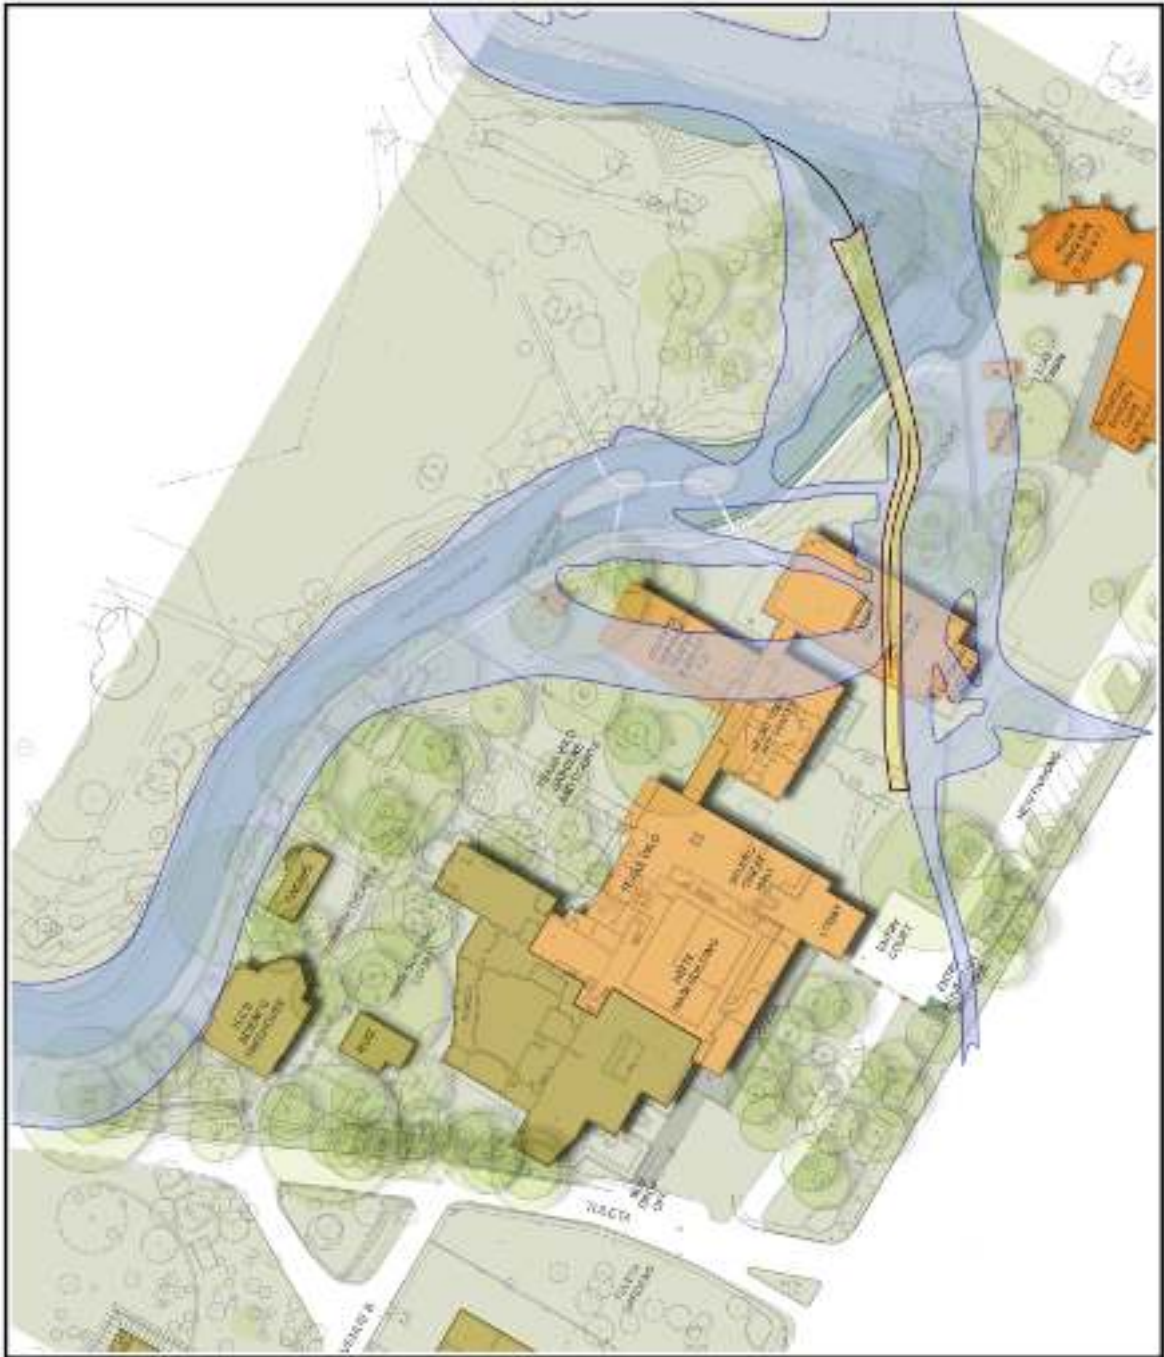
Figure 4-3. Map of the project area with overlay of the location of the acequia dam and areas that had previously been underwater (based on Luis Giraud map, 1879).

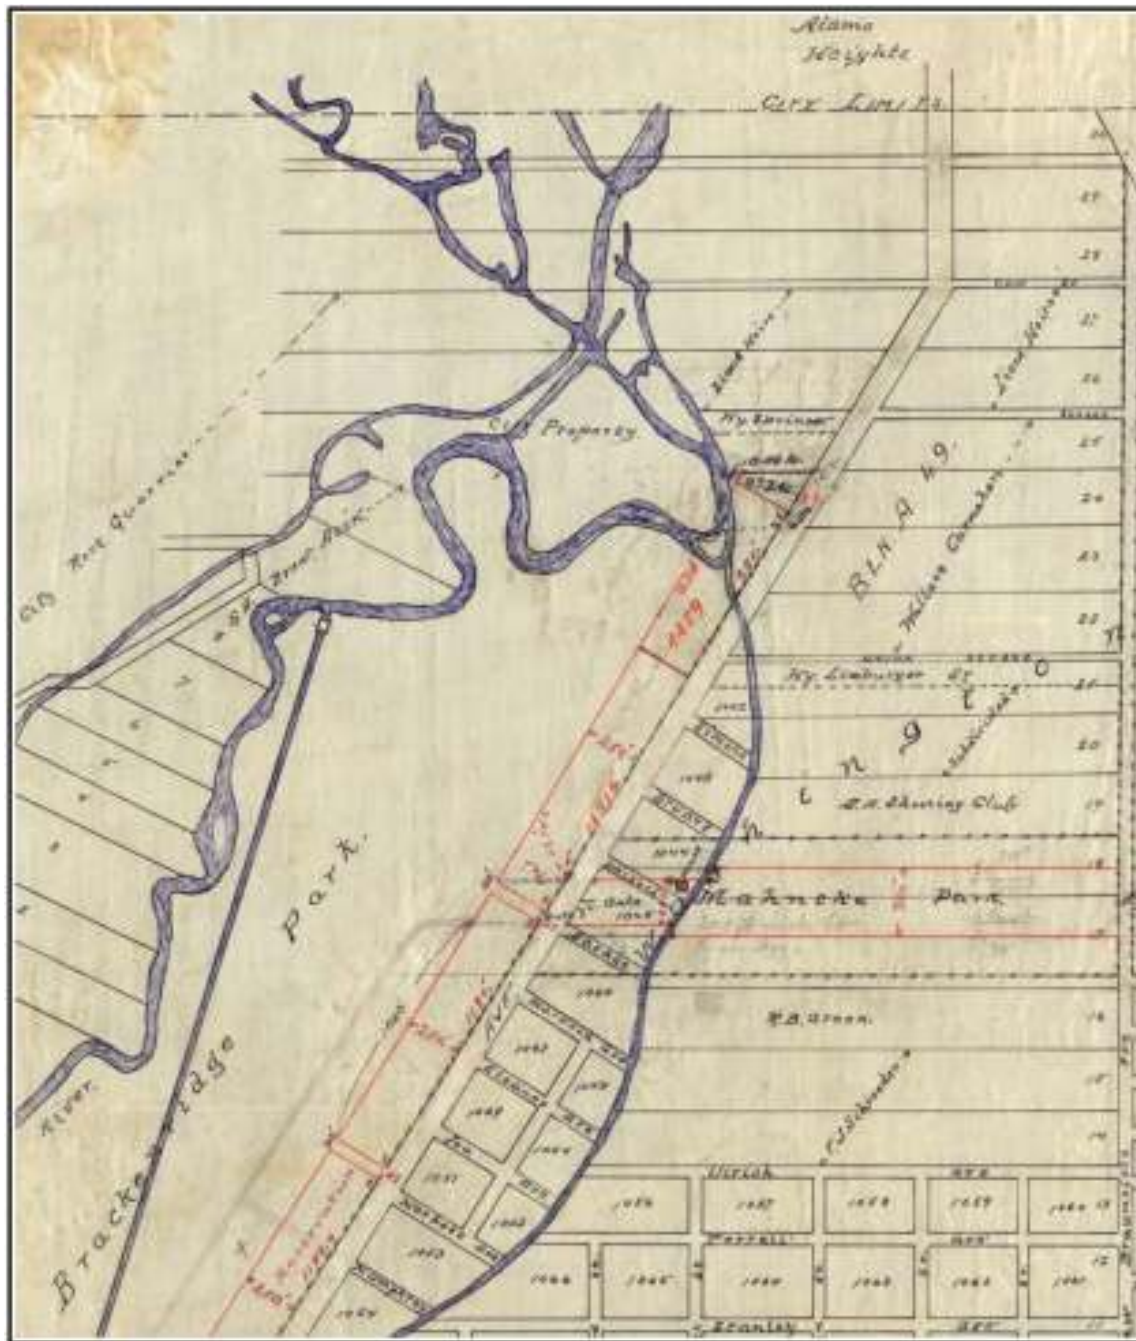
Another historic map consulted by the staff (dated 1908), was drawn by the City Engineer (Figure 4-4). This map marked

out the path of the *Acequia Madre*, despite the fact that the ditch itself had been closed for approximately three years by 1908—the time of this maps' interpretation.

Figure 4-4. Map of Brackenridge Park in 1908 showing the orientation of the Acequia Madre.

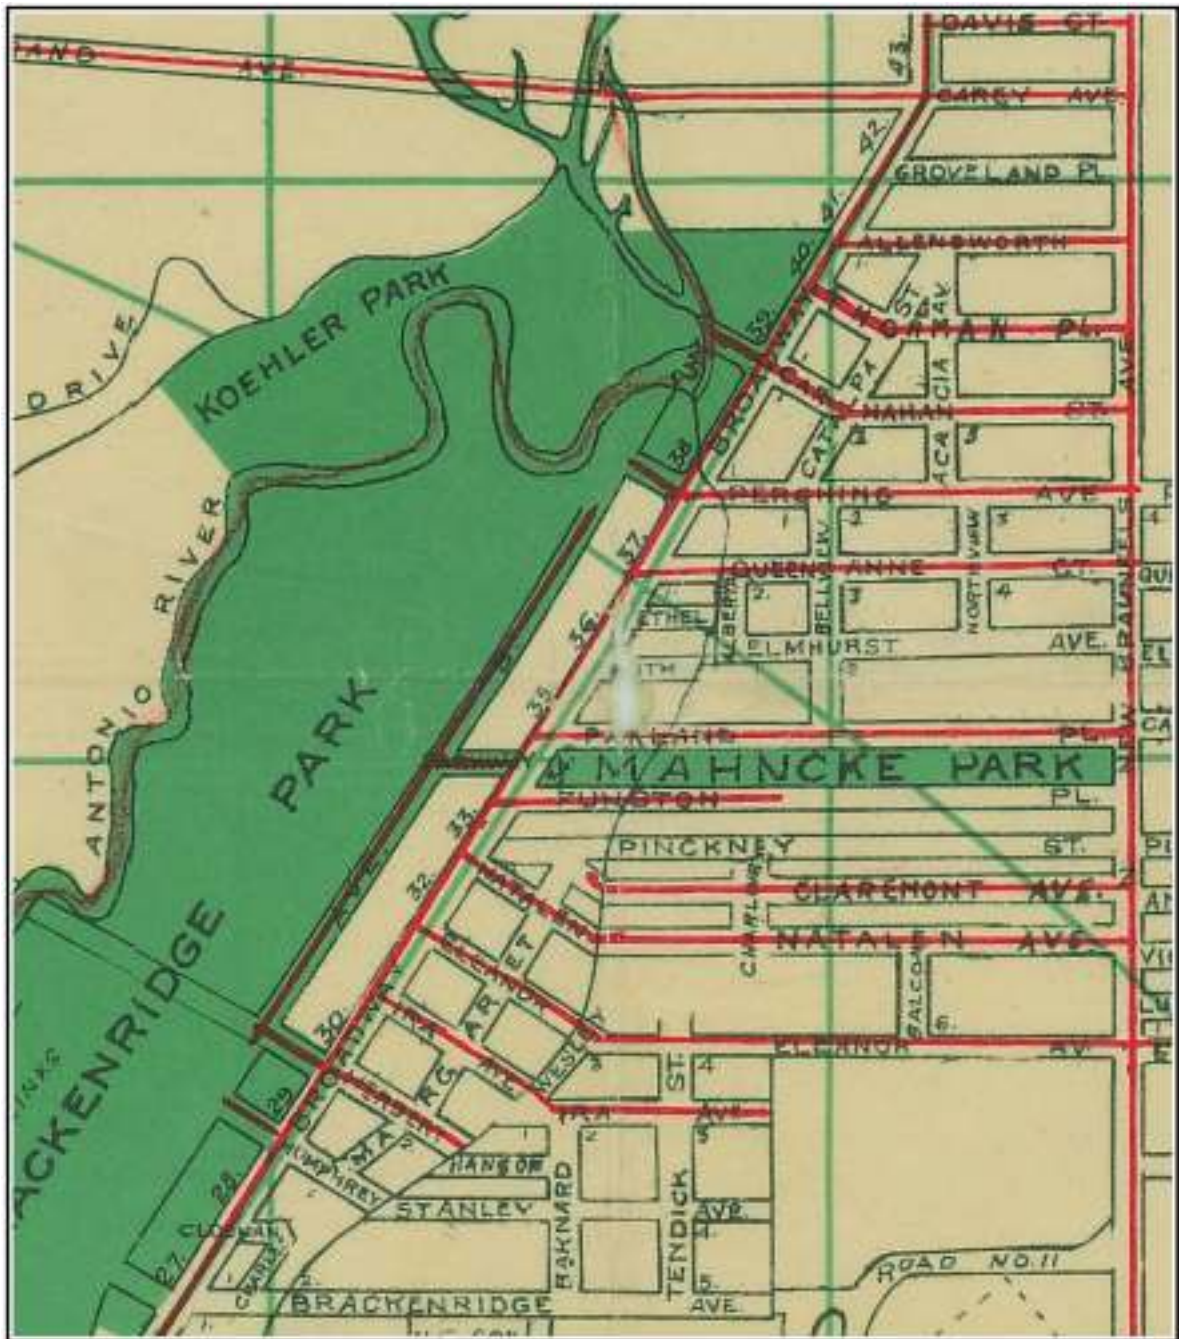
Another historic map was consulted. Dating to a few years after the aforementioned map, Jules A. Appler's map of San Antonio and its suburbs, was likely drawn in or around the year 1914 (Figure 4-5). Even though the *acequia* was closed

by this time, this map too, just as its 1908 predecessor, depicts the *acequia's* route. Appler's map shows the point at which the *acequia* emanates from the channel of the San Antonio River. It should be noted that the accuracy of this map may be questionable, due to potential lack of detail at such a large scale (note that only an enlarged section is shown in Figure 4-5).

Figure 4-5. Detail of an early 1900s map of the city showing Brackenridge Park area and the orientation of the Acequia Madre.

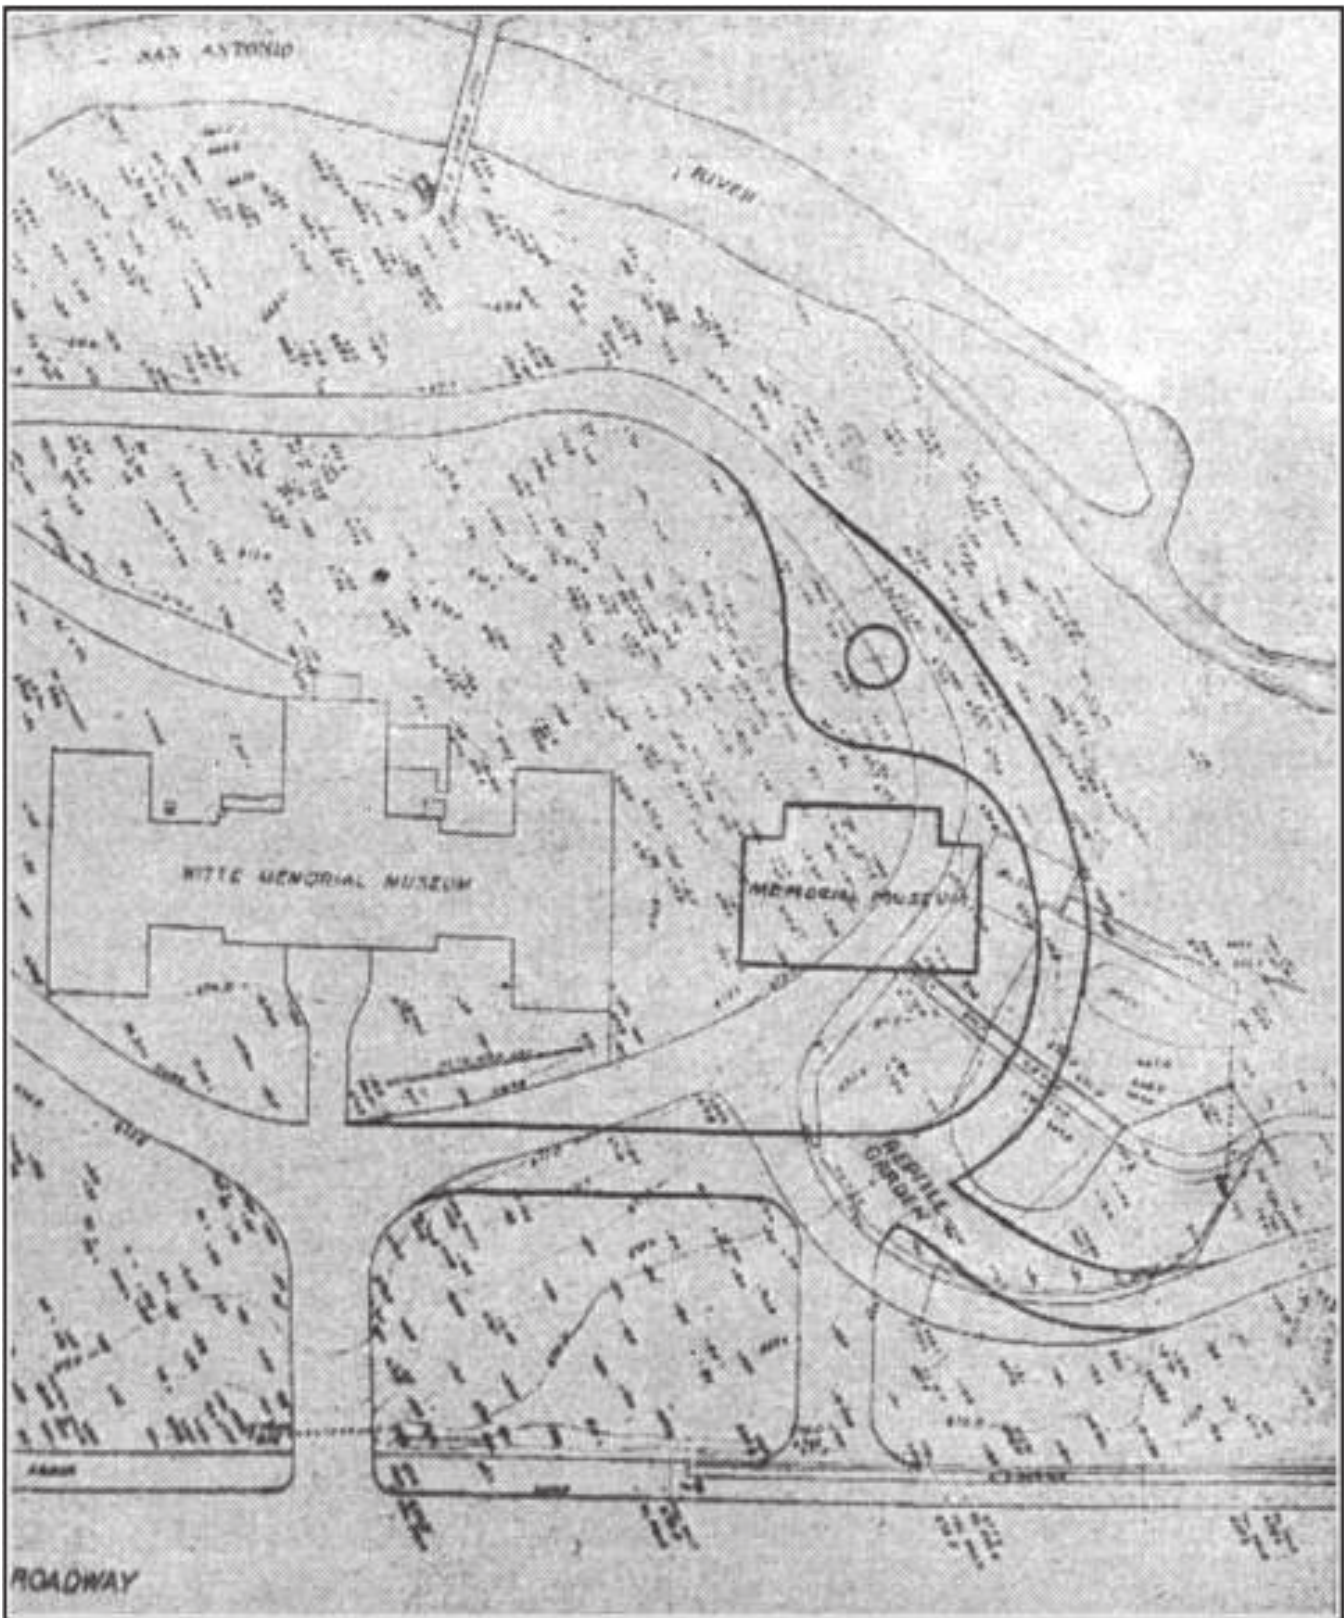
Figure 4-6. Map of the Witte Museum complex showing Pioneer Hall (labeled Memorial Museum) and other proposed changes (San Antonio Express News 1937).

In terms of elevation notations, it was clear from the original map that the elevation of the landform was to be raised approximately three feet. Additionally, the map provided two clearly identifiable clues. One of these related to the Reptile Garden; the other projected the degree of change that had been planned, as well as relaying what work had already been accomplished in the Museum and Hall vicinity. The map showed that a swale passed in front of Pioneer Hall towards Broadway Street. This seemed consistent with a history of the

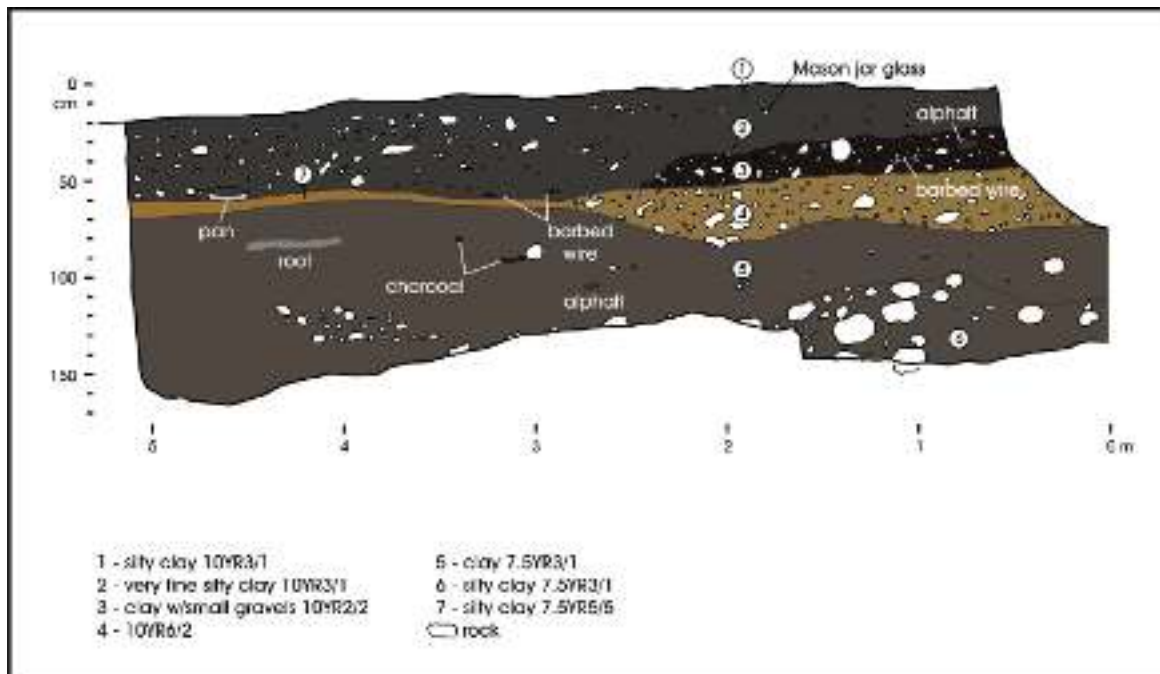
Figure 5-2. Profile of the east wall of BHT 1.

After a thin layer of topsoil (Zone 1) and fill (Zones 2 and 3) was removed, a layer of small limestone rocks mixed in a yellowish-brown soil was noted (Zone 4), (Figure 5-2).

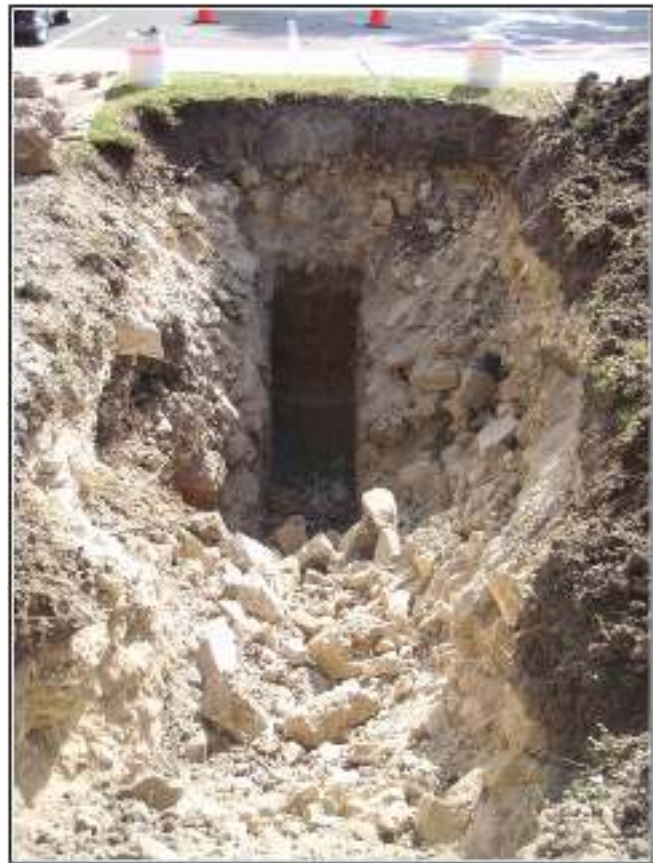
Figure 5-4. Eastern end of BHT 2 showing massive zone of unconsolidated fill materials overlying a deeply buried clay deposit. View is looking east.

Excavation of the trench revealed that roughly 60 cm of top soil covered approximately 7 to 9 feet of fill, except in the portion of the trench closest to the sidewalk (eastern portion). The top layer of fill consisted of large limestone rocks with sparse tan colored soil. The fill was very loose, and would often cave in from the walls of the trench (Figure 5-4).

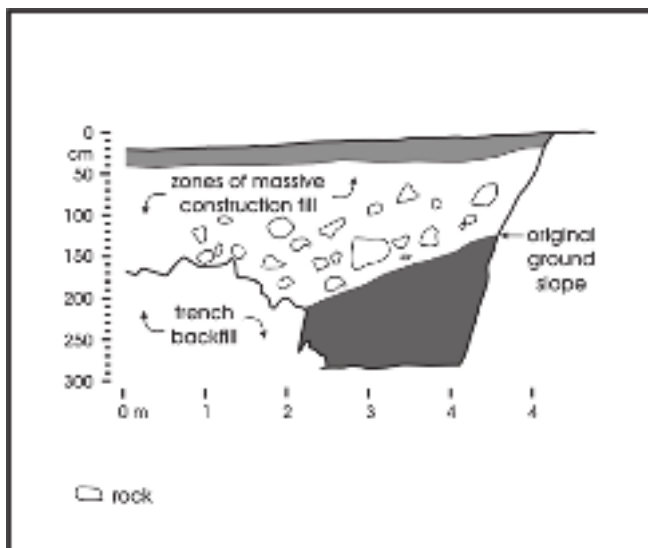
Figure 5-5. Stylized profile of the north wall of BHT 2.

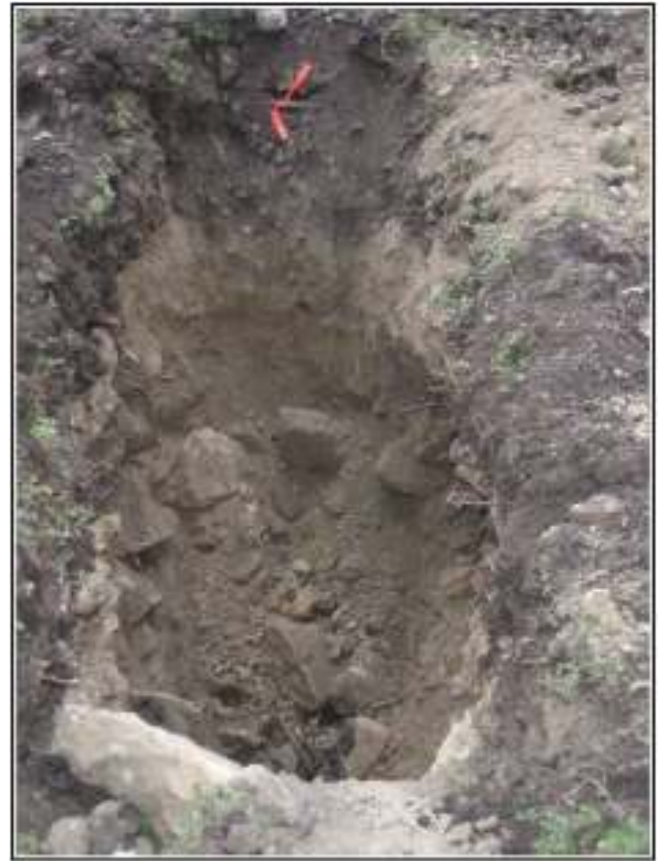
Figure 5-6. Unconsolidated fill materials encountered in BHT 3. Note the water pipe flagged with orange ribbon that caused the trench excavation to be abandoned. View toward the west.

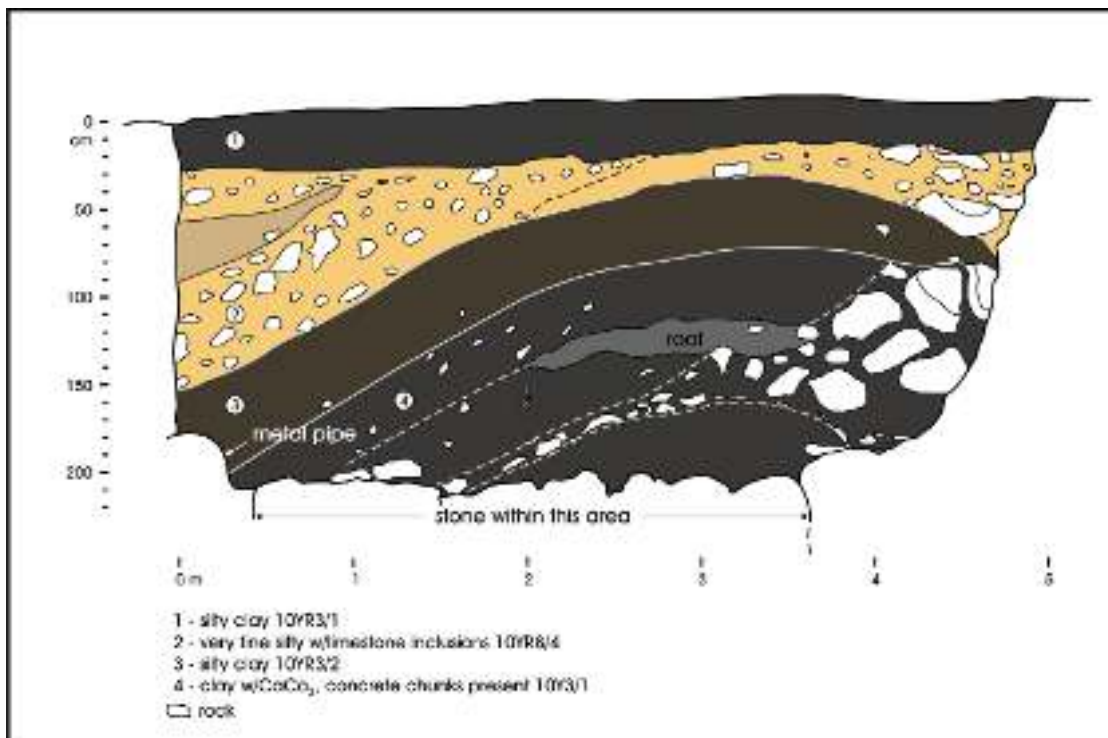
Figure 5-8. Profile of the north wall of BHT 4.

Large limestone rocks were observed at the base of the western portion of the trench. The stones proved to be fairly resistant to removal by excavators. Additionally, it became difficult to determine the nature of the stone at the depth in which they were encountered. The eastern portion of the trench became unstable due to the loose nature of the fill. Concrete chunks and bricks were not held in place, and would slide into the trench after each pass of the bucket. The location of the trench prevented the benching of the trench that would have allowed for the archaeologists to enter the trench or investigate further. After photographing and profiling the trench, the trench was backfilled.

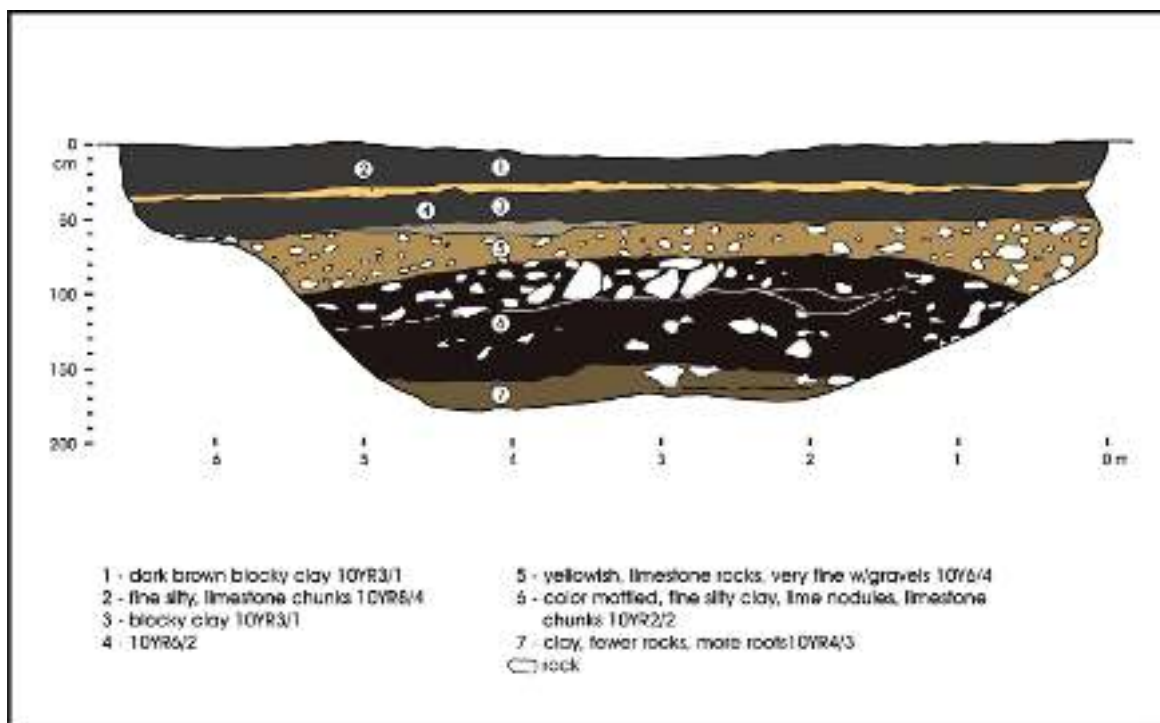
Figure 5-10. Profile of the south wall of BHT 5.

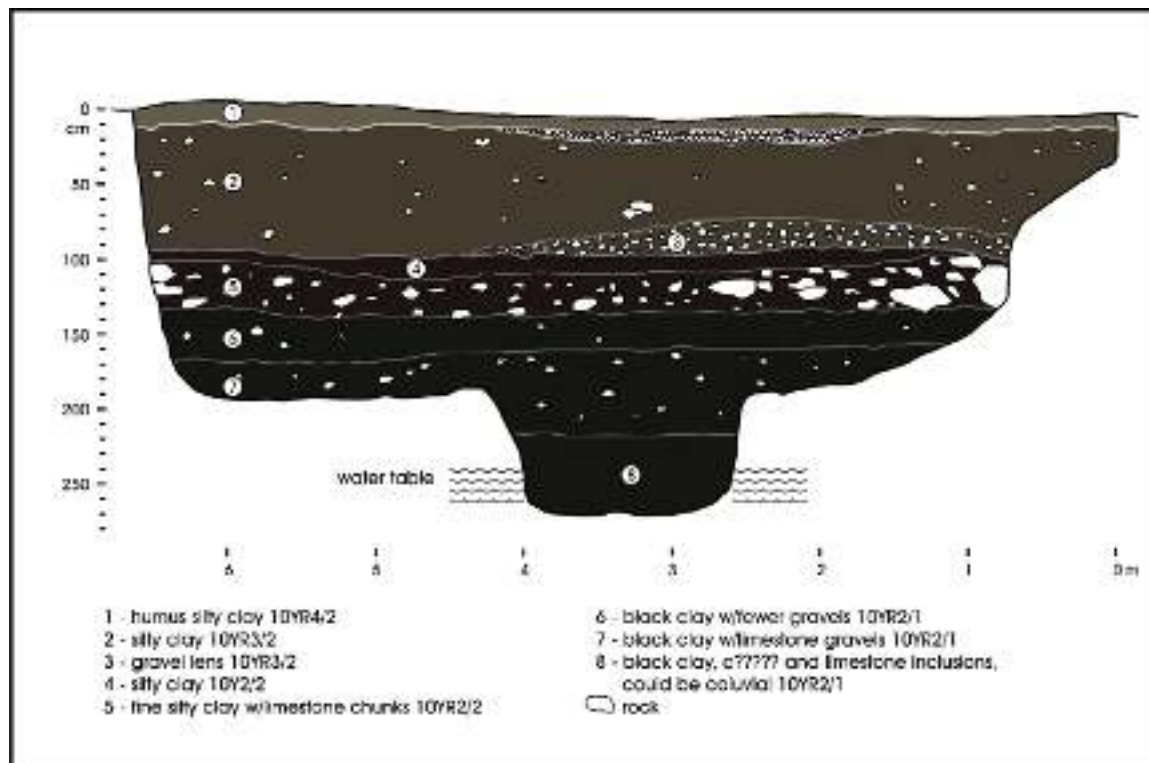
Figure 5-12. Profile of north wall of BHT 6.

The lower levels of the trench (Zones 6 through 9), though they continued to contain the limestone and concrete chunks, consisted of black clay. The soils are not *in situ* due to the inclusion of the building material fill. Density of the fill material dramatically dropped off towards the bottom of the trench. Because of this drop off of fill, and the potential for artifacts below the current excavated layer, the backhoe operator was asked to excavate a portion of the trench to a deeper level. At approximately 240 cm below surface, it was evident that the water table was encountered. It would appear that the soils encountered below the water table were intact. Excavations continued to approximately 260 cm
