# Intensive Survey and Testing Associated with the Rediscovery of the Acequia Madre and Alamo Dam, San Antonio, Bexar County, Texas

Prepared by:  
Center for Archaeological Research  
The University of Texas at San Antonio  
One UTSA Circle  
San Antonio, Texas 78249  
Archaeological Report, No. 417

**Intensive Survey and Testing  
Associated with the Rediscovery of  
the Acequia Madre (41BX8) and Alamo Dam,  
San Antonio, Bexar County, Texas**

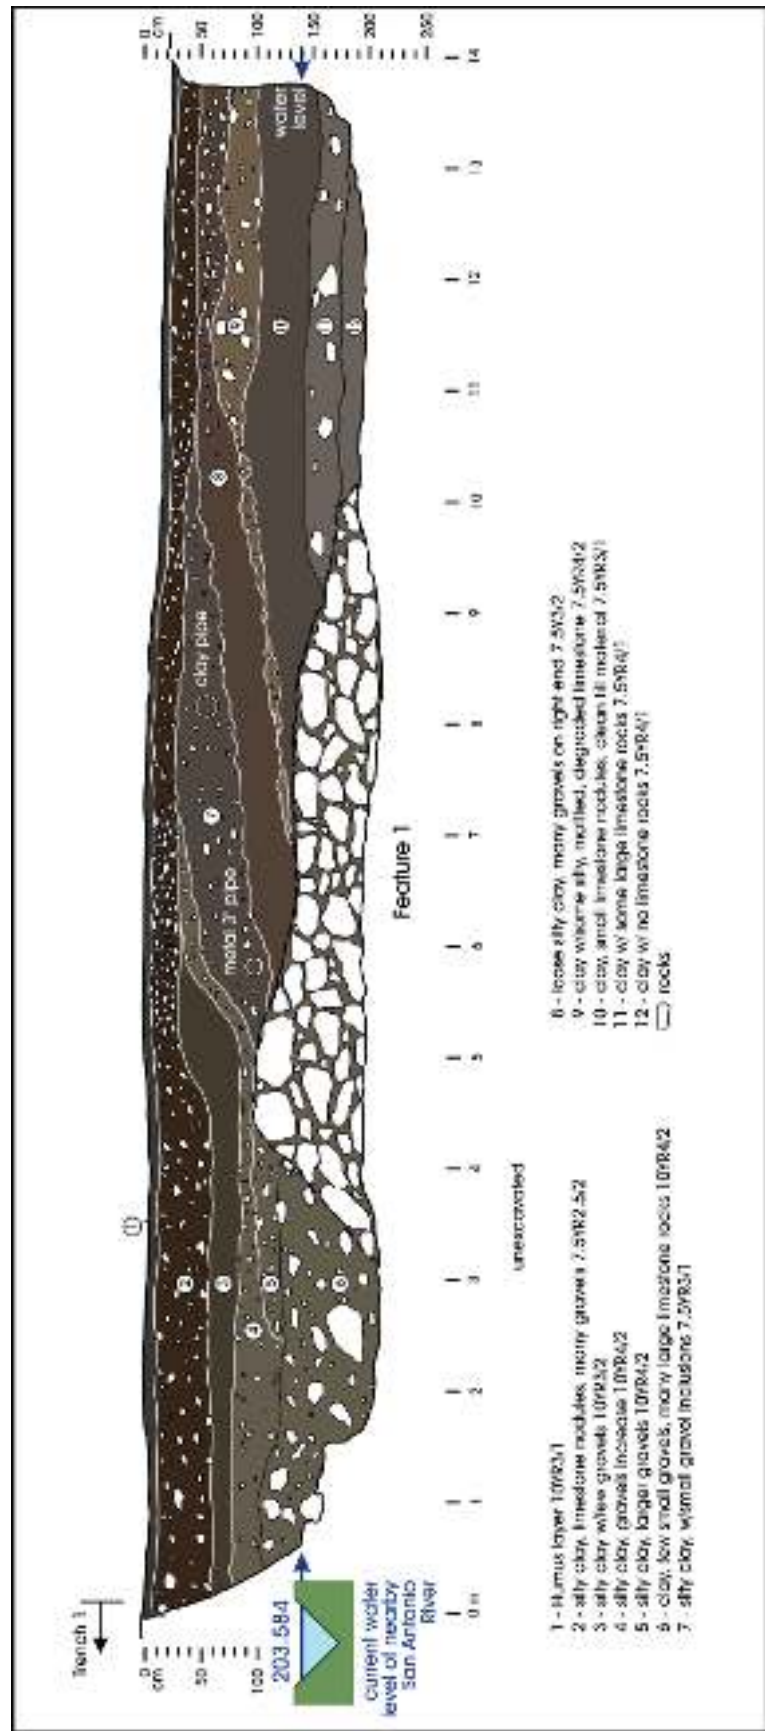
Figure 5-13. Profile of the east wall of BHT 7 showing Feature 1, remnants of the Alamo Dam.

A portion of the Alamo Dam was located in BHT 7, adjacent to the current channel of the San Antonio River. The dam consisted of large stacked limestone blocks. It appears that the top of the dam was likely sheered off during the 1930s during the construction of the stone wall lining the channel of the river.

Deeper excavation in the northern portion of BHT 7 revealed the water table. The stones were

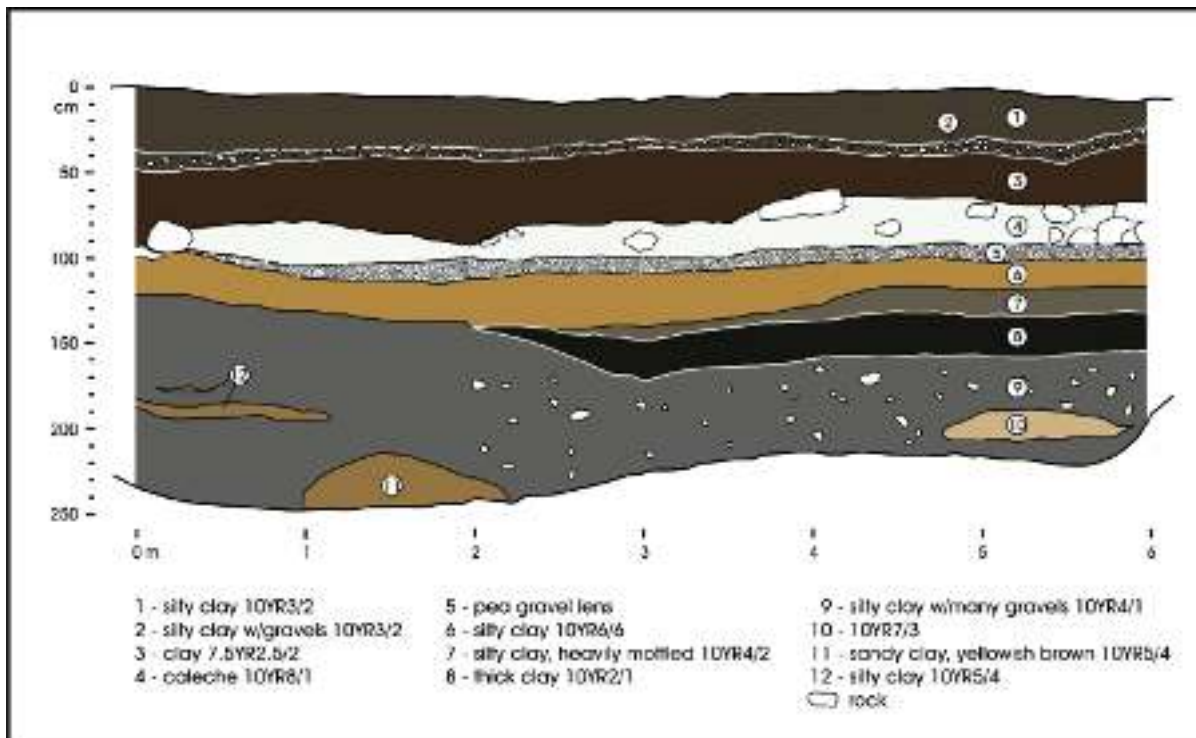
Figure 5-14. Profile of the east wall of BHT 8.

The first layer 30 cm below the surface consisted of top soil (Zone 1). Beneath the topsoil was a layer of limestone rocks that had very little matrix (Zone 2). The matrix

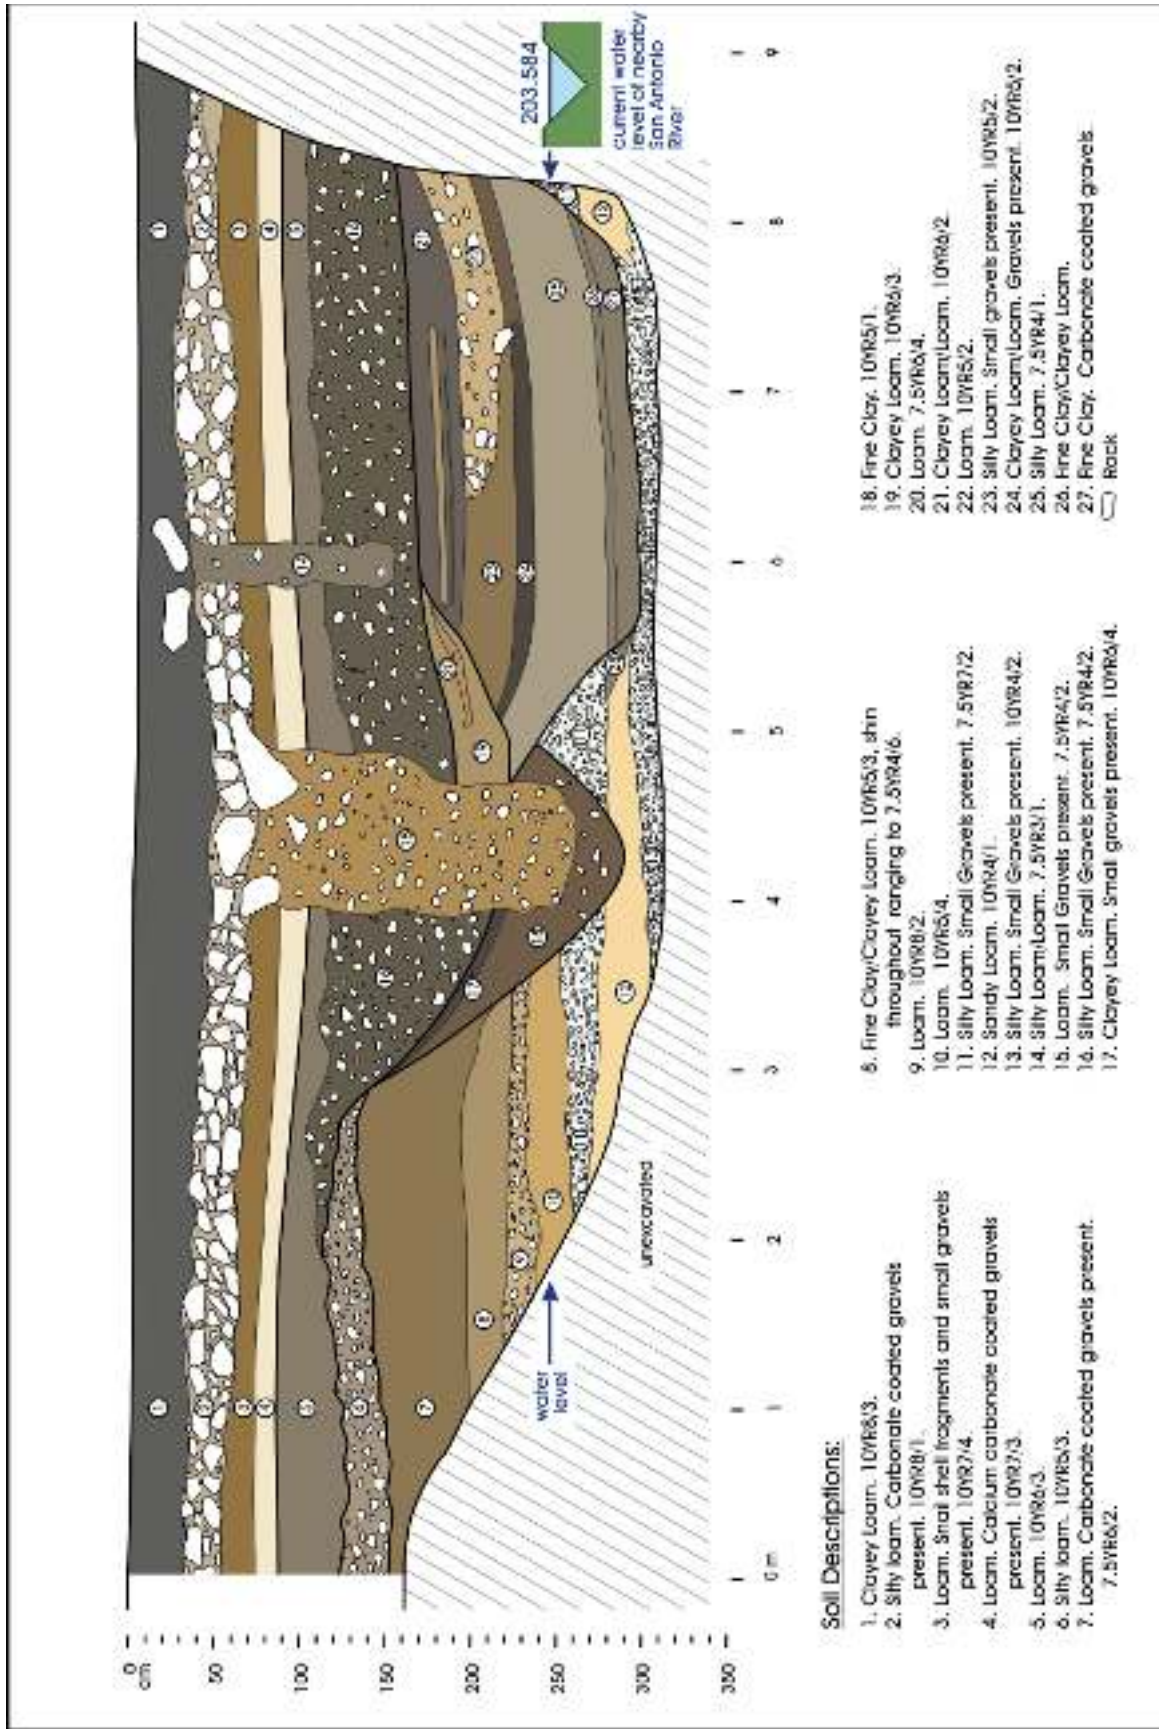
Figure 5-15. Profile of the north wall of BHT 9.

Evidence of the *Acequia Madre* (41BX8) was found in BHT 9, located in the grassy area in front of the Pioneer Hall between Curiosity Lane and Broadway. This trench extended to a depth of 12 feet below the surface before encountering the water table. Two ditch outlines were noted in the profile of the trench, one undercuts the other. They represent two paths of the *acequia*, one older than the other.

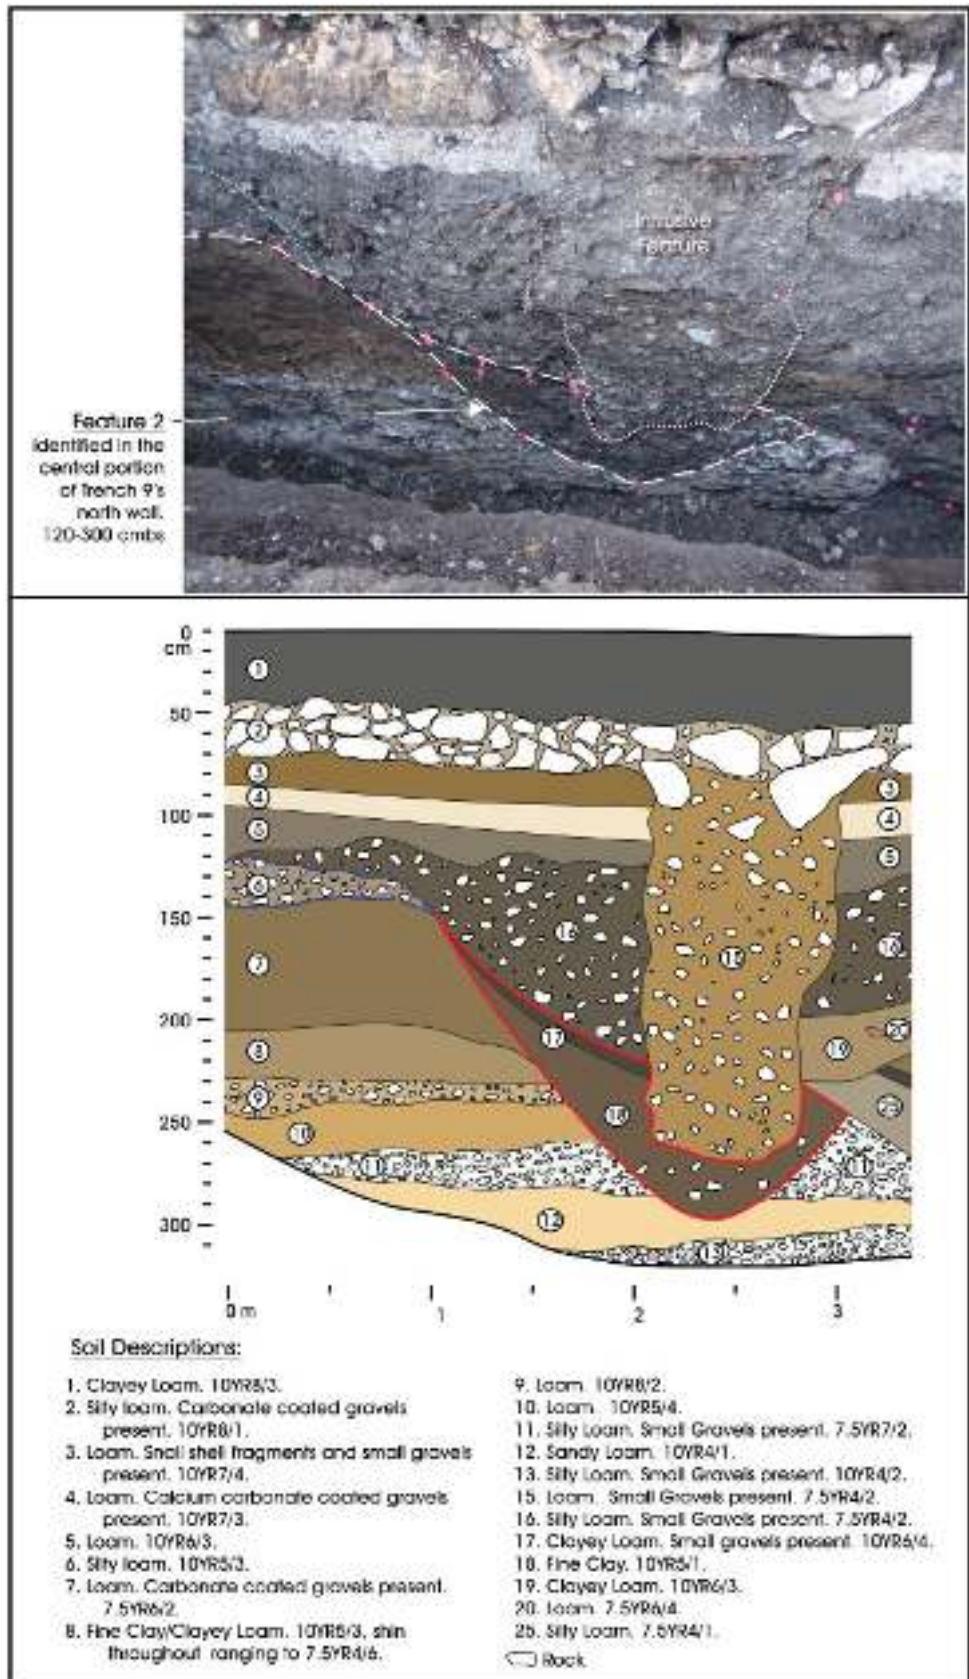
Figure 5-16. Feature 2 as identified in the north wall of BHT 9.

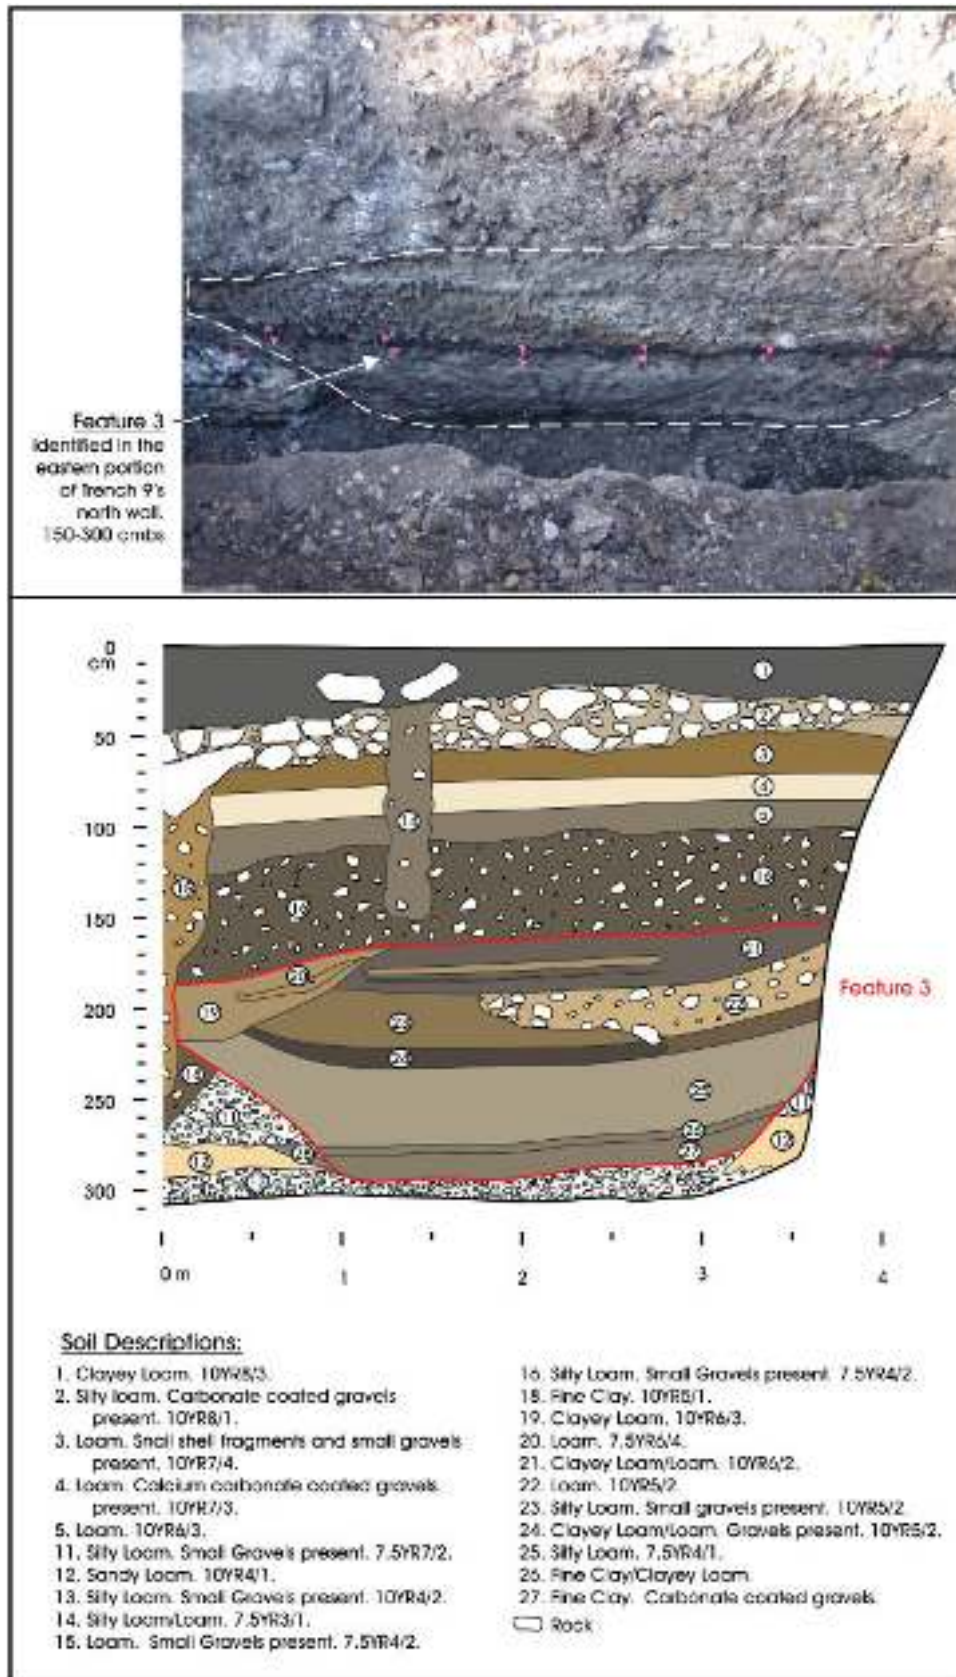
Figure 5-17. Feature 3 as identified in the north wall of BHT 9.

Feature 3 was noted within the profile of Backhoe Trench 9 (Figure 5-17). This feature was located adjacent to Feature 2, and appears to cut

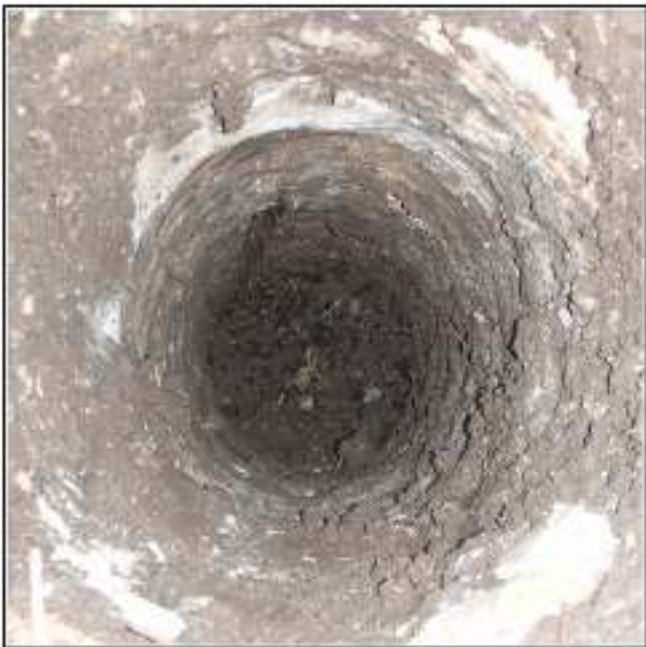
Figure 5-18. Auger Boring 1, note limestone zone near top of unit identical to Zone 2 in BHT 9 profile.

An absence of significant cultural material was noted in Auger 1. The soils encountered indicated that the fill extended to at least a depth of 153 cm below surface (or 5 feet) (Figure 5-18). The auger test did not appear to penetrate through to the fill material.

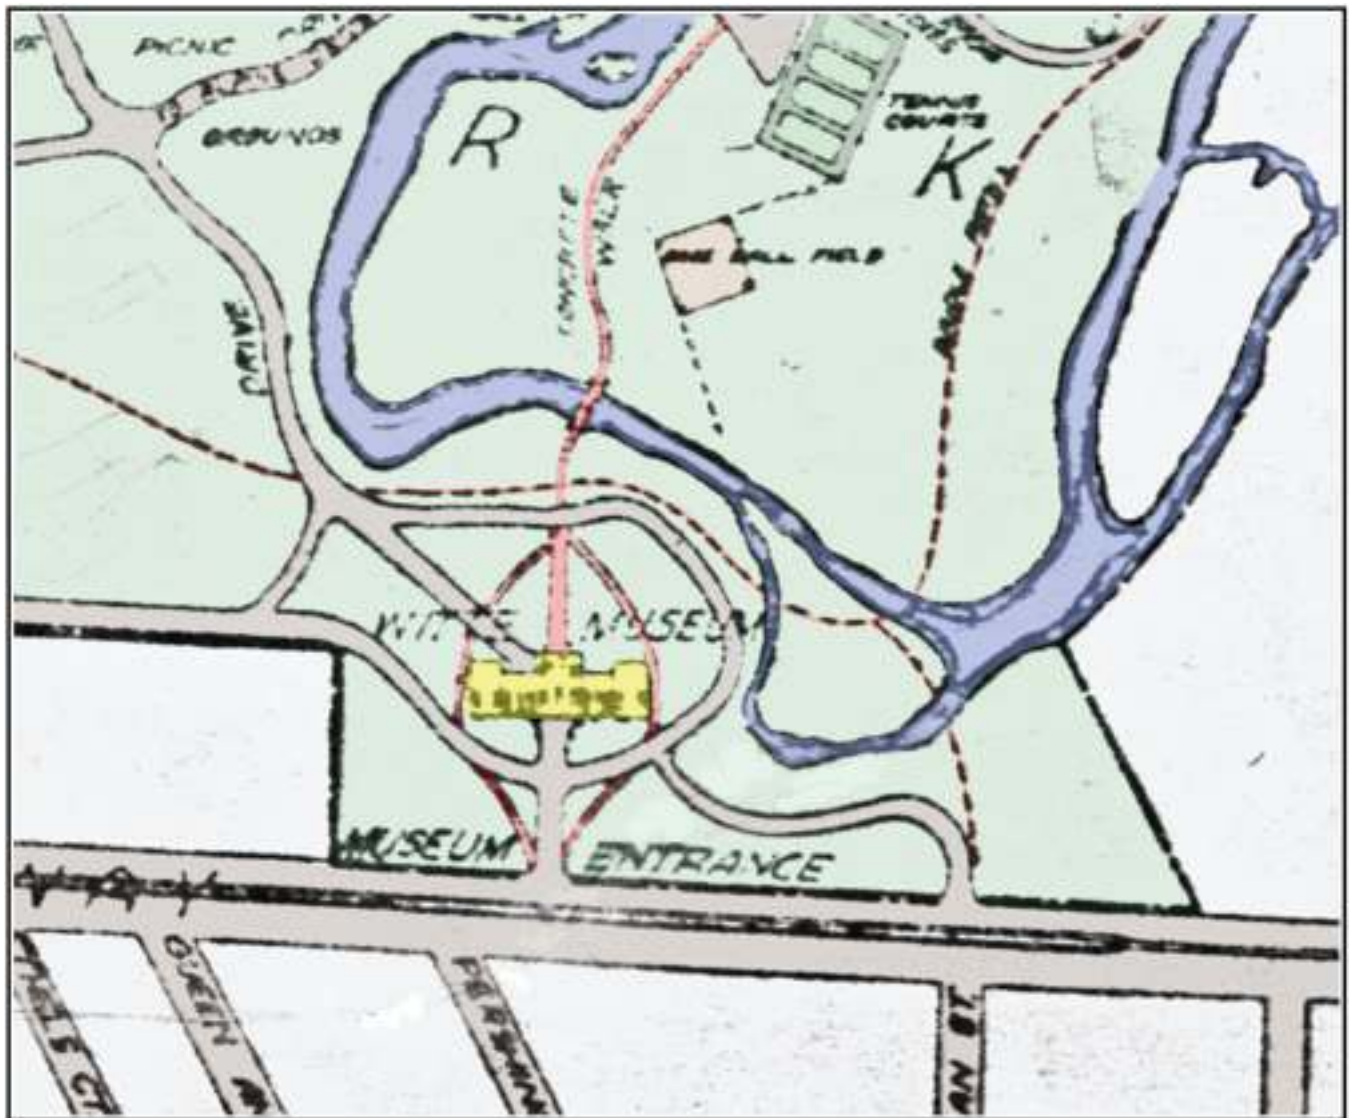
Figure 6-4. Map of the Witte Museum complex drawn between 1926 and 1933 showing the natural bends in the San Antonio River. Notice that a pond exists to the northwest of the museum, while the stone-walled culvert has not yet been constructed.
