Intensive Archaeological Pedestrian Survey and Construction Monitoring of the VFW Boulevard Drainage Improvements Project, Segment I, San Antonio, Bexar County, Texas

San Antonio River Improvements Series: Volume 1

Texas Antiquities Committee Permit No. 5957

Prepared by:
Center for Archaeological Research
The University of Texas at San Antonio
One UTSA Circle
San Antonio, Texas, 78249
Archaeological Report, No. 422

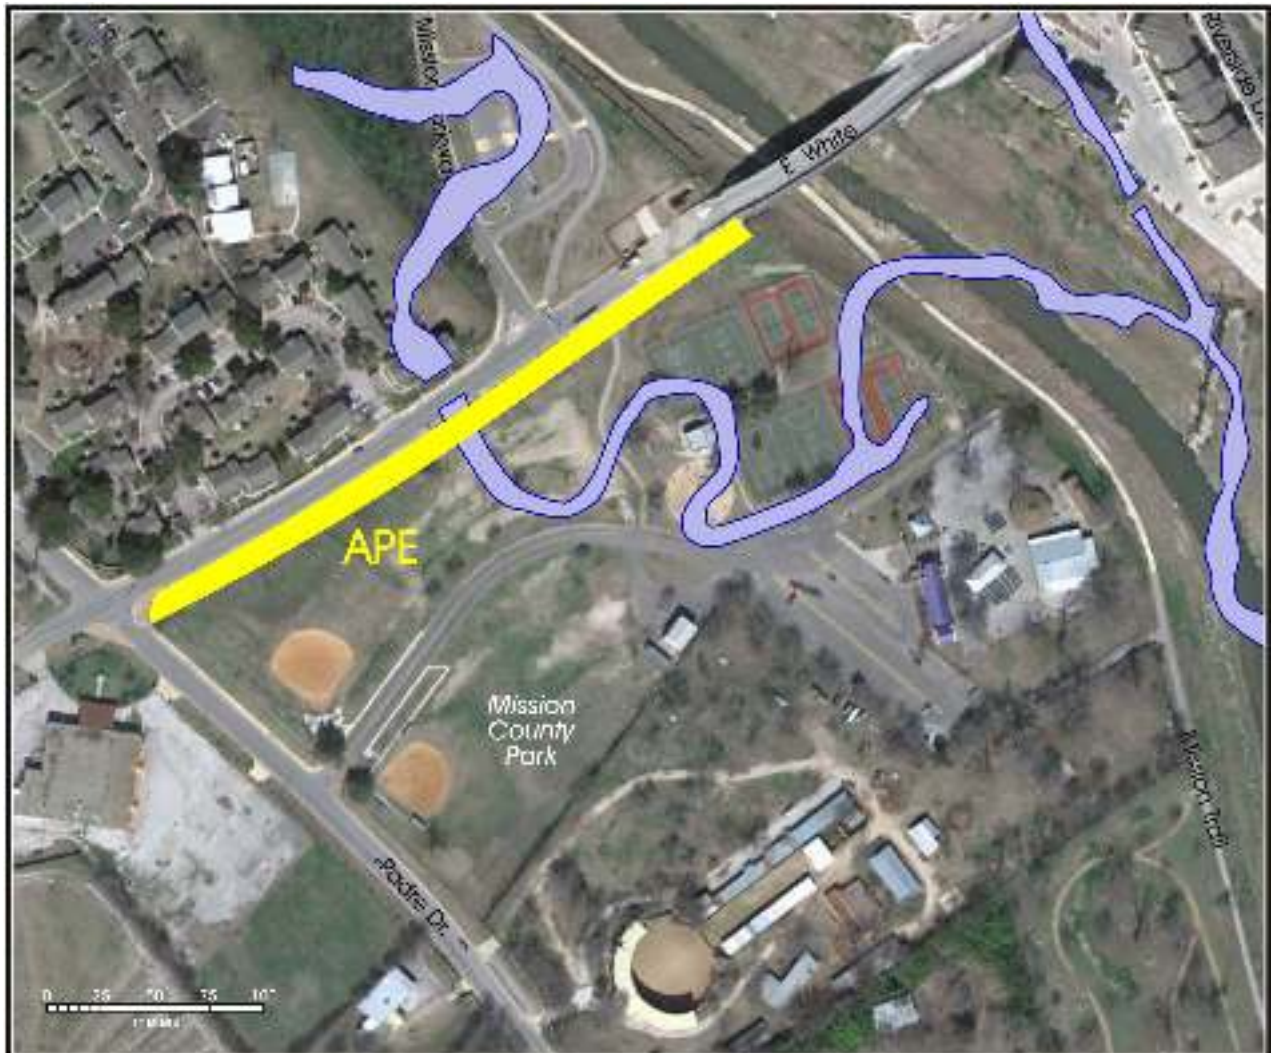
Figure 1-3. Location of proposed easement (APE) and the former alignment of San Antonio River within Mission County Park boundaries.

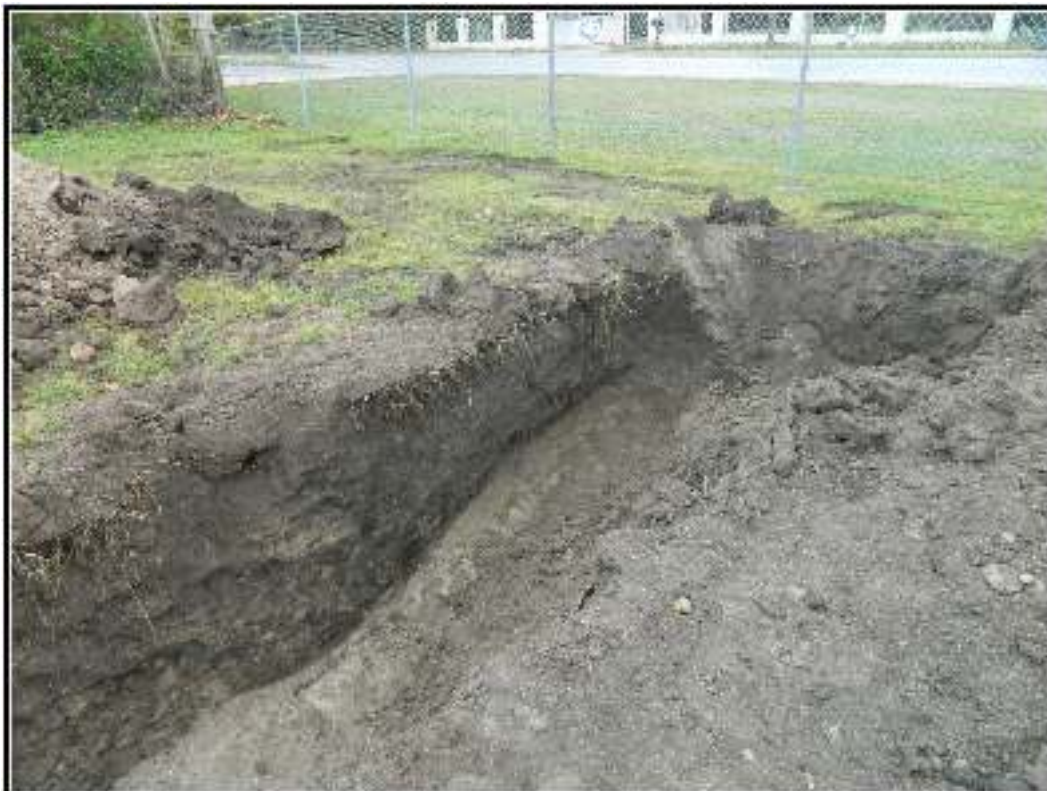
Figure 3-1. Photograph of edge of acequia (dark, in-filled zone), located during previous CAR investigations at 41BX1920 in Mission County Park (DiVito and Oksanen 2012).

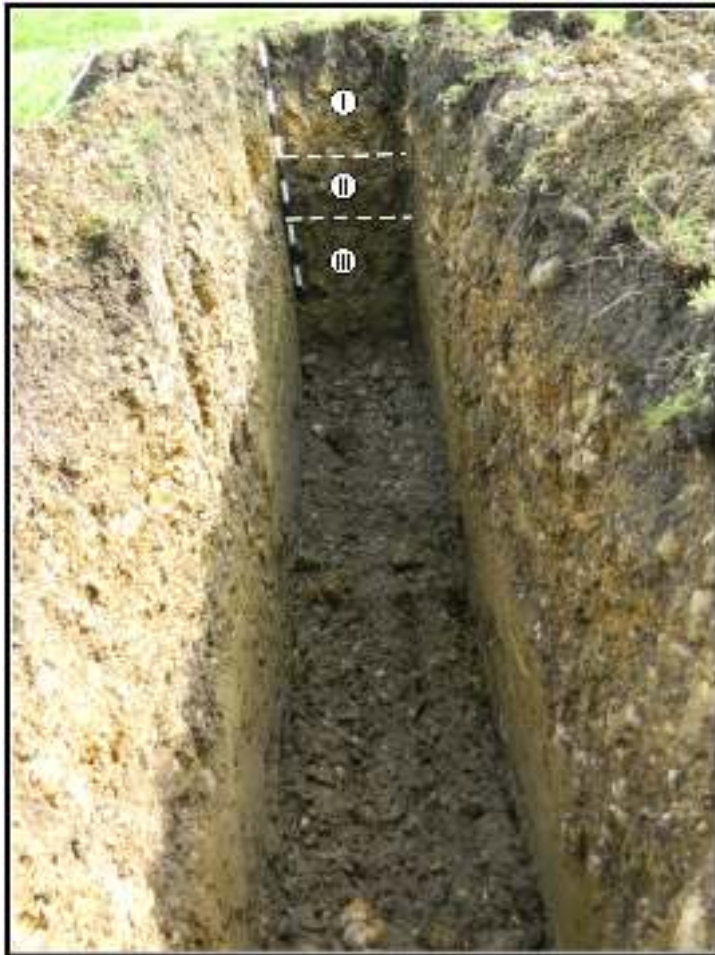
Figure 5-2. BHT 1 trench profile. Note multiple artificial fill layers.

BHT 1 (550817E, 3248957N, UTM:NAD83) was 6 m (19.7 ft.) in length and located at the northeast end of the proposed easement, approximately 165 m (541 ft.) southwest of the current

San Antonio River alignment. Based on pre-channelization aerial photographs (see Figure 3-6), this trench would have been situated on the east bank of the original river channel inside a meander loop. This trench revealed three distinct layers of construction fill material to an excavated depth of 200 cm (78.7 in.; Figures 5-2 and 5-3). No cultural materials were found in BHT 1. Given the depth of fill material and 1959 aerial photographs showing extensive construction impacts and re-contouring of the area, excavation of BHT 1 was terminated since the probability of locating intact archaeological deposits was considered very low.

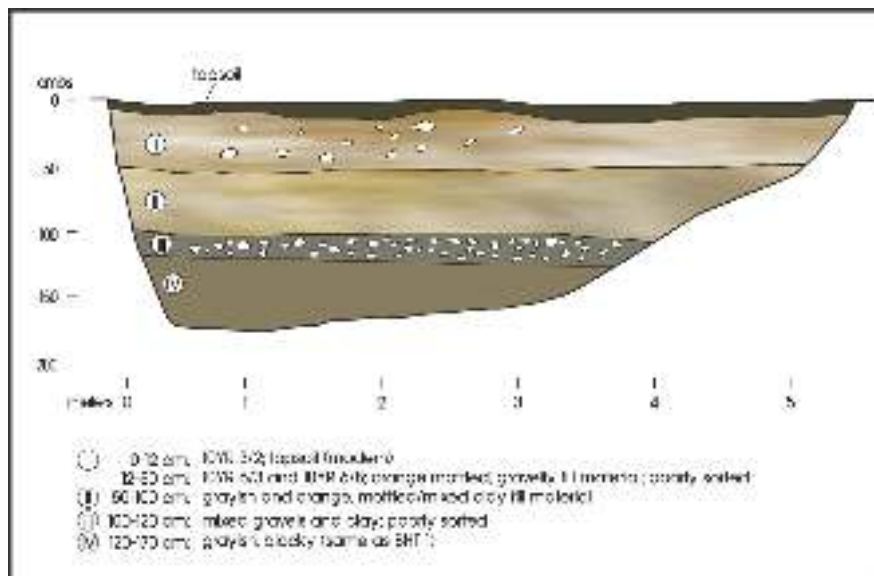
Figure 5-5. Profile drawing of BHT 2, southeast wall. Each zone indicates a separate layer of artificial construction fill.

BHT 2 (550793E, 3248941N, UTM:NAD83) was 5.5 m (18 ft.) in length and located approximately 200 m (656 ft.) southwest of the current San Antonio River alignment and 35 m (114.8 ft.) from BHT 1. This trench would have also been situated on the east bank of the original river channel inside a meander loop. Similar to BHT 1, BHT 2 revealed four distinct layers of construction fill material

to an excavated depth of 170 cm (67 in.; Figures 5-4 and 5-5). No cultural materials were found in BHT 2. Given the depth of fill material and 1959 aerial photographs showing extensive construction impacts and re-contouring of the area, excavation of BHT 2 was terminated since the probability of locating intact archaeological deposits was considered very low.

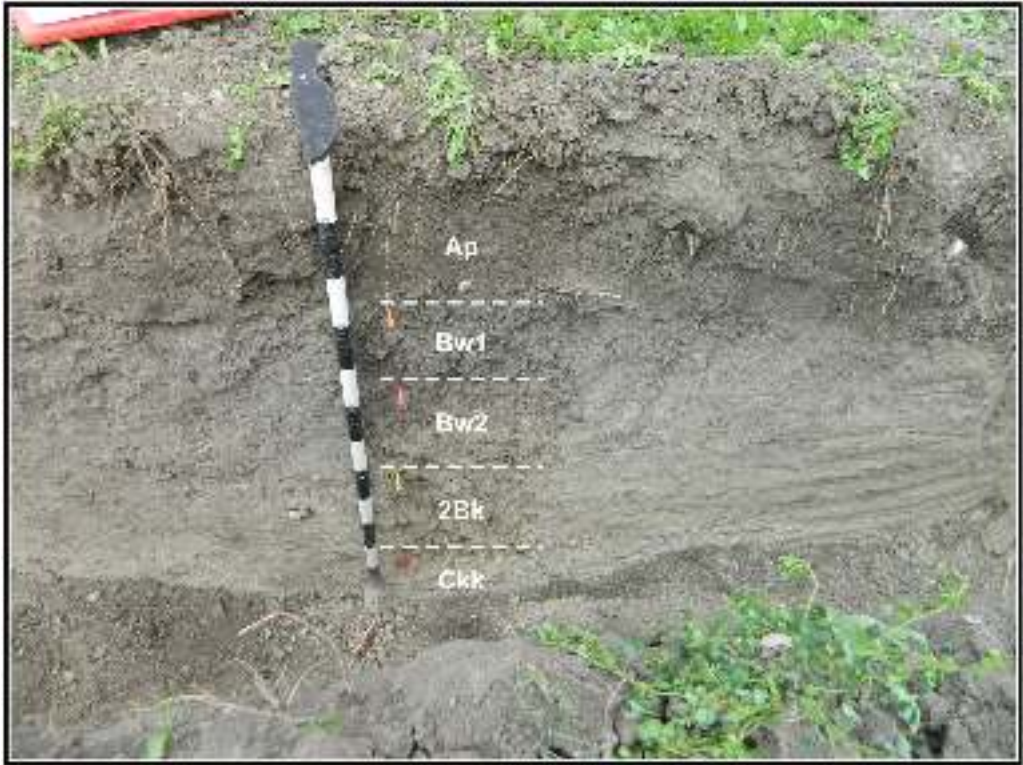
Figure 5-6. BHT 3 soil profile. An erosional unconformity exists between the Bw2 and 2Bk horizons.

BHT 3 (550754E, 3248914N, UTM:NAD83) was 5 m (16.4 ft.) in length and located 245 m (803.8 ft.) southwest of the current San Antonio River alignment and 45 m (147.6 ft.) from BHT 2. BHT 3 revealed an Ap-Bw1-Bw2-Bk-Ck horizon sequence to an excavated depth of 220 cm (86.6 in.; Figures 5-6 and 5-7). Soil texture ranged from silty clay loam in the

Ap horizon to silt loam in the lower horizons. Very fine, faint threads of secondary (pedogenic) calcium carbonate filaments were observed throughout the Bk horizon, and the Ck horizon exhibited massive structure and appears to consist entirely of extremely friable and powdery calcareous silt, which has not been cemented. No cultural materials were found in BHT 3.

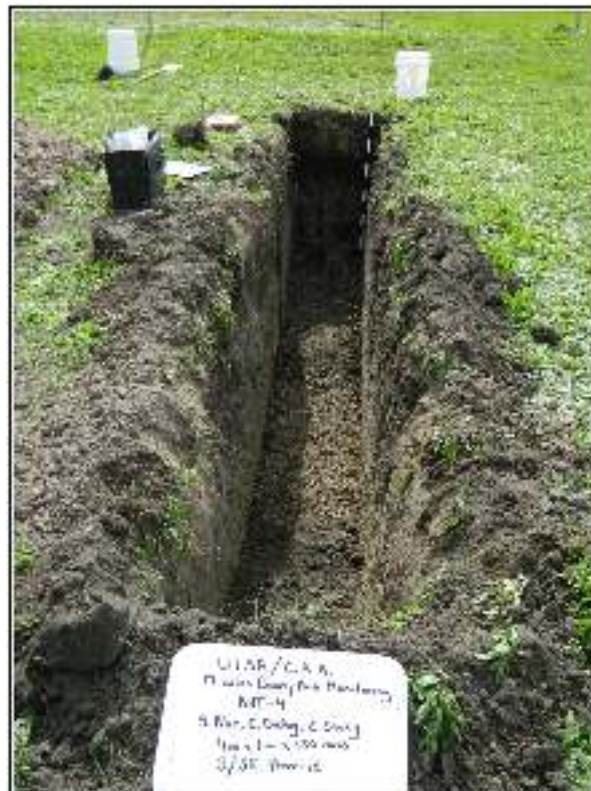
Figure 5-8. Overview of BHT 4, facing northeast.

BHT 4 (550728E, 3248895N, UTM:NAD83) was 5.5 m (18 ft.) in length and was located 275 m (902.2 ft.) southwest of the current San Antonio River alignment and 30 m (98.4 ft.) from BHT 3. BHT 4 revealed an A-Bw-2Bk-2Btk horizon sequence to a depth of 150 cmbs (59 in.); Figures 5-8 and 5-9). Soil texture ranged from silty clay loam to silt loam, with weak fine granular and weak moderate subangular blocky ped structure in the A and Bw horizons, which grade to moderate

coarse angular blocky structure in the Bt and Btk horizons. *Rabdotus* snails and fragments are present throughout all B horizons, and a few pieces of fire-cracked rock (FCR) less than 5 cm (2 in.) in diameter are present within the uppermost portion of the Bw horizon. The lower boundary of the A horizon is abrupt and wavy, which suggests perhaps the upper solum is a more recent addition of deposits, following erosion and truncation of a portion of the Bw horizon.

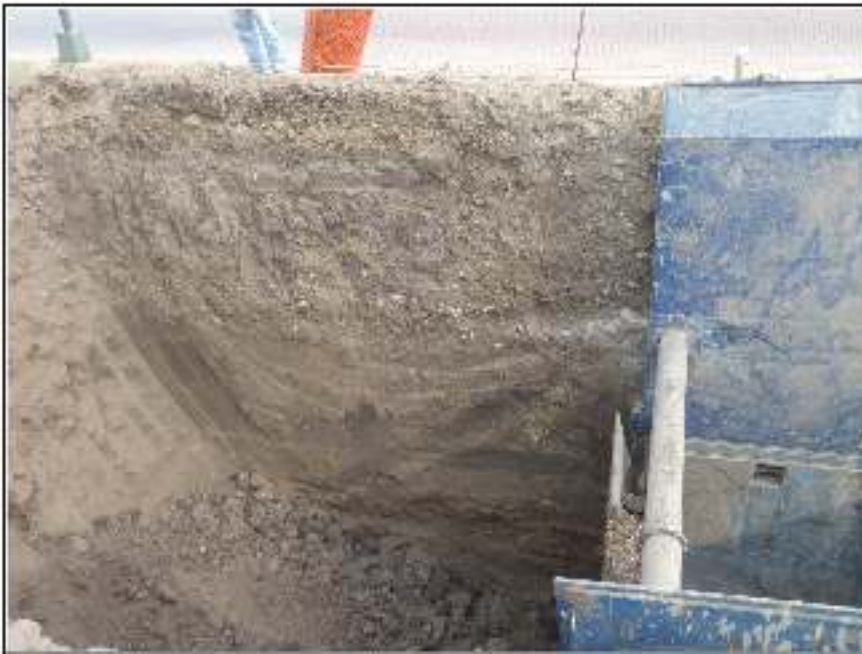
Figure 7-2. North wall profile exposed before moving the shoring unit.

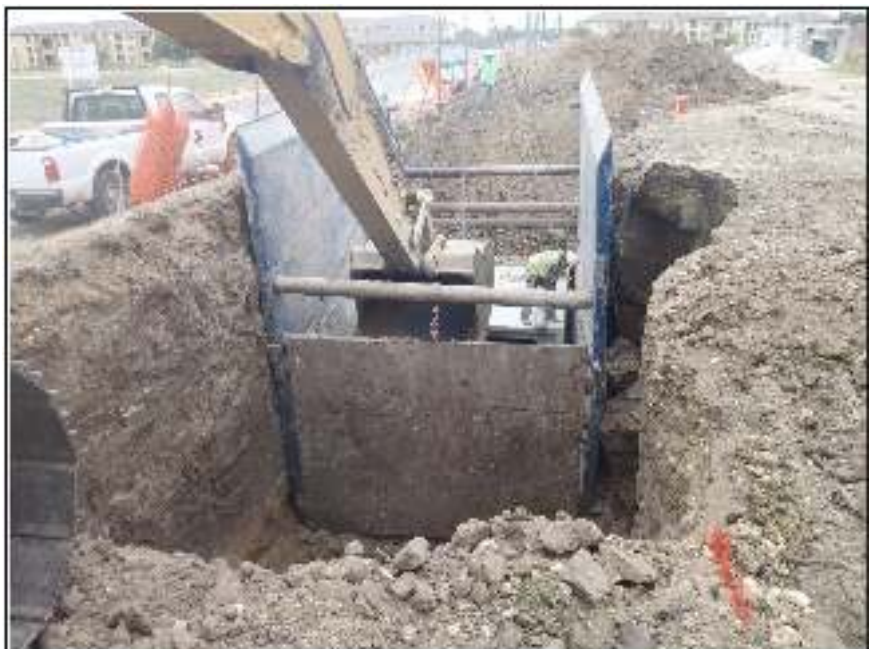
Figure 7-3. Excavator moving the exterior drainage pipe shoring unit.

The trenching and pipe installation was conducted by Zachry Construction Contractors using a 345D CAT Excavator which removed soil to an average depth of 4.6 m (15 ft.). The trench was 4.4 m (14.5 ft.) wide. Along an approximate 6.1 m (20 ft.) section of the trench paralleling VFW Boulevard, bucket-loads of matrix were removed from the western edge of the trench and placed on the ground next to the trench. After the monitor's inspection of the backdirt, a bulldozer was used to scoop up the matrix and deposit it into a larger pile which was also situated to the south on the Mission County Park grounds. The Excavator was then repositioned and the steel-plated wall-shoring unit was moved into place (Figure 7-2). Following these procedures, a commercial-grade crane lowered each 2.7-x-3.4 m (9-x-11 ft.) cement drainage pipe section into the trench while workers connected each section

to previously laid segments (Figure 7-3 and 7-4). A large gravel bucket was next filled and lowered into the trench and its contents poured around the newly laid pipe. Finally, the temporarily stored top soil was used to top-off the trench to the original ground surface.

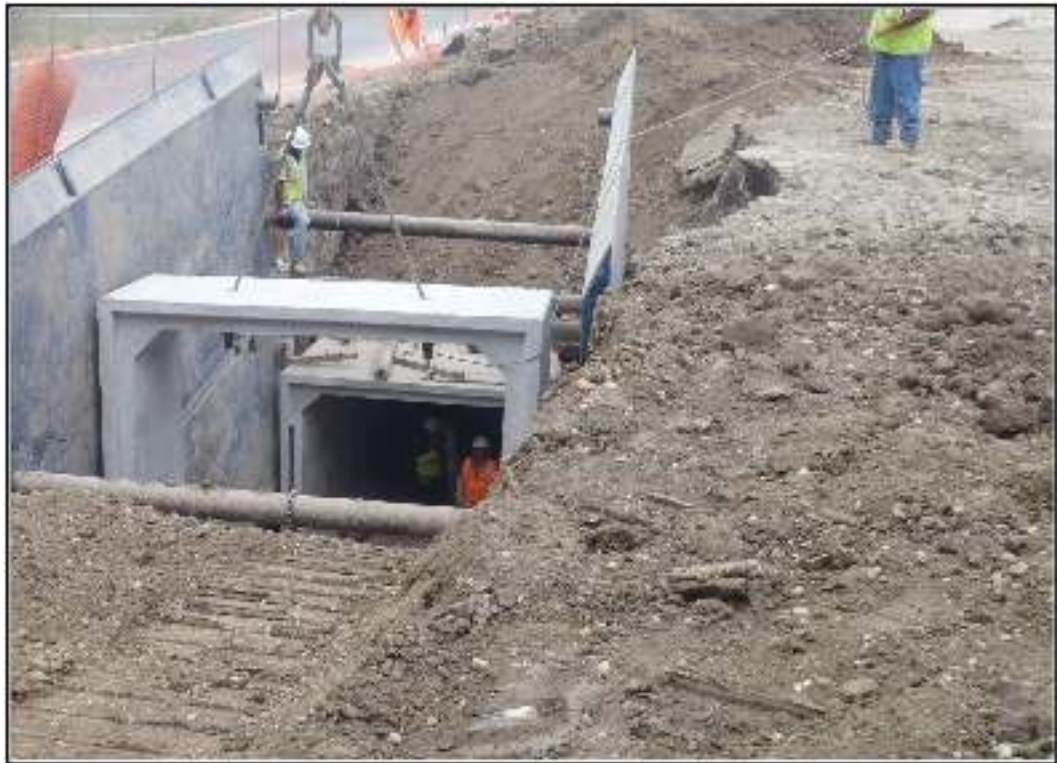
Figure 7-4. Final placement of drainage pipe.

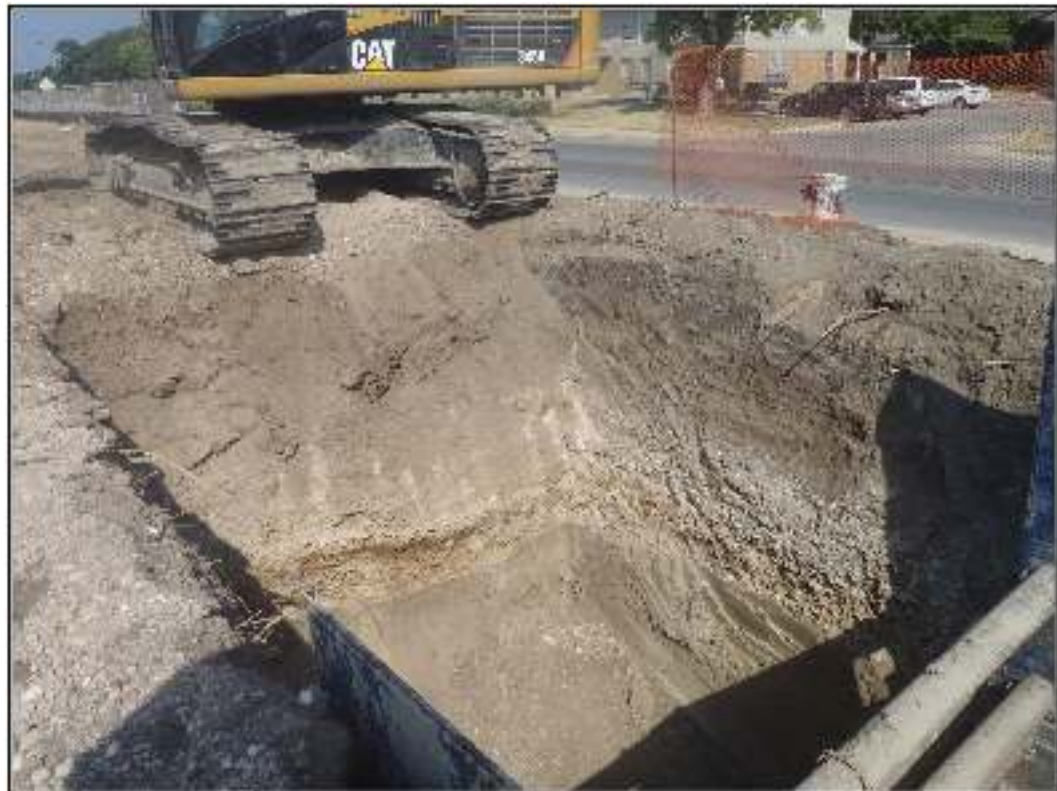
Figure 7-5. Increase of river gravels noted within 5-8 m (16.4-26.2 ft.) east of 41BX1917.
