# Bexar County Courthouse Monitoring/Restoration, San Antonio, Bexar County, Texas

Texas Antiquities Permit No. 7065

*Prepared by:*  
Center for Archaeological Research  
The University of Texas at San Antonio  
One UTSA Circle  
San Antonio, Texas 78249-1644  
Archaeological Report, No. 447

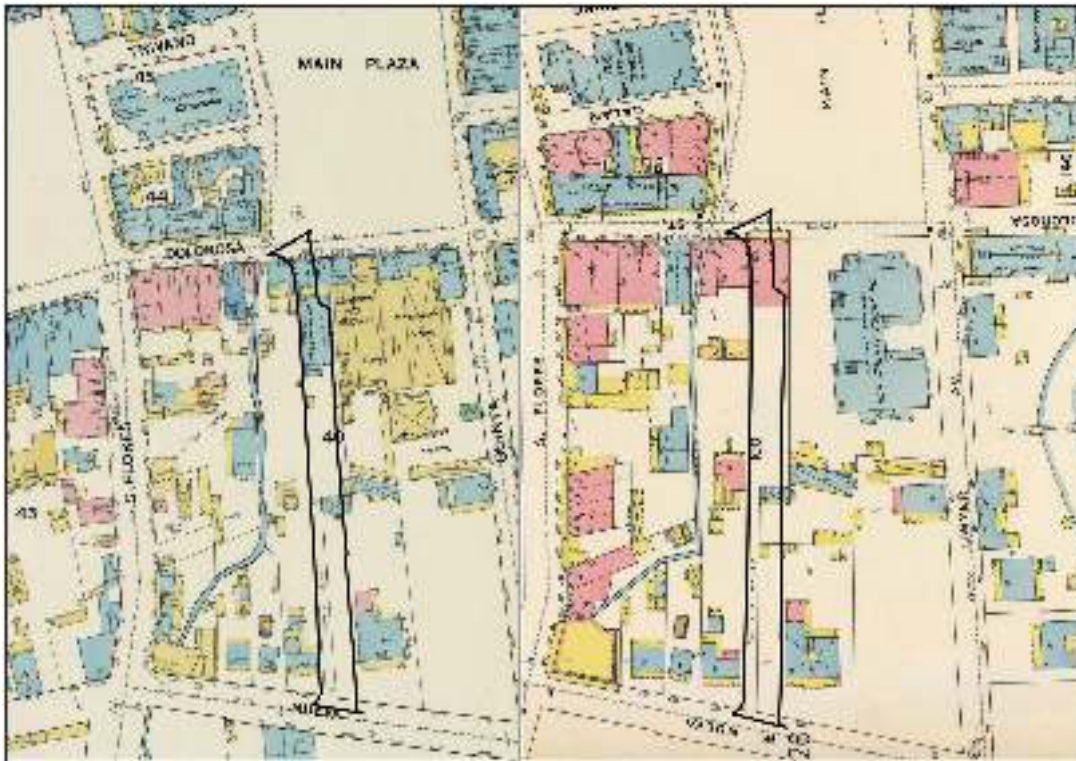
Figure 2-2. Sanborn Insurance maps depicting the project area in 1888 (left) and 1896 (right).

Sanborn maps of the project area dating to 1888 and 1896 indicate the St. Leonard's Hotel was in Section 2, and Section 1 was labeled as a private alley on both maps (Figure 2-2). According to a 1910 article in the *San Antonio Light*, the St. Leonard Hotel was "one of the leading hotels of the city and many prominent persons, including Mexican and American generals of the highest rank stopped at the hostelry" (*San Antonio Light* 1910). Features found during monitoring are thought to be from this period. Further discussion is presented in Chapter 4.

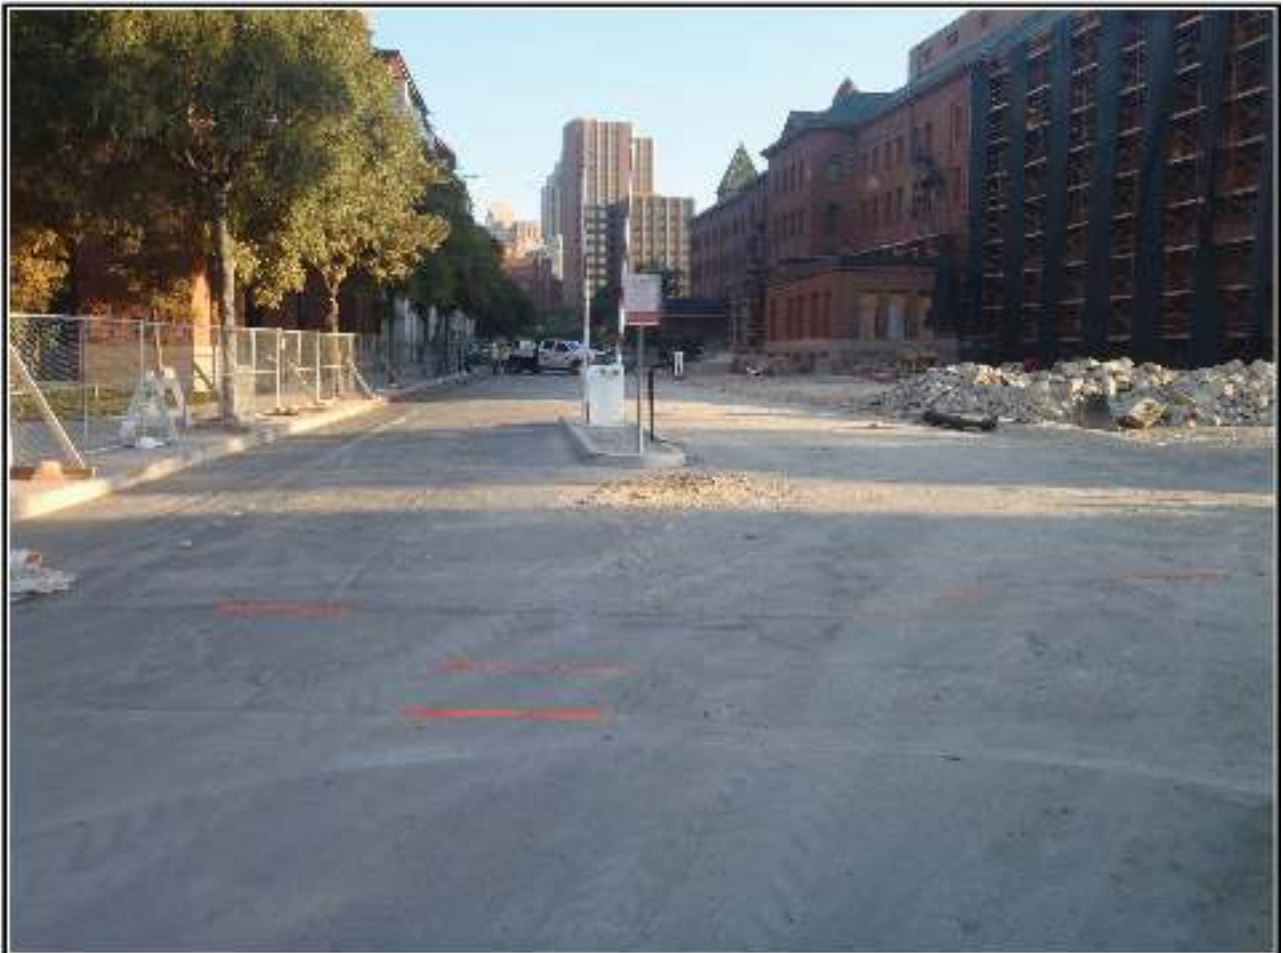
Figure 4-1. Southern portion of Section 1 (facing north).

and copper electrical lines that provided power to the entrance/exit arms situated at the entrance to the street. Throughout the area, cement pads were used to protect underground utilities. These cement pads were initially left in place, however, they were eventually removed by the D&D crew. During this time, no features were found within the area. Artifacts documented, but not collected, included one horseshoe (21 cm below the asphalt) and a few ceramics, including edgeware. Figure 4-1 shows the southern boundaries of Section 1.

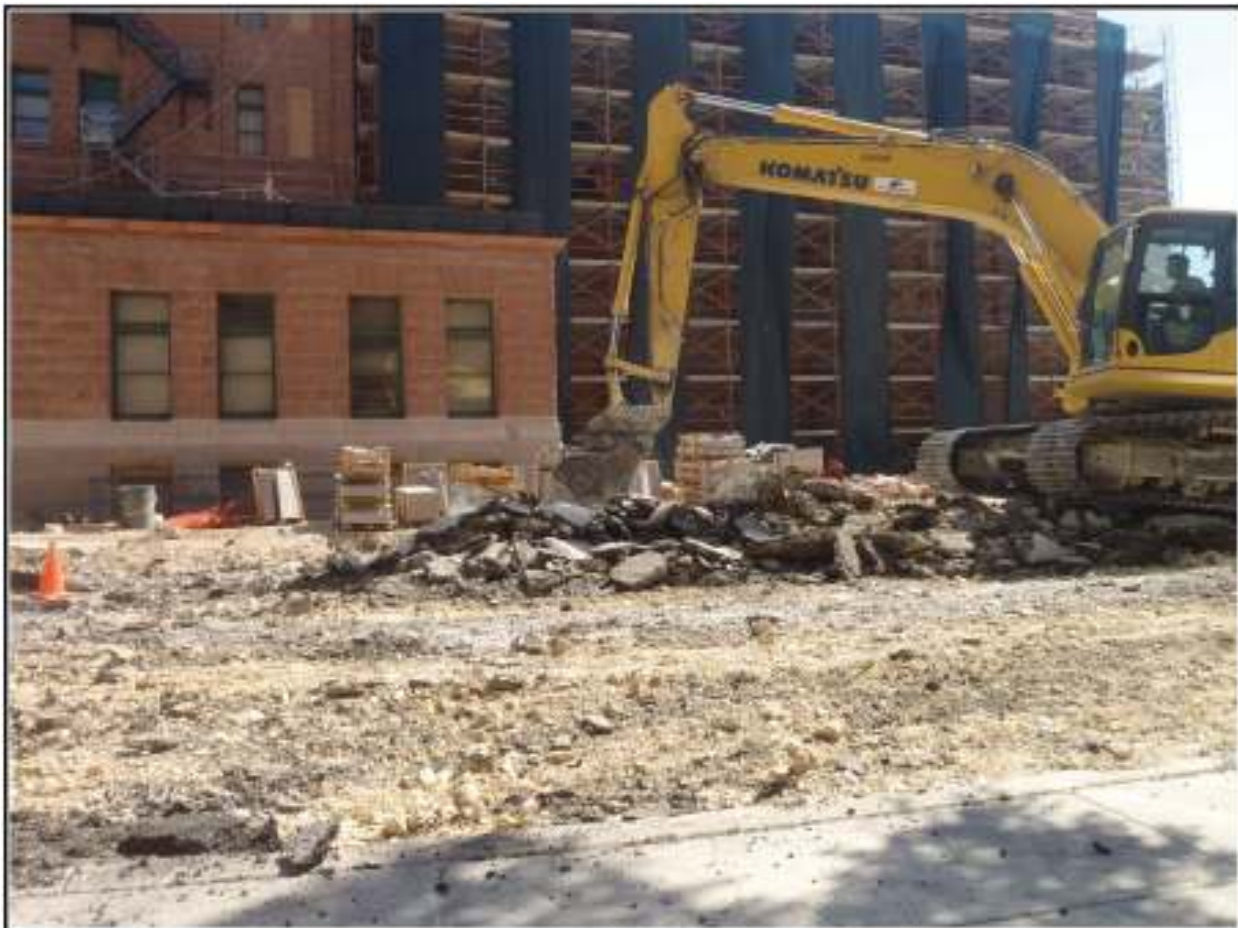
Figure 4-2. Removal of asphalt of Section 2 (facing east).

The first phase of the process consisted of an excavator removing soil using a bucket with a maximum capacity of 1.20 m<sup>3</sup> (Figure 4-2). After the initial removal of soil, a wheel loader

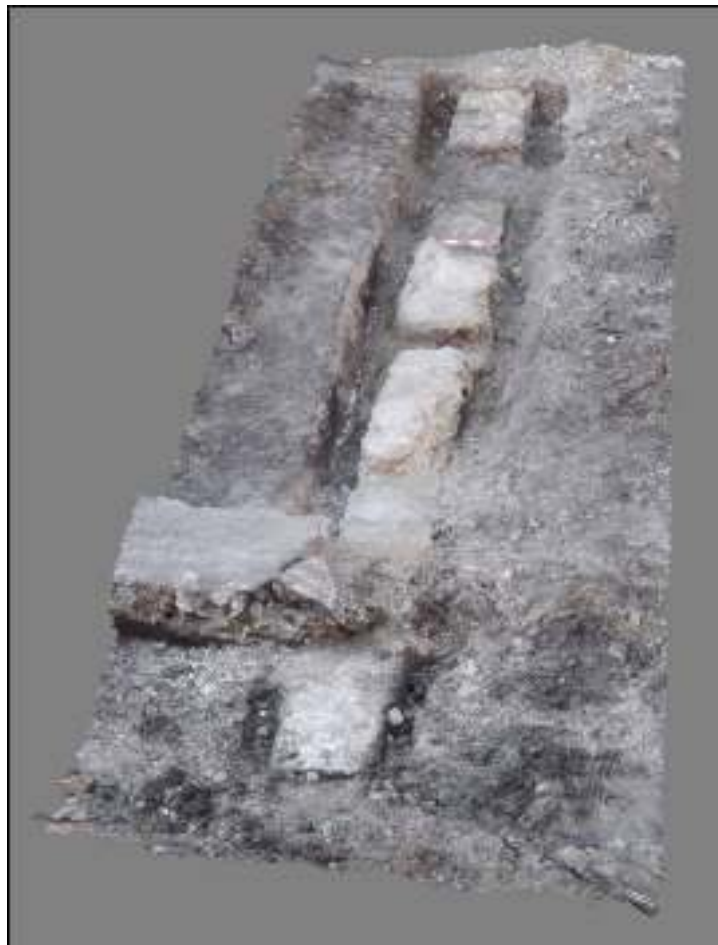
Figure 4-4. 3-D imaging of Feature 1.

The feature was a foundation that consisted of small limestone rocks with a sandy mortar paste (Figure 4-4). The foundation had a variable thickness due to multiple portions being removed by previous excavations, including the probable placement of the gas lines that went north to south across the entire roadway. The western portion of the feature was covered in concrete, and the eastern portion of the feature had a concrete pad that went across it in a north to south direction. While excavating along the edges of Feature 1, artifacts were collected in the soil on both the northern and southern section of the foundation (Figure 4-5). These artifacts are listed in Table 4-2 and suggest a late nineteenth-century affiliation.

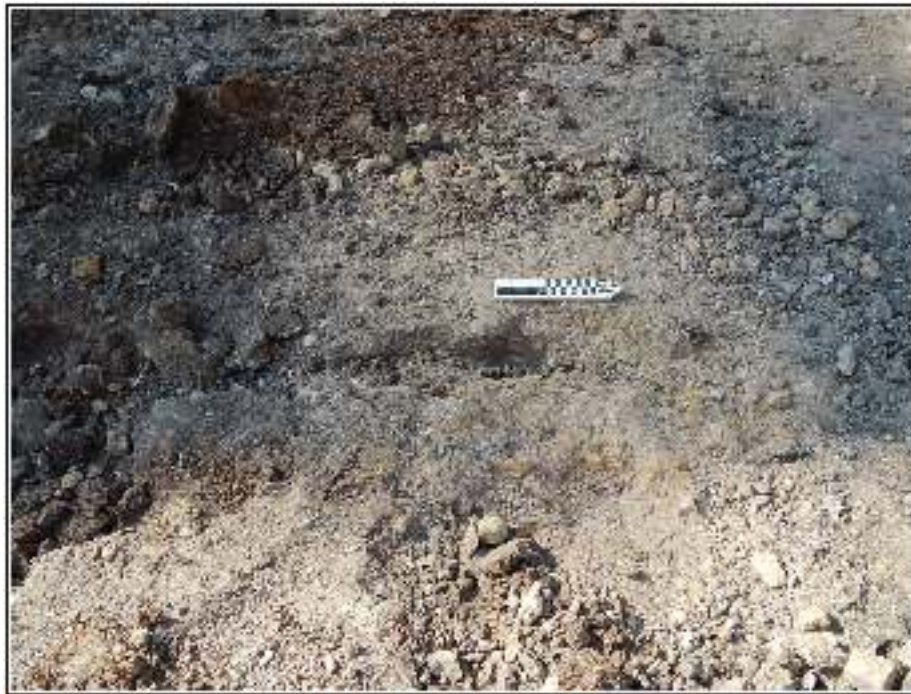
Figure 4-6. Feature 2 (facing west).

Feature 2 consisted of a foundation segment (0.50-x-0.10 m) aligned in a north to south direction (Figure 4-6). Feature 2 was found at a depth of 48.26 cm below the surface (cmbs). The foundation was made from limestone material similar to that of Feature 1. Feature 2 appears to be the remnants of a foundation, as multiple segments of foundation going in the same direction and in the same alignment were found in the middle section of the APE. Artifacts directly associated with Feature 2 consisted of glass (Table 4-3), with one diagnostic artifact, a NuGrape soda bottle, dating between 1915 and 1924 (Clinton M. M. McKenzie, personal communication 2015). Feature 2 was reburied with soil and left in place.

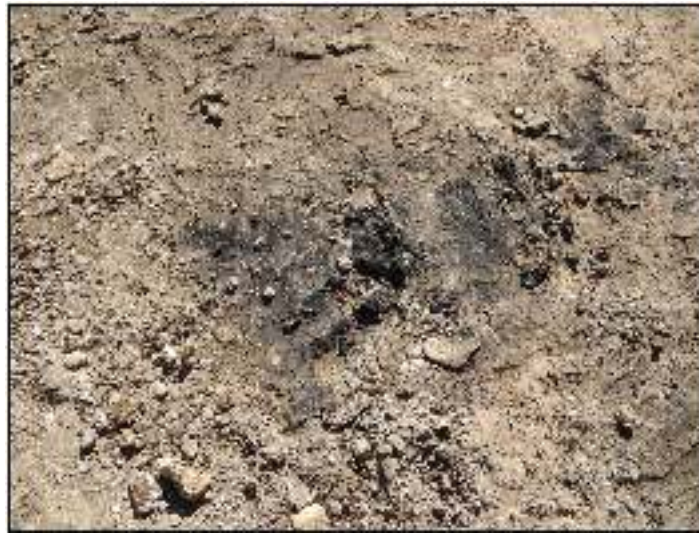
Figure 4-7. *Feature 3.*

Feature 3 consisted of a charcoal stain 0.30-x-0.30 m in size and located 50.80 cmbs (Figure 4-7). There were no artifacts associated with the stain, and no excavation was performed. Feature 3 was left in place.

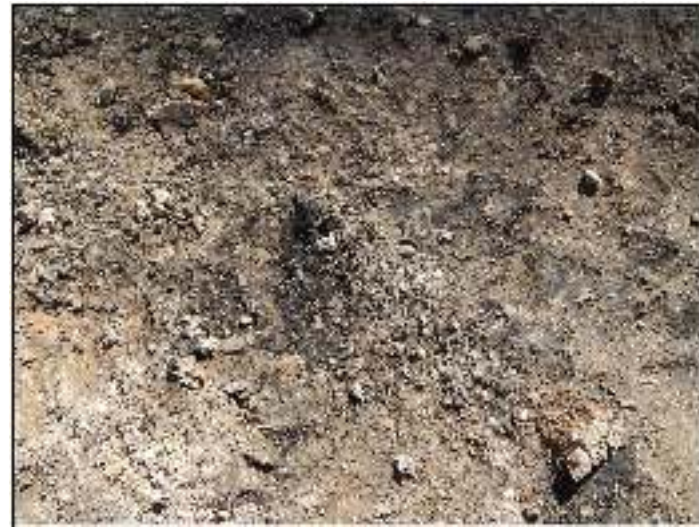
Figure 4-8. *Feature 4.*

Feature 4 consisted of a charcoal stain 0.20-x-0.20 m in size and located 50.80 cmbs (Figure 4-8). There were no artifacts associated with the stain, and no excavation was performed. Feature 4 was left in place.

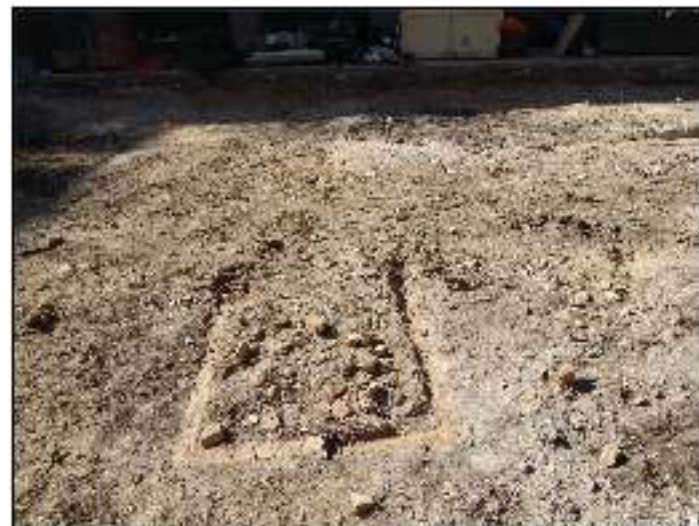
Figure 4-9. *Feature 5, a brick lined privy.*

Feature 5 consisted of a privy that was lined with handmade bricks (Figure 4-9). The bricks were laid out in a U-shaped pattern with the base of the U going in a north to south direction. The feature measured 0.80-x-0.70-x-0.12 m and was located 48.26 cmbs. The bricks were double stacked, at least. No further depth was excavated, and the bricks were preserved in place. CAR staff interpreted this feature to be a privy associated with the St. Leonard's Hotel. Privies with similar characteristics were identified during the Alamodome project (Brown and DelaO 1997). No artifacts were directly associated with Feature 5.

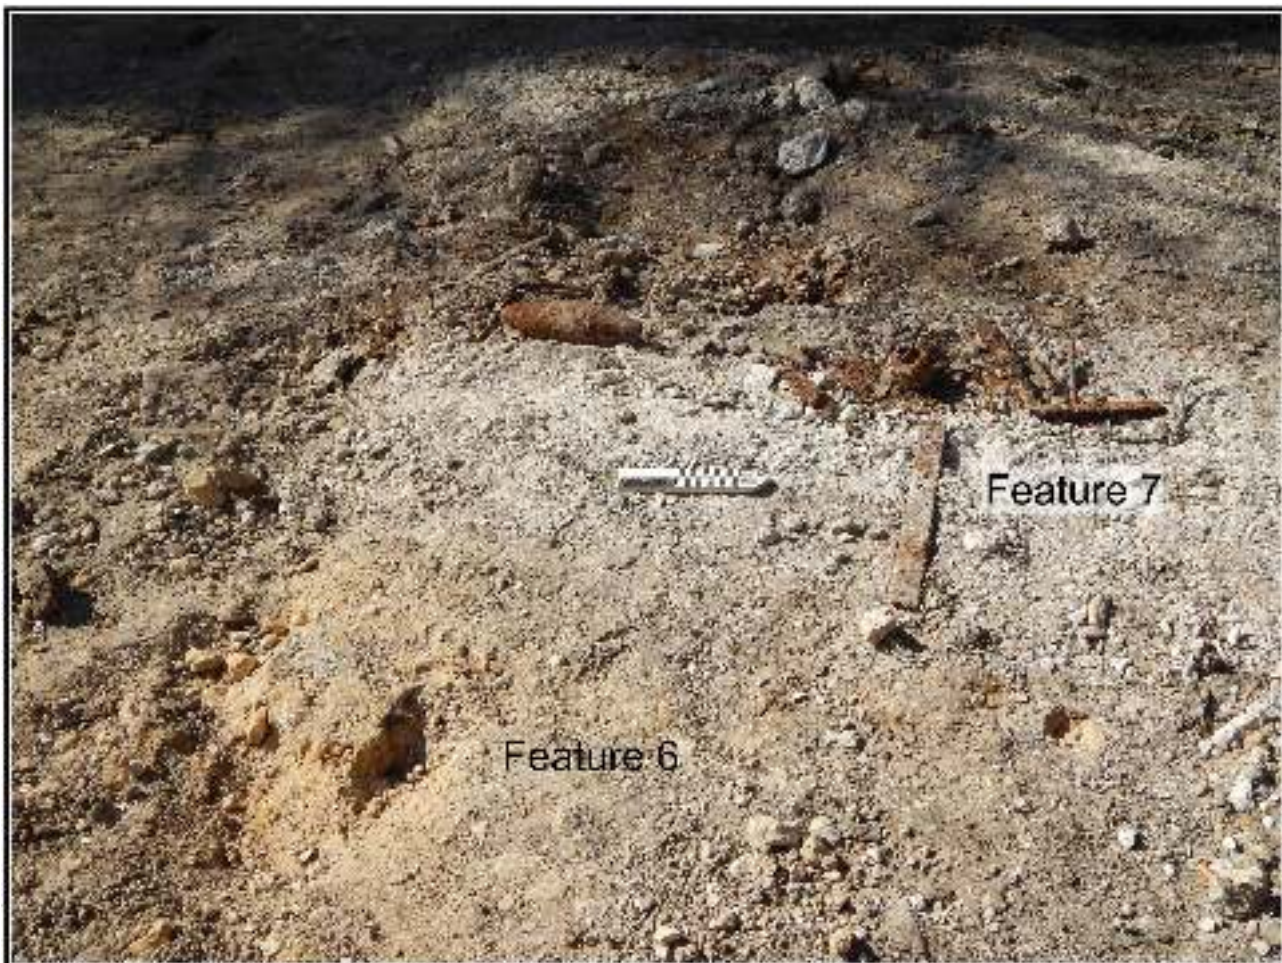
Figure 4-10. Features 6 and 7.

Feature 6 consisted of a limestone foundation (0.30-x-0.10 m) and was aligned in a north to south direction (Figure 4-10). This feature was in line with the segment from Feature 2. Feature 6 was found at a depth of 48.26 cmbs. The foundation was made from the same material as Feature 1. No artifacts were directly associated with this feature. Feature 6 was reburied with soil and left in place.

Feature 7 consisted of a concrete foundation (0.80-x-0.10 m) with rebar protruding from it (see Figure 4-10). The rebar was apparently of an older style according to the construction workers. Feature 7 was aligned in an east to west direction in close proximity to Feature 6. Feature 7 was 40.64 cmbs but was skimmed down to approximately 50.80 cmbs. Artifacts associated with Feature 7 were metal, including pieces of auto or machinery that were not collected.

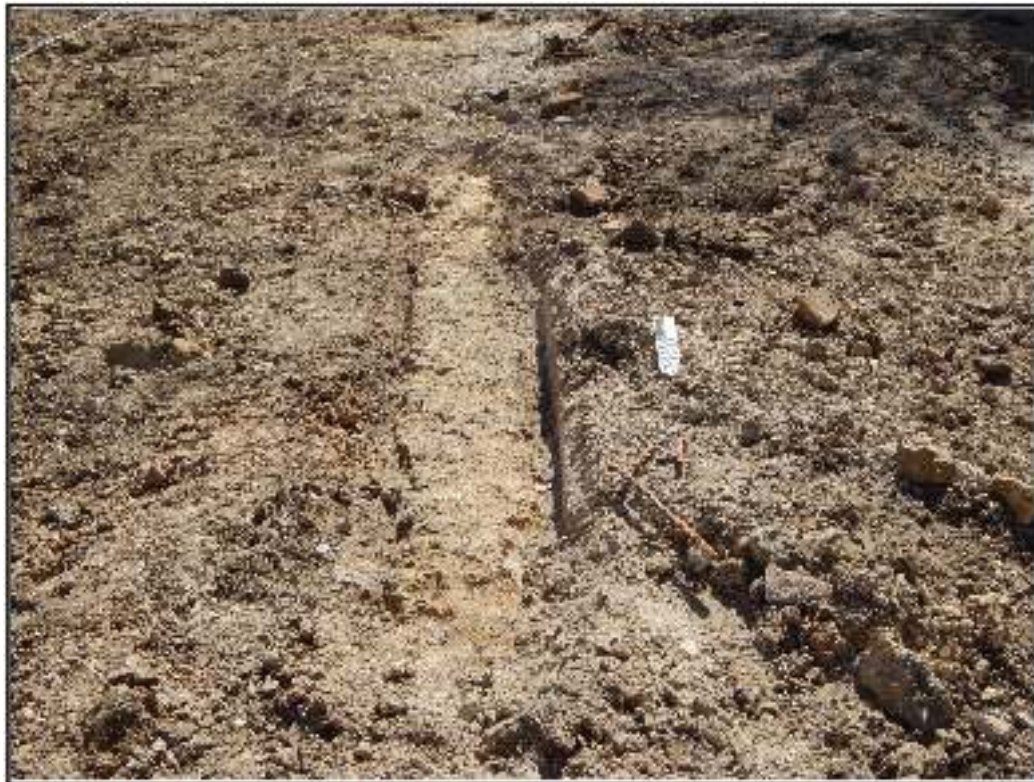
Figure 4-11. *Feature 8 (facing south).*

Feature 8 consisted of a foundation segment (1.50-x-0.10 m) and was aligned in a north to south direction (Figure 4-11). The feature was in line with the segment from Features 2 and 6. Feature 8 was found at a depth of 48.26 cmbs. The foundation was made from the same material as Feature 1. No artifacts were directly associated with this feature. Feature 8 was reburied with soil and preserved in place.

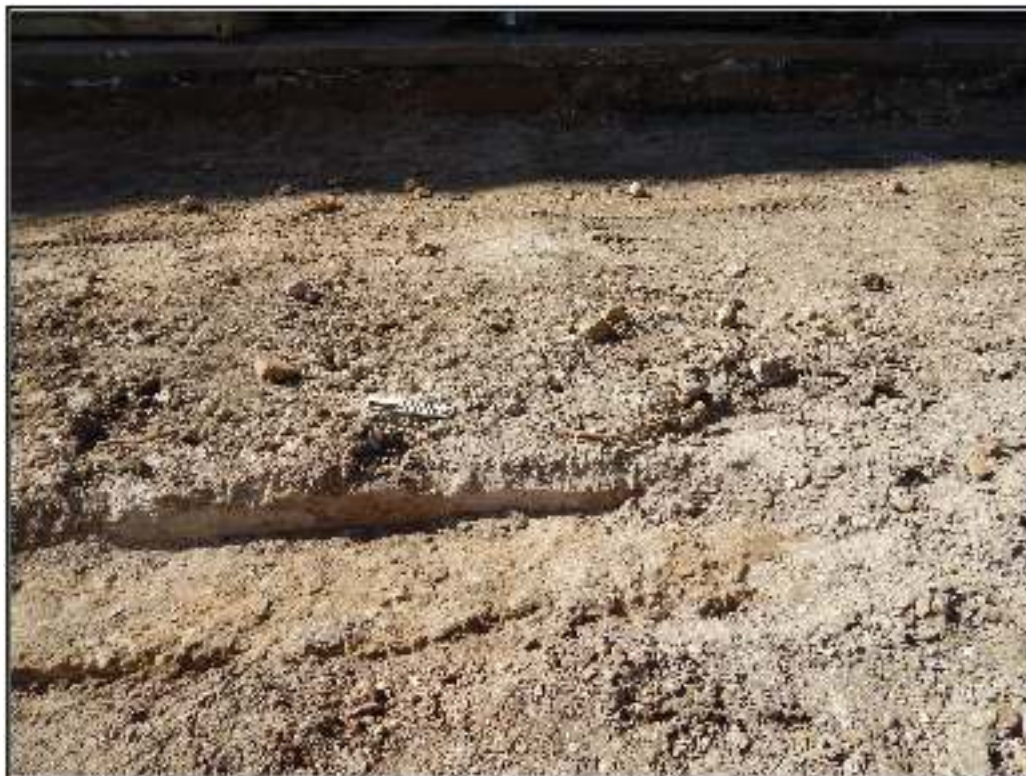
Figure 4-12. *Features 9 and 10 (facing west).*

Feature 9 (1.70-x-0.20 m) and Feature 10 (0.90-x-0.10 m) consisted of a cement and rebar foundation in the same style as Feature 7. The features ran parallel to each other in an east to west alignment and were perpendicular to Feature 8. Features 9 and 10 were approximately 40 cm apart from each other (Figure 4-12). Both features were above the desired level of the APE excavation and were skimmed down to 50.80 cmbs. No artifacts were associated with Feature 9 or Feature 10.

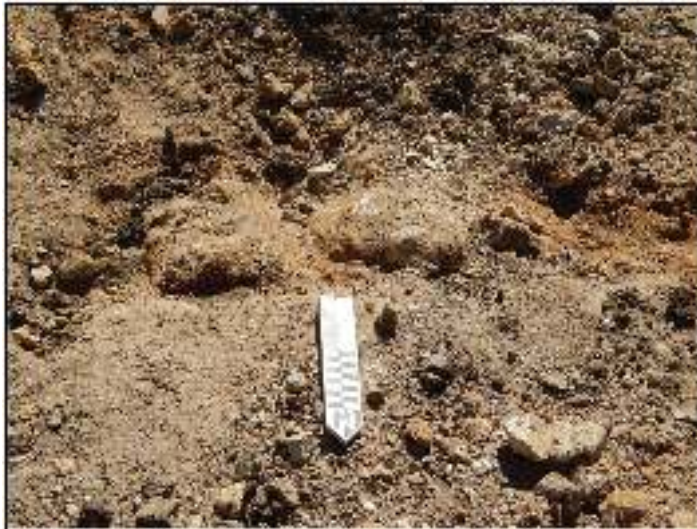
Figure 4-13. Feature 11 (facing south).

Feature 11 consisted of two large limestone blocks (Figure 4-13). Both blocks were approximately 15 cm across at their widest dimension. The feature was found at a depth of 50.80 cmbs. No artifacts were directly associated with Feature 11, and it did not align with any of the other features. Feature 11 was reburied with soil and left in place.

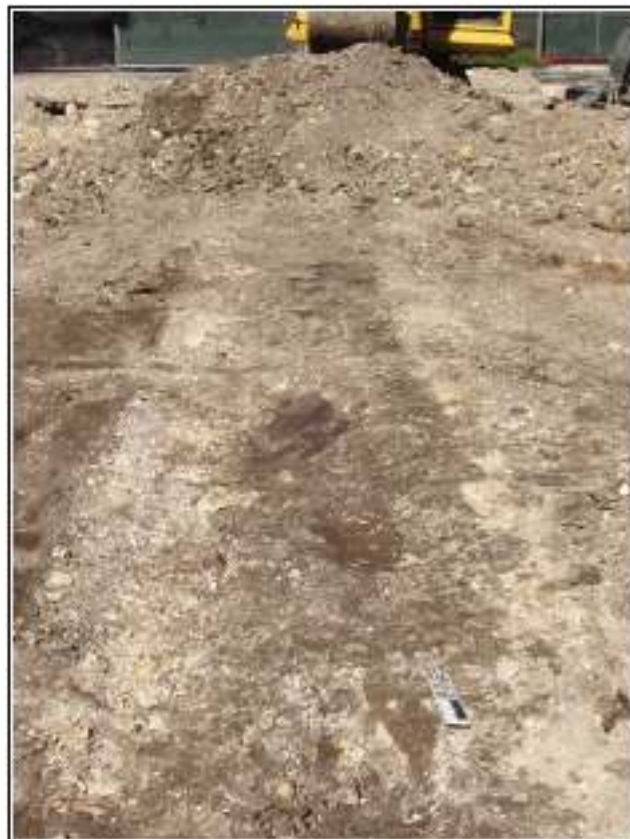
Figure 4-14. Features 12 and 13 (facing north).

Features 12 and 13 consisted of two strips of probable foundation that were similar in appearance to the other limestone rock foundations identified on the project area (Figure 4-14). The foundation was made from limestone. Features 12 and 13 were found at the surface of 50.80 cm. Both

features were approximately 5 cm in width. Feature 12 was 3.50 m in length. Feature 13 was broken into two sections with the southern section measuring 2 m in length and the northern section 1.60 m in length. Neither feature was in alignment with any of the previous features, and both were at a lower depth than other features. No artifacts were associated with Feature 12 or Feature 13. The features were left in place.

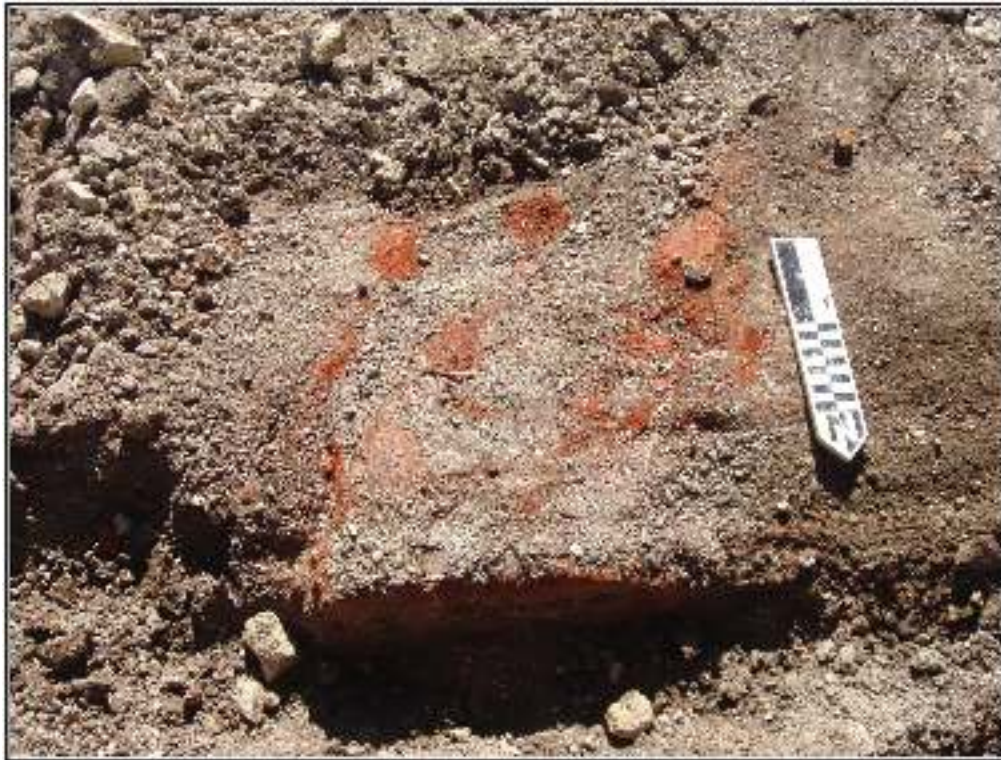
Figure 4-15. Feature 14 (facing south).

Feature 14 consisted of a brick “pier” corner (0.30-x-0.30 m) and was 45.72 cmbs (Figure 4-15). The feature was not associated with any other feature or with any artifacts. Feature 14 was reburied and left undisturbed.
