# Archaeological Monitoring for Ashley Road Project, San Antonio, Bexar County, Texas

Texas Antiquities Permit No. 7589

*Prepared by:*  
Center for Archaeological Research  
The University of Texas at San Antonio  
One UTSA Circle  
San Antonio, Texas 78249  
Archaeological Report, No. 451

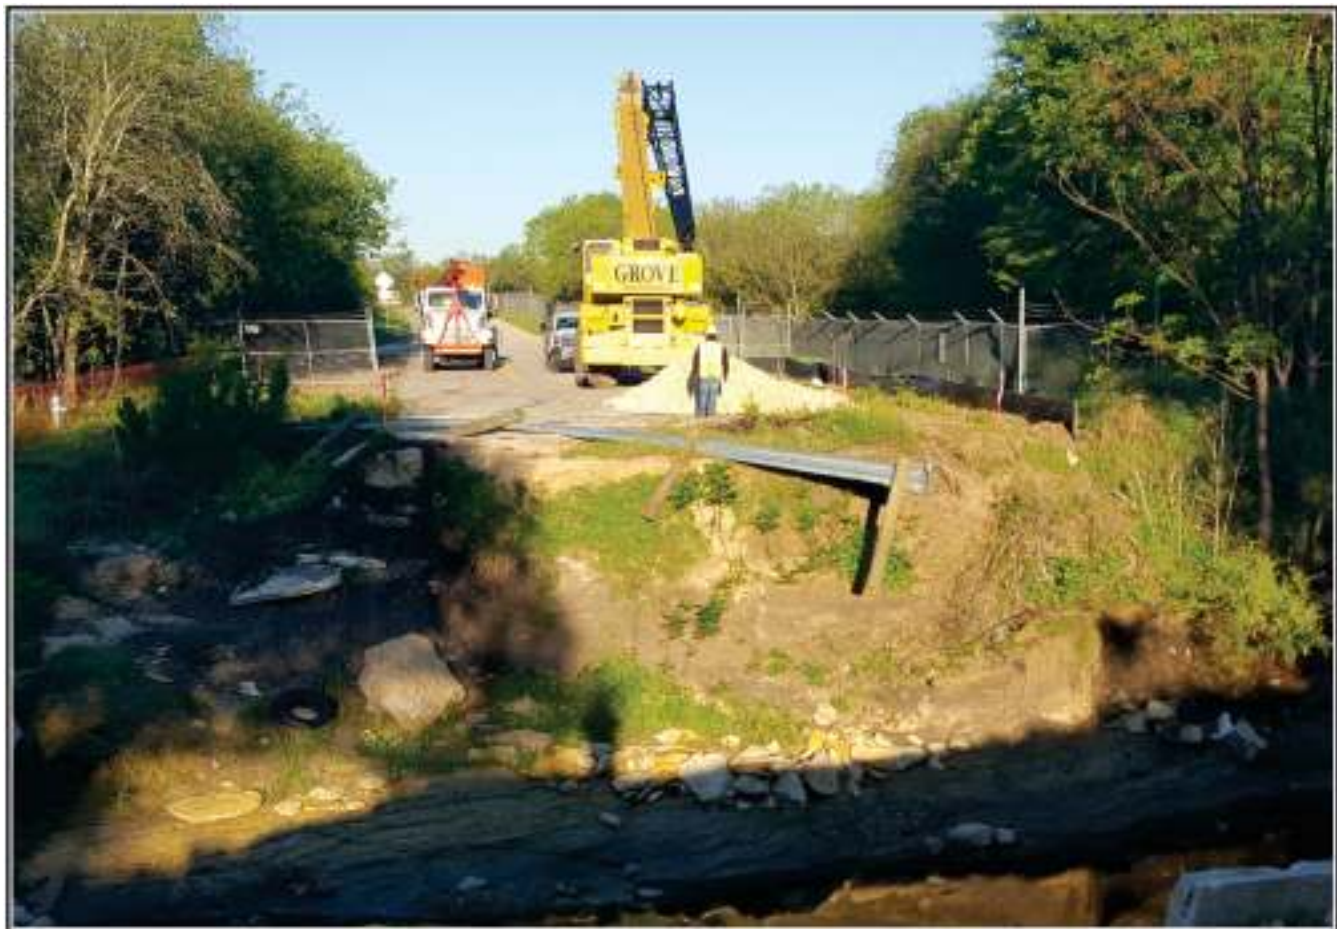
Figure 4-1. The banks of Sixmile Creek within the APE, taken from the east bank along Ashley Road.

Construction efforts associated with the project began on the east bank of Sixmile Creek (Figure 4-1) where the

culvert and bridge had been washed out in flooding events. The washed out concrete culvert was removed on March 17, 2016. On March 31, 2016, two holes were drilled reaching a depth of 11.3 m (37 ft.) for piers that would support the newly constructed bridge. The auger bit measured 60 cm (24 in.) in diameter. No cultural material was observed during the drilling of the pier holes on the east bank. As seen in Figures 4-2 and 4-3, the slope of bank was graded for the placement of a concrete riprap to create a six percent slope. Modern material in the form of a cassette tape was noted; however, no historic material was observed during these excavations.

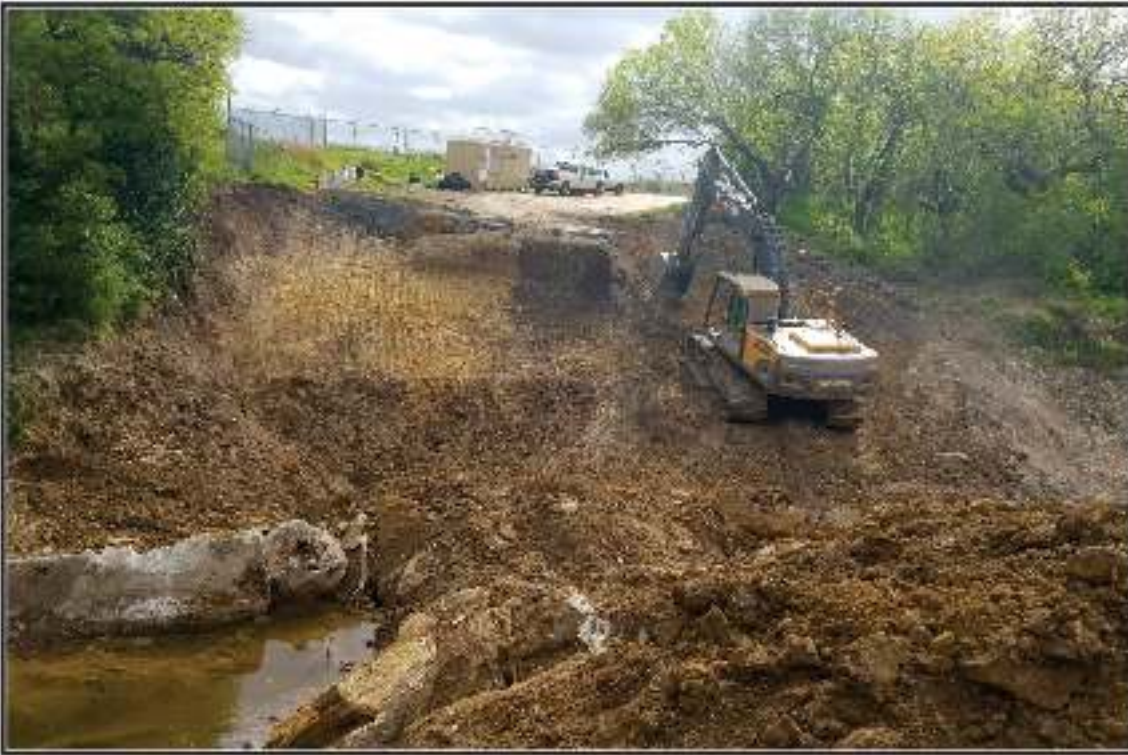
Figure 4-2. Grading of east bank of the creek for riprap.

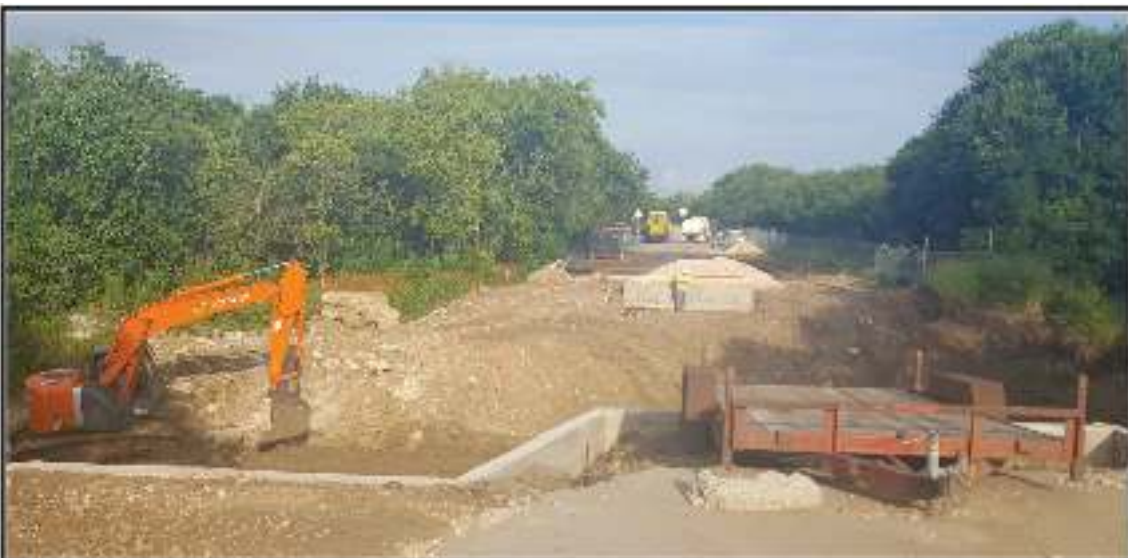
Figure 4-3. Concrete riprap on the east side of the creek.

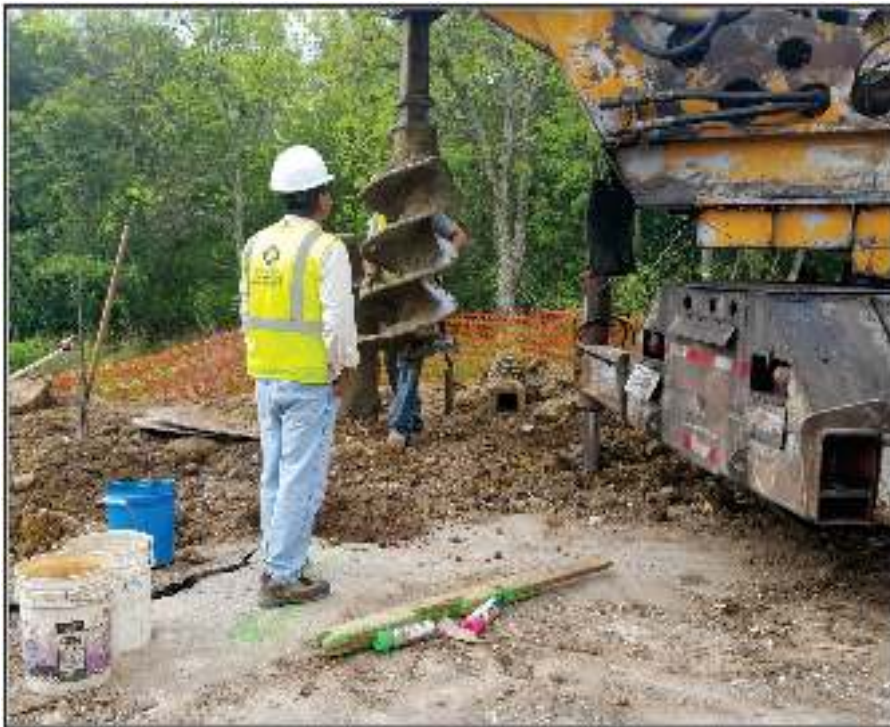
Work on the west bank of Sixmile Creek along Ashley Road started on March 23, 2016, with drilling for piers (Figure 4-4). Two holes were drilled to a depth of 12 m (42 ft.) with the same 60 cm (24 in.) auger bit used on the east side of the project area. No cultural material was observed during this time.

Figure 4-4. Drilling of holes for pier installation on the west bank.

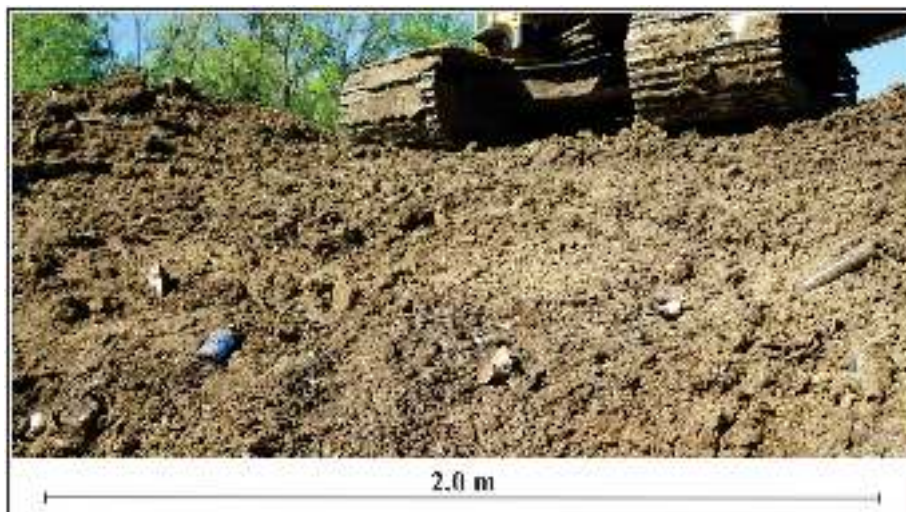
On March 24, 2016, during excavations associated with the slope grading for the concrete riprap on the northern side of Ashley Road, Feature 1 was encountered 0.9 m (3 ft.) below the asphalt. It consisted of a scatter of bottles, ceramics, and metal. As shown in Figure 4-5, Feature 1, subsequently recorded as site 41BX2138, measured 3 m (9.8 ft.) in length

Figure 4-5. Photo of Feature 1 on west bank of Sixmile Creek, north side of East Ashley Road.

by 2 m (6.5 ft.) in width (Figure 4-6). The matrix in which the feature was located consisted of a brown (10YR 5/3) clay loam alluvial deposits. A sample (n=6) of the artifacts from the feature was collected and taken back to the CAR lab for identification. Field Specimen 4 (Table 4-1), the china bowl with a Homer Laughlin Duraprint trademark, dates to 1914 (Restaurant Ware Collectors Network 2016).

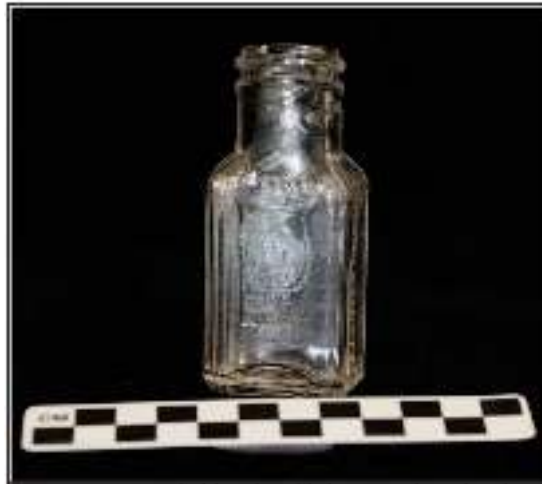
Material collected (Table 4-1) from the feature dates to the early twentieth century. Makers' marks were used to conclusively date the material. A Gebhardt Chili Powder glass bottle that dates to the 1920s (Digger Odell Publications 2016) is shown in Figure 4-7. The Phillips'® Milk of Magnesia bottle (Figure 4-8) dates as early as 1906. The material in Feature 1 more than likely represents domestic refuse from the nearby residents.

Figure 4-7. Gebhardt Chili Powder bottle recovered from Feature 1.

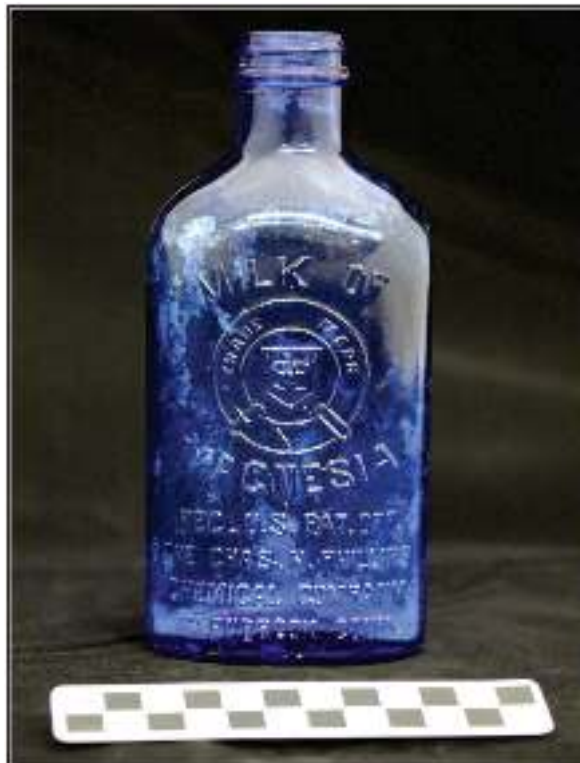
Figure 4-8. Phillips'® Milk of Magnesia bottle, collected from Feature 1.

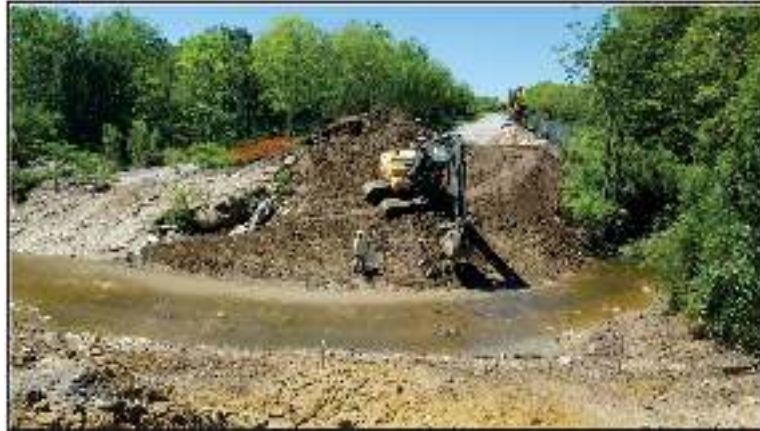
After CAR staff documented the feature, it was removed, and grading of the east bank continued. The southern portion of the bank had been previously impacted by sewer lines (Figure 4-9). On June 27, the final day of fieldwork, CAR monitored the removal of road base along with fill on the east side of

Figure 4-9. Grading of slope on east bank of Sixmile Creek.

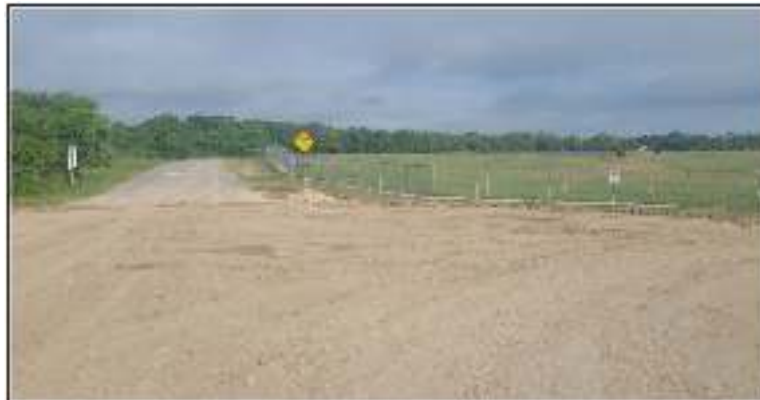
Sixmile Creek. On the same day, CAR archaeologists noted the removal of the road asphalt and fill at the corner of Ashley Road and Acequia Road (Figure 4-10). These activities did not require monitoring. Concrete ripraps had also been poured prior to the last day of fieldwork (Figure 4-11).

Figure 4-10. Asphalt and base removal at the corner of Ashley Road and Acequia Road.

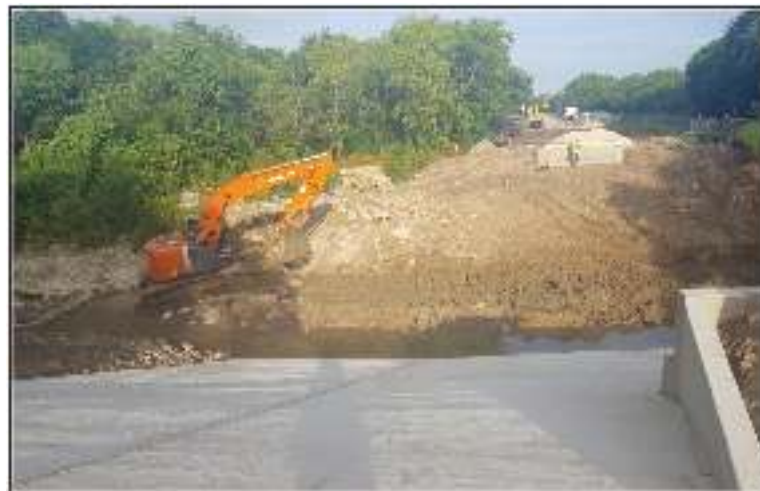
Figure 4-11. Picture of APE taken on June 27, 2016 (facing west).
