Archaeological Monitoring for the Construction of the IKE Smart City Kiosk at Mission Concepción, San Antonio, Bexar County, Texas

Prepared by:
Center for Archaeological Research
The University of Texas at San Antonio
One UTSA Circle
San Antonio, Texas 78249
Archaeological Report, No. 469

**Archaeological Monitoring for the Construction of the
IKE Smart City Kiosk at Mission Concepción,
San Antonio, Bexar County, Texas**

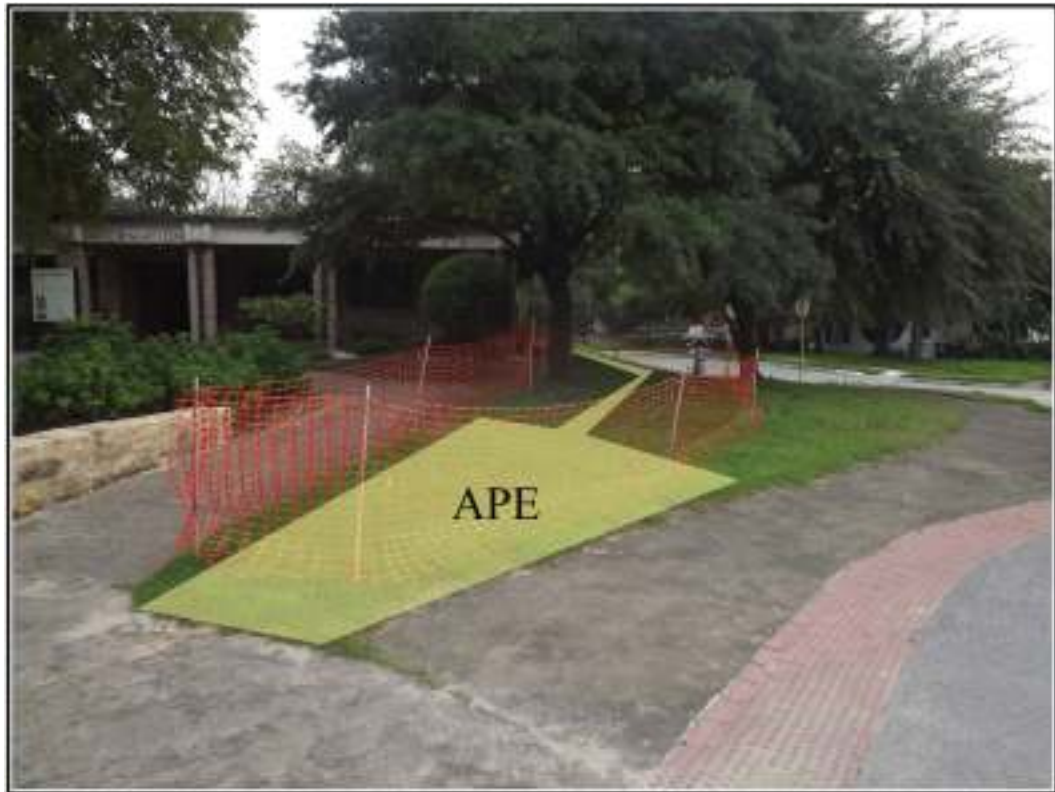
Figure 1-2. View of APE (prior to excavation) showing approximate locations of concrete pad and trench. The visitor's center is the building in the background.

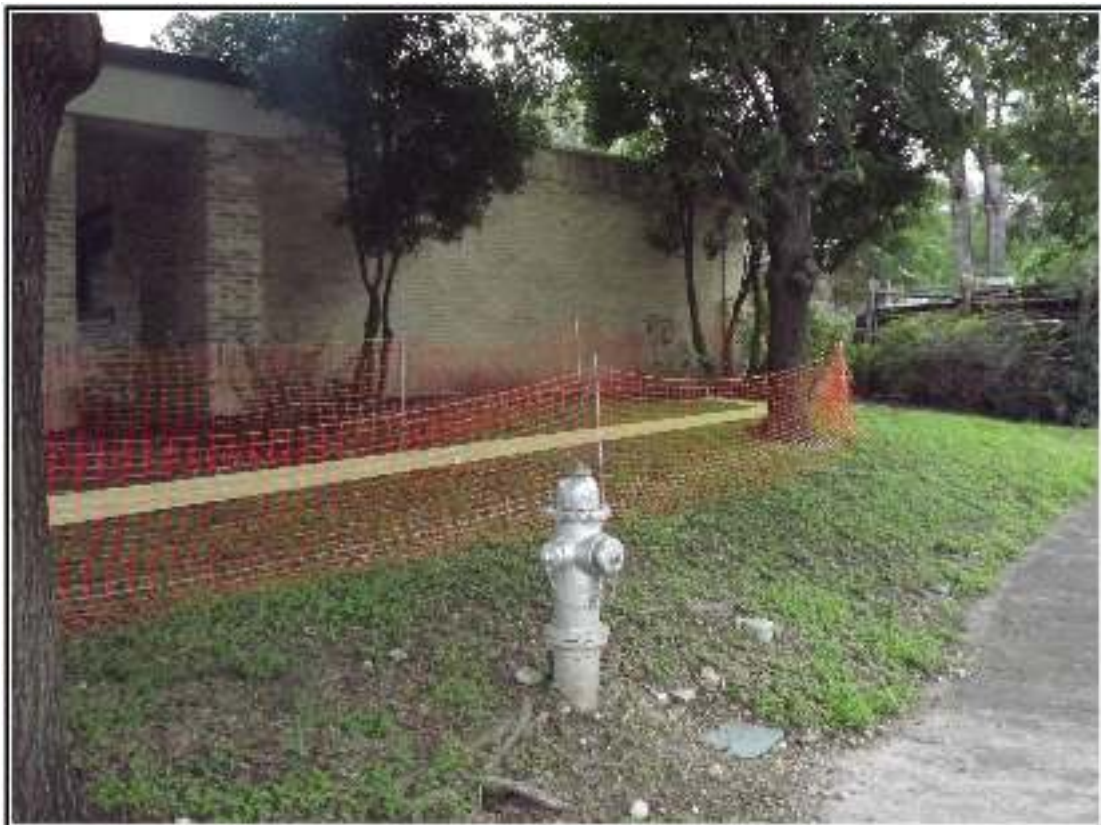
Figure 1-3. View to the northeast of proposed trench (highlighted area) with tie-in to the visitor's center.

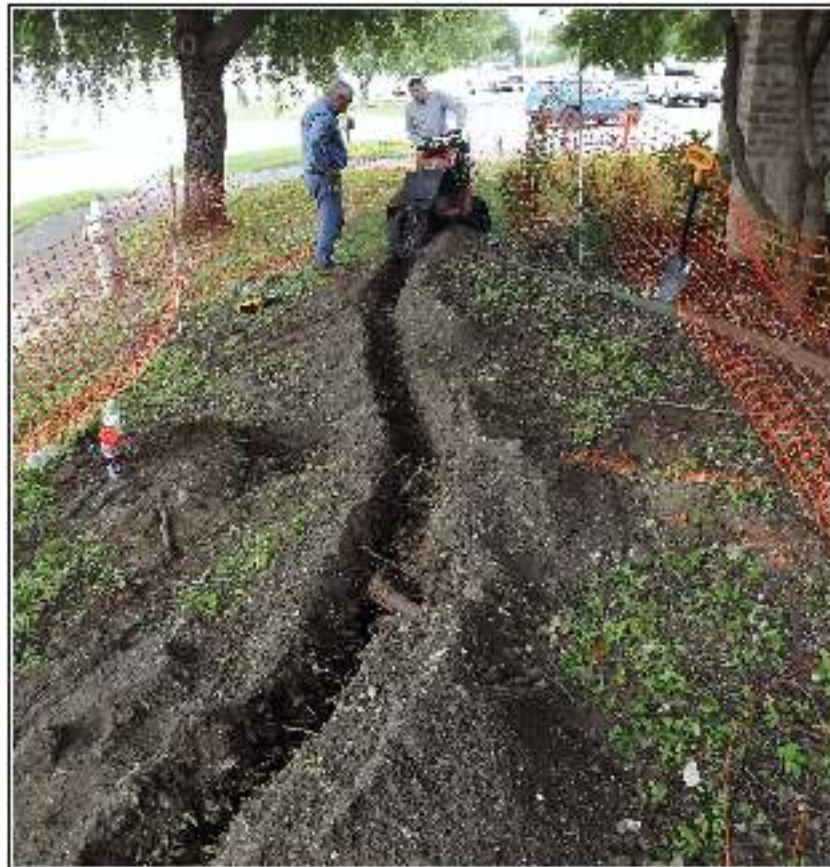
Archaeological monitoring and testing for the interactive kiosk and infrastructure at Mission Concepción took place on September 25, 28, and October 1, 2018. The first day consisted of monitoring trench excavation for an electrical conduit (Figure 4-1). The trench measured approximately 23 m (75.45 ft.) in length, 20 cm (7.87 in.) in width, and ranged from 40.8-50.8 cm (16-20 in.) below the surface (Figures 4-2 and 4-3). Visibility was limited by the narrowness of the trench. No features were observed, and no artifacts were found in situ. Three artifacts were collected from the back dirt including a cut faunal bone, a brick fragment, and a sandstone paver fragment.

Figure 4-1. View to the west of trench excavation adjacent to visitor's center.

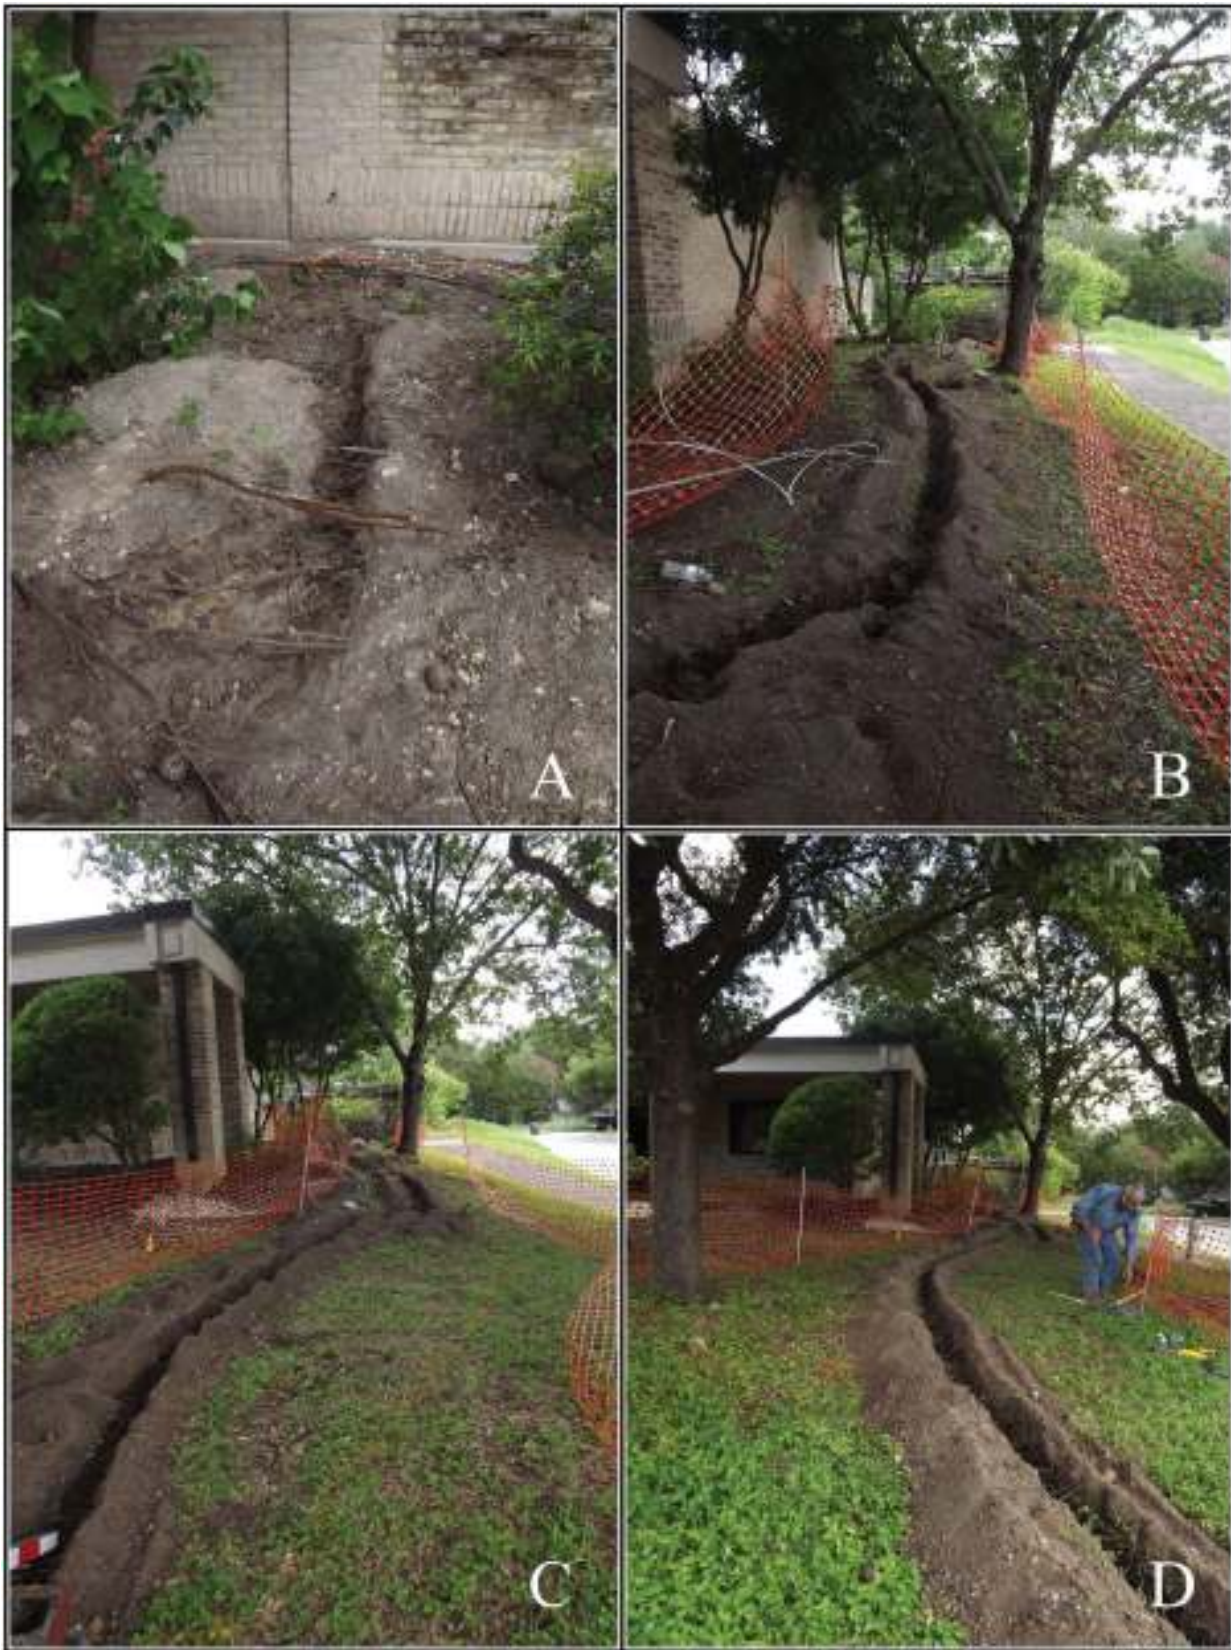
Figure 4-2. Views to the east showing trench location relative to the visitor's center. Image A shows the trench coming from the visitor's center. Images B and C show the trench location south of the building. Image D shows the trench termination at the sidewalk.

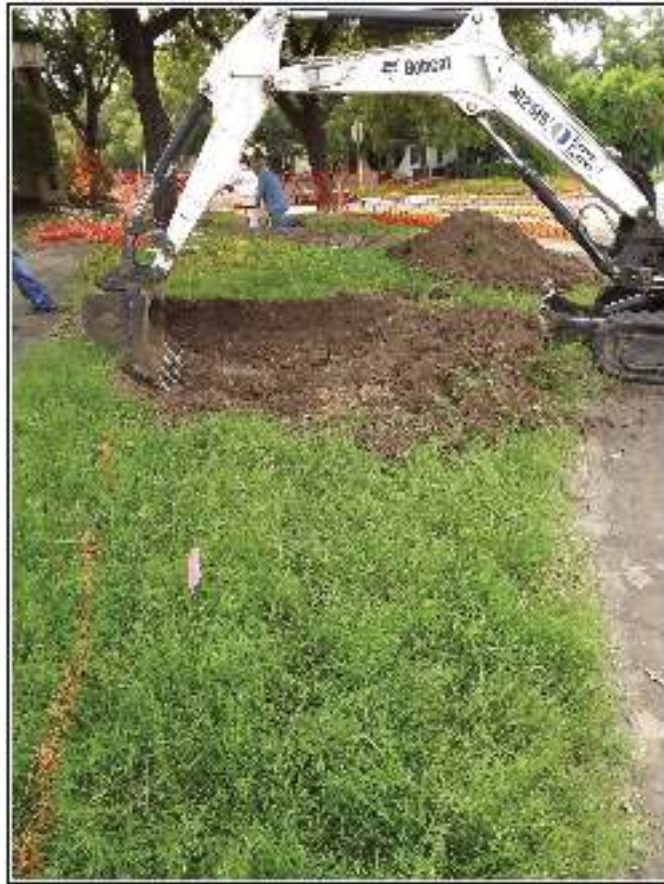
The excavation for the kiosk foundation used a mini-excavator with a 60.9 cm (2 ft.) toothed-bucket (Figure 4-3). The triangular footprint measured 4.2 m (14.1 ft.) in length and 3.7 m (12.4 ft.) at the largest width. The depth of the excavation was 15 cm (6 in.) below the grade of the sidewalk. The footprint lies on a slope and required deeper excavation of approximately 40-45 cm (15.7-17.7 in.) on the north side of the footprint. The excavation for a pedestal to support the

Figure 4-3. A view to the southeast of the excavation for kiosk foundation.

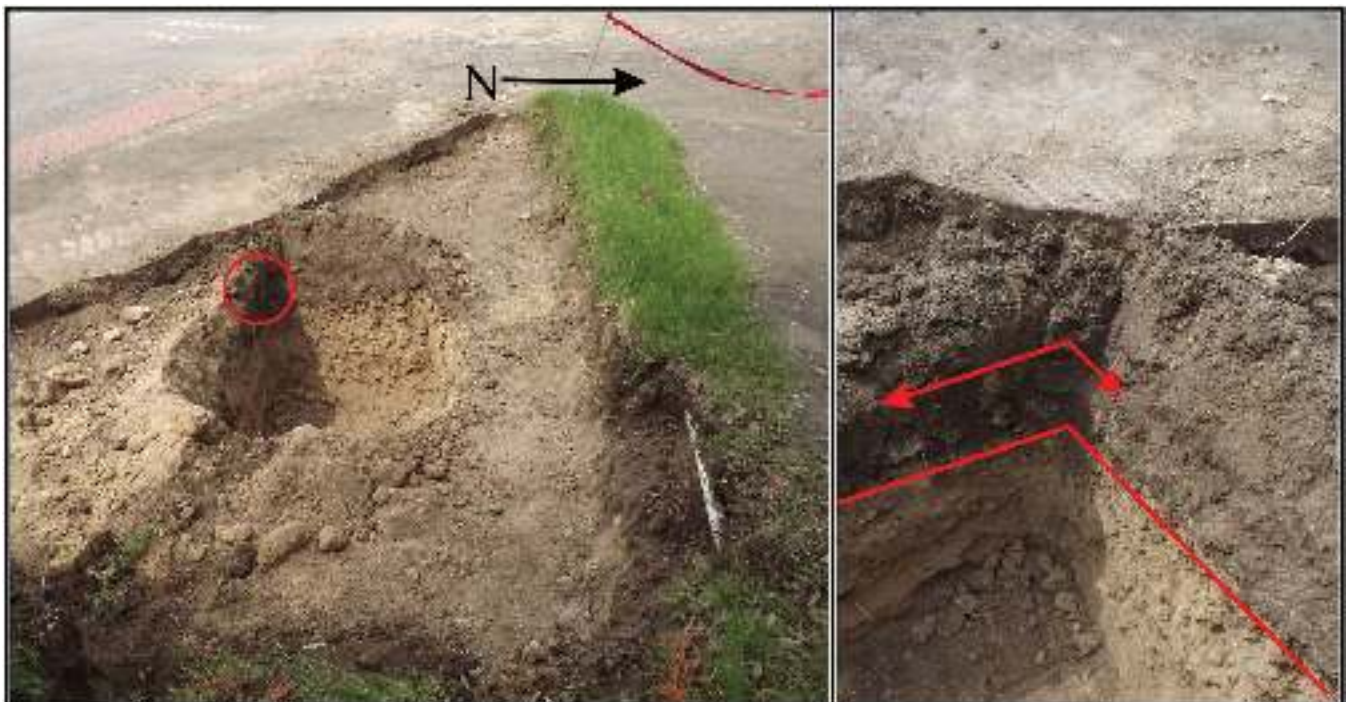
kiosk was placed off center within the footprint and measured 160 cm (5.2 ft.) in length, 70 cm (2.2 ft.) in width, and 1 m (39.3 in.) in depth. In the southwest corner of this excavation at approximately 30-40 cm (11.8-15.7 in.) below the sidewalk, several Spanish Colonial-era ceramic fragments, faunal bone, and mortar fragments were found (Figure 4-4). In addition, the surrounding soils appeared to be charcoal stained. Although not initially recognized as a feature upon review of several photographs, the stained horizon was identified as Feature 1. This information was relayed to Susan Snow of NPS on October 1, 2018, who visited the site and requested that CAR define the extent of the feature. The excavated foundation was scraped with a shovel revealing darkened soil under the overburden that was considered evidence of the midden. The midden's depth was documented based upon the grade of the present sidewalk with the assumption that any future work in the area use the sidewalk as a reference. In addition, a small test unit measuring 20-x-20 cm (7.8-x-7.8 in.; Figures 4-5 and 4-6) was excavated in the west wall of the kiosk pedestal excavation to determine the midden's integrity (i.e., if non-colonial artifacts were present).

Figure 4-4. Location (circled in red) where artifacts were found in kiosk pedestal excavation (left). Detail of southwest corner of excavation with red lines bracketing stained soils of the midden (right).

and charcoal. Table 4-1 list the artifacts found associated with Feature 1. While testing was minimal, results suggest that this portion of the midden is intact and likely capped by later construction and then old Mission Road. The midden dates to the Spanish colonial period based on the presence of the Yellow and Green Glaze II (Fox and Ulrich 2008) and Native American ceramics. Several of the ceramic fragments were refitted allowing identification of vessel components, the base (Figure 4-7) and jar with a lug or handle (Figure 4-8) of two Native American vessels, respectively. In addition, one Spanish vessel suggests a decorated jar (Figure 4-9). Following testing, the midden and test unit were covered with geo-fabric and soil for protection, and work was allowed to proceed.

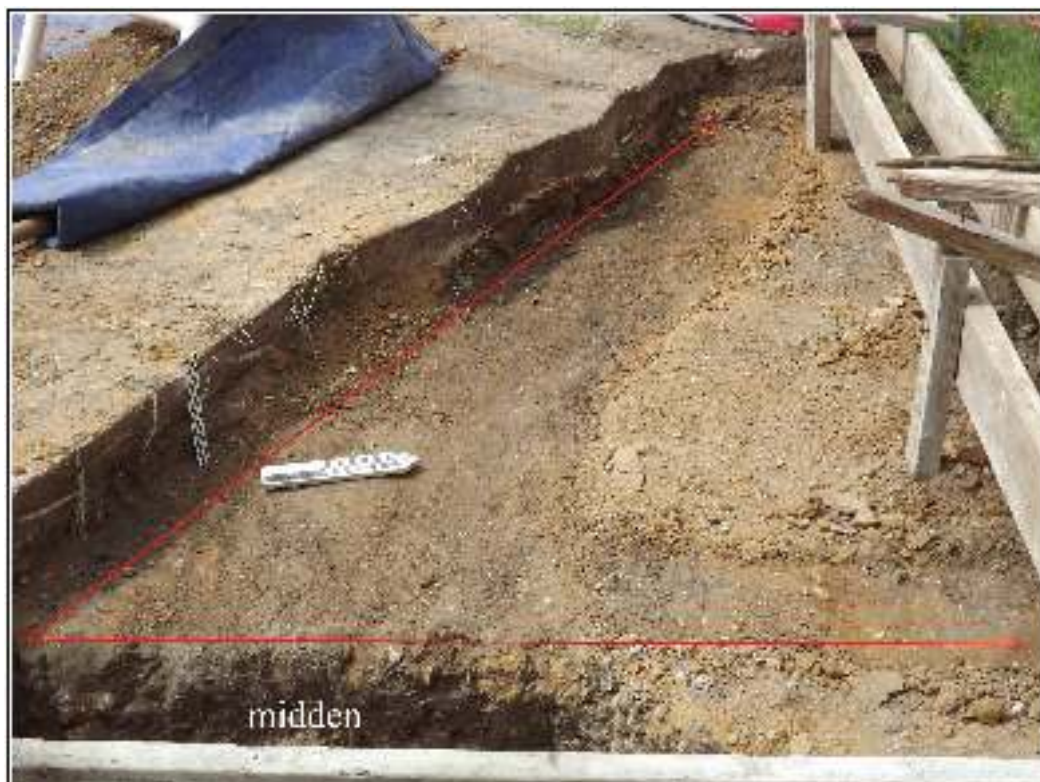
Figure 4-5. West and north extent of midden (red arrows) as determined by shovel scraping. Scale is metric. Arrow point indicates north.

Feature 1 is a Spanish Colonial-era sheet midden that lies within the footprint of the kiosk foundation and measures approximately 5.8 m (19 ft.) west to east and 3 m (9.8 ft.) north to south. The midden ranges from 15 to 20 cm (5.9 to 7.87 in.) in depth and approximately 20 cm (7.87 in) in thickness. The feature is likely larger as it continues into the wall of the foundation excavation. The homogeneous soil is a very dark brown (10YR 2/2) silty clay with grains of degraded limestone and fragments of charcoal. Artifacts found in association with the midden include diagnostic ceramics (Goliad, and Yellow and Green Glaze II), mortar fragments, faunal bone,

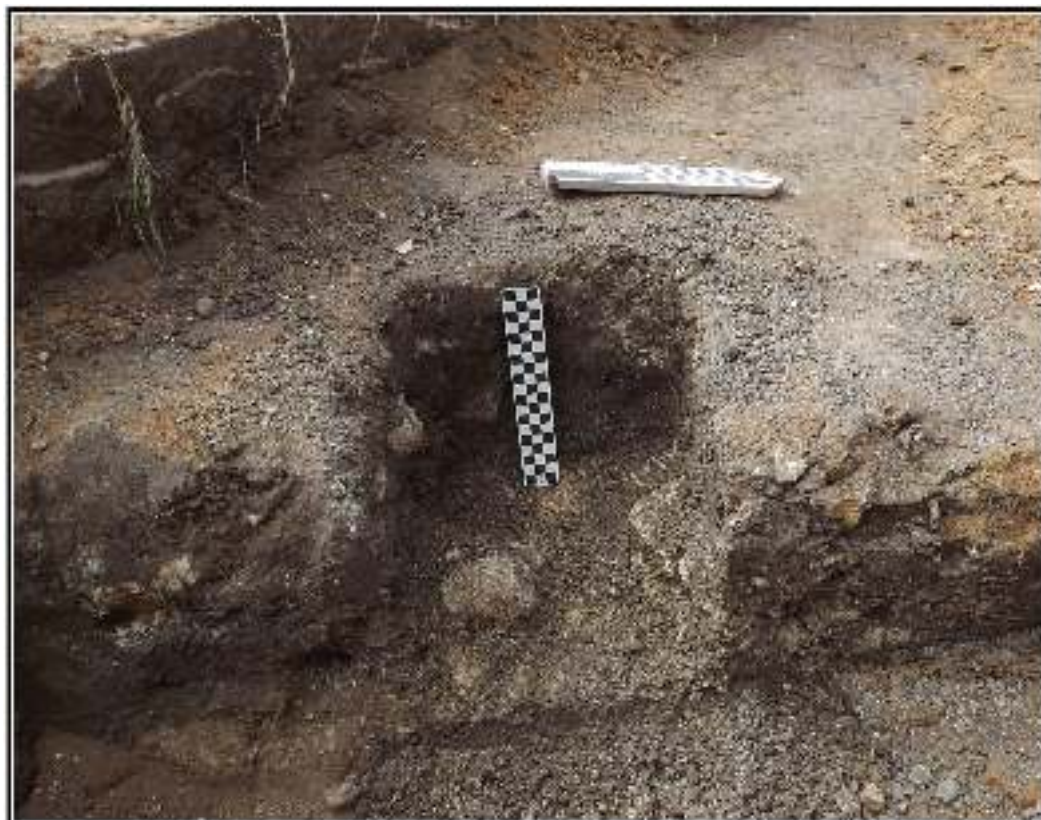
Figure 4-6. Location of test unit along the west wall of the kiosk pedestal excavation. Scale is metric. Arrow point indicates north.

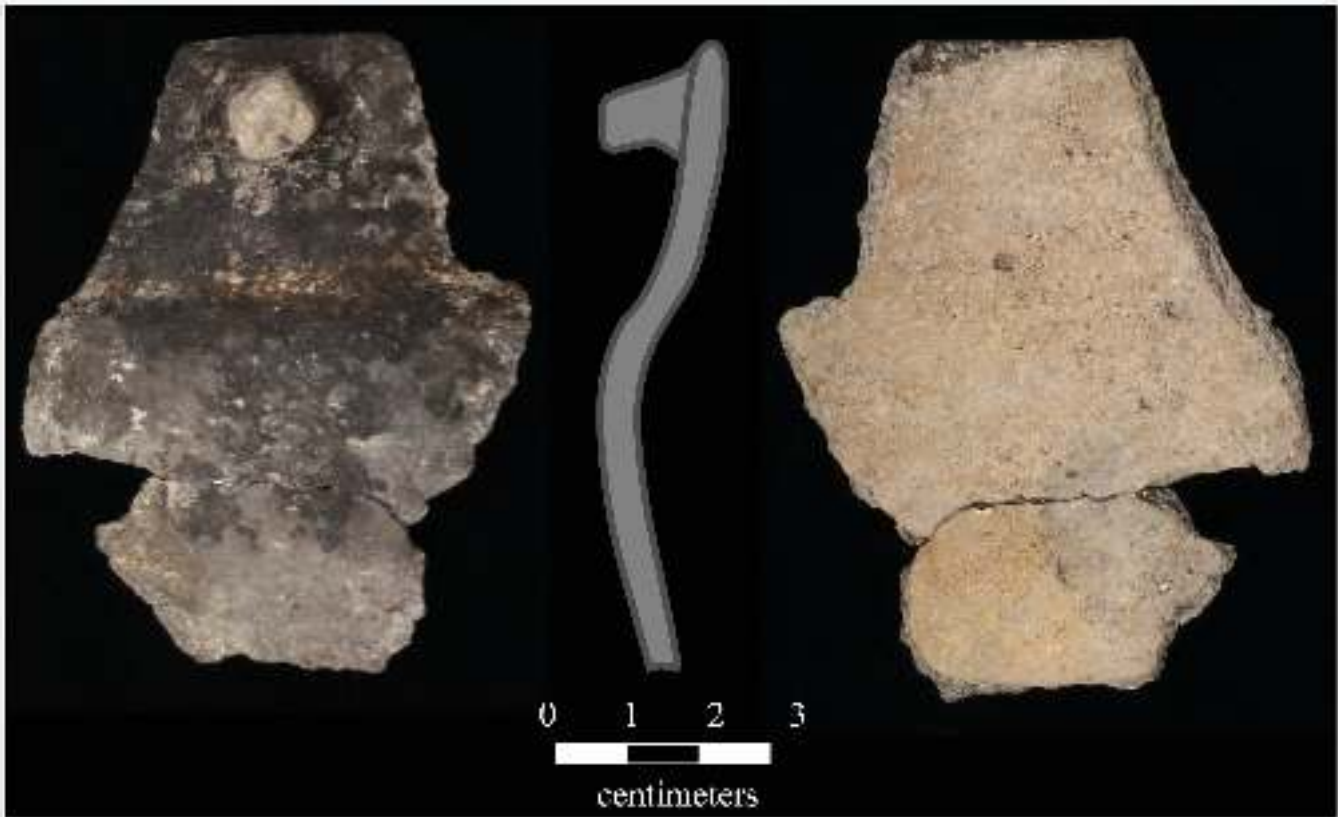
Figure 4-7. Calcium carbonate tempered Goliad jar. The exterior is on the left and interior on the right. The drawing of the jar's profile is in the center.

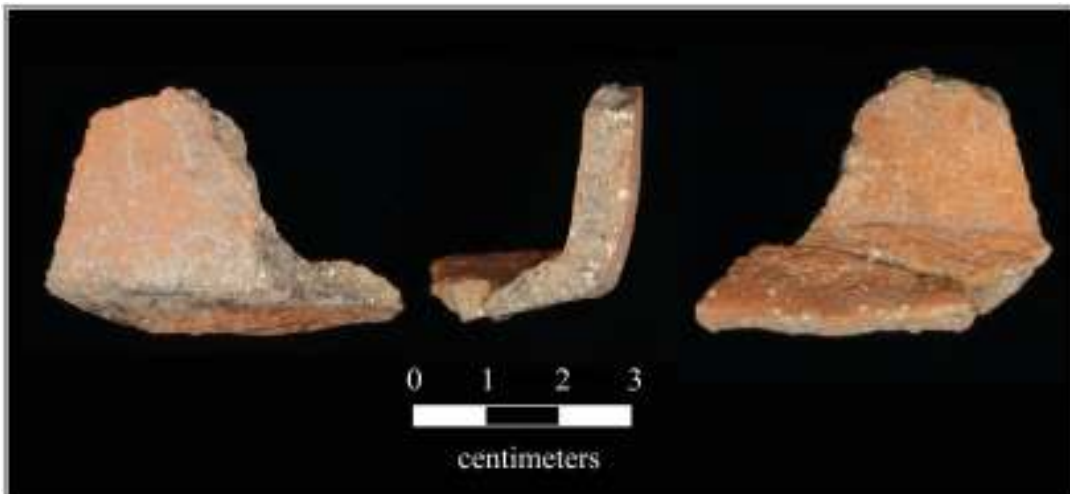
Figure 4-8. Bone tempered Goliad jar base. The exterior is on the left and interior on the right. Its profile is in the center.

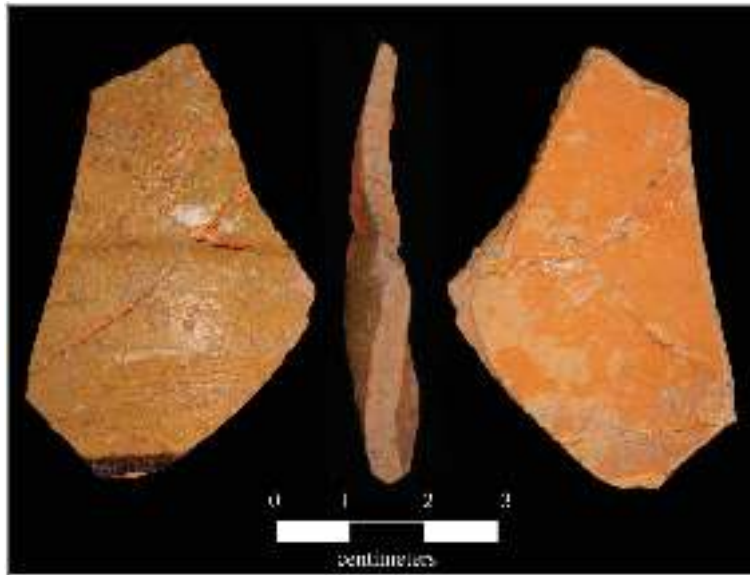
Figure 4-9. Refit of decorated Yellow and Green Glaze II jar body. The exterior is on the left and interior on the right. Its profile is in the center.
