Archaeological Investigation of the San Antonio River Authority San Pedro Creek Operational Facilities, San Antonio, Bexar County, Texas

Prepared by:
Center for Archaeological Research
The University of Texas at San Antonio
One UTSA Circle
San Antonio, Texas 78249
Archaeological Report, No. 475

**Archaeological Investigation of the San Antonio River Authority
San Pedro Creek Operational Facilities,
San Antonio, Bexar County, Texas**

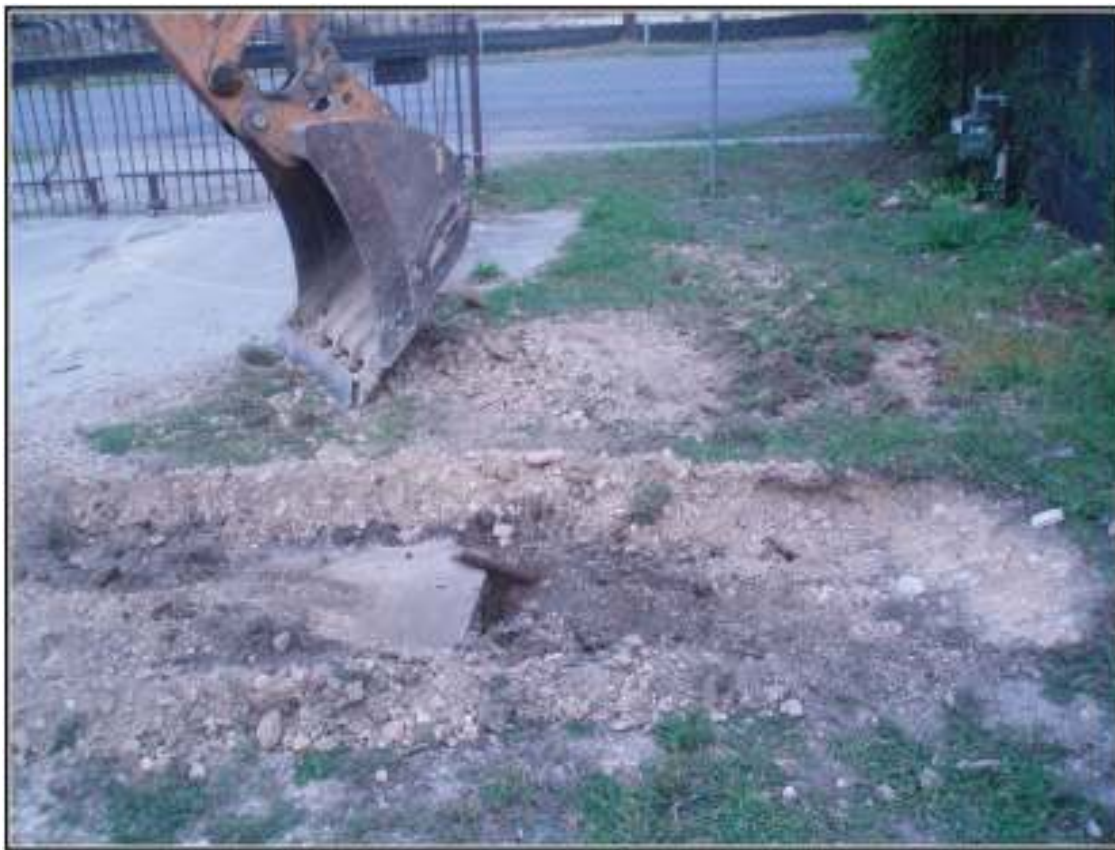
Backhoe Trench 1 was a roughly north-south oriented trench intended to explore the footprint of the historic house identified by the COSA-OHP. The trench extended 2.9 m in length and 1.0 m in width. The trench was terminated at 15 cm due to a cement slab obstruction (Figure 4-3). An attempt was made to relocate the trench to the east, but the same obstruction was encountered. The trench could not be attempted further south due to an existing driveway and fence. Before the trench was terminated, modern trash, including metal, glass and plastic were observed.

Figure 4-3. Backhoe Trench 1, facing northwest.

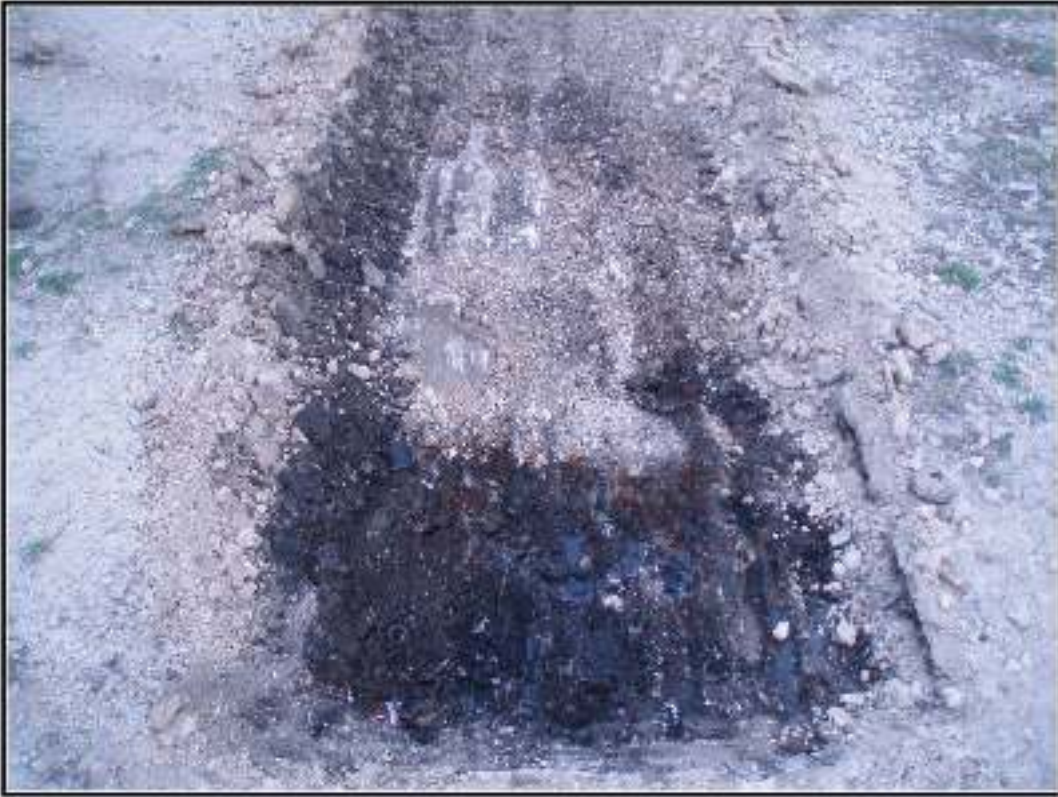
Backhoe Trench 2 (Figure 4-4) was a roughly east-west oriented trench, at a right angle to BHT 1 (see Figure 4-2), and was intended to explore the footprint of the historic house identified by COSA-OHP. The trench extended 2.3 m in length and 1 m in width. The trench was terminated at 12 cm due to encountering the same cement slab obstruction and potentially hazardous debris from an auto shop previously located on the property. The trench could not be relocated due to the existing driveway, as well as a fence and gas lines. Before the trench was terminated, a large quantity of rusting ferrous material and dark, greasy soil that appeared to be heavily oil-stained was observed.

Figure 4-4. Backhoe Trench 2, facing northwest. Note auto shop debris and cement.

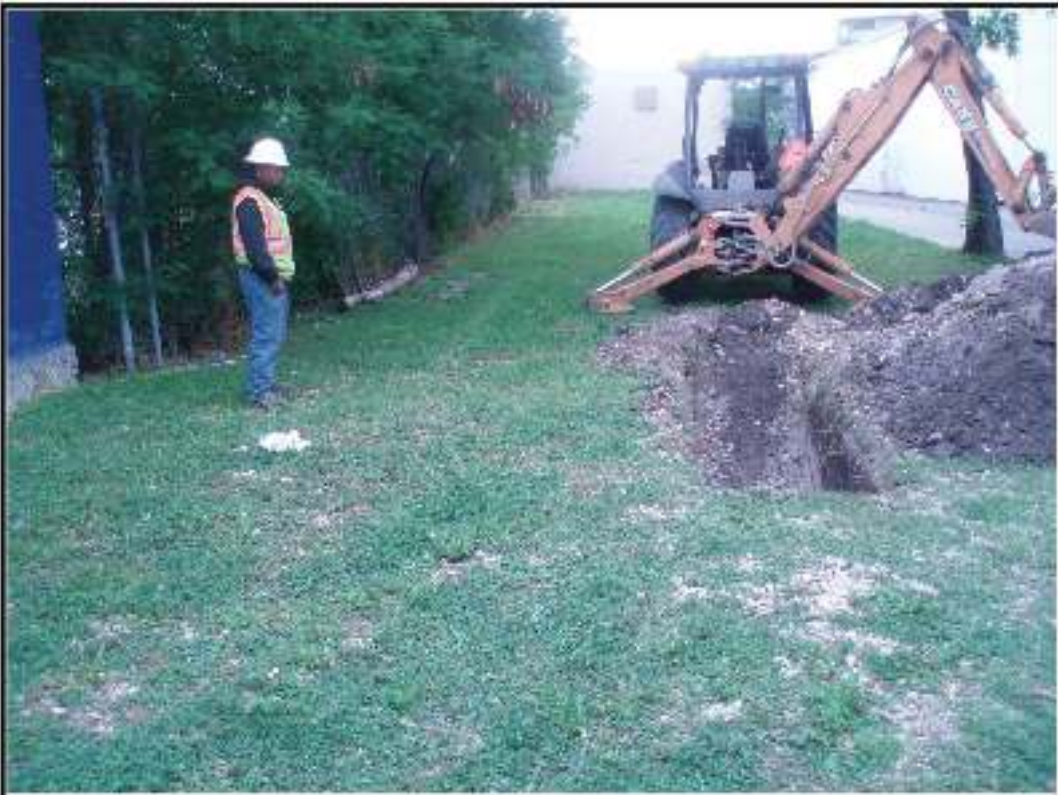
BHT 3 was a roughly east-west oriented trench intended to target potential privy deposits associated with the historic house (Figure 4-5). The trench extended 3.9 m in length and 1 m in width, and it reached a maximum depth of 1.5 m. Table 4-1 provides a description of the trench's five zones, and Figure 4-6 depicts the northern profile. Zone 1 extended 0-25 cmbs and consisted of clumpy, very dark gray (10YR

Figure 4-5. Backhoe Trench 3 location, facing southeast.

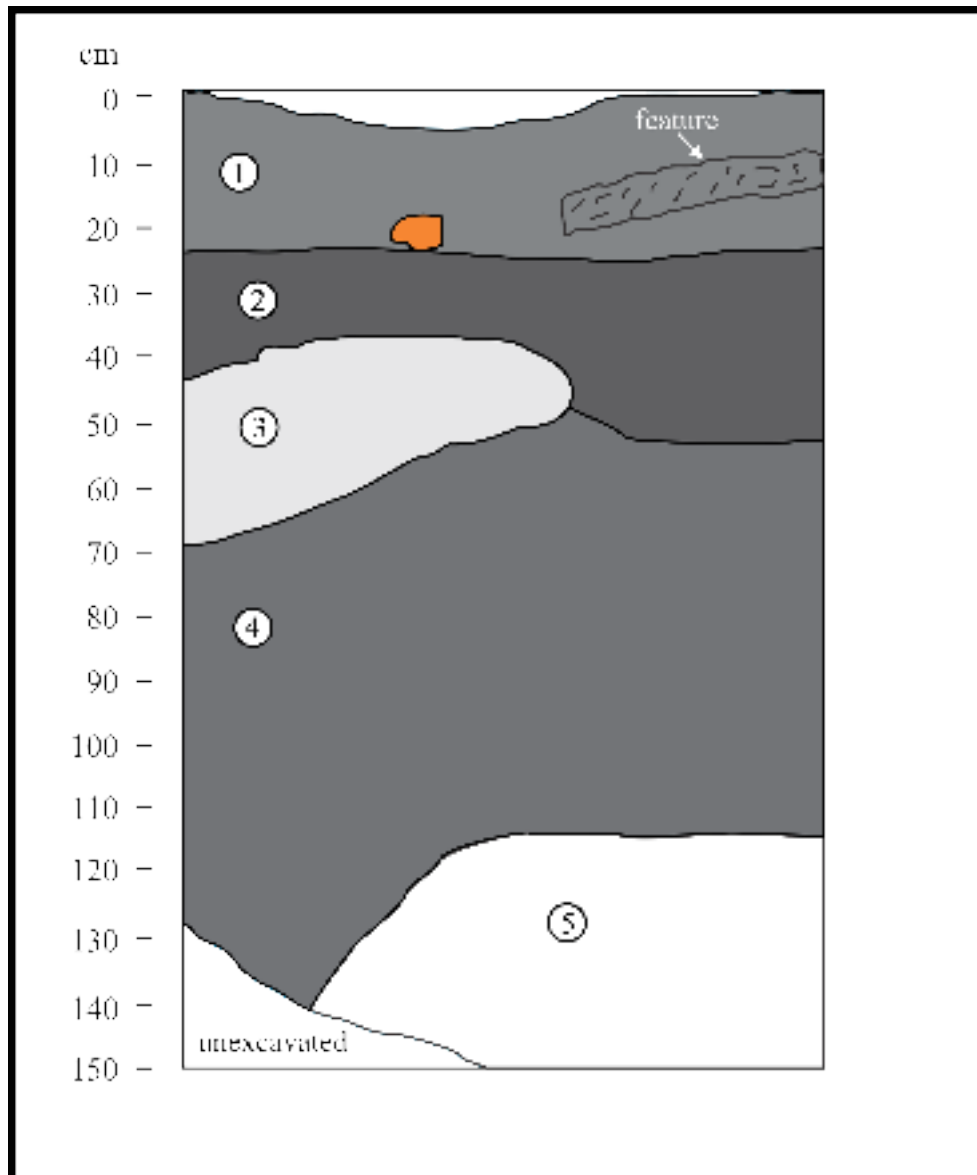
3/1) clay with some gravels. Cultural material was recovered from this zone, including a small historic feature containing ceramics, nails and 20-25 glass fragments (Figure 4-7) located 10-20 cmbs in the southern portion of the trench. Zone 2 extended 25-55 cmbs and consisted of a blocky, black (10YR 2/1) clay, containing some cultural material and charcoal. Zone 3 was a caliche intrusion in the northern portion of the trench extending from 45-55 cmbs. It consisted of a gray (10YR 6/1) sandy clumpy clay. This layer contained no cultural material. Zone 4 extended from 55-150 cmbs, consisted of black (10YR 2/1) blocky clay, and contained no cultural material. Zone 5 extended from 120-150 cmbs and consisted of white (10YR 8/1) clumpy clay, and it contained no cultural material.

Figure 4-6. Profile drawing of the north wall of BHT 3. Note metal in orange (upper left) and feature artifact concentration (upper right).

metal, and charcoal fragments were sparsely scattered within the northern profile from 15-55 cmbs. No cultural material was observed in the southern profile of the trench.

The presence of artifacts within the northern profile of the trench suggests that the site boundary may extend further north in the direction of the modern building. Construction of the building has likely impacted the site in that direction. The site may potentially extend to the east and west but is unlikely to extend further south, as that profile showed no cultural material.

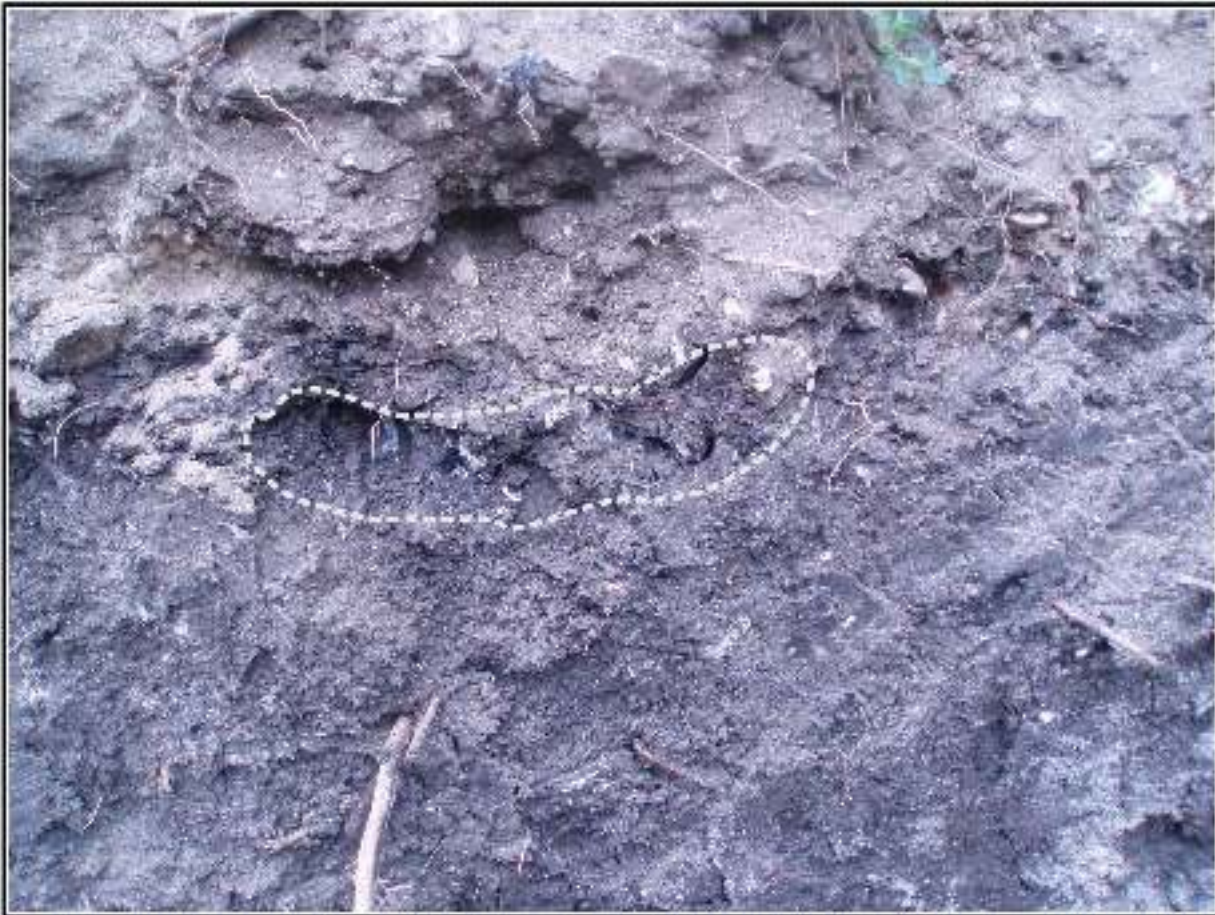
Figure 4-7. Feature (outlined in white dotted line) in north profile.

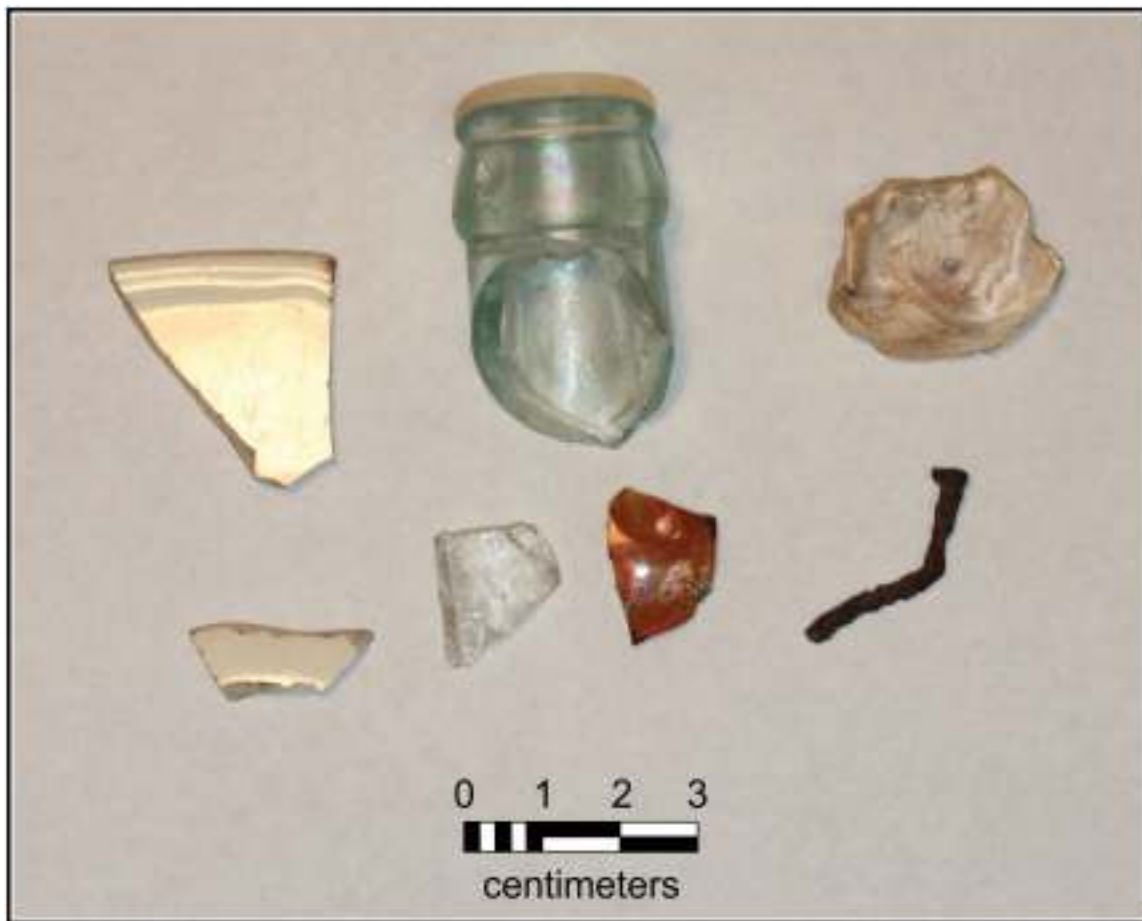
Artifacts collected from 41BX2285 included two gilded white earthenware rims, clear and brown body fragments of glass, an aqua glass bottleneck, a wire finishing nail, and an oyster shell (Table 4-2, Figure 4-9). Nearly all the artifacts collected were recovered from the feature. The one item collected from the backdirt, a gilded white earthenware rim, appeared to be from the same vessel as the sherd collected from the feature. Cultural material observed within the backhoe trench profile, but not collected, included unidentified ferrous metal fragments, charcoal, and clear, aqua, and brown glass body fragments.

The artifacts recovered from the site are consistent with a late historic occupation. Wire nails became the dominant nail form in the United States circa 1900 (Fontana and Greenleaf 1962:50). While bottle manufacture is not always an accurate temporal diagnostic (Lindsey 2017), the aqua bottleneck has a tooled finish, indicating a likely date 1885-1920 (Lindsey 2017). Sites containing only refined white earthenwares in Central Texas generally post-date the Civil War (Texas Archeological Stewardship Network 2006). The cultural material recovered shows little differentiation from other San Antonio assemblages dating to this period (Labadie 1987; THC 2019a).

Figure 4-9. Artifacts recovered from BHT 3. Top row, left to right: white earthenware, glass bottle fragment, and oyster shell. Bottom row, left to right: white earthenware, glass fragments, and wire nail.
