Archaeological Investigations Associated with Security Upgrades at the Alamo (41BX6), San Antonio, Bexar County, Texas

Jose E. Zapata and Clinton M.M. McKenzie

Prepared by:
Center for Archaeological Research
The University of Texas at San Antonio
One UTSA Circle
San Antonio, Texas 78249-1644
Archaeological Report, No. 487

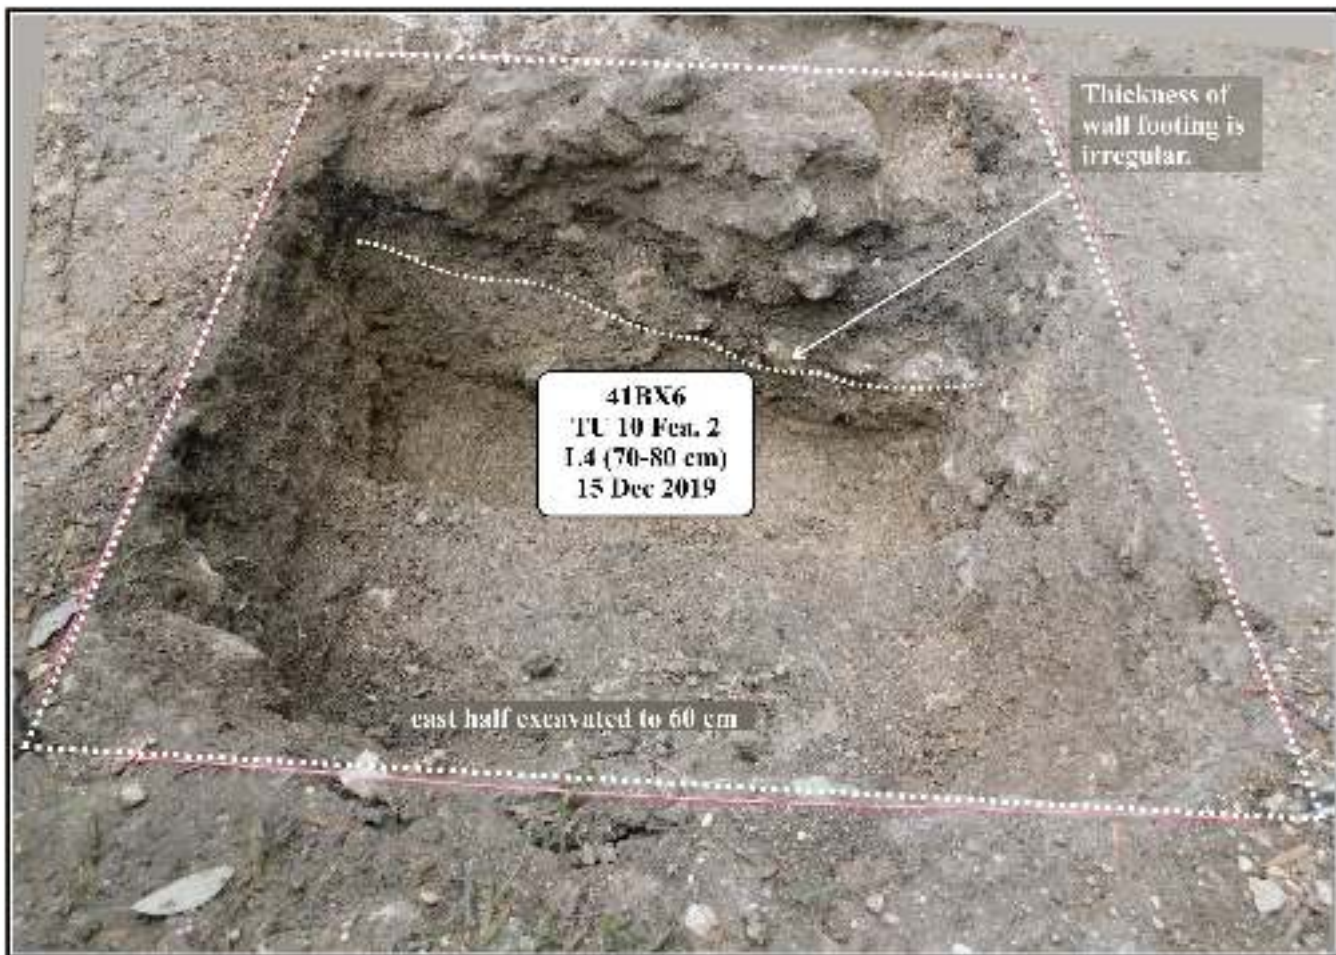
Figure 6-6. Area 1, Feature 2, west wall profile; note depth of footing is irregular (facing west).

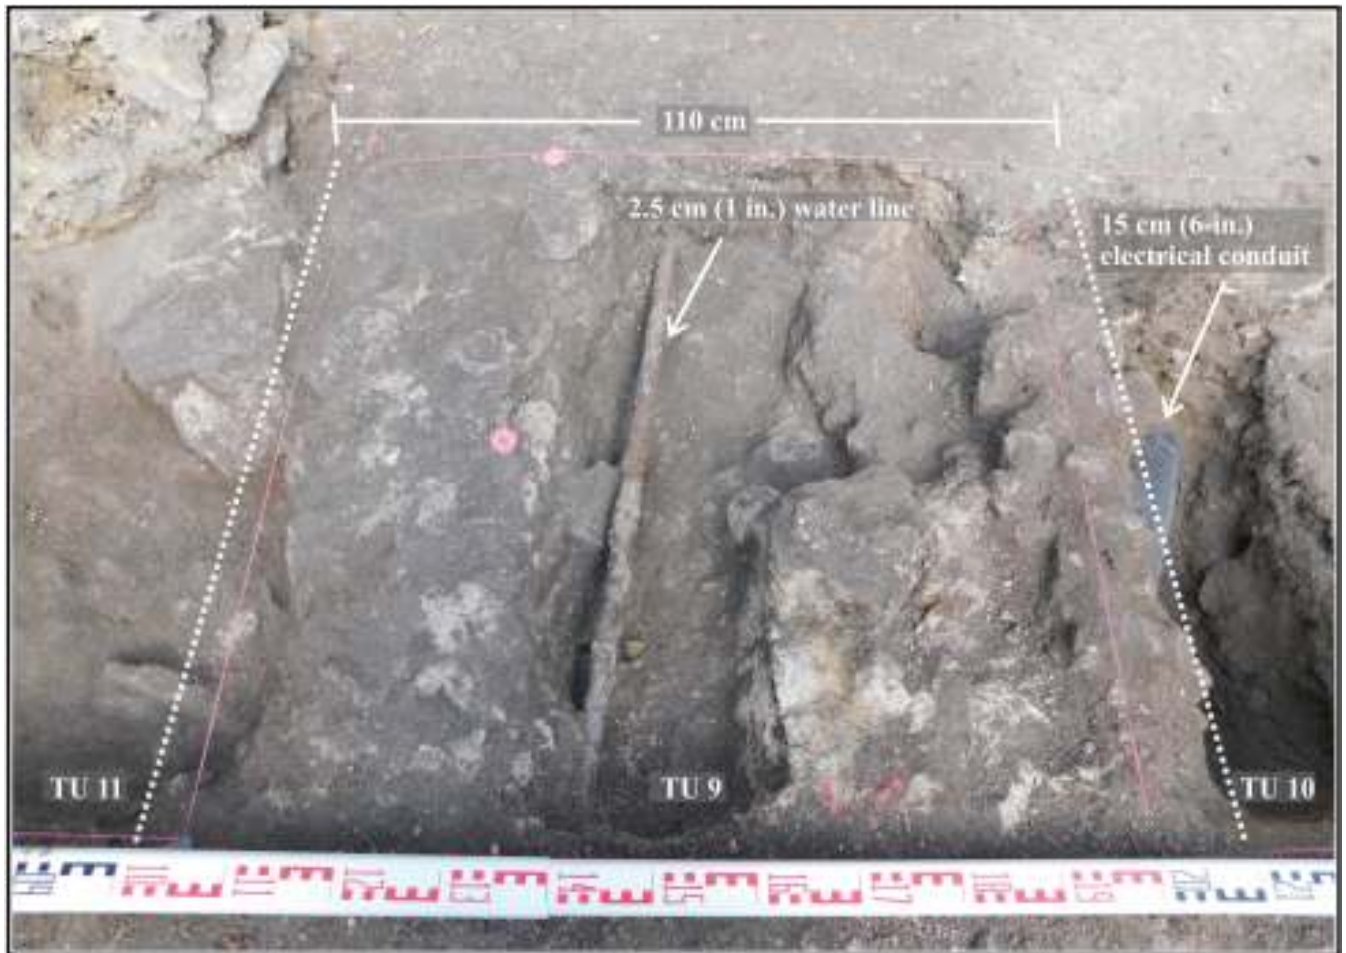
Figure 6-7. Area 1, Feature 2, completed excavations of TUs 9, 10, and 11 (view north).

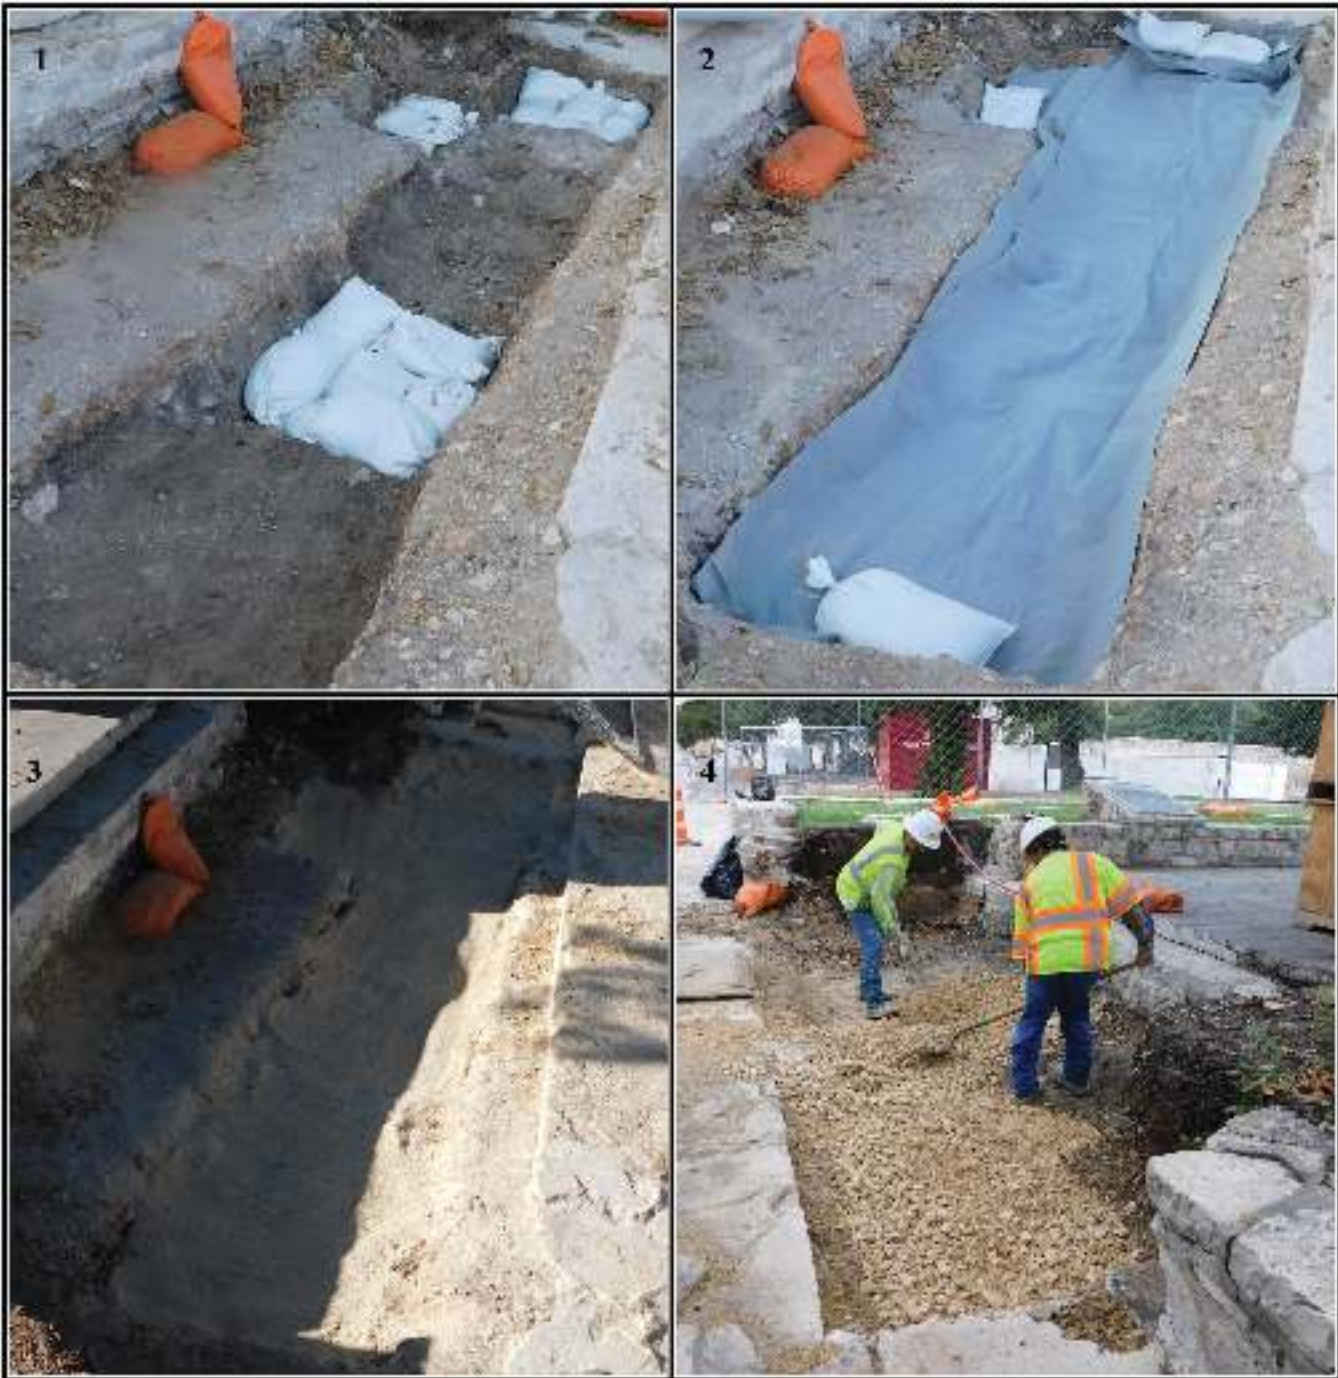
Figure 6-14. Protective covering over Feature 1, Area 3: 1) sandbags in low spots, 2) two layers of geo-fabric, 3) 15.2-20.3 cm (6-8 in.) layer of sand, and 4) caliche base covering (images 1, 2, and 4, view to the south and image 3, view to the north).

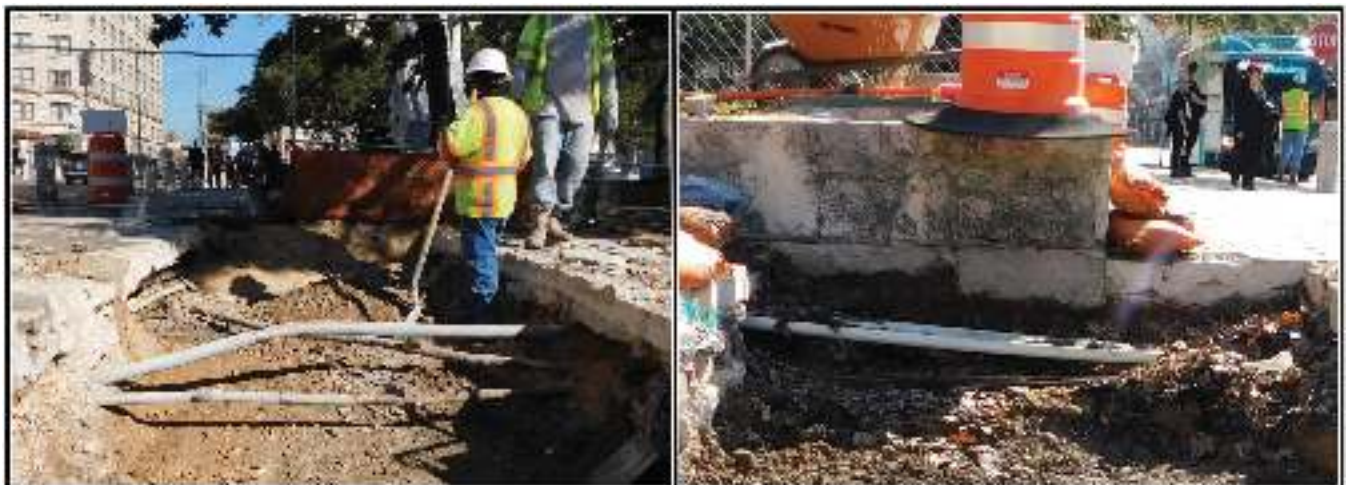
Figure 6-17. Area 4 note utility disturbance at the north (left) and south (right) ends.

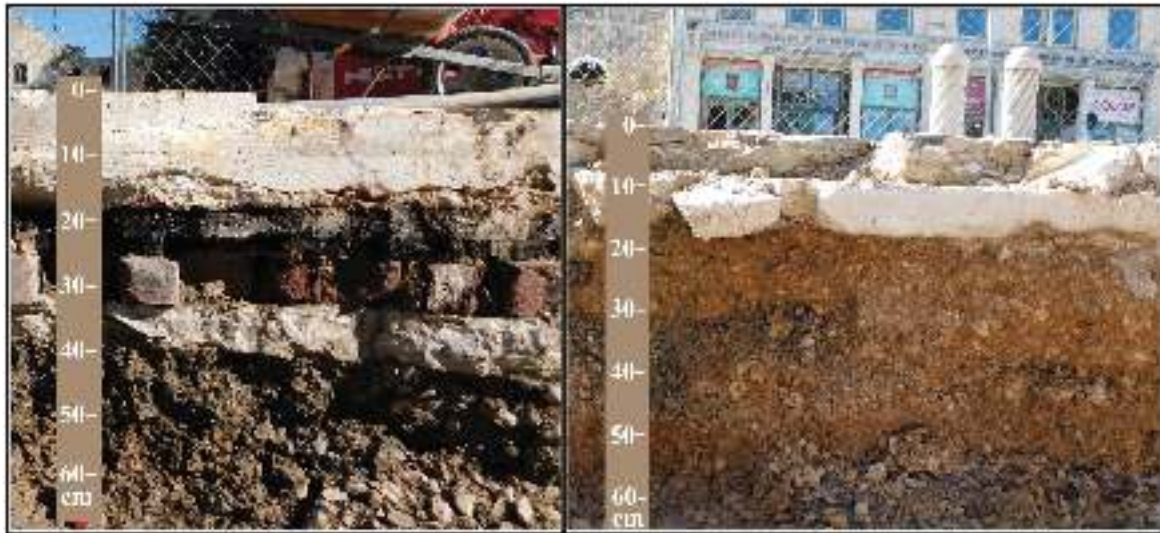
Figure 6-18. Area 4 excavation profiles; opposite sides of same location.

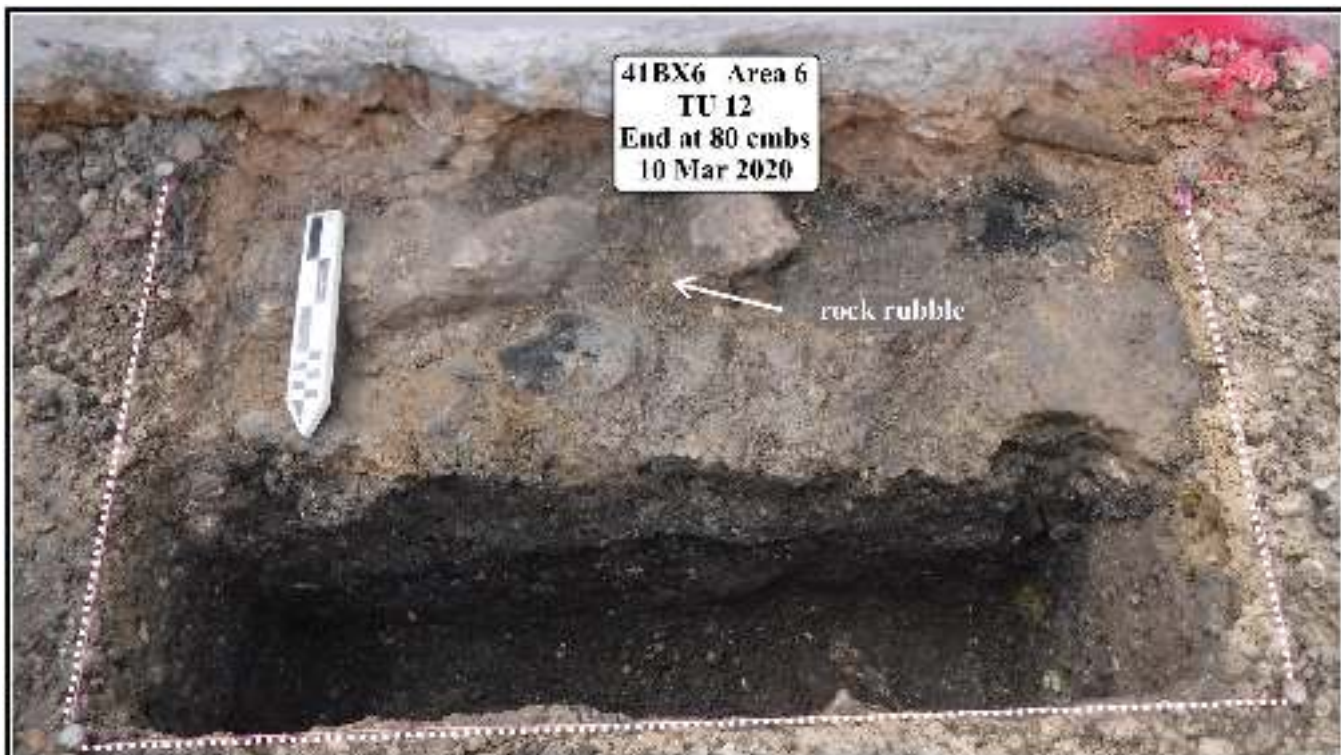
Figure 6-22. Test Unit 12 excavated to 80 cmbs (31.5 in.), with rock rubble intact.

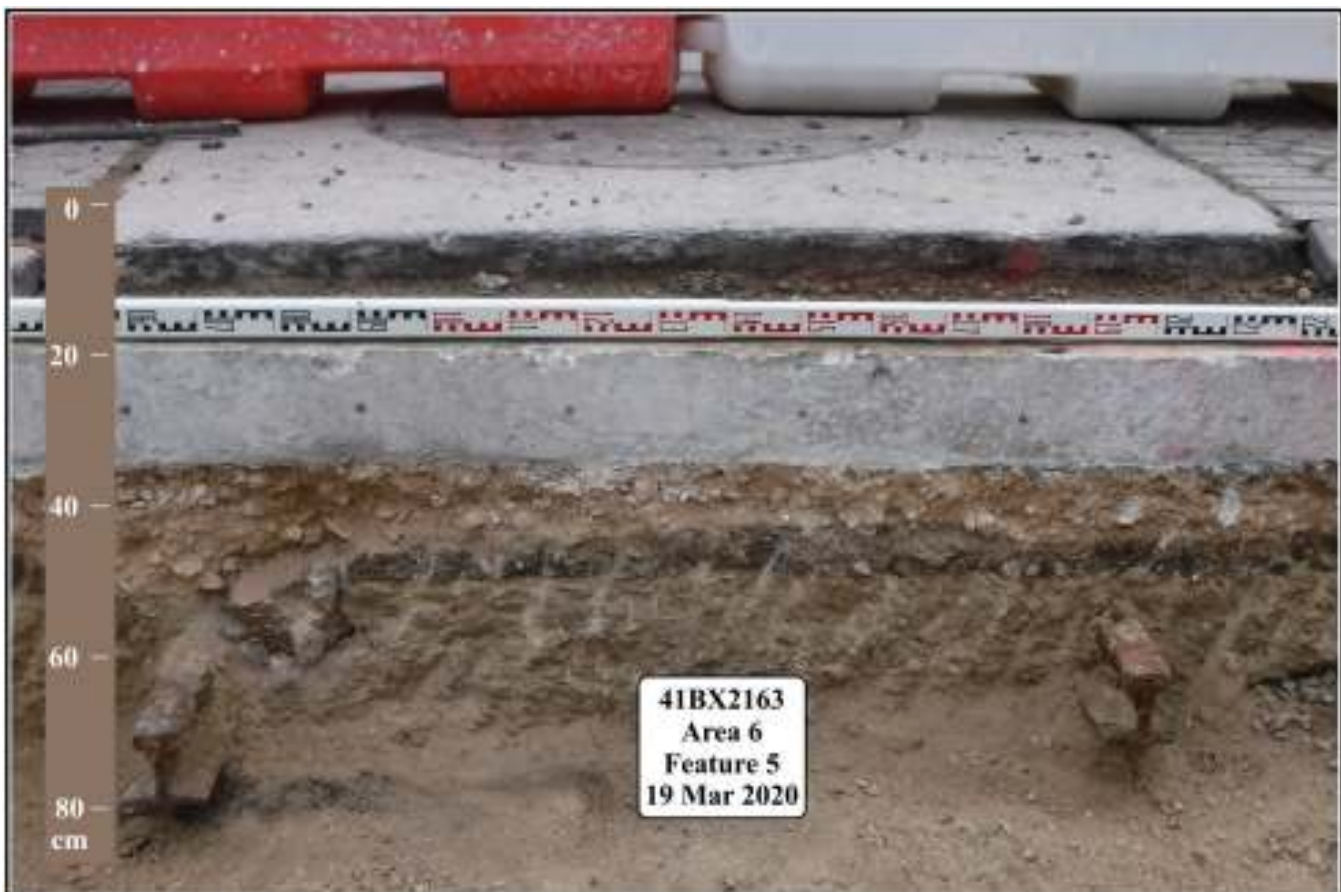
Figure 6-24. Feature 5, remnant of the Streetcar Rail System (41BX2163), view north.

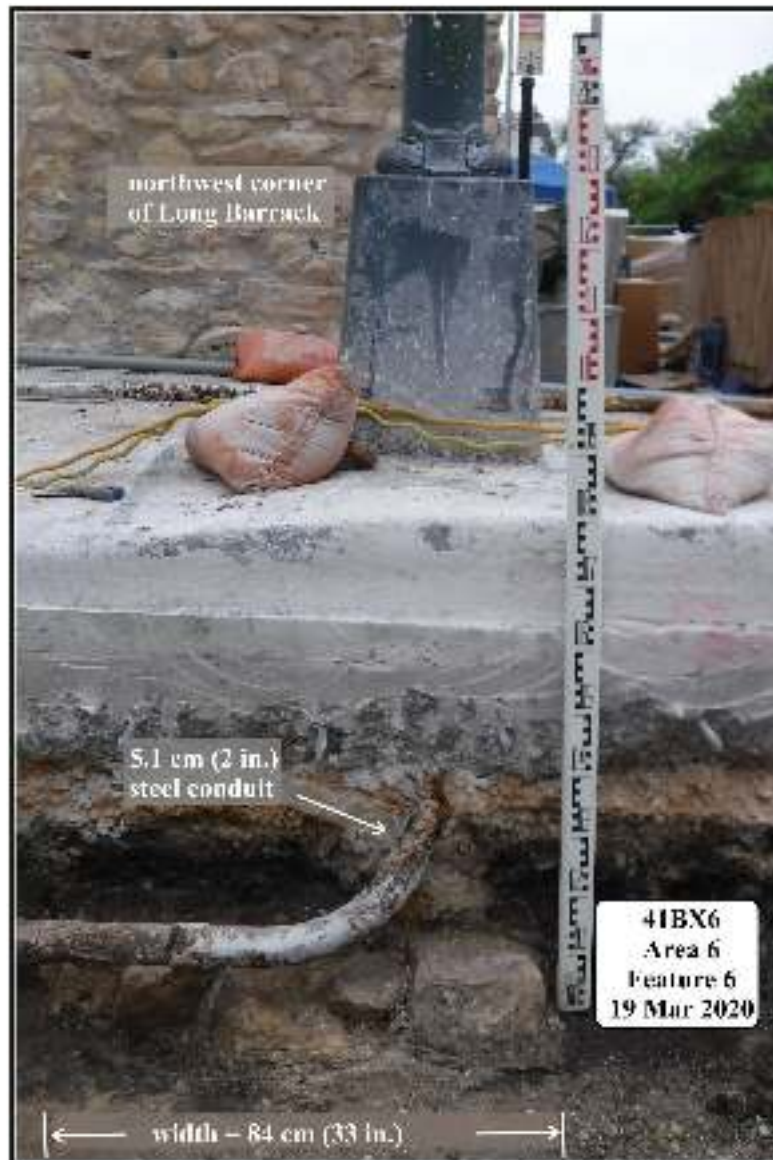
Figure 6-25. Feature 6, likely a Spanish Colonial wall footing (41BX6), view south.

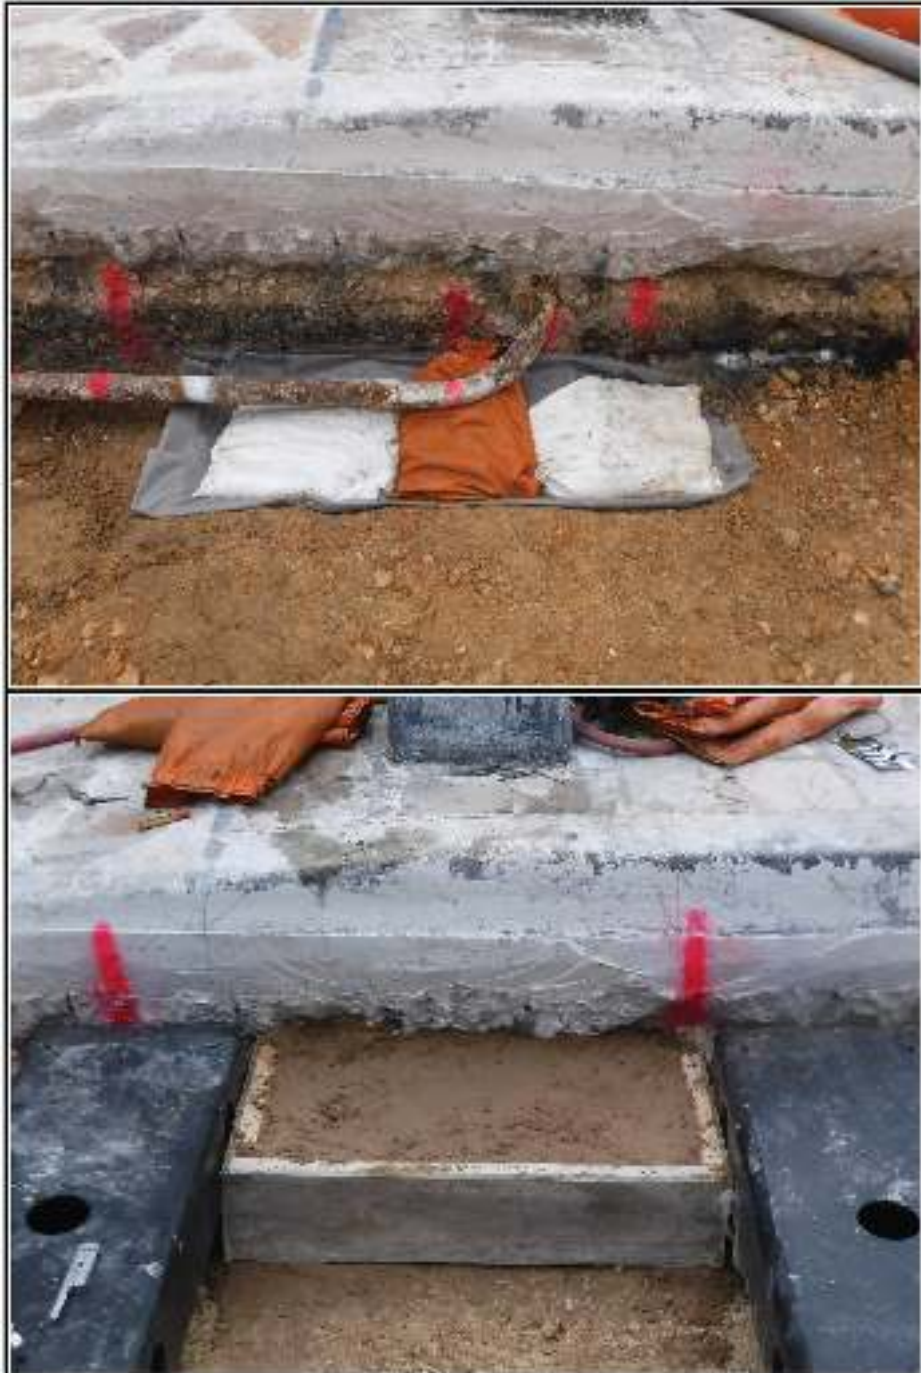
Figure 6-27. Measure taken to protect Feature 6 (view south).
