Monitoring of the Future Site of the Hyatt Convention Center Hotel, San Antonio, Bexar County, Texas

Technical Report, No. 1
Center for Archaeological Research
The University of Texas at San Antonio
©2007

Monitoring of the Future Site of the
Hyatt Convention Center Hotel,
San Antonio, Bexar County, Texas

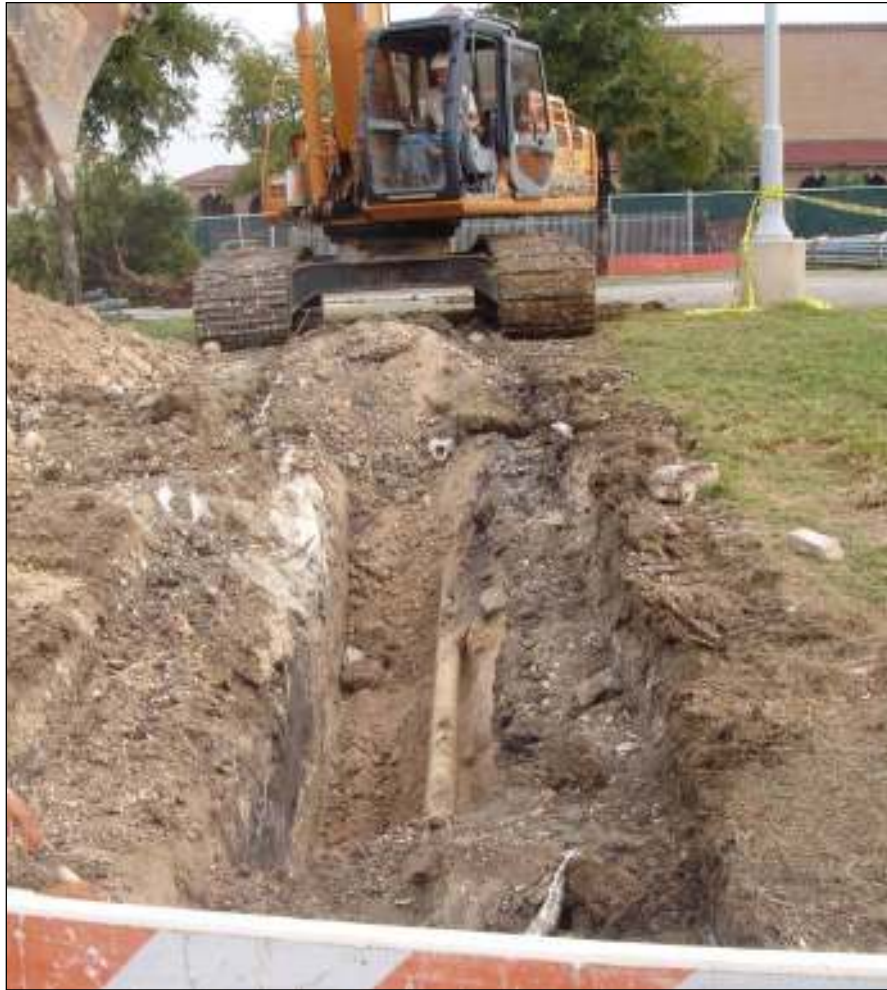
Figure 3-1. Photograph of mechanical excavation of utility trench, facing north.

The first phase of construction activities at the project site correlated with the need to place subsurface electrical lines outside of the hotel footprint (Figure 3-1). Monitoring of the trenching occurred from the Service Drive of the Convention Center addition to just south of E. Market Street, and then from that point to the middle of the previous path of Bowie Street. The trenching was accomplished through the use of a CASE 9040B trackhoe with an approximately 1-m³ bucket. The depth of the approximately 1-m wide trench was at least 5 ft. below surface. According to OSHA standards, areas deeper than 5 ft. had to either be shored or stepped. Stepping would result in a wider trench in areas that exceeded 5 ft. in depth. All soil removed during trenching was placed to the side of the trench, and utilized later as fill to cover the installed electrical lines.

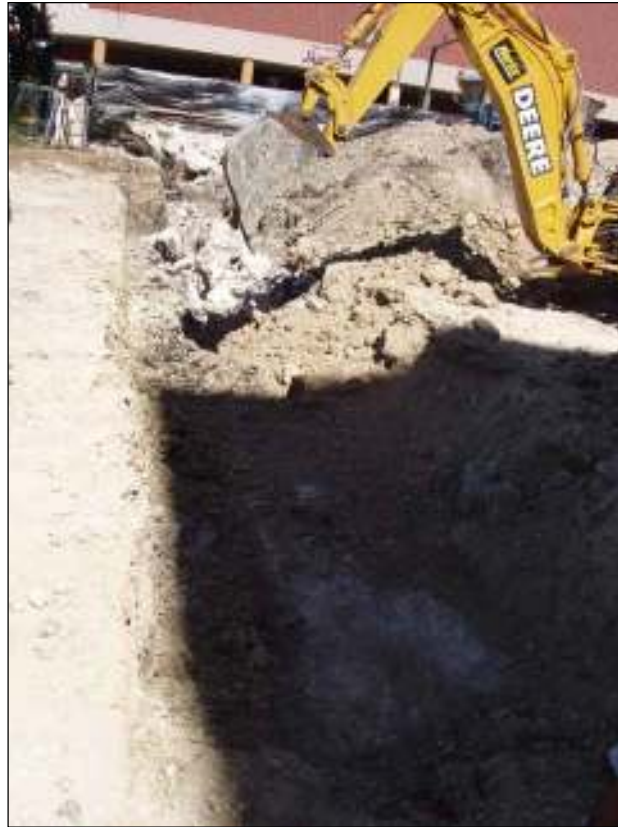
Figure 3-2. Photograph of mechanical excavation of the slurry wall guide-wall, facing north.

The second phase of monitoring focused on the excavation of the trench for the slurry wall guide-wall (Figure 3-2). The slurry wall, or diaphragm wall, was to be excavated to approximately 70 ft. below surface. To insure that the slurry wall remained in the correct position, a guide-wall was utilized to aid in the excavation. The guide-wall trench outlined the footprint of the future hotel. The trench for the guide-wall was 4 ft. in depth and approximately 6 ft. wide. The trench was excavated using a rubber-tired backhoe, with an approximately 1-m wide bucket. The soil from the trenching was placed next to the trench, allowing the backdirt to be scanned for content.

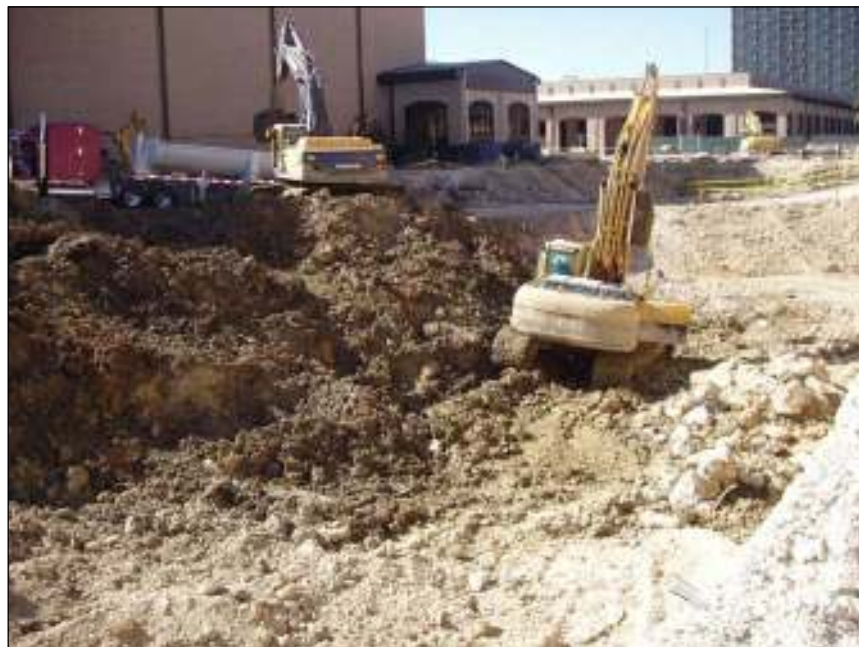
Figure 3-3. Photograph of mechanical excavation of the interior of hotel footprint, facing southwest.

excavation of the interior of the hotel footprint commenced (Figure 3-3). The soil inside the slurry wall was removed by a Volvo EC460B trackhoe, with a 5-ft³ bucket. The soil was removed in 10-ft. levels, to allow for a five-story, subterranean parking garage. Monitoring of this excavation was limited to viewing the profile, and usually at a distance due to the large machines and the depth of the excavations. The matrix was immediately loaded and taken to a dump site away from the project area.

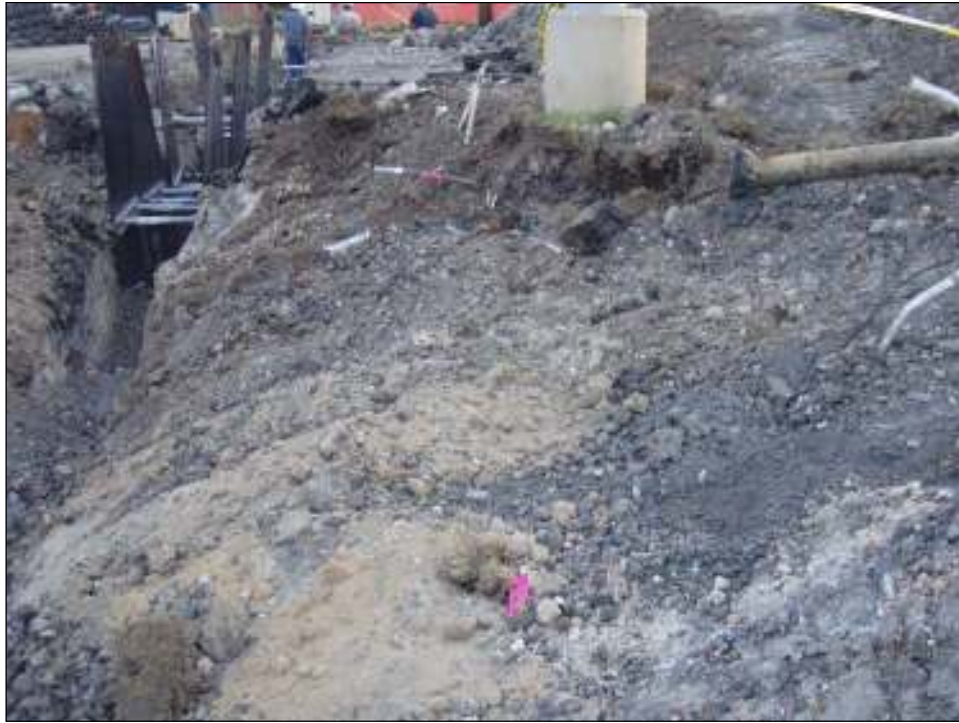
Figure 4-3. *Photograph of Feature 1, extent of feature marked by pink flagging tape, facing north.*

Feature 1 was located just outside the footprint of the hotel (Figure 4-3). The feature was uncovered while trenching for electrical lines during the early stages of the project (Phase 1). The feature consists of a scatter of trash approximately 9 ft. in length and 13 ft. wide. The trench appears to have hit the western portion of the trash scatter. The trash layer began approximately 30 cm below surface (cmbs) and extended for an additional 50 cmbs. Electrical lines encased in PVC pipe appear to have been placed within the top layer of the trash deposit.

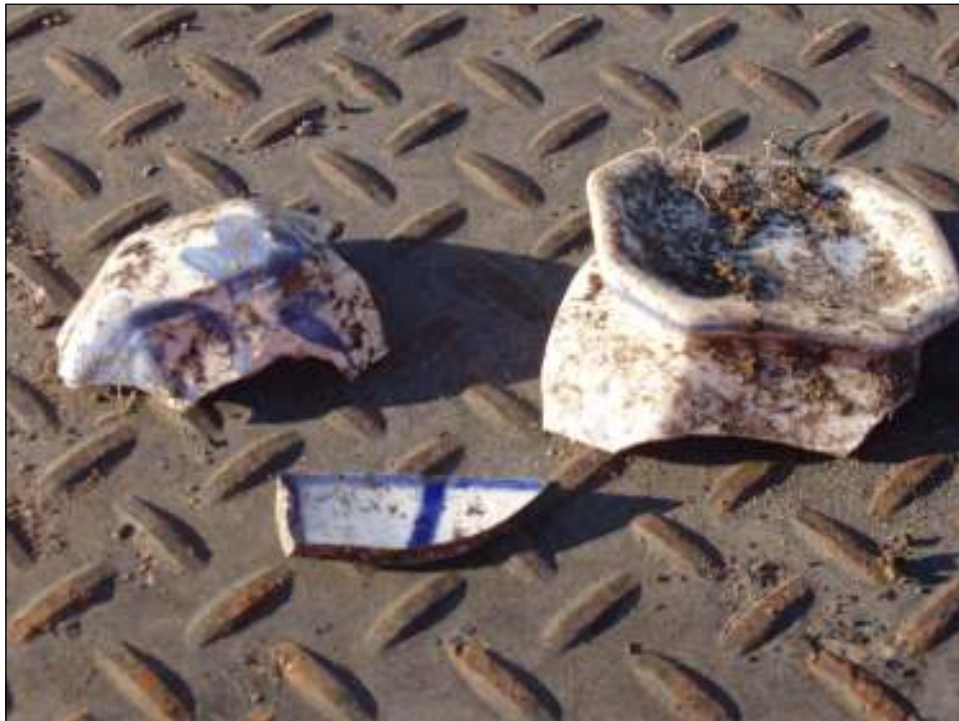
Figure 4-4. *Examples of ceramics observed in Feature 1.*

One fragment of white earthenware bears a stamped maker's mark of John Maddock and Sons. Since there is no "Ltd." added to the mark, it is possibly that the vessel was manufactured between 1880 and 1896 (Godden 1964). Other ceramic types encountered included Transfer ware, Ironstone, Semi-Porcelain Hotel ware, Yellow ware, Handpainted White Earthenware, Flow Blue, Sponge ware, Annular ware, stoneware, and undecorated white earthenware (Figure 4-4).

The ceramic fragments appear to represent cups, bowls, plates, pitchers, and a possible chamber pot. All fragments date within the 1880 to 1920 timeframe.

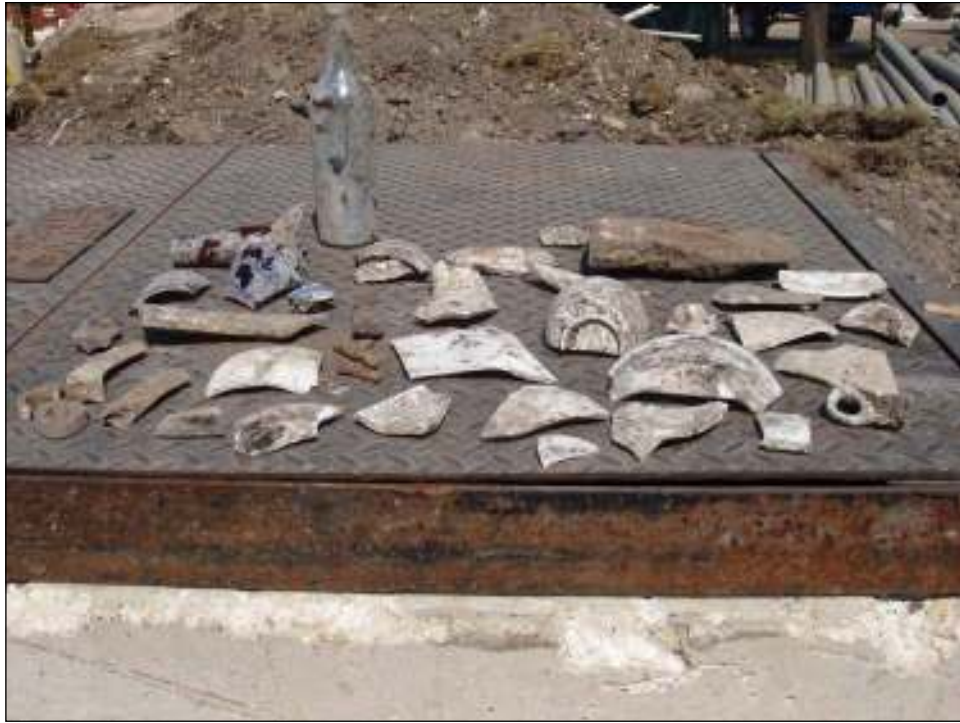
Figure 4-5. *Artifacts from Feature 1.*

Various color glass fragments were noted in the trash scatter as well. One intact, aqua glass bottle was noted, with a cork finish, and a kick-up that indicated that it was possibly a wine bottle. One intact, aqua glass ink well was recovered from the top layer of the trash scatter. No identifying marks were noted, but the well appears to have no mold lines and the finish is applied. A Scott's Four Roses cologne bottle also was recovered, dating to the early part of the twentieth century. A fragment of a brown glass bottle with a brandy finish was also encountered. Other fragments included milk glass, pressed glass, possibly from a bowl or lamp fixture, clear, olive, green, aqua, purple, and brown glass. A rusted axe head was encountered in the trash scatter. A majority of the bone fragments exhibited saw and machine cut marks. A small portion showed signs of hand butchering (Figure 4-5).

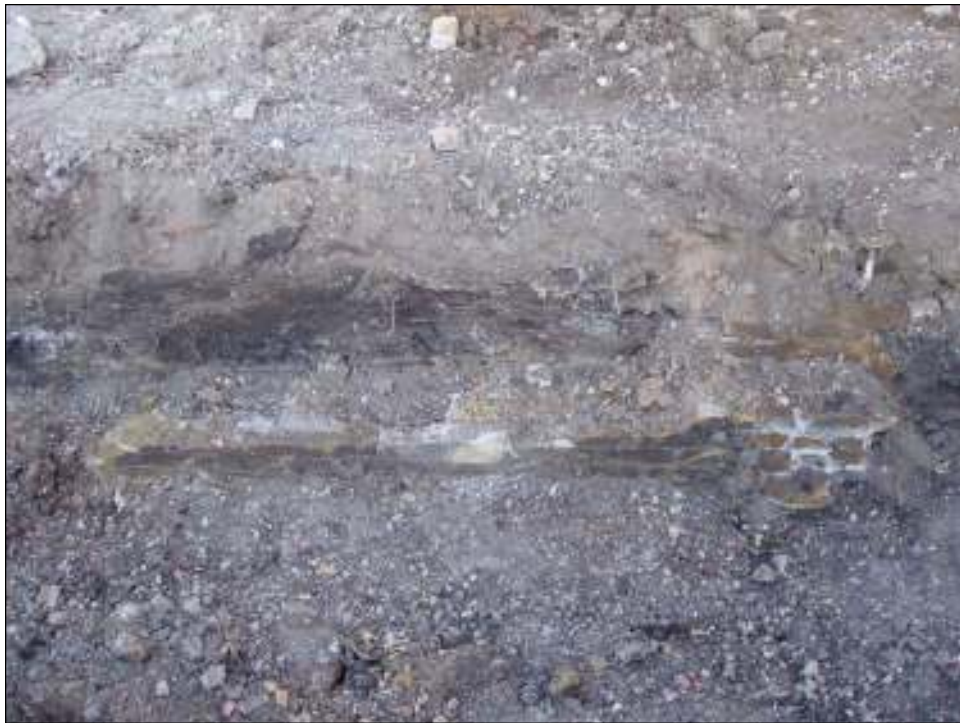
Figure 4-6. *Photograph of Feature 2, facing west.*

Feature 2 was a yellow brick foundation located near the outer western edge of the slurry wall guide-wall (Figure 4-6). The foundation was approximately 8 m long, running north-south. The top of the foundation was uncovered at 110 cmbs; with the base of the foundation at approximately 155 cmbs. The width of the wall was 35 cm. The guide-wall trench was dug several times, and during the final time the foundation portion was removed. The bricks were laid on top of a cement base that was reinforced with twisted rebar (Figure 4-7). The bricks were embossed with "LAREDO BRICK CO." The Laredo Brick Company was found in the Laredo city directory from 1920-21 to 1980 (Cook 1998), though it seems they were in business since 1891 (Gross and Meissner 1997). It was most likely founded by Andrew Hans Thaison, who arrived in Laredo in 1881 (Cook 1998). A few fragments of undecorated white earthenware were noted

in the backdirt, as well as an aqua glass bottle manufactured by ABC Co. It is possible the bottle held mineral water. The presence of the bricks indicates that the foundation was constructed between 1920 and the mid-1960s. The area was cleared in 1967 to make way for the construction associated with the 1968 HemisFair.

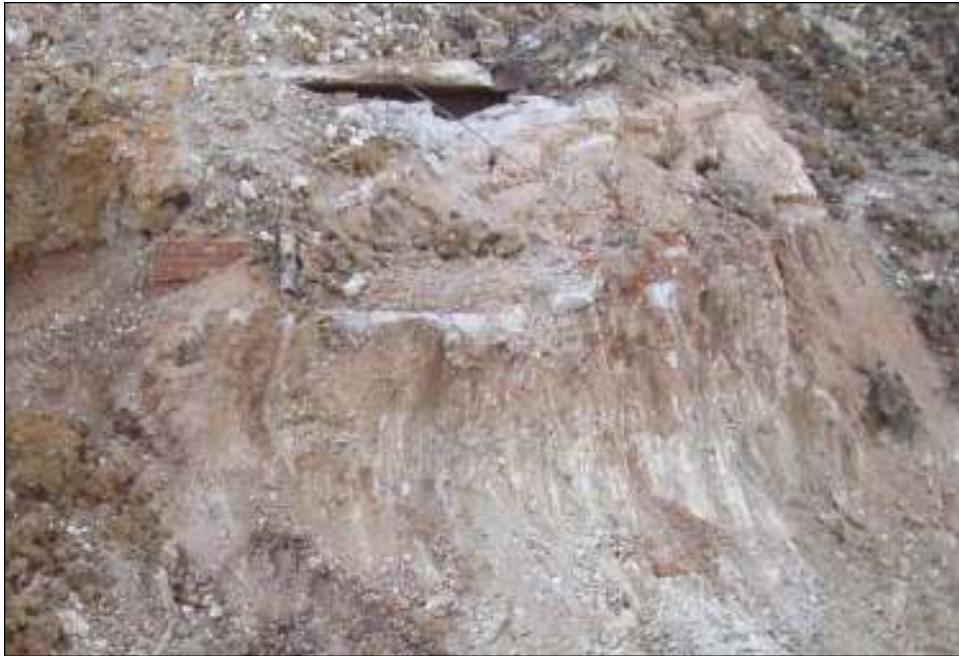
Figure 4-8. *Photograph of Feature 3, facing south.*

Feature 3 was a red brick foundation set on top of a reinforced concrete base (Figure 4-8). The foundation was located in the southwest portion of the hotel footprint. The length of the foundation could not be ascertained due to the large trackhoe having removed a large portion of it before it could be closely examined. Next to the foundation was a concentration of bricks, none of which were mortared together. The bricks in the foundation and pile had “ALAMO” stamped on one side. The Alamo Brick Company was founded by J. S. Magnus in 1880 as Bem Bricks, but the name was changed to Alamo Brick Company in 1920 (Cook 1998; Steinbomer 1983). Therefore, the structure could have been built between 1920 and the mid-1960s. No other cultural material was noted in the surrounding area.

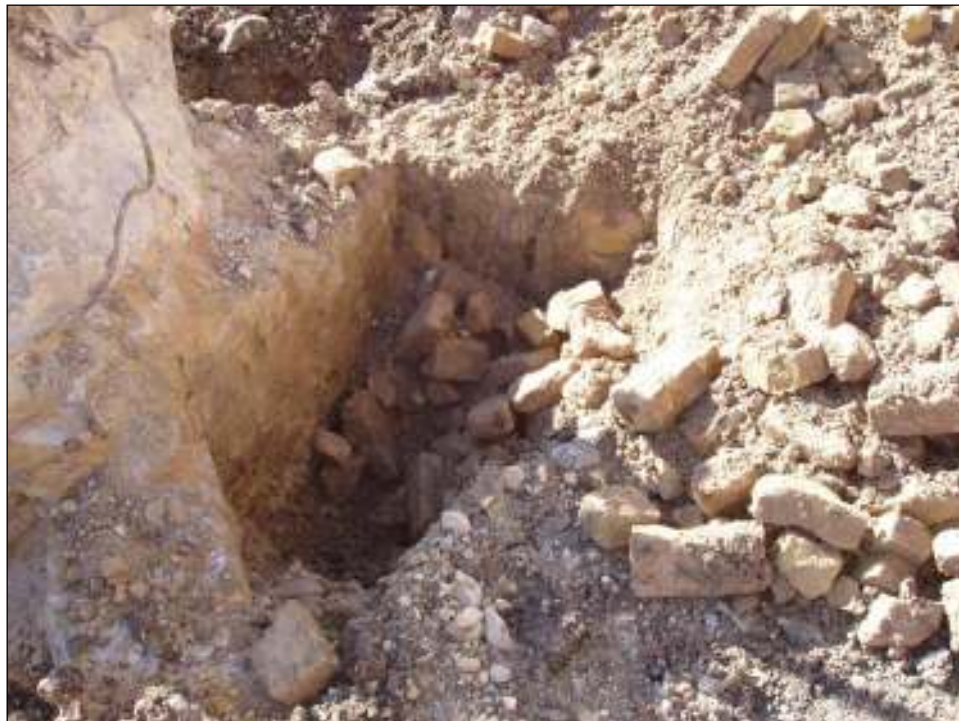
Figure 4-9. *Photograph of Feature 4, facing south.*

Feature 4 was an unidentified structure, possibly a foundation, located to the east of the Lila Cockrell Theater. The possible foundation was partially impacted by a previously installed cement pier that supported the parking garage (Figure 4-9). The foundation was constructed of yellow brick that exhibited no diagnostic marks. It is possible that it is a portion of a structure that appears on the 1912 Sanborn map (Figure 4-2), which was constructed after the San Antonio Planning Mill Co. was removed from the area. There was no associated cultural material encountered during the removal of the structure.

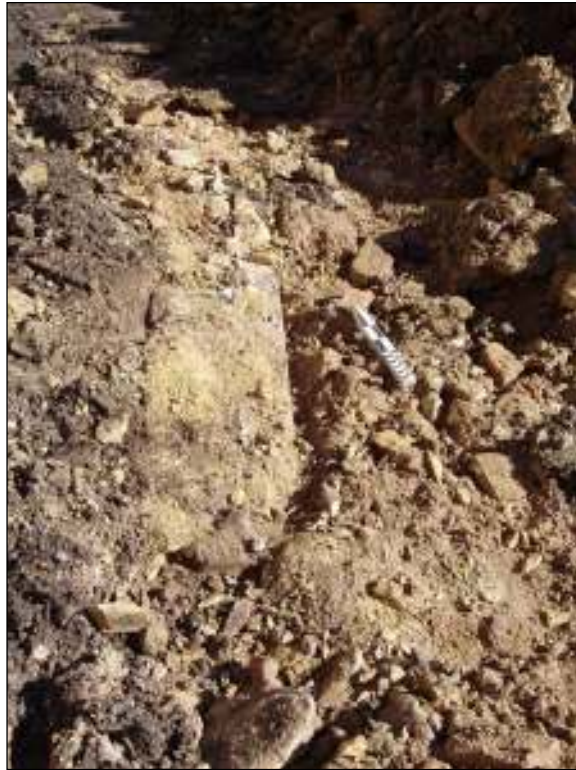
Figure 4-10. *Photograph of Feature 5, facing northeast.*

Feature 5 was a portion of a foundation composed of yellow and salmon colored bricks (Figure 4-10). The foundation was located to the east of the Lila Cockrell Theater, southeast of Feature 4. The foundation appears to have been disturbed previously, with loose fragments of mortared brick near the remaining part of the intact foundation. A pocket of flat glass fragments was located in the vicinity of the foundation.

It is possible that this foundation is related to the structure in Block 688 Lot 304 of the 1912 Sanborn map (Figure 4-2).

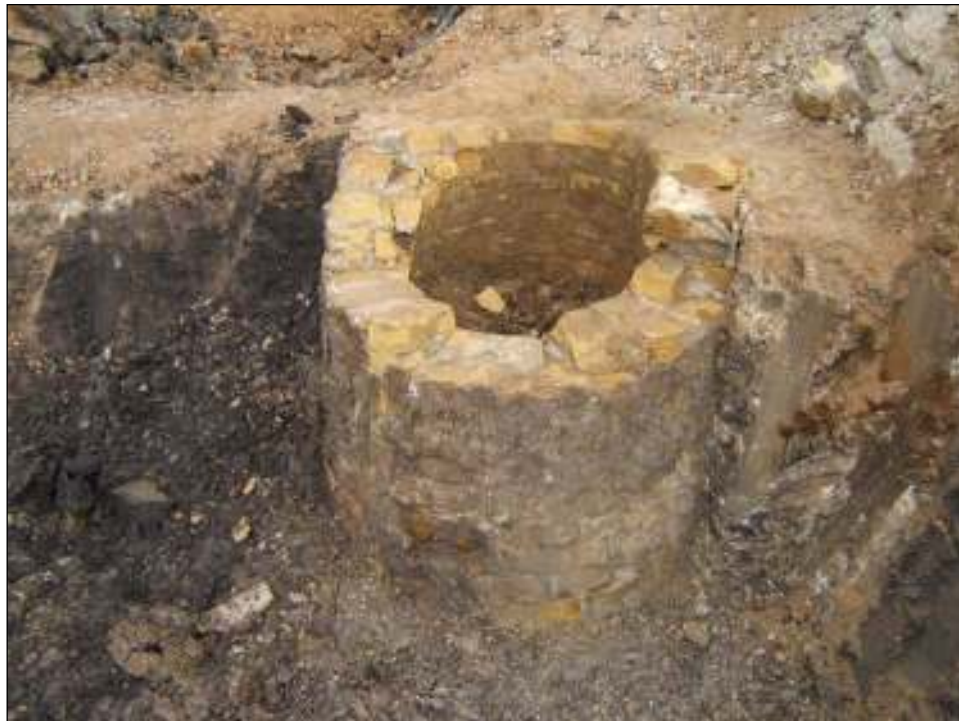
Figure 4-11. *Photograph of Feature 6, facing north.*

Prior to September 2005, trenching was conducted along the project area to locate any remaining portions of the Spanish Colonial acequia. One of these trenches located in projected path of the acequia, located just southwest of Feature 4, exposed an intact, hand-laid brick cistern (Figure 4-11) that was nestled between the wastewater drain and parking garage foundation. The well extended to a depth of about 15 ft. and the bricks date between 1896 and 1905. Since the cistern dates to a late-nineteenth/early twentieth century occupation, no additional time was spent recording and documenting the well other than photographing and measuring the structure.
