**Mission San José French Drain Installation Monitoring,
41BX3, San Antonio, Bexar County, Texas**

Technical Report, No. 3
Center for Archaeological Research
The University of Texas at San Antonio

Texas Antiquities Permit No. 4315

April 2007

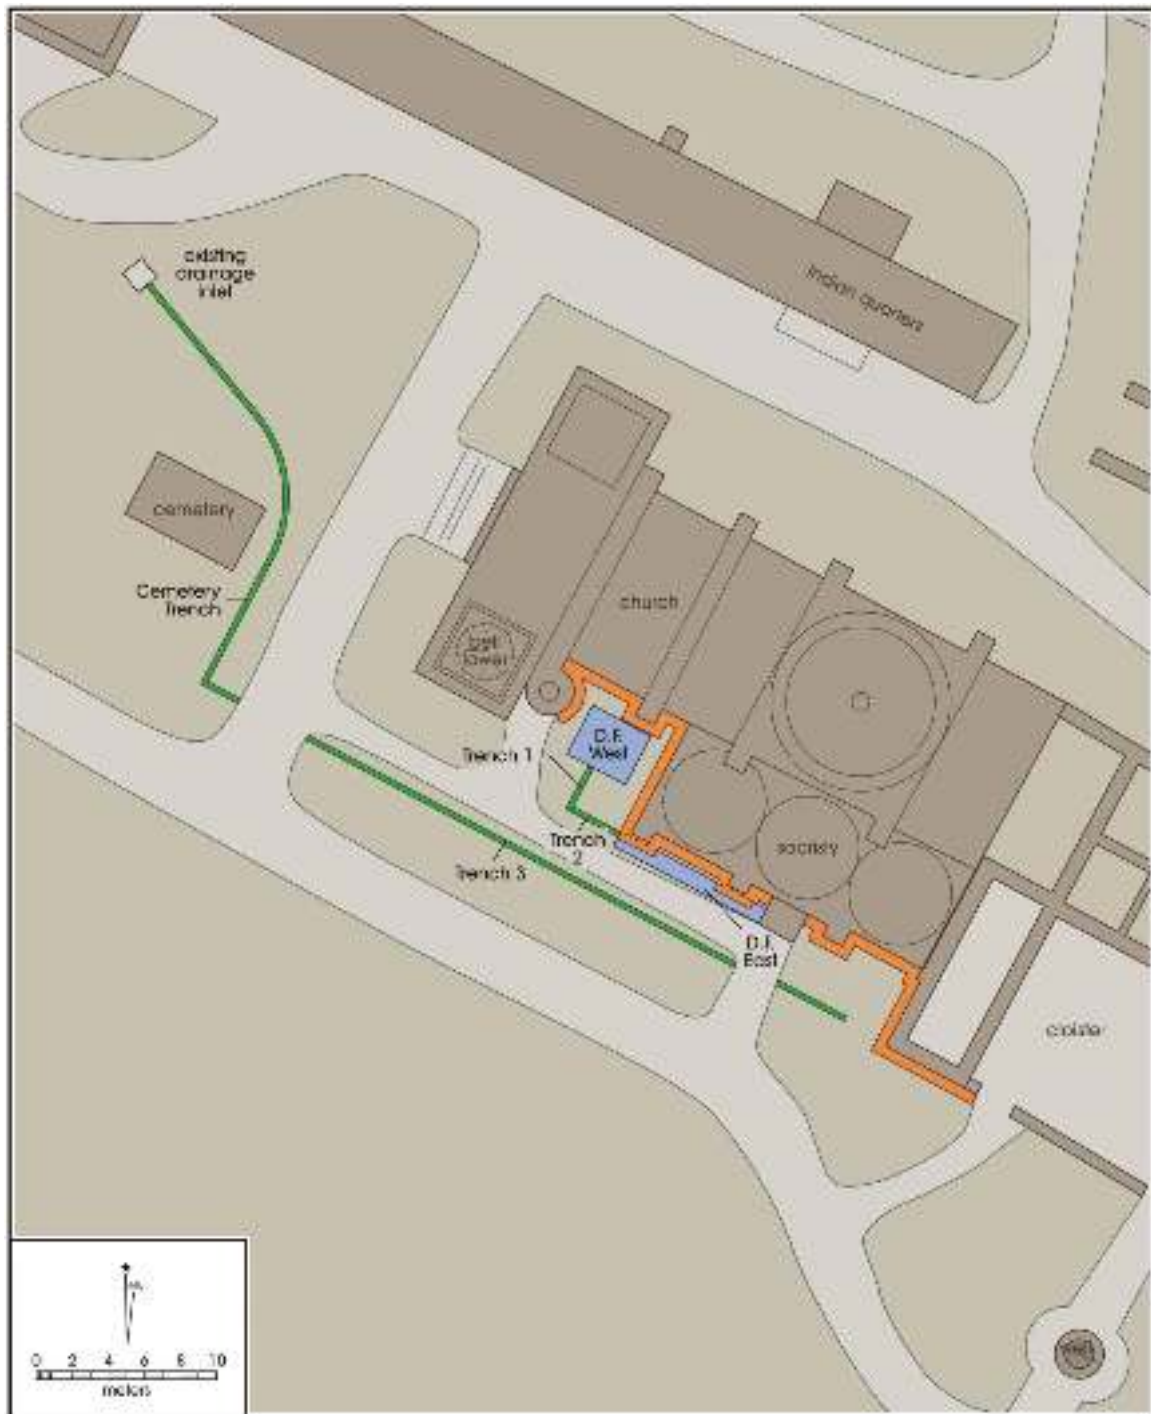
Figure 1-2. Map of the trenching at Mission San José. Orange shows trenching of foundation along church wall.

The drain fields were located along the south wall of the church and were connected to an existing drain inlet located west of the church via a drain pipe that runs between the existing cemetery and the church entrance (Figure 1-2). The installation of the drainage system was necessary to prevent foundation and wall damage caused by moisture rising from and through the foundation into the wall base.

Mechanical excavations at Mission San José were conducted over a period of seven days in November and December of 2006 and January of 2007. The excavations focused on three areas: (1) the exterior walls of the church and sacristy, (2) the drain fields, and (3) the trenches for the drainage of water from the drain fields (Figure 1-2).

Three segments of a trench were excavated to drain the water from the drainage fields (Figure 1-2). Trench 1 was excavated south of the western drainage field located between the church tower

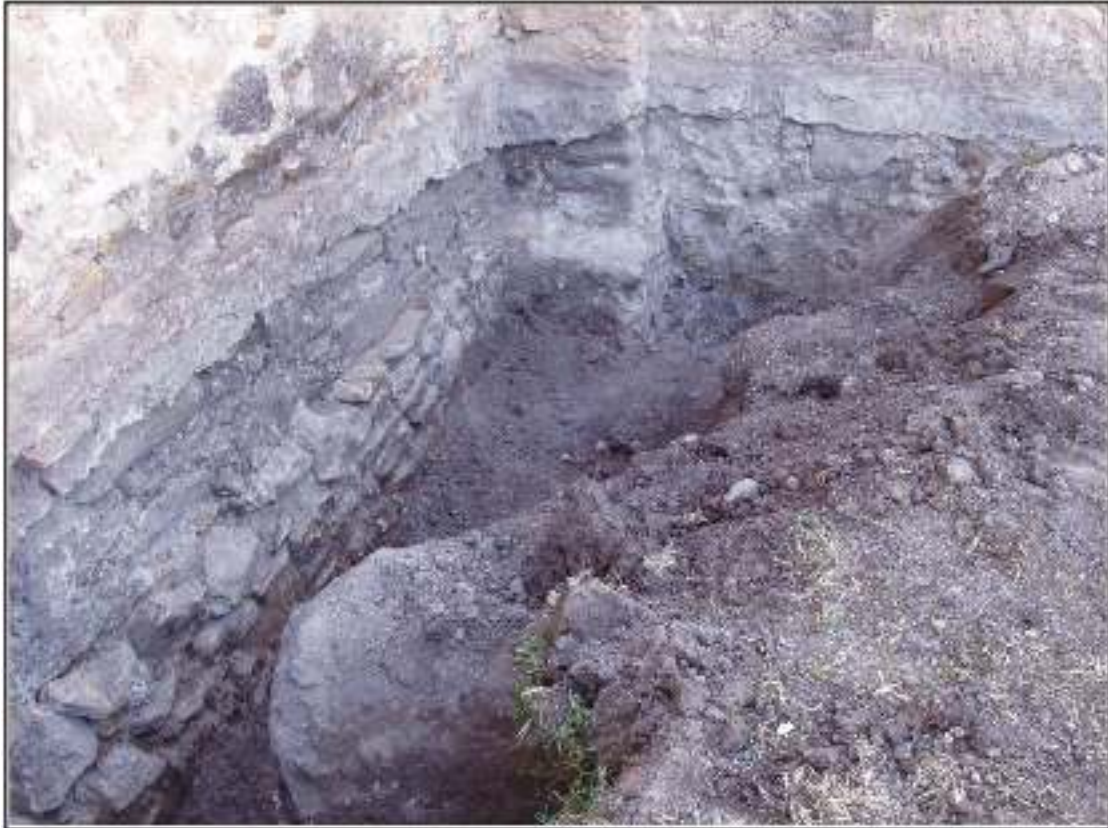
Figure 4-1. Photograph of soil removed from exterior of Church wall, west of the Rose Window. Facing northeast.

The first areas excavated were located along the southern wall of the church and sacristy (Figure 1-2). The soil was removed to allow the foundations to be re-pointed and then protected from the damaging effects of water runoff. The soil was removed to approximately 2 ft (60 cm) below the original Church floor level, creating the need to excavated approximately 5 ft (1.5 m) below the present surface (Figure 4-1). Excavations started on the east side of the Rose Window, and immediately produced one unique artifact. Against the sacristy foundation, between the Rose Window and a buttress to the east, a 1932 Mexican Peso was uncovered. The peso was converted into a religious medallion with the addition of a loop, and carved with the image of Our Lady of Guadalupe on one side. It appears that the face side of the coin was ground down, because the letters in the words “INDEPENDENCIA Y LIBERTAD” that were stamped on the edge of the coin are shortened. The image of Our Lady of Guadalupe was soldered onto the coin, and then rays emanating from her, stars, and two rose and vine motifs were incised into the coin (Figure 4-2).

The excavation along the exterior of the south wall of the sacristy revealed that the foundation extended to a depth of 80 to 100 cm below the current surface level. Along the exterior of the south wall of the Church, it appears that the foundation extends to approximately 1.5 m below the surface. Results of the trenching indicate that much of the area has been previously disturbed, with mixed soils and eighteenth to twentieth century artifacts. Common cultural remains encountered included fragments of ceramic, glass, brick, concrete and unidentified mammal bone. No concentrations of artifacts were notes within the material scattered throughout the areas investigated. Two artifacts were collected and are stored at the UTSA-CAR laboratory according to NPS guidelines. Fragments of human remains were identified in the laboratory and subsequently reburied in the trench where they were found.

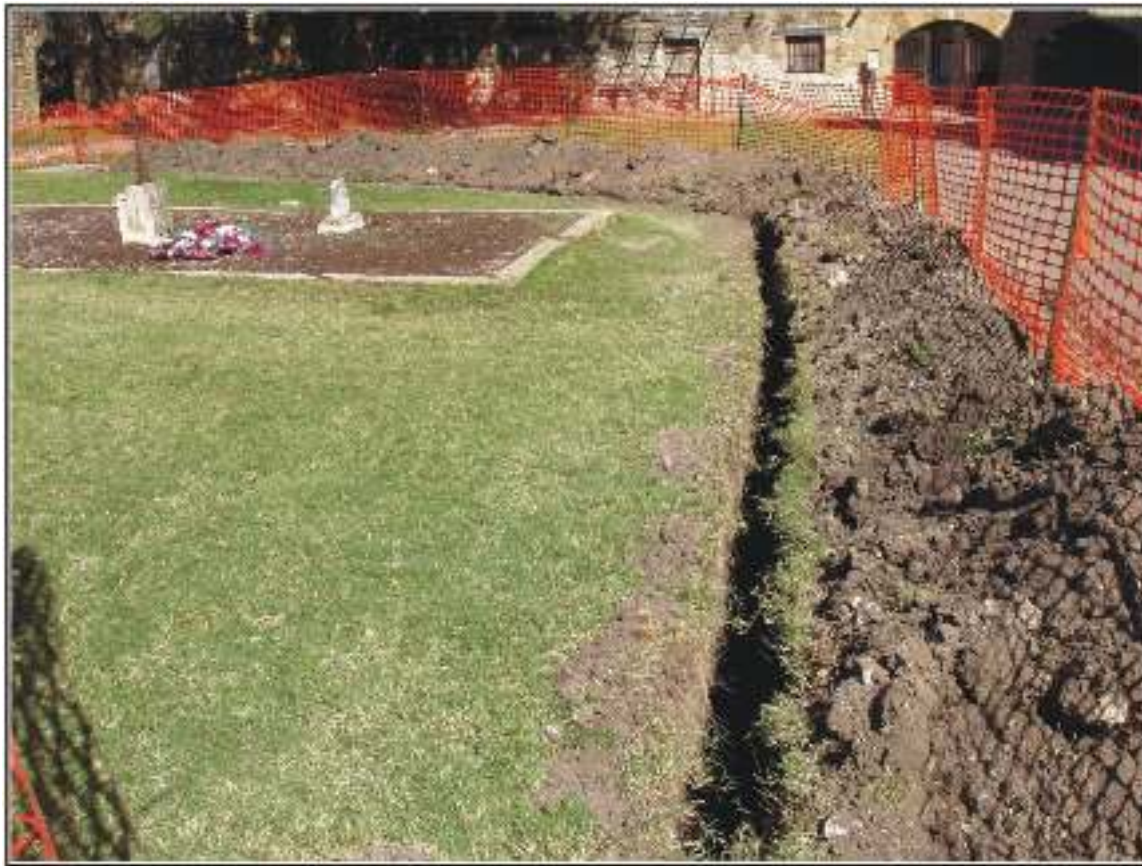
The excavation of the Cemetery Trench, past the small cemetery in front of the church produced very few artifacts (Figure 4-3). A few bone fragments of medium to large mammals were noted, as well as a couple of fragments of brown and clear glass. At the bend in the trench, near the northeast corner of the cemetery, a fragment of a rib was identified at the bottom of the trench, approximately 35 cm below surface. This, and a few other bones recovered from the backdirt, was taken to the UTSA-CAR laboratory to determine if they were human. The trench was not extending beyond that depth, and the bone was not found in association with others, so the trenching continued down the line. One additional rib fragment was identified among the bones returned to the lab. Upon cleaning and examination with comparative materials, it was determined that the two rib fragments were human remains. The human remains were reburied in accordance with the NPS Incidental Finds Agreement with the Archdiocese and in concurrence with the Texas Historical Commission/SHPO since the land is property of the state and Archdiocese. The soils in this portion of the trench were previously disturbed, with modern material such as plastic coated wire and pull tabs noted in the backdirt.

Figure 4-3. *Photograph of the trenching past the cemetery. Facing northwest.*
