**Archaeological Monitoring for the
Valley Ditch at the Intersection
of East Commerce and North
Cherry Streets, San Antonio,
Bexar County, Texas**

Texas Antiquities Committee Number: 4487

prepared by
Center for Archaeological Research
The University of Texas at San Antonio
Technical Report Number 6
© 2007

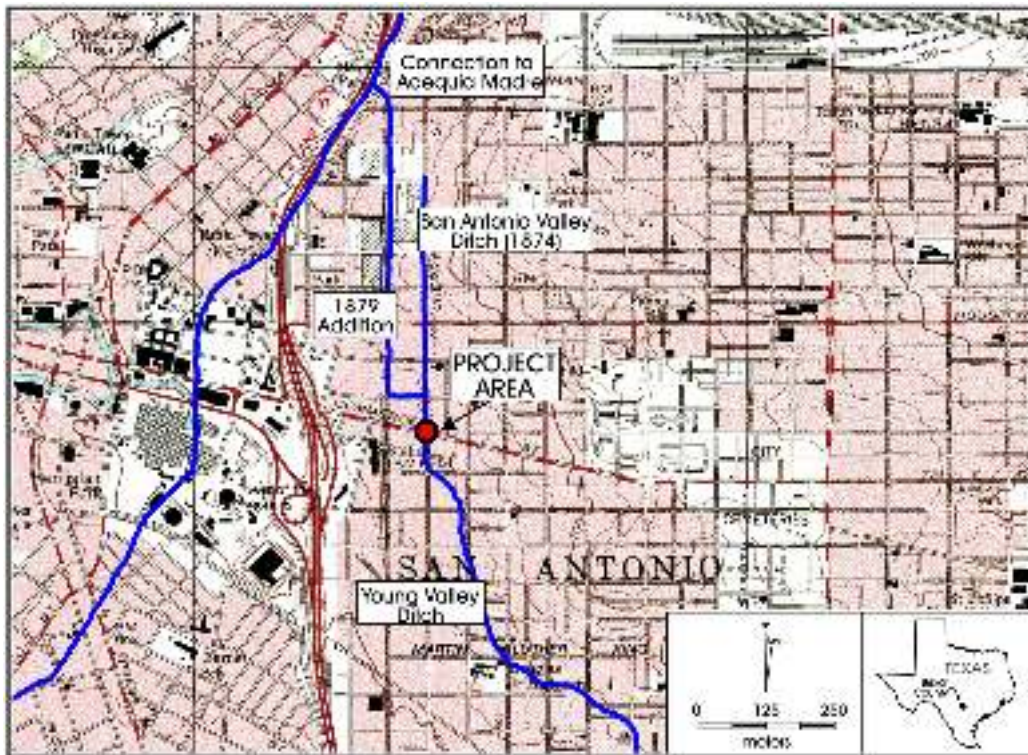
Figure 1-1. Location of the project area and San Antonio Valley Ditch on the San Antonio East 7.5 Minute Series USGS Quadrangle map.

Gross and Mendez (1997), using city maps dating to 1877 and 1889, located the probable course of the Valley Ditch (See figures 1-1, 1-2). They surmised that the Valley Ditch ran along the east side of Cherry Street. The maps indicate that it originates at an unknown point north of Sherman Street and runs south past present day Durango Street (Gross and Mendez 1997:243). The Young Ditch begins at Idaho Street and turns southeast for two to three miles to a tributary of the San Antonio River near Mission Concepción (Cox 2005:57). The 1889 map shows the 1879 extension of the Valley Ditch beginning at Acequia Madre. The Valley Ditch addition runs north to south along Walnut Street and turn east at Centre Street (Gross and Mendez 1997:243).

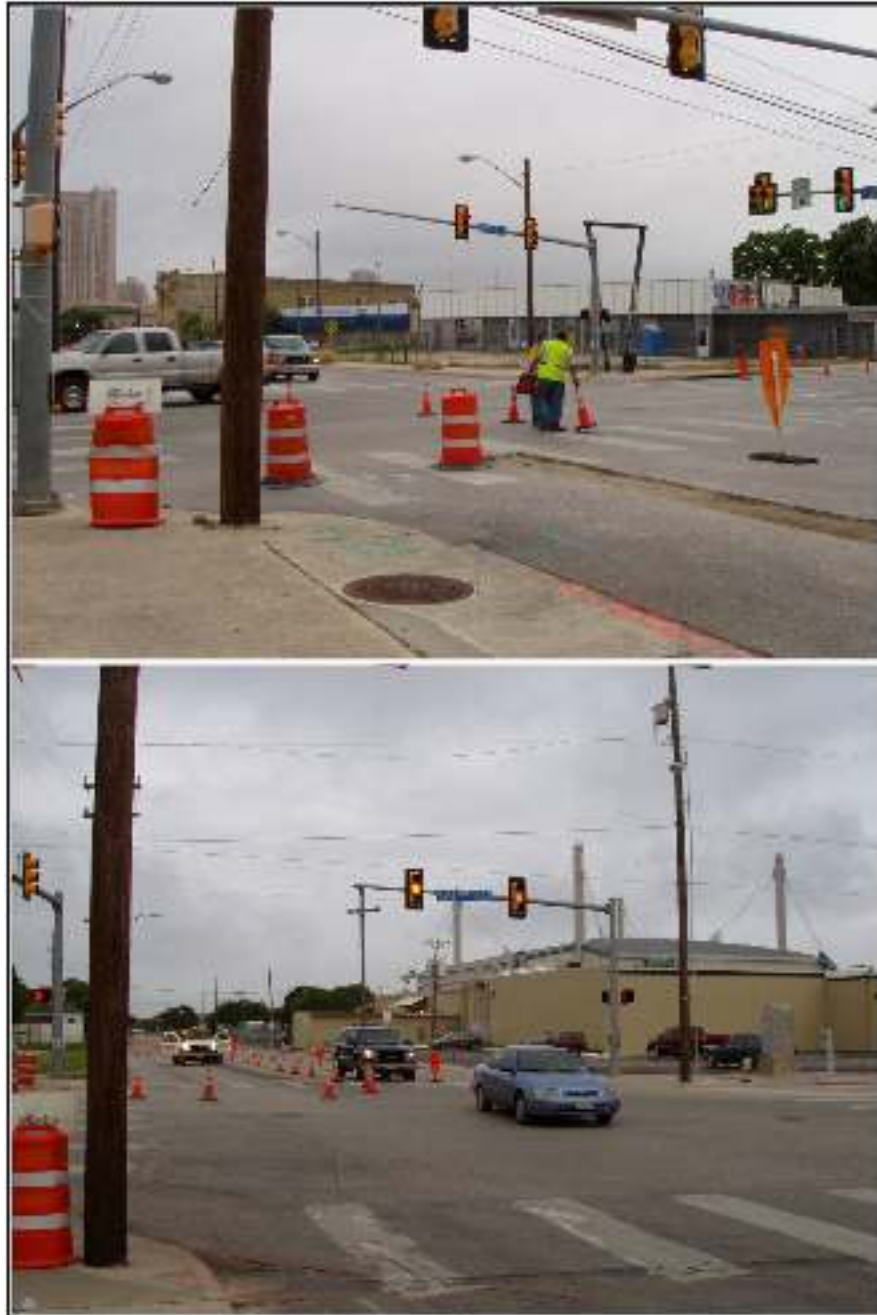
Figure 1-2. Project area showing views north (top) and south (bottom) on Cherry Street ;

The project area is an urban environment in downtown San Antonio, Texas. It is surrounded by older residential housing, light industrial and commercial buildings (Figure 1-2). The project area lies within the Denver Heights neighborhood and a short distance from several significant archaeological and historical properties (see Figure 1-3). Selected historic properties include St. Paul Methodist Episcopal Church (c. 1880), the Southern Pacific Depot (1902), the sites of the Steve's Lumber Yard (1883; see Figure 1-4), Alamo Iron Works (1884), and the site of Otto Zirkel Marble Works (ca. 1880). Approximately three blocks to the west of the project area is the Carver Community Cultural Center, and the original city cemeteries.

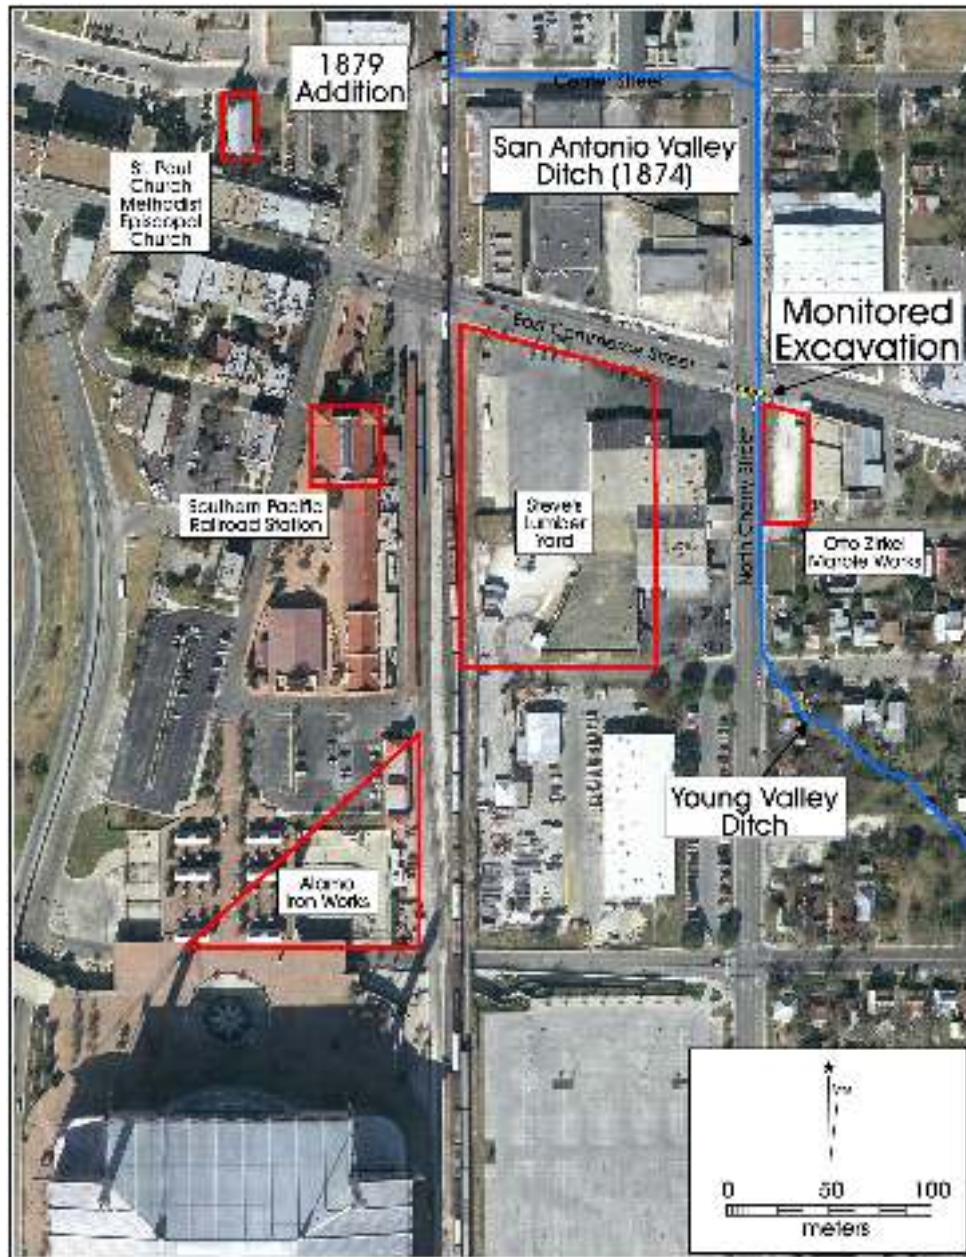
Figure 1-3. Project area showing location of monitored excavation, the San Antonio Valley and Young Valley ditches, and selected historic sites .

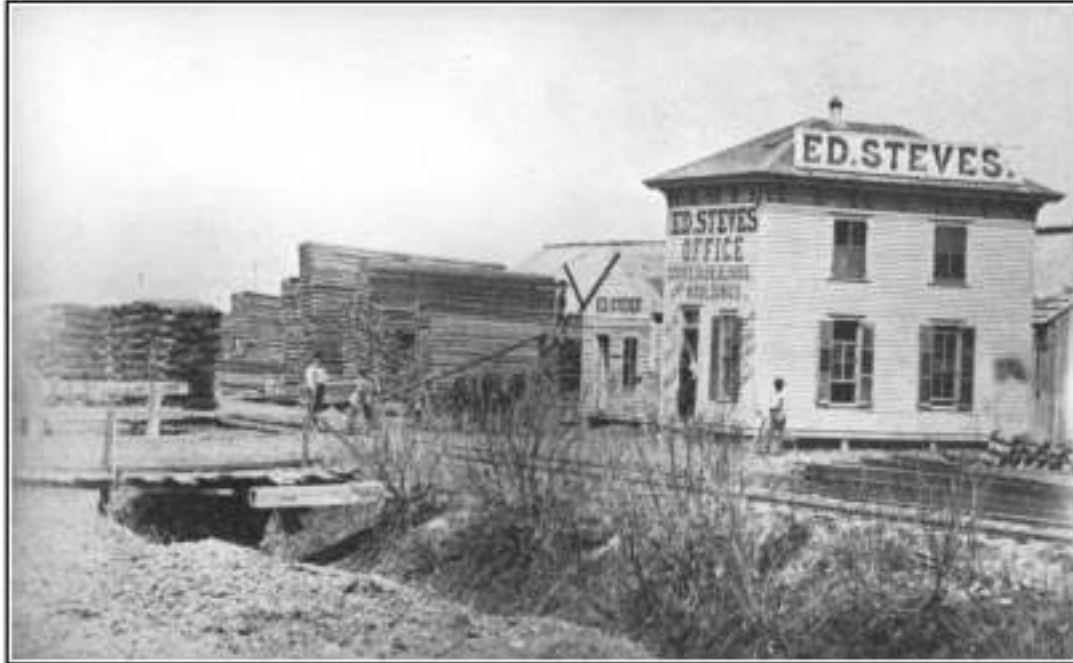
Figure 1-4. *Photograph of Steves Lumber Company in 1881 with the Valley Ditch crossing diagonally in the foreground (photo courtesy of the Witte Museum, San Antonio, Texas).*
