# Archaeological Monitoring Along the Salado Creek at IH-10, San Antonio, Bexar County, Texas

Texas Antiquities Permit No. 4880

*Prepared by:*  
Center for Archaeological Research  
The University of Texas at San Antonio  
Technical Report, No. 13

The Center for Archaeological Research of The University of Texas at San Antonio conducted archaeological monitoring of backhoe trenching along the Salado Creek at the IH-10 intersection. The construction is associated with the proposed Salado Creek Hike and Bike Trail. Four backhoe trenches were excavated along the banks of the Salado Creek, within the TxDOT Right-of-Way. The project area is within environs of where the Young Perry Alsbury Homestead and cemetery are said to be located. Backhoe trenching yielded no evidence of the historical homestead or cemetery.

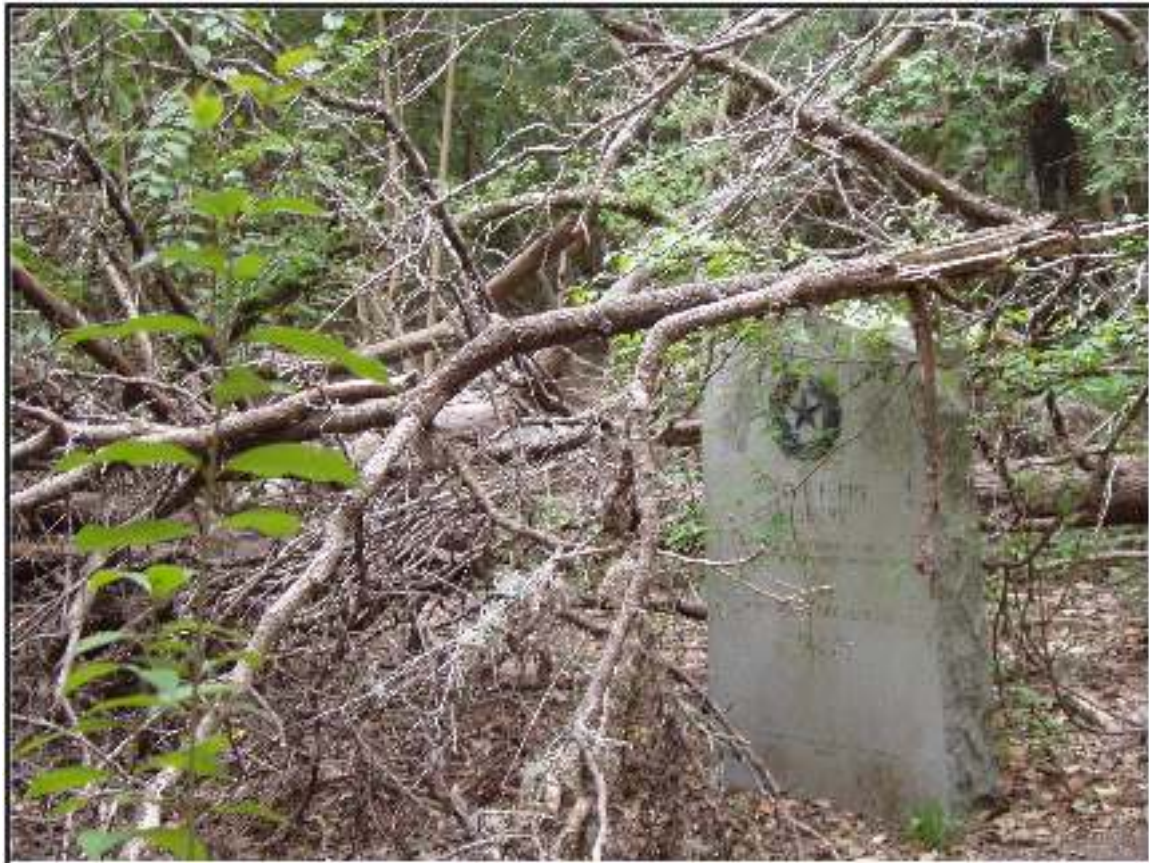
The previous archaeological work did not locate the Alsbury Cemetery and Homestead site although the project APE was located in the vicinity of a 1936 Texas Centennial Marker found outside of the IH-10 ROW. Figure 2 shows the condition of the Centennial Marker during the current investigations but it was not within the boundaries of the current APE.

Figure 2. 1936 Centennial Marker.

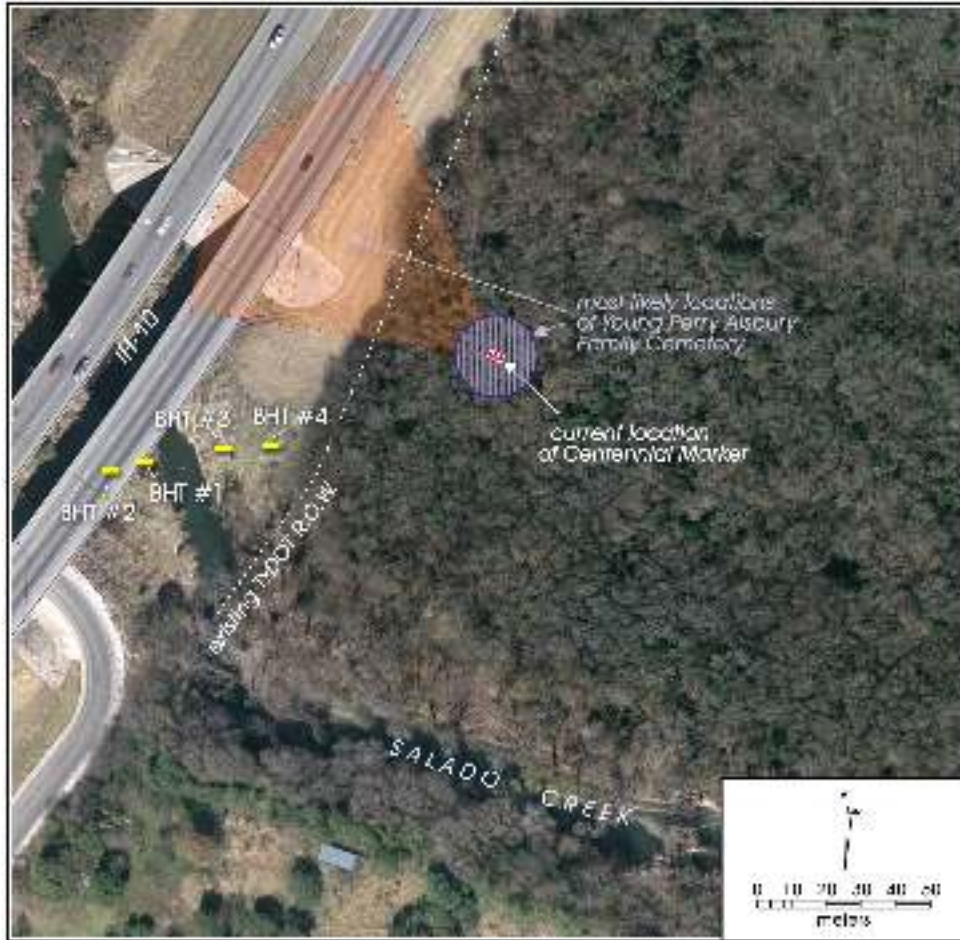
Figure 3. Location of the backhoe trenches and Centennial Marker.

BHT 2 was excavated north east of BHT 1 (Figure 3), and was orientated west-east. The backhoe trench measured 2.4 m long and 90 cm wide. The terminal depth of the backhoe was 180 cmbs. The four soil horizons observed in BHT 1 were also observed in BHT 2. No cultural material was observed in BHT 2, with the exception of some modern debris in the upper 10 cm.

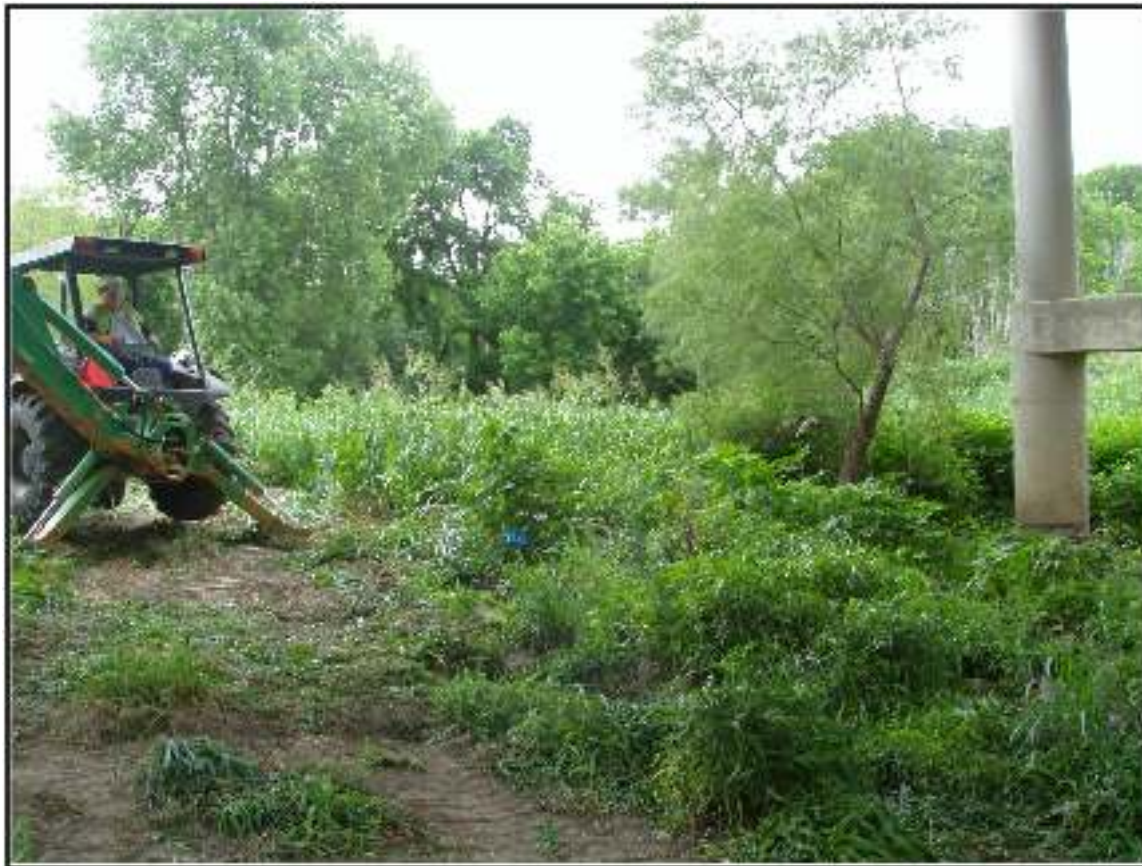
BHTs 1 and 2 were excavated on the west bank of the Salado Creek, under the IH-10 Bridge (Figure 3 and Figure 4). BHT 1 was orientated west to east and was approximately four meters from the edge of the creek. It was 2.0 m long and 90 cm wide. The final depth of the trench was 180 cmbs. Four soil horizons were observed in BHT 1 (Figure 5). Zone 1 was a thin humus layer (10 cm thick) defines the top portion of the profile. Zone 2 was a dark brown (10YR 4/3) silty loam and extends from 10 to 60 cmbs. Zone 3 is a dark grayish brown (10YR 4/2) clay that transitions into a silty clay in Zone 4, at 120 cmbs. Although modern trash (soda cans and plastic) was noted in the first zone of the trench, no prehistoric or historical material was encountered in BHT 1.

Figure 4. Location of Backhoe Trench 1 and 2, on the west bank of the Salado Creek.

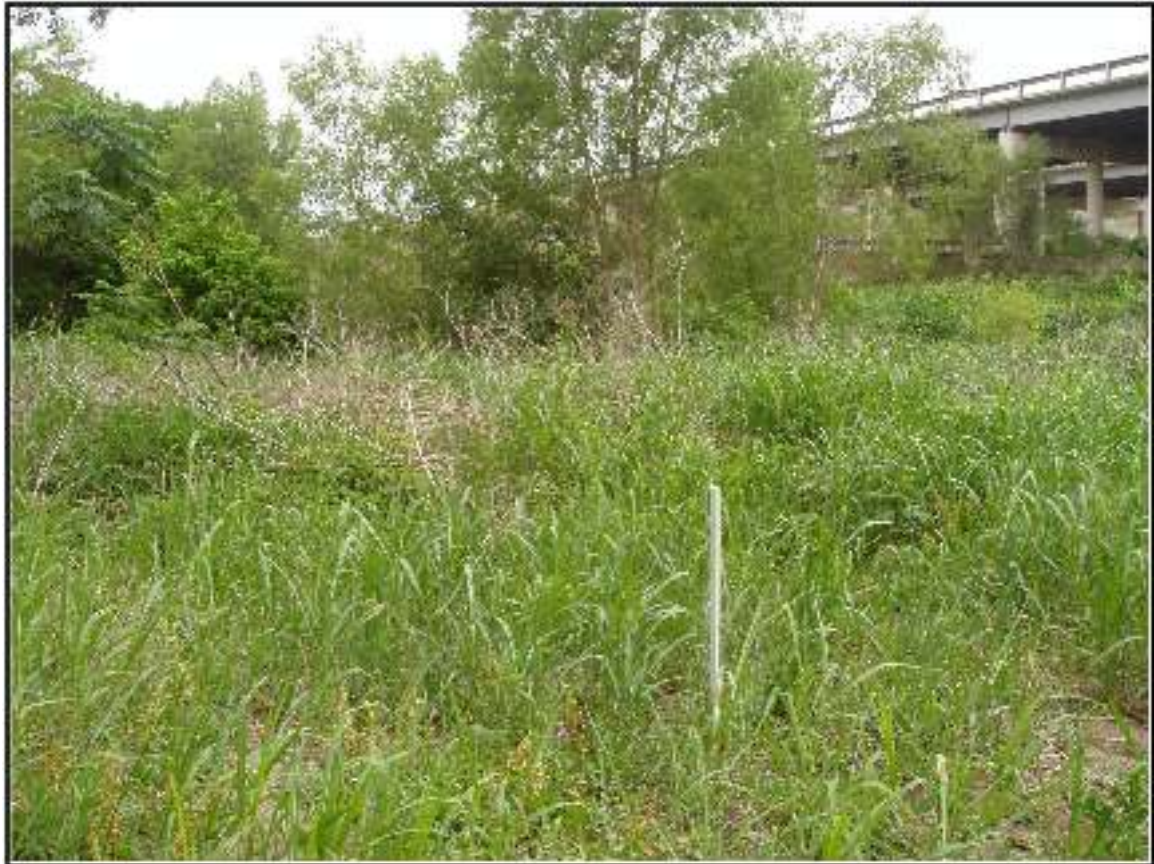
BHT's 3 and 4 were excavated on the east bank of the Salado Creek (Figure 3 and 6). BHT 3 was orientated west-east and measured 2.5 m long and 90 cm wide. The trench was 2.5 m east of the creek. The trench terminated at 180 cmbs and the water table was encountered. Four soil horizons were noted in BHT 3. Zone 1 was a dark grayish brown (10YR 4/2) sandy loam that extended from ground surface to 50 cmbs. Zone 2 spanned from 50 to 140 cmbs and consisted of very dark grayish brown clay (10YR 3/2). Zone 3 was a thin deposit, only 10 cm thick. It consisted of a grayish brown (10YR 5/2) sandy clay with gravel inclusions (20%). Zone 3 occupied the remainder of the trench and was a dark grayish brown (10Y 4/2) clay matrix. Zone 4 was a dark grayish brown (10YR 4/2) clay. No cultural material was observed in BHT 3.

Figure 6. Location of Boekhoe Trench 3 and 4, on the east bank of the Salado Creek.
