# Archaeological Investigations of an Architectural Feature at Trueheart Ranch (41BX1816), Bexar County, Texas

*Prepared by:*  
Center for Archaeological Research  
The University of Texas at San Antonio  
Technical Report, No. 18

In May of 2009, The University of Texas at San Antonio-Center for Archaeological Research (UTSA-CAR) conducted archaeological investigations at the Trueheart Ranch. A stone arch feature and rock alignments were recorded on the premises. The goal of the San Antonio Missions National Historical Park was determine if the features were of the Spanish Colonial Period and warranted inclusion in the park's holdings. Two 1-x-2 meter and one 1-x-0.5 meter units were hand excavated by CAR staff. In addition, three trenches were hand excavated to investigate rock alignments noted on the surface. Artifacts collected from these investigations and all project related documentation are curated at the CAR laboratory. The archway was recorded as site 41BX1816. Our assessment is that the arch and associated rock alignments date to the later half of the nineteenth century.

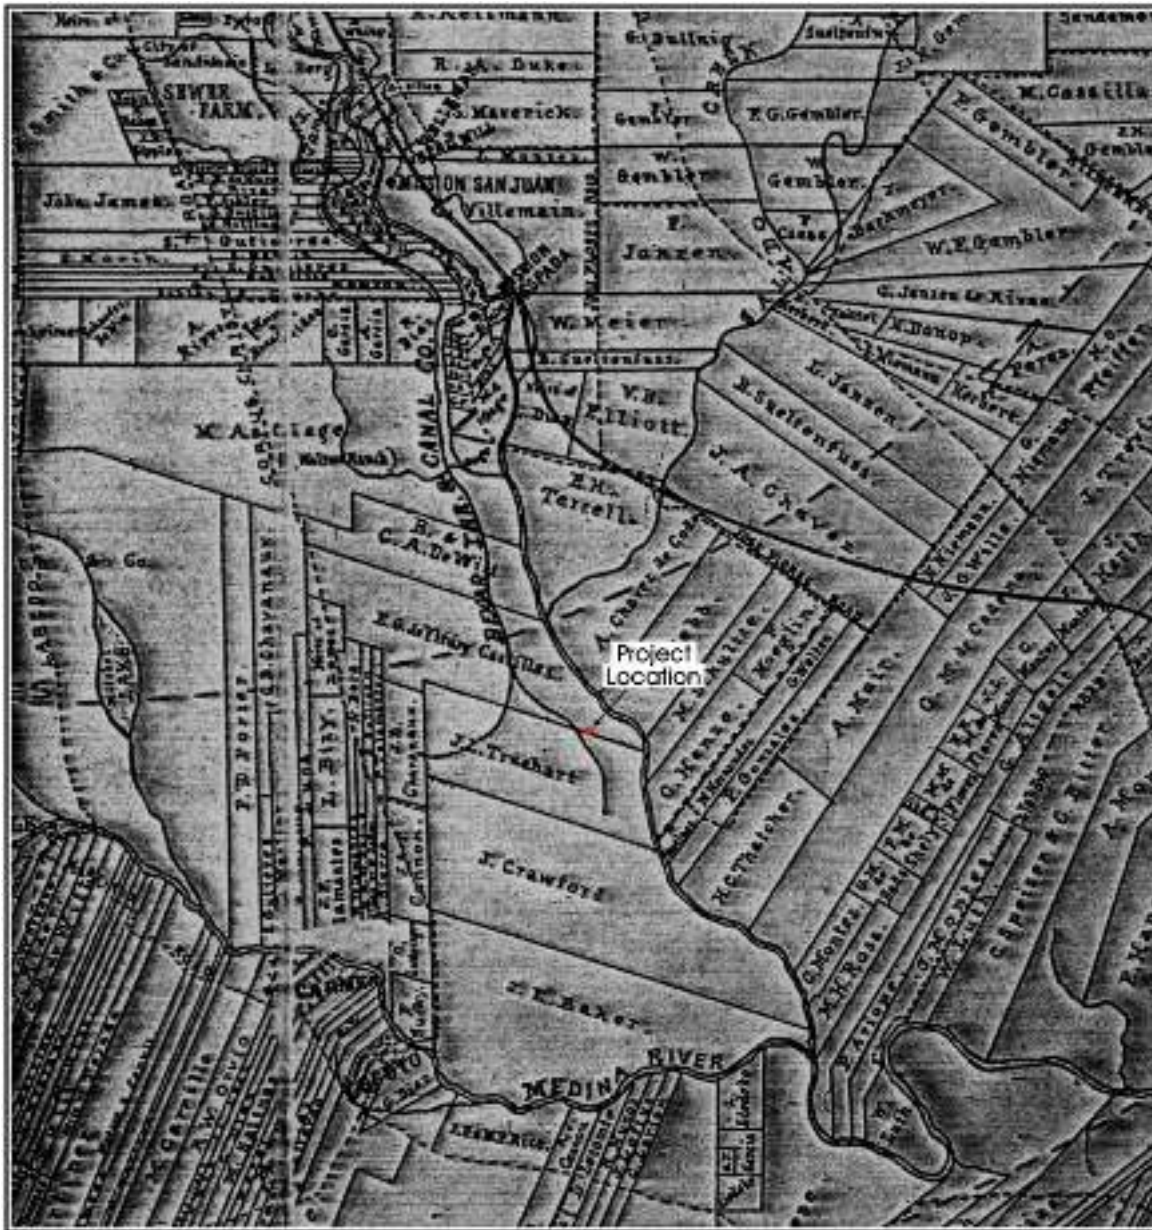
Figure 2. John D. Rullman's 1897 map showing the project location in relationship to the Trueheart property and the San Antonio River.

district clerk. In 1848, he became the county clerk. After marrying Petra de la Garza in 1848, Trueheart worked on the property he obtained in the marriage (Figure 2). He improved the land, constructed an irrigation system to water the croplands, and allowed a number of families to settle on portions of the property on small farm plots. The 1897 Rullman map depicted in Figure 2 shows a drainage labeled as "Bexar Irrigation and Canal Company".

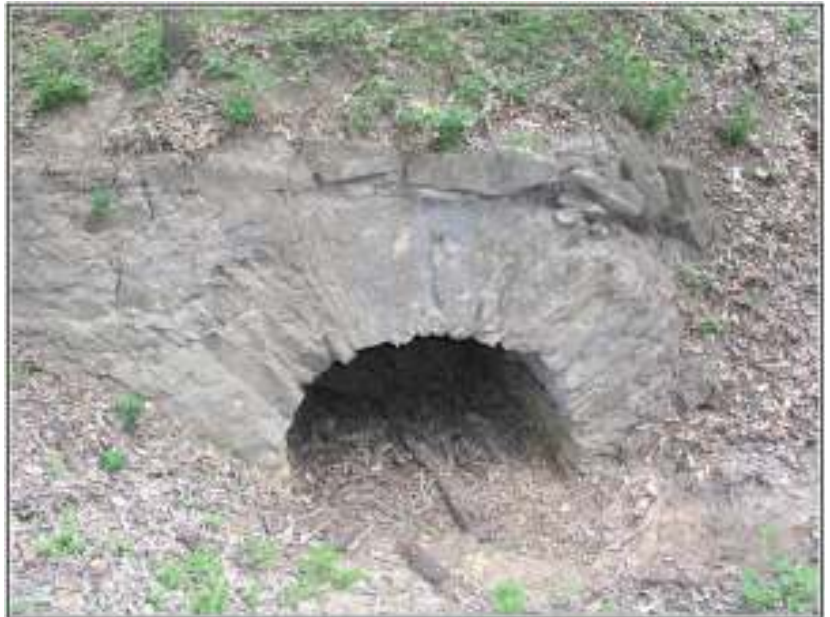
Figure 3. *East face of archway.*

The stone archway appears to have also been constructed of native limestone (Figure 3 and 4). HABS documentation completed in the 1935 by Charles Bertrand reports that the archway is contemporaneous with the construction of the house and was used by the builders of the house to transport lime during the construction of the house (HABS 2009). Photographs of the arch were taken in 1936 by Arthur W. Stewart to be included in the HABS documentation.

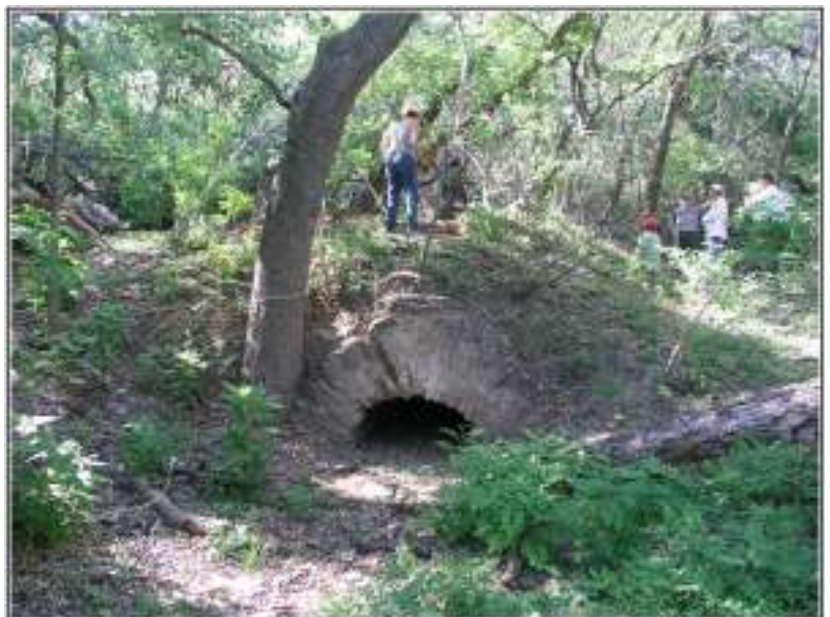
Figure 4. *West face of archway.*

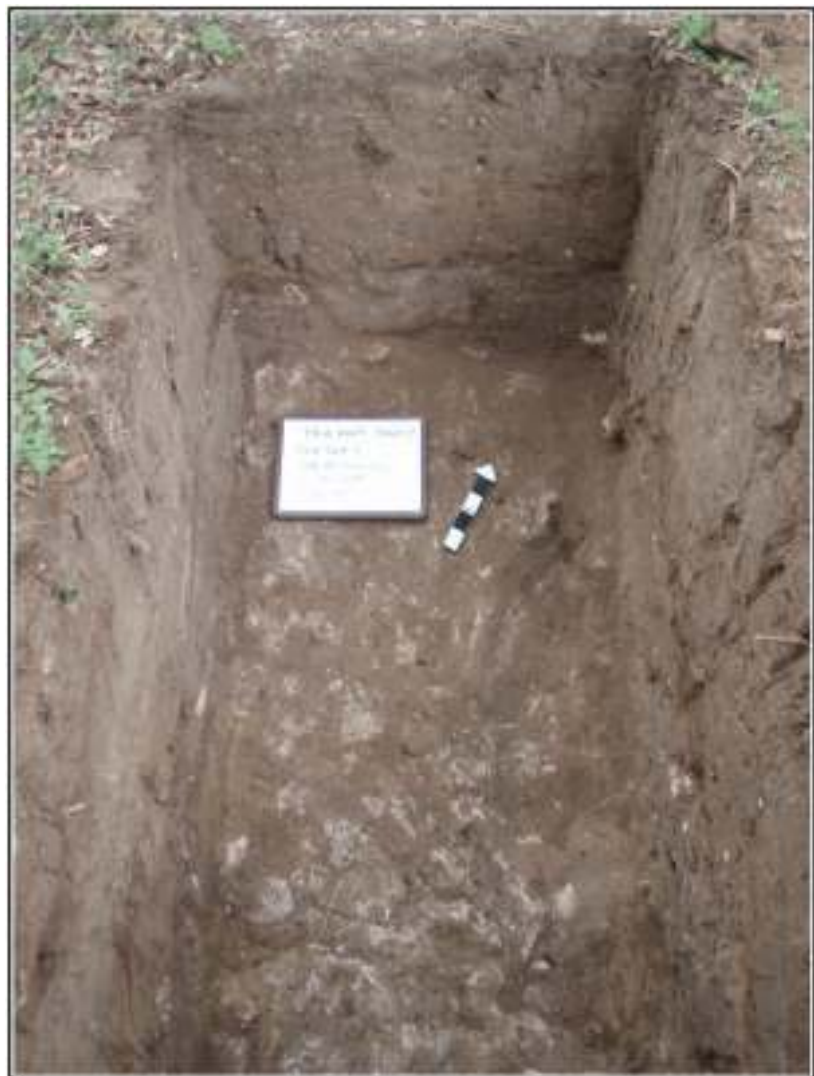
Figure 7. Excavation Unit 1 with the top of the archway uncovered.

matrix, though a change was noted in the southern portion of the unit between 70-80 cmbd. Overall the soil appears to be compact, though a few pockets of softer matrix were encountered. Excavation of this level produced bone fragments, debitage, a brick fragment, and mortar and plaster (Table 1). Carbonate flecks were also noted in this level. Level 5 (80-100 cmbd) exhibited a variation of soil colors in the southern portion of the unit. Overall, the matrix appears to remain compact, though a shift to a sandy silt was noted. Cultural materials encountered included debitage, burned rock, burned limestone and lime. Charcoal and carbonate flecks were observed throughout the level. Level 6 (100-143 cmbd) initially was to be excavated to 120 cmbd. Due to the need to uncover the top of the arch, the level was excavated below this depth to fully expose the top of the archway. The arch was first encountered in the northwest corner of the unit at 125 cmbd. The lowest elevation at which the archway was uncovered was in the southeast corner at 143 cmbd (Figure 7). The only cultural material recovered was a bone fragment. The soil encountered was a compacted silty clay. Roots averaging approximately 4 cm in diameter were encountered just above the arch.

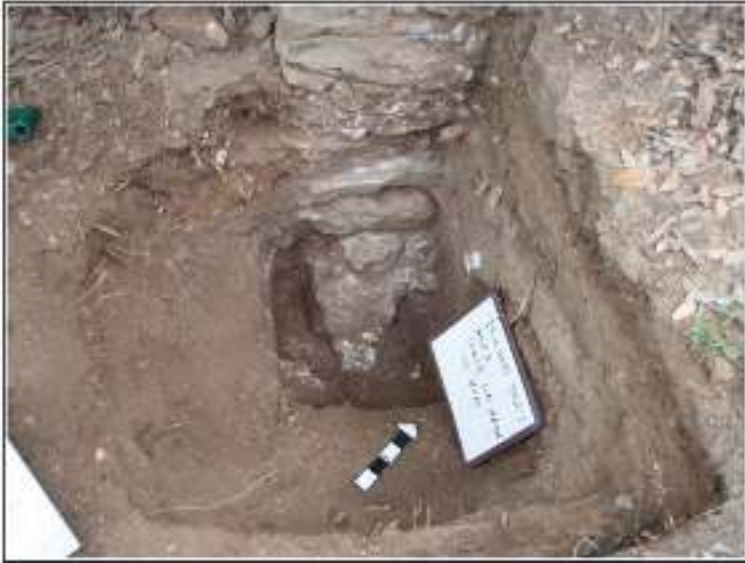
Figure 9. *Base of the archway in Excavation Unit 2.*

vessel was recovered during the excavation of this level. Excavation of this unit was terminated when the base of the archways was located at 150 cm below datum. The arch appears to have been built on a limestone footer (Figure 9). Additional soil to the east of the unit was removed to get a

better understanding of the construction of the feature. The base of the archway feature was exposed at 150 cmbd.

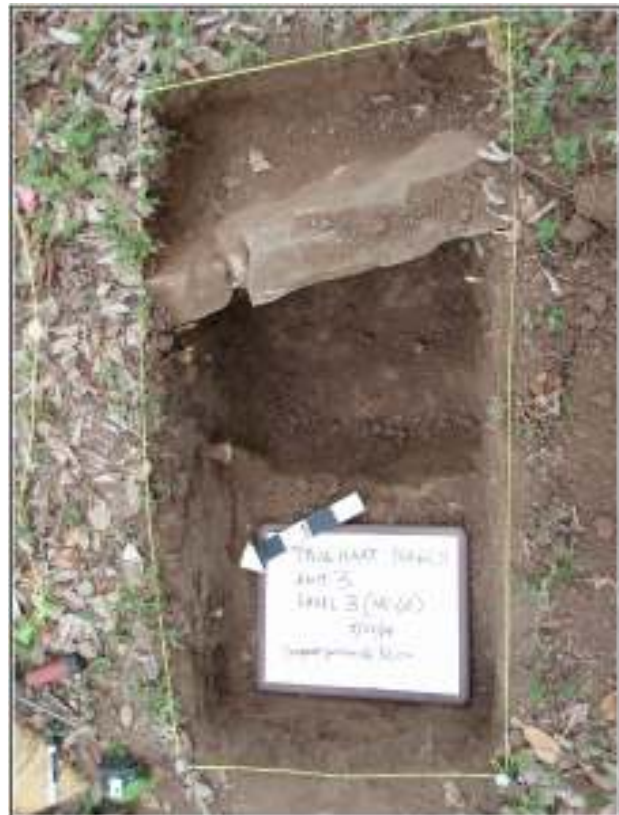
Figure 10. *Excavation Unit 3 showing the upright stones.*

Excavation Unit 3 was located southwest of the archway and to straddle the upright stones that were exposed on the surface. The unit was 1-x-0.5 meters. The first few centimeters excavated in the unit consisted of sandy silt that quickly became compacted. Carbonate nodules were noted throughout the level. The top portions of the stones were fully exposed during the excavation of Level 1 (0-20 cmbd). A yellowish mortar was noted between the two stones that resembles the mortar in the archway. One metal wire fragment was recovered during the excavation of Level 1 (Table 2). Level 2 (20-40 cmbd) exposed more of the stones. The stones appear to be leaning to the west, possibly due to flooding episodes that would have washed water over the path. The soil continued to be compact with carbonate flecks throughout. Along the base of the stones, an orange, sandy clay was noted with a heavy density of gravels. The orange soil was not consistent along the stones, but appeared in pockets. No cultural materials were encountered during the excavation of Level 2. Level 3 (40-60 cmbd) was excavated to reveal the base of the stones. The stones appeared to be only one course deep, the base of the stones was revealed at 55 cmbd (Figure 10). River gravels were noted against the base of the stones, but not in the remainder of the unit. No cultural material

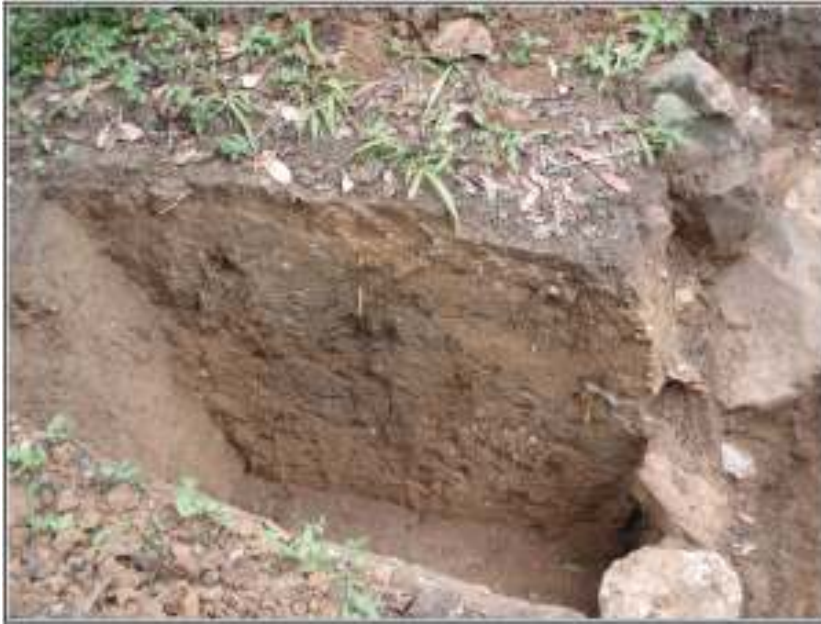
Figure 11. West wall profile of Trench 1 and the rock alignment in Trench 3.

Two trenches (T1 and T3) were excavated northeast of the archway in an area believed to be in the pathway of the possible road or aqueduct. These trenches were excavated by hand, and the matrix was not screened. Trench 1 was excavated east to west. Trench 3 was perpendicular to Trench 1, running north to south. Trench 1 was excavated to a depth of 1 meter below surface. No cultural material was noted during the excavation. In the eastern portion of the trench two stones were observed that appeared to be in line. Trench 3 was excavated by hand to determine if there was a rock alignment. The alignment continued in a north-south direction (Figure 11). The alignment consisted mainly of limestone, but a few fragments of sandstone also were noted. The top of the alignment was approximately 20 cmbd, and appears to have extended to 50 cmbd. The alignment was only one stone wide and one course thick. No mortar was noted between the stones. No cultural material was encountered in Trench 3.

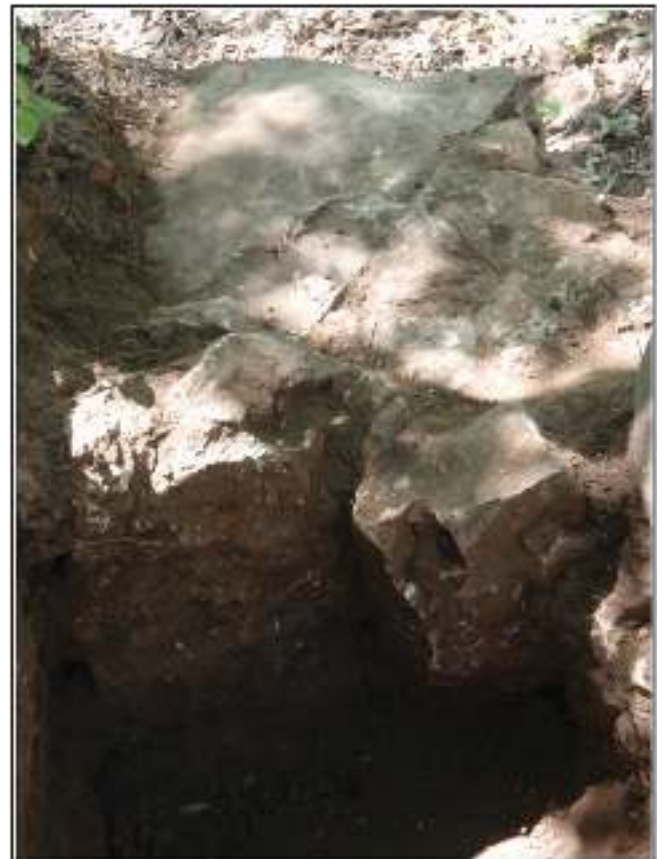
Figure 12. Stacked stones in Trench 2.

adjacent to a rock alignment. The matrix was not screened and the unit was excavated in 20 cm levels below surface (bs). The soil was removed from the top of the wall next to the archway. In Level 1 (0-20 cmbs), the top of the wall was exposed and revealed that a course of upright stones were set abutting the flat stones of the wall (Figure 12). Excavation in the northern portion of Trench 2 revealed no stones. Level 2 (20-40 cmbs) exposed the base of the upright stones. No other stones were noted underneath, and none extended further to the north (Figure 12). The trench was not located right up against the retaining wall. It is possible that behind the upright stones the retaining wall would have been encountered. No cultural material was encountered during the excavation of Trench 2. It is not clear whether this stone alignment continued to the edge of the arch because the area was not excavated.

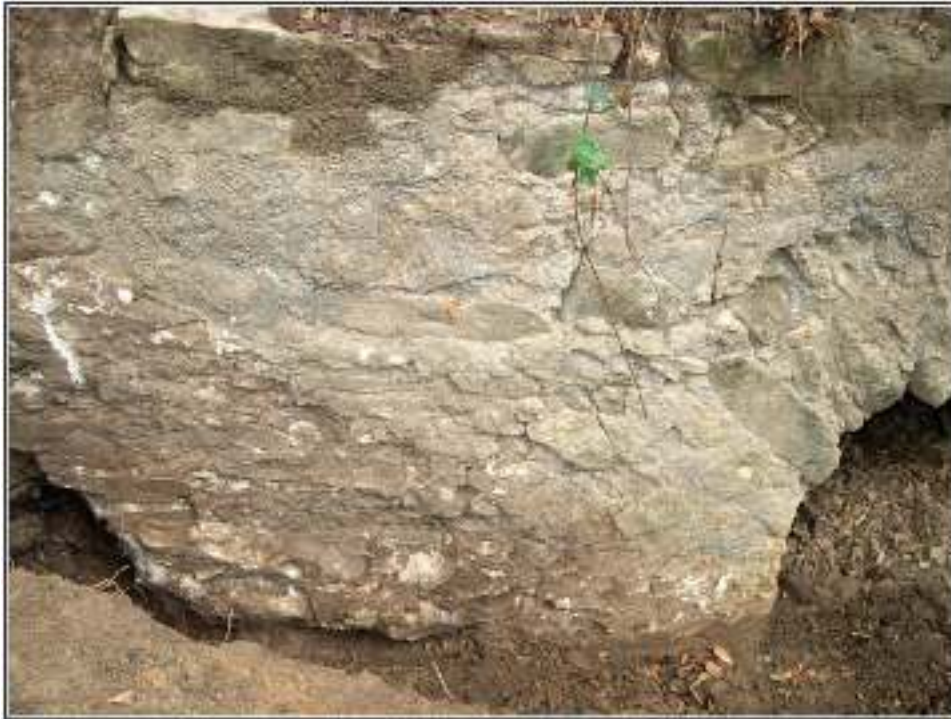
Figure 13. *Base of the retaining wall along the north face of the arch.*

To expose the extent of the retaining wall, archaeologists used shovels and a pick to remove the soil and find the edge of the feature (Figure 13). This trench was identified as Trench 4. The retaining wall may have acted as protection during flooding episodes. The wall is one course thick, and extended to a maximum depth of approximately 130 cmbs. The base of the retaining wall was sitting on soil rather than large footing stones such as those under the arch (Figure 13). The end of the wall protruded to the south approximately 2 meters from the arch. It appeared that there was possibly a second arch, but further excavation revealed that the depth of the wall decreased as it moved to the south.

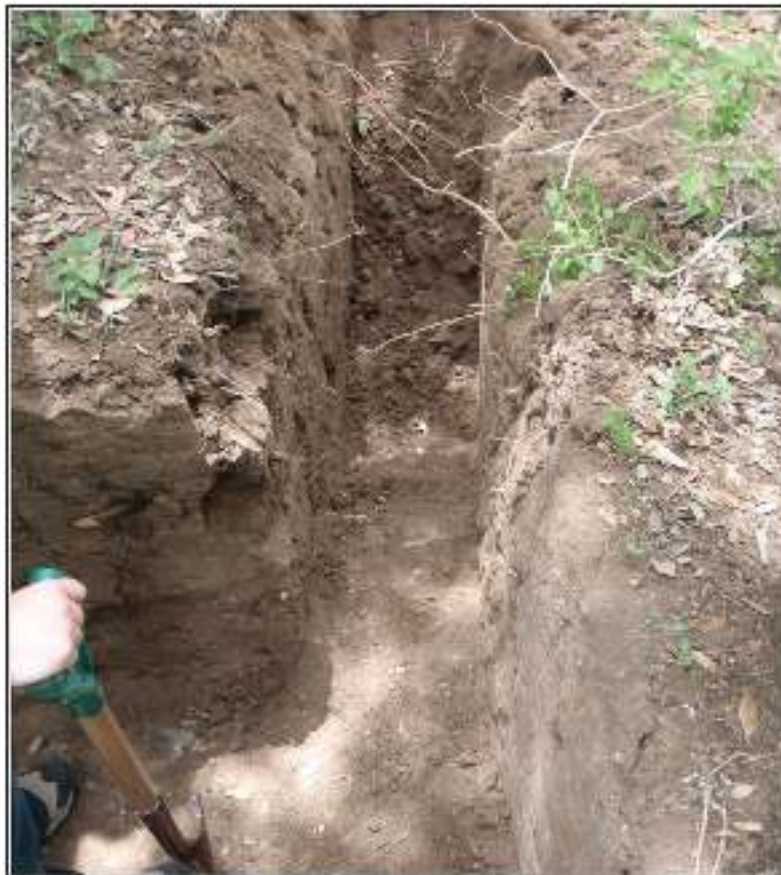
Figure 14. *NPS BHT 1, looking southwest.*

In addition to the areas excavated by CAR staff, NPS brought out a mini-excavator to trench in areas of interest. NPS-BHT 1 began at the south wall of Excavation Unit 1 and ran to the south (Figure 5). The trench was approximately one bucket wide (50 cm) and extended approximately two meters to the southwest (Figure 14). The trench removed a portion of EU 1's south wall. It was excavated to see if a second arch was located in the vicinity. The trench revealed that there was no second arch and that the arch was a lone standing feature. The exterior edge of the arch was uncovered and followed the curve of the arch to the base of the feature (Figure 14). There was no evidence suggesting that the feature was built to serve as an aqueduct.

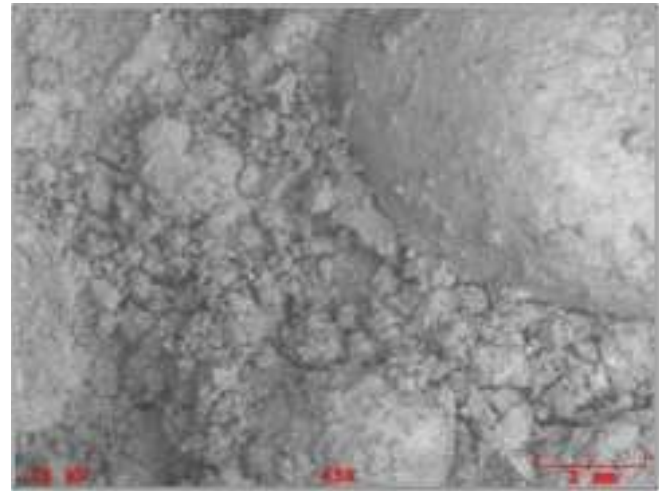
Figure 15. Scanning electron micrograph of mortar from Espada Aqueduct.

Therefore, in terms of broad constituent elements, the two samples are very similar. However, the two samples different in terms of two criteria. First, the microscopic examination of the structure of the mortars indicates that the sample derived from the Mission Espada Aqueduct is coarser than the sample from the arch (Figure 15 and 16). Typically, the older the mortar is, the less likely that it is refined whereas, the more recent it is, the more likely that it is factory-refined.

Second, the Espada mortar sample contained high proportion (34%) of Silica (Si) by weight and lower proportions (22% of Calcium (Ca) by weight (Table 3 and 4). The silica is derived from the sand and the calcium from the lime constituent of the mortar. In contrast, the mortar sample from the arch contained
