# **Monitoring the Planting and Removal of Plants at the Commander's House (41BX351) San Antonio, Bexar County, Texas**

Texas Antiquities Committee Permit No. 5595

*Prepared by:*  
Center for Archaeological Research  
The University of Texas at San Antonio  
One UTSA Circle  
San Antonio, Texas 78249  
Technical Report, No. 19

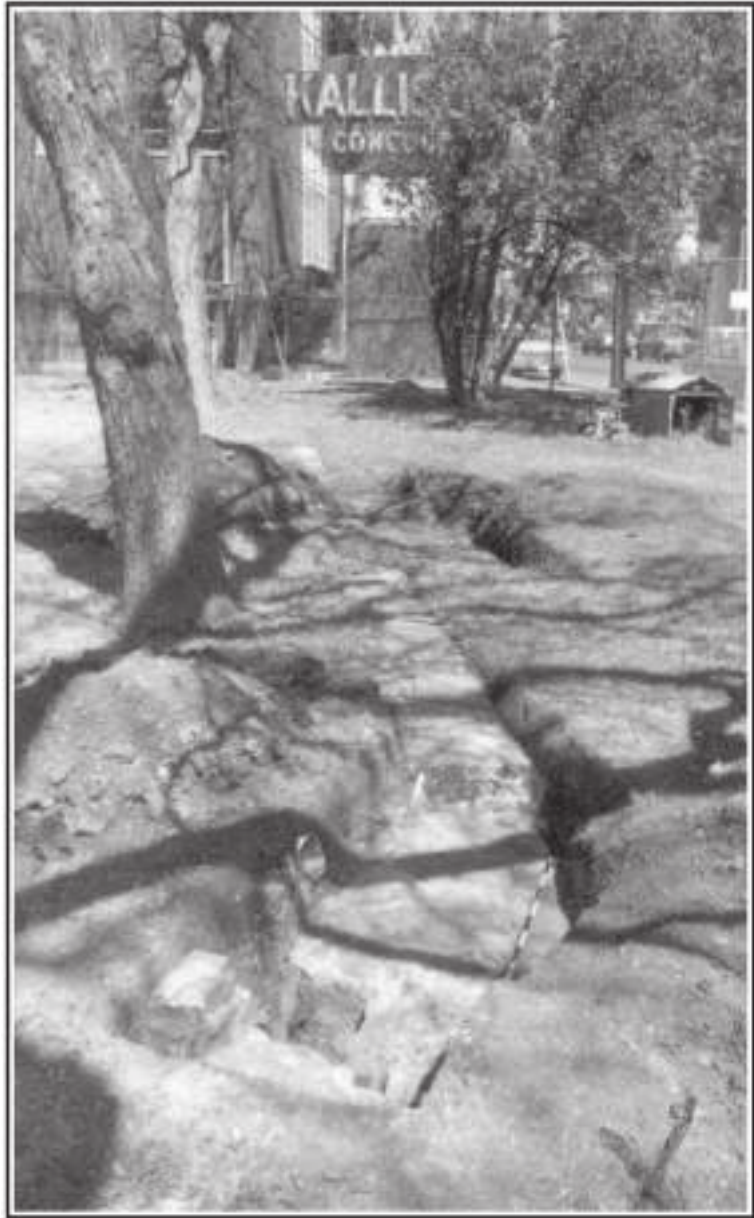
The excavations showed that this portion of the acequia was stone-lined with a cement cap that had been added on top of the walls at some point in the past (Fox 1978:3). The excavations also found cement plugs at each end of the acequia. Fox (1978:7) speculated that this closed-off portion had been used as a fish pond after the acequia was no longer in use. There were also cement plugs blocking the two laterals that were encountered, one going west and the other east (Figures 1-2 and 1-3).

Figure 1-3. *Photograph of the west wall of the San Pedro Acequia on the grounds of the Commander's House taken during excavation by CAR, showing curve of the acequia and a gate to a lateral that led west (foreground). Facing North.*

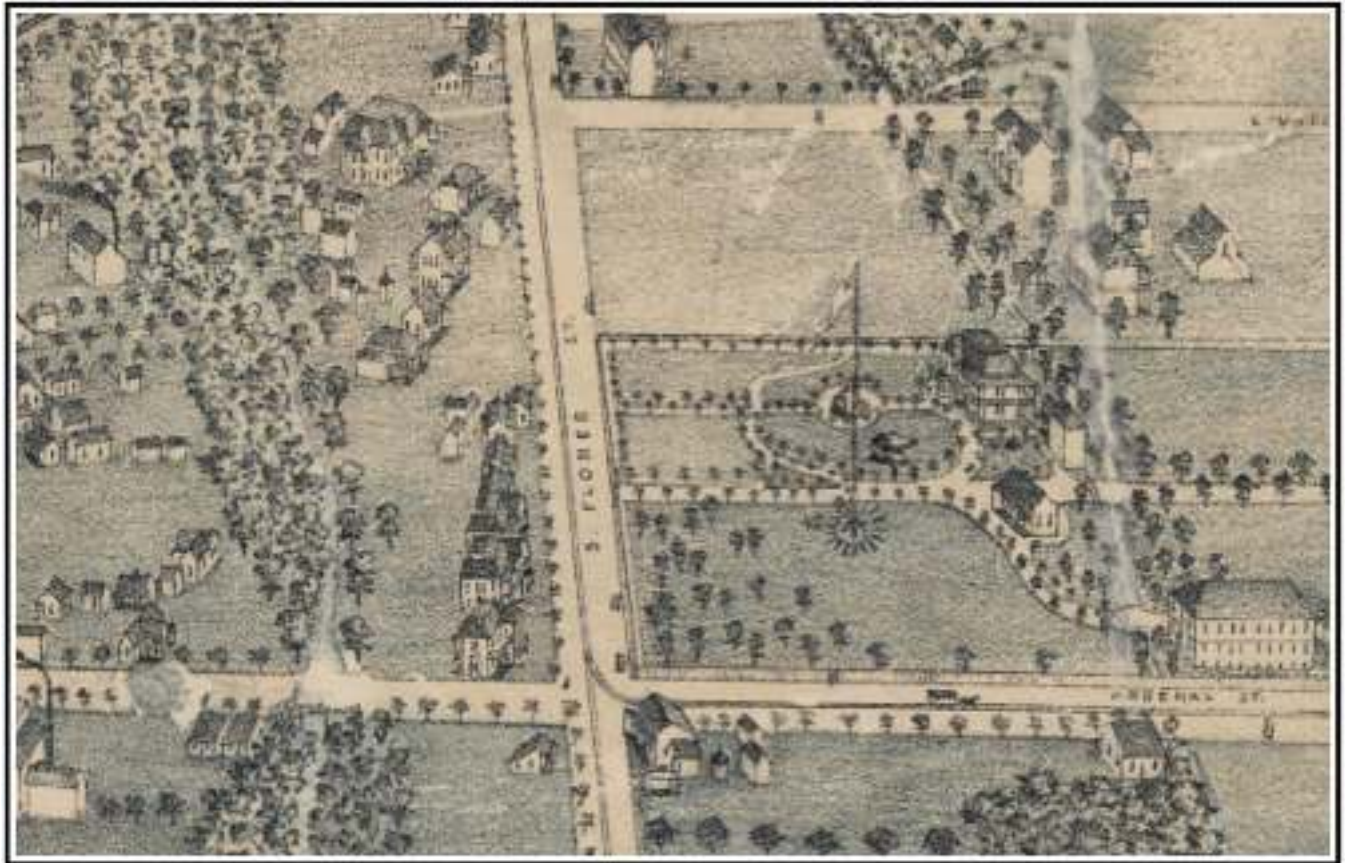
Figure 2-2. Detail of the 1886 Bird's Eye map of San Antonio, showing the Commander's House. Map faces northeast.

Another Bird’s Eye map of San Antonio drawn in 1886 shows that the balcony has been rebuilt on at least the visible sides of the house (Figure 2-2). A photograph, taken about 1888, shows the balconies, as well as the landscaping surrounding the building. Figure 2-2 clearly shows that the wing extending from the east side of the building had not been built at this time, though a bay window had been added on the ground floor room at the northwest corner of

Several references, in particular the web site of the Office of Historic Preservation (City of San Antonio 2010b), state that the house was completely rebuilt about 1883. However, the drawing of the building in the 1886 Bird’s Eye map (Figure 2-2) appears to show the same building as that seen in the 1873 Bird’s Eye map (Figure 2-1), with the exception of the bay window, including the double narrow windows at the north and south ends of the building. Note that these windows are clearly evident in a photograph taken about 1888 (Figure 2-3).

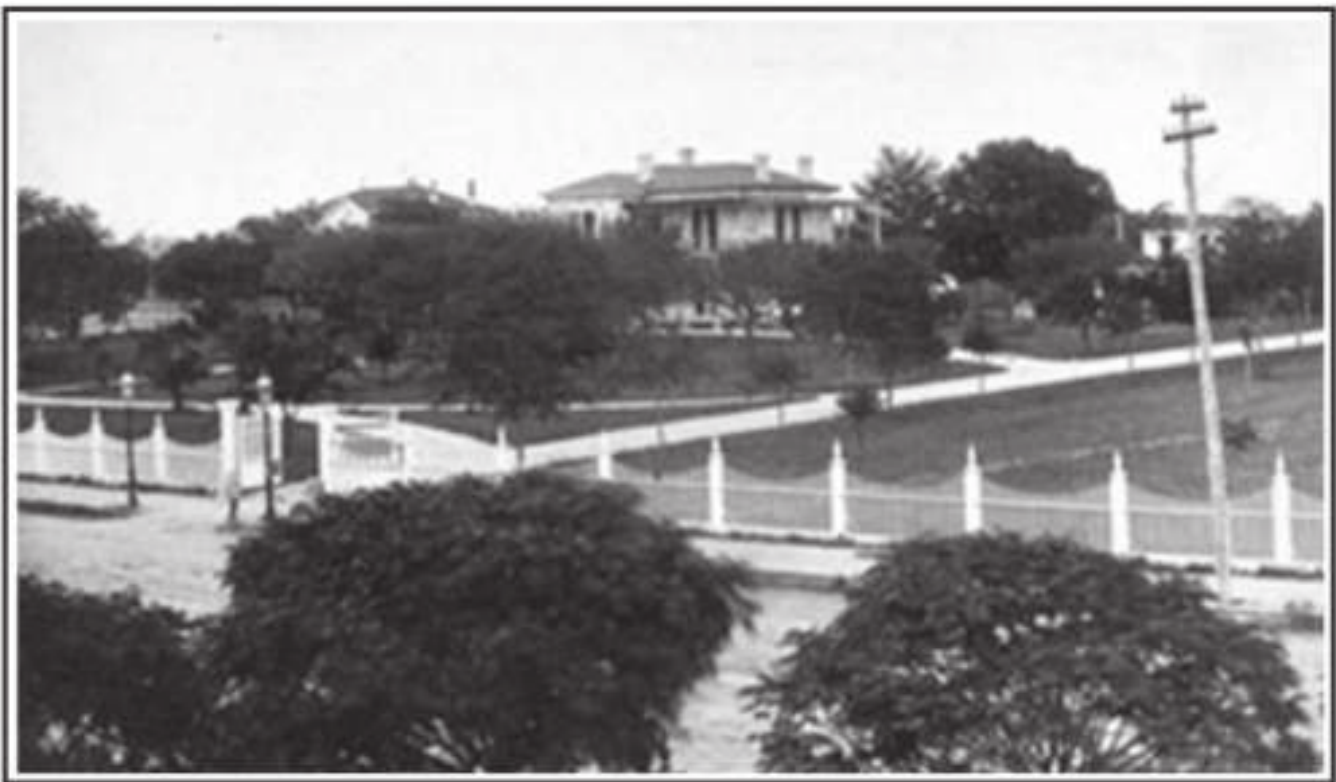
Figure 2-3. Photograph of the Commander’s House taken about 1888 (Photograph is in the collection of the Institute of Texan Cultures, #073-1684).

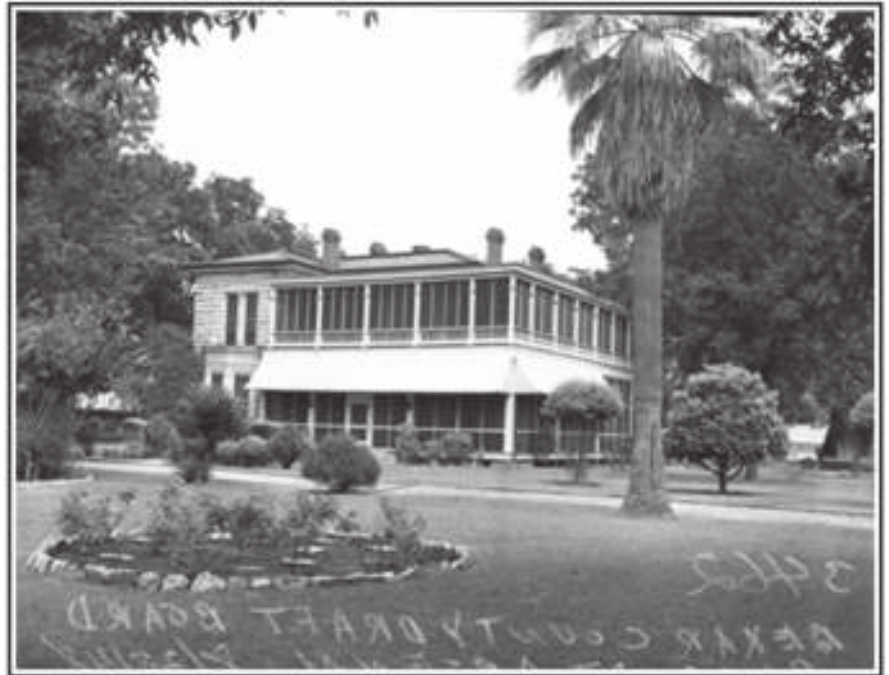
Figure 2-4. *Photograph of the Commanders House taken in 1948. Note that the balconies have been enclosed (Photograph is in the collection of the Institute of Texan Cultures, #L-6432-F).*

The year after the photograph in Figure 2-4 was taken in 1948, the Arsenal was closed, although the buildings were still used as office space by various federal departments. In 1968 these included: the General Services Administration, the Federal Housing Authority, the U.S. Department of Labor, the U.S. Sport Fisheries and Wildlife Agency, the U.S. Air Force Recruiting Station, the U.S. Army Recruiting Station, and the U.S. Army Corps of Engineers. In addition, the Texas National Guard used space at the Arsenal (Garner 1968:1).

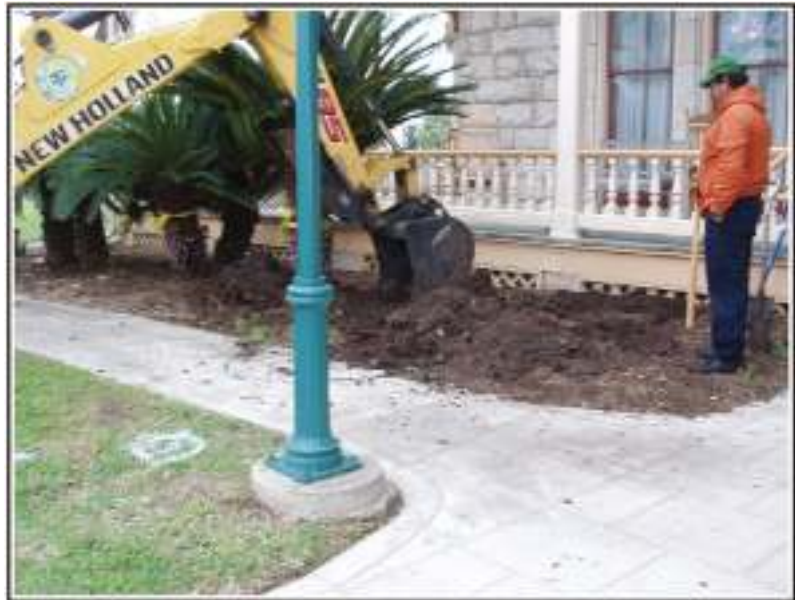
Two cycads and one palm were removed during the project. The palm was replanted in a side flowerbed (see location #7 in Figure 1-2). They were removed by digging around them enough to cut most of the roots and then pulling them free of the ground with a backhoe (Figure 3-1). No artifacts of any kind were observed during this operation, nor were any cultural features impacted.

Figure 3-1. Removing plantings from the front flower bed. The twin trunk of the final cycad to be removed is visible at the upper left of the photograph.

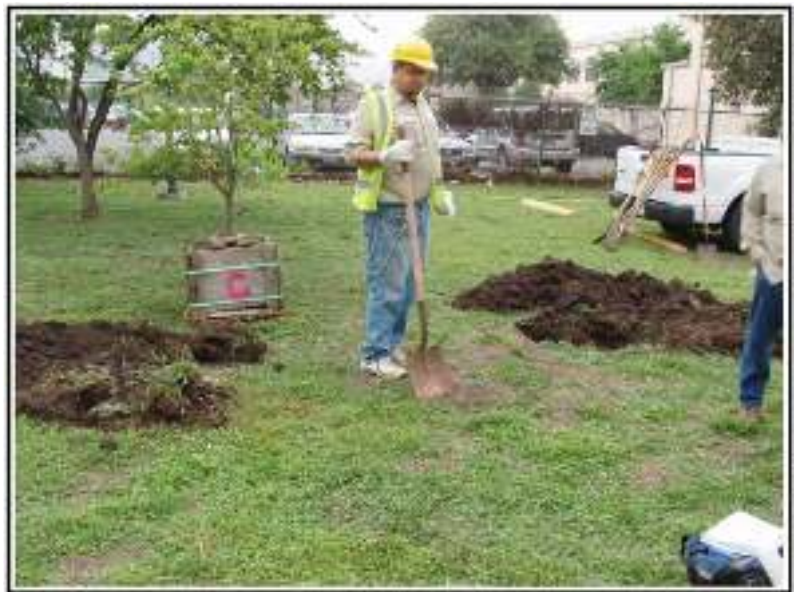
Hole #2 was dug to plant a Mexican Buckeye (*Ungnadia speciosa*) tree west of the northern parking lot (Figure 1-2). The original hole had to be abandoned when the backhoe struck a 2-inch PVC water line that fed the irrigation system (Figure 3-2). The final depth of the hole was 58 cm. The sediment was brown sandy clay loam with ca. 5 percent small

Figure 3-2. Moving Hole #2 after encountering an irrigation line. The final location is on the right. Facing North.

gravels until about 30 cm bs, below which reddish caliche and gravels were encountered. The matrix appeared to be fill derived from an old driveway. No cultural materials were observed.

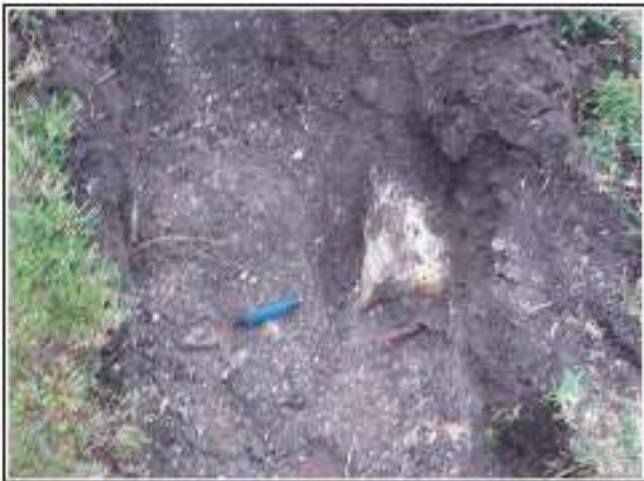
Hole #5 was dug in front of the house (though, as noted above, historically this would have been considered the back of the house) (Figure 1-2). The sediment in the original location of the hole, which was southeast of the stump of a dead palm, was medium brown sandy clay loam with ca. 5 percent small gravels. The percentage of gravel increased and numerous caliche nodules became apparent with increasing depth. At 45 cm bs, the excavation exposed a large limestone block. The block was very roughly shaped into a rectangle and was stacked onto another large rock (Figure 3-3).

To limit disturbing this apparent architectural feature, Feature 1, the upper limestone block was not uncovered completely. The exposed portion measured 23 cm by 31 cm. Its location was measured from the sidewalks found to its west and north (Figure 1-2). The corner of the stone was 2.97 m east of the north/south running sidewalk and 3.25 m south of the sidewalk running east/west. The hole that exposed the limestone block was backfilled without disturbing the stones.

The limestone blocks appear to be part of an architectural feature such as the corner of the foundation of a structure of some kind,

Figure3-3. Limestone block in Hole #5.

possibly an outbuilding or the footer for a wall. Given the location, behind the house as it was originally used, it is possible that it is the upper part of a stone-lined privy. However, as the purpose of the project was not to investigate this feature, it was simply recorded, and an alternate hole was excavated.

Cultural materials and/or features were encountered in only one hole, #5. This hole, located in front of the house, encountered two roughly trimmed limestone blocks set on top of each other (Figure 3-3). The feature appears to be part of a foundation although this cannot be determined with certainty unless and until a larger area is exposed in the future

The Commander's House, site 41BX351, represents an important part of San Antonio's history. It was originally built as the home of Doctor James M. Devine, three-time mayor of the city, and was later used as the home of the Commander of the U.S. Army Arsenal. In addition, the San Pedro Acequia (41BX337) runs through the eastern side of the property and a lateral of the acequia runs just north of the house. Because of the importance of this site and the associated acequia, we recommend that any future projects involving sub-surface disturbances in the park be assessed for their potential to disturb historic features and/or deposits. At a minimum, any project that requires disturbance of the ground within the park should be monitored by an archaeologist. If future opportunities arise, also we recommend that the nature of the stacked limestone blocks found in the vicinity of planting Hole #5 be more fully investigated.

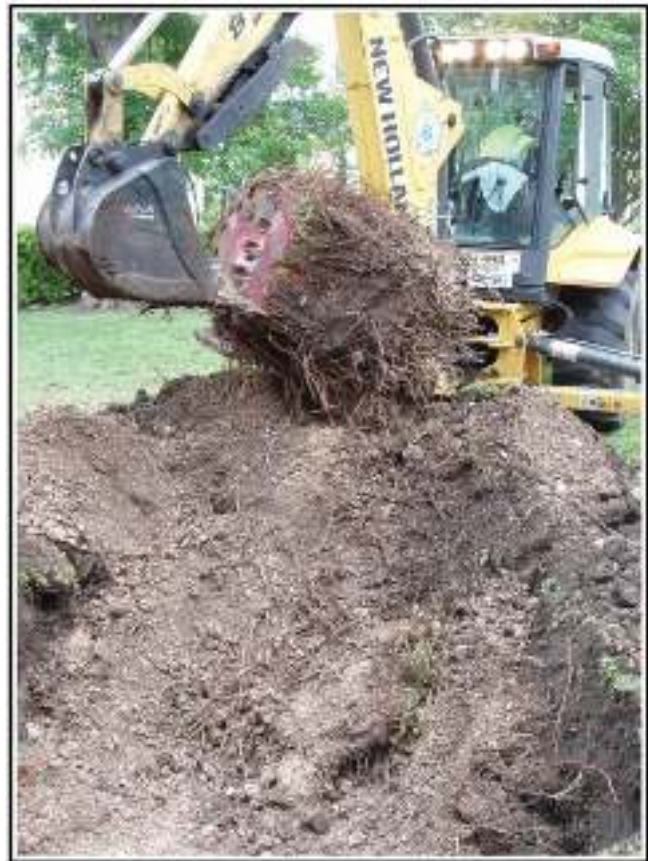
Hole #6 was dug in the southwestern part of the park (Figure 1-2). The removal of the stump required the digging of a much larger hole than the previous holes (Figure 3-4). The final hole measured 3.45 m by 3.95 m and was 1.25 m deep. The sediment was medium brown silty clay loam to about 60 cm bs and then changed to a much lighter gray very sandy clay with approximately 50 percent gravels most of which were 5 to 7 cm in maximum diameter. This layer continued to the bottom of the hole and appeared to be a natural sediment. No cultural materials were observed.

Figure3-4. Removal of palm stump prior to planting of new palm.
