Archaeological Assessment of Three Locations on the San Antonio River, San Antonio, Bexar County, Texas

SAAN-2010-SCI-0001
Texas Antiquities Permit No. 5622

Prepared by:
Center for Archaeological Research
The University of Texas at San Antonio
Technical Report, No. 23

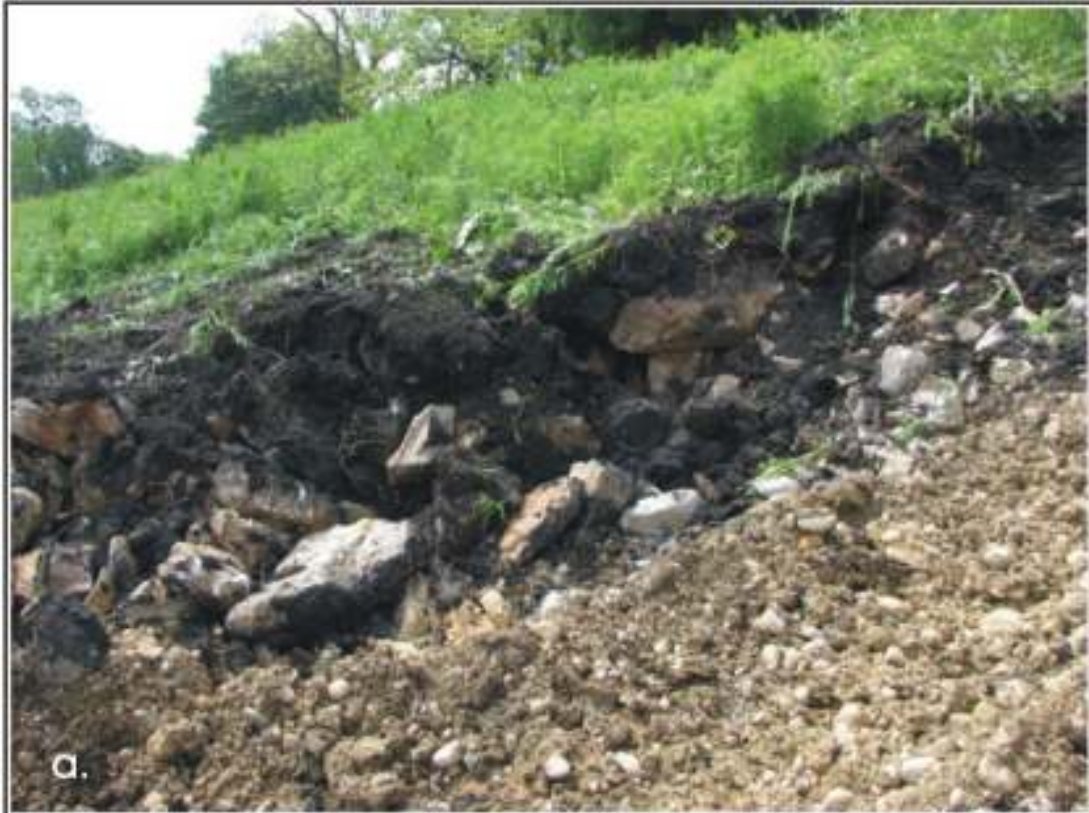
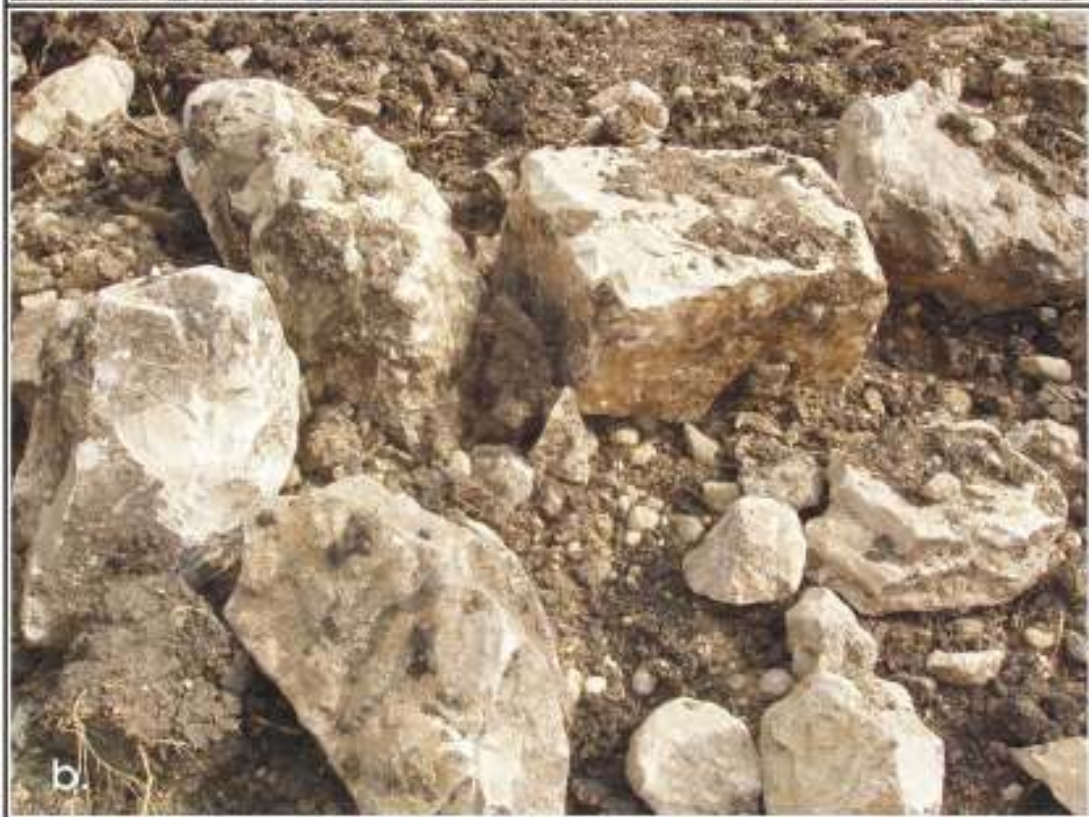
Figure 1-3. Possible area of San José Dam: a) overview of the area, showing large limestone rocks, facing southwest; b) close-up of limestone rocks that have been trimmed.

Some of these rocks appeared to be stacked (Figure 1-3a) and some were clearly trimmed (Figure 1-3b). As this area was near the known location of the Colonial Period San José Dam, constructed to divert water into the San José Acequia (Figure 1-4), there was concern that the construction had uncovered a remnant of the dam.

Three BHTs were dug in Area 1. No evidence of a remnant of the San José Dam was encountered. All sediment in the three trenches was fill. The large limestone rocks observed in Area 1 were determined to be placed during the rechannelization to prevent erosion of the lower banks during flood events.

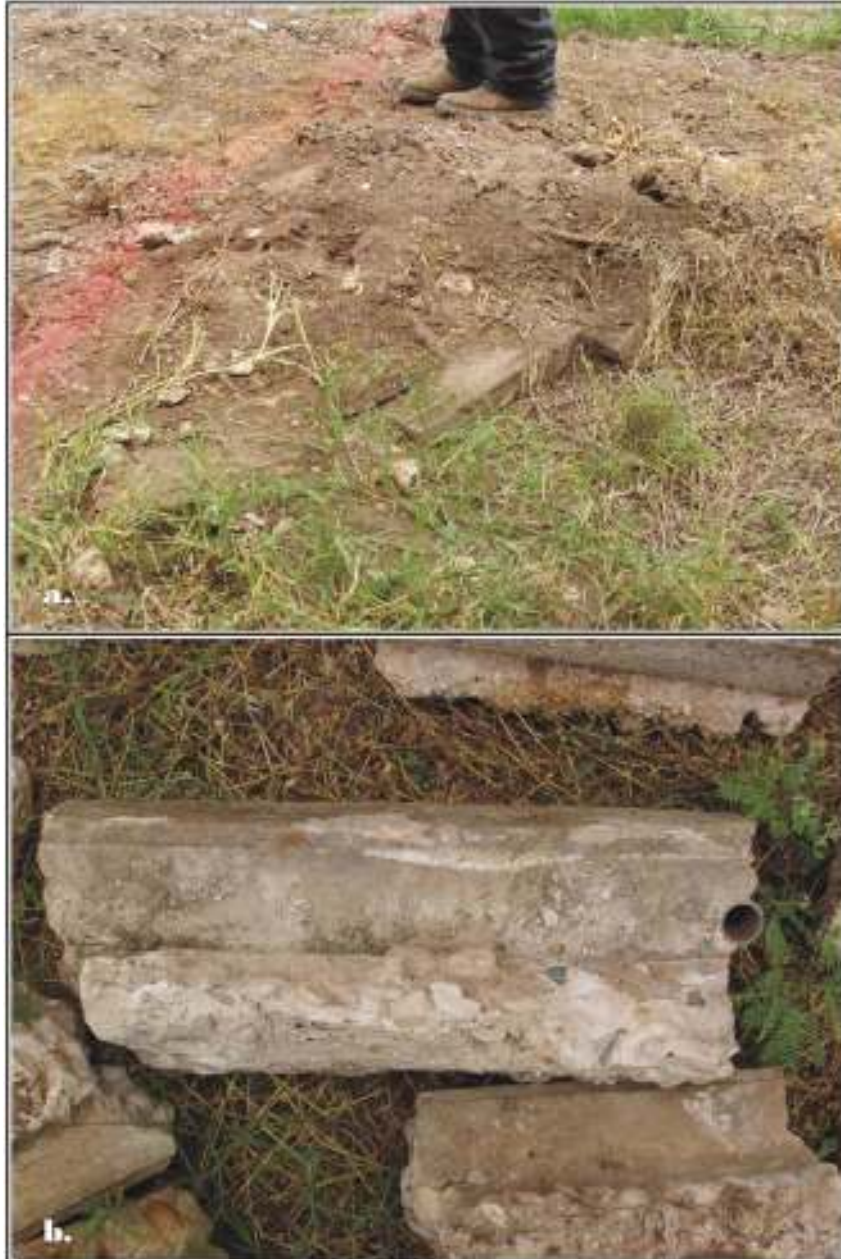
In April 2010, City Archaeologist Kay Hinds was notified by a concerned citizen that a group of concrete curb-like pieces were present on the rechannelized river bank, near the presumed location of the Poor Family Cemetery. These “curbs” appeared to be out of place, apparently disturbed when the area was mechanically cleared of vegetation (Figure 1-7a); however, the characteristics of the concrete, and the overall shape of the curbing (Figure 1-7b) suggested that these may not have been street curbs and were reminiscent of the concrete curbs sometimes placed around grave sites in the 1920–1940s, usually to hold marble or limestone chips as part of a decoration of the gravesite (K. Hinds, personal communication 2010). The location of the Poor Family Cemetery nearby made the finding of these curbs a matter of concern, even though maps indicated that this area was at or very near the original river course that had been filled in during the river rechannelization project (Figure 1-6).

Figure 1-7. Concrete "curbs" found near Poor Family Cemetery; a) "curbs" as they were facing south. (Note: red paint on ground on left side of photograph indicates location of Trench 3); b) "curbs" after they had been moved aside before trenching began.

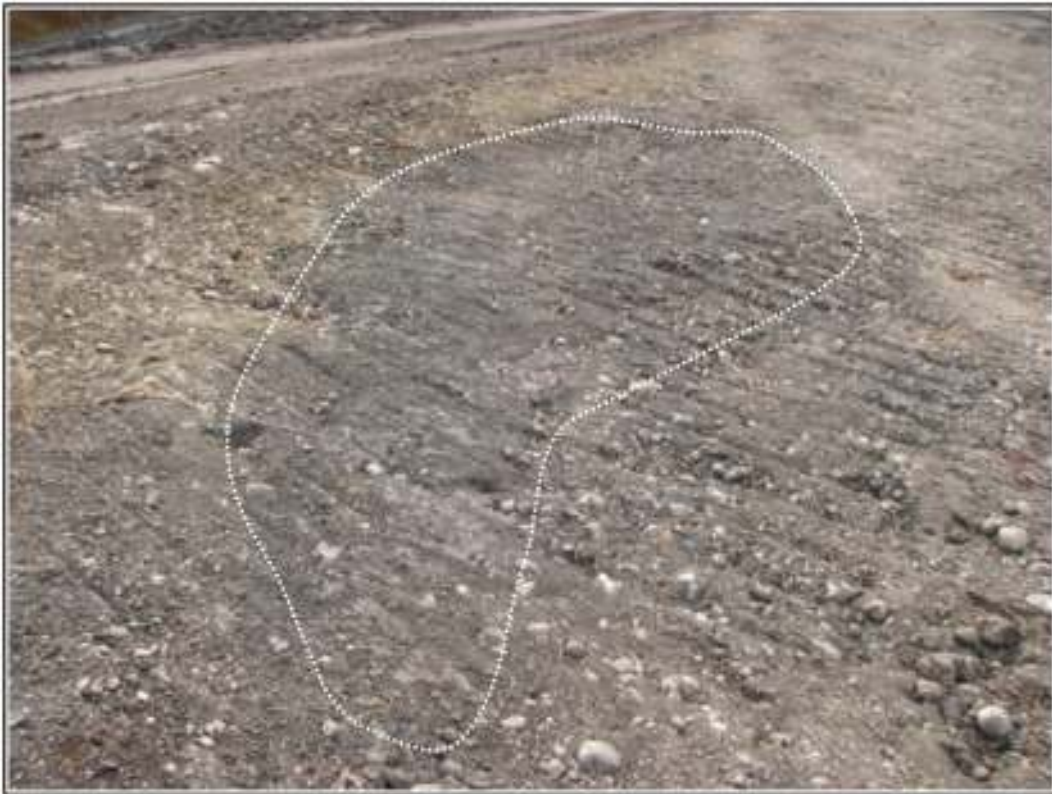
In April 2010, while visiting the area where preliminary grading of the rechannelized riverbank between Mission Road and Theo Avenue was underway, City Archaeologist Kay Hinds noted an area south of Concepción Park (see Figure 1-2) where she observed a few prehistoric artifacts and fragments of burned rocks, in what appeared to be an organically enriched sediment that had been graded to build a temporary construction road along the river (Figure 1-8).

Figure 1-8. Location where burned rock and chert artifacts were noted on the disturbed surface in Area 3. Facing south-southeast.

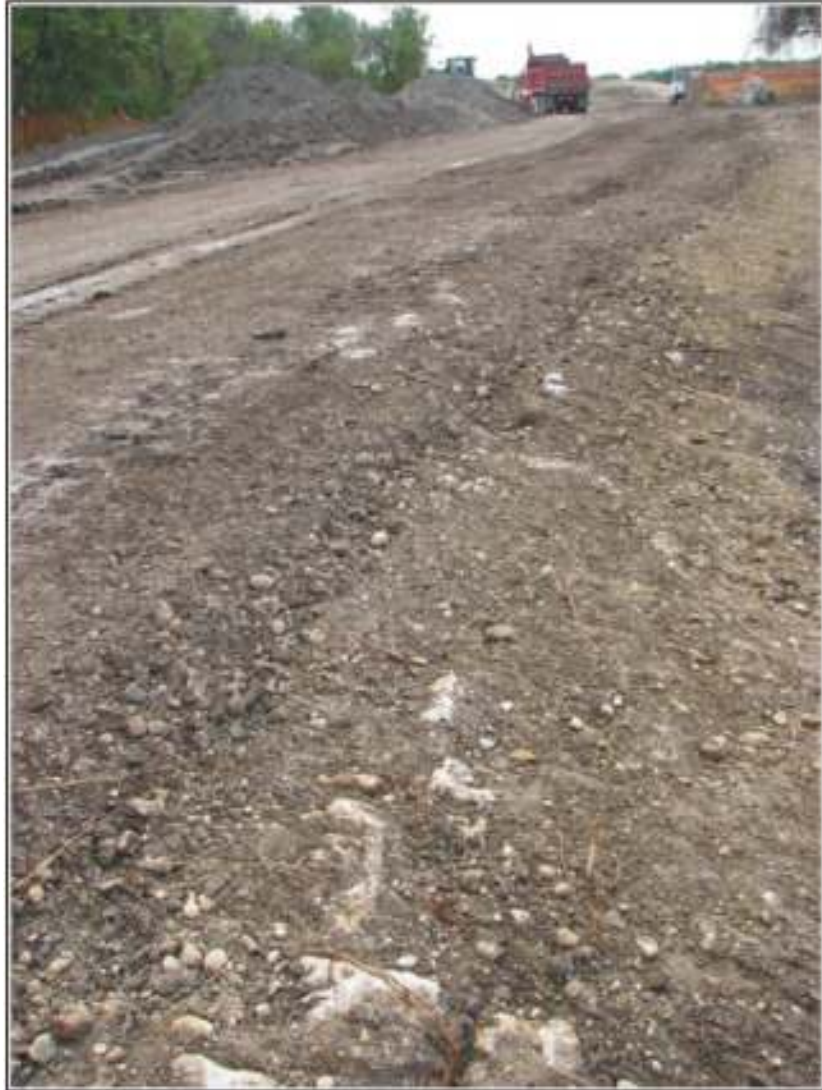
In addition, she observed an apparent alignment of large limestone rocks (Figure 1-9). Only the tops of the rocks were exposed by the grading of the bank to create a passable road surface for heavy construction equipment.

Figure 1-9. Possible rock alignment on east bank of San Antonio River in Area 3, as originally seen, facing southeast.

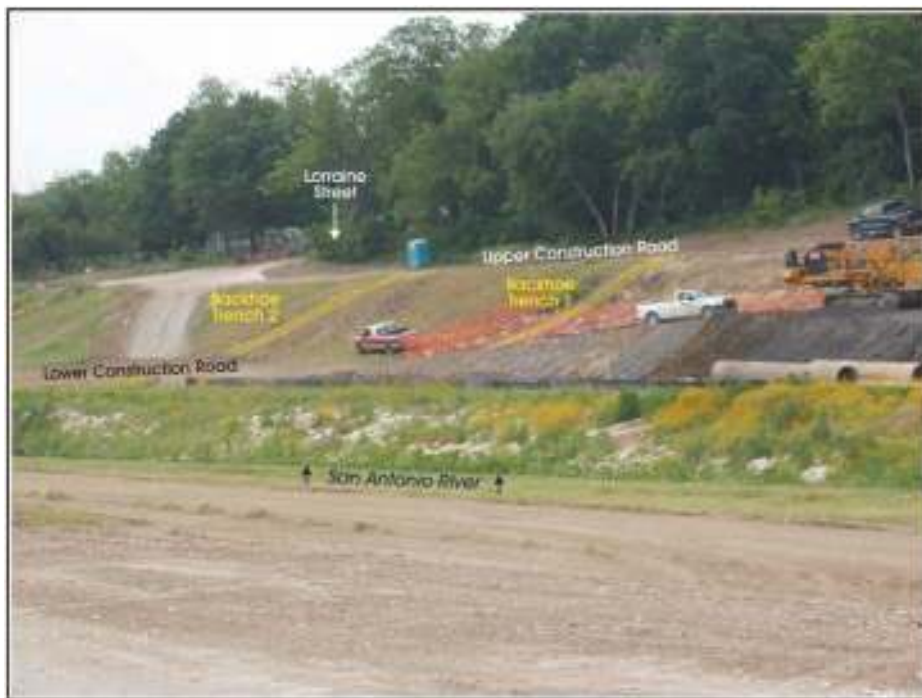
The river bank at Area 1 had already been modified to a limited extent by the construction of two dirt roads: one near the top of the river embankment and a second not far above the level of the river. The latter sometimes climbed higher on the embankment, as can be seen in Figure 3-1. Some cases involved three dirt roads.

Figure 3-1. Area 1, seen from across the river, after Trenches 1 and 2 had been backfilled. Note the two levels of construction roads. The San Antonio River; not visible in this photograph, runs just below the line of concrete and limestone crossing the middle of the picture. Facing south-southeast.

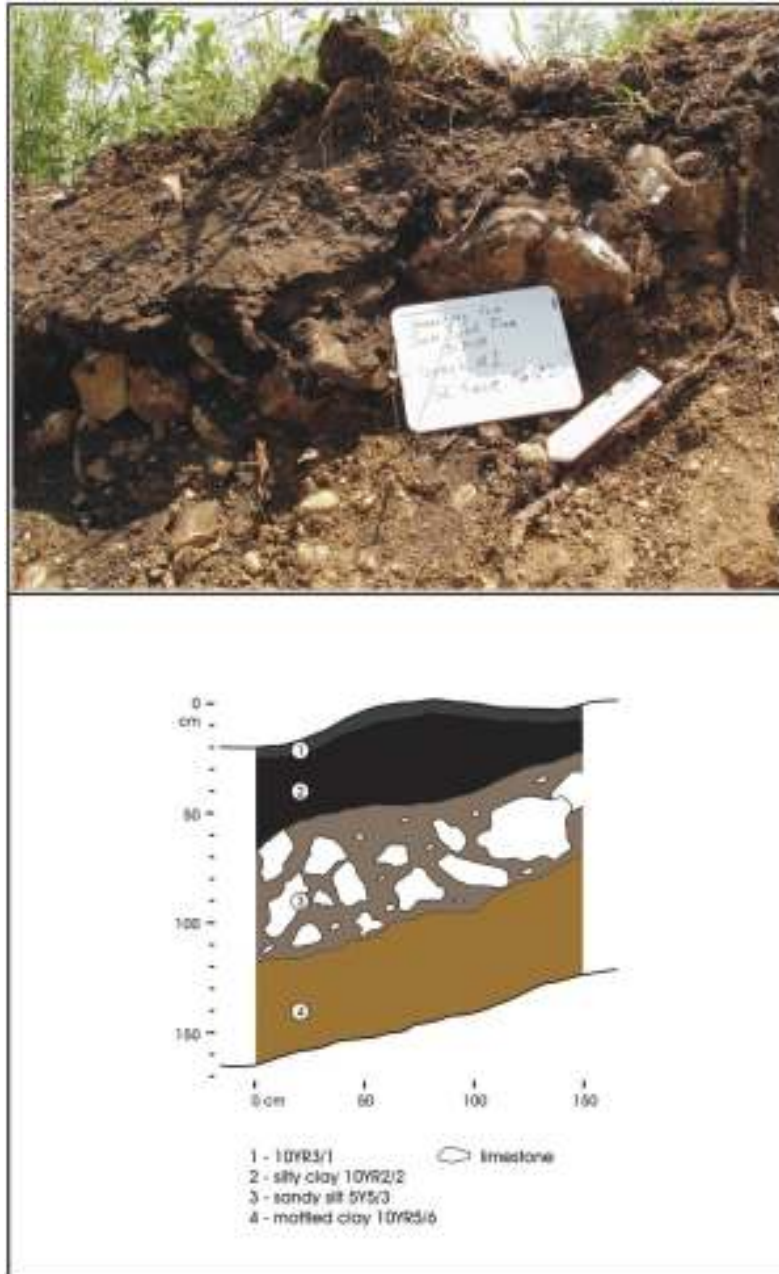
BHT 1 was dug about 2 m north of, and parallel to, the line of limestone rocks uncovered during grading of the river bank. It began at the edge of the upper construction road and was dug to the edge of the plastic fencing seen in Figure 2-1, just above the lower construction road (see also Figure 3-1a). Figure 3-2 shows the upper segment of the south wall of BHT 1.

Figure 3-2. South wall of Trench 1: a) photograph, and b) profile of upper part of trench.

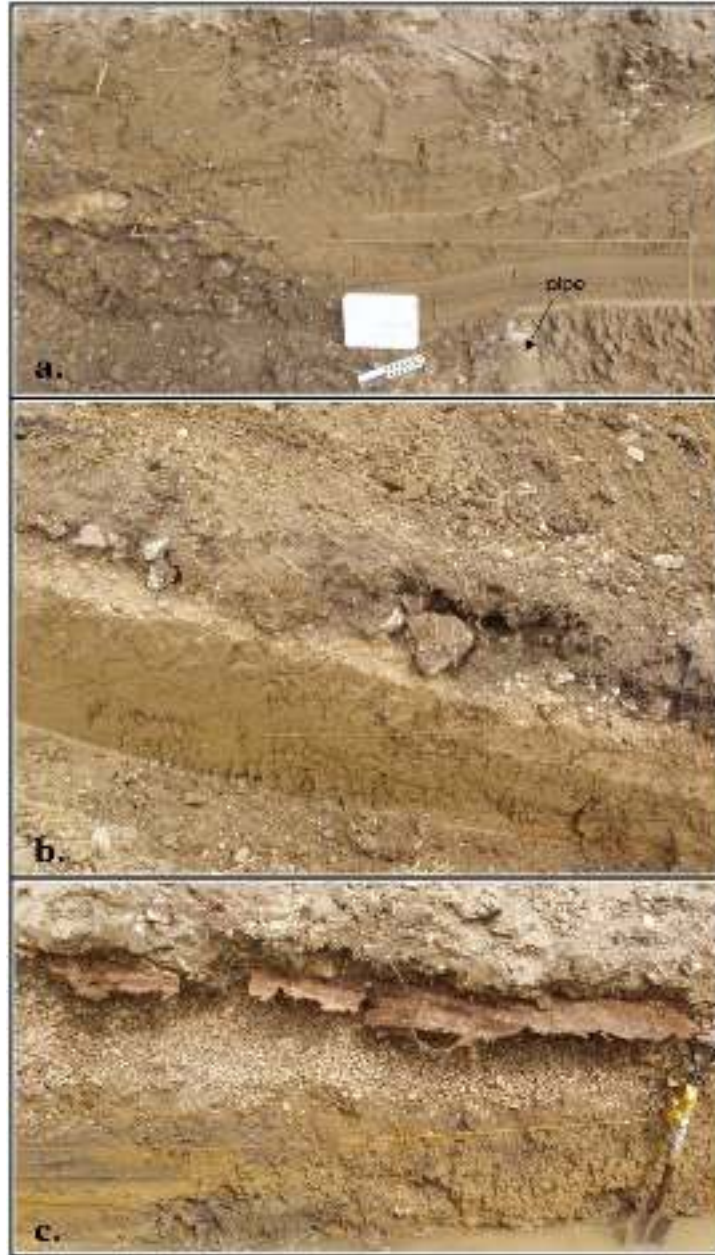
Although there was some variation in the nature of the sediments seen in BHTs 1 and 2, both trenches showed that approximately one-third down the slope from the upper construction road there was a layer of large rock and occasional large chunks of concrete placed on the slope. This was clearly seen during excavation of the trenches and in the profiles.

Figure 3-3. The north wall of Trench 2; a) west end of trench, under upper road; b) middle section with large rocks; c) trench under lower road

The three trenches excavated to examine the sediments in this area have demonstrated that the entire river bank in this area has been constructed by shaping fill into the steeply sloped embankment. The upper and lower portions of the embankment are protected from erosion during flood events by a layer of large limestone and concrete riprap. No evidence of any remaining portion of the San José Dam was observed.

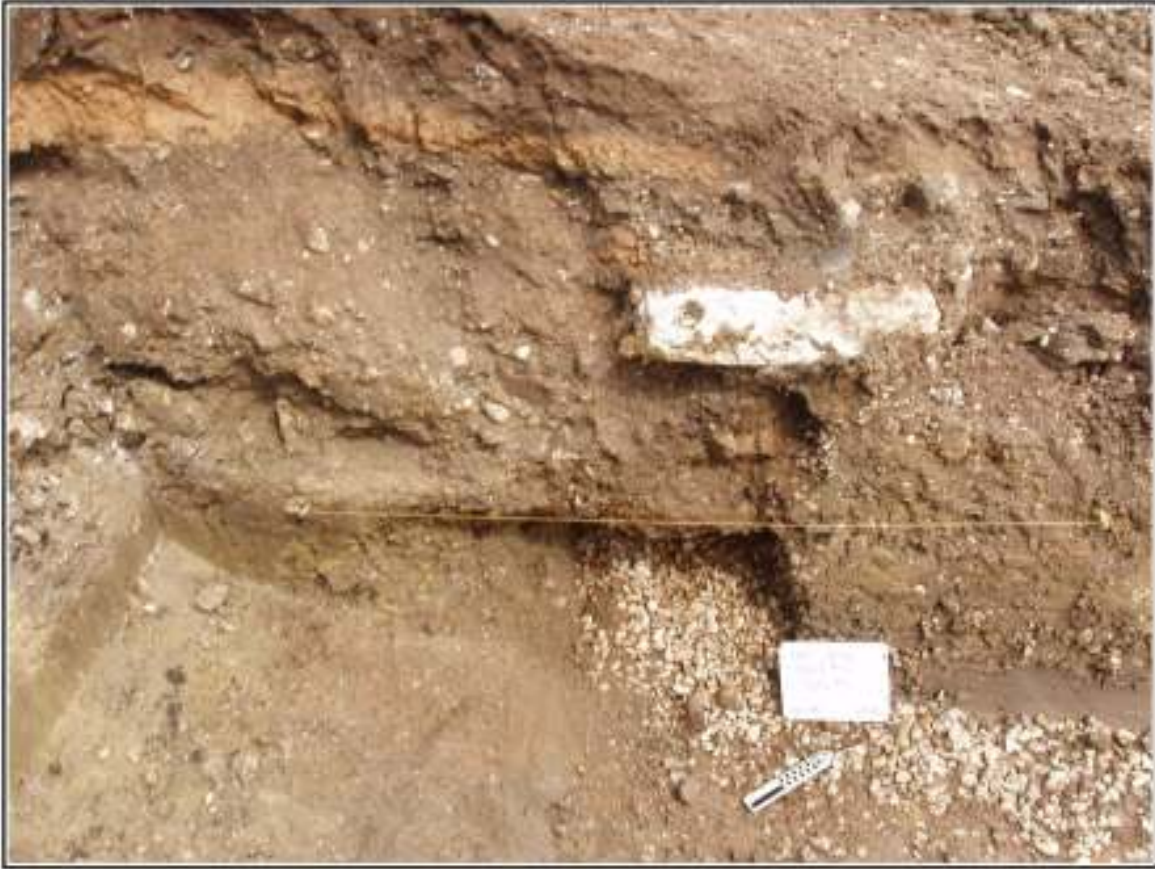
BHT 5 was dug in order to determine if the slope of the river bank above the upper construction road was also fill. The trench was only 3.5 m long. The entire profile was fill material. Figure 3-4 is a photograph of a portion of the south wall of BHT 5, showing multiple layers of fill, large concrete slabs, and a pocket of gravel.

Figure 3-4. South wall of Trench 5 in Area 1. Note disturbed deposits.

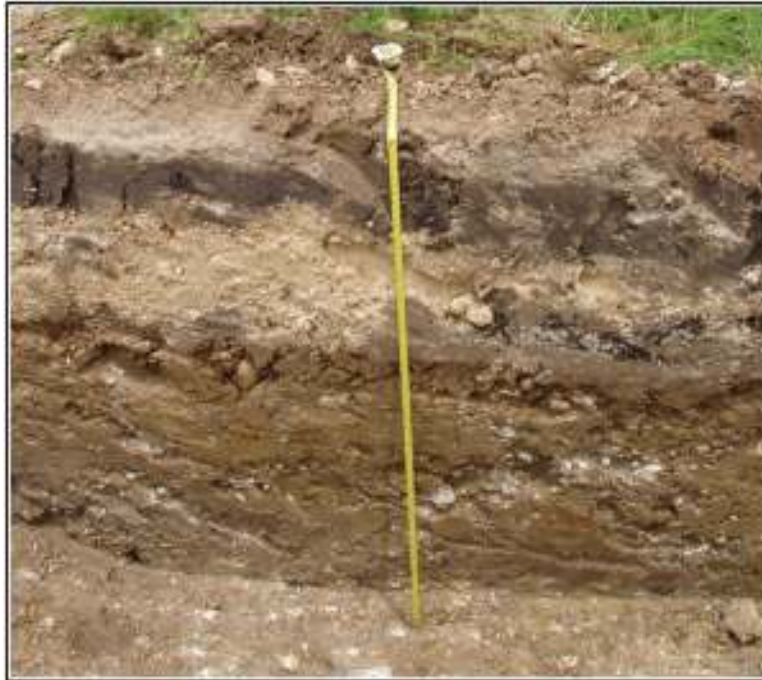
BHT 3 was dug immediately adjacent to one area where the concrete curbs had been seen (Figure 1-7a). The southern part of BHT 3 was dug to a depth of 1.8 m (6 ft.). Figure 3-5 shows a photograph of this part of the trench. All sediments were either clays not seen in natural soils in the area, mixtures of gravels in sandy clay loams, or caliche, all typical fill materials. This part of the trench was backfilled and the northern half was dug the next day.

Figure 3-5. East wall of the south half of Trench 3, showing layers of fill to 1.8 m below surface.

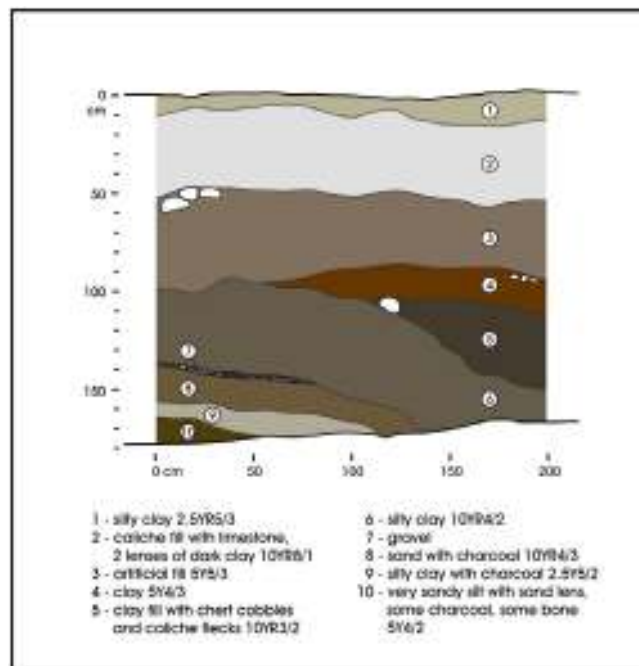
Figure 3-6 shows the profile of the east wall of BHT 3, exhibiting the various layers of fill. The sandy clay loam in the bottom layers of the northern part of the trench may be natural sediments, the result of over-bank flooding near the old river channel.

Figure 3-6. Profile of the east wall of Trench 3.

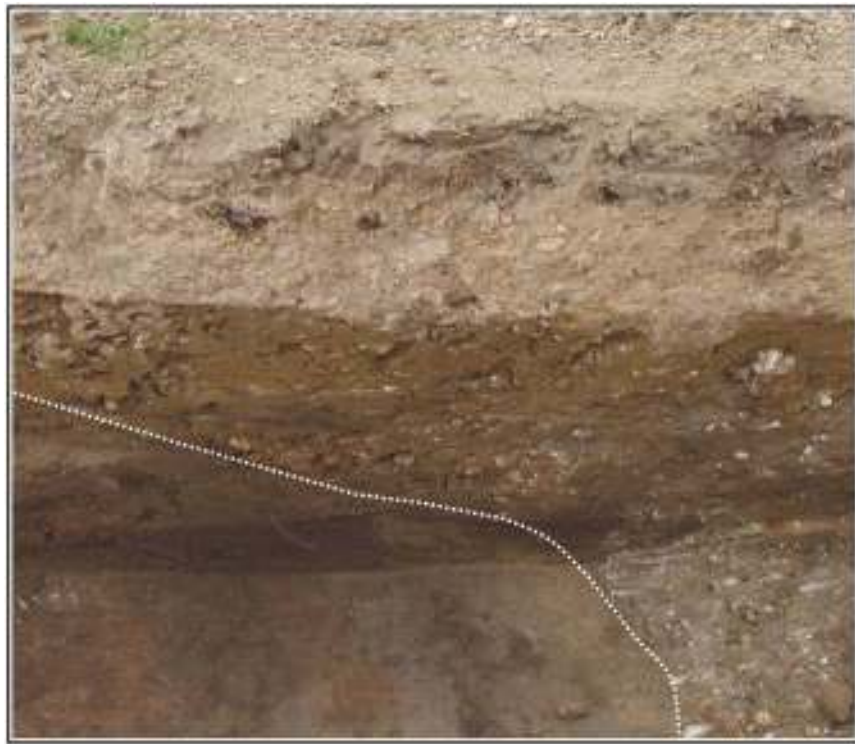
These layers contained scatters of charcoal as well as sparse artifacts, all of which appeared to be modern or historic, dating back to no later than the last quarter of the nineteenth century. Each was isolated, unrelated to the others. A piece of copper wire, two pieces of barbed wire and the distal end of the femur of a cow or bison, along with other bone fragments, were recovered from the lowest two levels of BHT 3. One piece of the barbed wire is identifiable as a variation of Patent #176,120, April 11, 1876 (Devil's Rope Museum 2007). The other was too rusted to be identified. The copper wire is a pulled wire; therefore, it almost certainly arrived in San Antonio after trains began to bring manufactured goods into San Antonio in the late 1870s. These artifacts were located in the walls of the trench ranging in depths from 138 to 170 cm. Figure 3-7 shows the slope of the sandy clay loams that may be natural sediments with the layers of fill seen in Figure 3-6 above them. These materials do not seem to be part of a trash midden since they are sparse and lack concentration.

Figure 3-7. East wall of Trench 3. White line marks sloping sediments with layers of fill above them.

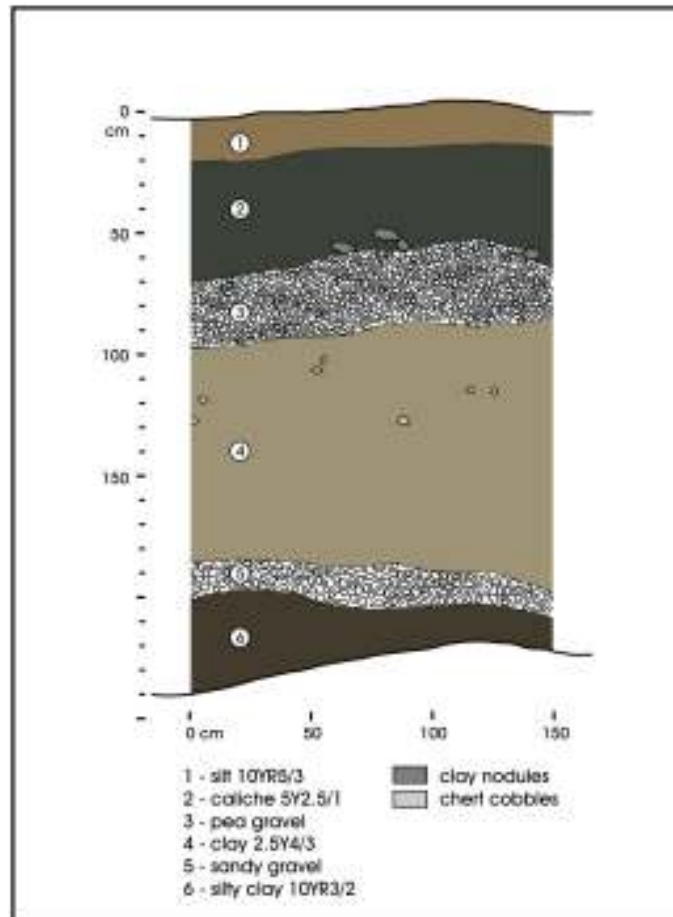
BHT 4 was dug approximately 6 m west of BHT 3, originally to a depth of 1.9 m. In BHT 4, only the northern-most part of the trench showed any sign of the sandy clay loam seen in parts of BHT 3 that may have been natural sediments (Figure 3-8). The remainder of BHT 4 contained the same kinds of fill seen in BHT 3.

Figure 3-8. East wall of Trench 4, showing layers of fill (Zones 1-4) above natural deposits.

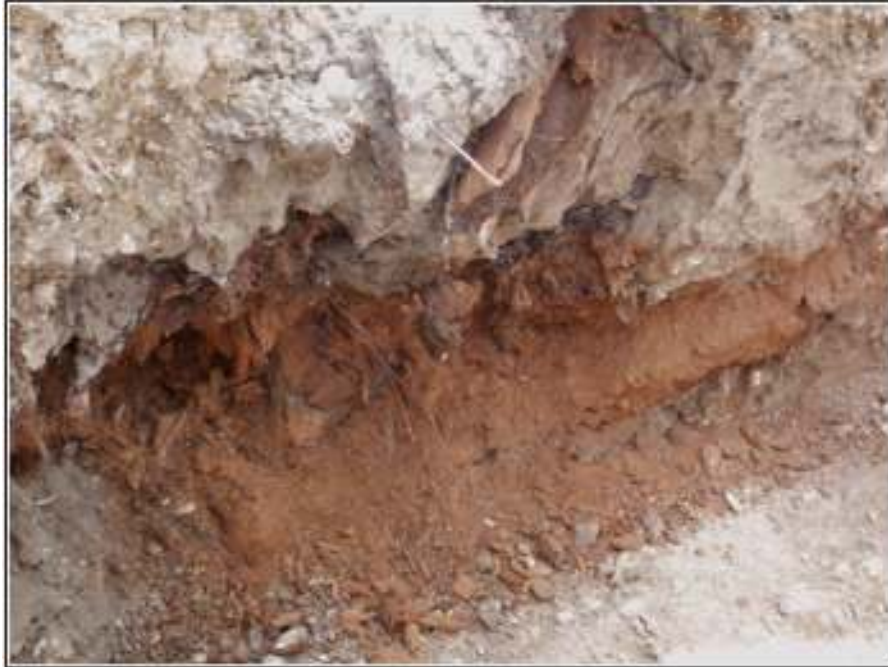
To verify that this part of the riverbank was part of the old river course that had been filled during rechannelization, the southern third of BHT 4 was dug to 3.1 m (10 ft). The layers of fill continued to that depth, and contained the remains of several tree trunks (Figure 3-9).

Figure 3-9. The west wall of Trench 4, showing several tree trunks buried in the fill at a depth of 3.8 m.

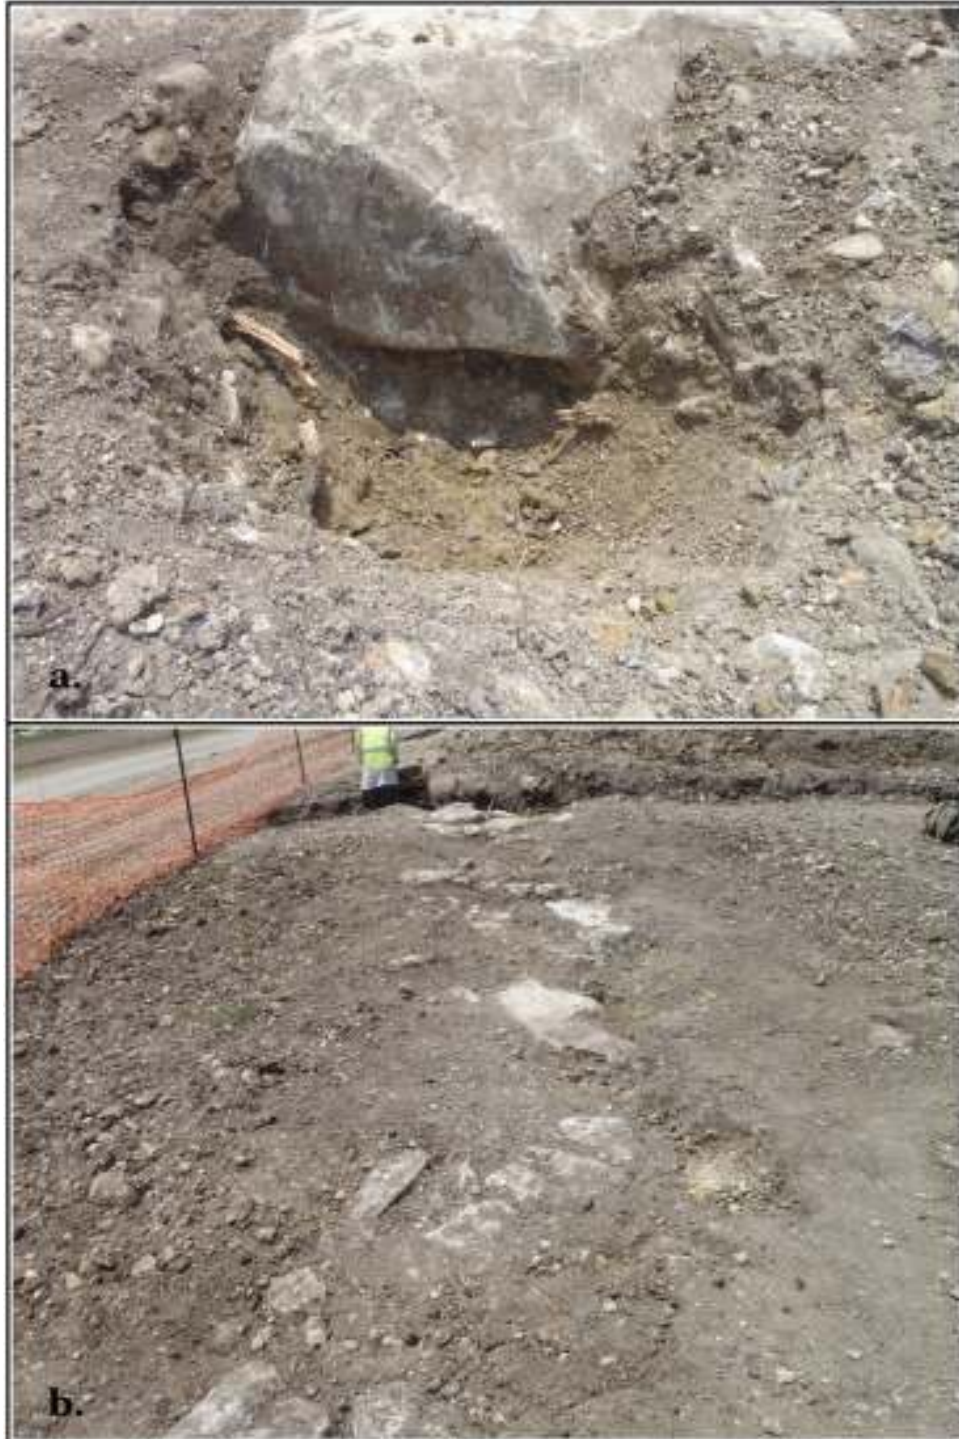
historic structure. The stones were cleared with hand tools enough to show that they were not stacked but instead formed a single layer (Figure 3-12a). Furthermore, it appeared that they were only roughly aligned along the edge of the rechannelized river embankment (Figure 3-12b).

Figure 3-12. The limestone rocks in Area 3: a) single layer of rocks; b) view of cleared rocks, showing they are only roughly aligned.

Two BHTs were dug in Area 3. The two chert artifacts recovered from the ground surface were associated with a layer of sandy clay loam that overlay several meters of fill material and do not represent an *in situ* prehistoric site. The rock alignment noted nearby was determined to be the top of the layer of rock riprap placed on the slope below Area 3 to retard erosion during flood events.

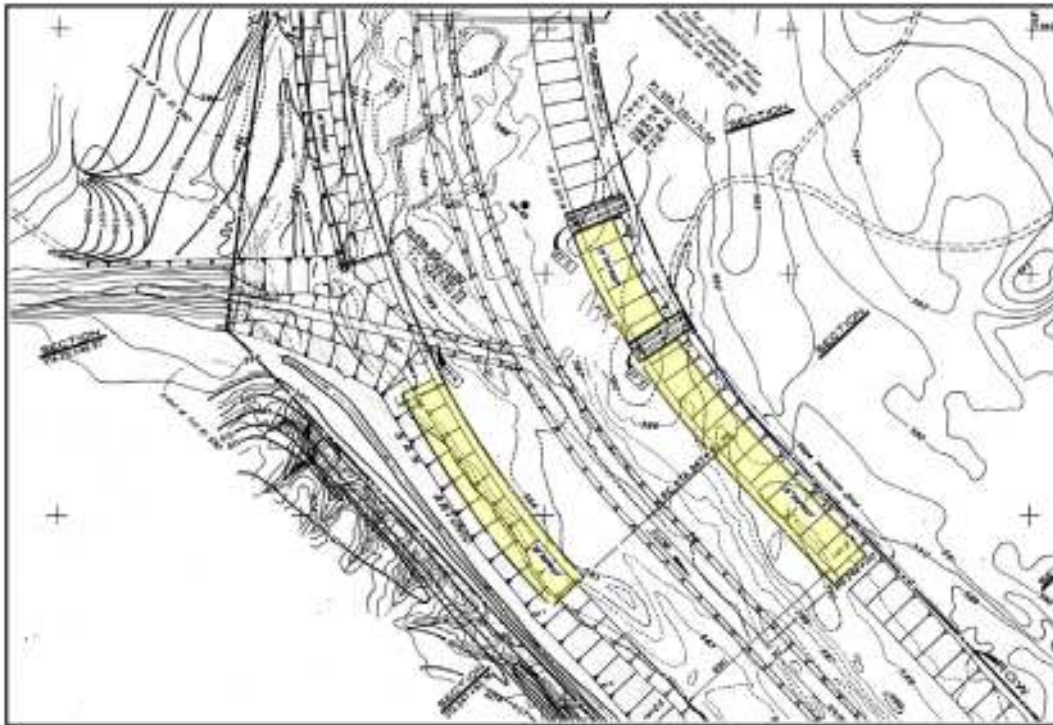
We did not determine how far up the bank of the river these rocks extended. However, examination of the detailed schematic sheet of the original channel improvement project shows that riprap was to be placed along the upper part of the new river embankment (Figure 3-13) at this location. The limestone shown in Figure 3-13 appears to be part of that riprap.

Figure 3-13. Detail plan for Area 3, from original plans for rechannelization of the river. Note reference to riprap along embankment walls (U.S. Army Corps of Engineers, Ft. Worth District, San Antonio River Channel Improvements Detail Plan, Sheet 27.2, 1957).

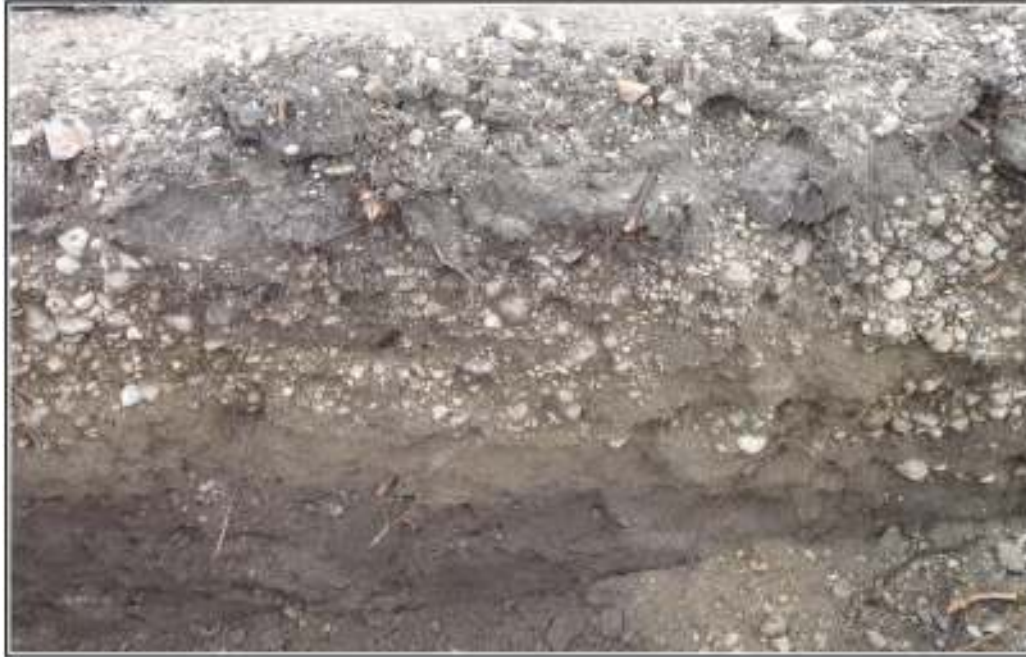
BHT 6 was 8.6 m long and 1.4 m deep. The uppermost layer of silty clay loam in which the prehistoric artifacts and burned rock had been observed on the surface was found to vary in thickness from about 3 cm to 20 cm, and overlay a series of layers of gravel, and other fill (Figure 3-14).

Figure 3-14. South wall of Trench 6 in Area 3. Note gray clay layer at bottom of trench.

Not surprisingly, descriptions of the profiles from BHTs E and L (Meissner et al. 2007:58) are very similar to the profiles shown in Figure 3-14 and 3-15. It should be noted that BHTs E and L were 1.7 m and 3.5 m deep respectively and that the mix of gravel and sandy clay seen in the lower part of the profiles of both BHTs 6 and 7 continued to the bottom of the older trenches.

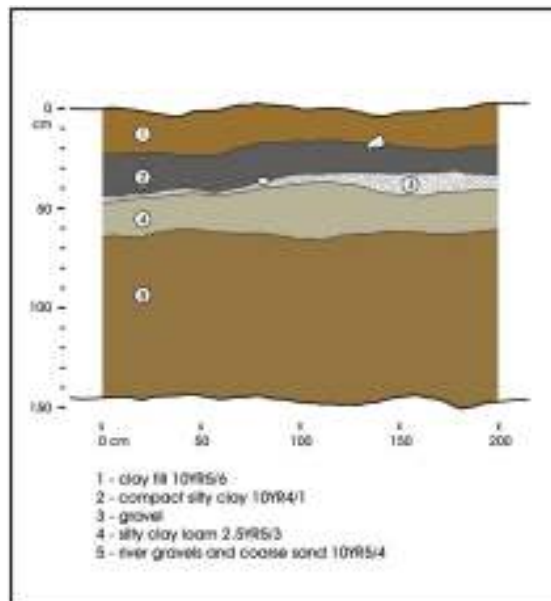
BHT 7 was placed approximately 6 m north of BHT 6 and was 9.2 m long and 1.45 m deep. Figure 3-15 shows a profile drawing of a portion of the north wall of the trench. Note that though BHTs 6 and 7 are quite close together, the profiles are somewhat different. The layer of silty clay loam that contained the artifacts found on the surface near BHT 6 is beneath a layer of reddish clay fill in BHT 7.

Figure 3-15. North wall of Trench 7 in Area 3.

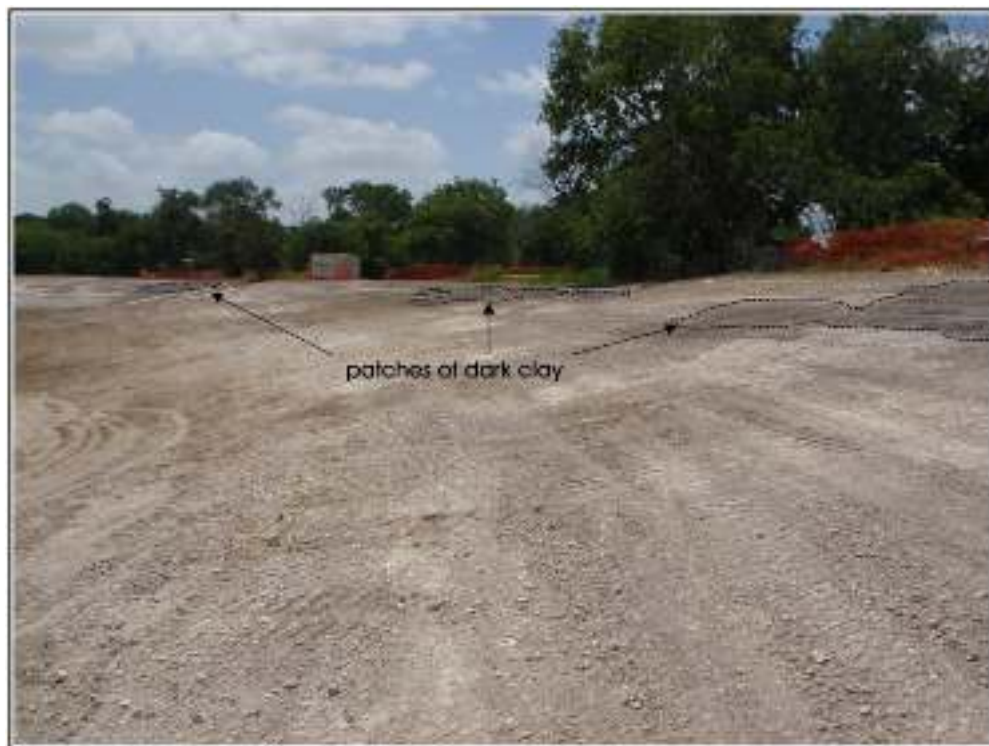
The association of the two lithic tools and few fragments of burned rock with the clay loam present on the surface is a strong indication of the fact that these artifacts were likely introduced to the location. However, this did not explain the presence of a layer of matrix that appeared to be organically enriched in the area. It is this dark gray deposit that is seen at the base of BHT 6 in Figure 3-14 and would suggest that there was an archaeological deposit in the area. However, no artifacts were noted upon careful examination of the gray layer in the bottom of either trench. Later examination of other graded portions of the river bank allowed us to identify several patches of dark gray deposits (Figure 3-16).

Figure 3-16. *Patches of dark clay soils exposed along west bank of river just south of Lorraine Street. These are natural deposits and contain no cultural materials.*
