**Architecture Assessment of the Condition of
Rooms 1, 2 and 3 at Rancho de las Cabras
(41WN30), Wilson County, Texas**

by
Kristi M. Ulrich

Prepared by:
Center for Archaeological Research
The University of Texas at San Antonio
Technical Report, No. 24

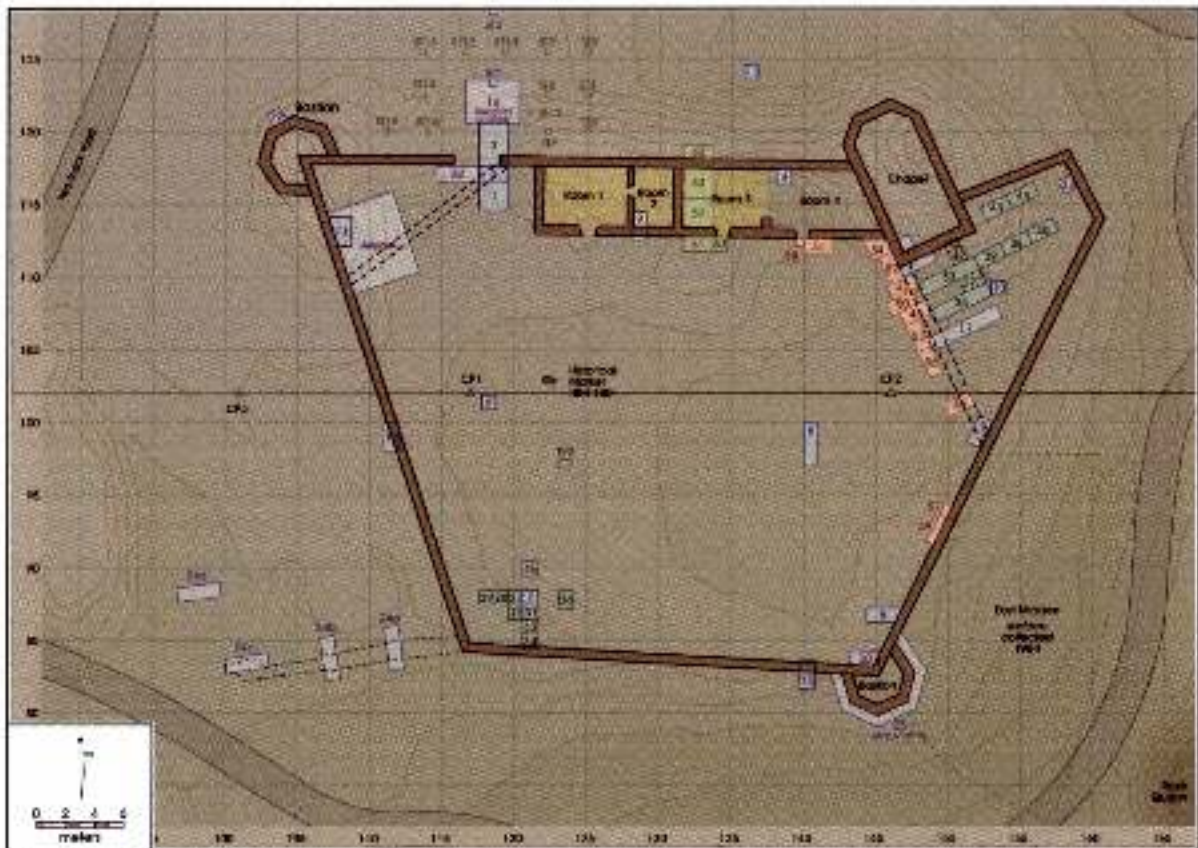
Figure 2. Rancho de las Cabras compound.

The purpose of the project was to uncover the walls of Rooms 1, 2 and 3 of the Rancho compound that were buried since 1985 (Figure 2) and assess and document their condition. Following the architectural assessment of the walls, they were to be covered by geo-fabric and sterile sand. The fabric was to be used to prevent the accumulation of sand in crevices, as well as keep sand from lying directly on top of the wall, and make for easier removal should the walls need to be uncovered in the future. The original plans called for the treatment of the sand with herbicide and the establishment of a vegetation cover on top of the sand to reduce the loss of sand caused by rainfall and windy conditions.

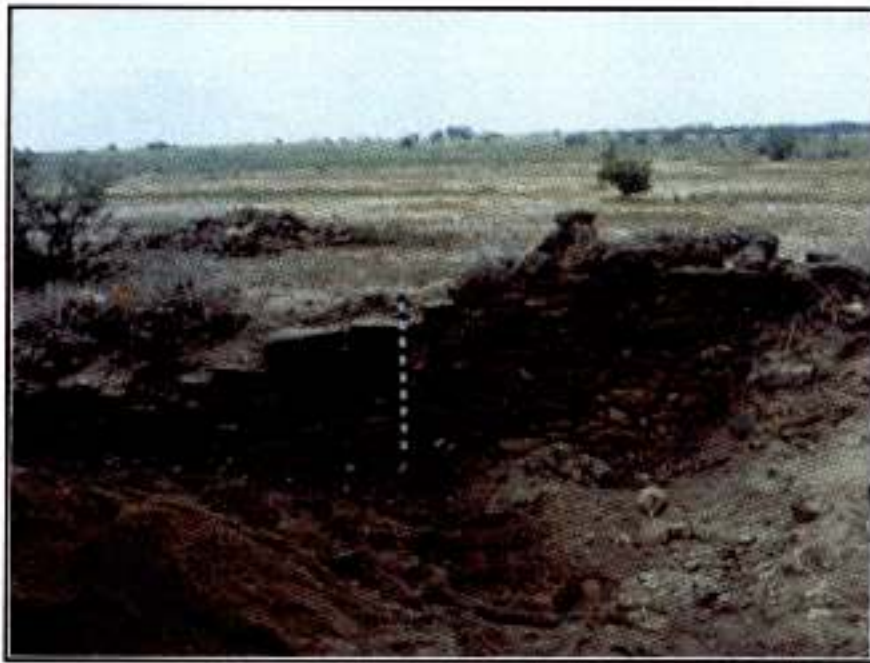
Figure 4. North wall of Room 3. View shows the lack of vegetation in the 1980s.

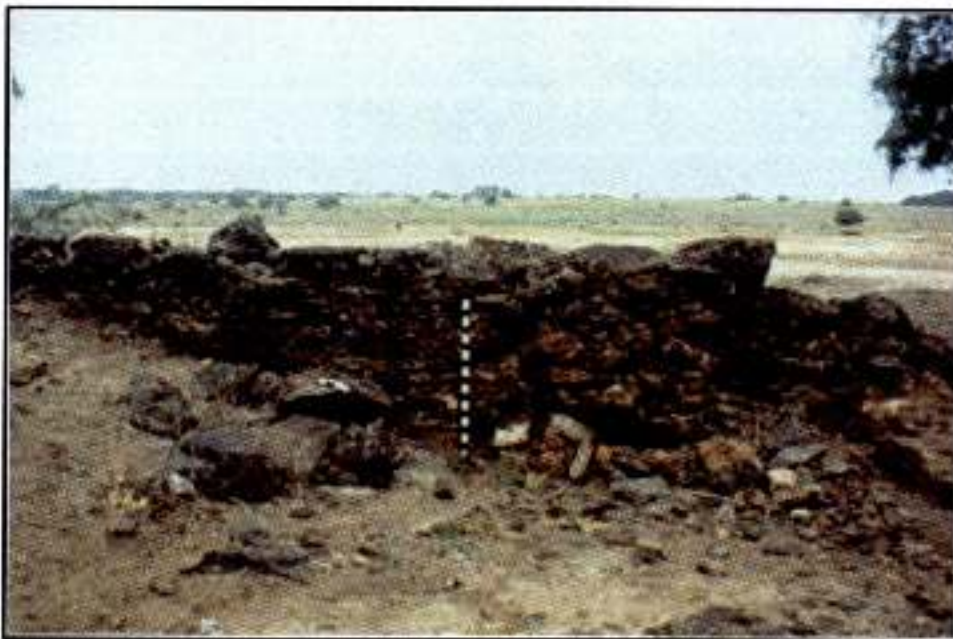
Figure 6. *View of the north wall, facing north, that shows the open pasture to the north of the site (Room 1).*

During the early stages of the sand removal, the outline of the west wall of Room 1 was noted. The river sand appeared to have ended just on top of the wall. The sand was removed, leaving the soil with increase clay content. The wall outline was at ground level. The north wall of Room 1 was approximately 98 cm at its highest point on the exterior of the wall and 123 cm in height on the interior of the room. A depressed area was noted on the inside of Room 1 near the western wall of the room. This depression was interpreted as a looter's pit during the 1985 excavations. The North wall of Room 1 was 42 cm at its lowest point on the outside of the wall. The 1985 map showed "looters' pits" immediately adjacent to the north wall on the inside. Excavations continued into the other rooms, though it was noted that a lot of soil appeared to have built up in the northeast corner of Room 1. This may be due to the screening that occurred within the rooms which was evident in the pictures taken in the 1980s with backdirt piles in the rooms (Figure 10 and 11). When compared to the older photographs, the north wall appeared to have been more exposed in 1985.

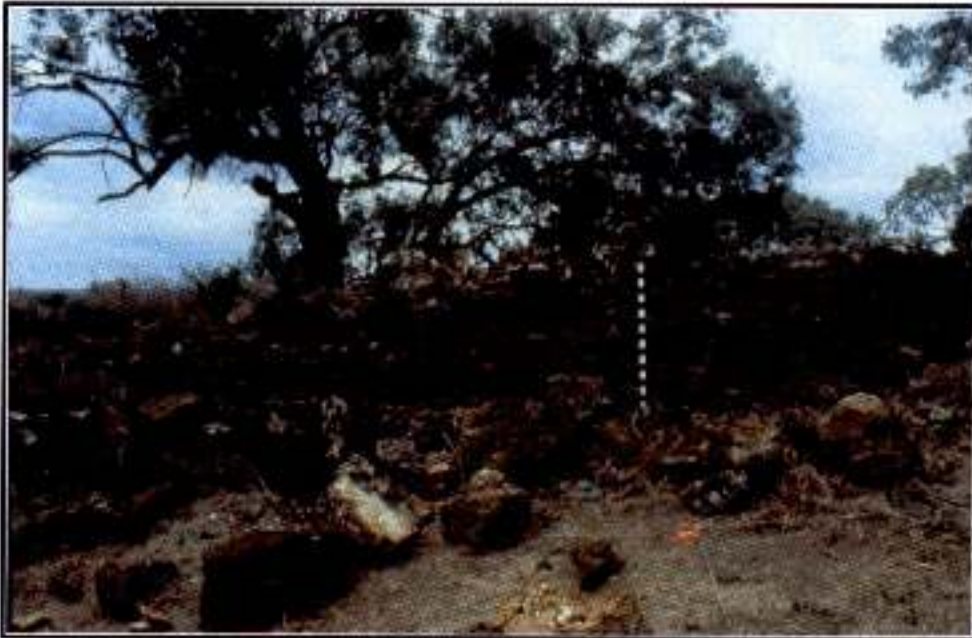
Figure 7. The north side of the north wall of Room 1 taken during the 1980s, facing south.

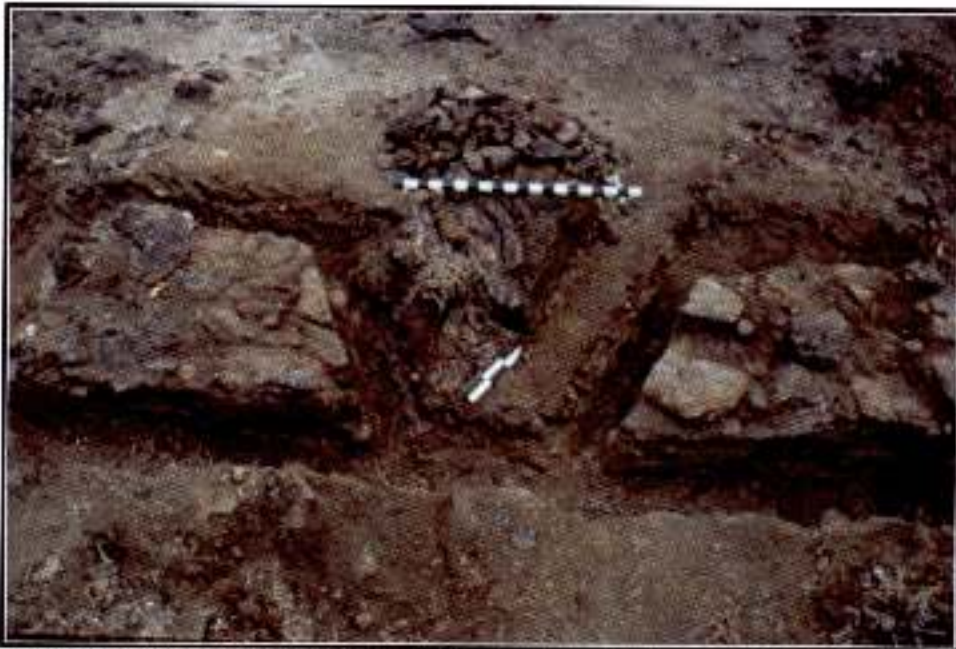
Figure 8. *The south wall and door opening to Room 1. Photograph taken during the 1980s.*

During the removal of the sand in Room 1, the doorway in the south wall was not well defined (Figure 15) compared to how well it is shown in the 1985 photographs (Figure 8). A section of the south wall close to Room 2 appears to be missing at this point, though photos from 1985 show it as intact then.

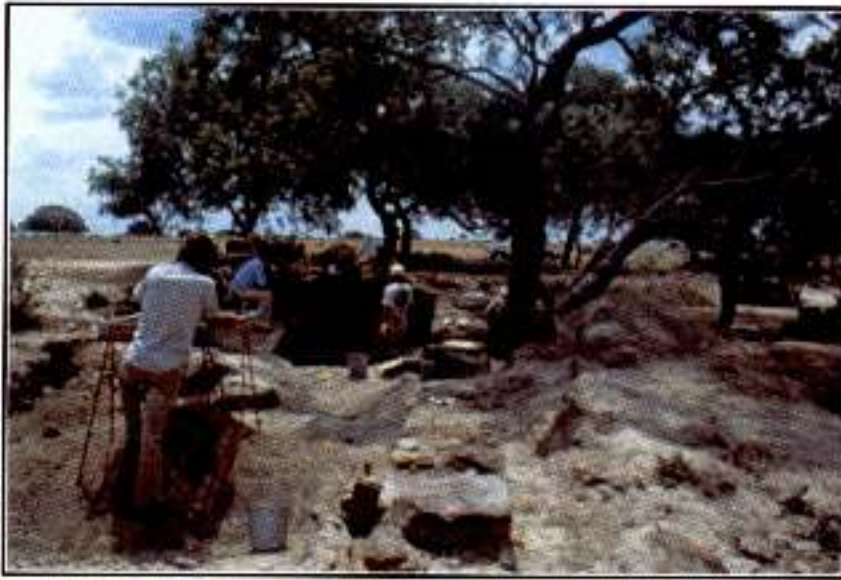
Figure 11. *View of the excavations within Room 3 with screening occurring in Room 4, facing west.*

Slides of the 1985 excavations reveal that the archaeologists were screening within the rooms as well (Figures 10 and 11). Notes do not indicate where the screened dirt was deposited after excavations were over but the photographs suggest that the dirt was simply used to backfill the excavated units.

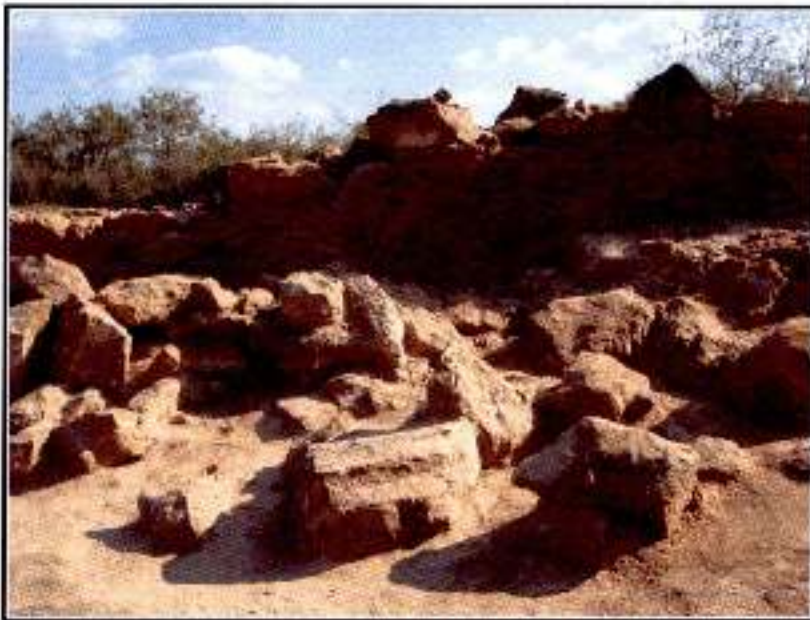
Removal of the sand on the first day began near the doorway in the north wall just west of Room 1 (Figure 2) since the break in the wall was clearly visible and it provided a known starting point. The removal of the sand began on the outside (north) of the north wall and within hours shifted to the inside as to maintain even amounts of sand on both sides of the wall. Along the outside of the wall, a few stones were already exposed on the surface due to natural erosion. These stones provided the starting point and a guide as to how much sand needed to be removed. As the sand was being removed, it became evident that there was a lot of wall fall on both the exterior and the interior of the compound (Figures 12 and 13). Sand was carefully removed from between the wall fall stones. The wall fall was sitting directly on the original ground surface.

Figure 12. *The wall fall present along the north side of the north wall between Rooms 1 and 2, facing south.*

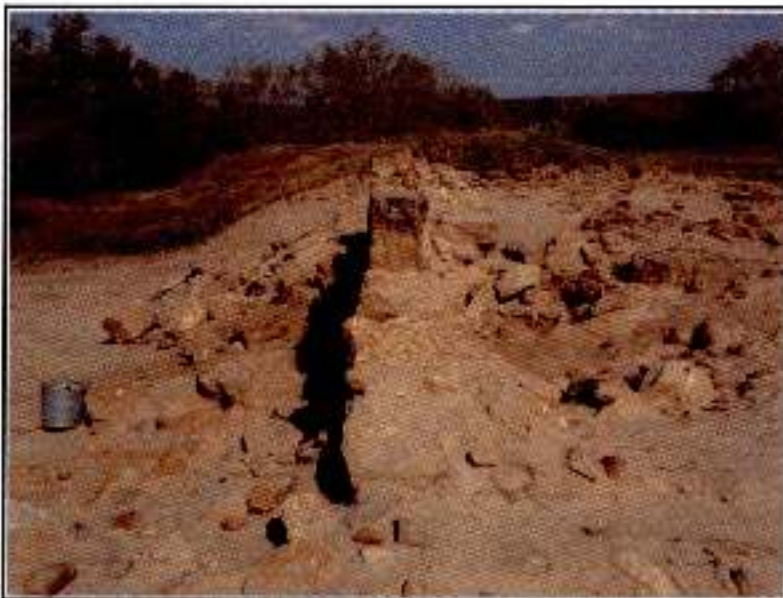
Figure 13. *View of the wall fall on the either side of the north wall in Room 1, facing east.*

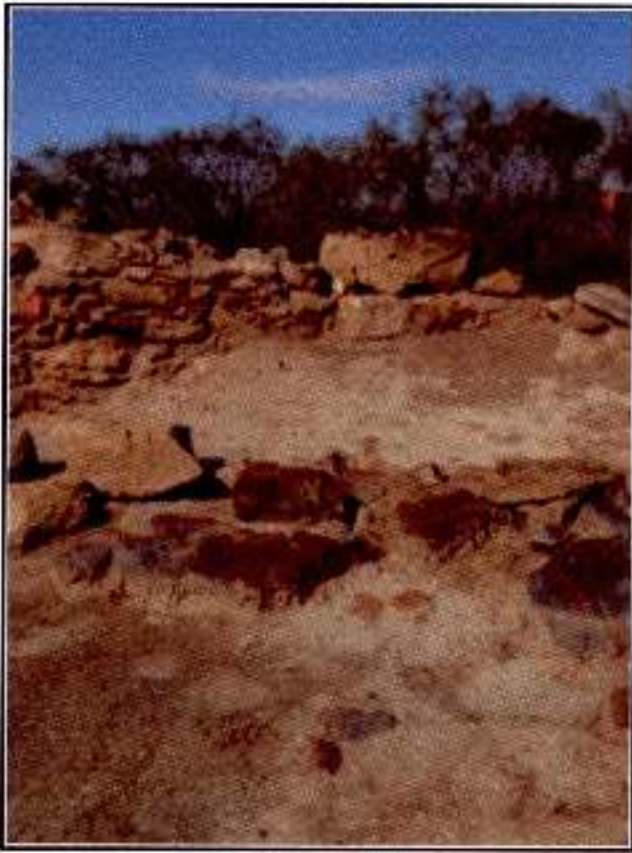
A distinct soil change was noted that made it easy to distinguish between the sand fill and the 1985 surface. While the introduced fill consisted of clean light colored sand (see Figure 14), the substrate also was sandy but it retained a noticeable clay component and was dark gray in color (see Figure 14) and therefore it could be distinguished both visually and by feel (texture).

Figure 14. *Light sand fill on top of dark gray sandy clay representing original 1985 ground surface.*

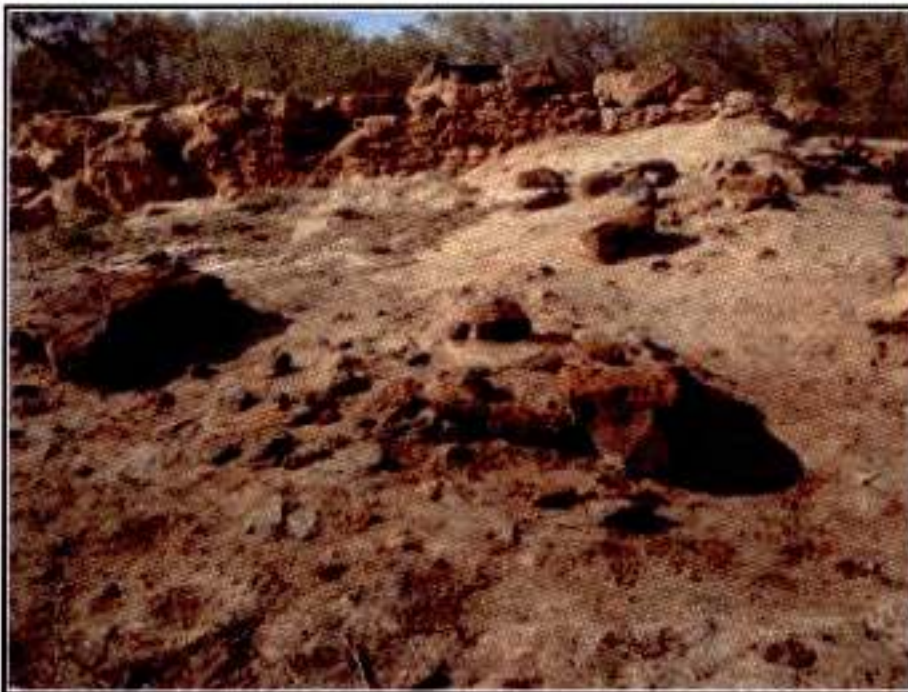
Figure 15. *Southeast corner of Room 1 showing doorway and northeast corner of room.*

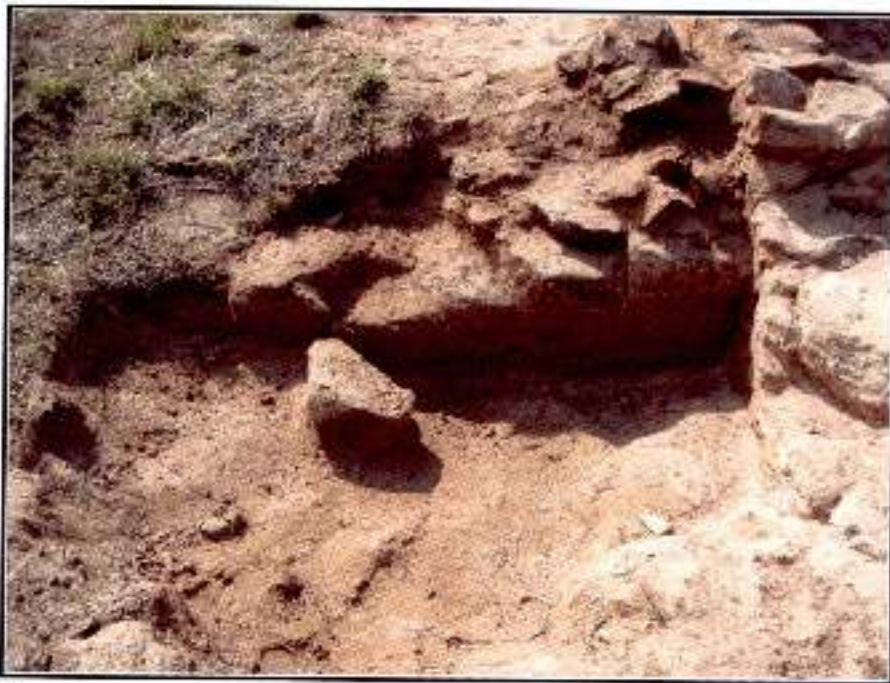
A small portion of the interior wall between Room 1 and 2 was uncovered. On the Room 1 side, the wall is at surface level. On the Room 2 side, the wall is approximately 50 cm in height. The map indicates that a larger portion exists, and that an opening appears between the two rooms (Figure 9). Removal of the sand did not reveal the opening, and only the eastern façade of the wall was exposed in the northwest portion of Room 2 (Figure 16). The wall appears to abut the north wall, and is not joined. Also, the interior wall appears to have been built using a different construction technique than the north wall. Soil covered portions of the top of the wall, and the entire western façade.

Figure 16. *The eastern façade of the northern portion of the wall dividing Rooms 1 and 2, facing west.*

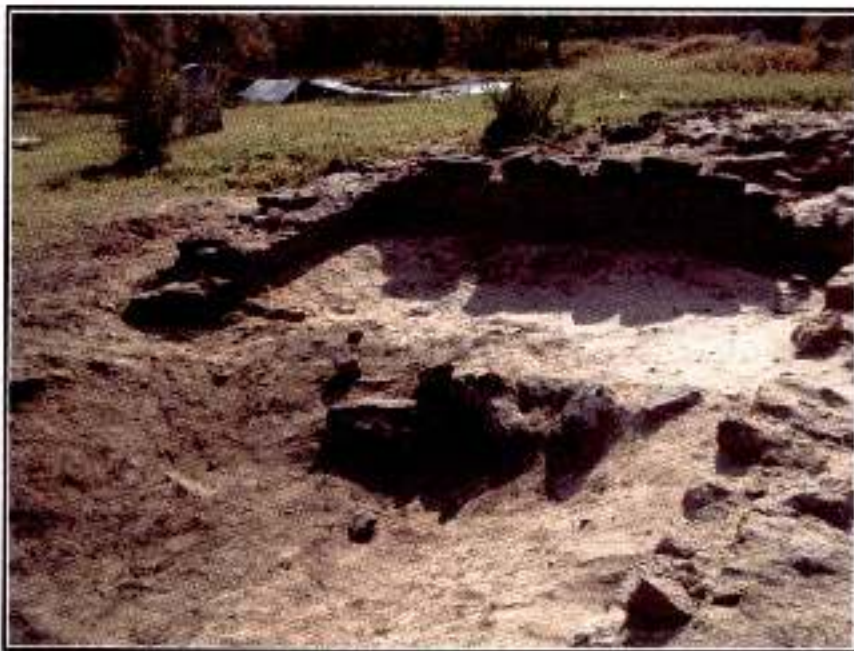
The sand layer that was removed in Room 3 decreased in thickness toward the east across the room. The area along the western wall of the room appeared to have the most sand. The west wall measured between 37 and 58 cm in height along the interior of Room 3 (Figure 17).

Figure 17. *View of Room 3 showing west and south walls, facing southwest.*

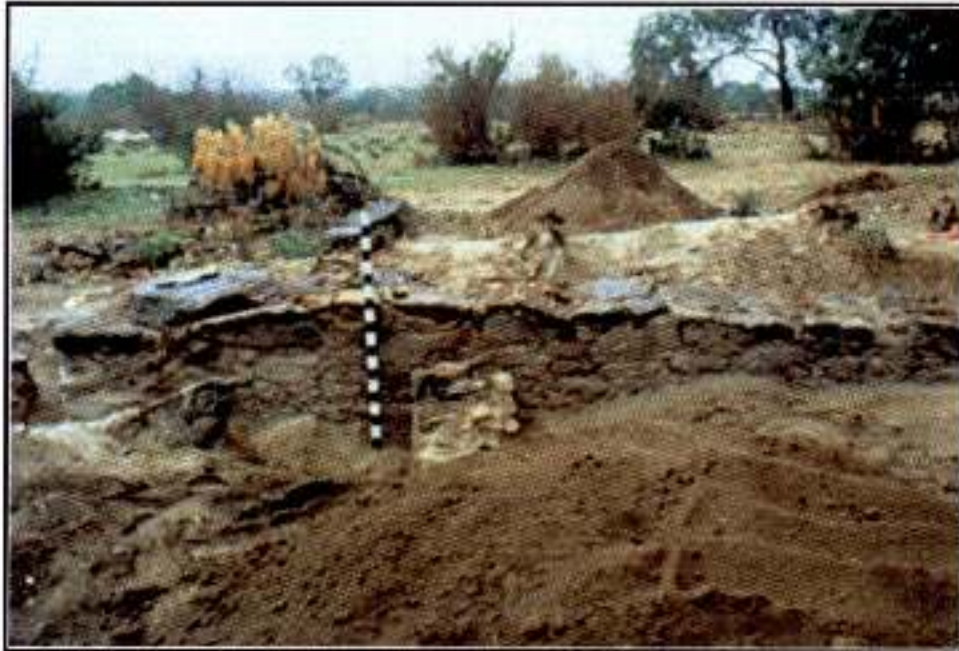
More of the fill from the interior of Room 3 was removed to east, and another protrusion was located. This one could be the same one in the 1985 photograph, although there is less height to the wall at present (Figure 18). This is likely due to the backfilling, or screening within the room during the 1980s excavations. The majority of the south wall of Room 3 is several centimeters in height at present. Due to the amount of fill from screening in the 1980s, it is difficult to determine exactly which protrusion is the one that was depicted in the map of the complex.

Figure 18. *The south wall of Rooms 3 and 4 showing the protrusion that could possibly be the division of the two rooms.*

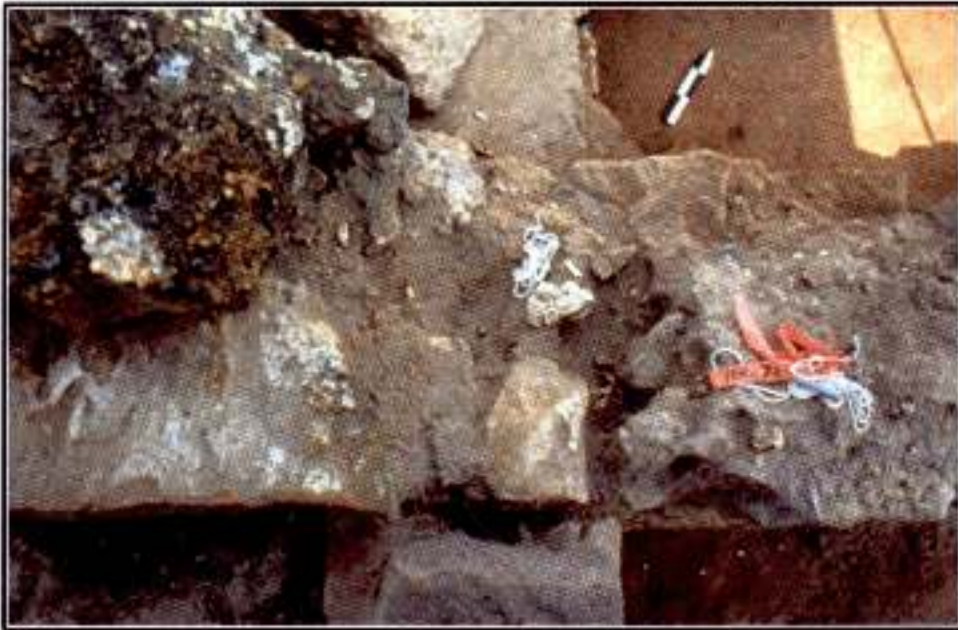
The largest quantity of sand removed was from the north side of the north wall. Removal work initially began at the furthest west portion of the wall, but after approximately 3 meters was exposed, the section north of Room 2 was removed. As the sand was removed from north of the north wall, it was evident that there was a lot of wall fall present. Comparison of the 1980s photographs to the current view found that much of the wall fall in certain areas has not changed. One photograph did reveal that a few stones moved over the years in the vicinity of the junction of the wall between Rooms 2 and 3 and the north wall (Figure 19).

Figure 19. View of the intersection of the interior wall for Rooms 2 and 3 and the North wall. The conglomerate stone on top was found north of the wall when the sand was removed during this project.

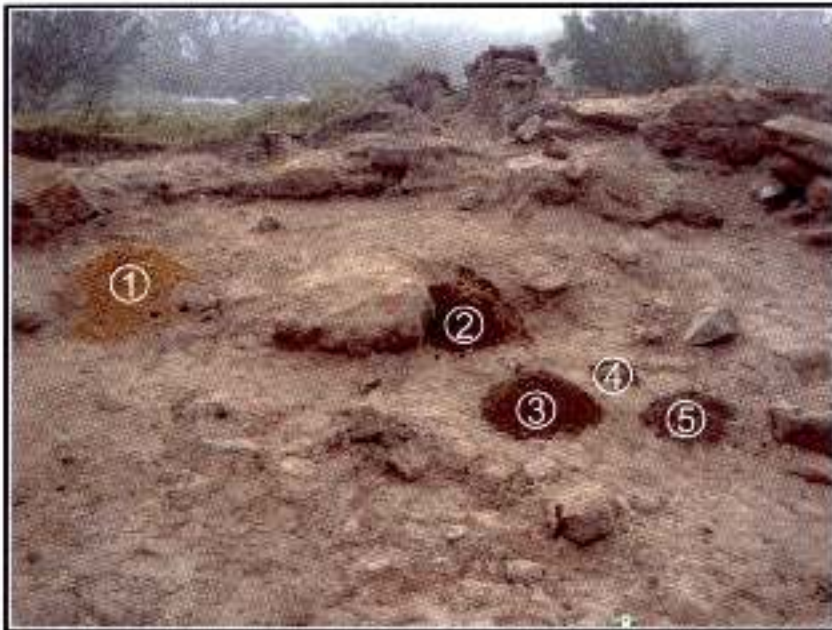
As the sand was removed from north of the north wall of Rooms 2 and 3, archaeologists encountered a series of rodent tunnels. In a few areas, rodent "beds" were removed consisting of tunnels filled with grasses and/or roots. On several occasions when archaeologists returned to the site, mounds of soil had been pushed up by rodents. On one occasion, 5 rodent mounds were produced between visits to the site (Figure 20). One of the mounds consisted of pure yellow commercial grade sand (Rodent Mound 1). It was the first time that this yellow sand was noted along the wall. Further investigations showed that rodents had been pushing the sand out of the backfilled units located within Room 3. The matrix seen in the four other mounds appeared to consist of sandy clay that was very similar to the natural soil at the site. Three rodent soil mounds produced animal bones. These artifacts were collected and returned to the CAR laboratory.

Figure 20. *Mounds of dirt pushed up by rodents that appeared during the course of the removal of sand. On this day five mounds were created, producing artifacts in a few of them.*

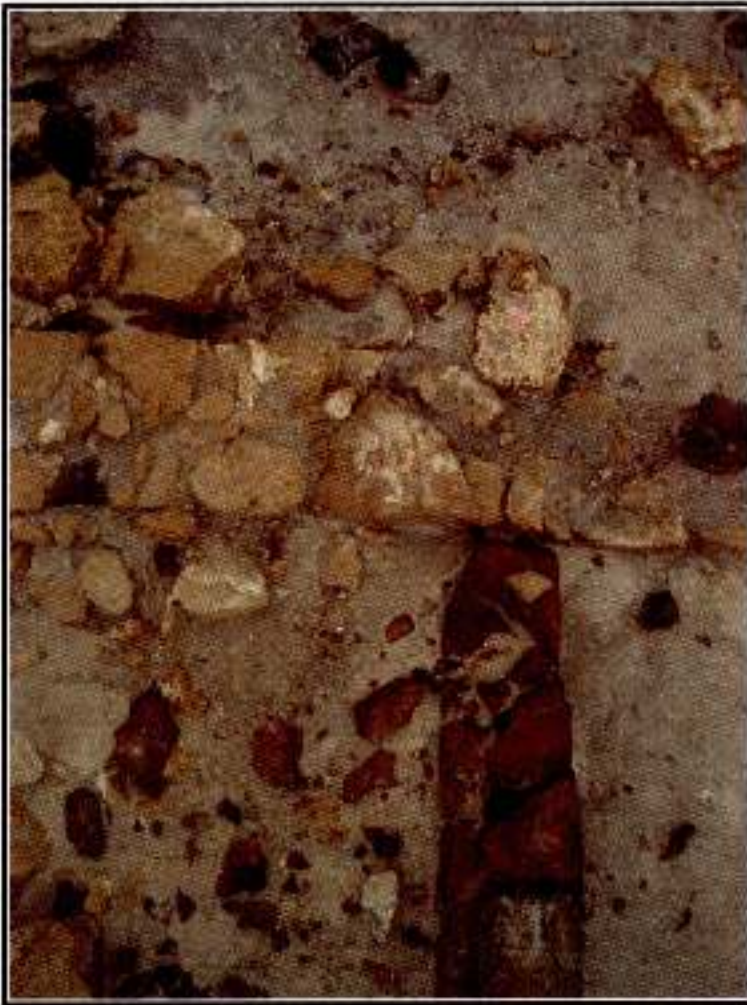
The walls were constructed using large sandstone slabs and smaller irregular stones employed as chinking. Given the obvious rectangular shape of many of the building stones, it is likely that some of them were quarried and possibly also shaped before incorporating them in the walls of the Rancho. In general, the outer walls were 80-85 cm in maximum thickness (Figure 21) and there was no particular patterning regarding the placement of small or large stones along the tops or bottoms of the walls. As mentioned above, the tallest surviving but partial outer wall remnant was 1.35 meters high. Inner dividing walls appeared to be slightly narrower (75-80 cm) than outer walls.

Viewing the walls immediately after they were uncovered gives the appearance that the wall stones were held in place by mortar. However, the sand surrounding the individual rocks is loose and most likely represents fill sand rather than decomposing mortar. Cleaning of the wall revealed that small amounts of clay matrix or perhaps mortar, was left between the stones. However, it is difficult to determine whether this matrix represents the remnants of mortar or clay that has leached from the sandy fill.

Figure 21. Intersection of the cross-wall between Rooms 2 and 3 and the south wall of the rooms.

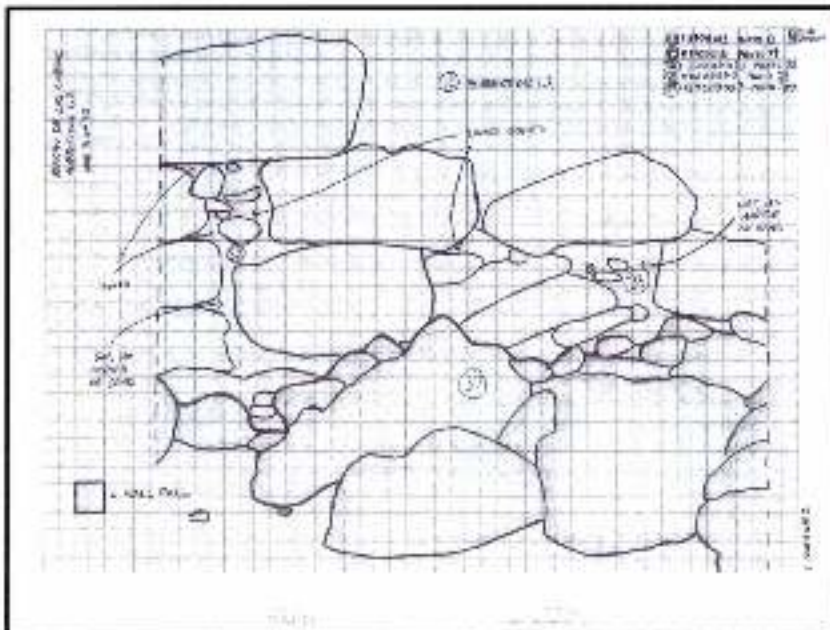
After the sand covering the walls and rooms was removed, the walls were documented using a documentation protocol developed for the SAMNIIP for Mission Espada. Specifically, the walls were divided into sections. Detailed drawings were made of each section, specifically noting any anomalies (Figure 22). Next, digital photographs of the wall sections were taken to add to the drawings (Figure 23).

Figure 22. Sketch of a segment of the north wall of Room 1.

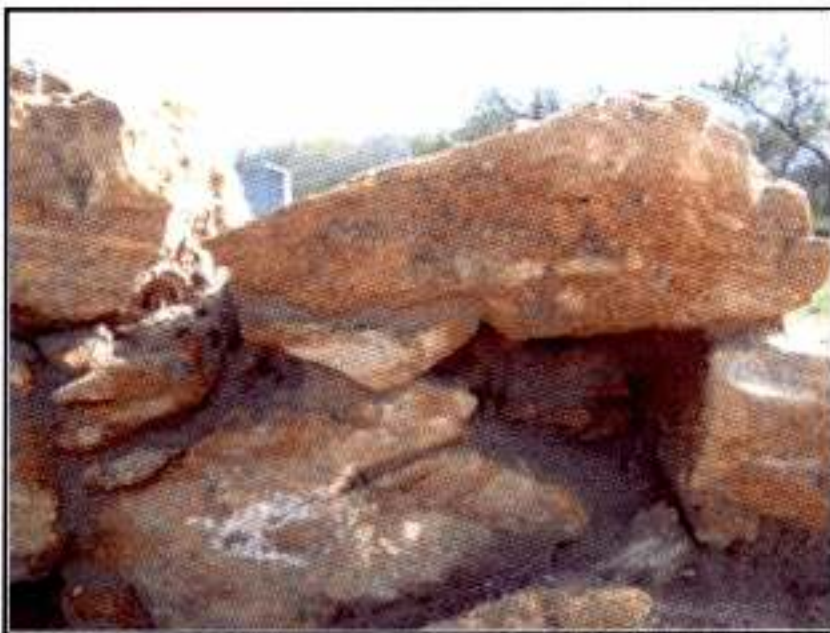
Figure 23. Detail of a portion of the sketched wall shown in previous figure.

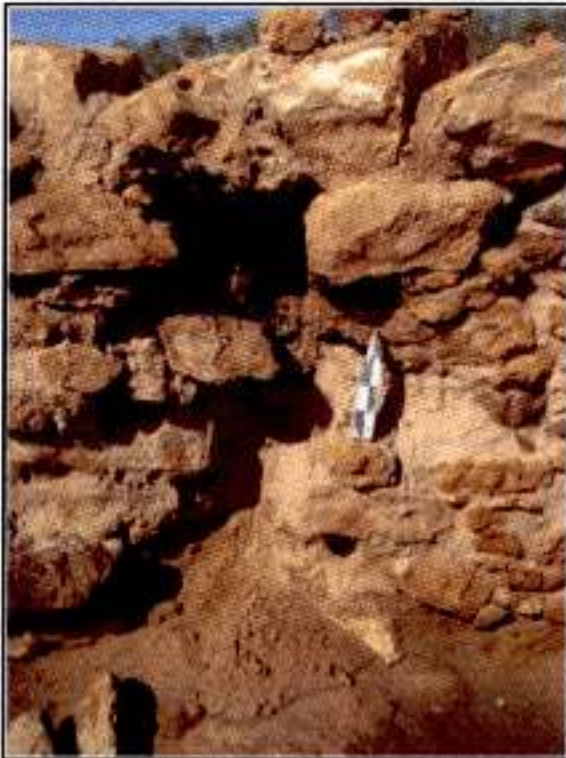
During late October and early November several strong rainstorms passed through the Floresville and San Antonio region. During subsequent visit to the site following the storms, it was noted that the sand was washing out of the unprotected walls. The loss of sand and some chinking stones from between the stacked stones appeared to greatly destabilize segments of the wall (Figure 24). The north wall of Room 1 suffered the most deterioration as water seemed to rush through the interior of the room and around the wall to the north.

Figure 24. Sand washed out from between the building stones along the north wall of Room 1.

To prevent further damage and in agreement with the staff of the San Antonio Missions National Historical Park it was decided to rebury the walls. A fine-grained, sterile sand was selected as the covering. To prevent the sand from coming in direct contact with the walls, a water permeable geo-textile, Mirafi® 180N, was selected as a cover.

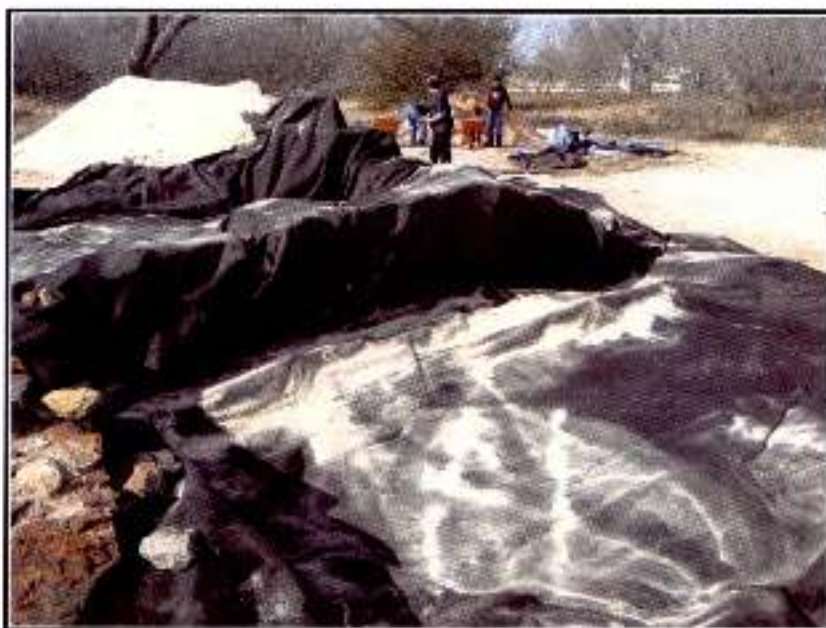
Figure 25. Geo-textile pulled over the cross-wall of Rooms 2 and 3 prior to being covered with sand, facing northwest.

Mirafi® 180N is a nonwoven geo-textile that is composed of polypropylene fibers that are water permeable, but will not allow the sand to pass through the barrier. The geo-textile comes in a roll measuring 4.5 meters in width and 91 meters in length. Sheets were cut from the roll to cover sections of the rooms from the north to south. Each sheet was over-lapped approximately 30-40 cm. The geo-textile was fitted over the walls and in between the crevices of the wall fall so that the sand could fill all voids (Figure 25). In the section of the wall that was subjected to the most deterioration while exposed, a section of geo-textile was placed against the wall and sandstone rocks (from a pile formed over the years of discarded stone) were placed in the void to buttress the wall segment. These rocks were again covered with geo-textile before being covered in sand.

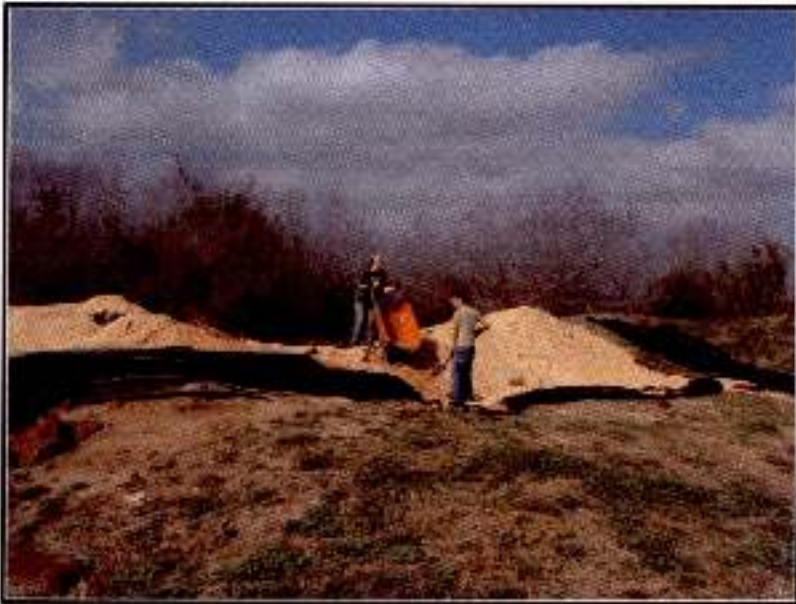
Figure 26. *Backfilling with sand using shovels and wheelbarrows.*

The sand used was a fine-grained version referred to as “washed sand” by the supplier. The sand was brought to the site in 12 ton loads. A total of 120 tons of sand was used to cover the Rancho walls. The sand was placed on the walls by hand. Wheelbarrow-loads of sand were dumped in staging locations around the walls, and then shoveled into place (Figure 26).

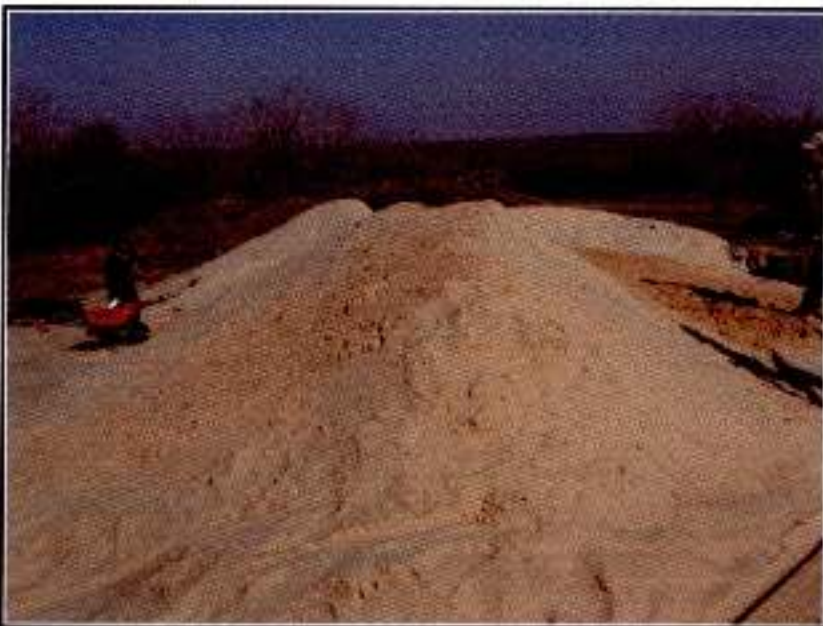
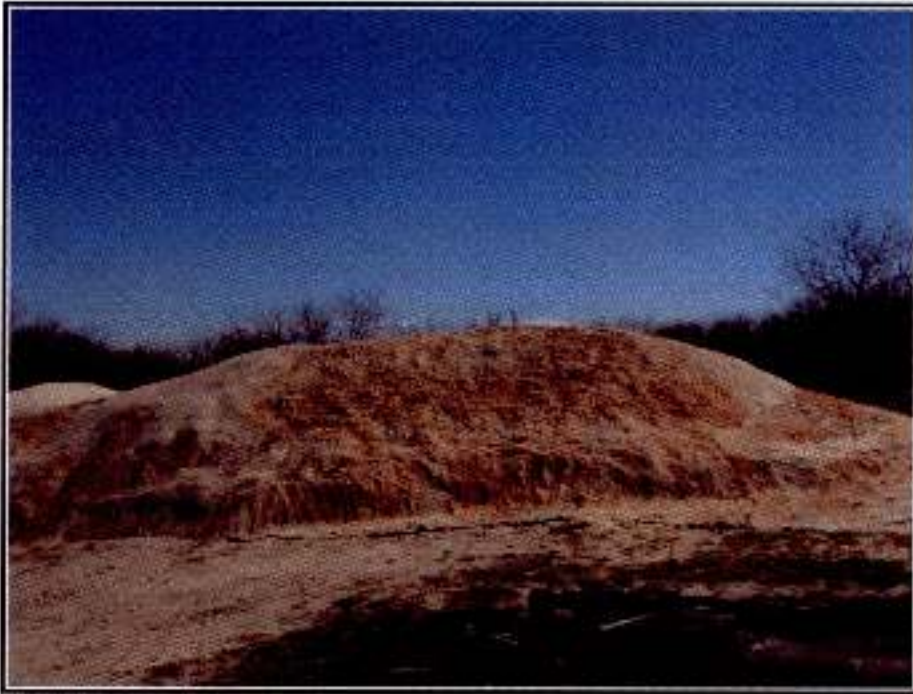
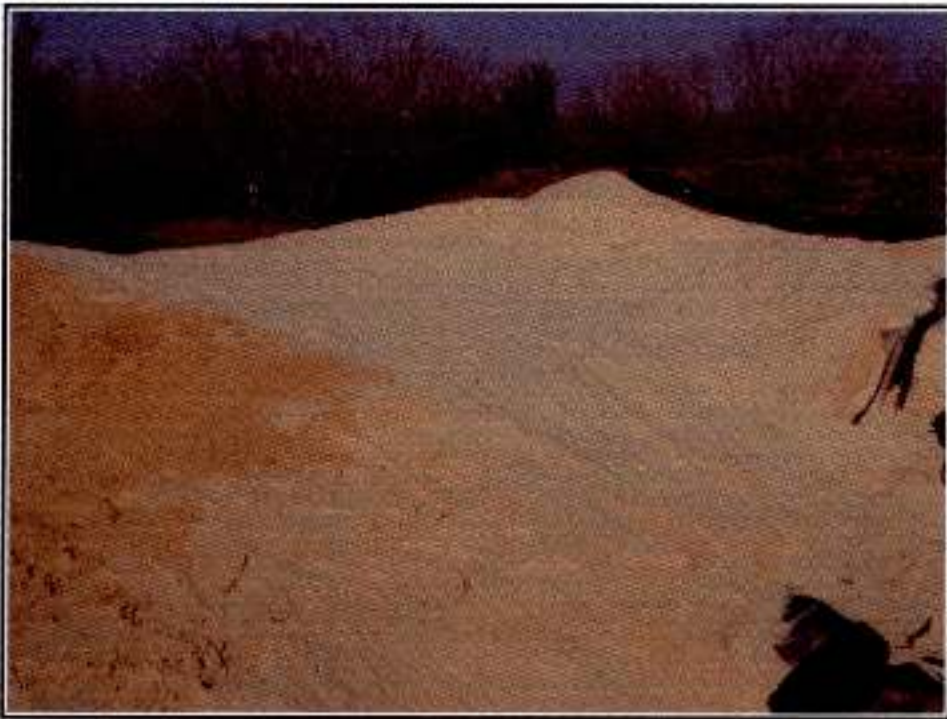
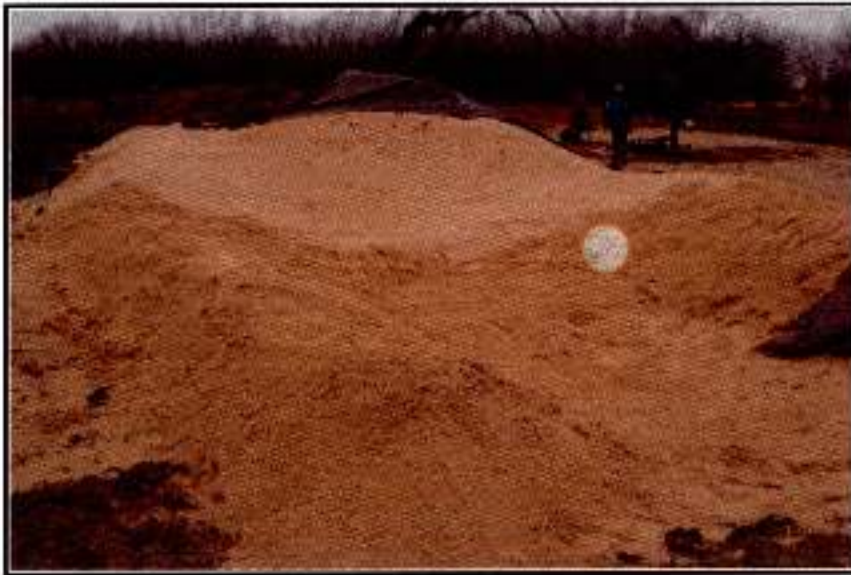
Figure 27. *Sand covering the north wall of Room 1, facing southeast.*

Figure 28. *Sand covering the northwest portion of the northern wall that was exposed, facing south.*

Figure 29. *Sand covering the interior of Room 2, facing northeast.*

Figure 30. *Sand covering the walls and interior of Room 3.*

The crew was instructed to maintain equal slopes on either side of the walls as they were being re-buried to ensure even pressure from the weight of the sand on the walls. Approximately one foot of sand was placed on the tops of walls and the wall fall surfaces within the rooms (Figures 27-30).

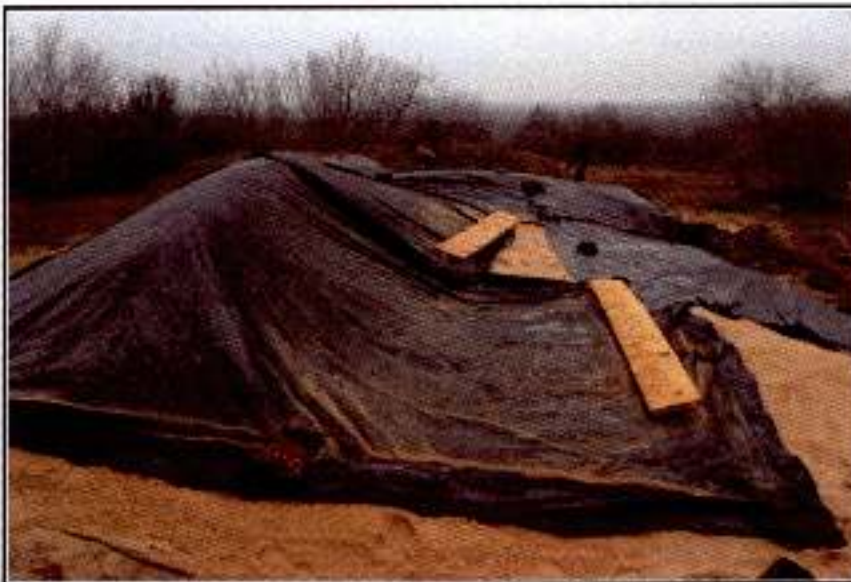
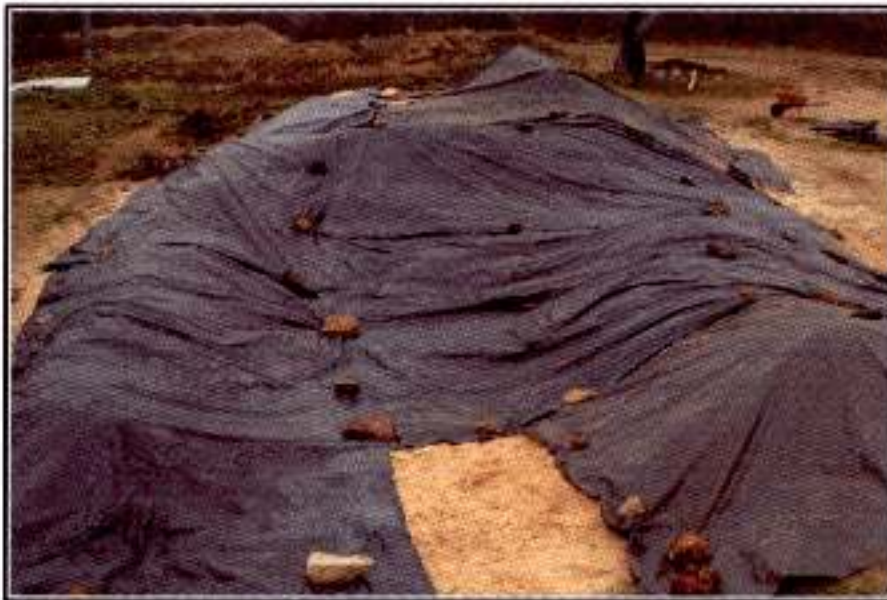
Figure 31. *The north wall of Room 1 covered with geo-textile after the completion of the project, facing east.*

Figure 32. *Overview of the rooms covered in black plastic and remaining geo-textile at the completion of the project, facing west.*

Once the walls were reburied, CAR archaeologists used all of the remaining geo-textile supplemented by 3 millimeter-thick black plastic to cover the sand to prevent it from washing or blowing away (Figure 31-32). This step was simply a preventative measure until an appropriate vegetative cover could be identified and placed on the mounds of sand by SAMNIP staff. It took approximately 15 days to recover the walls by hand.
