**Archaeological Investigations of Room 17,  
the Church at Mission San Juan Capistrano (41BX5),  
San Antonio, Bexar County, Texas**

Texas Antiquities Permit No. 5880

*Prepared by:*  
Center for Archaeological Research  
The University of Texas at San Antonio  
One UTSA Circle  
San Antonio, Texas 78249-1644  
Technical Report, No. 28

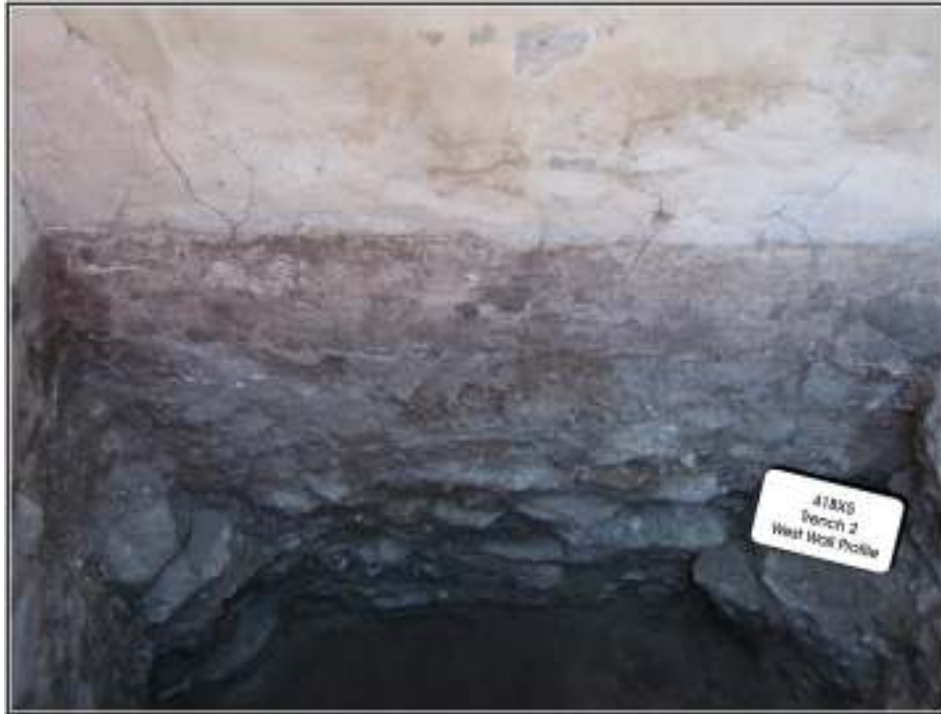
Figure 3. West wall of Trench 2 showing the wall and foundations exposed in the current re-opening of the trench.

Schuetz reported the base of the wall was located at 2.8 feet (.85 m) beneath the surface, and the base of the buttress was located at 3.5 feet (1.07 m) below the surface. The terminal depth of the current excavations found the base of the wall foundation to be at 4.49 feet (1.37 m) below surface in Trench 2 (Figures 3 and 4). Approximately 1.0 foot (30 cm) of topsoil covered the plaster on the wall. Below this level, foundation stones were not plastered. This is the depth where Schuetz's excavations may have begun.

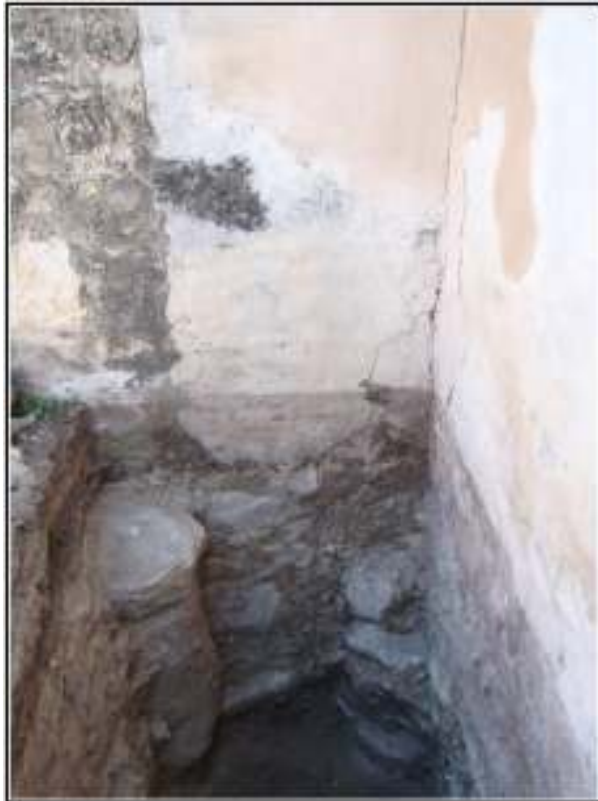
Figure 5. Overview of the south wall of Trench 2 showing the wall of the buttress and foundation.

The foundation of the stone and mortar buttress was found at 4.27 feet (1.30 mbs), but the concrete buttress support extended to 4.43 feet (1.35 mbs) (Figures 5 and 6).

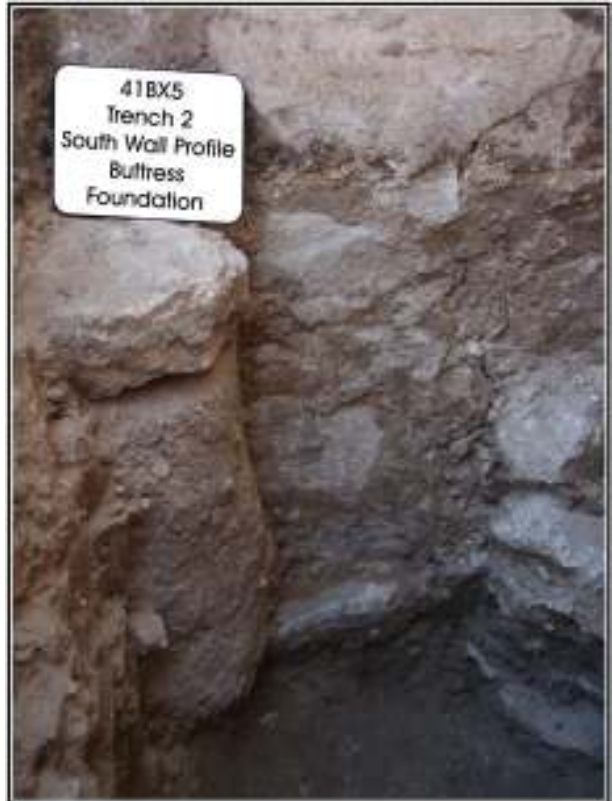
Figure 6. Detail of the south wall of Trench 2 showing the foundation.

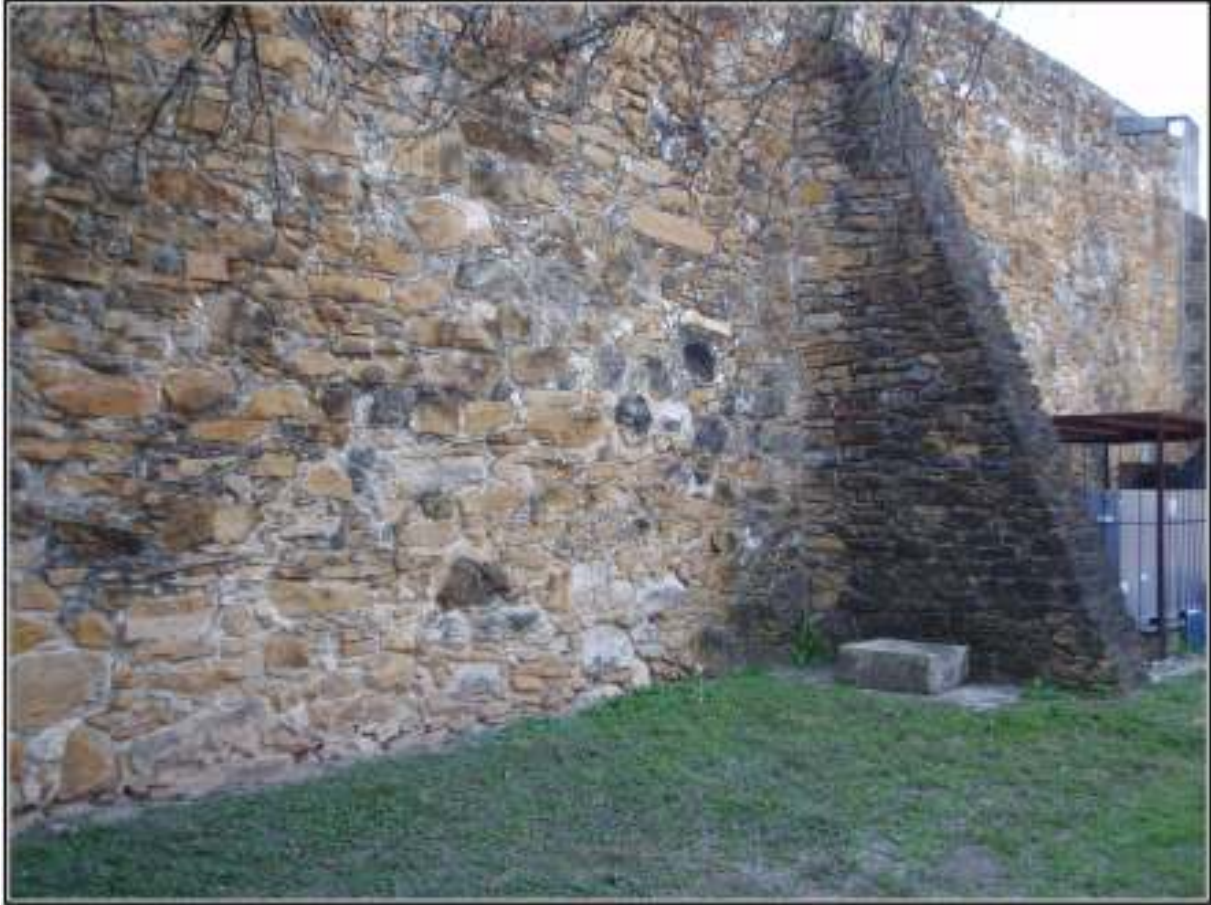
Trench 5 (see Figure 2) was located approximately 15.6 feet (4.75 m) south of the west wall window (Figure 8). Schuetz's trench was approximately 6.4 feet (1.9 m) long and 2.75 feet (.84 m) wide. Her excavation extended to approximately 4.2 feet (1.28 m) below the surface when sterile clay was encountered. CAR was unable to reopen the entire trench because a drainage feature was built on the southern end (Figures 8-9). The dimensions CAR was able to reopen were 4.4-x-2.46 feet (1.3-x-.75 m).

*Figure 8. Western wall of church showing the location of Trench 5 and the stone drainage feature obstructing the southern part of Trench 5.*

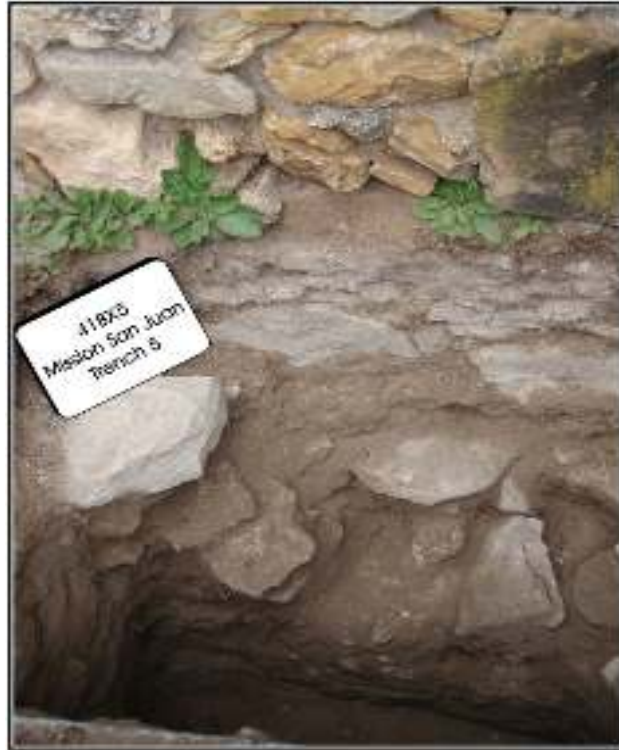
Figure 10. Trench 5 view of foundation and electrical cable (lower left corner).

The excavations in Trench 5 of the west wall revealed a stone foundation built out from the wall (at .45-.55 m) down to approximately 2.26 feet (.80 mbs) (Figure 9). These stones were left in situ while the western portion of the unit was excavated to the bottom of the trench (Figure 10). The profile revealed poured concrete below the stone (at .87-1.3 mbs) as described by Schuetz (1968a:145) which is present to the base of the excavation at approximately 4.27 feet (1.30 mbs) (Figures 10-11). An electrical cable also crosses through the trench.
